Broken Hill Public Art Condition Survey and Conservation Plan

Prepared for: Broken Hill City Council
Submission Date: February 2023

This report presents the results of a condition survey assessing the works held within Broken Hill City Council's public art collection. A total of 56 works were condition assessed.

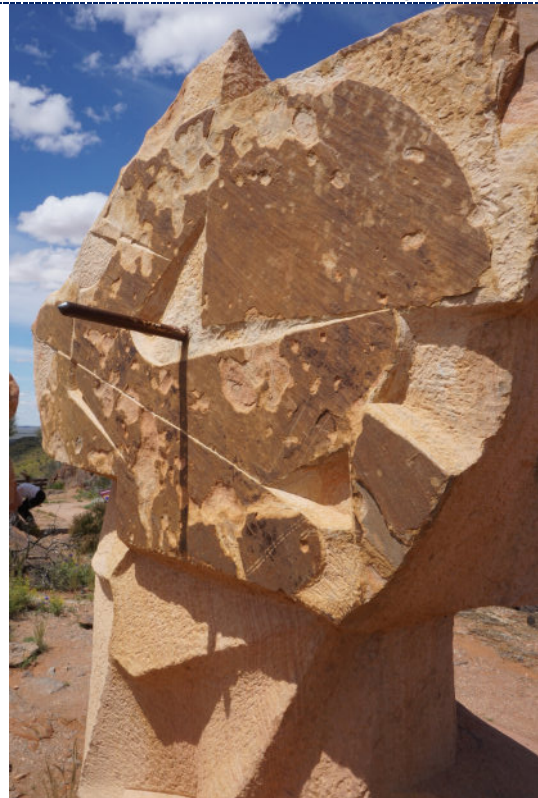
Figure 14: Details – surface abrasions and delamination.

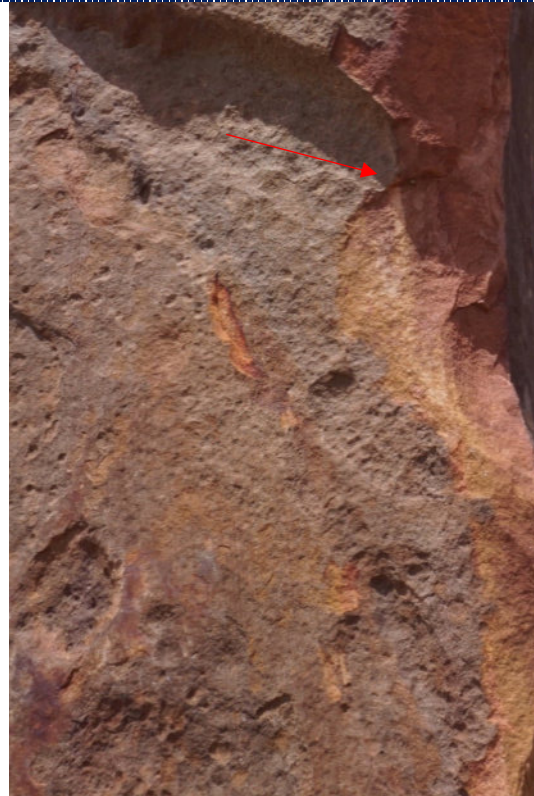
Figure 20: Detail – Surface delamination.

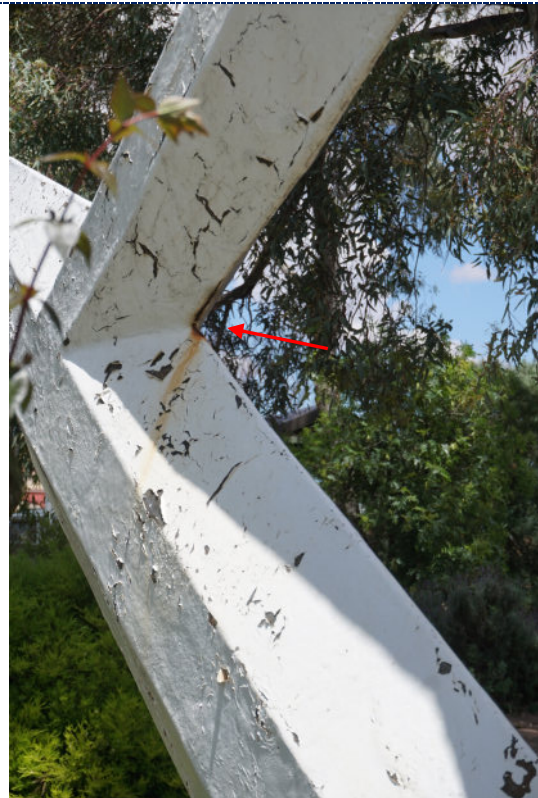
Figure 12: Detail – dirt particulate and significant surface paint loss and crazing; iron corrosion product staining (arrow).

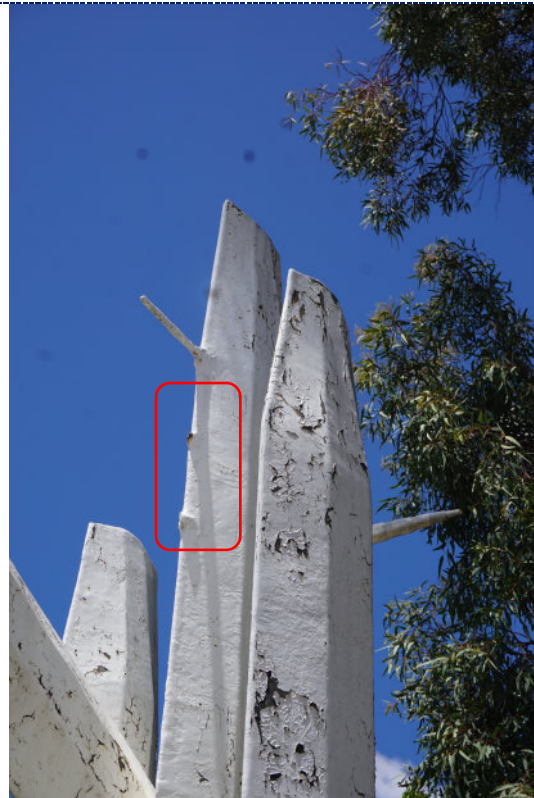
Figure 18: Detail – dirt particulate and significant surface paint loss and crazing; missing spikes.

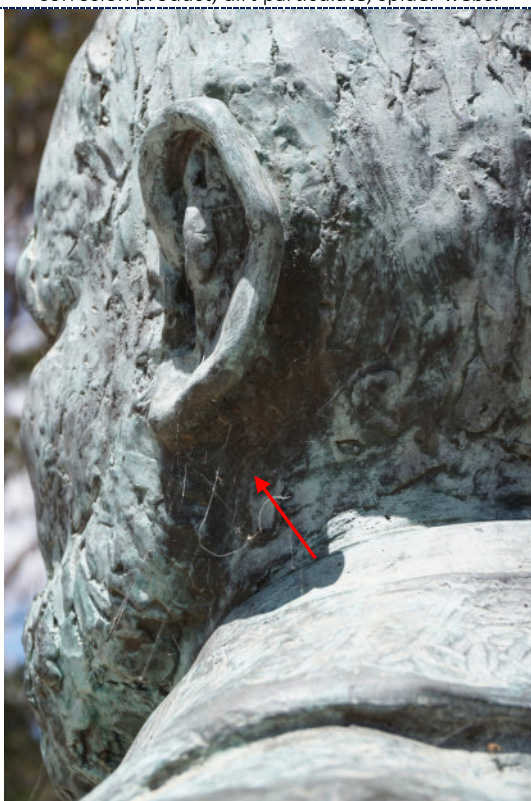
Figure 11: Detail – atmospheric pollution-driven copper corrosion product, dirt particulate, spider webs.

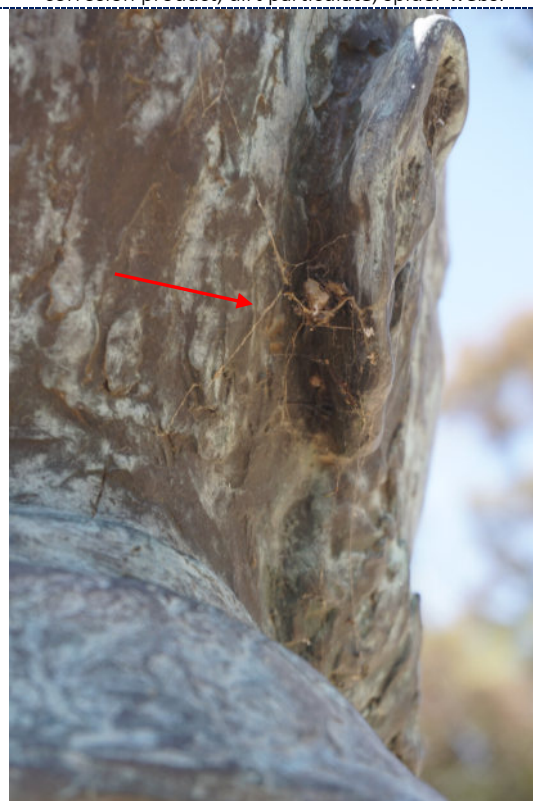
Figure 12: Detail – atmospheric pollution-driven copper corrosion product, dirt particulate, spider webs.

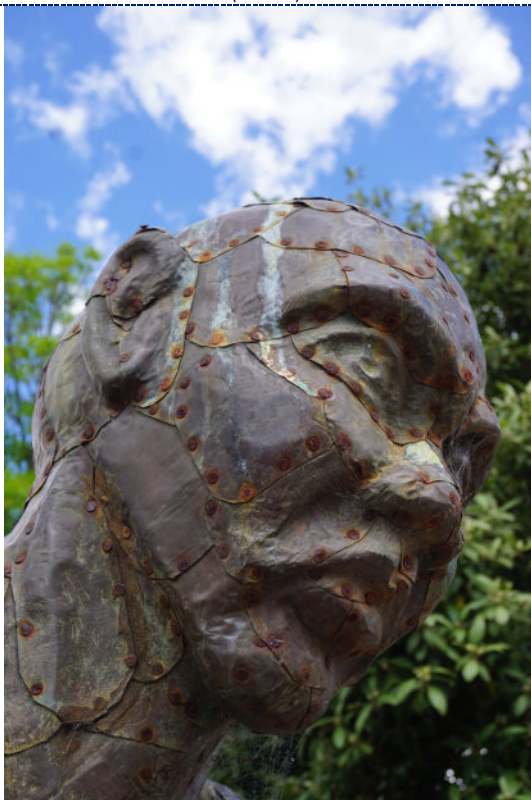
Figure 9: Detail – exterior, surface corrosion products stemming from bird excrement; corroded iron nail heads.

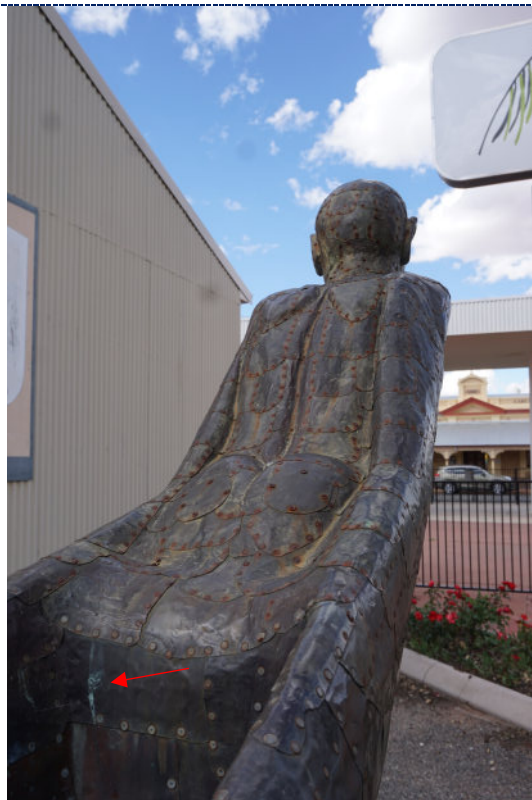
Figure 10: Detail – interior, dirt particulate, isolated surface corrosion products; corroded iron vs zinc plated nail heads; bird excrement (arrow).

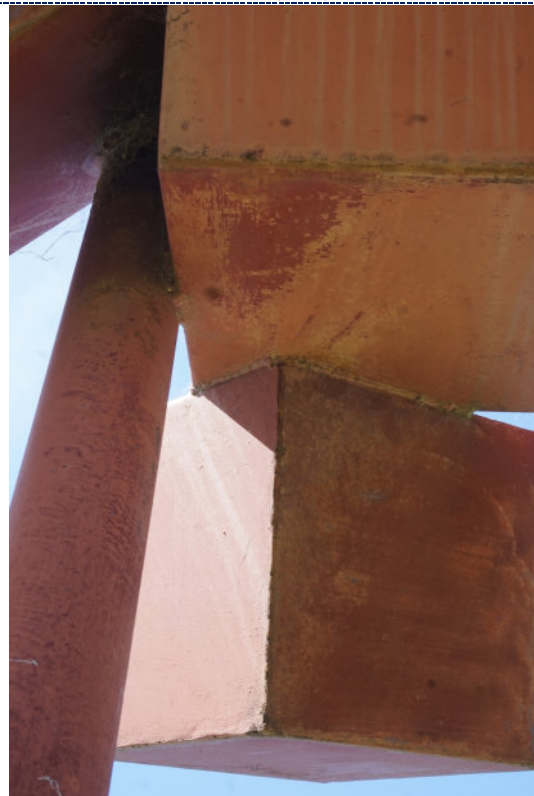
Figure 16: Detail – paint chalking, flaking paint loss; spotted surface corrosion.

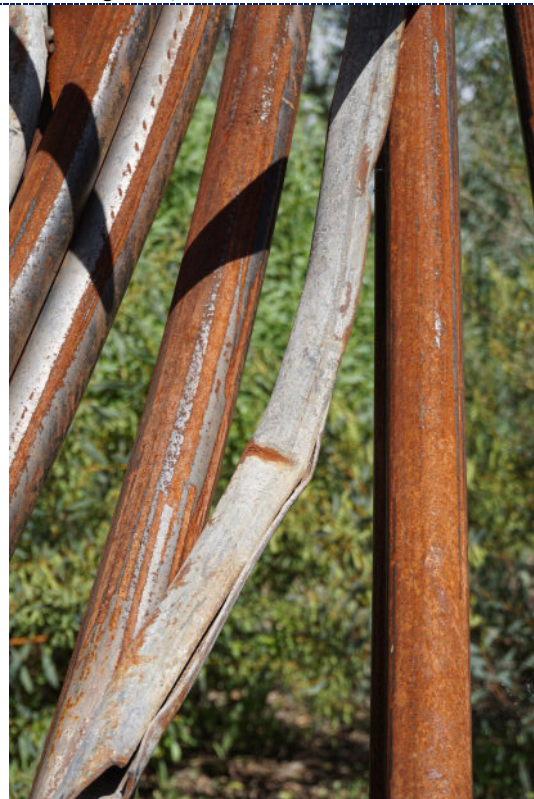
Figure 10: Detail – dirt particulate; surface corrosion.

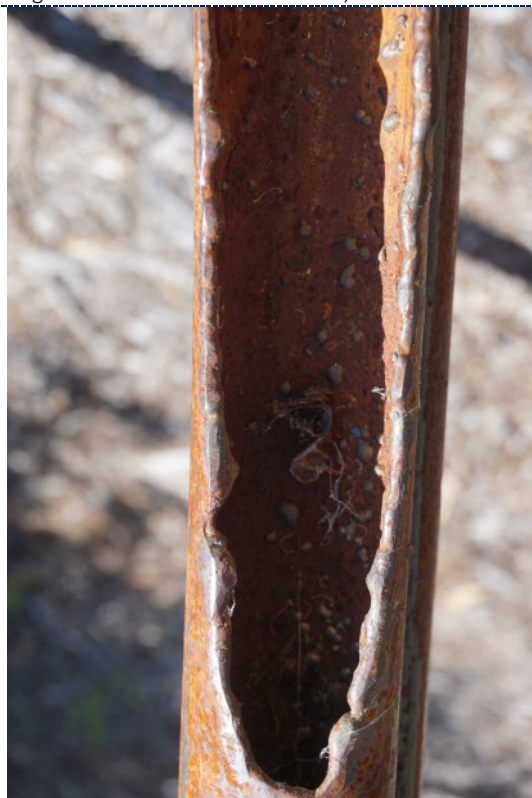
Figure 14: Detail – spider webs; surface corrosion.

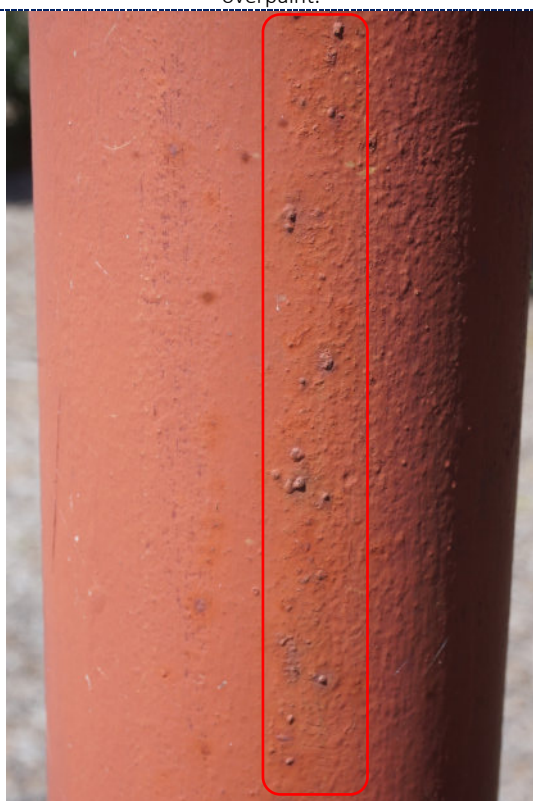
Figure 7: Detail – paint chalking, blister corrosion with flaking paint.

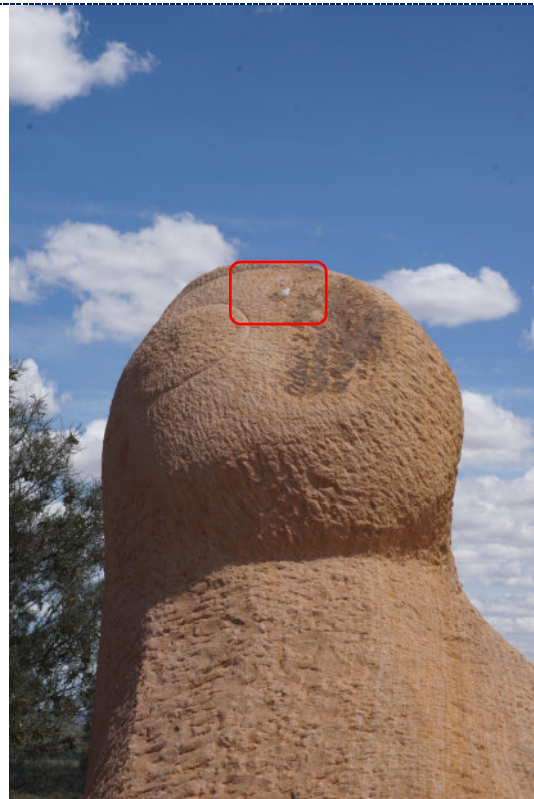
Figure 12: Detail – white accretion, likely bird excrement.

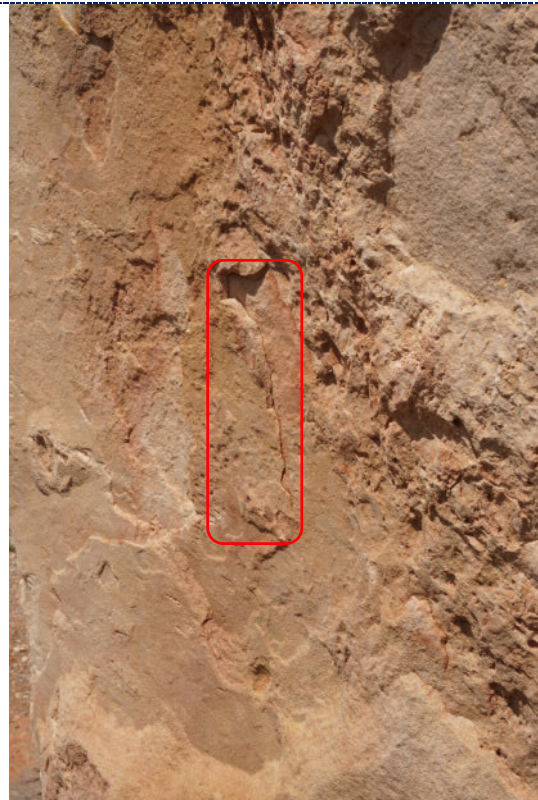
Figure 8: Detail – stone delamination and small vertical crack.

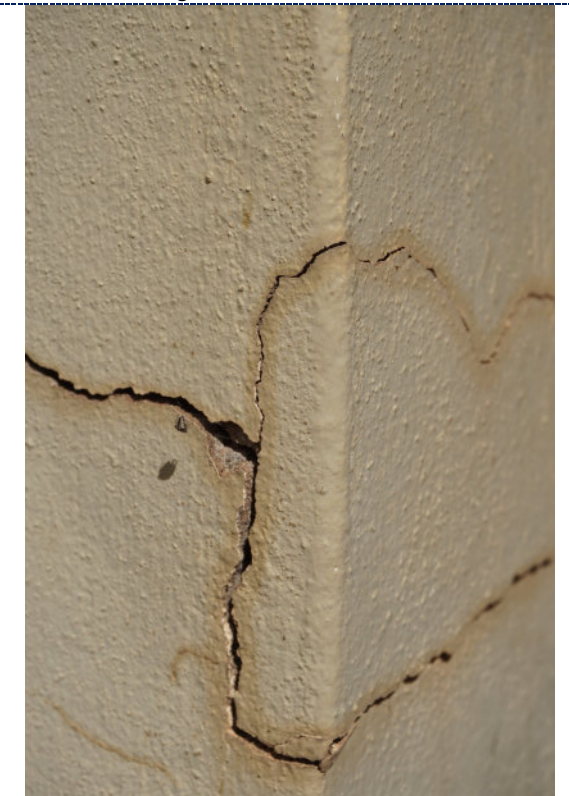
Figure 11: Detail – surface cracks and deformation to the mortar; chalking (UV degradation) and fading of the paint; staining to the exterior of the cracks; small losses.

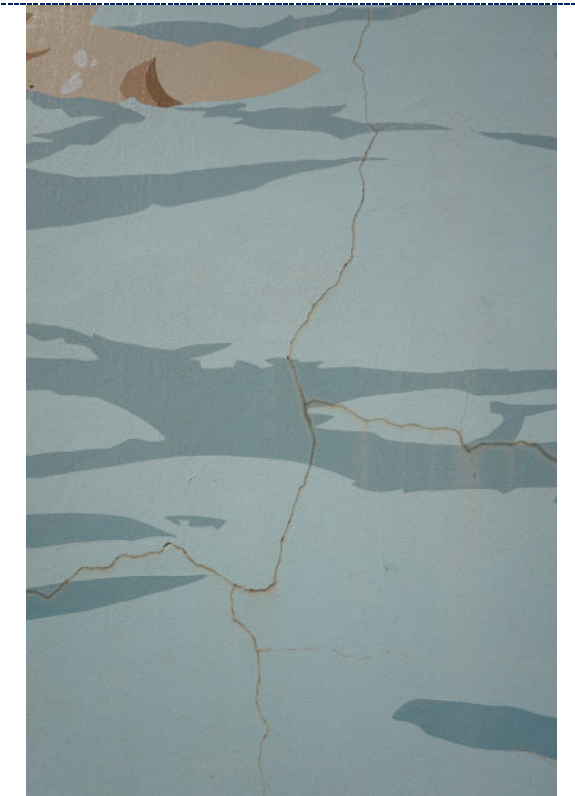
Figure 12: Detail – surface cracks and deformation to the mortar; chalking (UV degradation) and fading of the paint; staining to the exterior of the cracks.

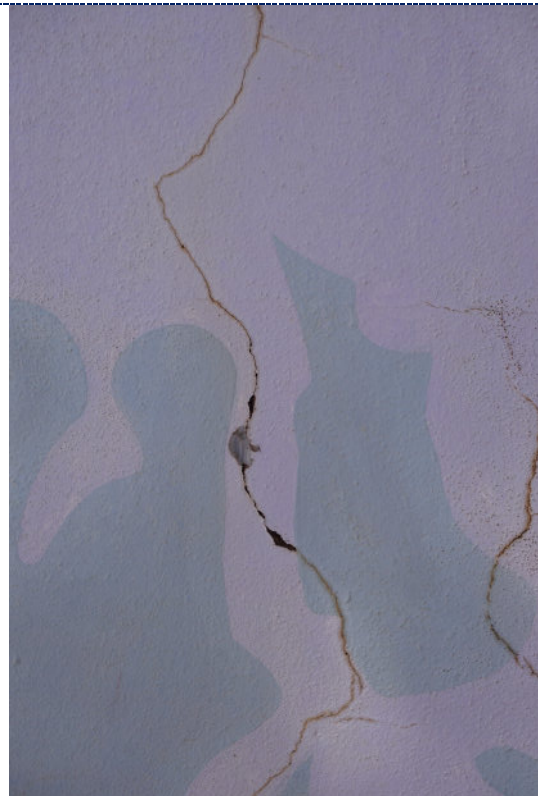
Figure 16: Detail – surface cracks and deformation to the mortar; chalking (UV degradation) and fading of the paint; staining to the exterior of the cracks; small losses.

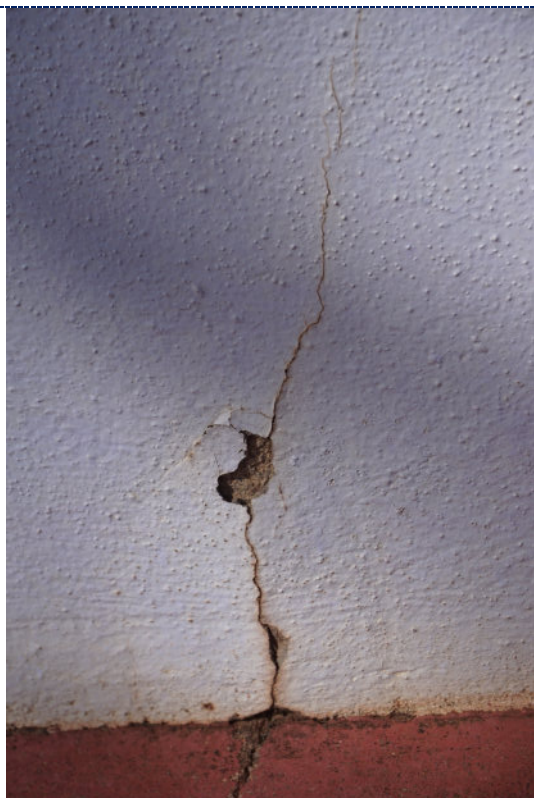
Figure 17: Detail – surface cracks and deformation to the mortar; chalking (UV degradation) and fading of the paint; staining to the exterior of the cracks; small losses.

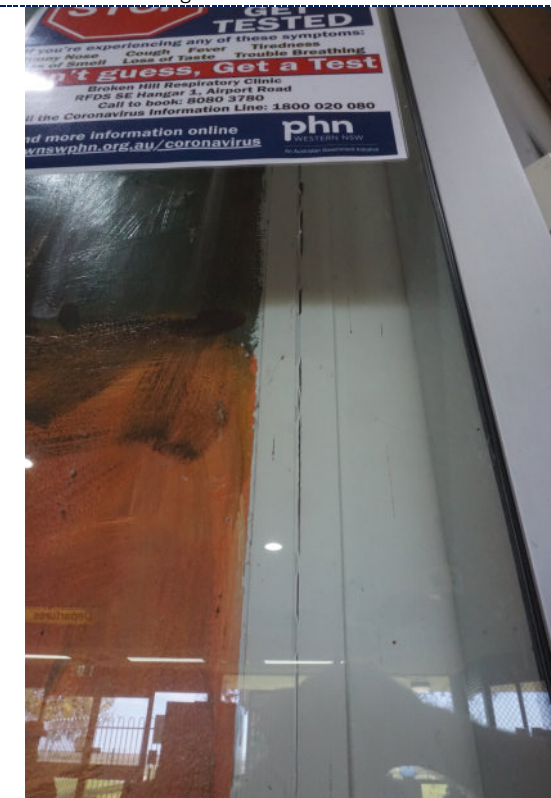
Figure 3: Section 1 – surface cracks.

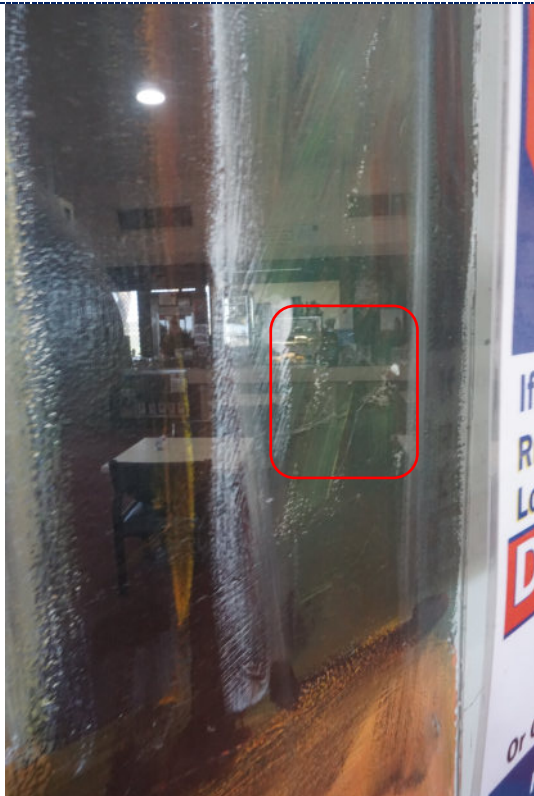
Figure 5: Section 1 – Detail – surface cracks with loss.

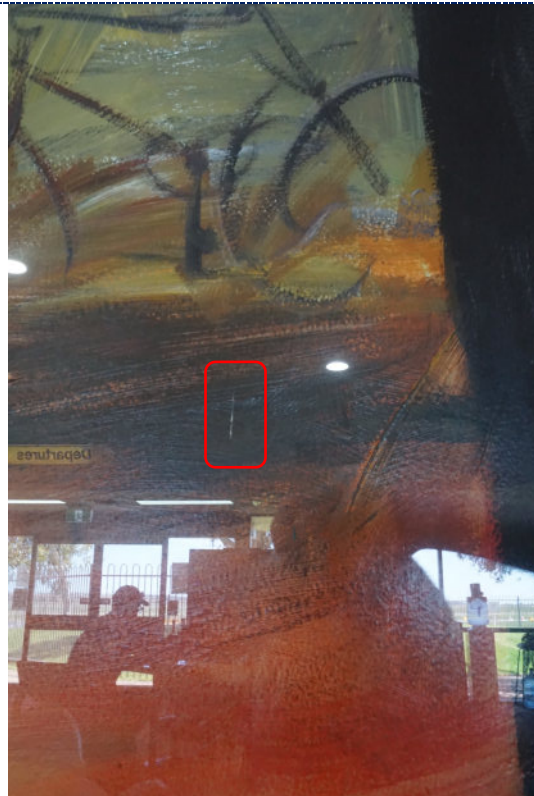
Figure 6: Section 1 – Detail – white surface accretion.

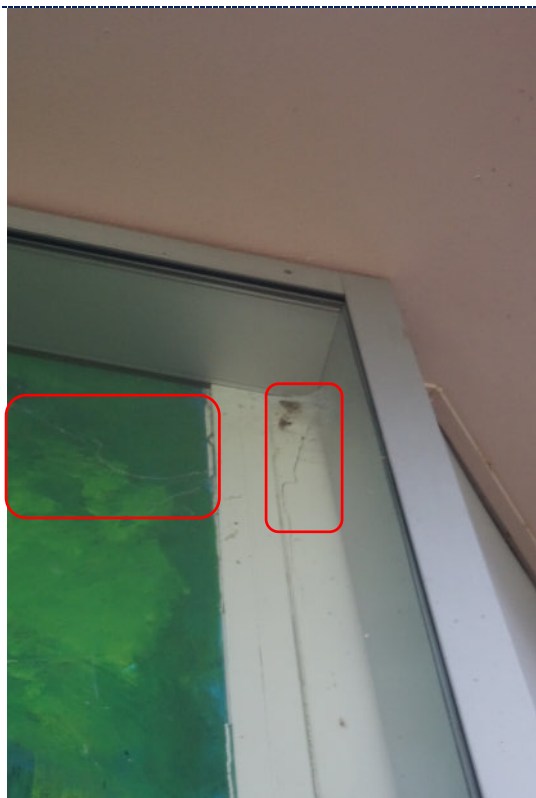
Figure 9: Section 1 – Detail – surface cracks and spider webbing.

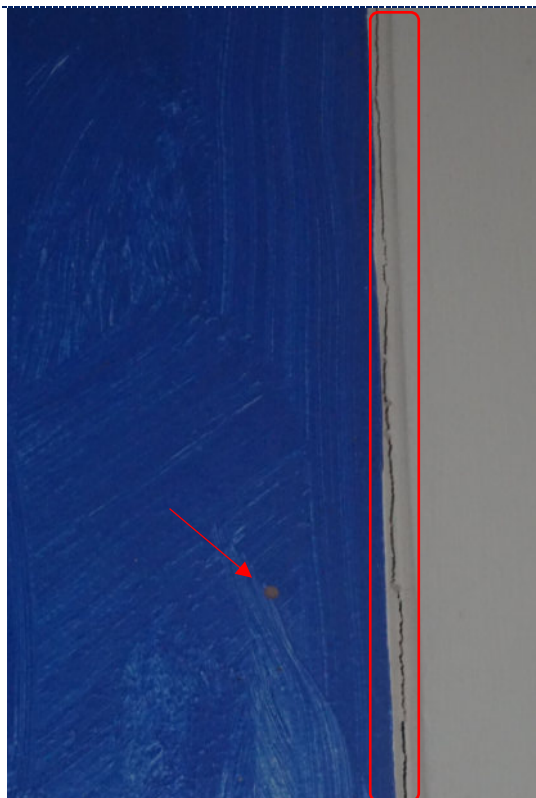
Figure 35: Section 3 – Detail – surface accretion and elongated crack.

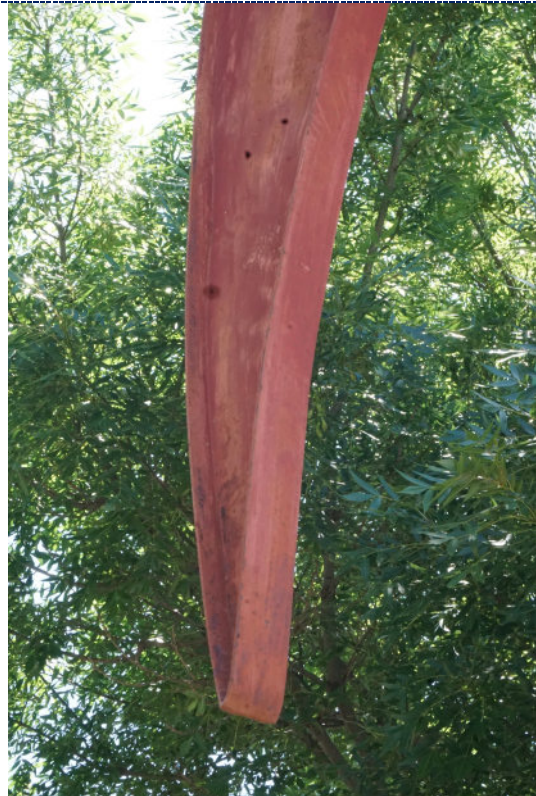
Figure 8: Detail – chalking paint, flaking paint loss, abrasions and corrosion; overpaint.

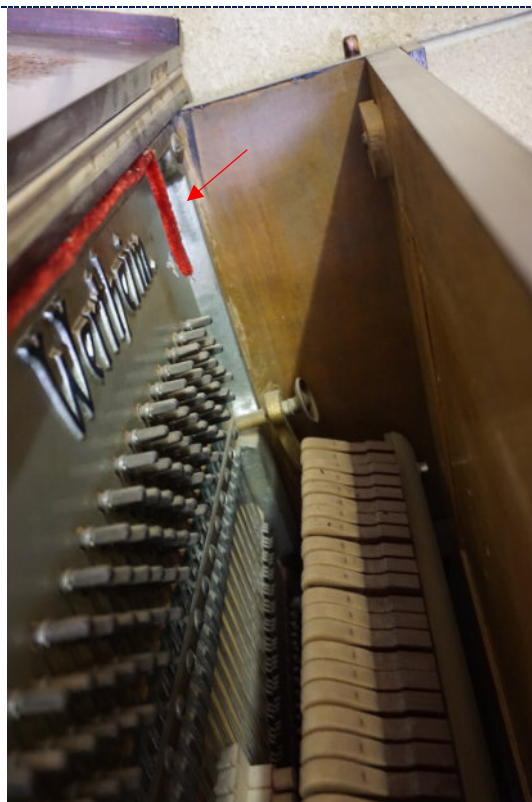
Figure 10: Detail – dirt particulate; loose-hanging felt.

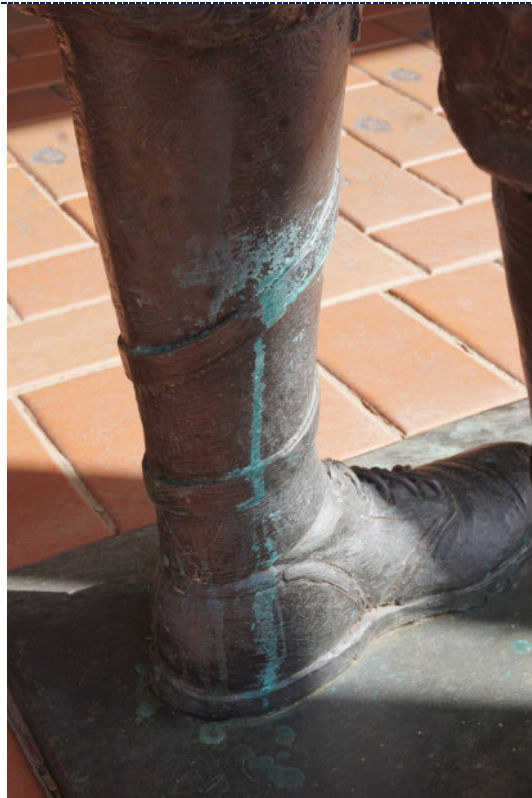
Figure 6: Detail – dirt particulate; corrosion product appearing to stem from acidic dog urine.

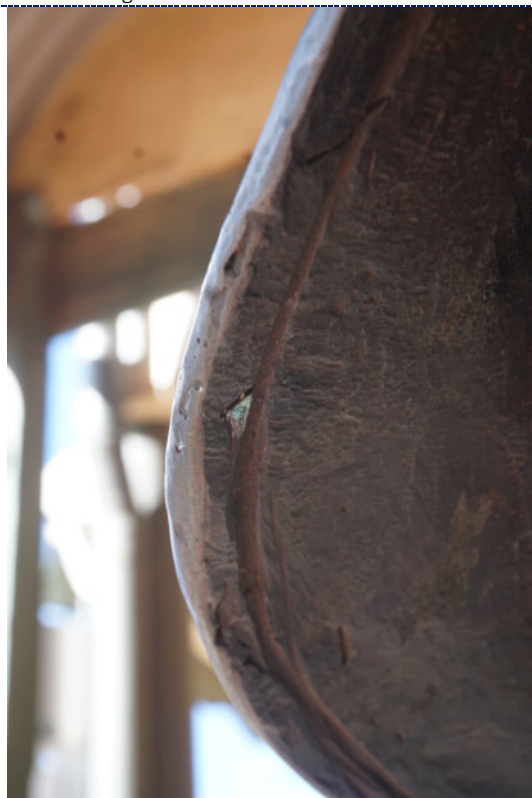
Figure 14: Detail – corrosion product inside small casting defect.

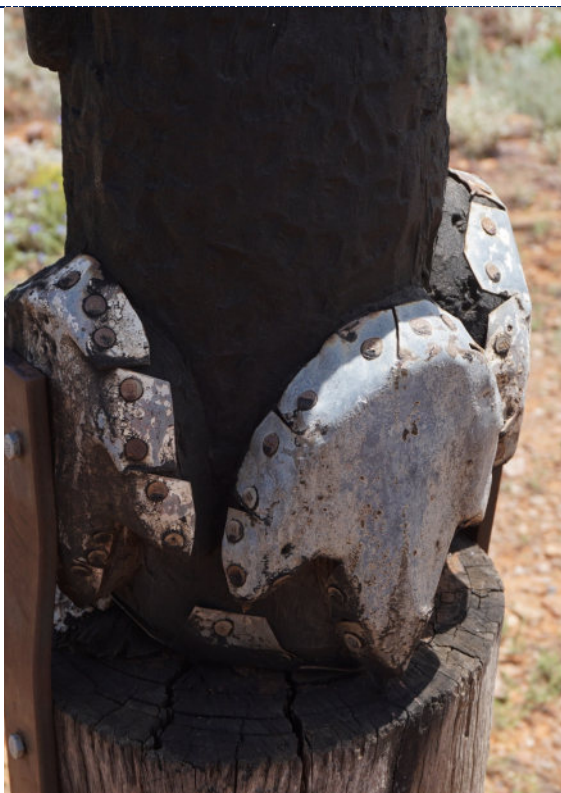
Figure 43: Detail – Pole 6, exterior, UV degradation (darkening) to wood surface, chemical degradation of the spherical metal components, including the presence of pitting and iron corrosion products on the iron nails.

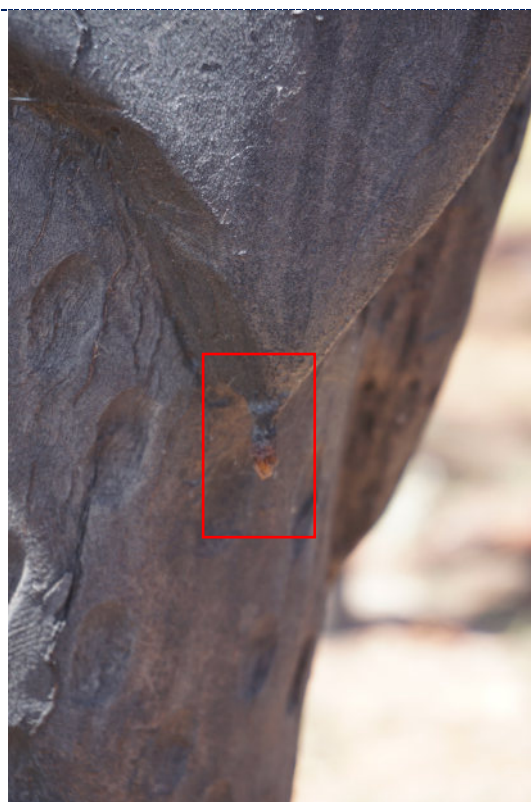
Detail 50: Detail – Pole 7, exterior, UV degradation (darkening) to wood surface, sap-like deposits (accretions) along the lower edge of the pole (highlighted in red).

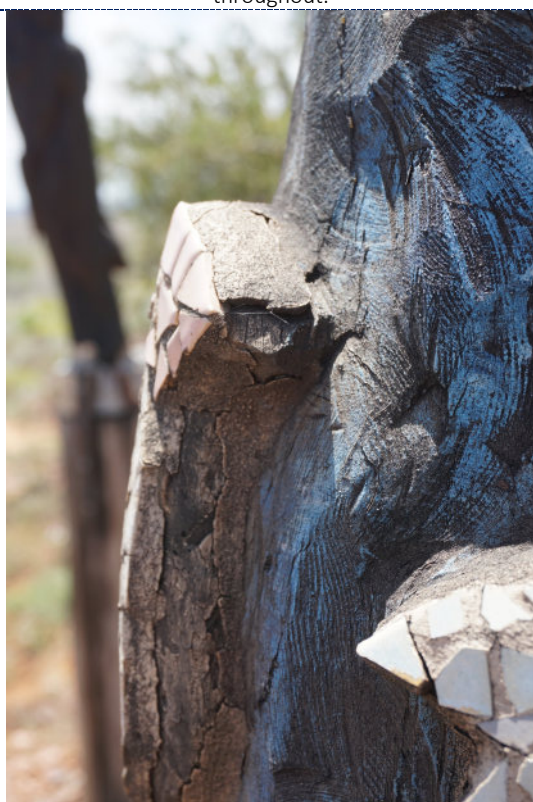
Figure 57: Detail – Pole 8, exterior, UV degradation (darkening) to wood surface, extensive losses to wood and painted surfaces and degradation to the binder securing the mosaic tiles in place.

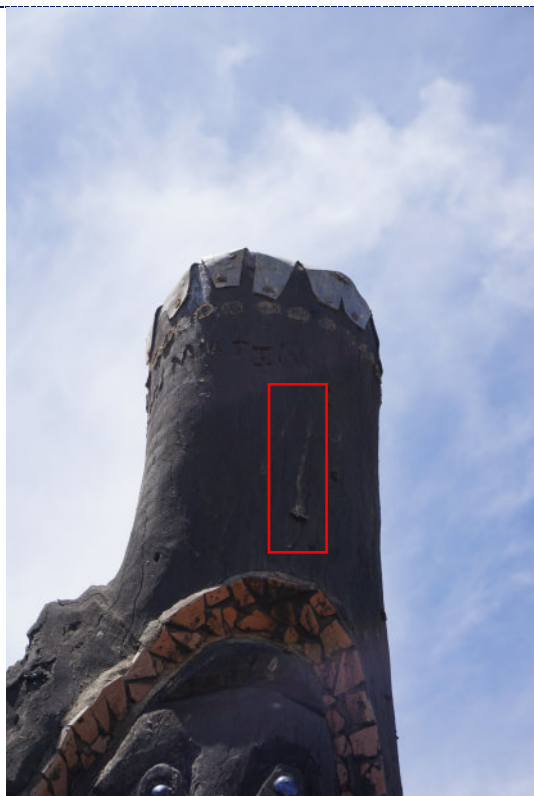
Figure 63: Detail – Pole 9, exterior, UV degradation (darkening) to wood surface, minor losses to the mosaic tiles surrounding the figure. Bird excrement noted above the carved figure (highlighted in red).

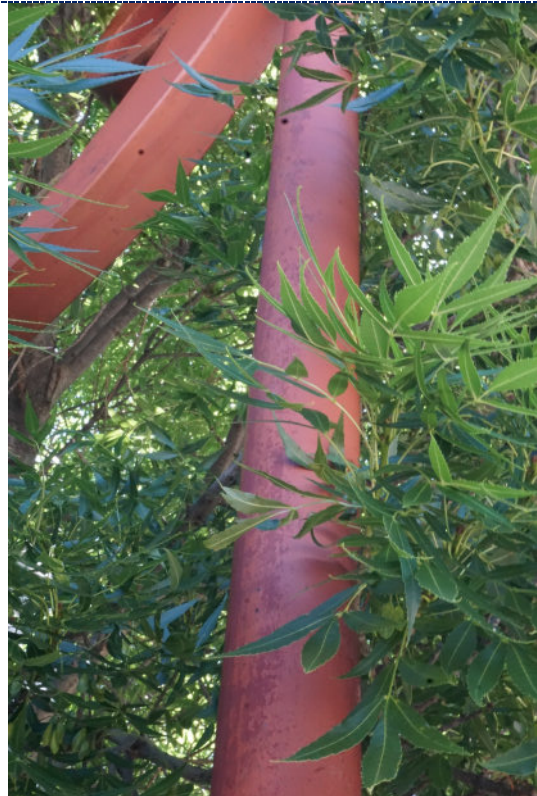
Figure 8: Detail – foliage intrusion; paint chalking, flaking paint loss with overpaint.

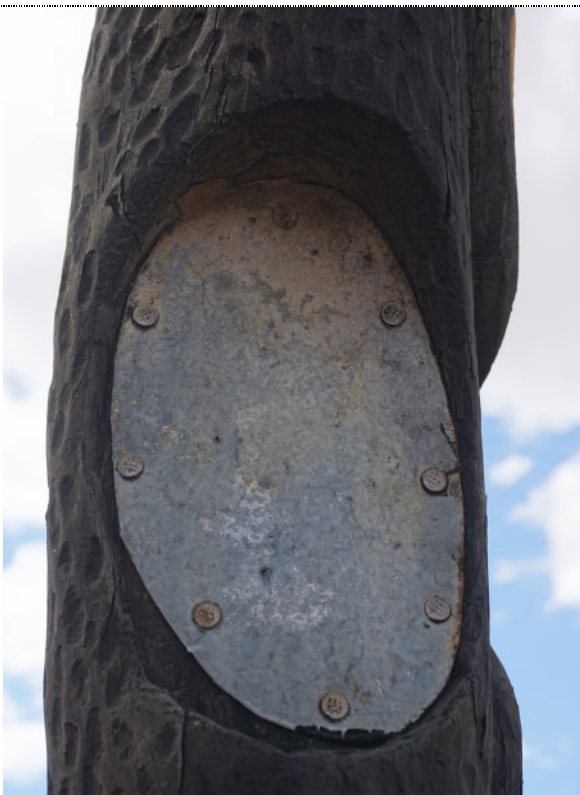
Figure 26: Detail – Pole #2003.0018 *Emus and eggs*, exterior, tarnishing and corrosion noted on the circular metal decorative element and nails affixing the element in place.

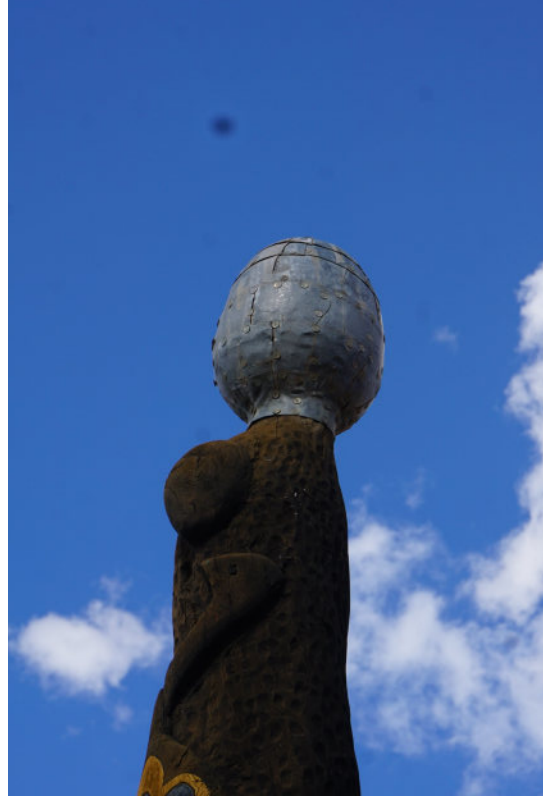
Figure 28: Detail – Pole #2003.0018 *Emus and eggs*, exterior, tarnishing and corrosion noted on the circular metal decorative element and nails affixing the element in place. UV degradation (darkening) to wood surface throughout.

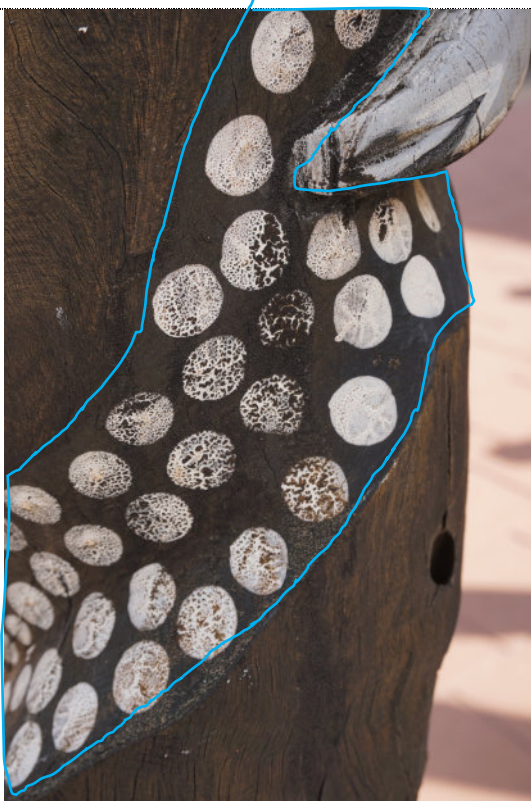
Figure 40: Detail – Pole #2003.0019 *Galahs*, exterior, UV degradation (darkening) to wood surface throughout. Surface dirt and insect debris noted throughout. Fading and losses noted to the painted surfaces, particularly the white painted dots (highlighted in blue).

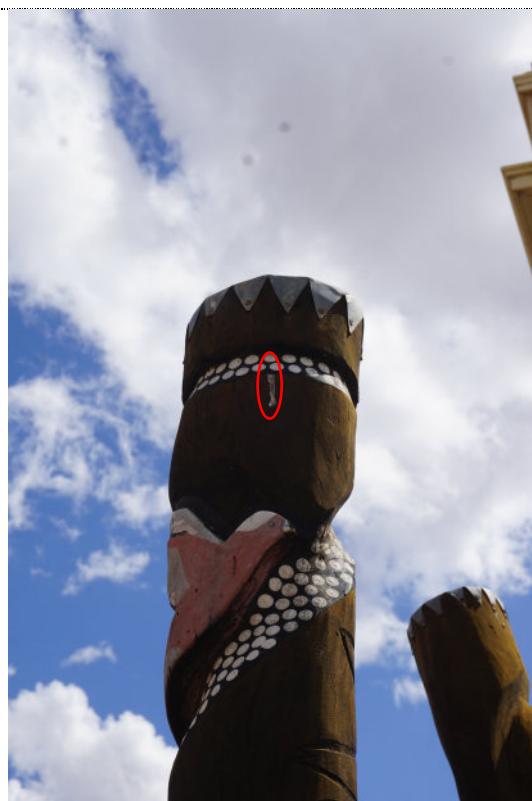
Figure 41: Detail – Pole #2003.0019 *Galahs*, exterior, UV degradation (darkening) to wood surface throughout. Surface dirt and insect debris noted throughout, including the presence of bird excrement (highlighted in red).

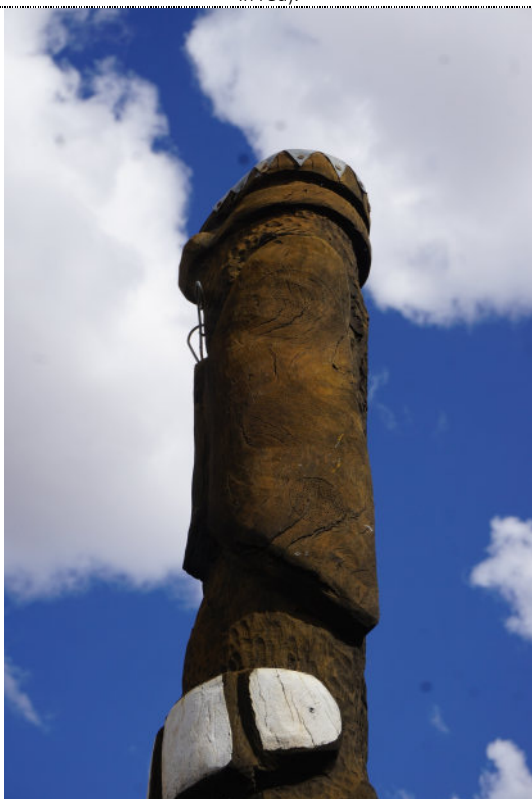
Figure 52: Detail – Pole #2003.0020 *Untitled*, exterior, UV degradation (darkening) to wood surface throughout.

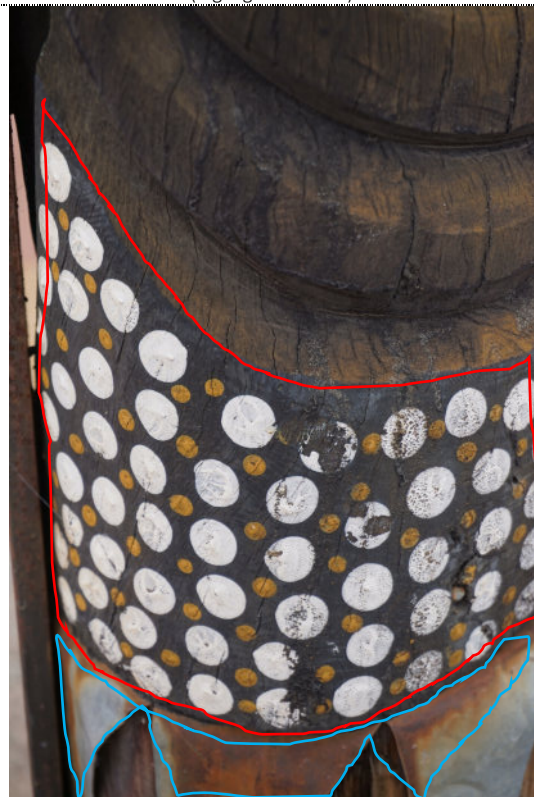
Figure 77: Detail – Pole #2003.0022, *Untitled*, exterior, UV degradation (darkening) to wood surface throughout. Surface dirt also noted throughout. Fading and losses noted to the painted surfaces, particularly the white and yellow ochre painted dots (highlighted in red). Extensive iron corrosion and staining noted on the metal components below the bands of painted dots (highlighted in blue).

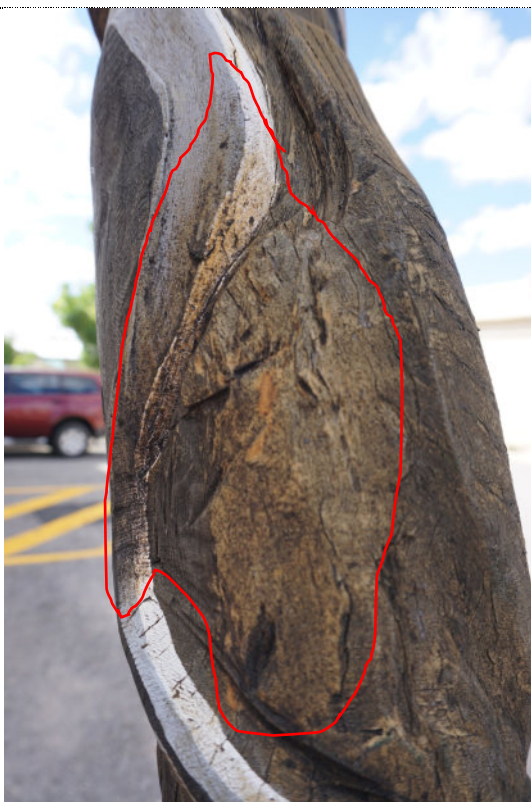
Figure 100: Detail – Pole #2003.0024, *Untitled*, exterior, UV degradation (darkening) to wood surface throughout. Staining, suggestive of iron staining, is noted over the white painted carved designs and surrounding wood surfaces (highlighted in red). The painted areas are also faded, which is consistent with UV degradation and display outdoors.

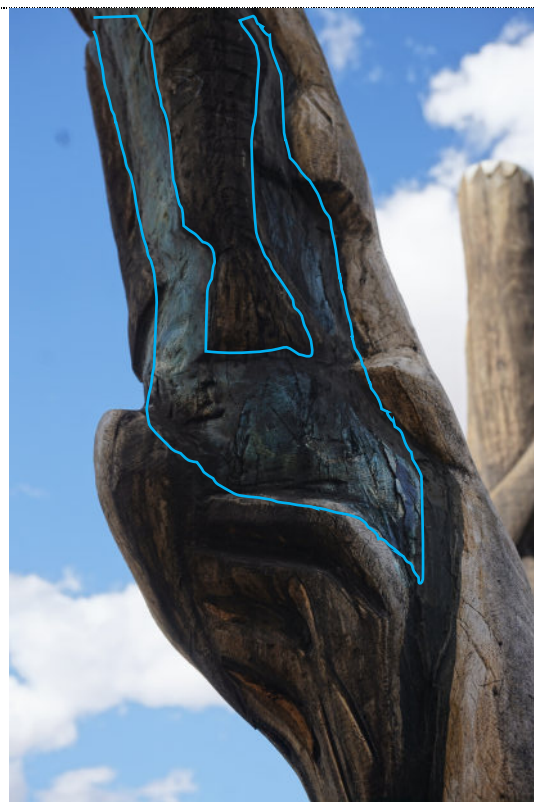
Figure 101: Detail – Pole #2003.0024, *Untitled*, exterior, UV degradation (darkening) to wood surface throughout. Staining, suggestive of iron staining, is noted over the blue painted carved designs and surrounding wood surfaces. The painted areas are also faded and lost (highlighted in blue), which is consistent with UV degradation and display outdoors.

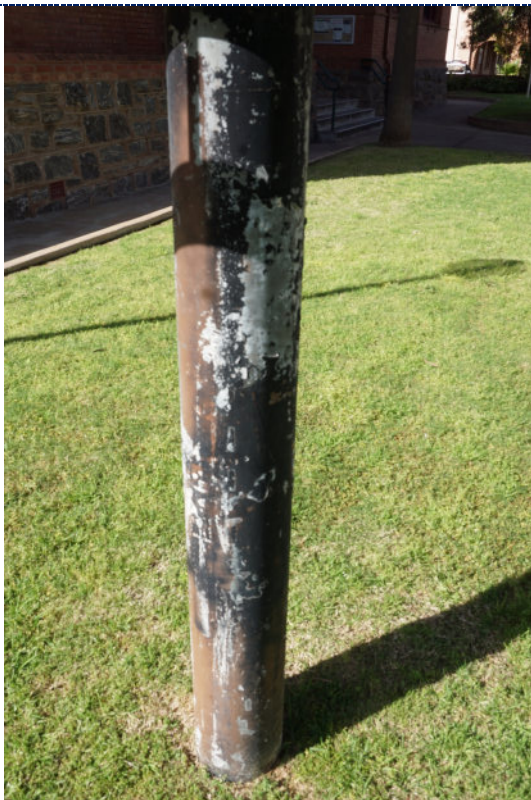
Figure 7: Detail – support pole. Extensive loss of paint layer exposing steel substrate. Surface corrosion occurring.

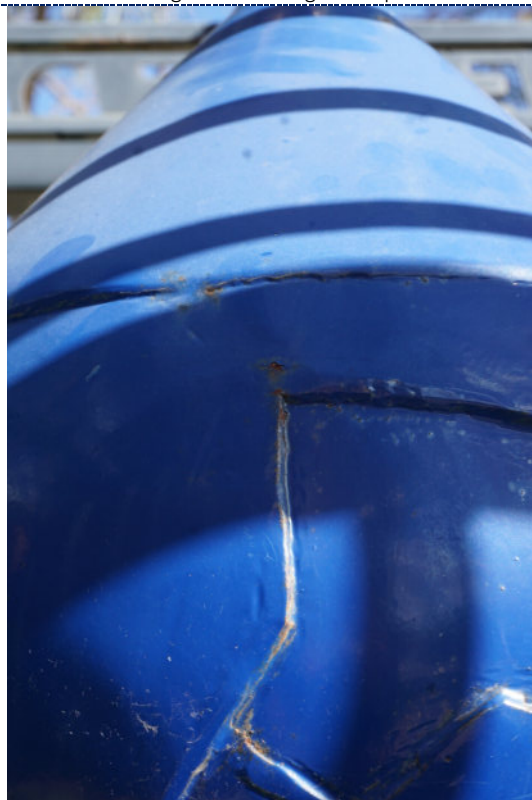
Figure 8: Detail – blanching of blue paint layer, appearing as white hazy bloom on upper section of 'drop' component. Minor losses and areas of corrosion also visible.

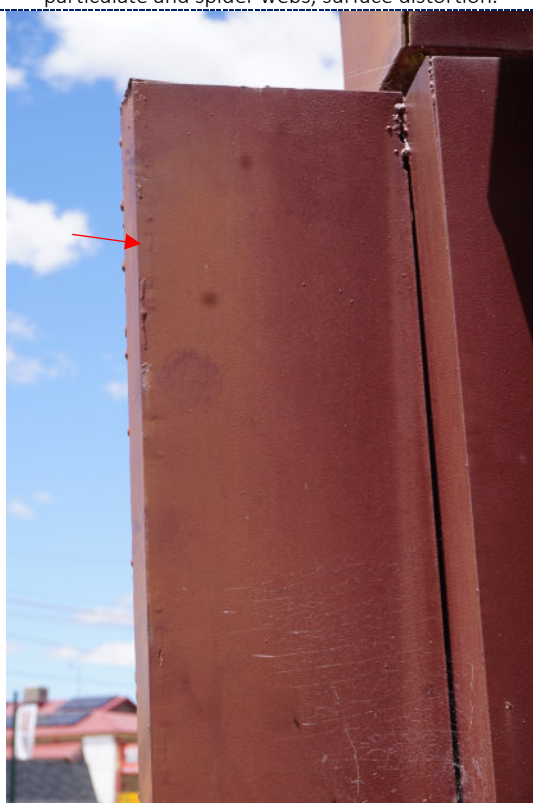
Figure 7: Detail – paint fading and degradation; dirt particulate and spider webs.

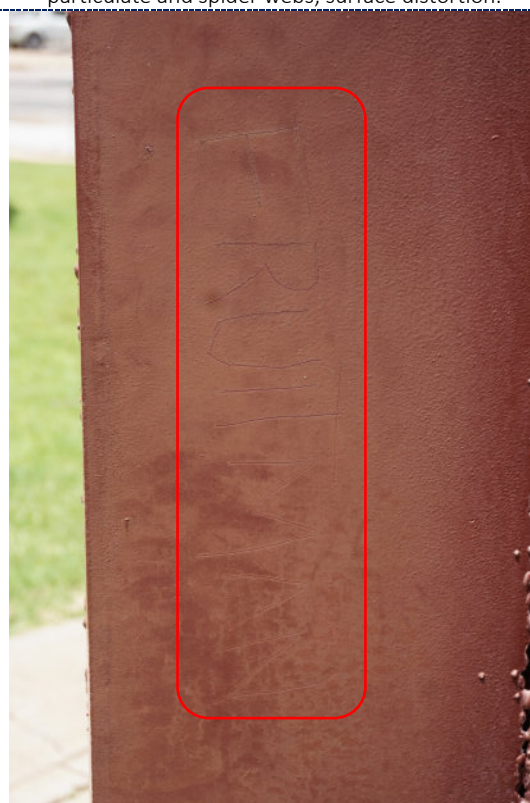
Figure 8: Detail – paint fading and degradation; incised graffiti, "FRUITMAN".

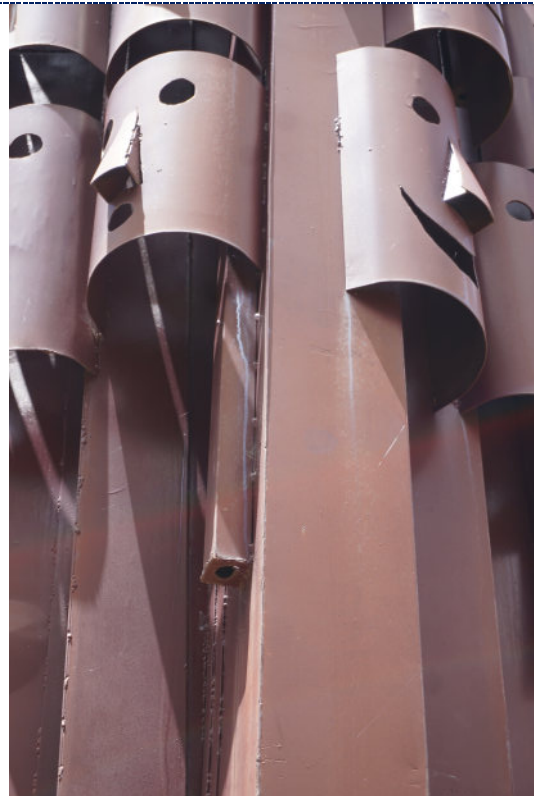
Figure 12: Detail – paint fading and degradation; dirt particulate and spider webs.

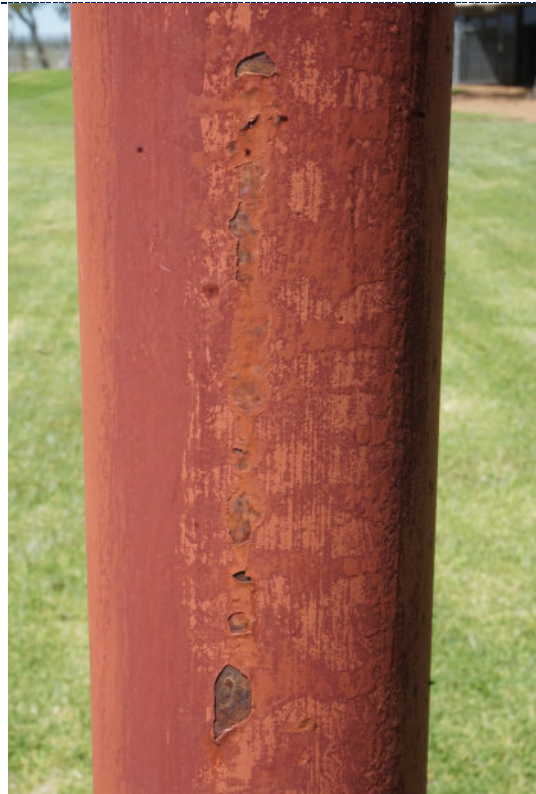
Figure 8: Detail – paint chalking, flaking paint loss with overpaint; corrosion in areas of paint loss.

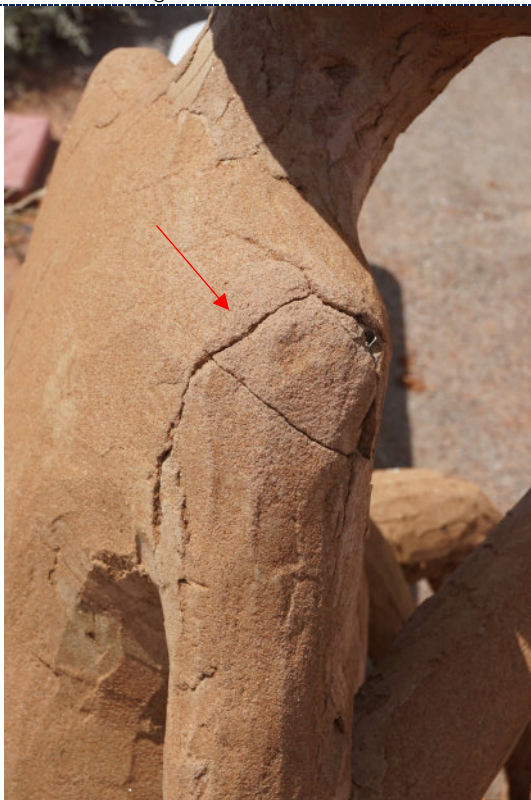
Figure 7: Detail – dirt particulate, large cracks and loss revealing internal iron armature at shoulder.

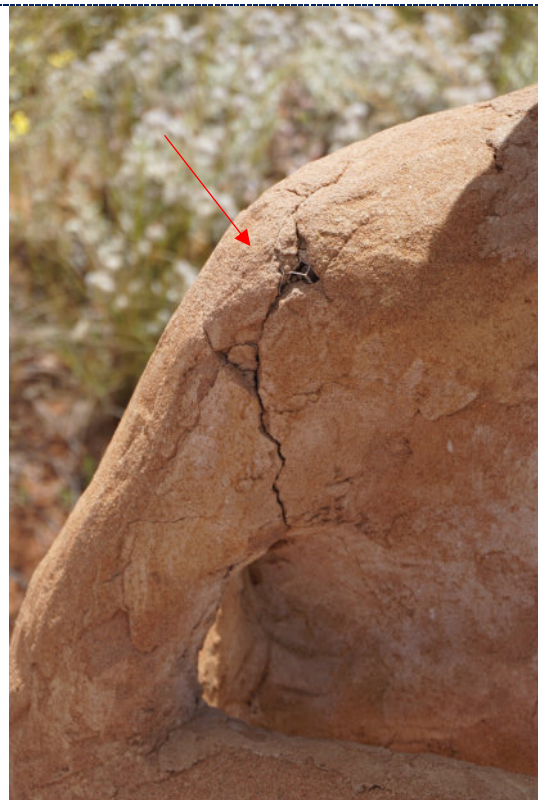
Figure 8: Detail – dirt particulate, large cracks and loss revealing internal iron armature at shoulder.
