# *Broken Hill Public Art Condition Survey and Conservation Plan*

Prepared for: Broken Hill City Council  
Submission Date: February 2023

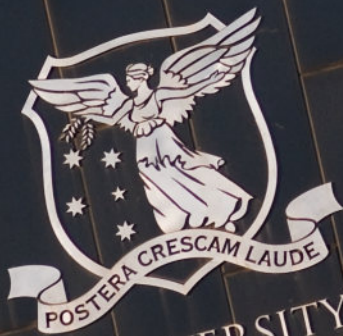
THE UNIVERSITY OF  
MELBOURNE

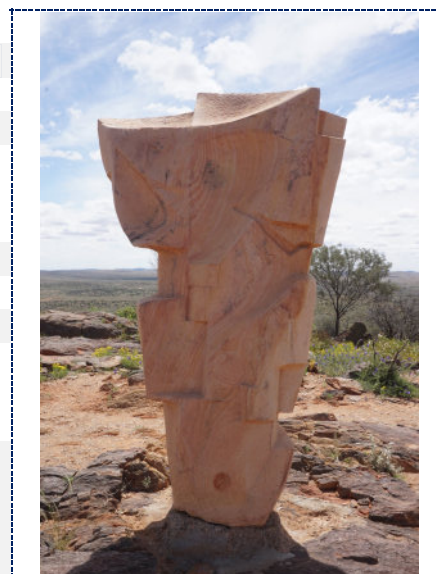
Previous repairs/ modifications?  YES  NO

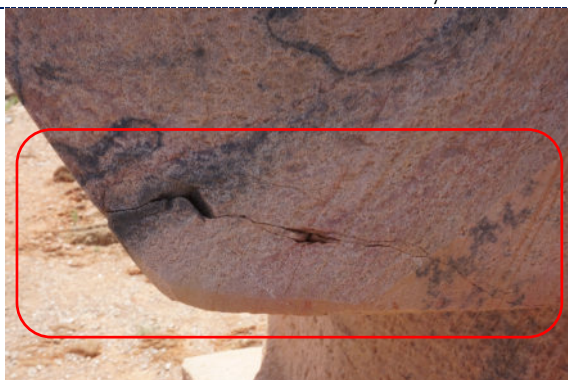
Figure 9: Details – recto, upper proper right side, horizontal crack and small losses.

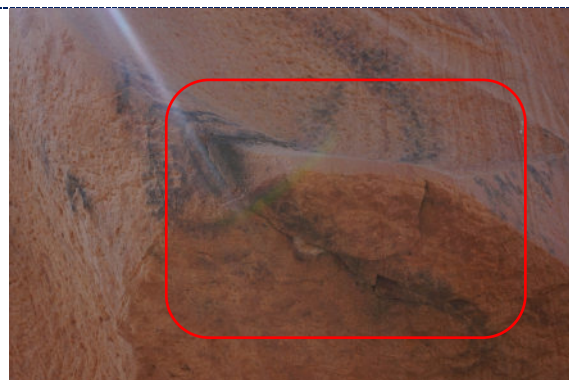
Figure 10: Details – recto, upper proper right side, crack, small losses and insect casing.

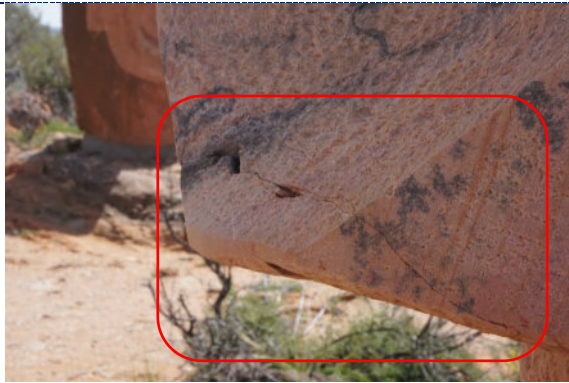
Figure 11: Details – recto, upper proper right side, horizontal crack and small losses.

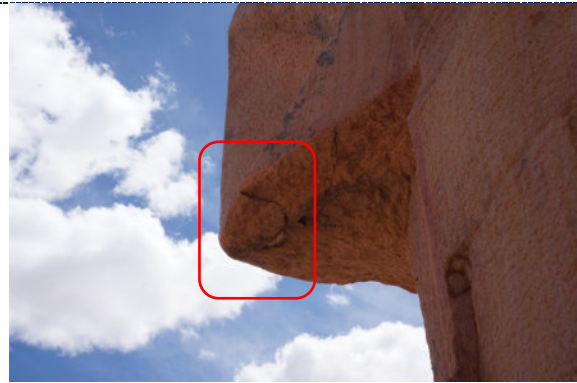
Figure 12: Details – recto, upper proper right side, crack, small losses and insect casing.

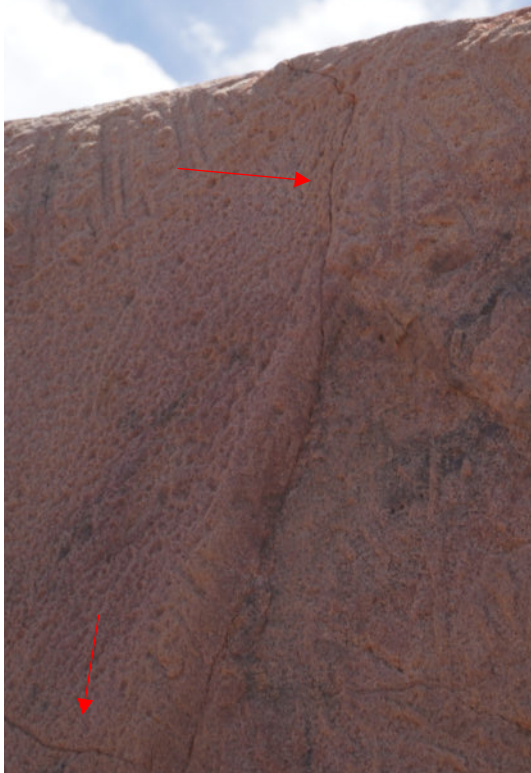
Figure 13: Detail – horizontal and vertical cracks.

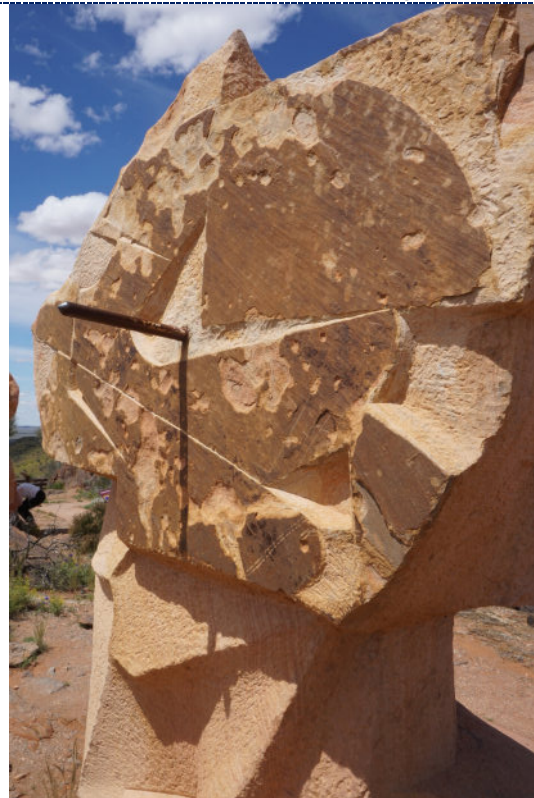
Figure 14: Details – surface abrasions and delamination.

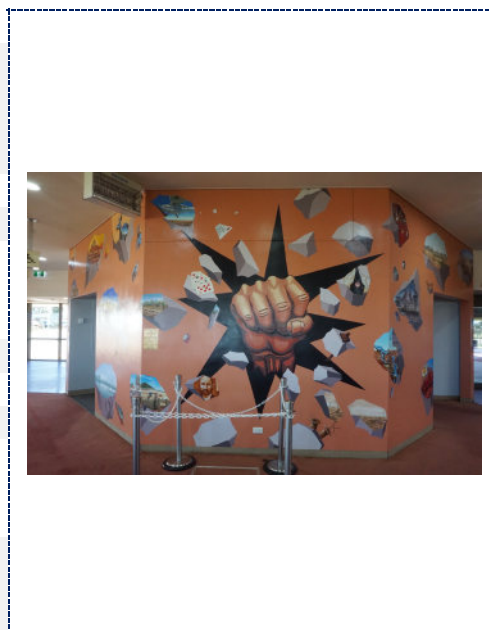
Previous repairs/ modifications?  YES  X NO

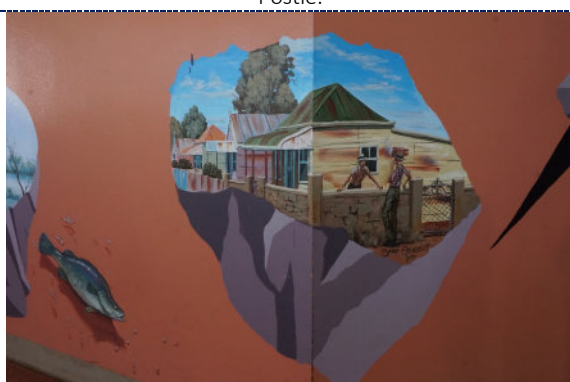
Figure 17: Work 10 – Detail – Broken Hill residential houses.

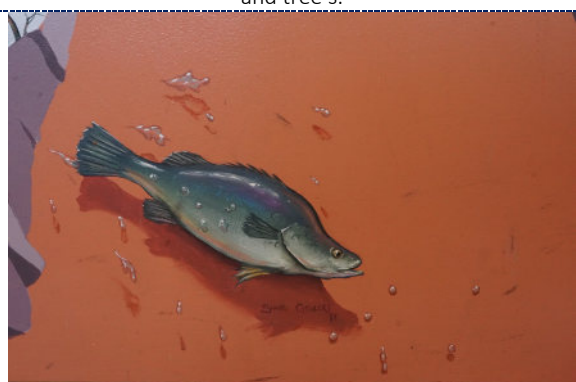
Figure 18: Work 11 – Detail – Barramundi.

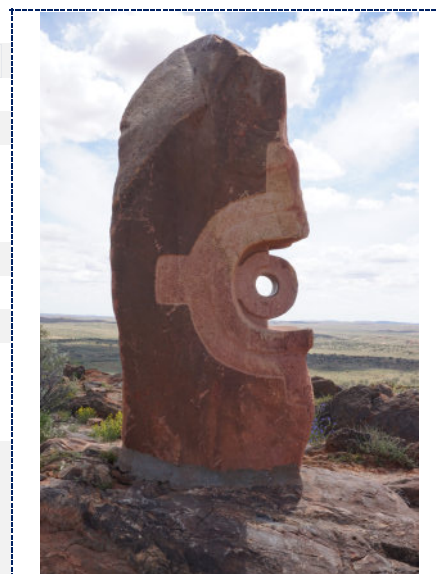
Previous repairs/ modifications?  YES  NO

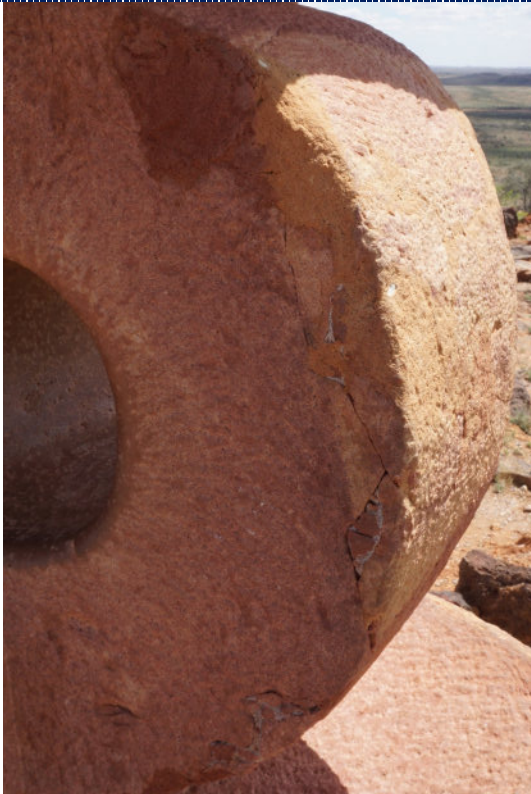
Figure 5: Detail – previous repair.

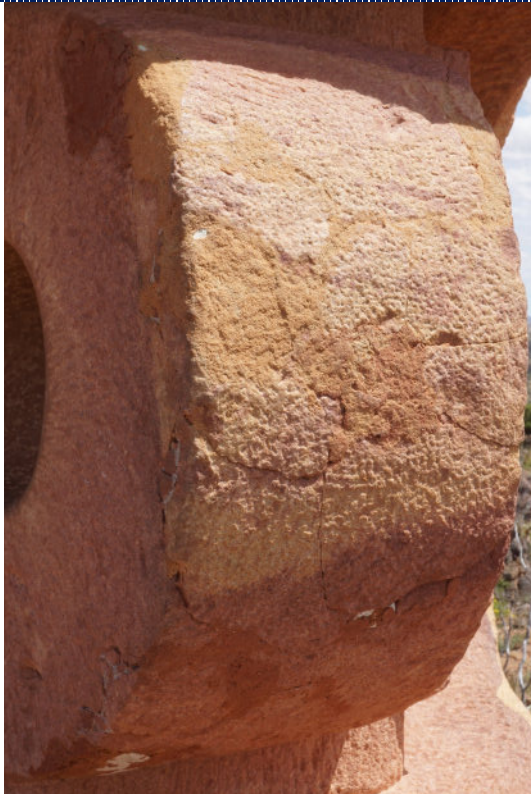
Figure 6: Detail – previous repair.

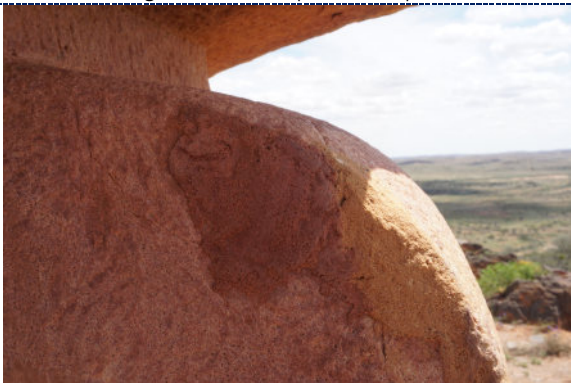
Figure 7: Detail – previous repair.

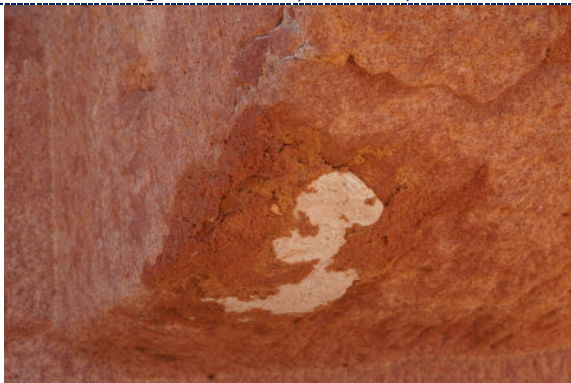
Figure 8: Detail – previous repair.

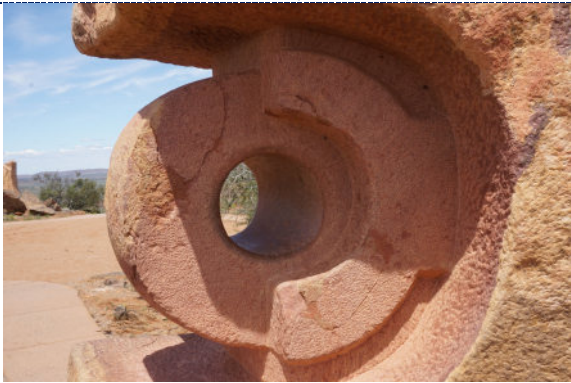
Figure 9: Detail – previous repair.

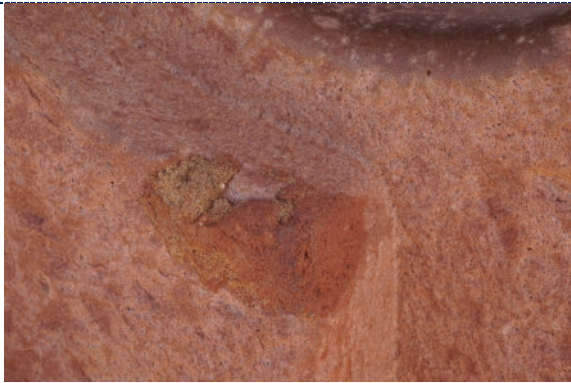
Figure 10: Detail – previous repair.

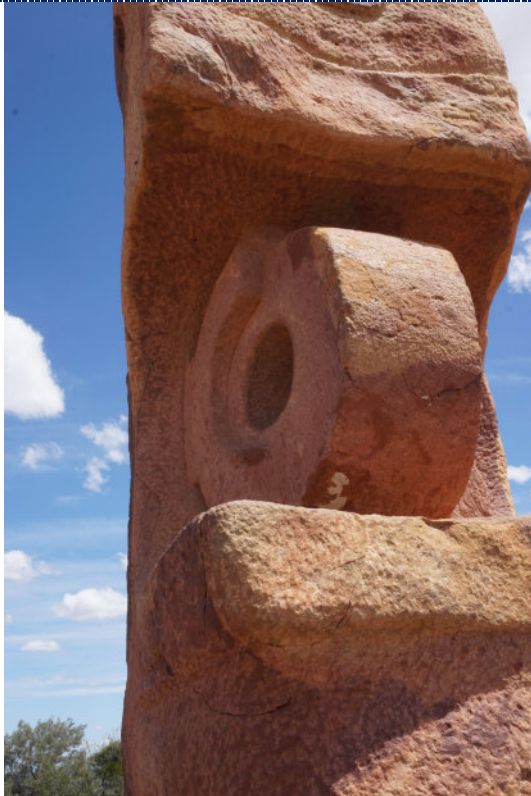
Figure 11: Detail – previous repair.

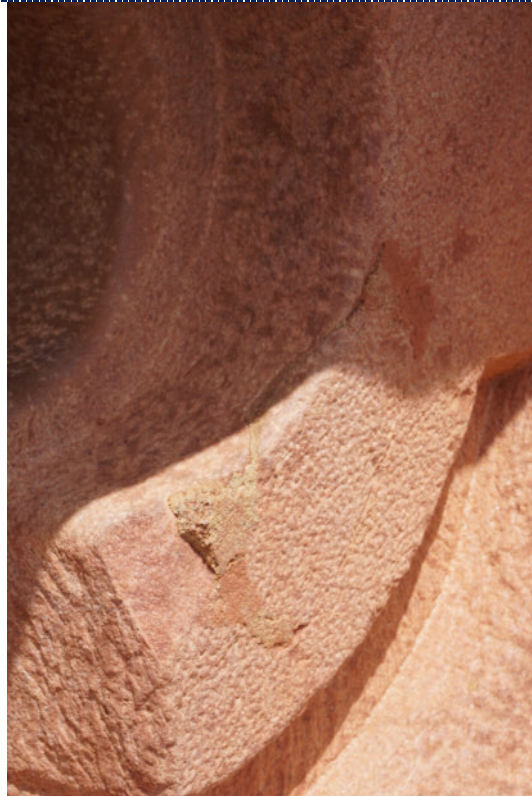
Figure 12: Detail – previous repair.

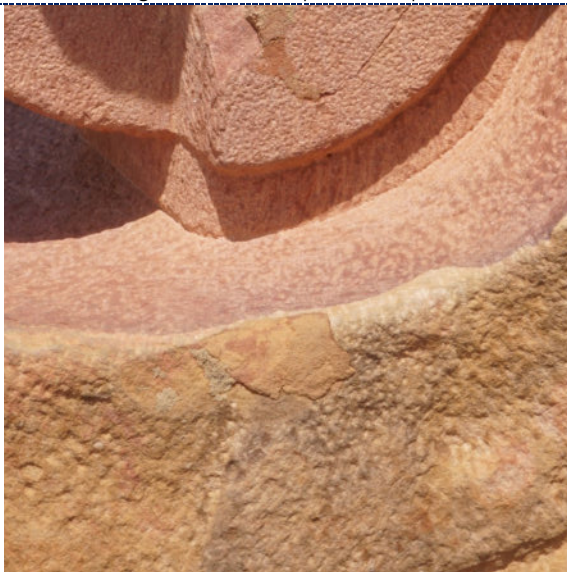
Figure 13: Detail – verso lower, previous repair.

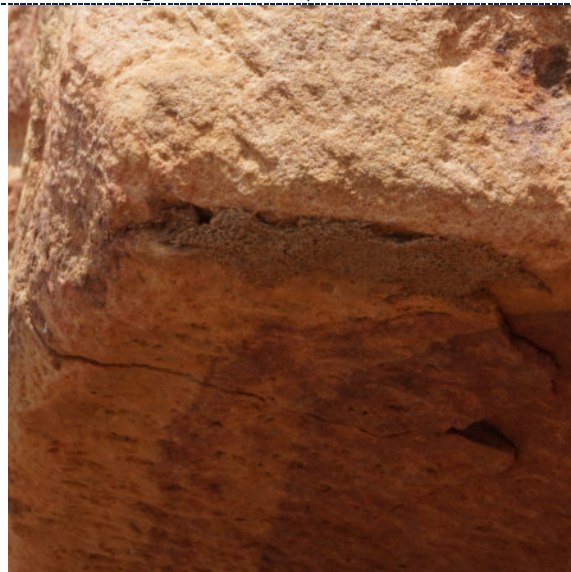
Figure 14: Detail – verso upper, previous repair.

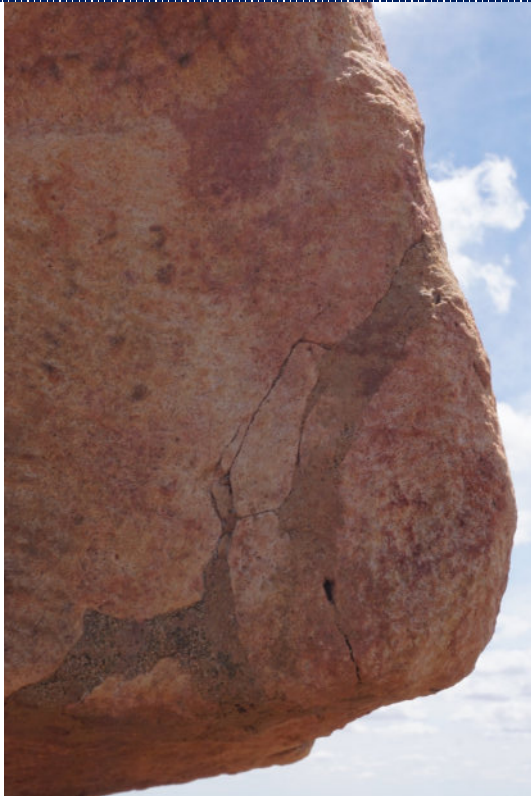
Figure 15: Detail – upper corner, previous repairs and cracks,

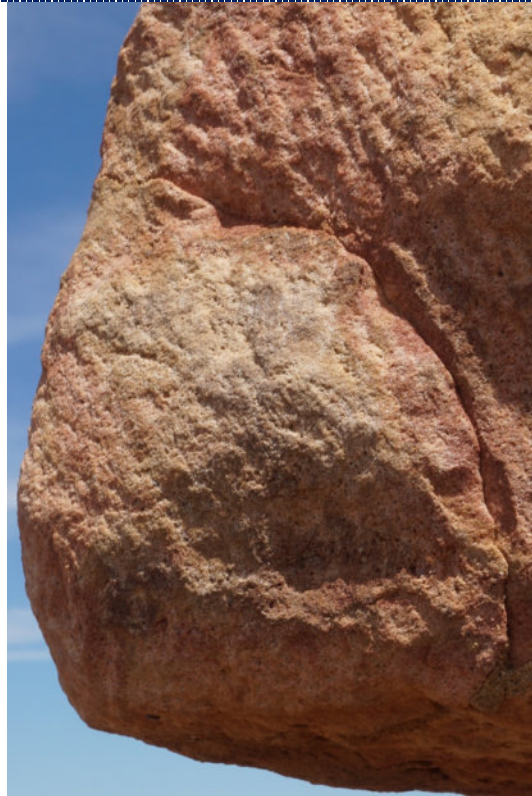
Figure 16: Detail – verso, upper corner, crack.

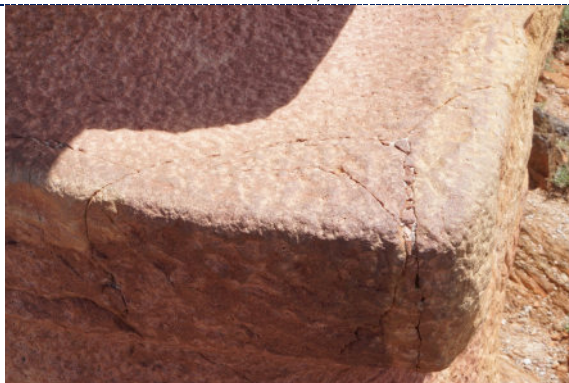
Figure 17: Detail – base, lower corner, cracks.

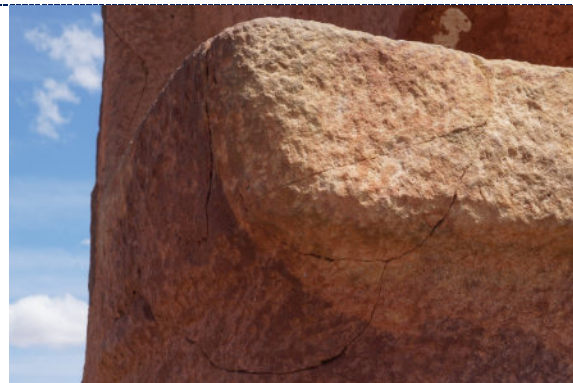
Figure 18: Detail – base, lower corner underside, cracks.

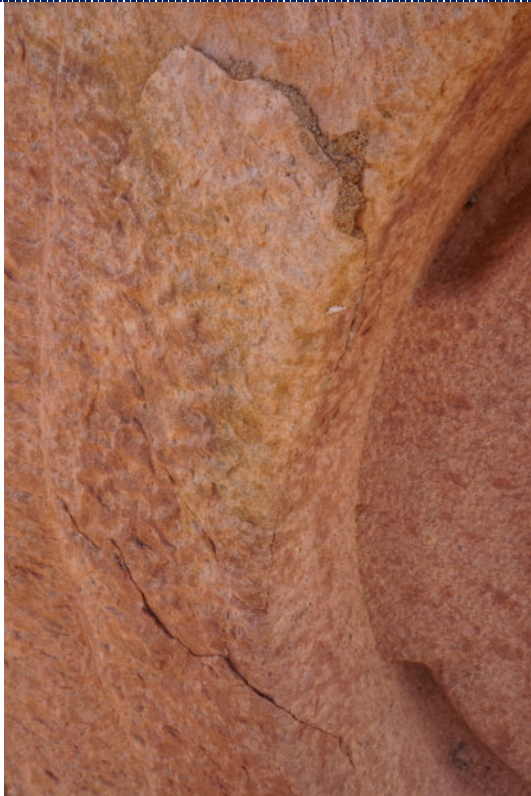
Figure 19: Detail – cracks and repair outer edge of cut out.

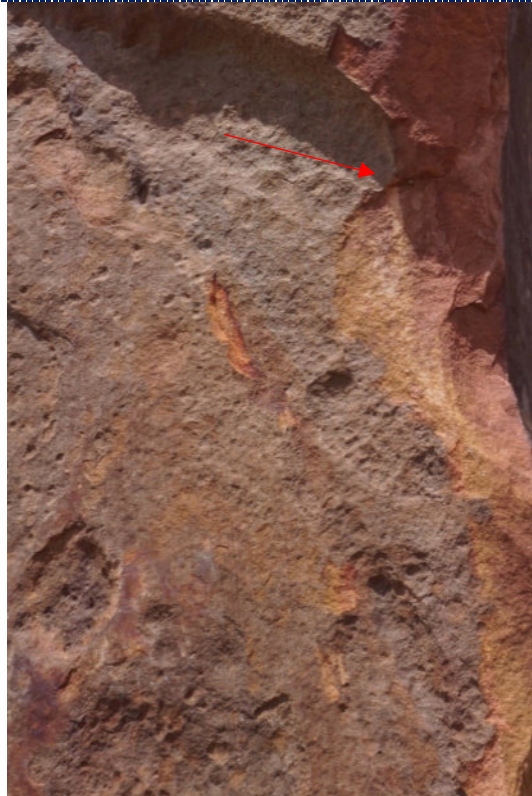
Figure 20: Detail – Surface delamination.

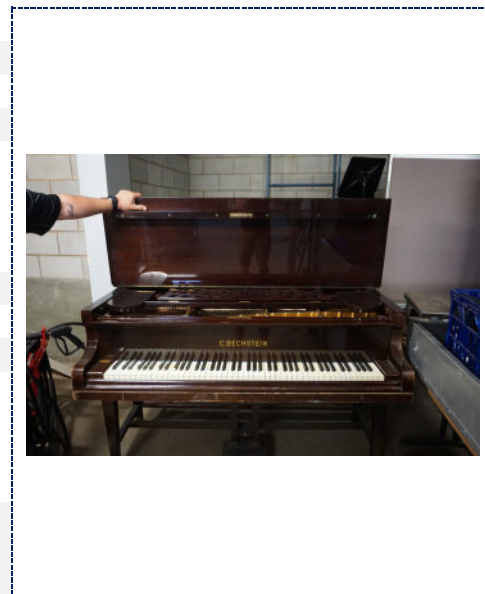
Previous repairs/ modifications?  YES  NO

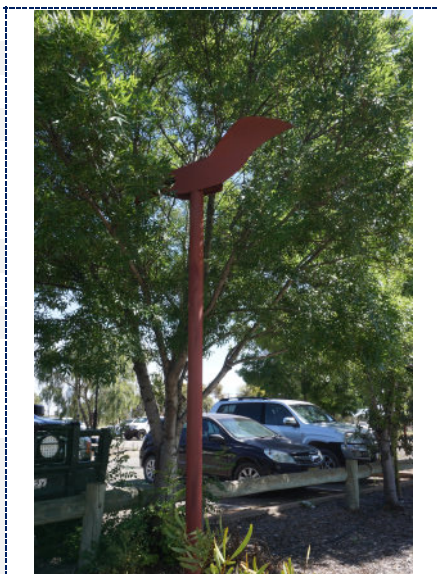
Previous repairs/ modifications?  YES  NO

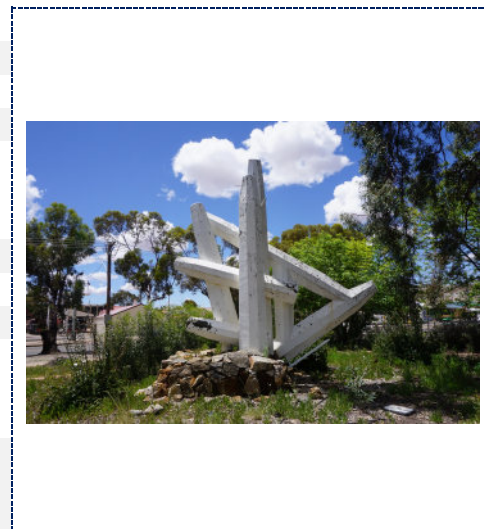
Previous repairs/ modifications?  YES  NO

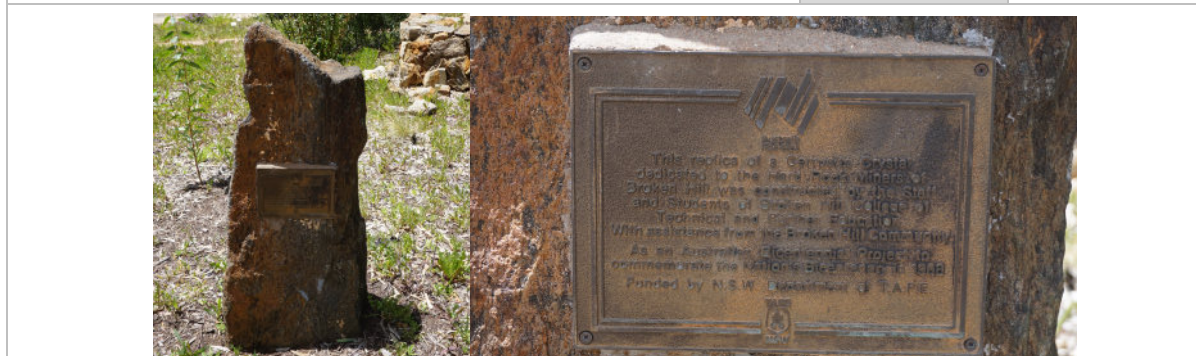
| INTERPRETIVE/ ATTRIBUTION PLAQUE? | YES | NO |

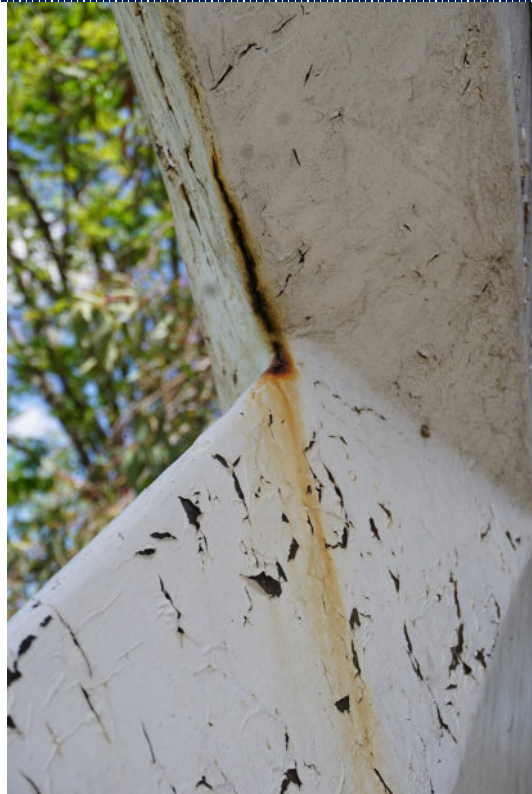
Figure 6: Detail – surface paint loss, crazing and iron corrosion product staining.

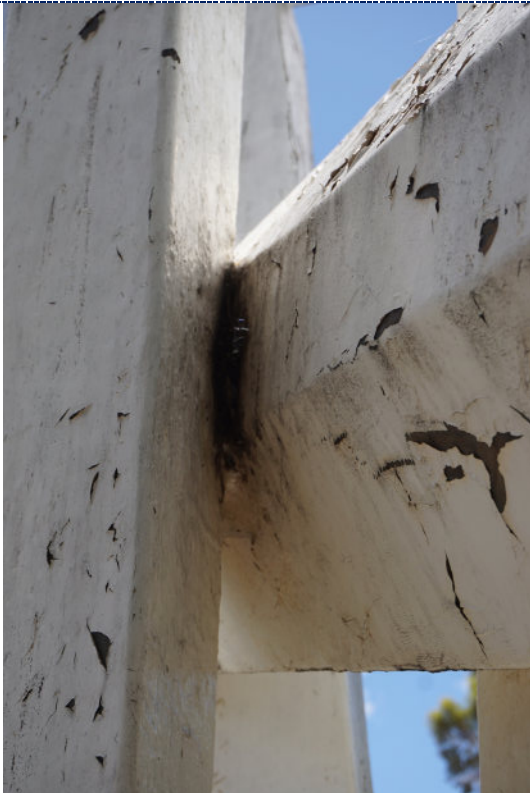
Figure 7: Detail – dirt particulate and surface paint loss and crazing.

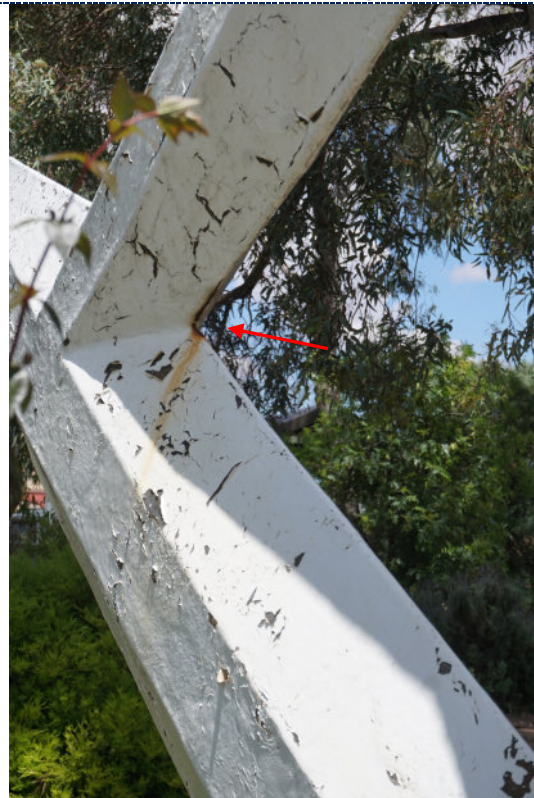
Figure 12: Detail – dirt particulate and significant surface paint loss and crazing; iron corrosion product staining (arrow).

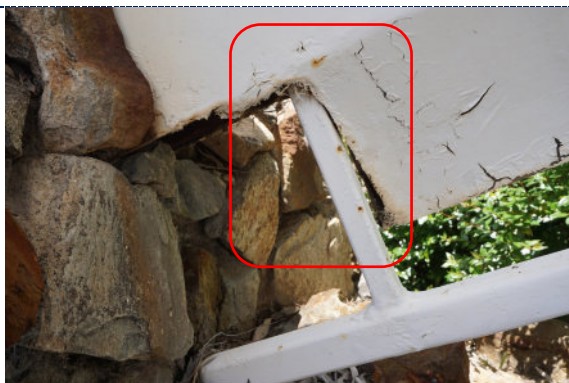
Figure 13: Detail – small areas of iron corrosion products at base.

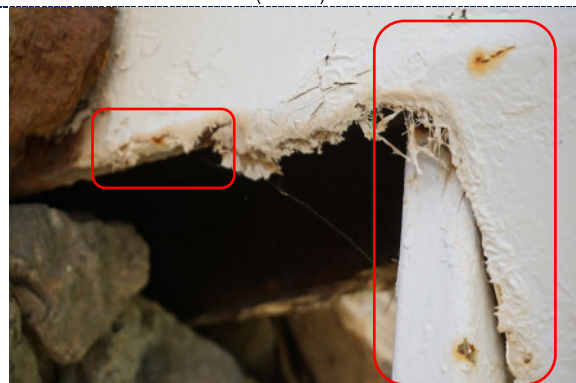
Figure 14: Detail – small areas of iron corrosion products at base.

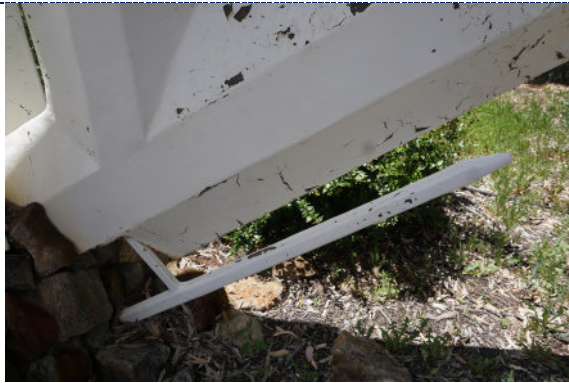
Figure 15: Detail – dirt particulate and significant surface paint loss and crazing.

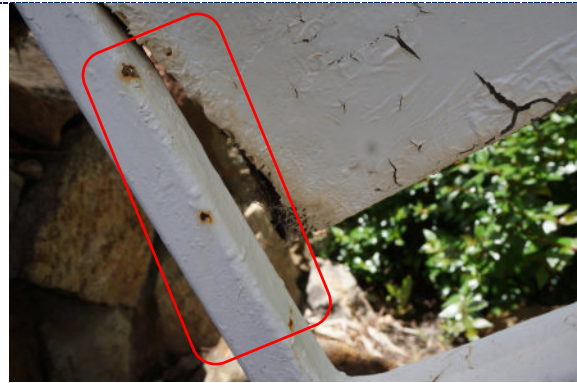
Figure 16: Detail – small areas of iron corrosion products at base.

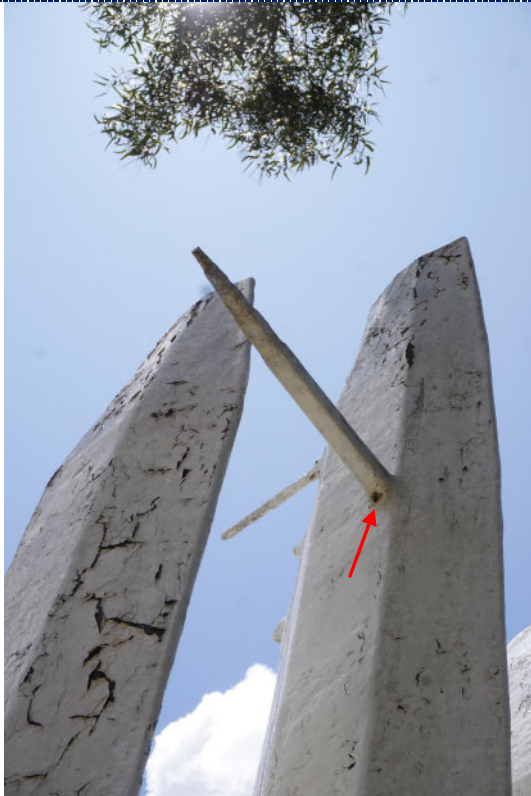
Figure 17: Detail – dirt particulate and significant surface paint loss and crazing; iron corrosion product staining (arrow).

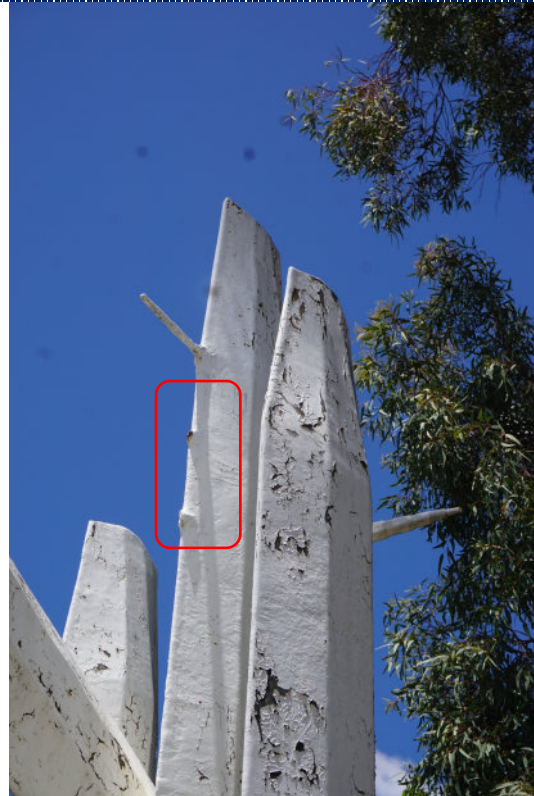
Figure 18: Detail – dirt particulate and significant surface paint loss and crazing; missing spikes.

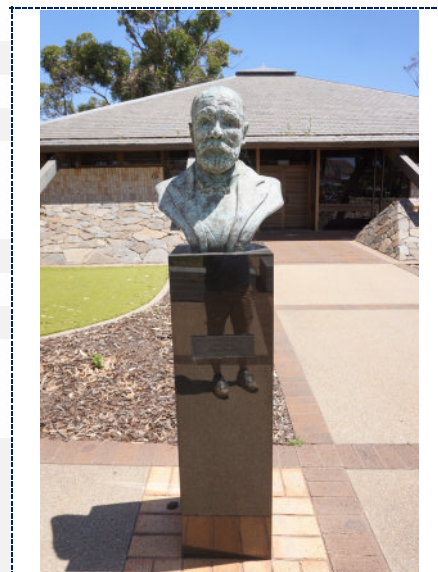
Previous repairs/ modifications?  YES  NO

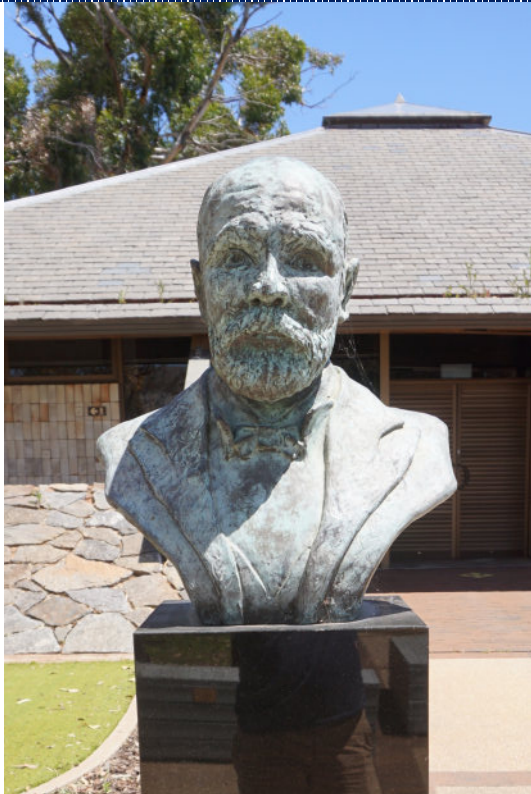
Figure 5: Detail – bust, front. Atmospheric pollution-driven copper corrosion product on bronze figure.

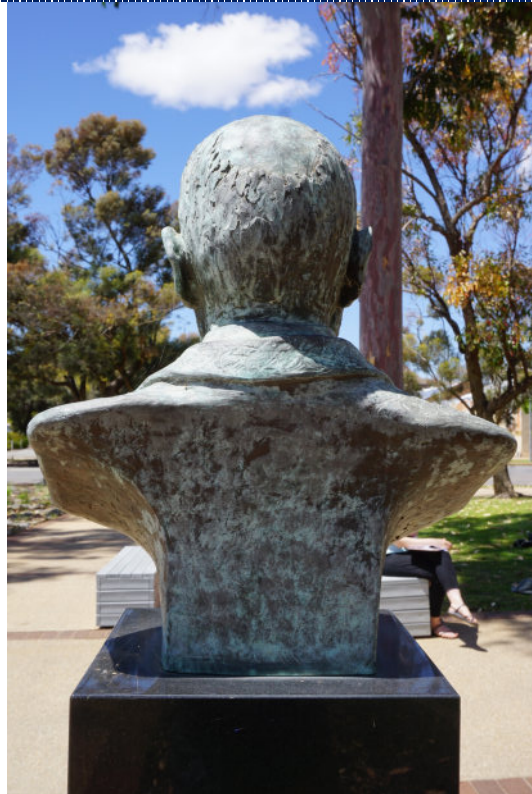
Figure 6: Detail – bust, back. Atmospheric pollution-driven copper corrosion product on bronze figure.

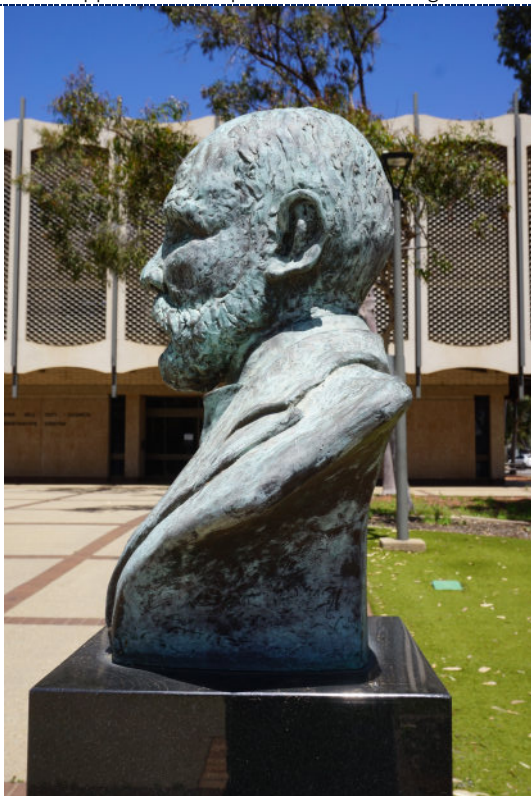
Figure 7: Detail – bust, proper left. Atmospheric pollution-driven copper corrosion product on bronze figure.

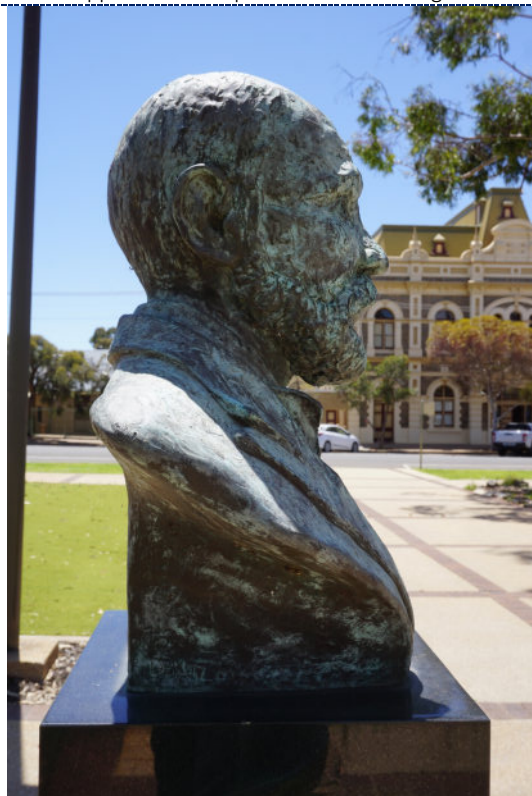
Figure 8: Detail – bust, proper right. Atmospheric pollution-driven copper corrosion product on bronze figure.

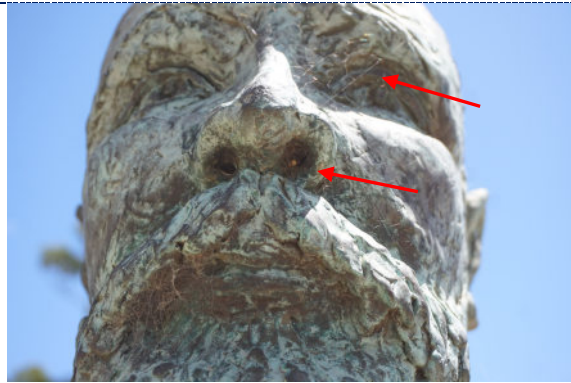
Figure 9: Detail – atmospheric pollution-driven copper corrosion product, dirt particulate, spider webs.

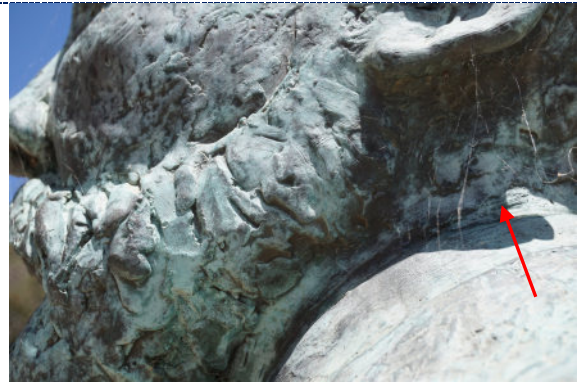
Figure 10: Detail – atmospheric pollution-driven copper corrosion product, dirt particulate, spider webs.

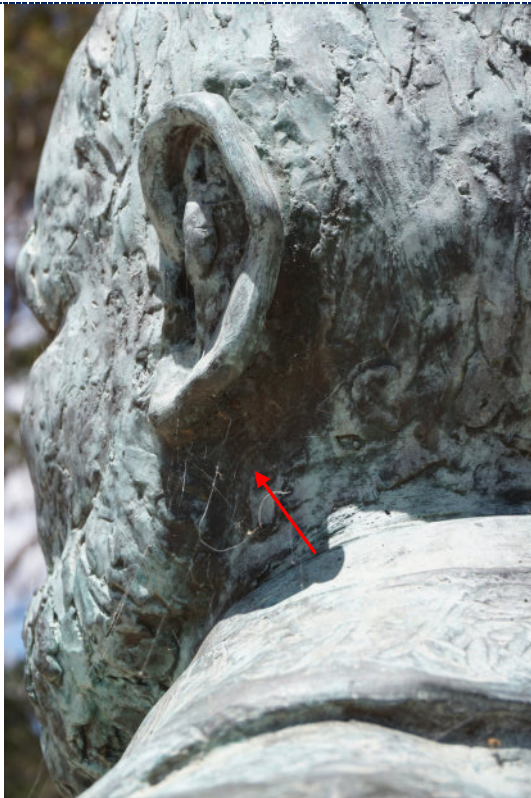
Figure 11: Detail – atmospheric pollution-driven copper corrosion product, dirt particulate, spider webs.

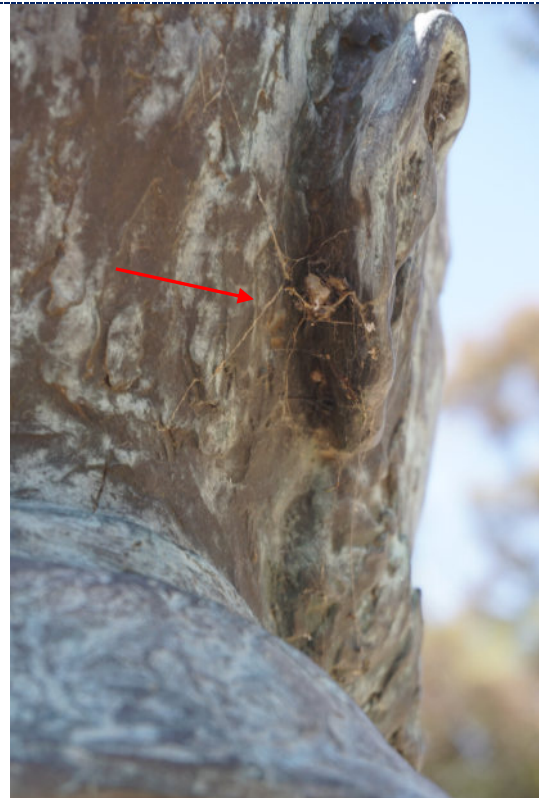
Figure 12: Detail – atmospheric pollution-driven copper corrosion product, dirt particulate, spider webs.

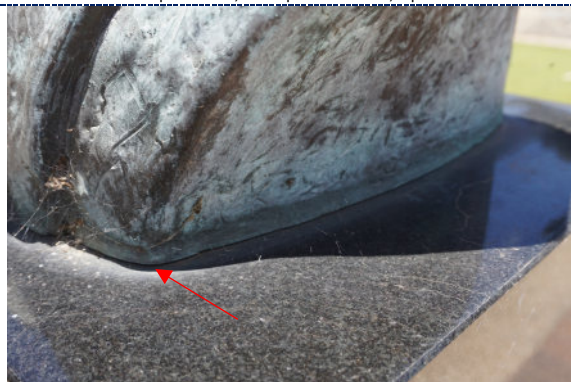
Figure 13: Detail – atmospheric pollution-driven copper corrosion product, dirt particulate, spider webs.

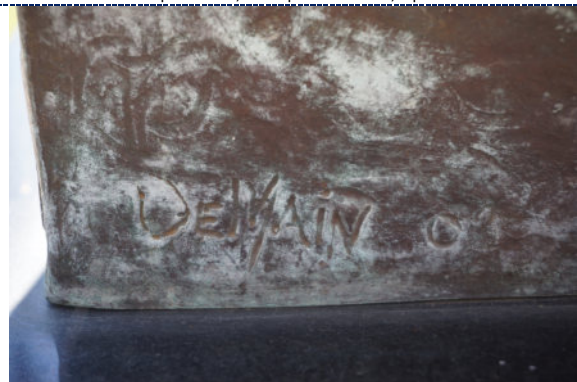
Figure 14: Detail – atmospheric pollution-driven copper corrosion product and artist's signature.

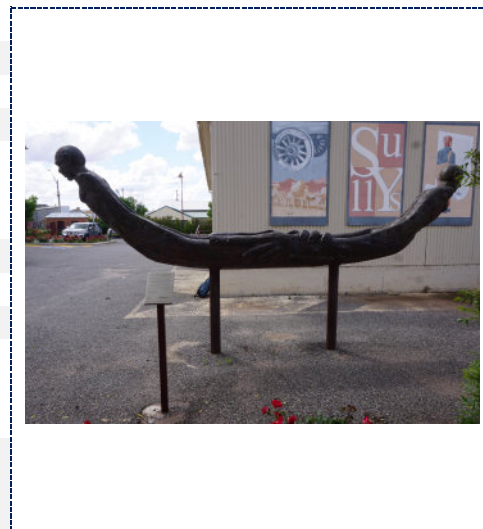
Previous repairs/ modifications?  YES  NO

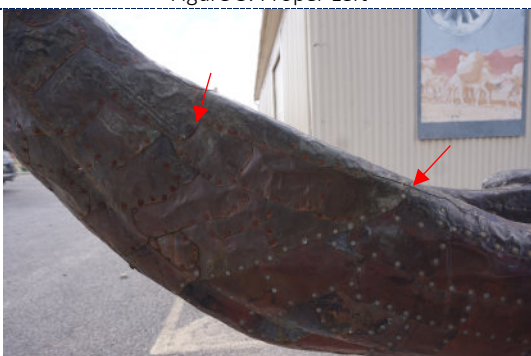
Figure 5: Detail – exterior, isolated surface corrosion products; corroded iron vs zinc plated nail heads.

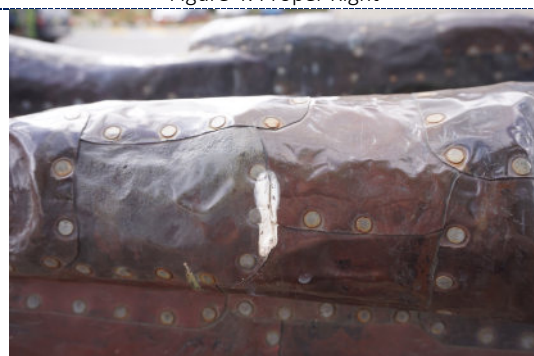
Figure 6: Detail – exterior, zinc nail heads; bird excrement.

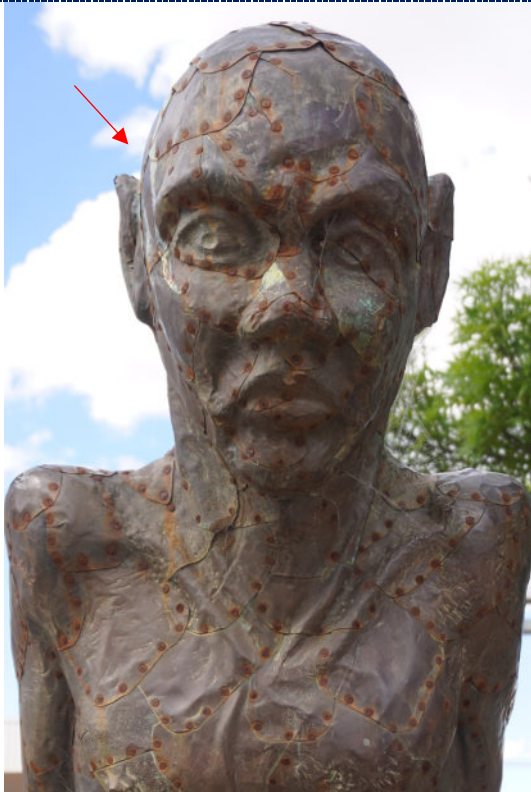
Figure 7: Detail – exterior, isolated surface corrosion products; corroded iron nail heads; bird excrement (arrow).

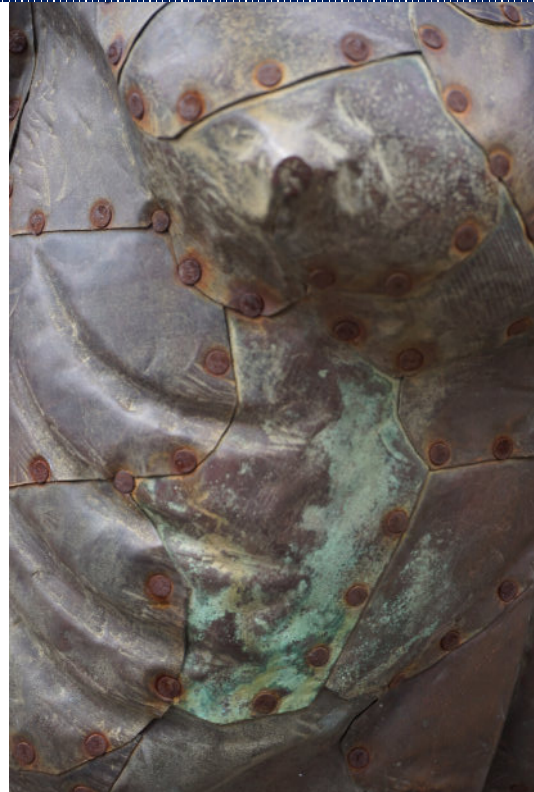
Figure 8: Detail – exterior, surface corrosion products; corroded iron nail heads.

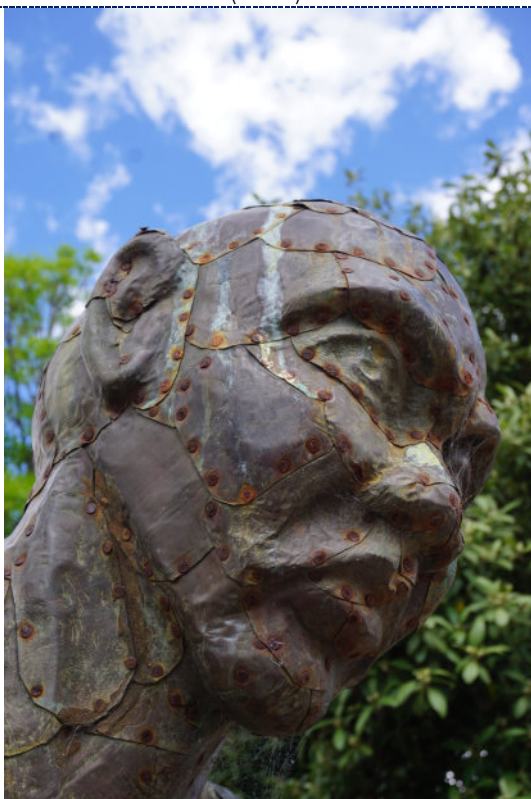
Figure 9: Detail – exterior, surface corrosion products stemming from bird excrement; corroded iron nail heads.

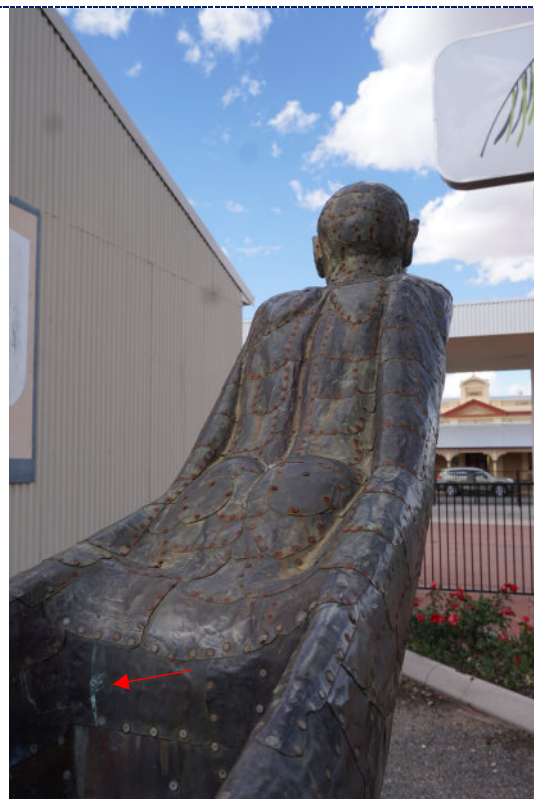
Figure 10: Detail – interior, dirt particulate, isolated surface corrosion products; corroded iron vs zinc plated nail heads; bird excrement (arrow).

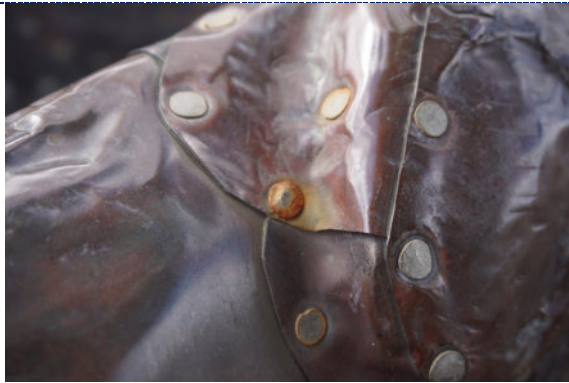
Figure 11: Detail – exterior, corroding zinc-plated nail.

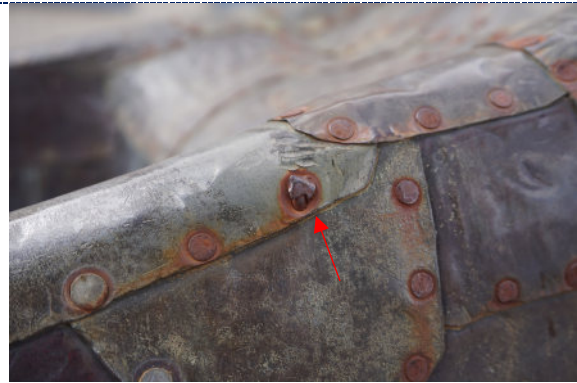
Figure 12: exterior, corroding nail heads and iron staining; one nail head is deformed.

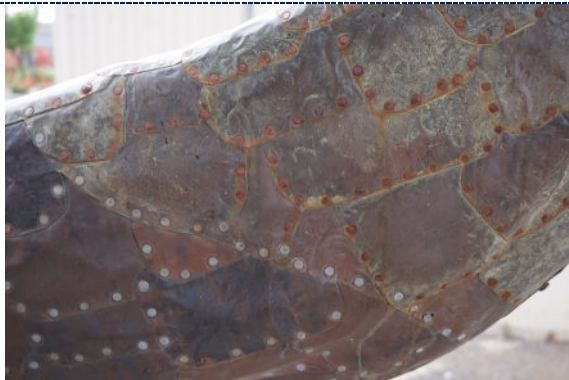
Figure 13: Detail – exterior, isolated surface corrosion products; corroded iron vs zinc plated nail heads.

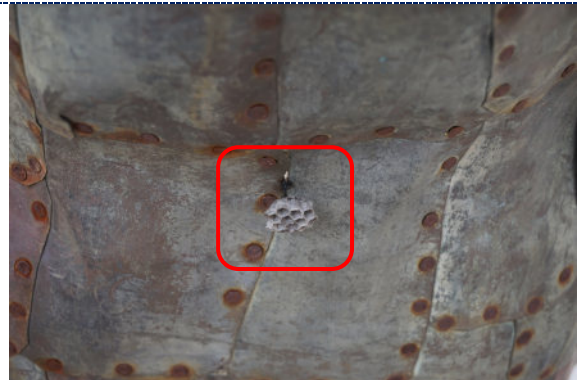
Figure 14: Detail – exterior-bottom, isolated surface corrosion products; corroded iron vs zinc plated nail heads; small wasp nest.

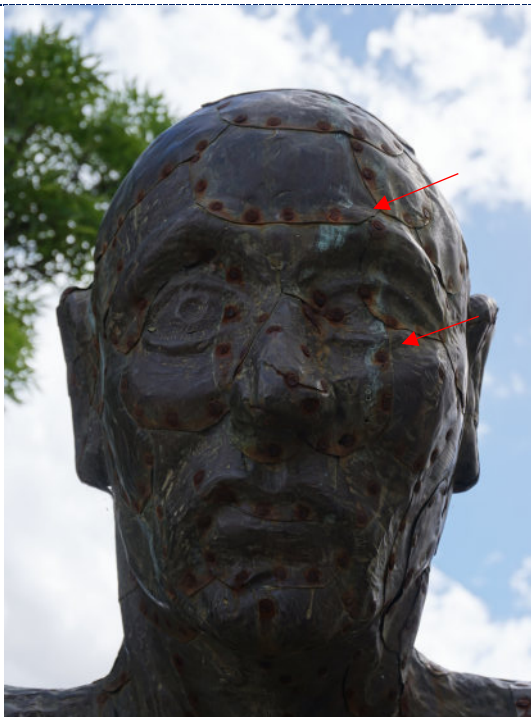
Figure 15: Detail – exterior, isolated surface corrosion products; corroded iron nail heads.

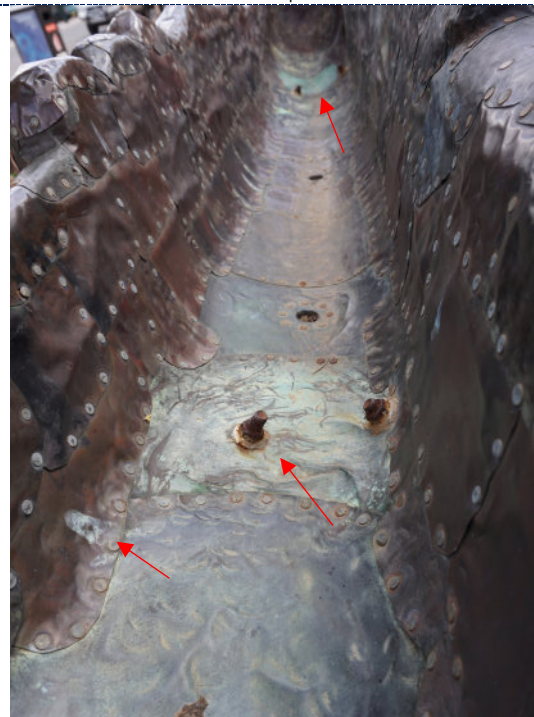
Figure 16: Detail – interior, dirt particulate, green copper corrosion in areas where water pools; corroded bolts where mounts are attached; bird excrement.

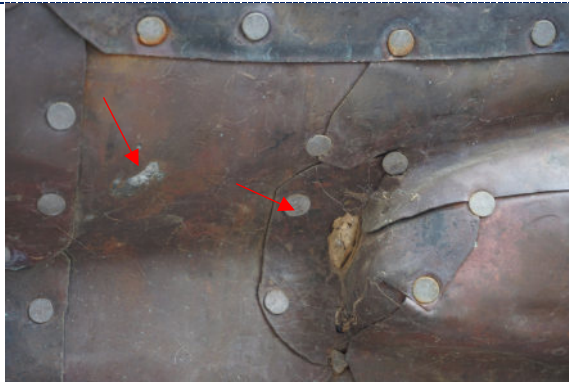
Figure 17: Detail – exterior, dirt particulate, spider webs; minor corrosion to zinc nail heads; isolated surface corrosion.

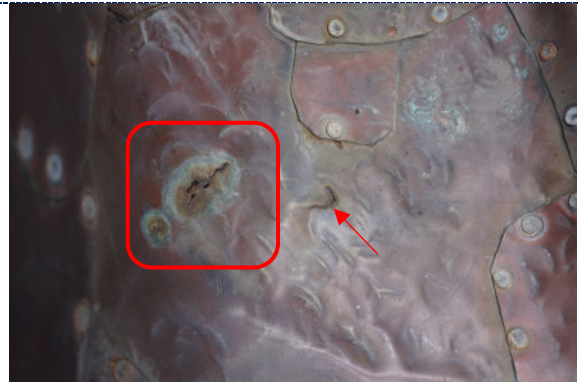
Figure 18: Detail – exterior, corrosion perforating copper plate; minor corrosion to zinc nail heads.

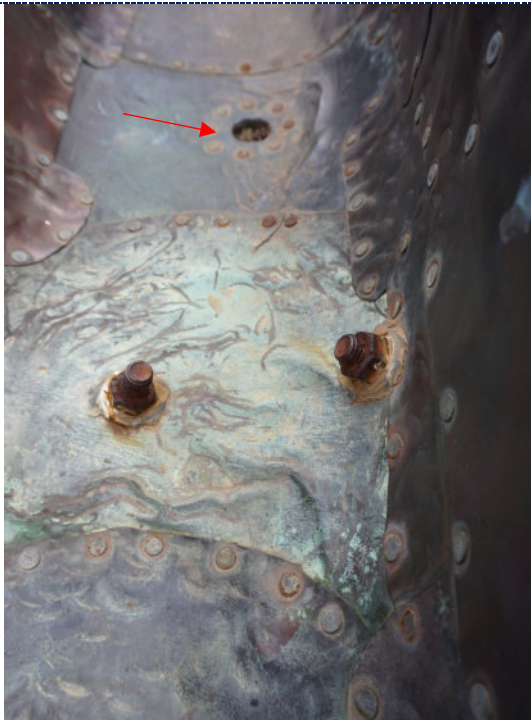
Figure 19: Detail – interior, dirt particulate, green copper corrosion in areas where water pools; corroded bolts where mounts are attached; biomatter clogging drains.

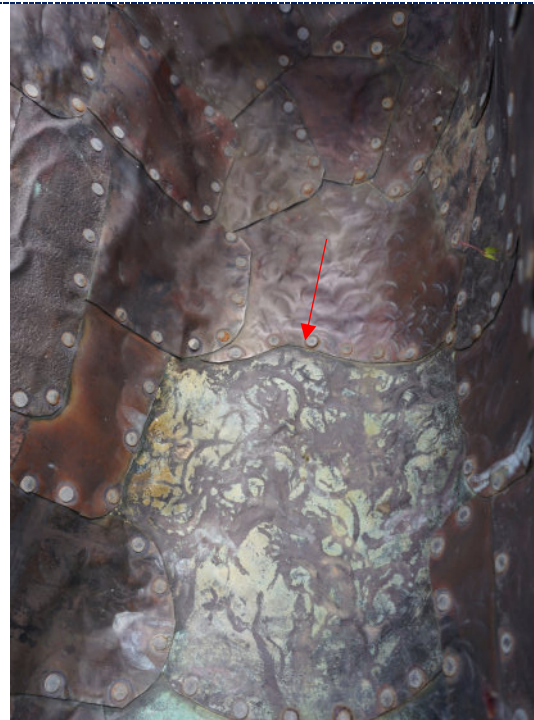
Figure 20: Detail – interior, dirt particulate, green copper corrosion in areas where water pools.

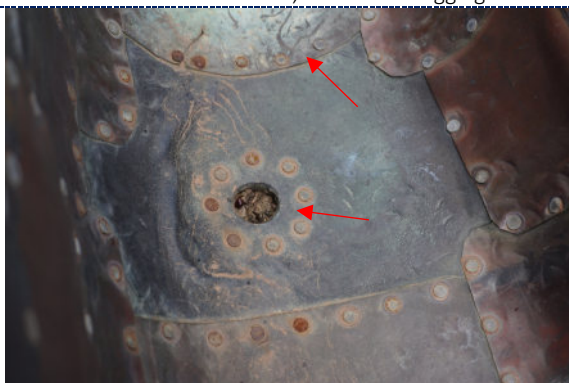
Figure 21: Detail – interior, dirt particulate, green copper corrosion in areas where water pools; biomatter clogging drains.
