# *Broken Hill Public Art Condition Survey and Conservation Plan*

Prepared for: Broken Hill City Council  
Submission Date: February 2023

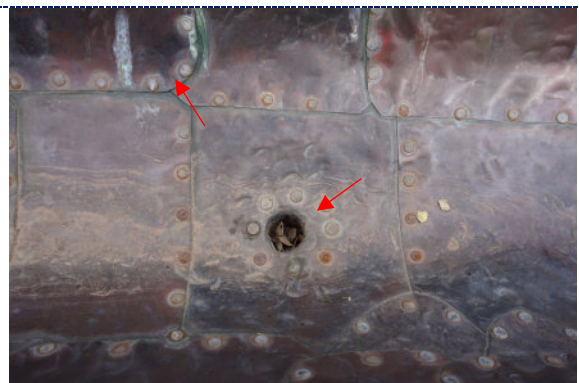
Figure 22: Detail – interior, dirt particulate, copper corrosion stemming from bird excrement; biomatter clogging drains.

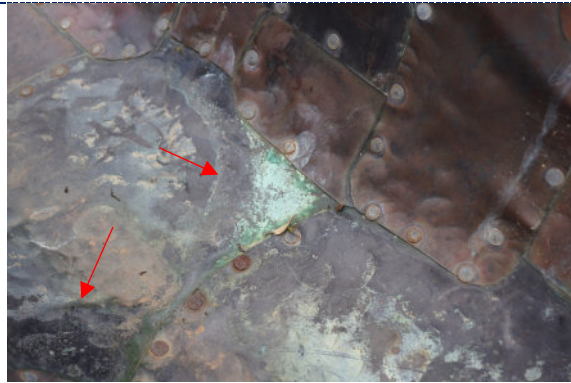
Figure 23: Detail – interior, dirt particulate, green copper corrosion in areas where water pools.

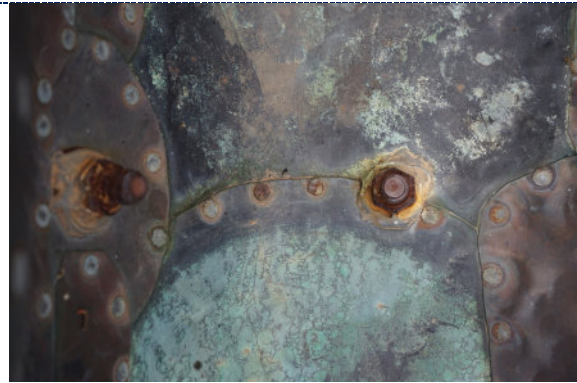
Figure 24: Detail – interior, dirt particulate, green copper corrosion in areas where water pools; corroded bolts where mounts are attached.

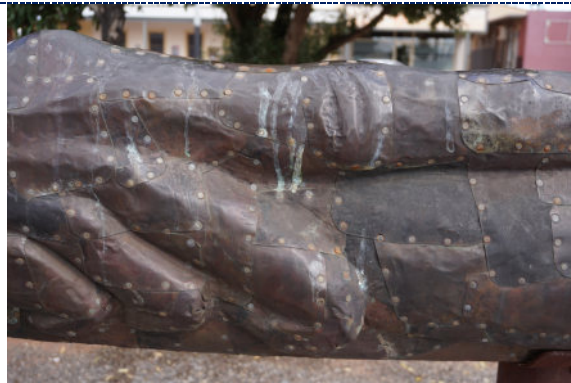
Figure 25: Detail – exterior, dirt particulate; copper corrosion product stemming from bird excrement.

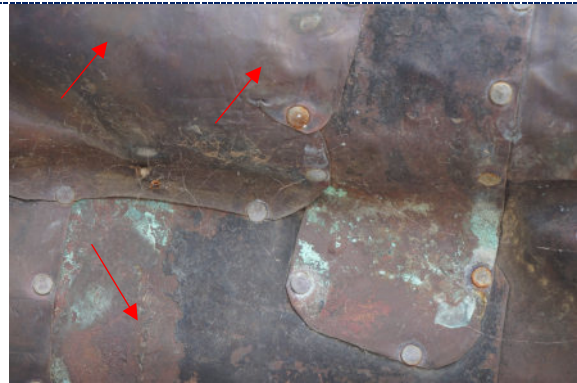
Figure 26: Detail – exterior, dirt particulate, spider webs; minor corrosion to zinc nail heads; isolated surface corrosion.

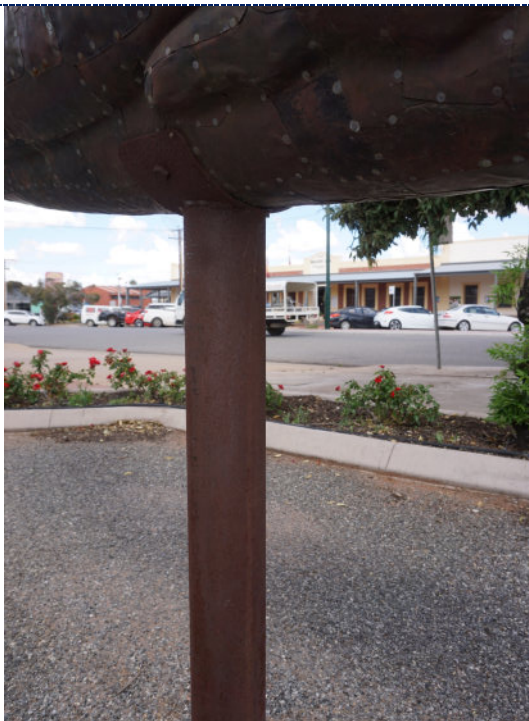
Figure 27: Detail – exterior, surface corrosion on iron mount.

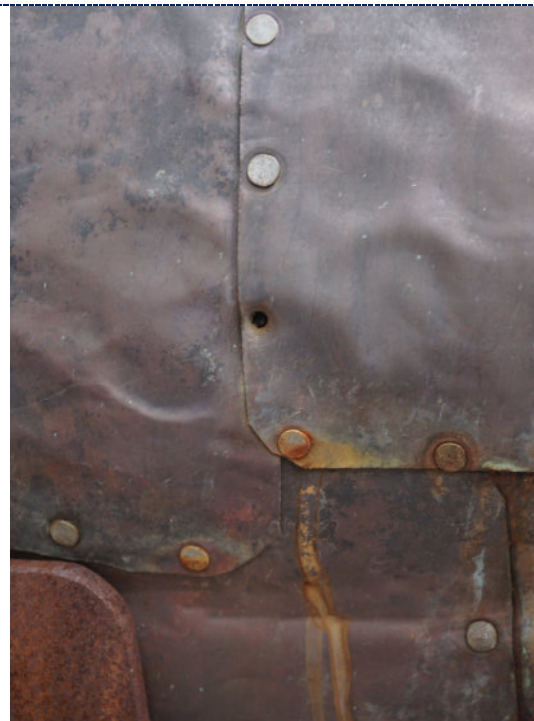
Figure 28: Detail – exterior, missing nail; corroding zinc-iron nails and iron corrosion staining.

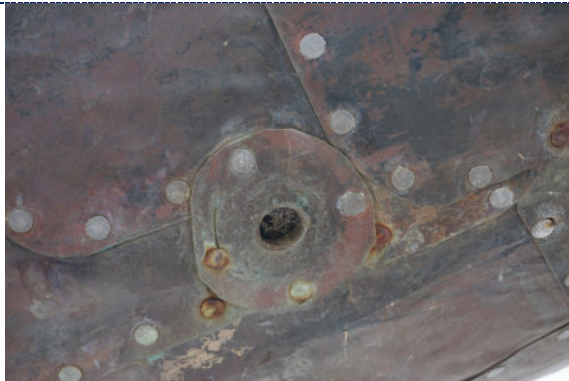
Figure 29: Detail – exterior, dirt particulate, spider webs; corrosion to zinc nail heads; biomatter clogging drains.

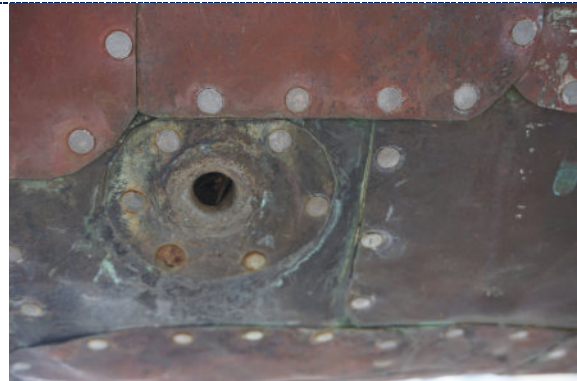
Figure 30: Detail – exterior, dirt particulate, spider webs; corrosion to zinc nail heads; biomatter clogging drains.

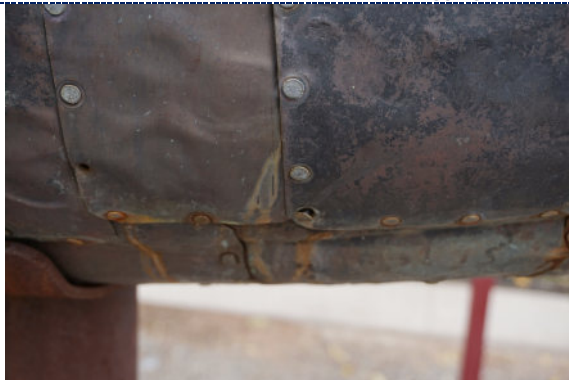
Figure 31: Detail – exterior, missing and loose nail; corroding zinc-iron nails and iron corrosion staining.

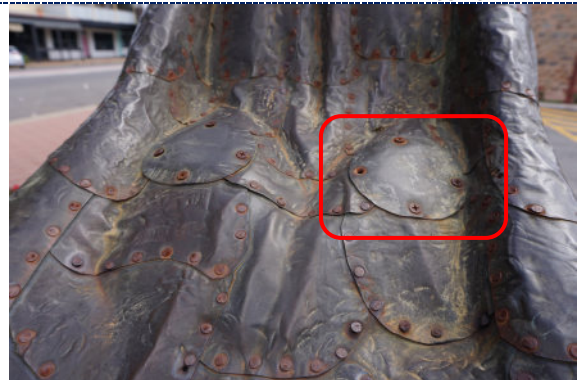
Figure 32: Detail – interior, dirt particulate, corroded iron nails and screws; one screw missing; iron corrosion product staining.

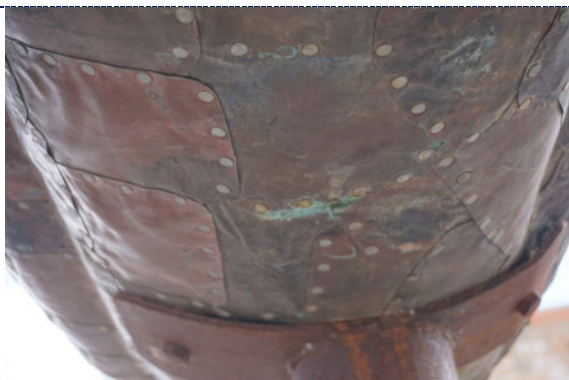
Figure 33: Detail – exterior, copper corrosion product.

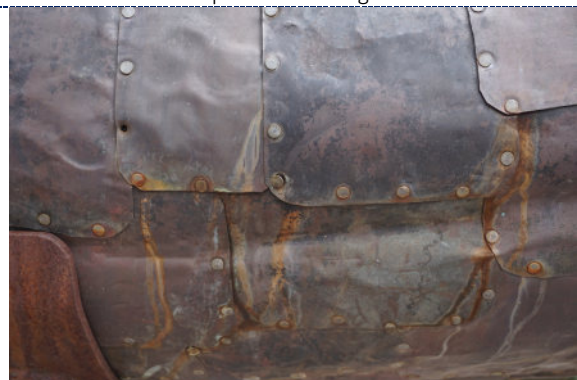
Figure 34: Detail – exterior, missing and loose nail; corroding zinc-iron nails; significant iron corrosion staining.

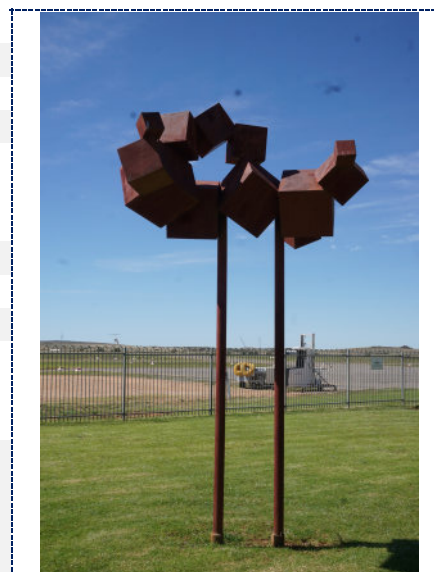
Previous repairs/ modifications?  YES  NO

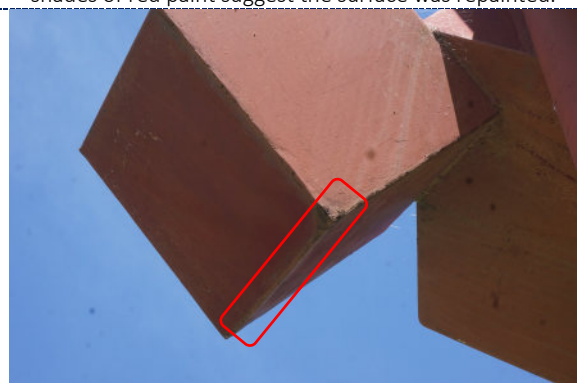
Figure 10: Detail – flaking paint; surface corrosion at join (circle).

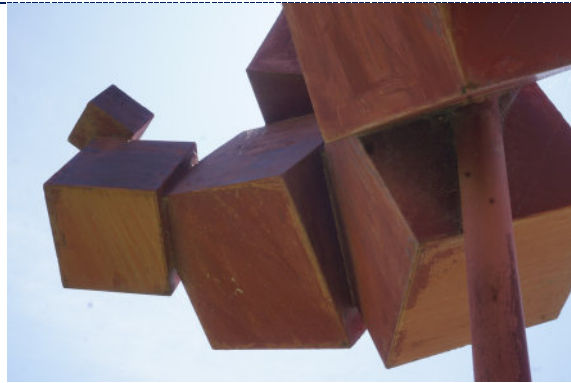
Figure 11: Detail – paint chalking, flaking paint loss with overpaint; dirt particulate and spider webs.

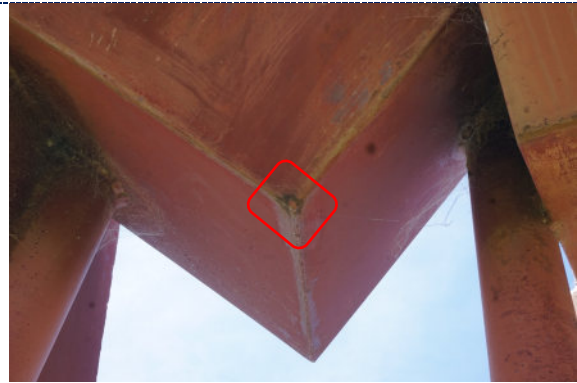
Figure 12: paint chalking, flaking paint loss with overpaint; dirt particulate and spider webs; surface corrosion at corner (circle).

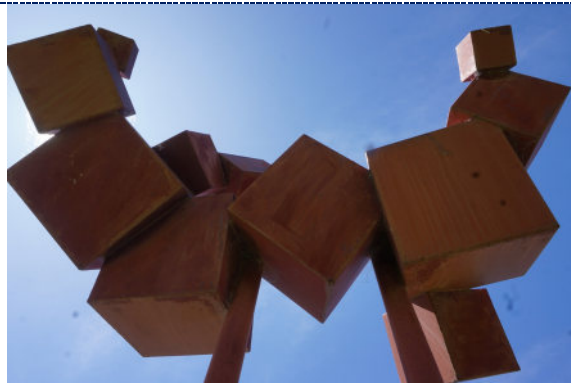
Figure 13: Detail – paint chalking, flaking paint loss with overpaint; dirt particulate and spider webs. The two shades of red paint suggest the surface was repainted.

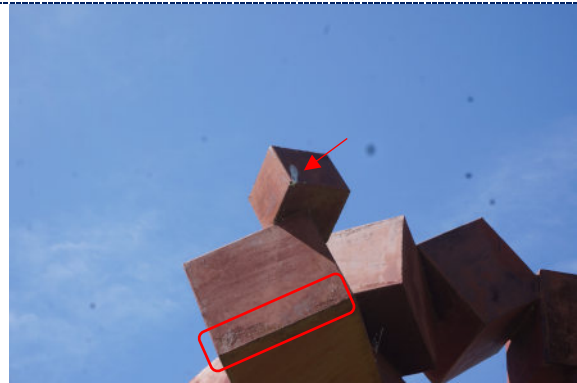
Figure 14: paint chalking, flaking paint loss with overpaint; dirt particulate, spider webs and bird excrement; surface corrosion at join (circle).

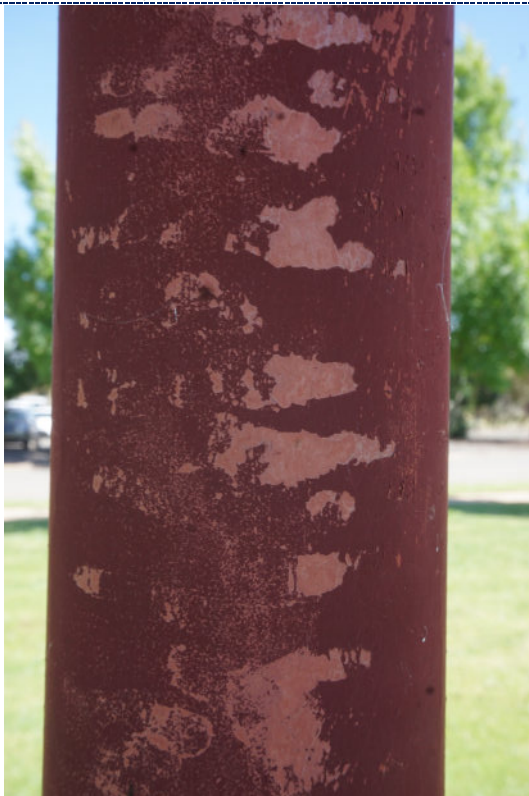
Figure 15: Detail – flaking paint and paint loss.

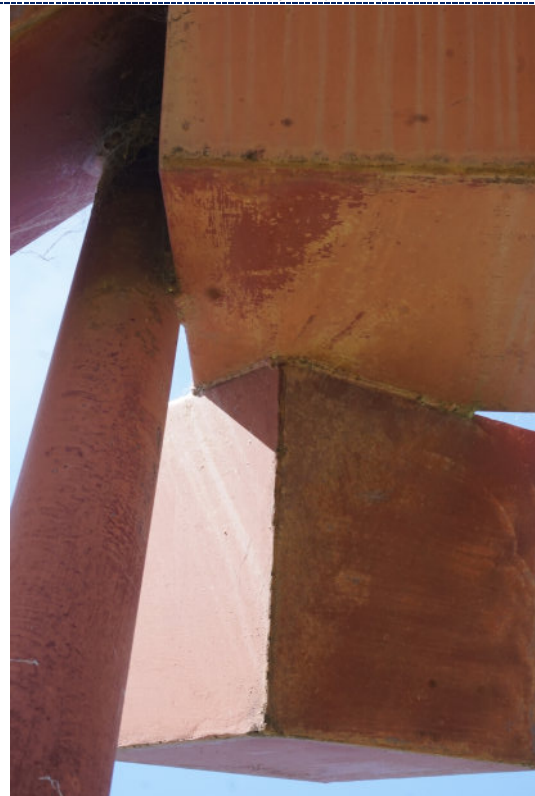
Figure 16: Detail – paint chalking, flaking paint loss; spotted surface corrosion.

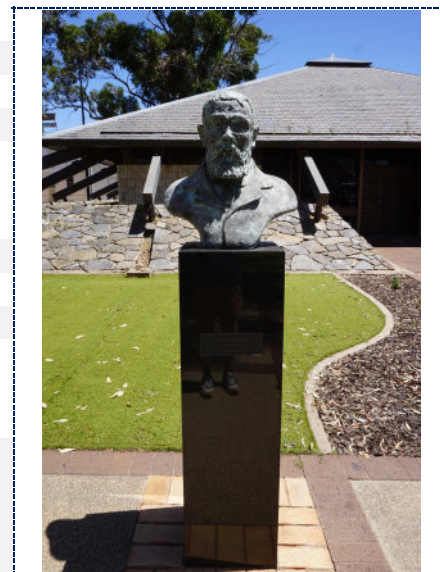
Previous repairs/ modifications?  YES  NO

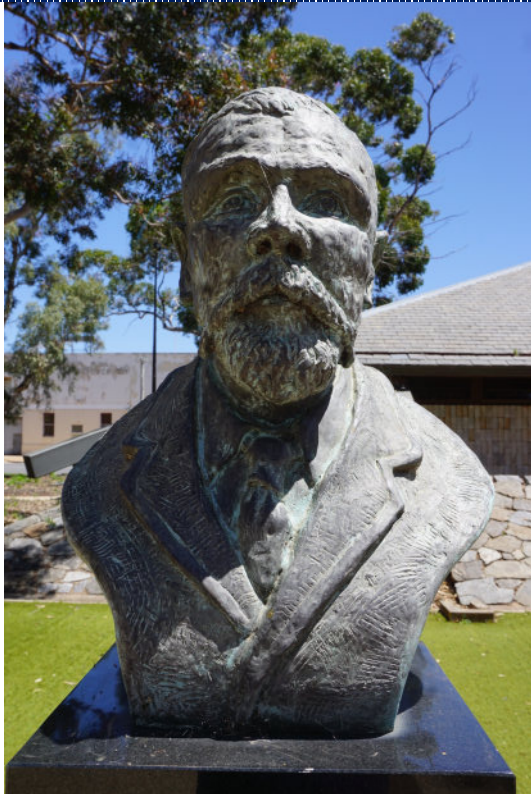
Figure 5: Detail – bust, front. Atmospheric pollution-driven copper corrosion product on bronze figure.

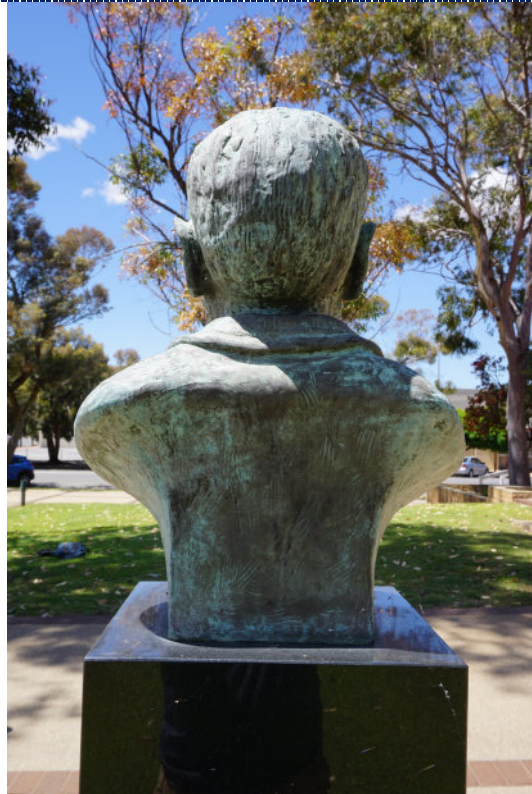
Figure 6: Detail – bust, back. Atmospheric pollution-driven copper corrosion product on bronze figure.

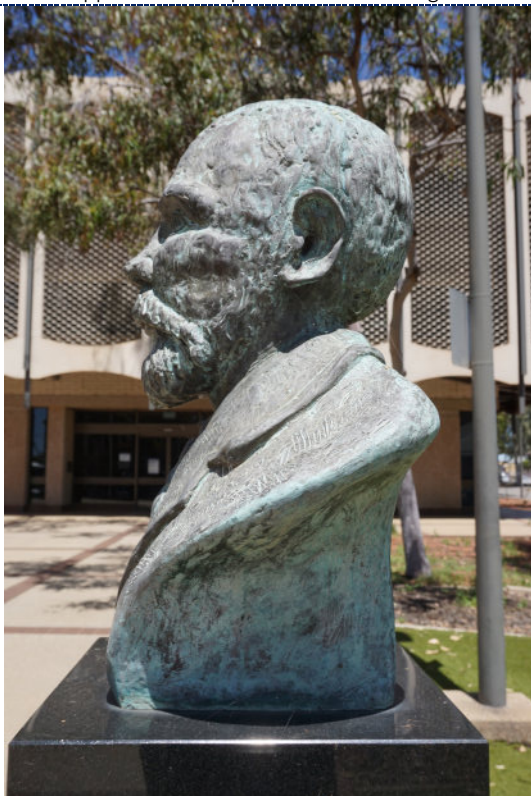
Figure 7: Detail – bust, proper left. Atmospheric pollution-driven copper corrosion product on bronze figure.

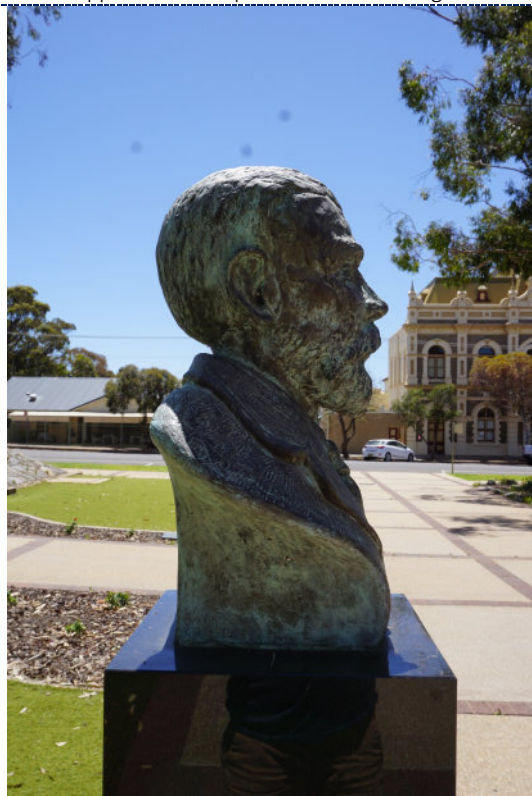
Figure 8: Detail – bust, proper right. Atmospheric pollution-driven copper corrosion product on bronze figure.

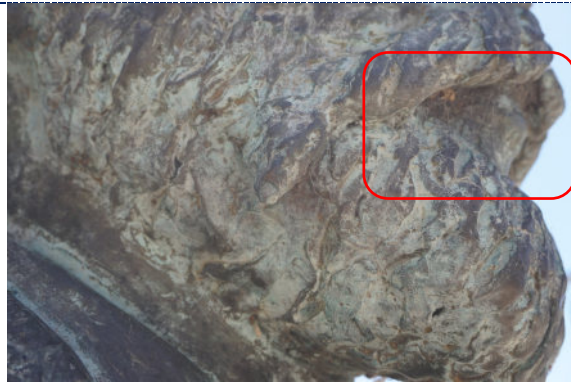
Figure 9: Detail – atmospheric pollution-driven copper corrosion product, dirt particulate, spider webs.

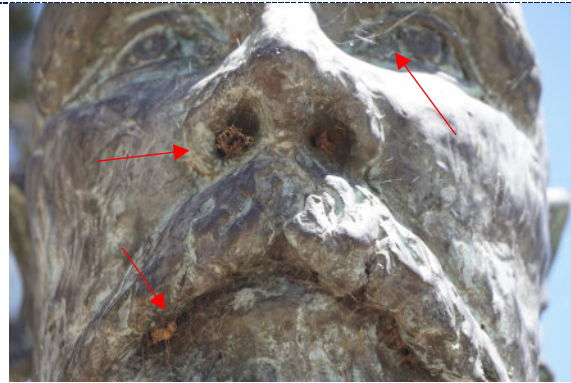
Figure 10: Detail – atmospheric pollution-driven copper corrosion product, dirt particulate, spider webs.

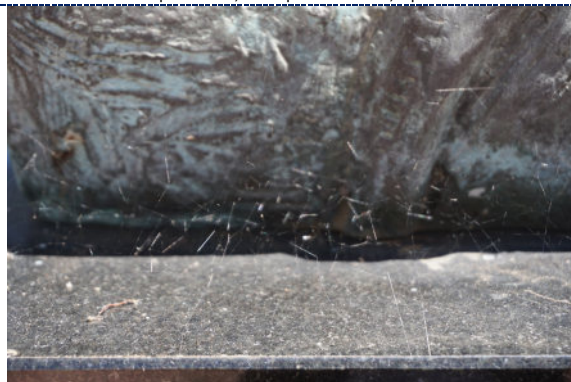
Figure 11: Detail – atmospheric pollution-driven copper corrosion product, dirt particulate, spider webs.

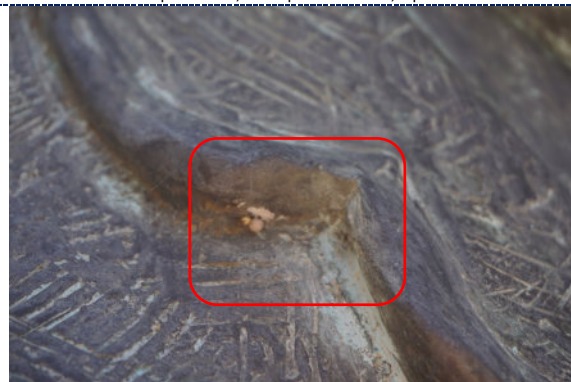
Figure 12: Detail – atmospheric pollution-driven copper corrosion product, dirt particulate, spider webs.

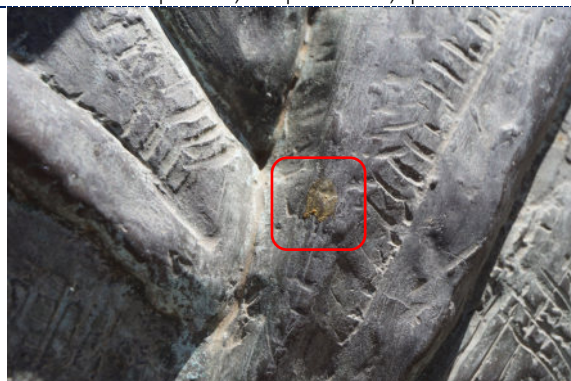
Figure 13: Detail – atmospheric pollution-driven copper corrosion product and bird excrement.

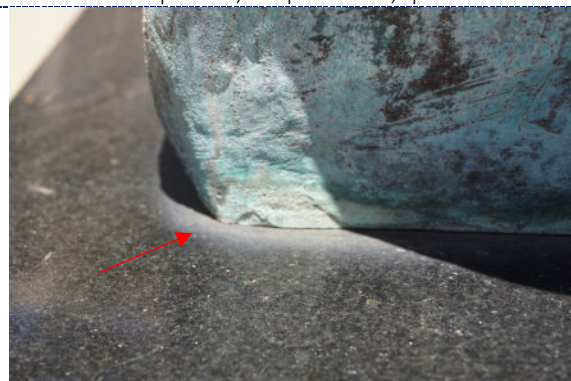
Figure 14: Detail – increased copper corrosion product stemming from collected water at plinth interface.

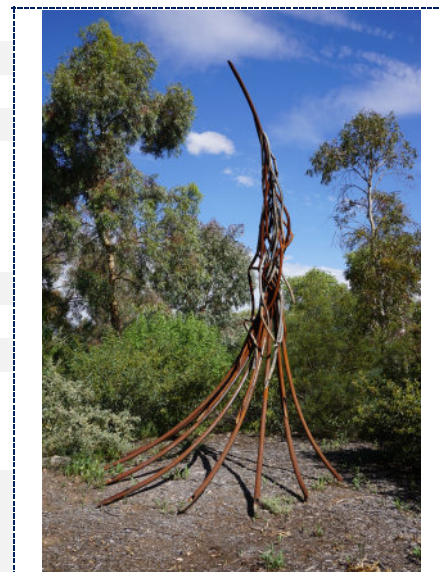
Previous repairs/ modifications?  YES  NO

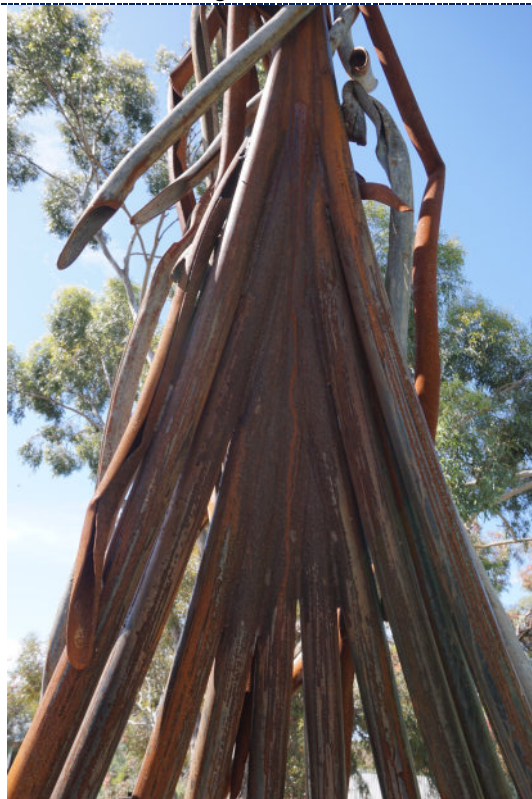
Figure 4: Detail – surface corrosion.

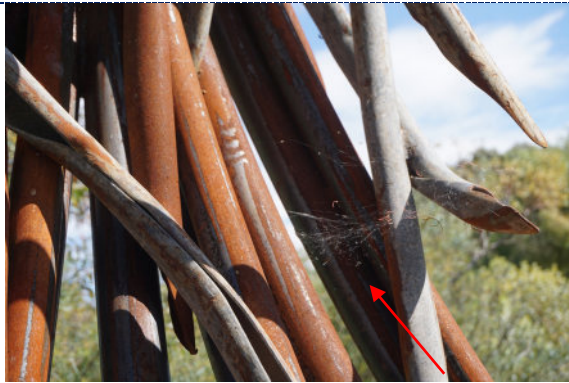
Figure 5: Detail – dirt particulate, spider webs; surface corrosion.

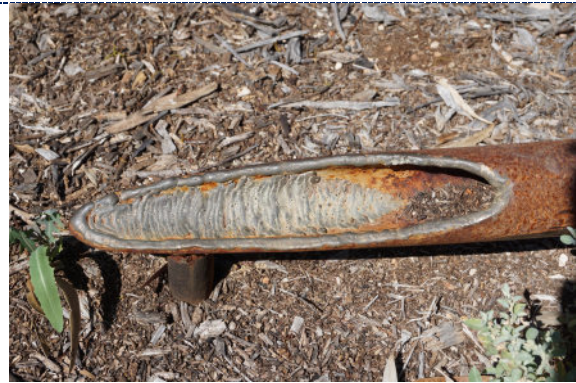
Figure 6: Detail – dirt particulate within tube; surface corrosion.

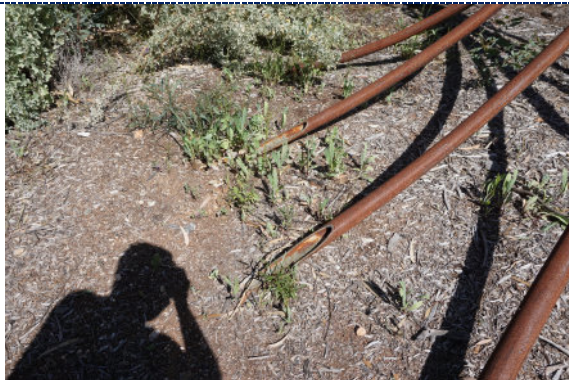
Figure 7: Detail – dirt particulate; rolled steel mounted at ground; accumulation of biomatter.

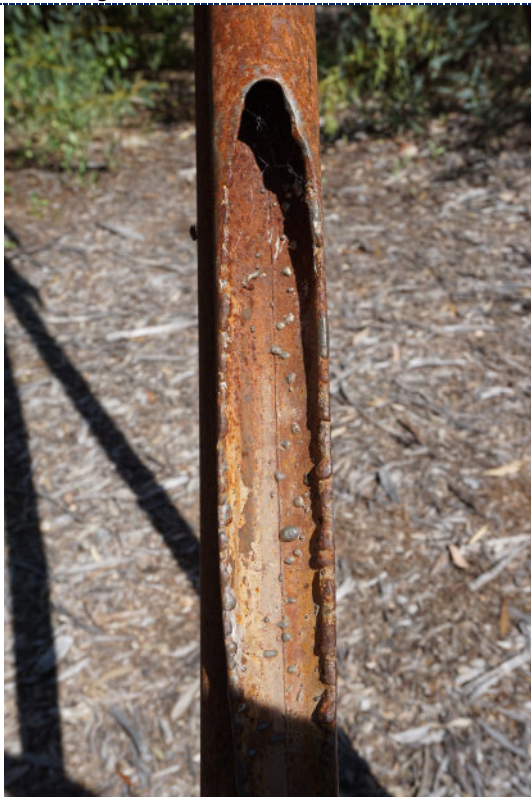
Figure 9: Detail – dirt particulate; surface corrosion.

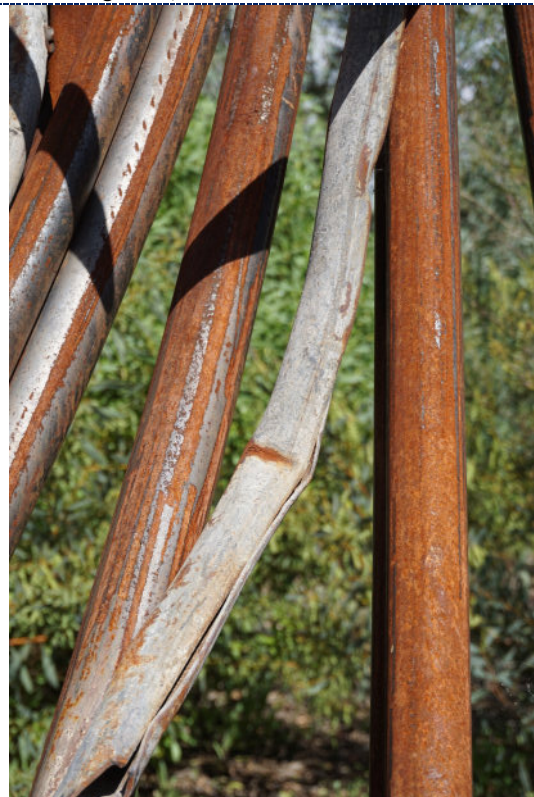
Figure 10: Detail – dirt particulate; surface corrosion.

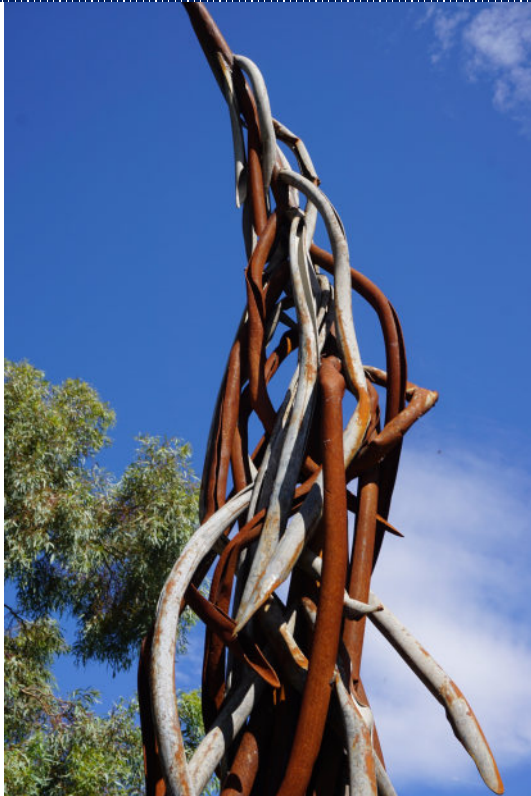
Figure 11: Detail – surface corrosion.

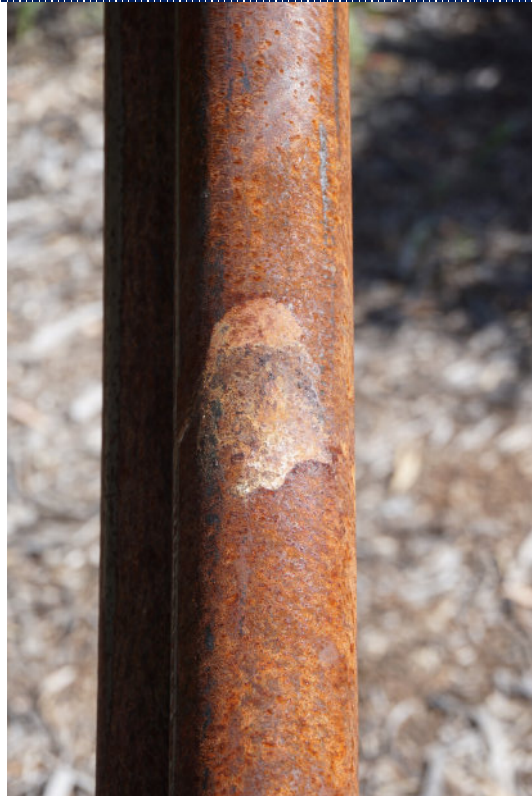
Figure 12: Detail – bird excrement; surface corrosion.

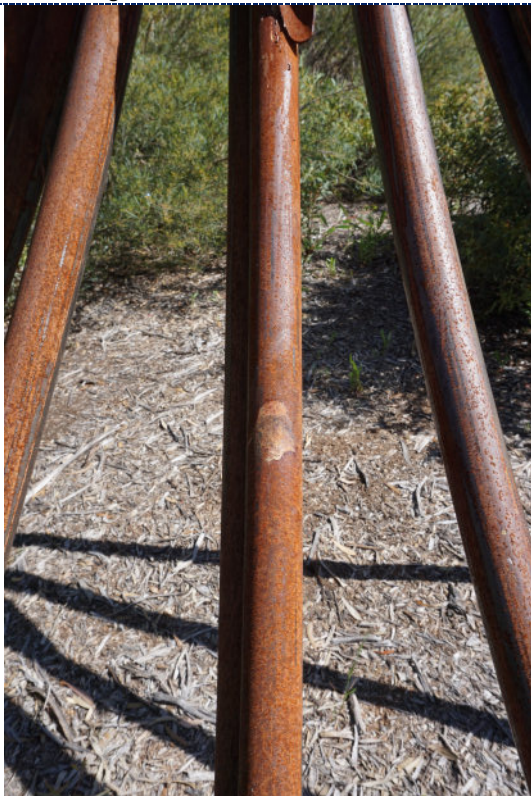
Figure 13: Detail – bird excrement; surface corrosion.

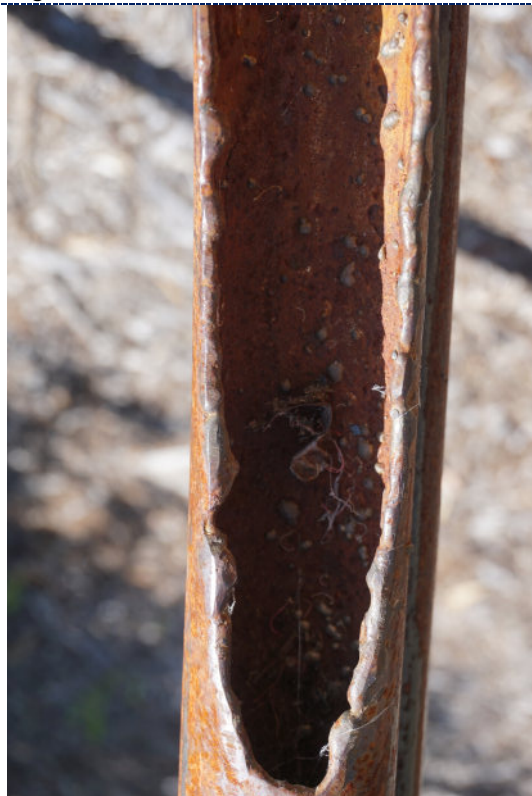
Figure 14: Detail – spider webs; surface corrosion.

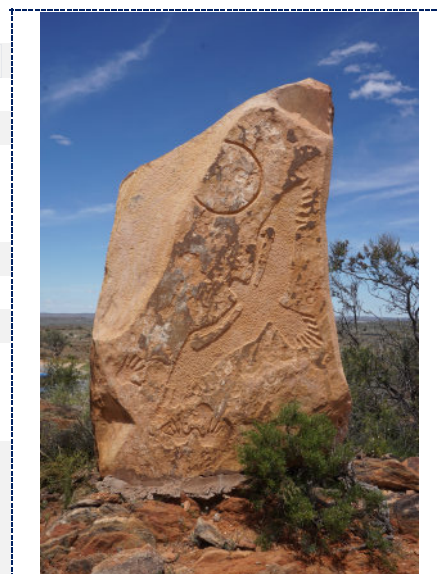
Previous repairs/ modifications?  YES  NO

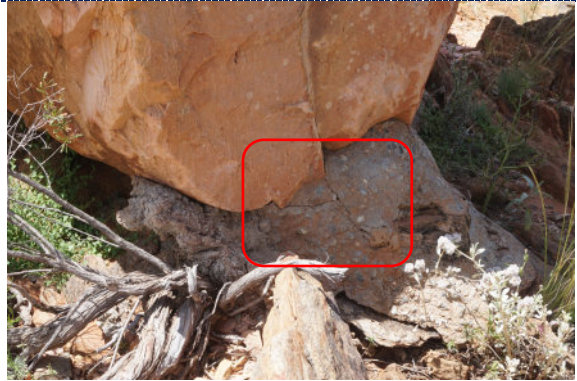
Figure 6: Detail – several small cracks to concrete mortar.

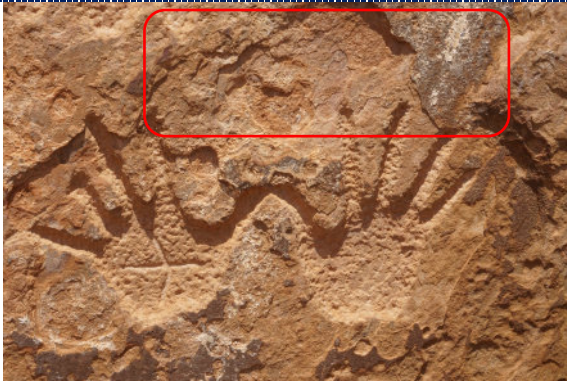
Figure 7: Detail – possible delamination to sandstone substrate.

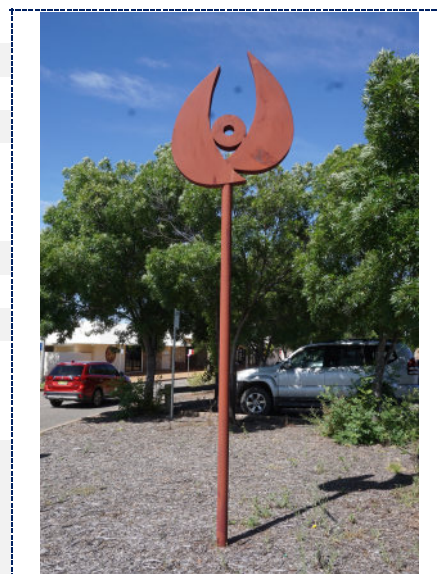
Previous repairs/ modifications?  YES  NO

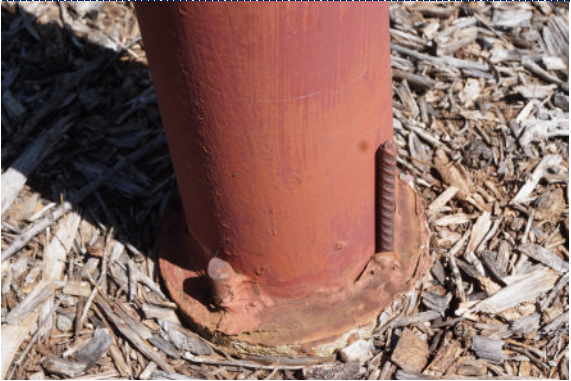
Figure 6: Detail – paint chalking, flaking paint loss with overpaint; corrosion at base.

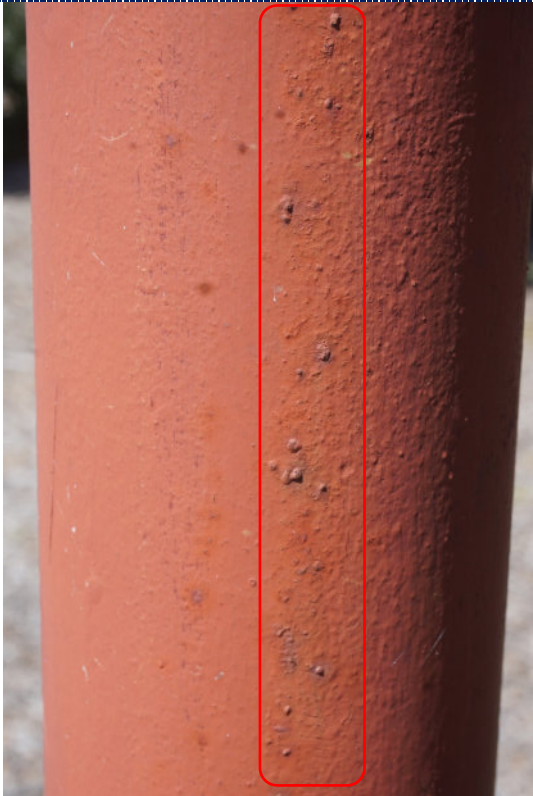
Figure 7: Detail – paint chalking, blister corrosion with flaking paint.

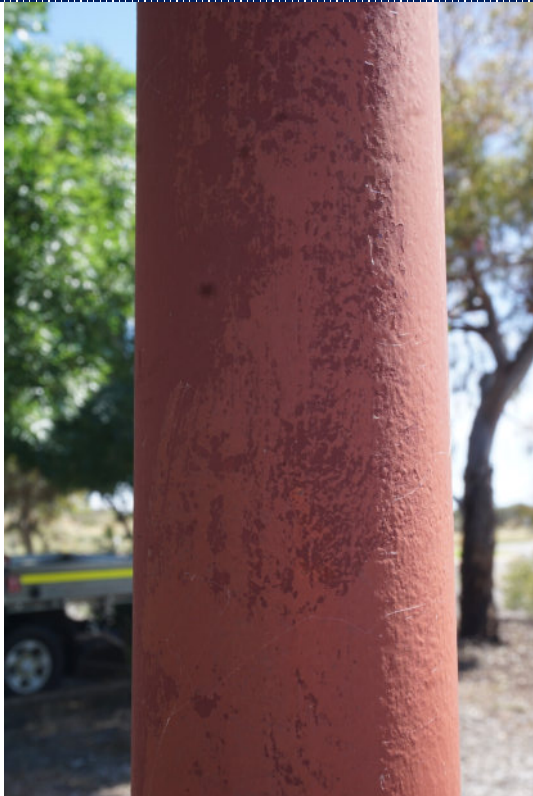
Figure 8: Detail – paint chalking, flaking paint loss with overpaint.

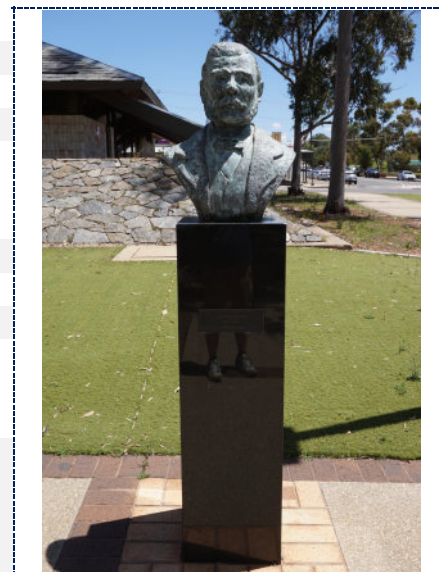
Previous repairs/ modifications?  YES  NO

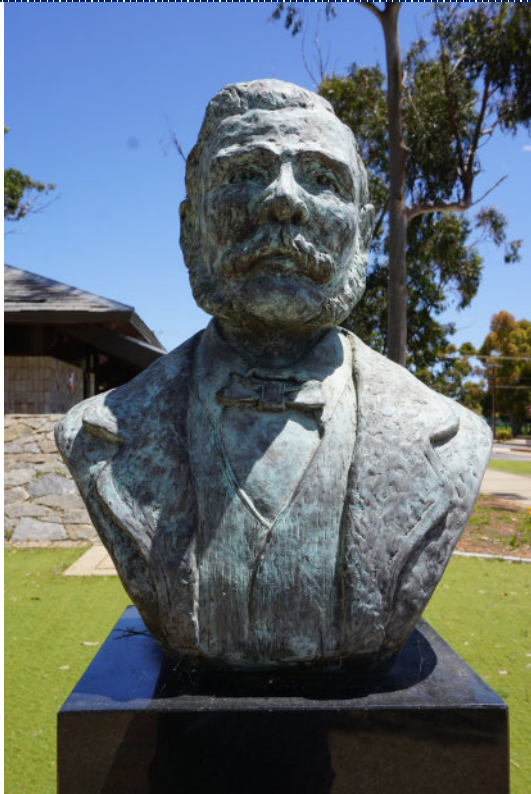
Figure 5: Detail – bust, front. Atmospheric pollution-driven copper corrosion product on bronze figure.

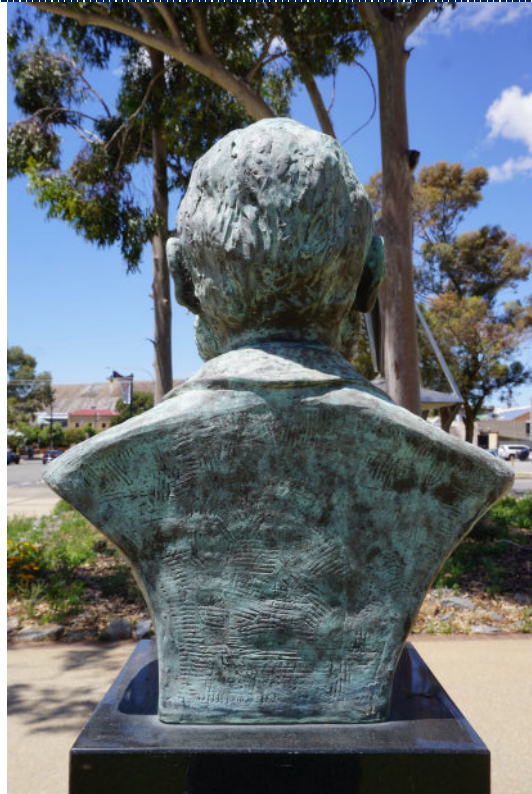
Figure 6: Detail – bust, back. Atmospheric pollution-driven copper corrosion product on bronze figure.

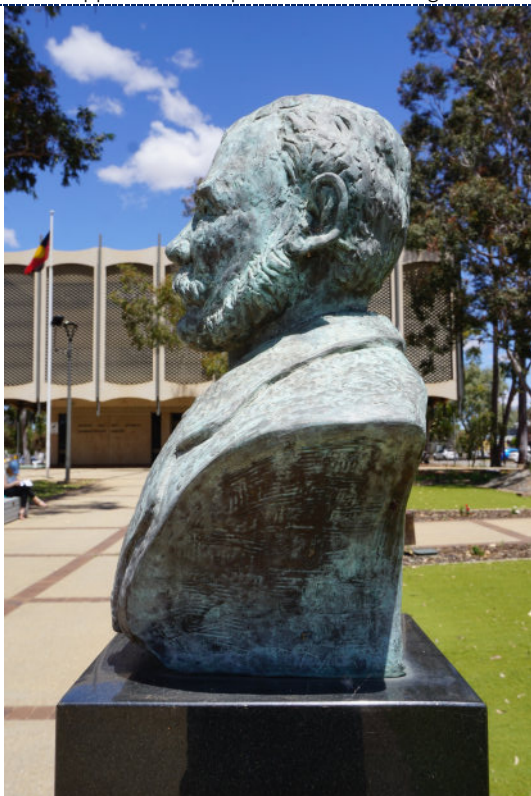
Figure 7: Detail – bust, proper left. Atmospheric pollution-driven copper corrosion product on bronze figure.

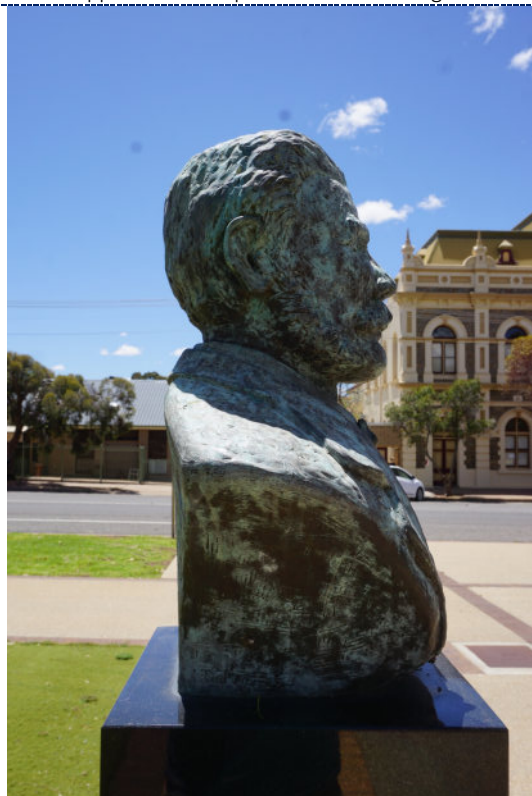
Figure 8: Detail – bust, proper right. Atmospheric pollution-driven copper corrosion product on bronze figure.

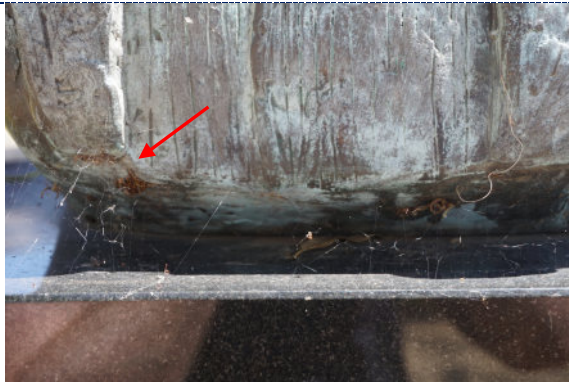
Figure 9: Detail – atmospheric pollution-driven copper corrosion product, dirt particulate, spider webs.

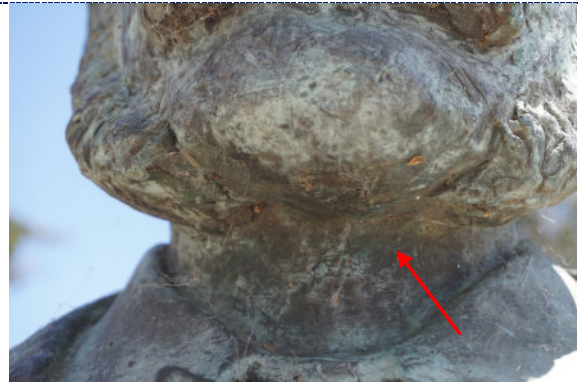
Figure 10: Detail – atmospheric pollution-driven copper corrosion product, dirt particulate, spider webs.

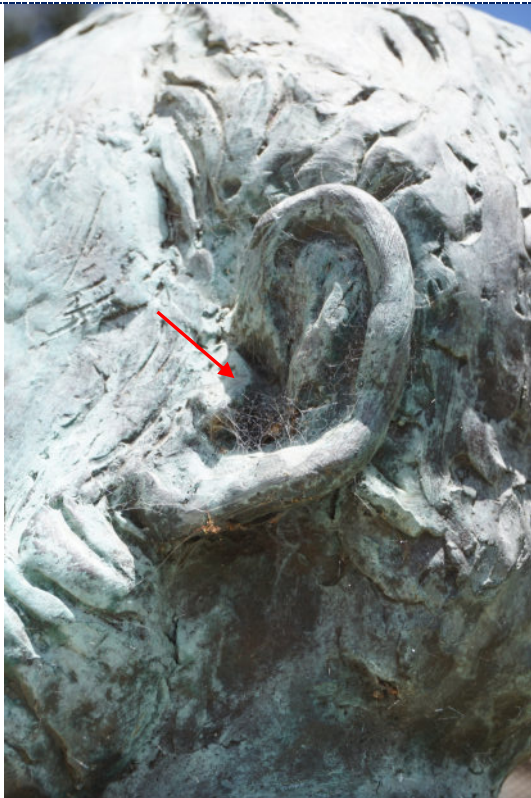
Figure 11: Detail – atmospheric pollution-driven copper corrosion product, dirt particulate, spider webs.

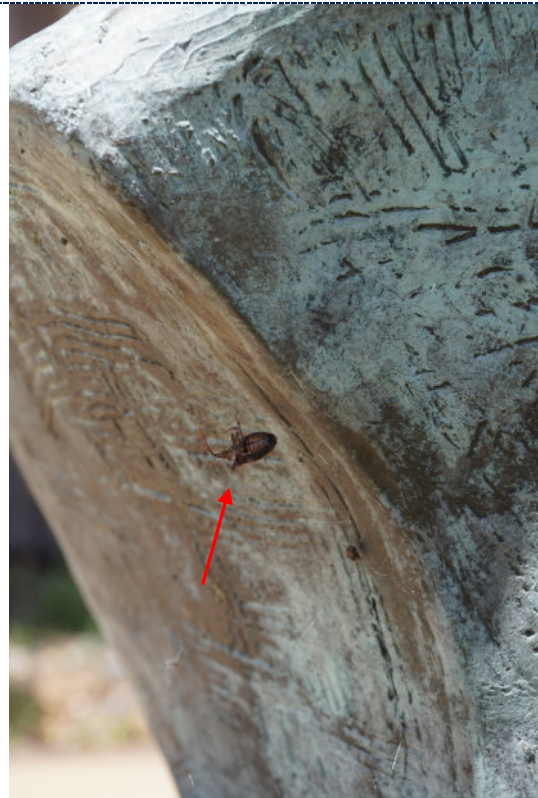
Figure 12: Detail – atmospheric pollution-driven copper corrosion product, dirt particulate, spider webs.

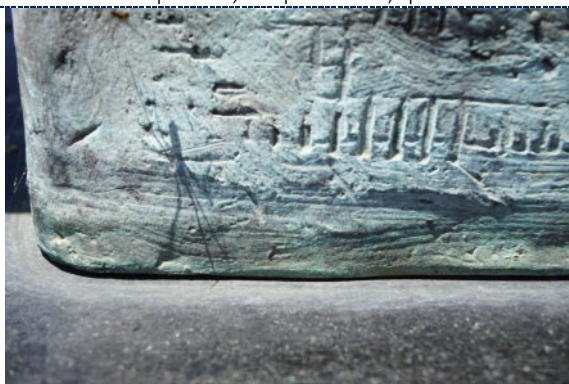
Figure 13: Detail – dirt particulate and increased copper corrosion product stemming from collected water at plinth interface.

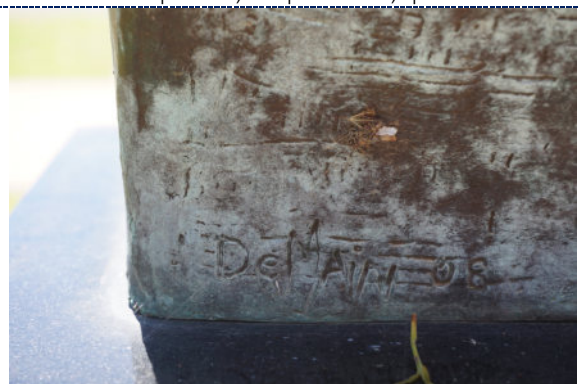
Figure 14: Detail – atmospheric pollution-driven copper corrosion product and artist's signature.

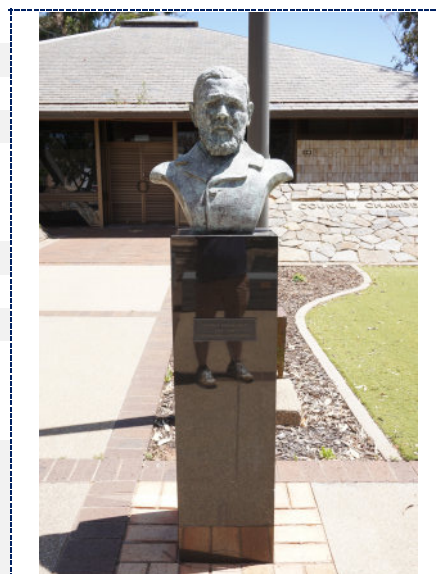
Previous repairs/ modifications?  YES  NO

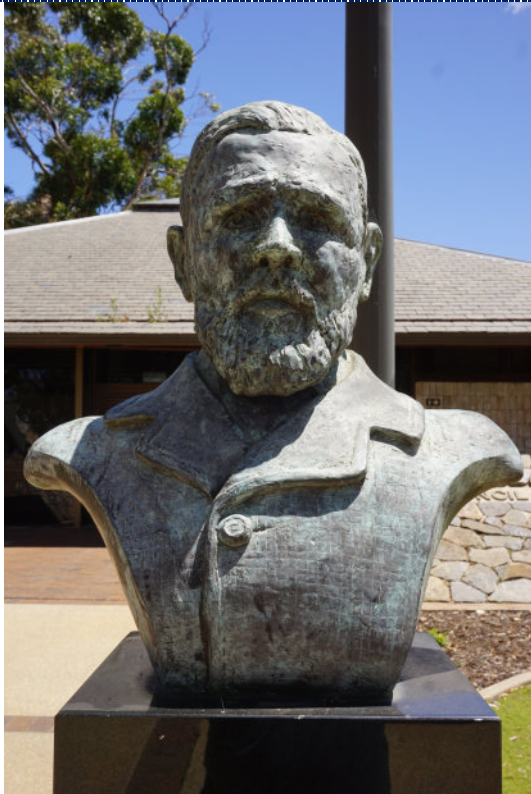
Figure 5: Detail – bust, front. Atmospheric pollution-driven copper corrosion product on bronze figure.

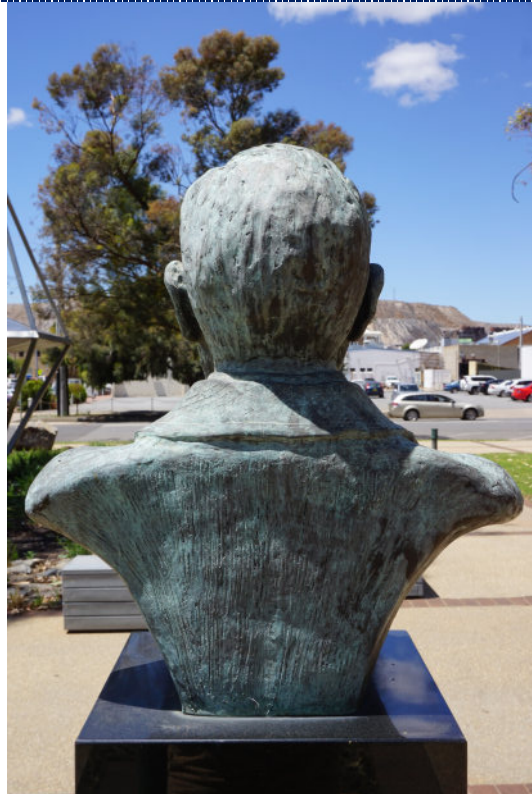
Figure 6: Detail – bust, back. Atmospheric pollution-driven copper corrosion product on bronze figure.

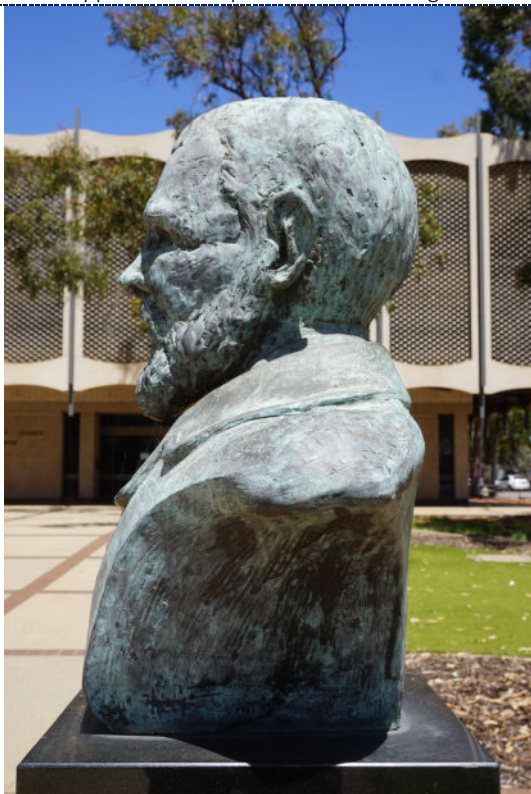
Figure 7: Detail – bust, proper left. Atmospheric pollution-driven copper corrosion product on bronze figure.

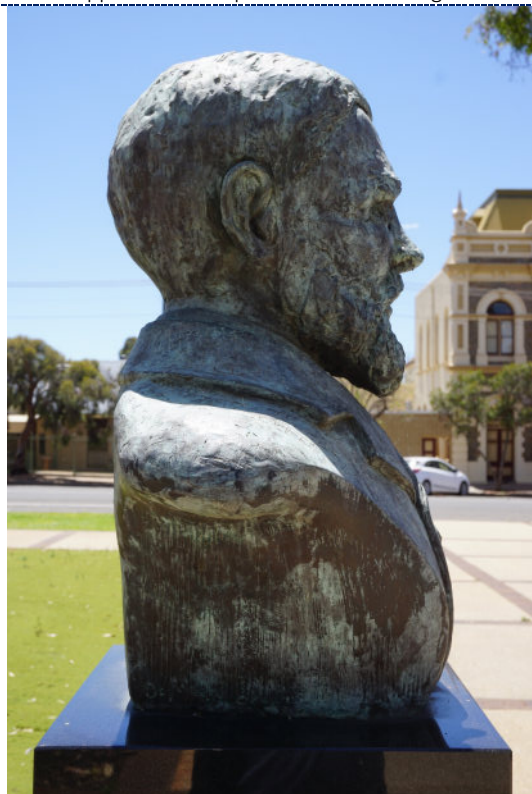
Figure 8: Detail – bust, proper right. Atmospheric pollution-driven copper corrosion product on bronze figure.

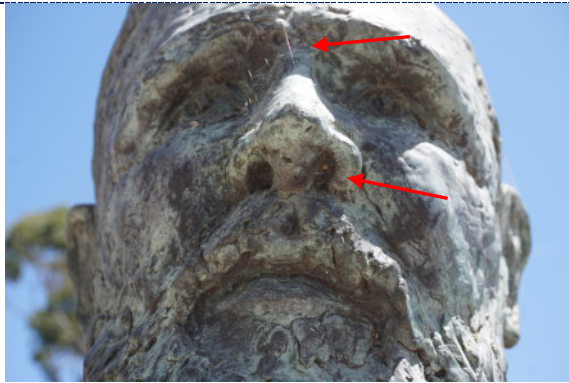
Figure 9: Detail – atmospheric pollution-driven copper corrosion product, dirt particulate, spider webs.

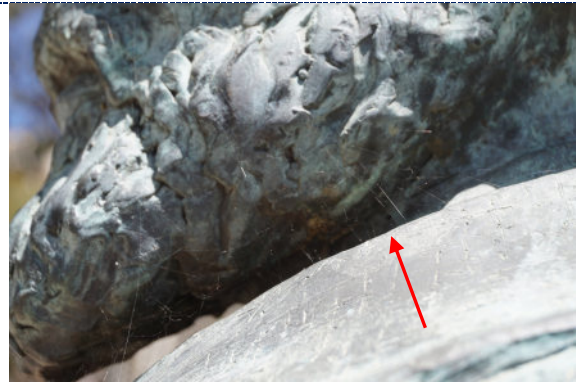
Figure 10: Detail – atmospheric pollution-driven copper corrosion product, dirt particulate, spider webs.

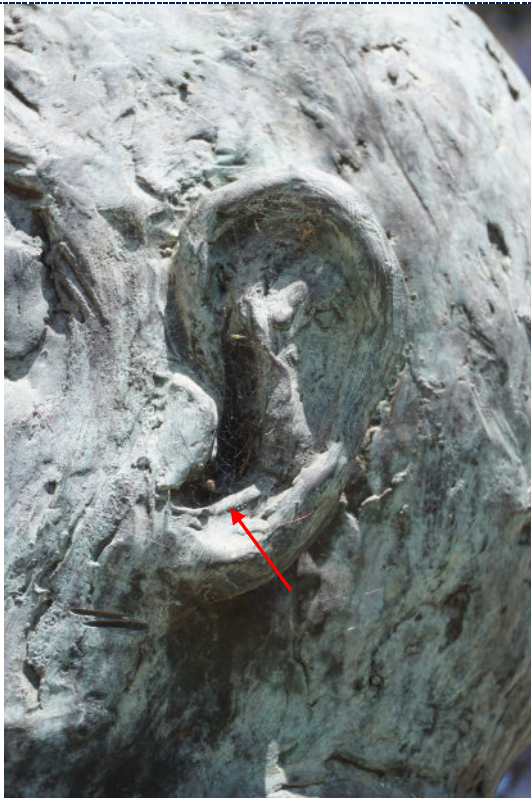
Figure 11: Detail – atmospheric pollution-driven copper corrosion product, dirt particulate, spider webs.

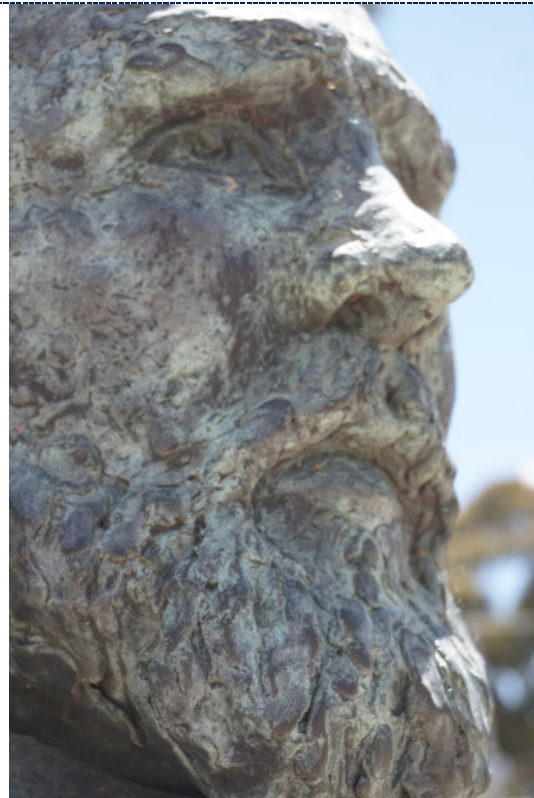
Figure 12: Detail – atmospheric pollution-driven copper corrosion product, dirt particulate, spider webs.
