# *Broken Hill Public Art Condition Survey and Conservation Plan*

Prepared for: Broken Hill City Council  
Submission Date: February 2023

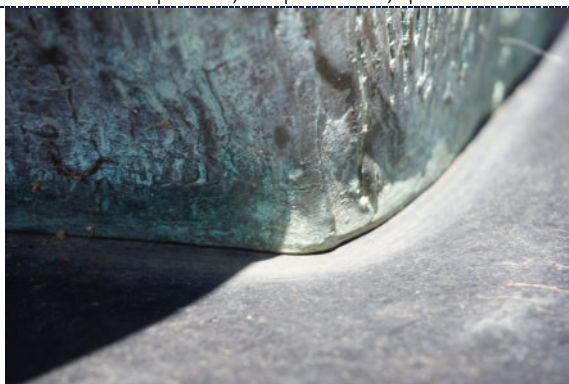
Figure 13: Detail – atmospheric pollution-driven copper corrosion product, dirt particulate, spider webs.

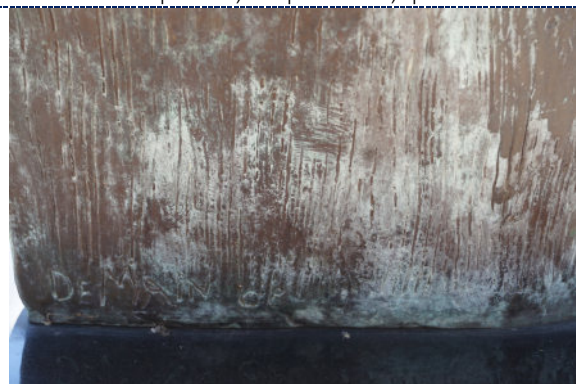
Figure 14: Detail – atmospheric pollution-driven copper corrosion product and artist's signature.

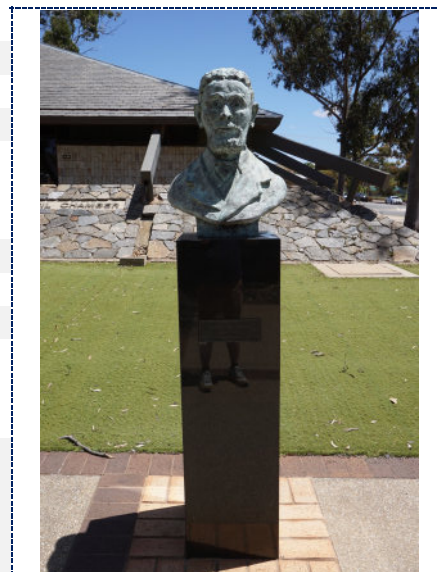
Previous repairs/ modifications?  YES  NO

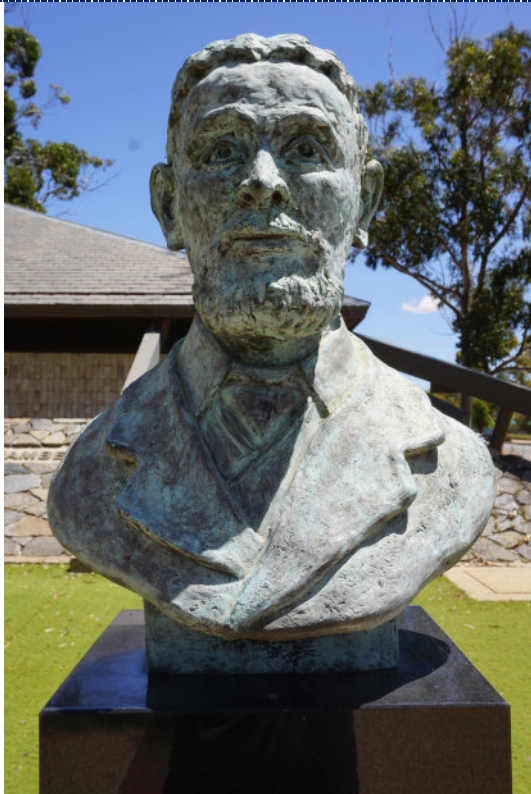
Figure 5: Detail – bust, front. Atmospheric pollution-driven copper corrosion product on bronze figure.

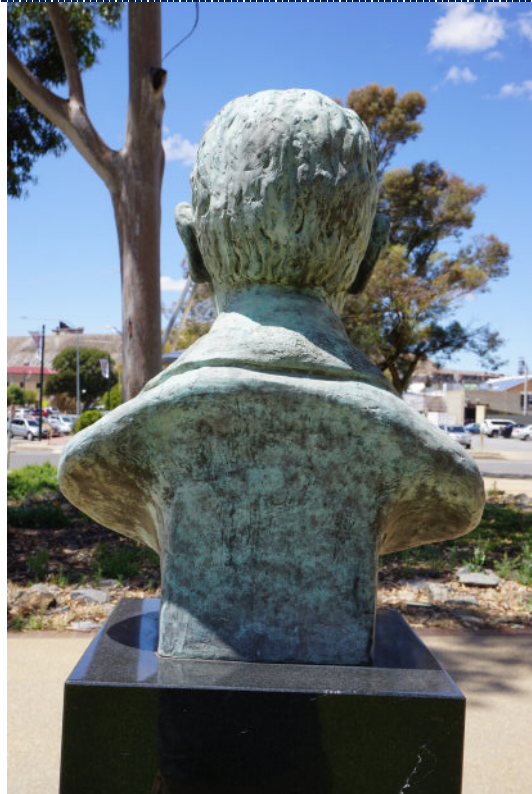
Figure 6: Detail – bust, back. Atmospheric pollution-driven copper corrosion product on bronze figure.

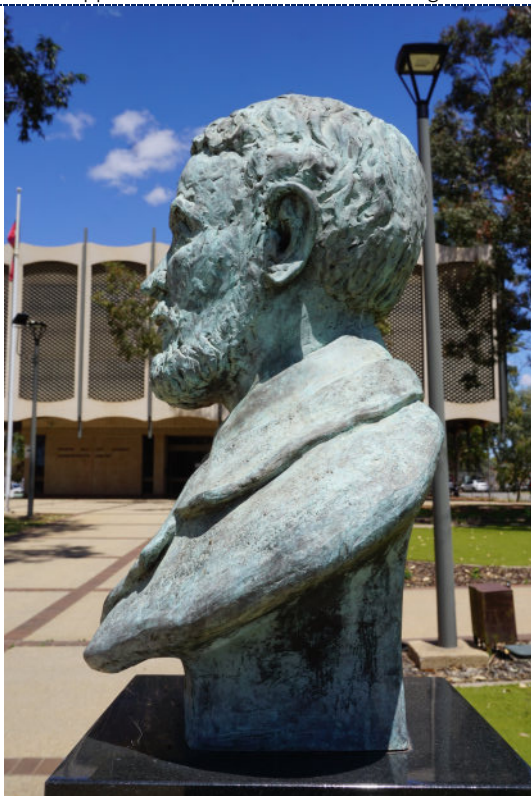
Figure 7: Detail – bust, proper left. Atmospheric pollution-driven copper corrosion product on bronze figure.

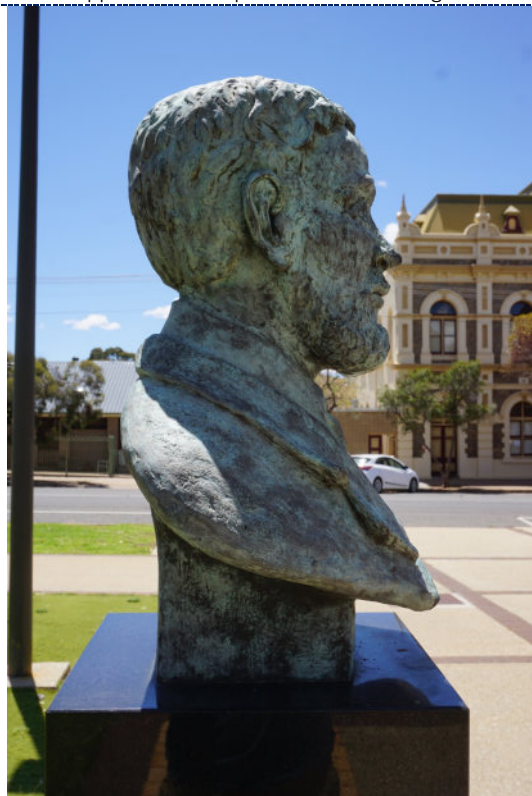
Figure 8: Detail – bust, proper right. Atmospheric pollution-driven copper corrosion product on bronze figure.

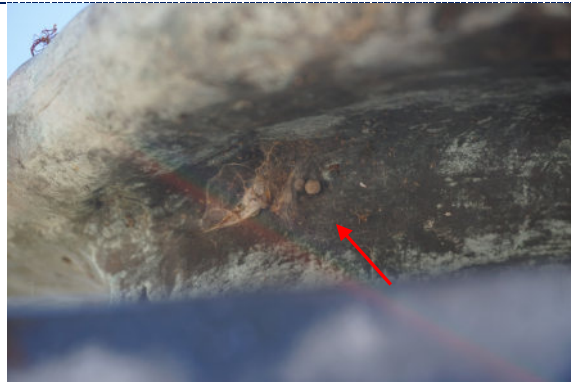
Figure 9: Detail – atmospheric pollution-driven copper corrosion product, dirt particulate, spider webs.

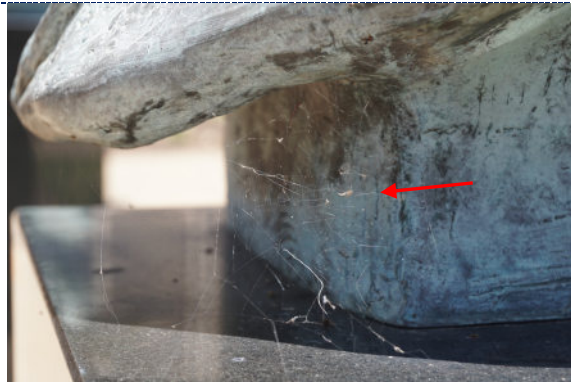
Figure 10: Detail – atmospheric pollution-driven copper corrosion product, dirt particulate, spider webs.

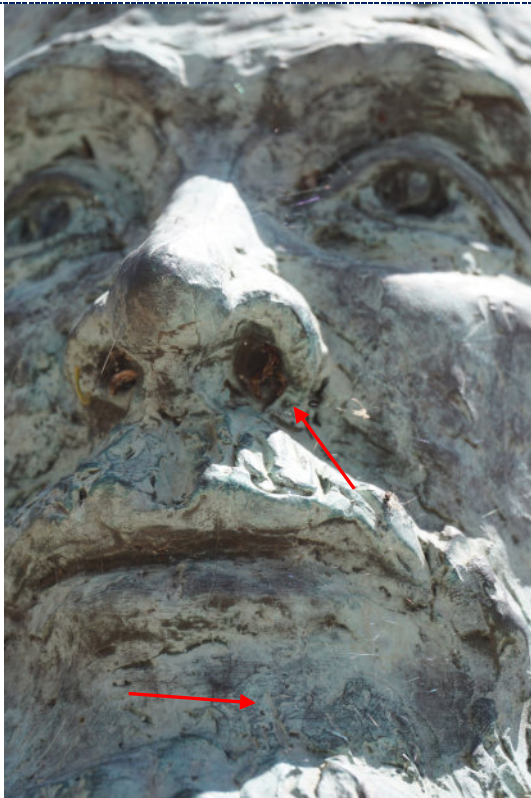
Figure 11: Detail – atmospheric pollution-driven copper corrosion product, dirt particulate, spider webs.

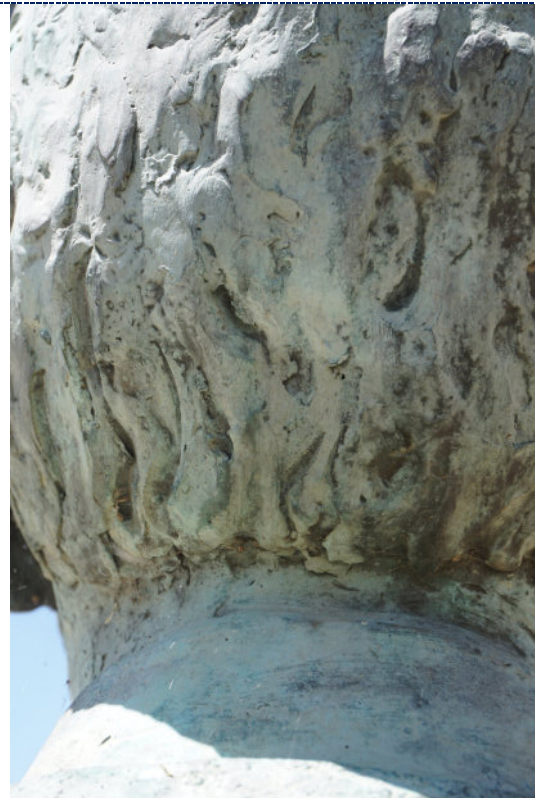
Figure 12: Detail – atmospheric pollution-driven copper corrosion product, dirt particulate, spider webs.

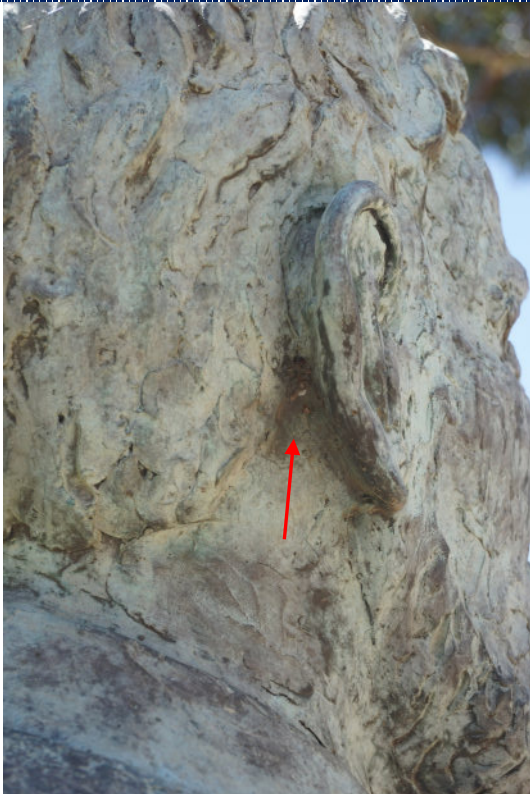
Figure 13: Detail – atmospheric pollution-driven copper corrosion product, dirt particulate, spider webs.

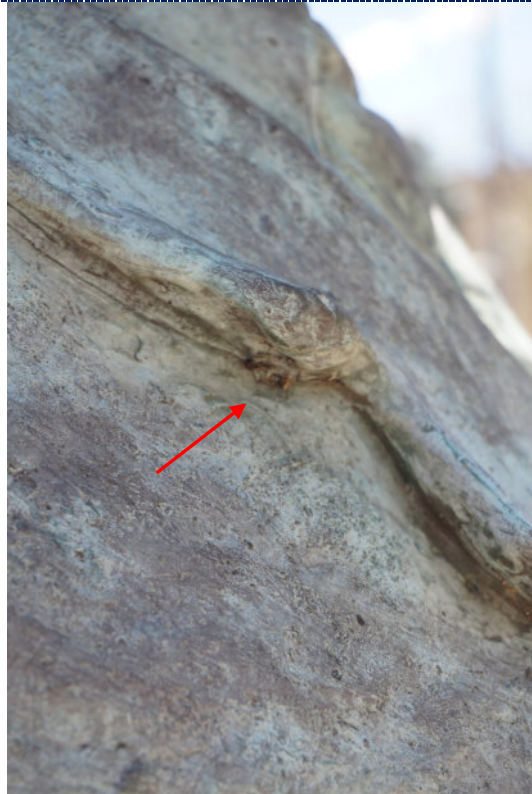
Figure 14: Detail – atmospheric pollution-driven copper corrosion product, dirt particulate, spider webs.

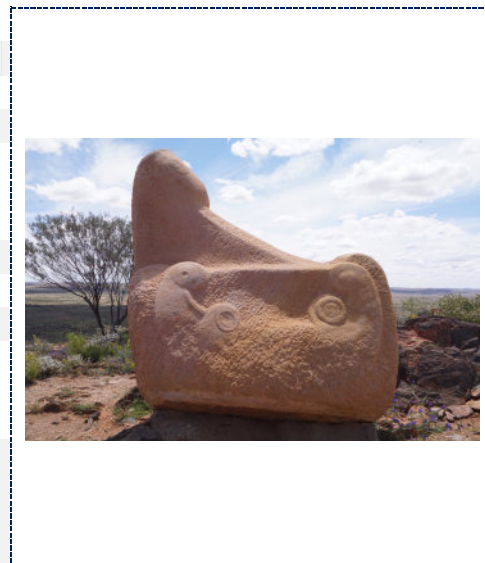
Previous repairs/ modifications?  YES  X NO

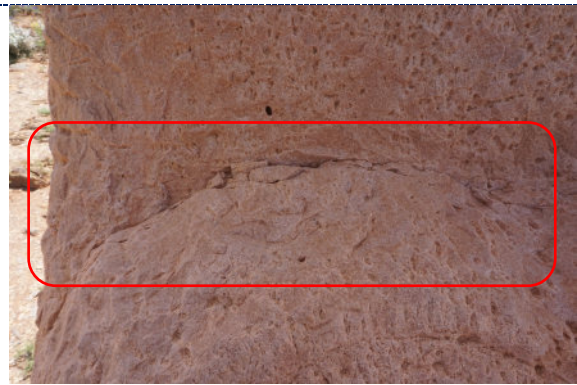
Figure 8: Detail – horizontal crack with minor stone delamination.

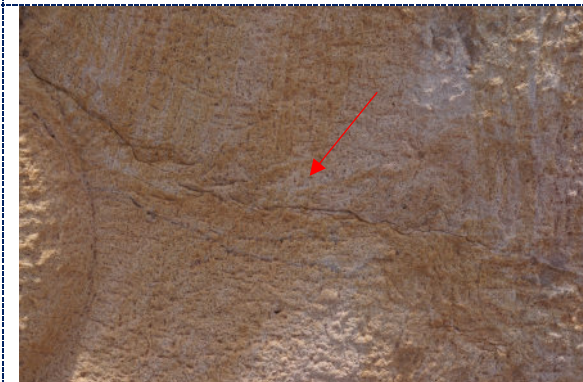
Figure 9: Detail – horizontal crack with minor stone delamination.

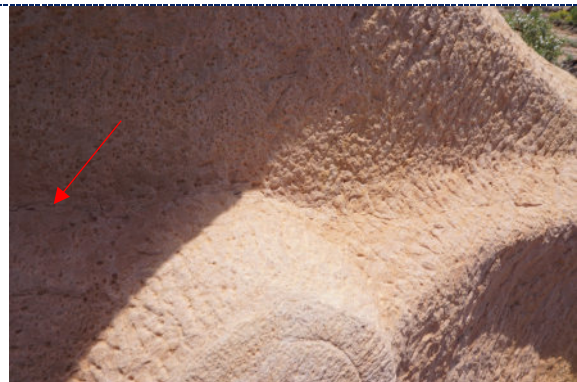
Figure 10: Detail – horizontal crack with minor stone delamination.

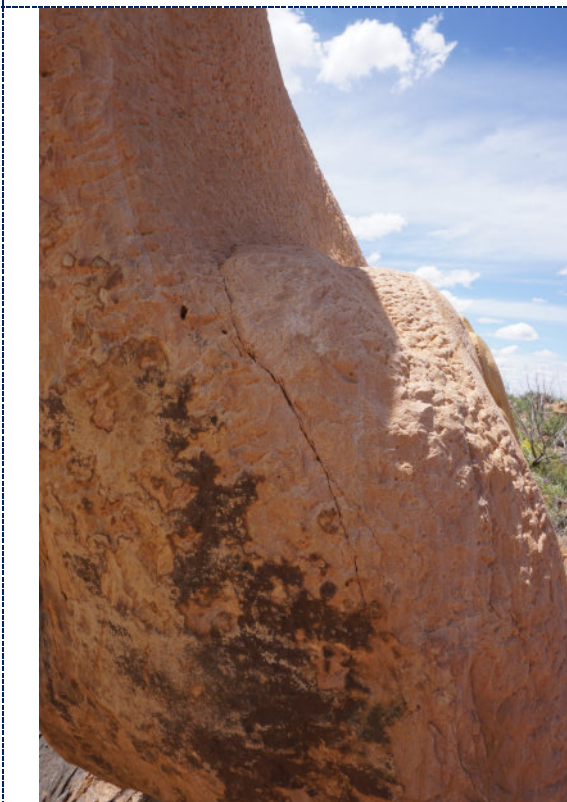
Figure 11: Detail – vertical crack with minor stone delamination.

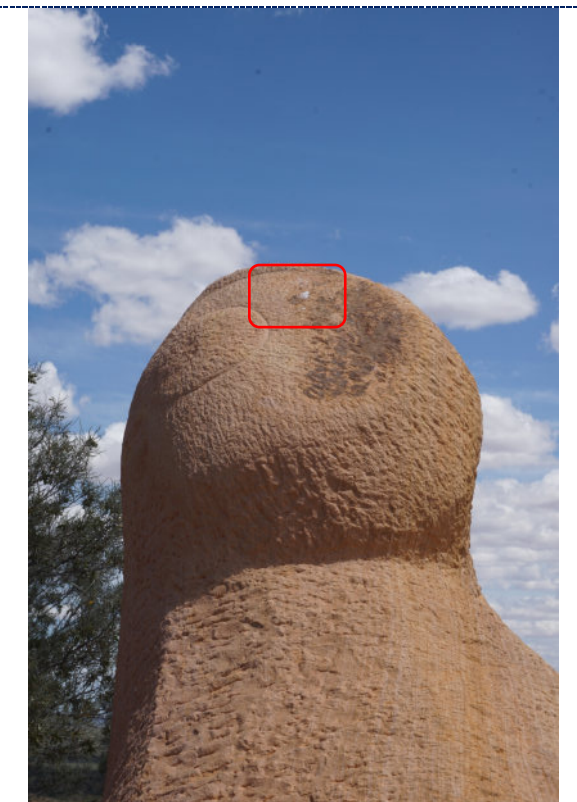
Figure 12: Detail – white accretion, likely bird excrement.

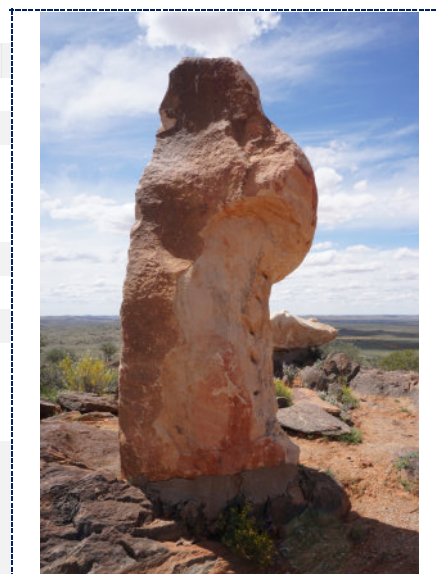
Previous repairs/ modifications?  YES  NO

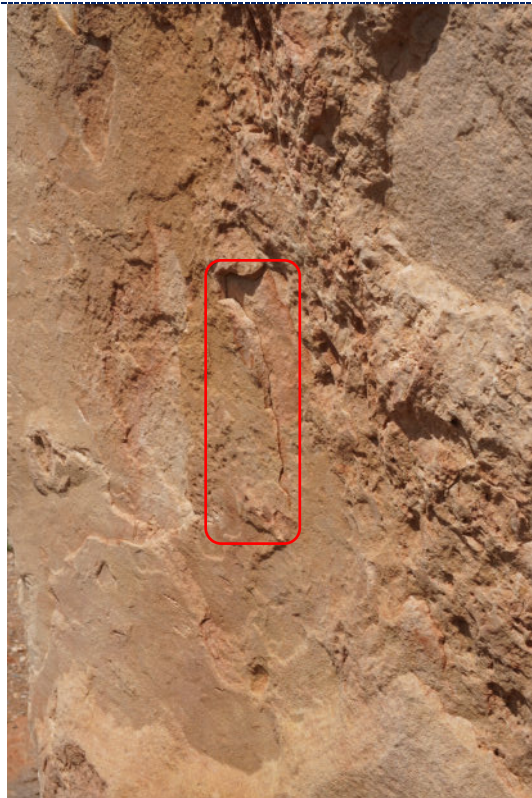
Figure 8: Detail – stone delamination and small vertical crack.

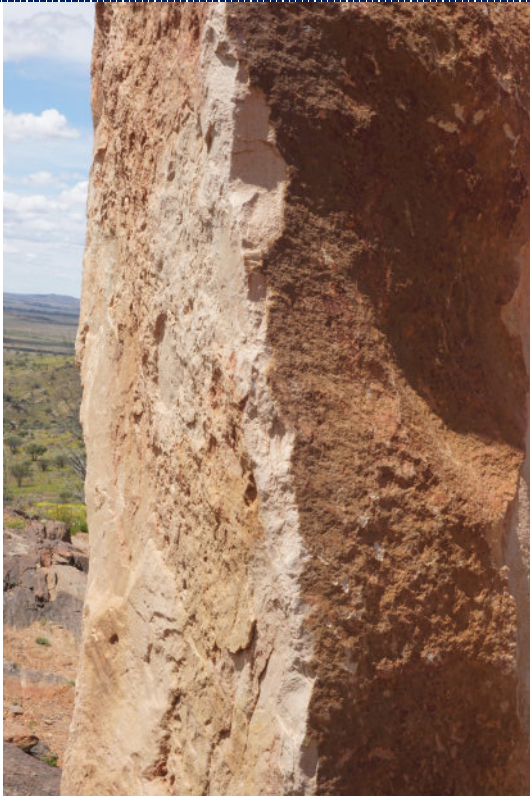
Figure 9: Detail – minor stone delamination.

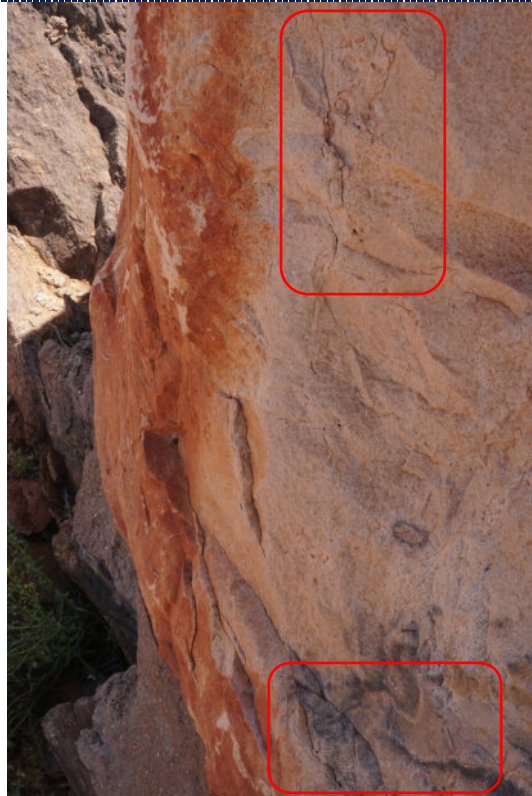
Figure 10: Detail – small cracks, likely occurring naturally in the stone.

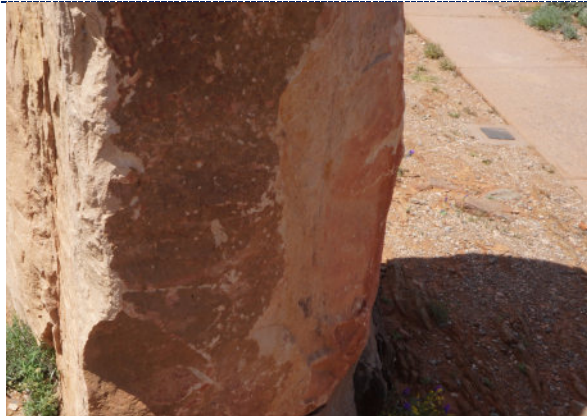
Figure 11: Detail – small surface losses and abrasions.

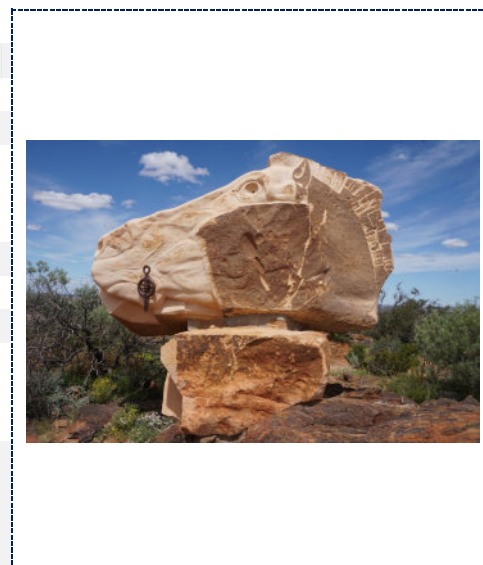
Previous repairs/ modifications?  YES  X NO

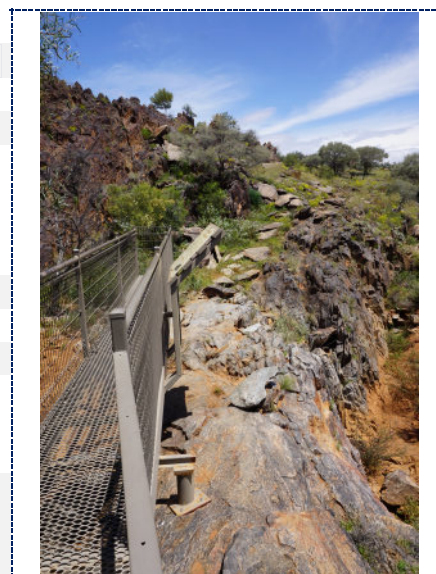
Previous repairs/ modifications?  YES  NO

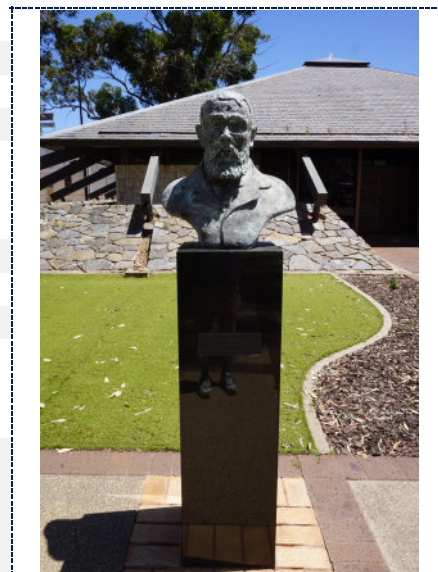
Previous repairs/ modifications?  YES  NO

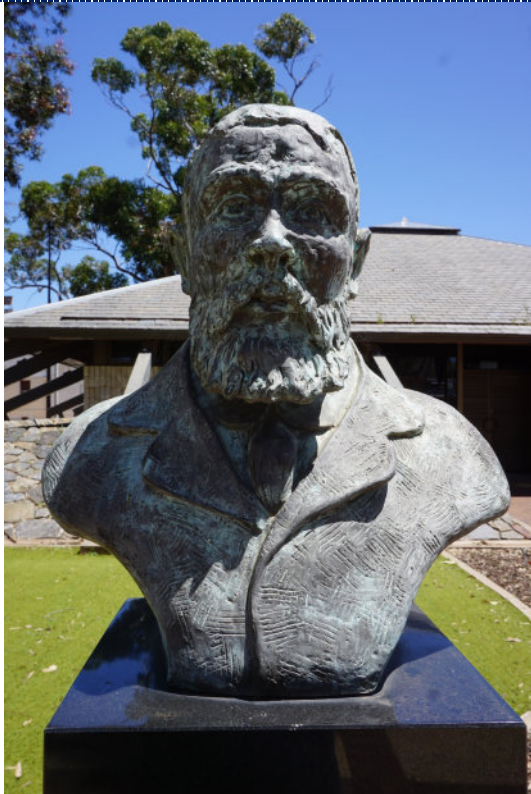
Figure 5: Detail – bust, front. Atmospheric pollution-driven copper corrosion product on bronze figure.

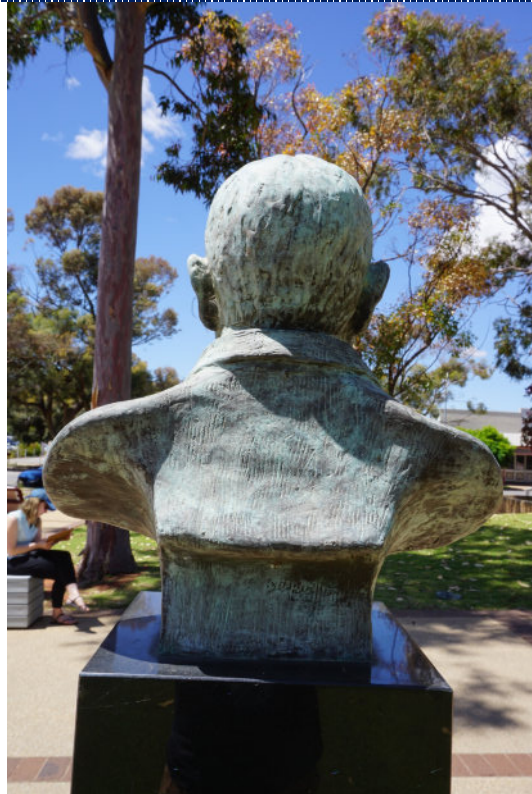
Figure 6: Detail – bust, back. Atmospheric pollution-driven copper corrosion product on bronze figure.

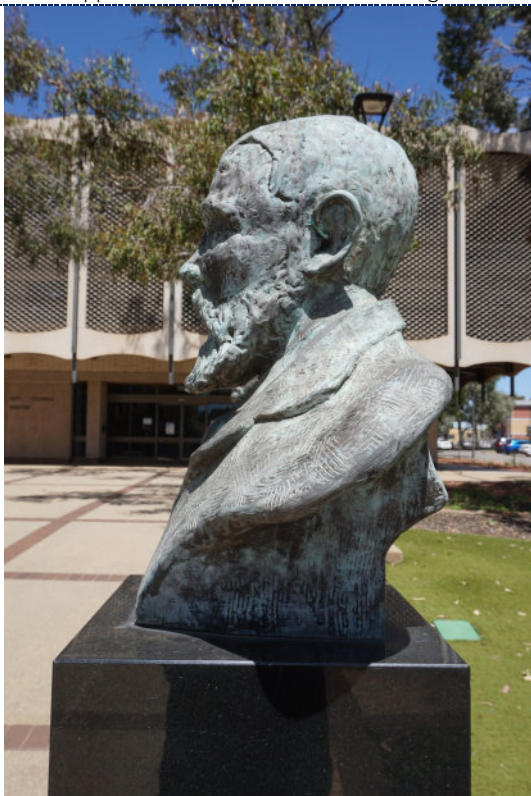
Figure 7: Detail – bust, proper left. Atmospheric pollution-driven copper corrosion product on bronze figure.

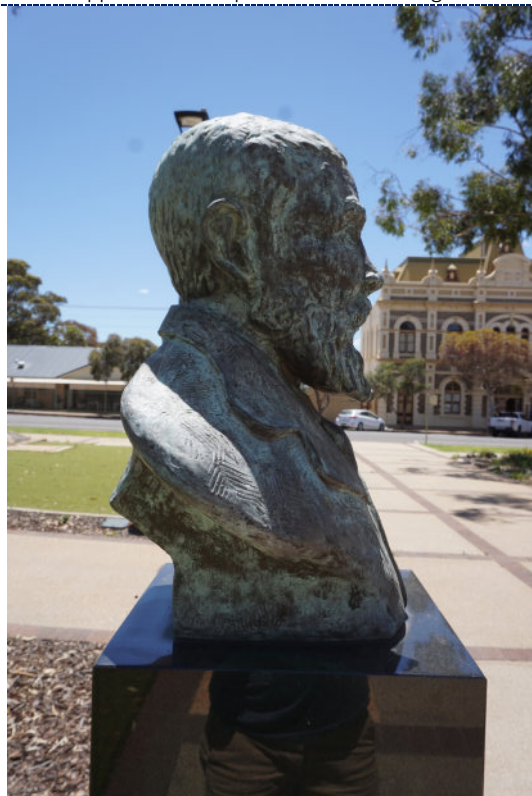
Figure 8: Detail – bust, proper right. Atmospheric pollution-driven copper corrosion product on bronze figure.

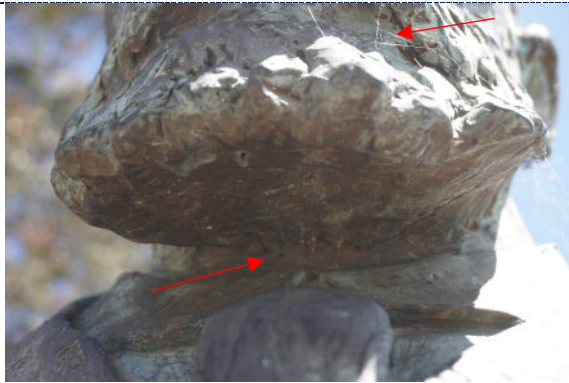
Figure 9: Detail – atmospheric pollution-driven copper corrosion product, dirt particulate, spider webs.

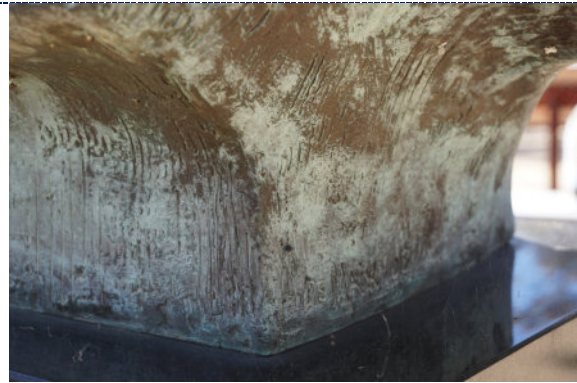
Figure 10: Detail – atmospheric pollution-driven copper corrosion product, dirt particulate, spider webs.

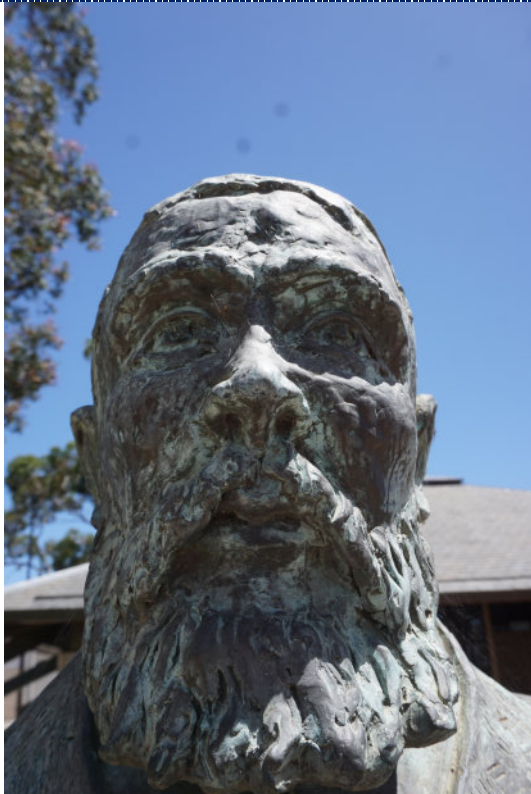
Figure 11: Detail – atmospheric pollution-driven copper corrosion product, dirt particulate, spider webs.

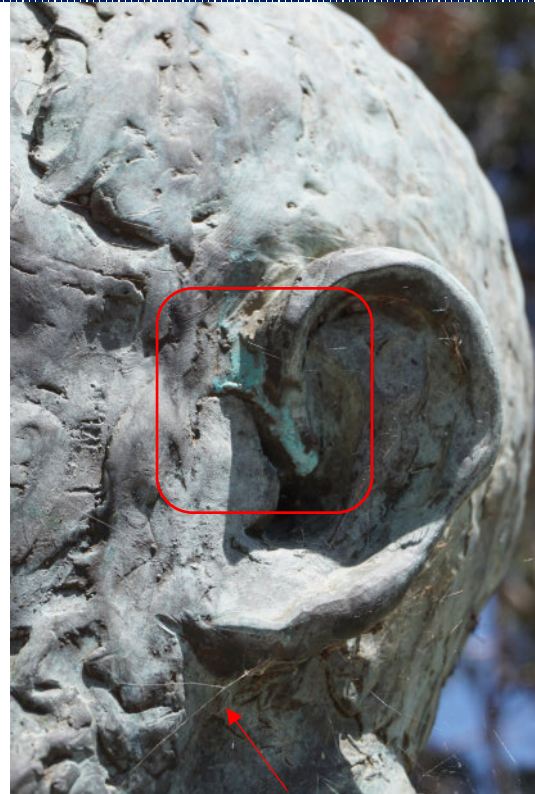
Figure 12: Detail – atmospheric pollution-driven copper corrosion product, dirt particulate, spider webs.

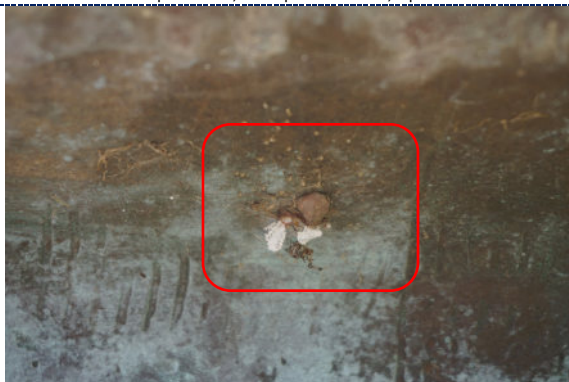
Figure 13: Detail – atmospheric pollution-driven copper corrosion product, dirt particulate, spider webs.

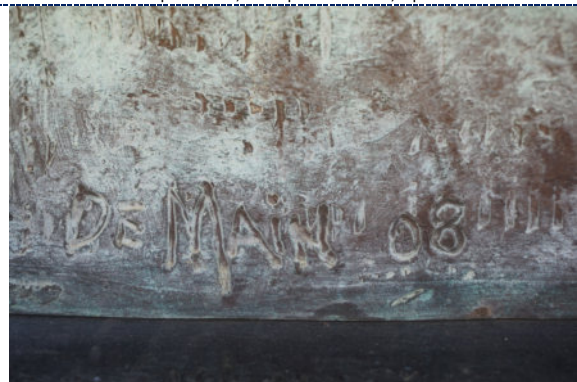
Figure 14: Detail – atmospheric pollution-driven copper corrosion product and artist's signature.

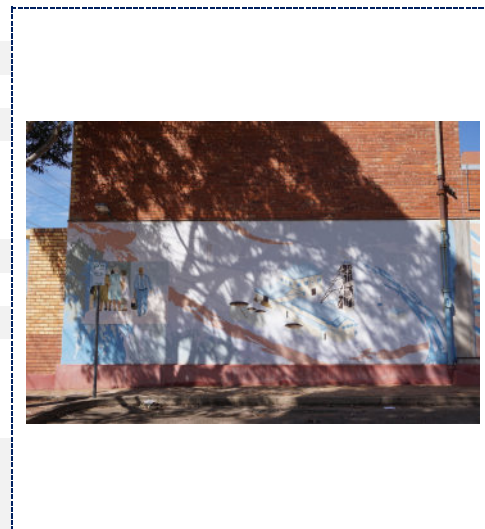
Previous repairs/ modifications?  YES  X NO

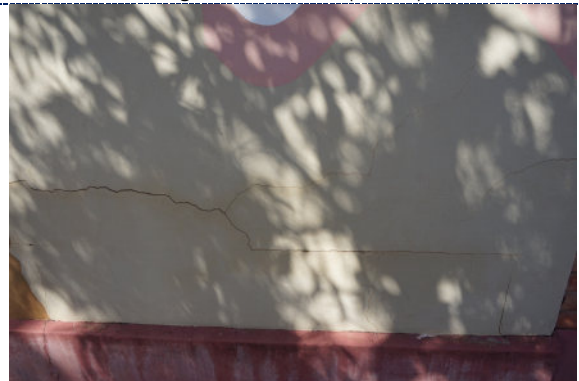
Figure 4: Detail – surface cracks and deformation to the mortar; chalking (UV degradation) and fading of the paint; staining to the exterior of the cracks.

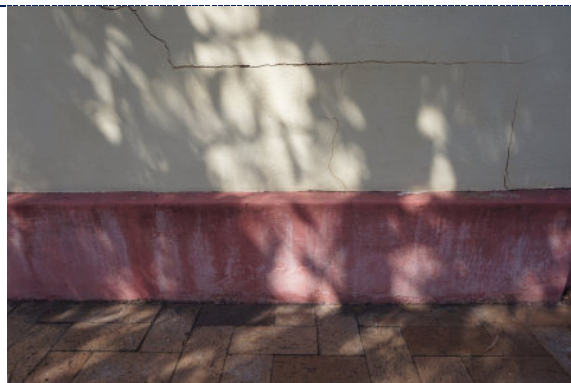
Figure 5: Detail – surface cracks and deformation to the mortar; chalking (UV degradation) and fading of the paint; staining to the exterior of the cracks.

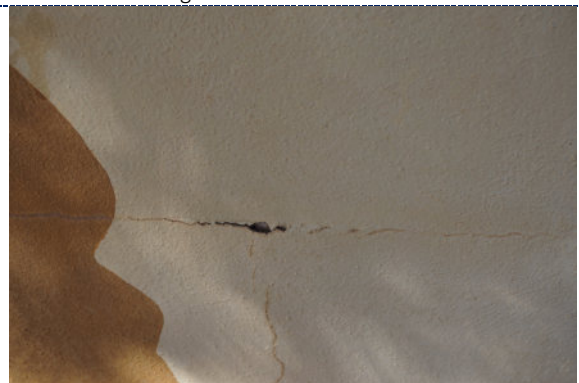
Figure 6: Detail – surface cracks and deformation to the mortar; chalking (UV degradation) and fading of the paint; staining to the exterior of the cracks; small losses.

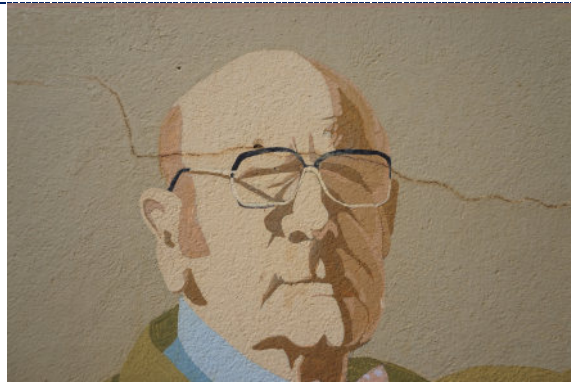
Figure 7: Detail – surface cracks and deformation to the mortar; chalking (UV degradation) and fading of the paint; staining to the exterior of the cracks; accumulation of biomatter.

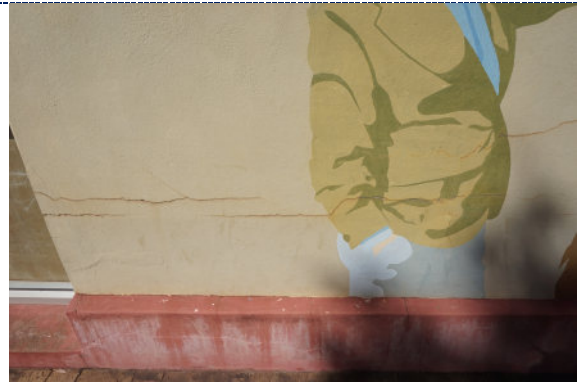
Figure 8: Detail – surface cracks and deformation to the mortar; chalking (UV degradation) and fading of the paint; staining to the exterior of the cracks.

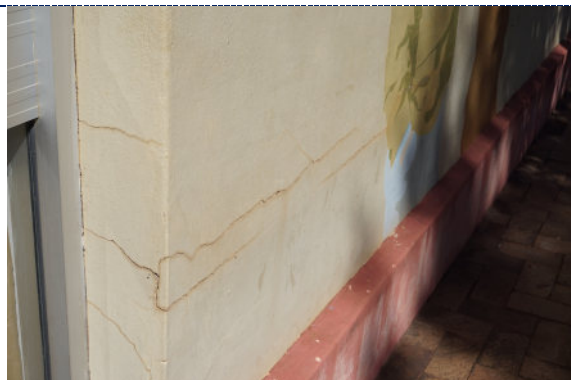
Figure 9: Detail – surface cracks and deformation to the mortar; chalking (UV degradation) and fading of the paint; staining to the exterior of the cracks.

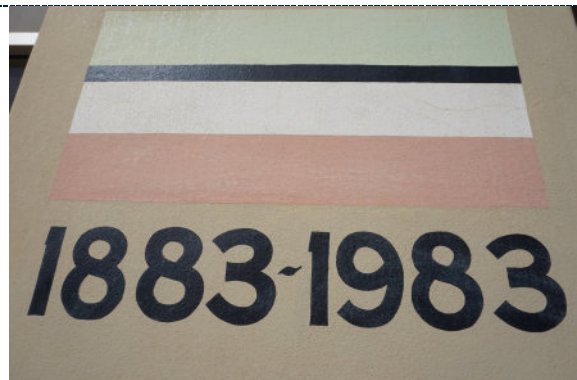
Figure 10: Detail – chalking (UV degradation) and fading of the paint.

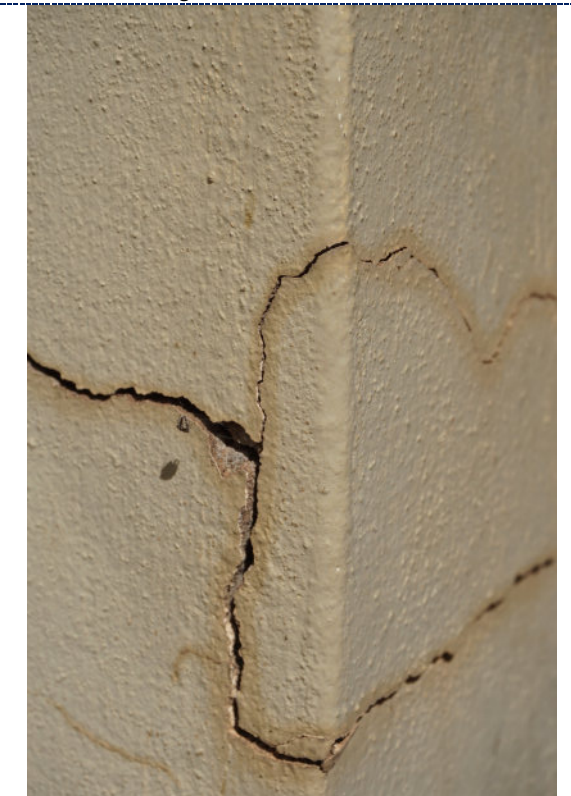
Figure 11: Detail – surface cracks and deformation to the mortar; chalking (UV degradation) and fading of the paint; staining to the exterior of the cracks; small losses.

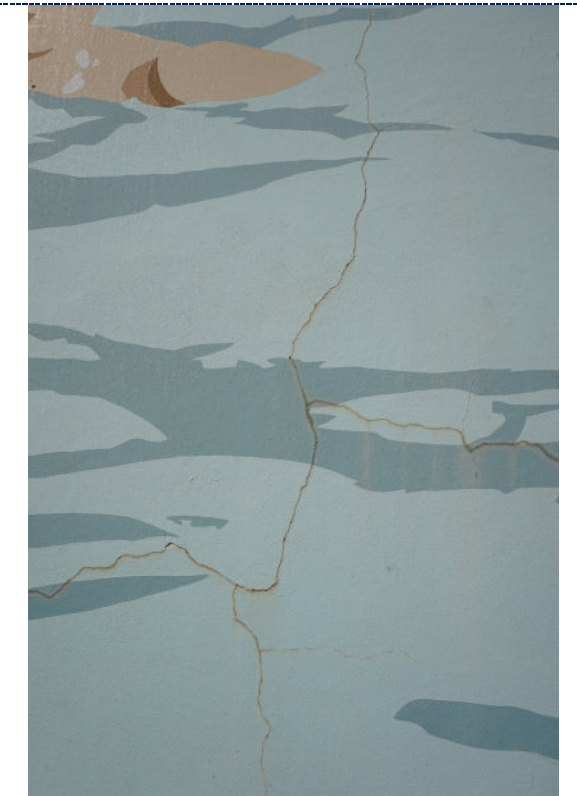
Figure 12: Detail – surface cracks and deformation to the mortar; chalking (UV degradation) and fading of the paint; staining to the exterior of the cracks.

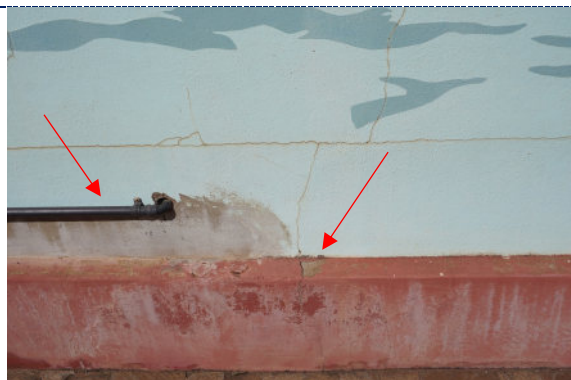
Figure 13: Detail – surface cracks and deformation to the mortar; chalking (UV degradation) and fading of the paint; staining to the exterior of the cracks; large loss to the paint adjacent to the pipe; loss to mortar.

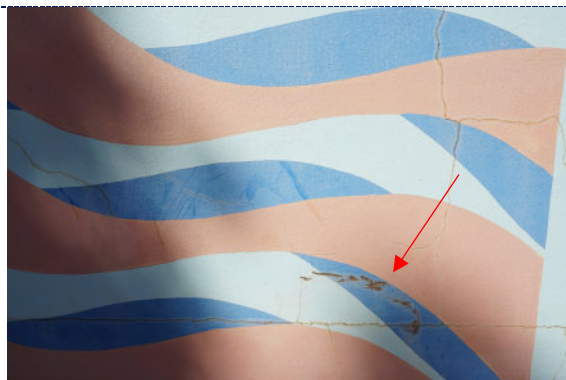
Figure 14: Detail – surface cracks and deformation to the mortar; chalking (UV degradation) and fading of the paint; staining to the exterior of the cracks; paint loss.

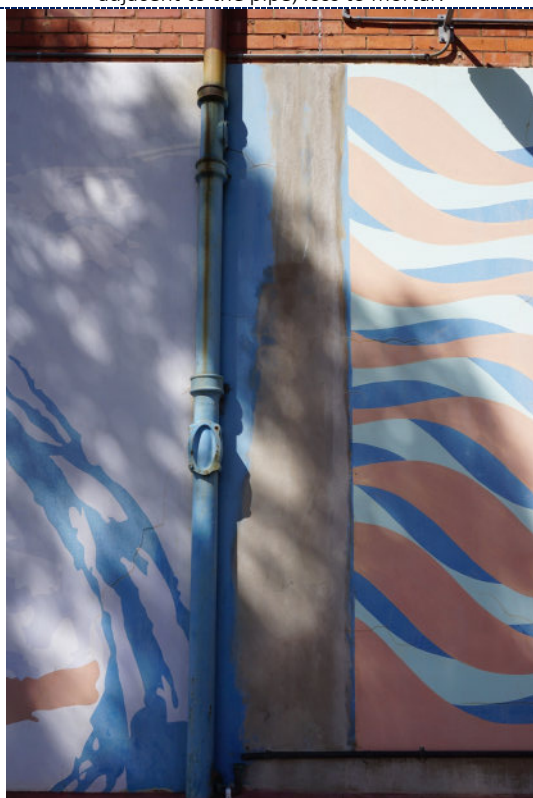
Figure 15: Detail – surface cracks and deformation to the mortar; chalking (UV degradation) and fading of the paint; staining to the exterior of the cracks; large loss to the paint adjacent to the pipe.

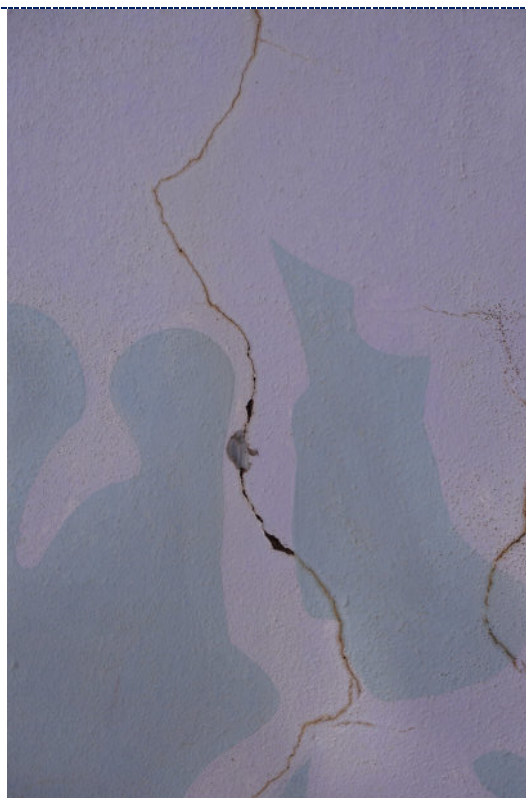
Figure 16: Detail – surface cracks and deformation to the mortar; chalking (UV degradation) and fading of the paint; staining to the exterior of the cracks; small losses.

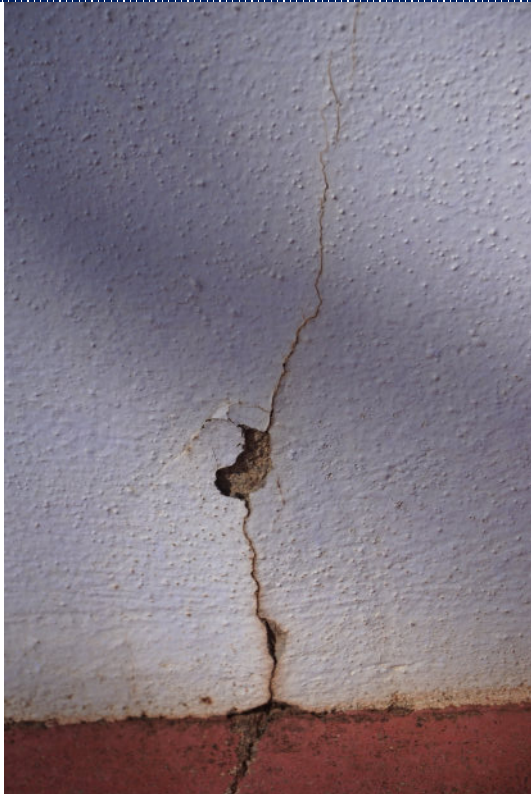
Figure 17: Detail – surface cracks and deformation to the mortar; chalking (UV degradation) and fading of the paint; staining to the exterior of the cracks; small losses.

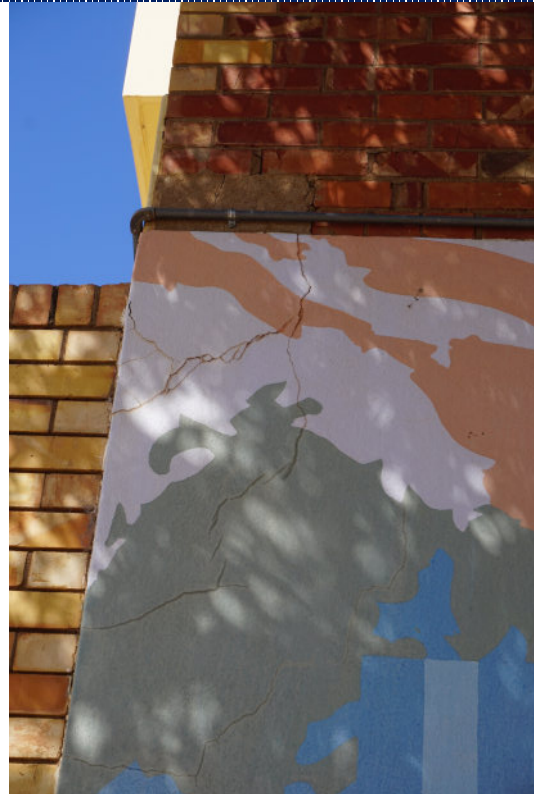
Figure 18: Detail – surface cracks and deformation to the mortar; chalking (UV degradation) and fading of the paint; staining to the exterior of the cracks; small losses.

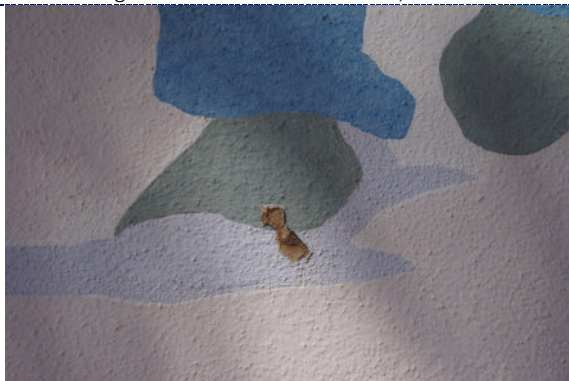
Figure 19: Detail – surface accretion; chalking (UV degradation) and fading of the paint.

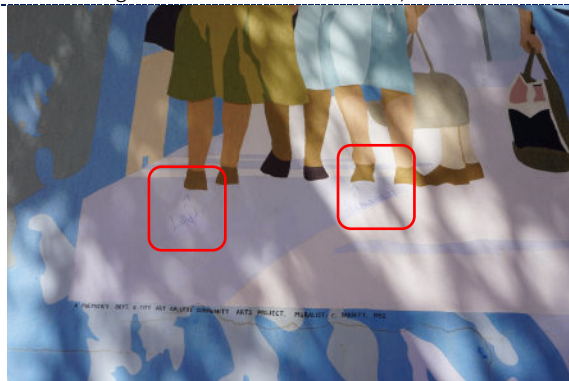
Figure 20: Detail – surface cracks and deformation to the mortar; chalking (UV degradation) and fading of the paint; staining to the exterior of the cracks; inked graffiti.

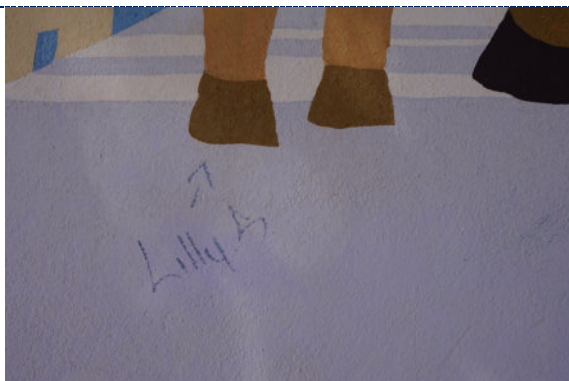
Figure 21: Detail – inked graffiti.

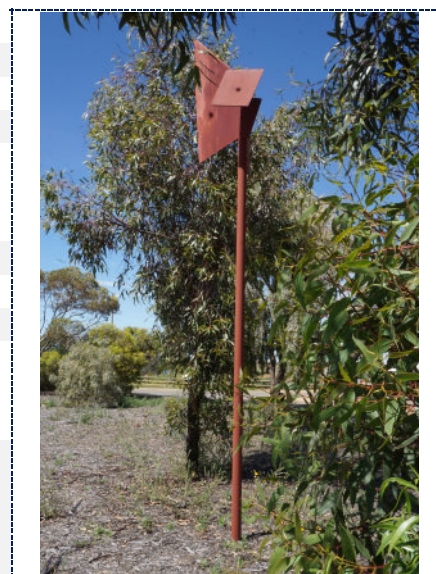
Previous repairs/ modifications?  YES  NO

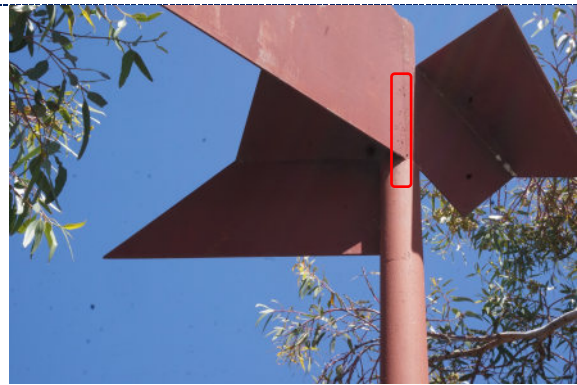
Figure 6: Detail – paint chalking, overpaint; spider webs; corrosion in areas of paint loss.

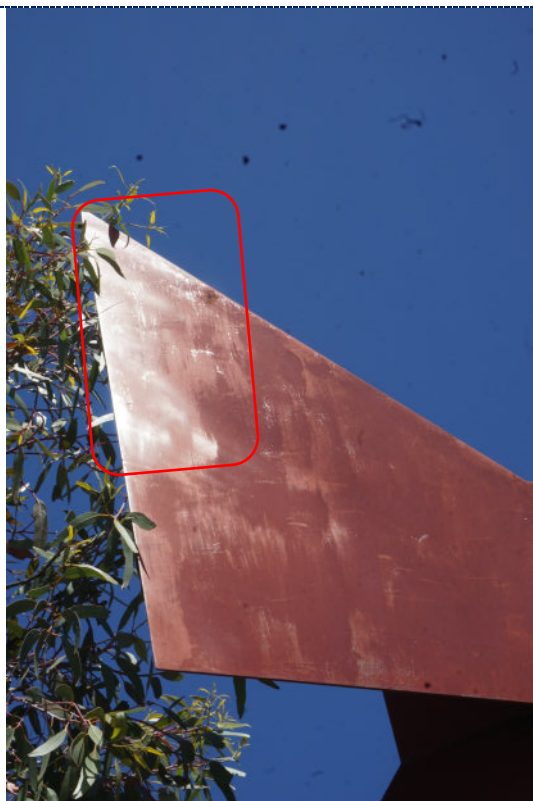
Figure 7: Detail – paint chalking, flaking paint loss with overpaint.

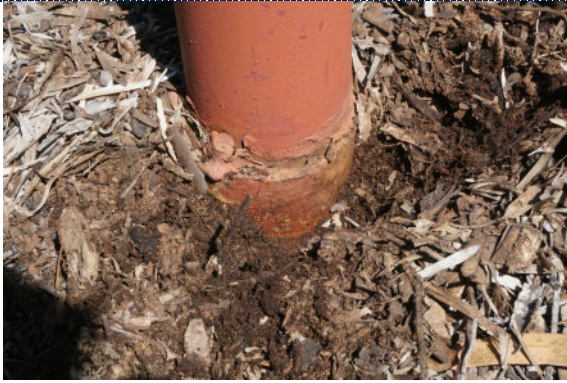
Figure 11: Detail – accumulation of biomatter at base; corrosion to iron.

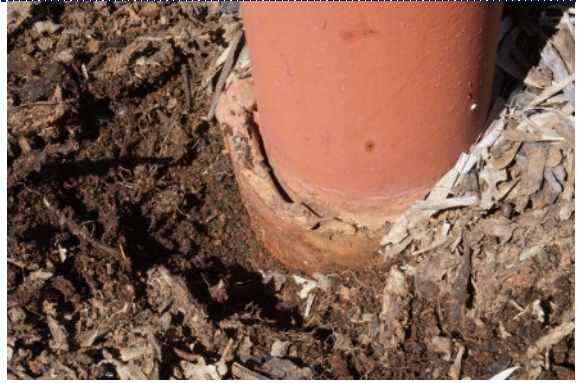
Figure 12: Detail – accumulation of biomatter at base; corrosion to iron.

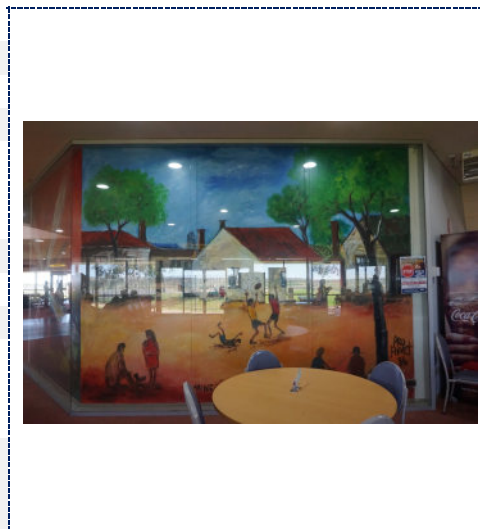
Previous repairs/ modifications?       YES       NO

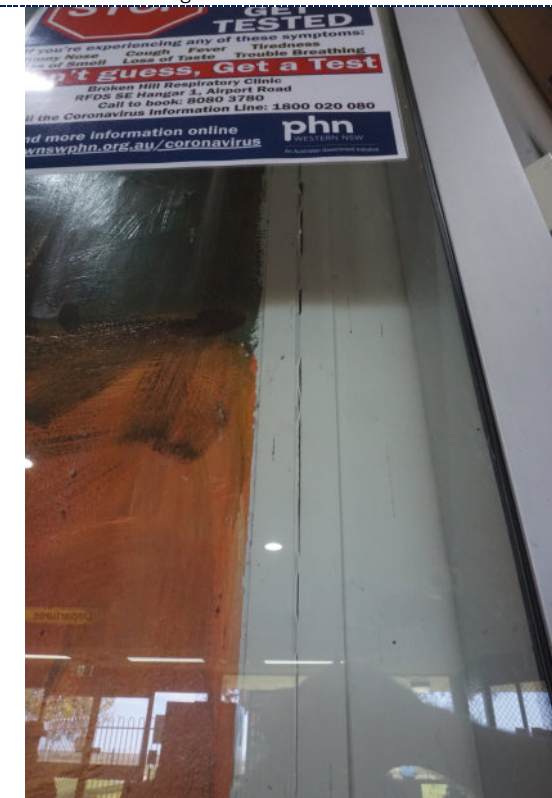
Figure 3: Section 1 – surface cracks.

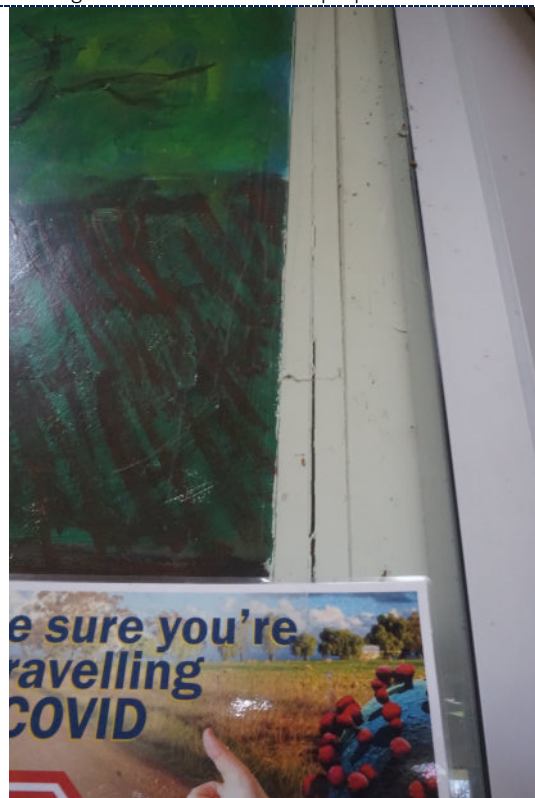
Figure 4: Section 1 – surface cracks.

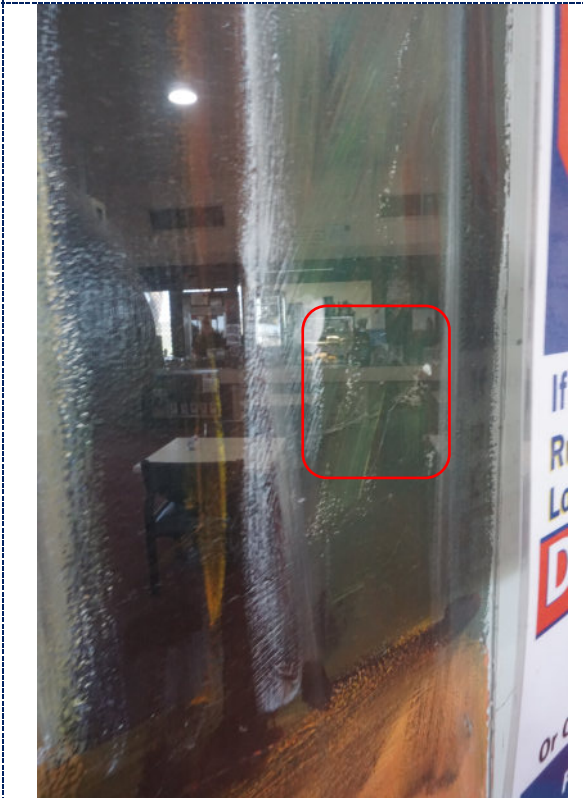
Figure 5: Section 1 – Detail – surface cracks with loss.

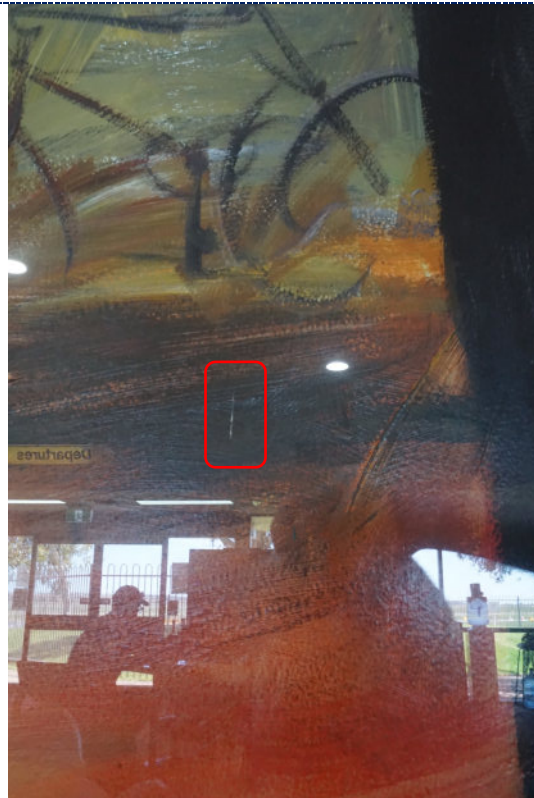
Figure 6: Section 1 – Detail – white surface accretion.
