# *Broken Hill Public Art Condition Survey and Conservation Plan*

Prepared for: Broken Hill City Council  
Submission Date: February 2023

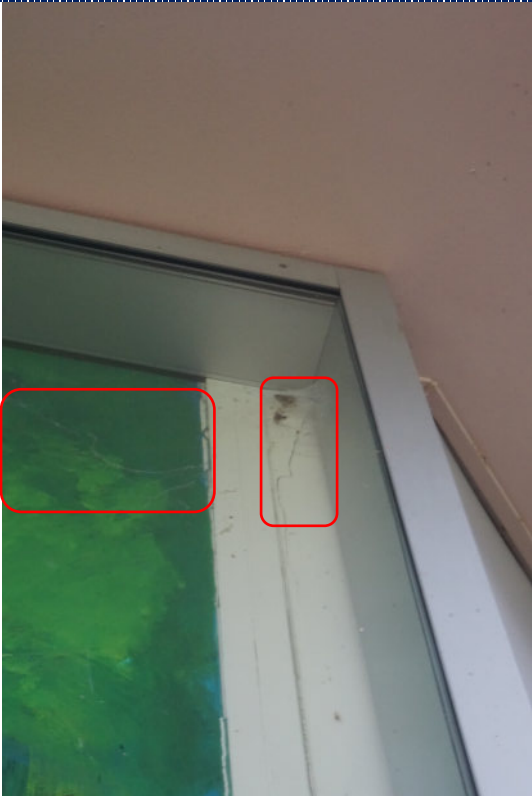
Figure 9: Section 1 – Detail – surface cracks and spider webbing.

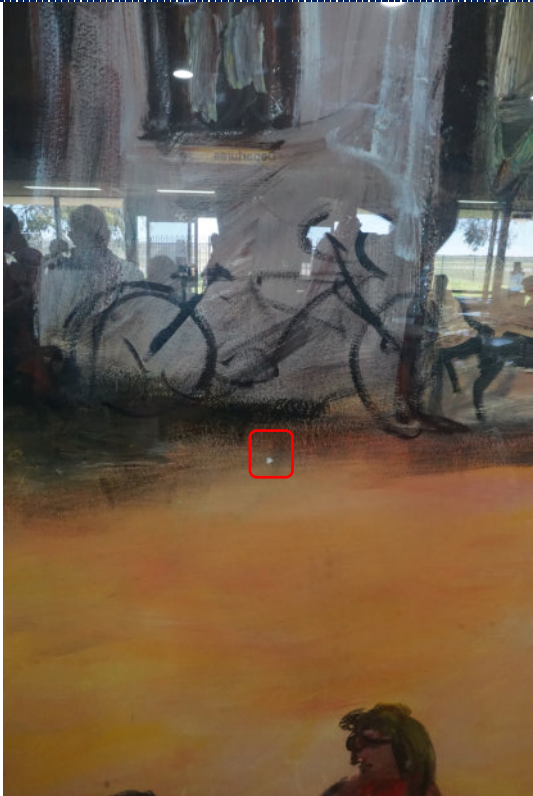
Figure 10: Section 1 – Detail – surface Loss.

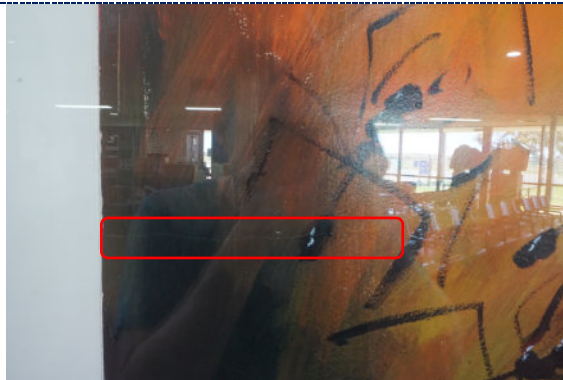
Figure 23: Section 2 – Detail – surface crack.

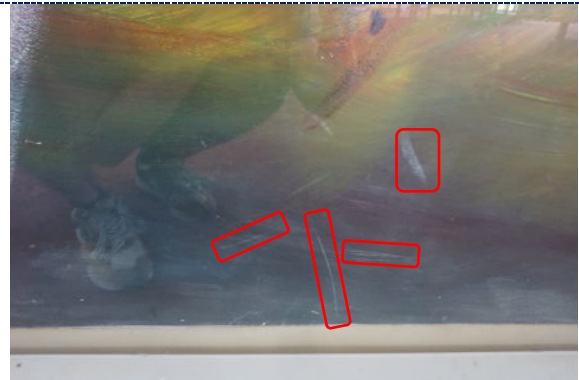
Figure 24: Section 2 – Detail – cluster of localised abrasions.

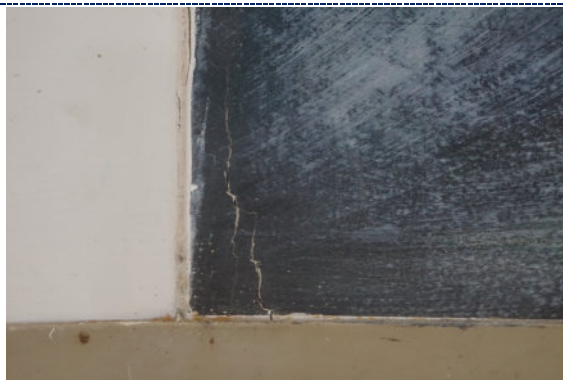
Figure 25: Section 2 – Detail – surface cracks.

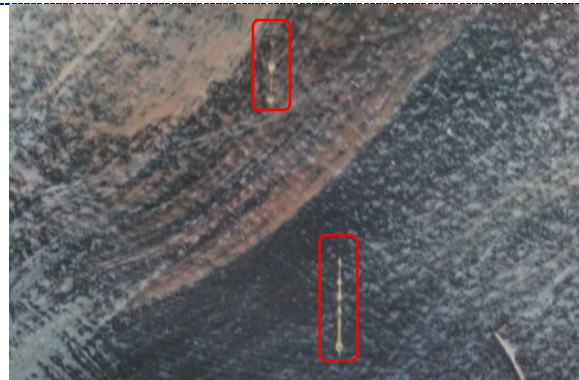
Figure 26: Section 2 – Detail – surface accretions.

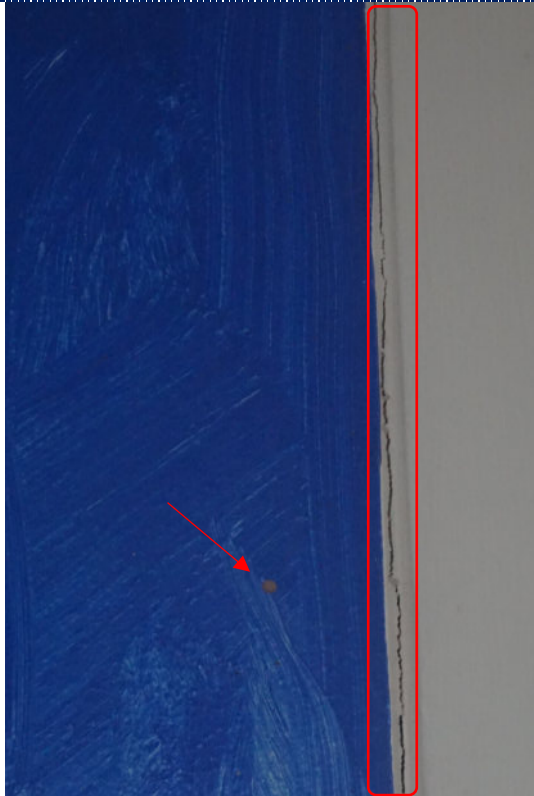
Figure 35: Section 3 – Detail – surface accretion and elongated crack.

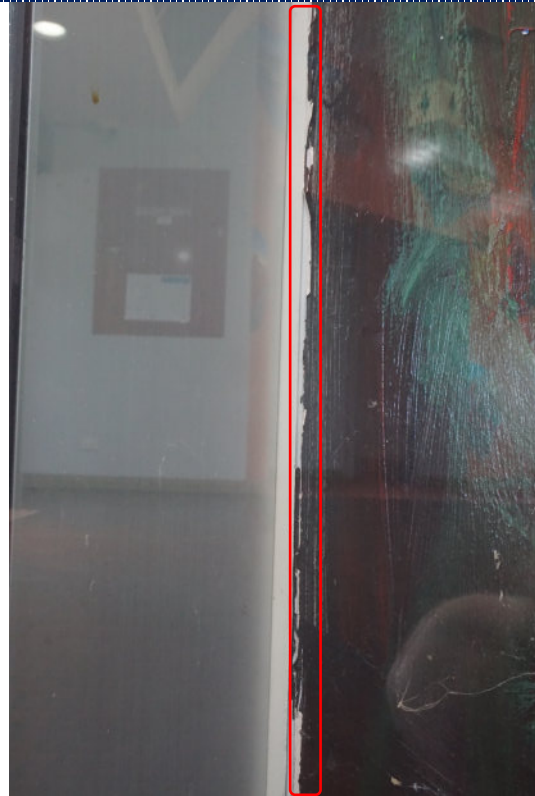
Figure 36: Section 3 – Detail – friable lifting paint layer at edges.

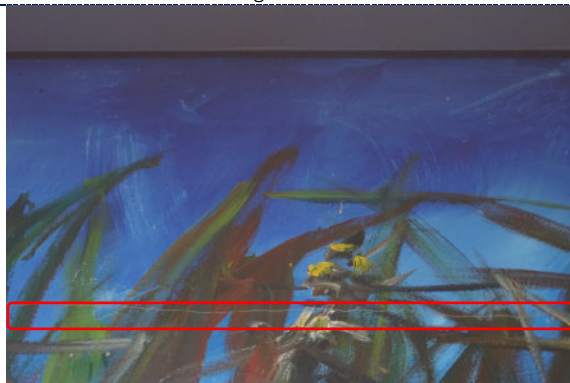
Figure 37: Section 3 – Detail – horizontal surface crack.

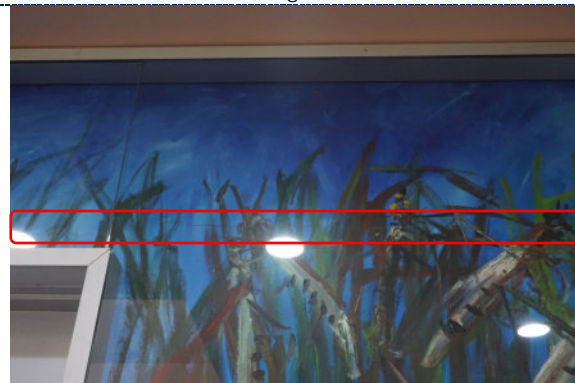
Figure 38: Section 3 – Detail – horizontal surface crack.

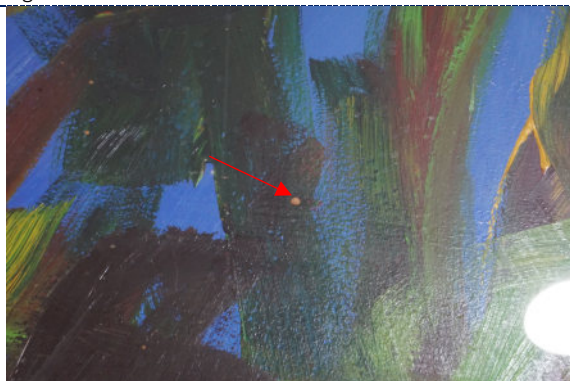
Figure 39: Section 3 – Detail – brown surface accretion.

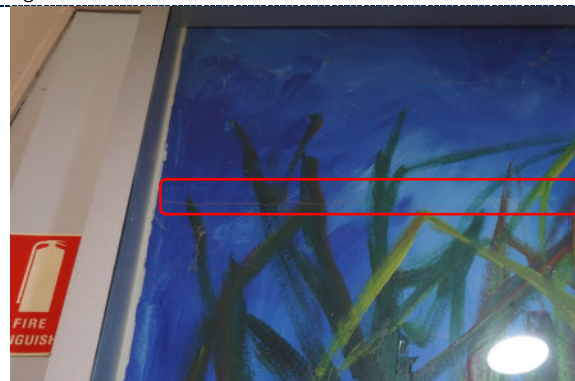
Figure 40: Section 3 – Detail – horizontal surface crack.

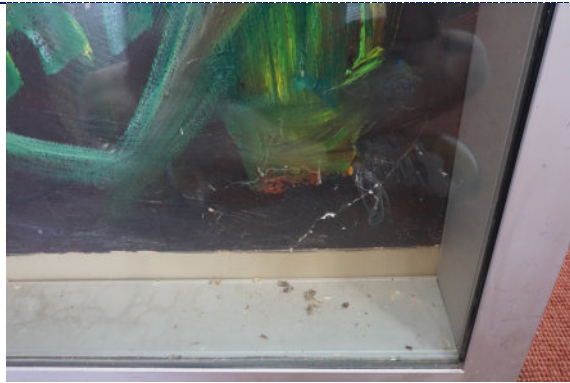
Figure 41: Section 3 – Detail – dirt particulates, surface cracks and spider webs.

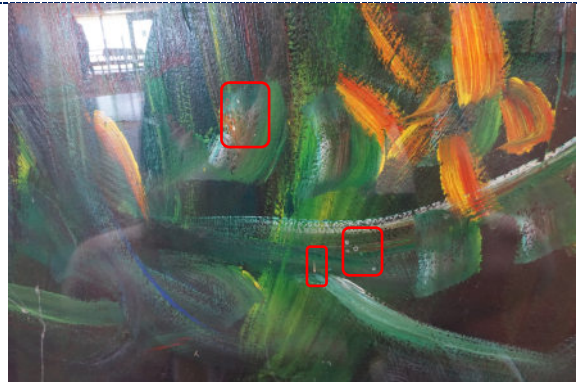
Figure 42: Section 3 – Detail – multiple surface accretions.

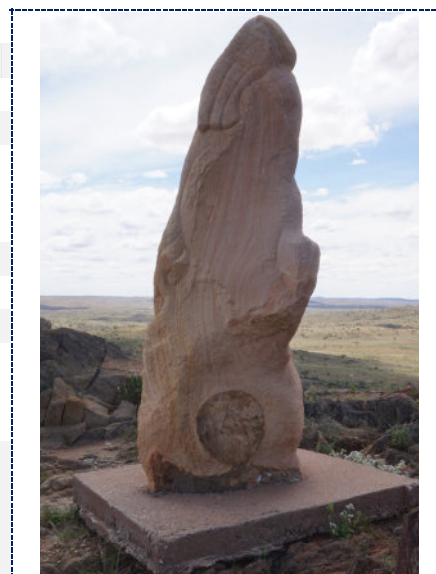
Previous repairs/ modifications?  YES  NO

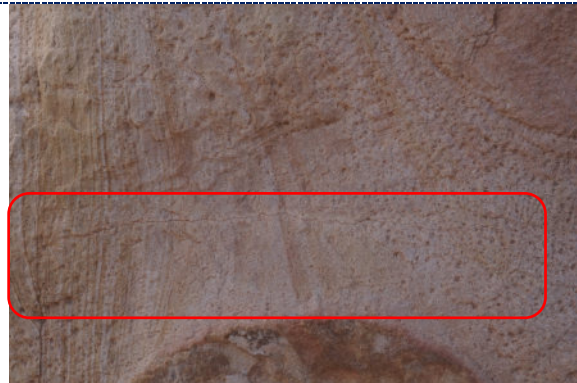
Figure 8: Detail – crack visible through centre.

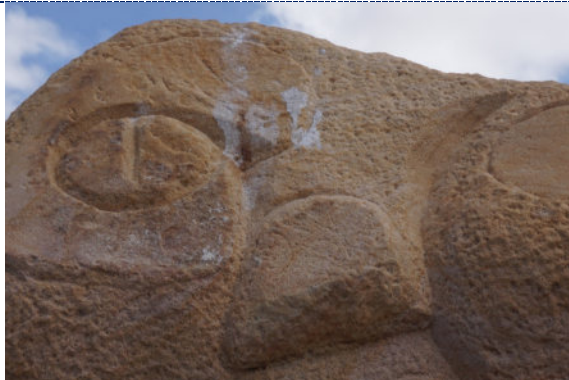
Figure 9: Detail – bird excrement accretion.

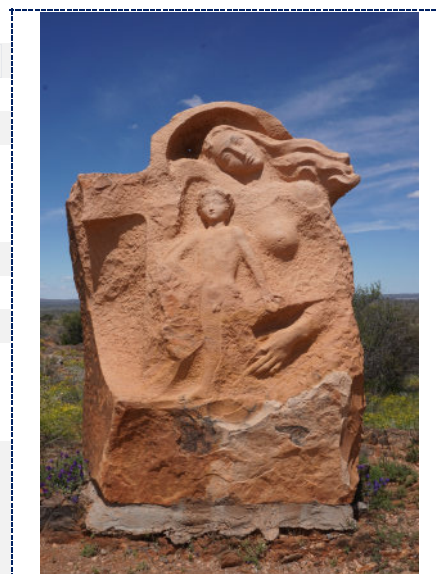
Previous repairs/ modifications?  YES  NO

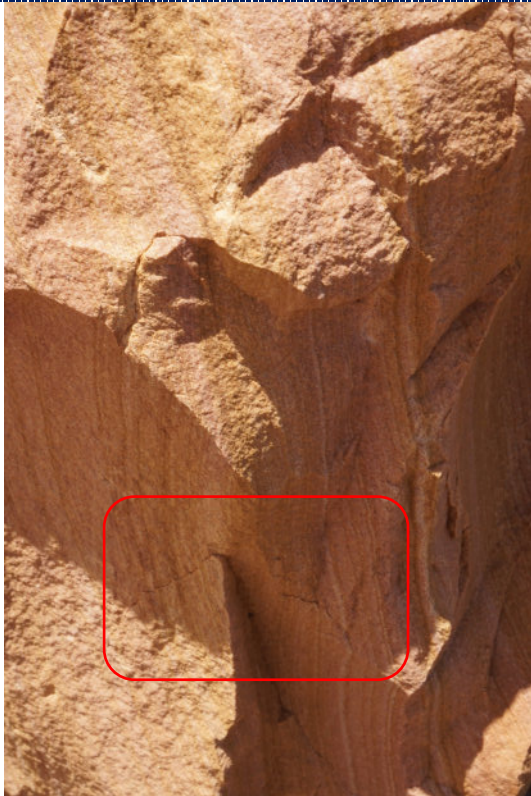
Figure 13: Detail – small crack and possible delamination present.

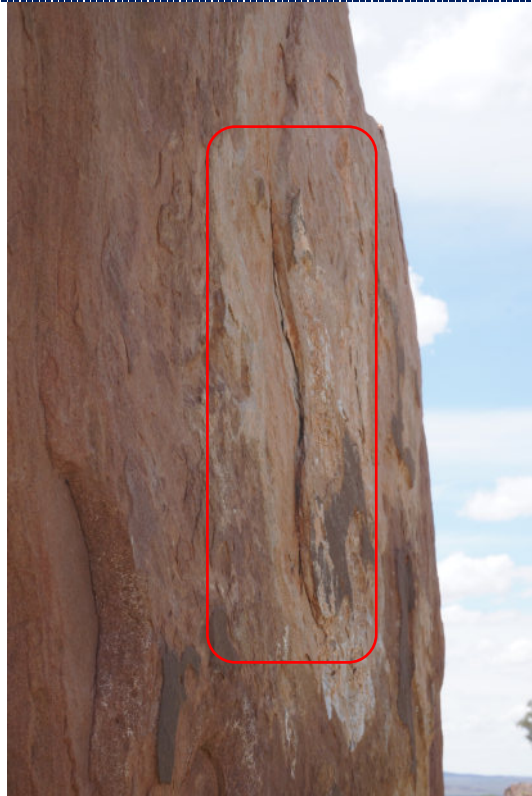
Figure 14: Detail – possible evidence of surface delamination.

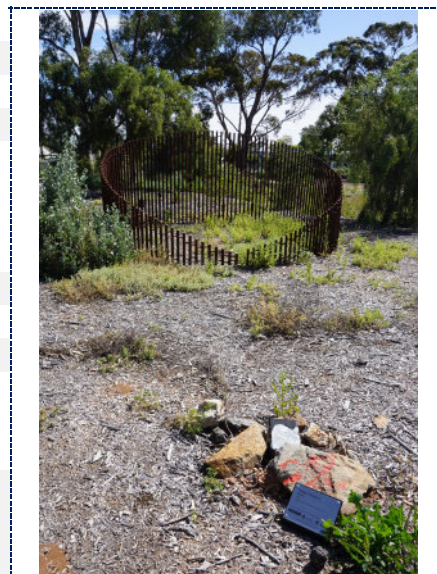
Previous repairs/ modifications?  YES  NO

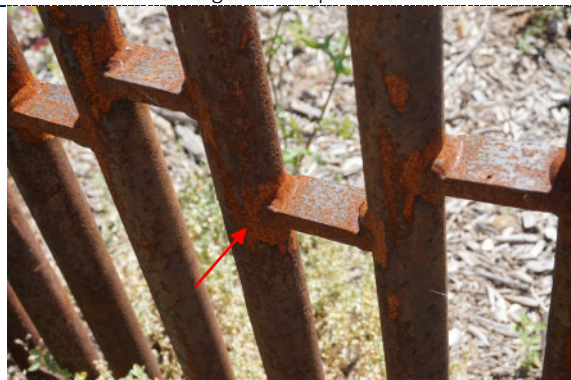
Figure 5: Detail – dirt particulate; surface flash rusting at new welds created during manufacture of artwork.

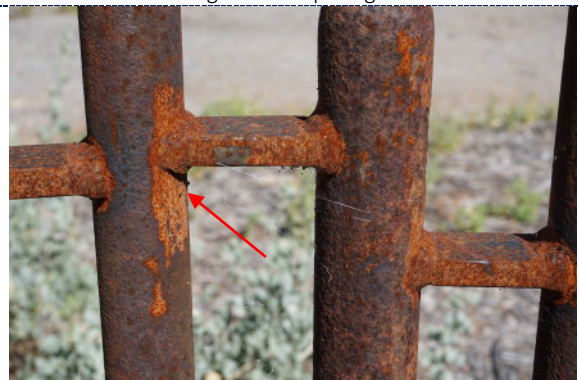
Figure 6: Detail – dirt particulate; surface flash rusting at new welds created during manufacture of artwork.

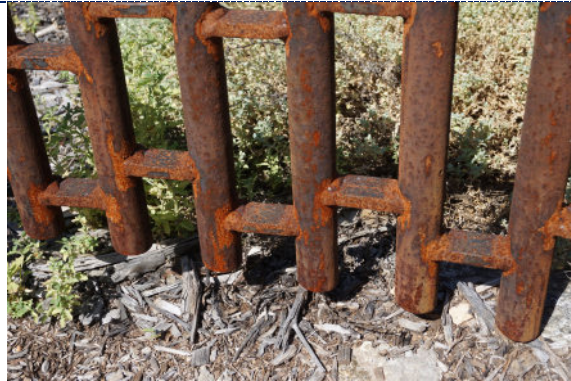
Figure 7: Detail – dirt particulate; surface flash rusting at new welds created during manufacture of artwork.

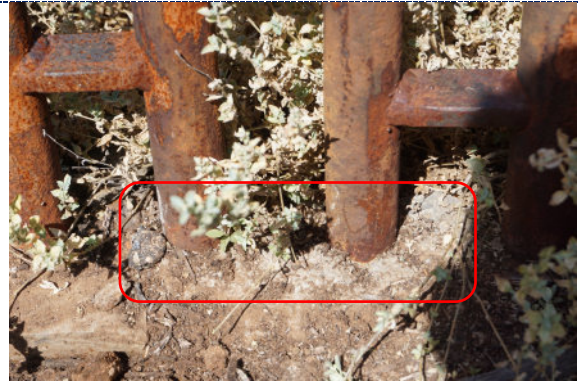
Figure 8: Detail – dirt particulate; surface flash rusting at new welds created during manufacture of artwork; iron inset into concrete.

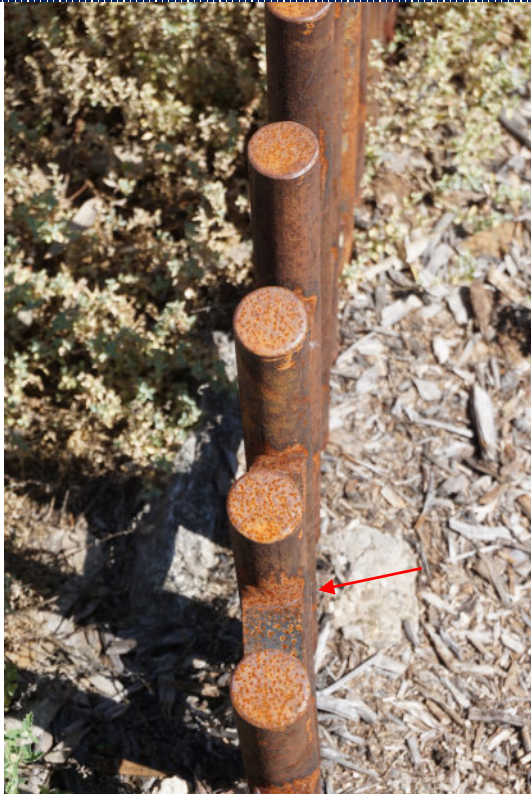
Figure 9: Detail – dirt particulate; surface flash rusting at new welds created during manufacture of artwork.

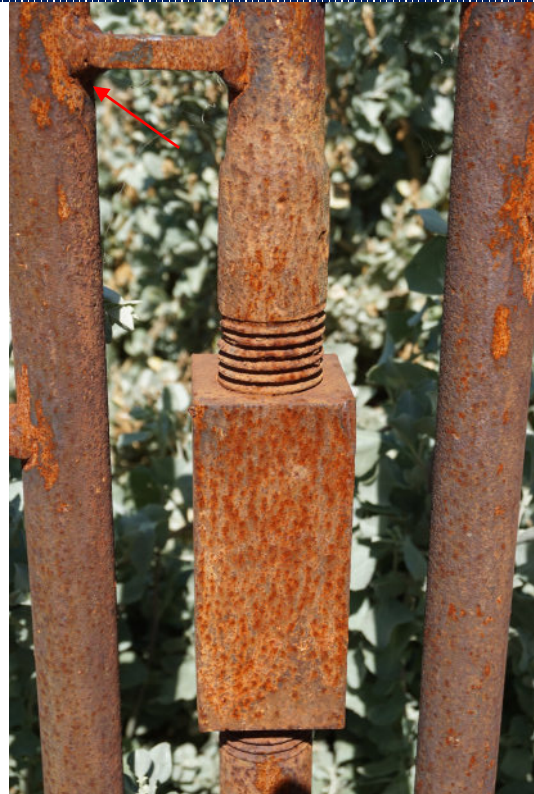
Figure 10: Detail – dirt particulate; surface flash rusting at new welds created during manufacture of artwork.

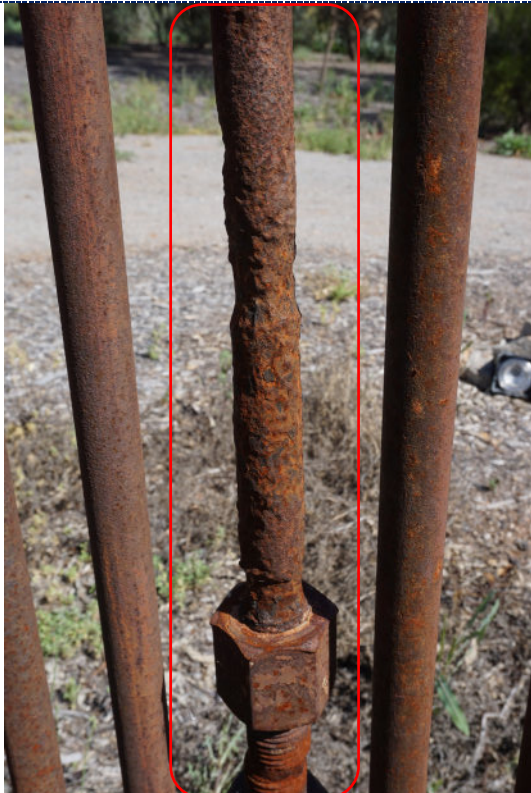
Figure 11: Detail – loss to iron due to corrosion, likely occurring prior to artwork manufacture.

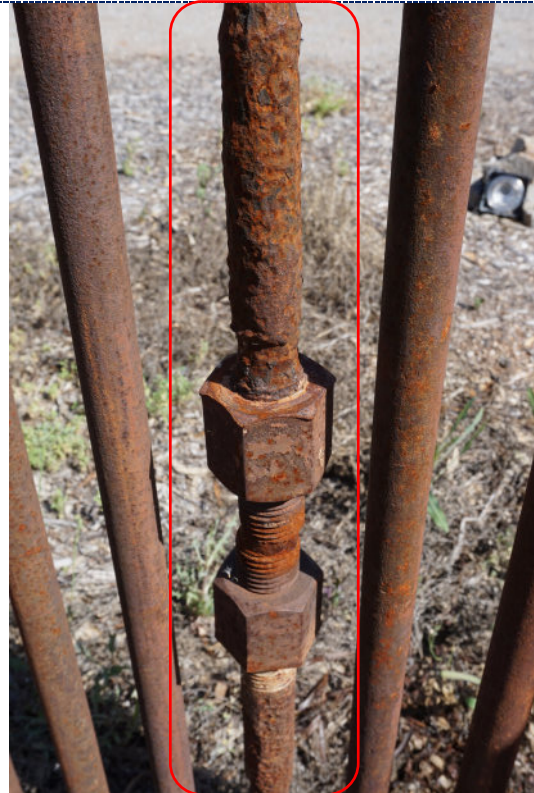
Figure 12: Detail – loss to iron due to corrosion, likely occurring prior to artwork manufacture.

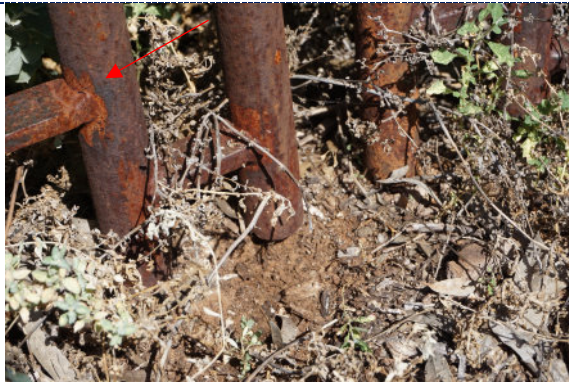
Figure 13: Detail – dirt particulate; surface flash rusting at new welds created during manufacture of artwork.

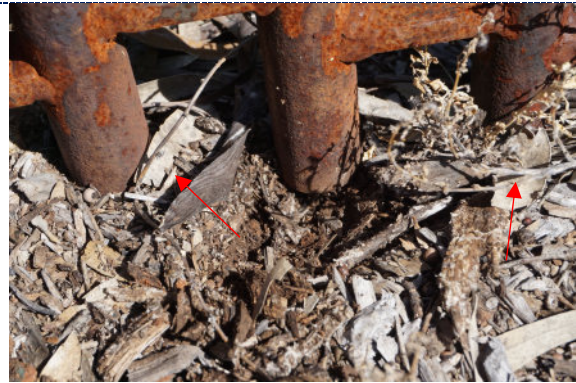
Figure 14: dirt particulate; surface flash rusting at new welds created during manufacture of artwork; biomatter collecting around the base of the work.

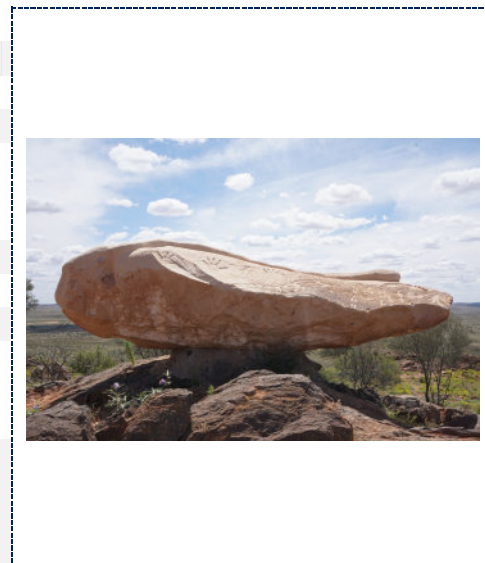
Previous repairs/ modifications?  X YES  NO

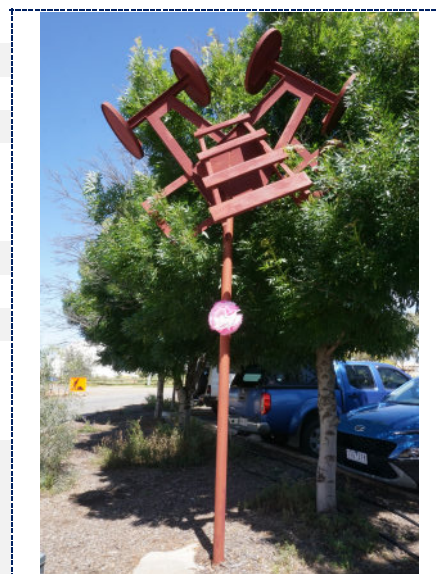
Previous repairs/ modifications?  YES  NO

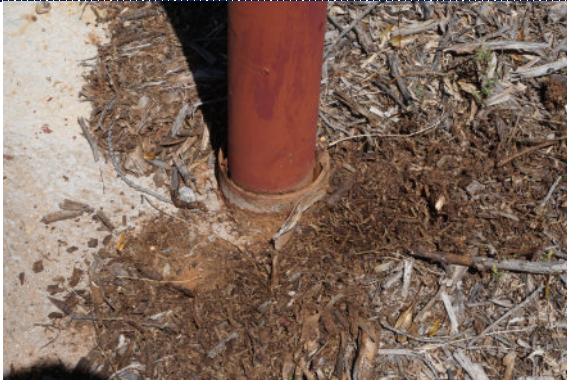
Figure 5: Detail – accumulation of biomatter at base; corrosion to iron.

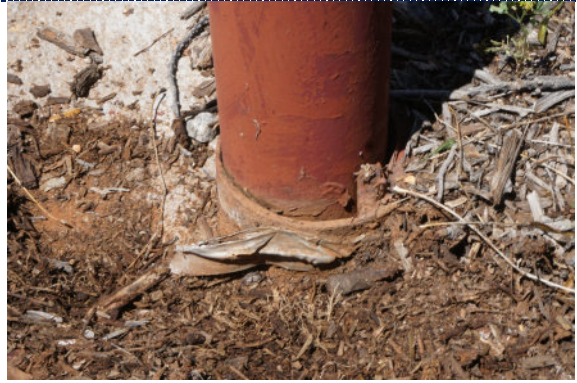
Figure 6: Detail – accumulation of biomatter at base; corrosion to iron.

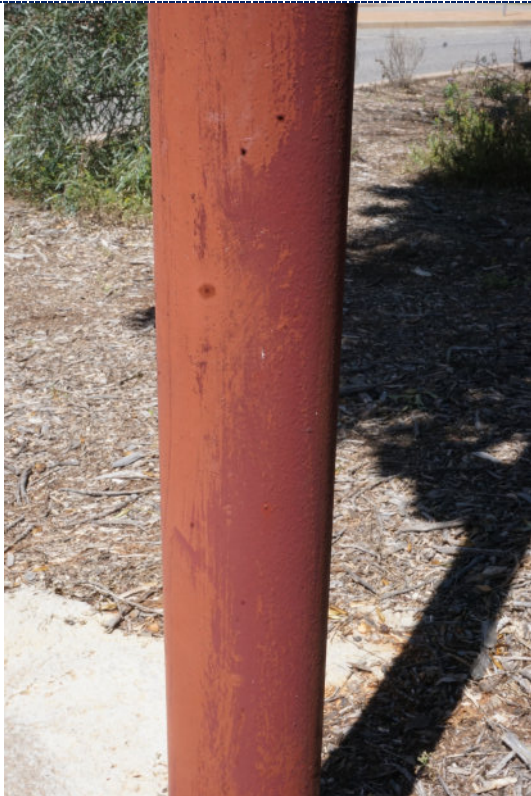
Figure 7: Detail – paint chalking, flaking, overpaint.

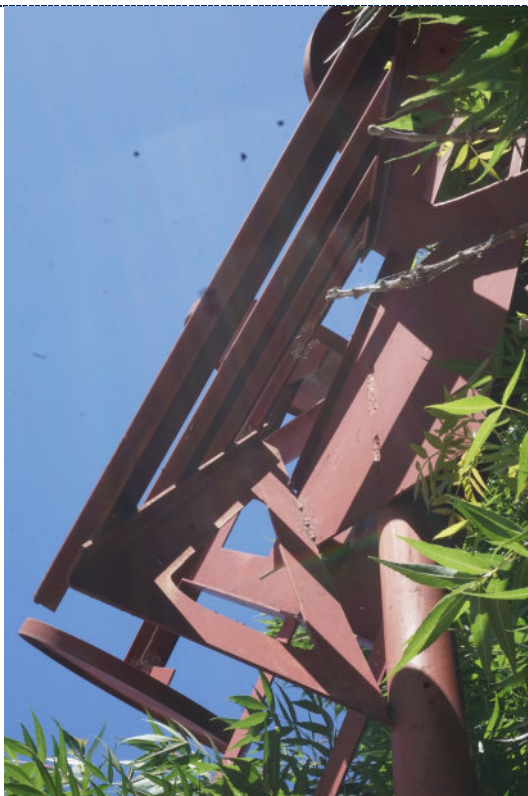
Figure 11: Detail – paint chalking, flaking, overpaint;  
surface corrosion; woody plant growth interaction.

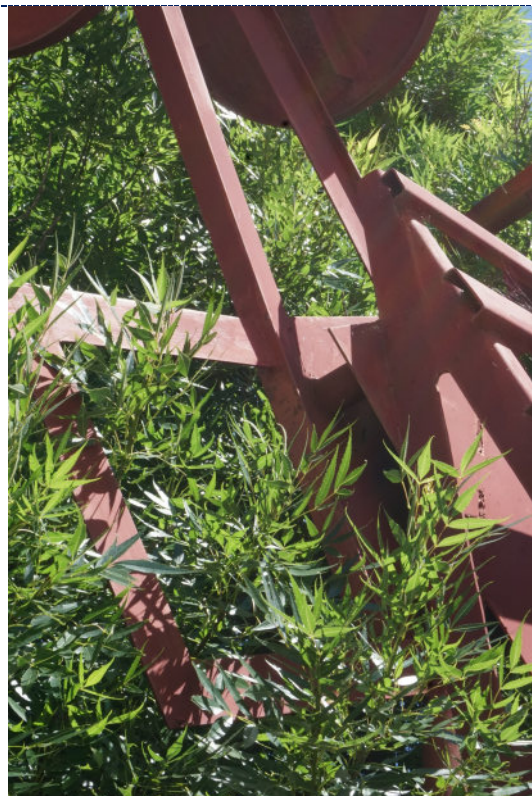
Figure 12: Detail – paint chalking, flaking, overpaint;  
surface corrosion; woody plant growth interaction.

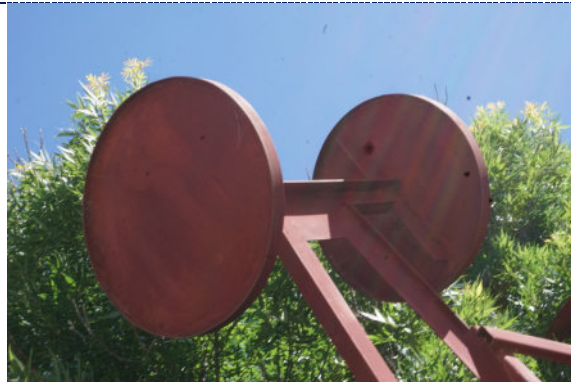
Figure 13: Detail – paint chalking, flaking, overpaint.

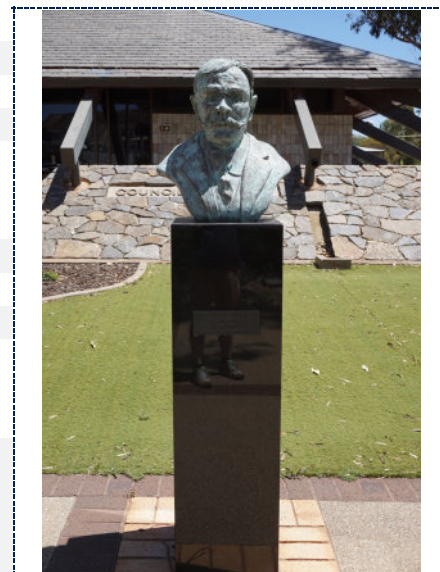
Previous repairs/ modifications?  YES  NO

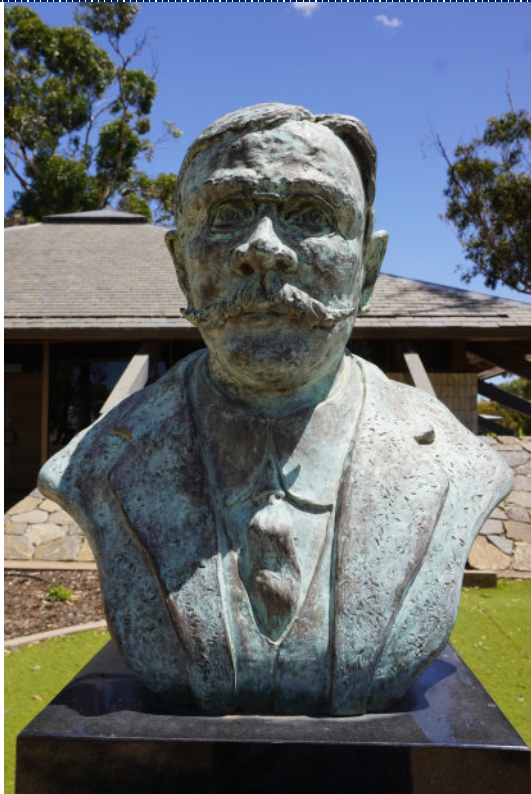
Figure 5: Detail – bust, front. Atmospheric pollution-driven copper corrosion product on bronze figure.

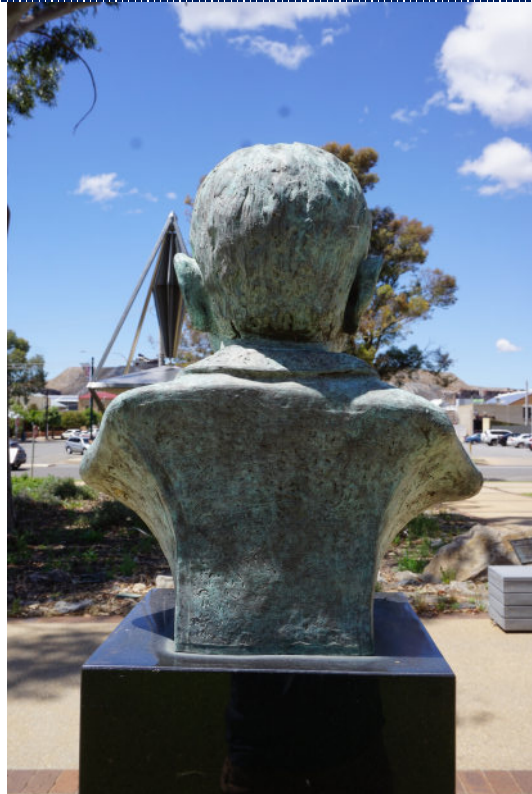
Figure 6: Detail – bust, back. Atmospheric pollution-driven copper corrosion product on bronze figure.

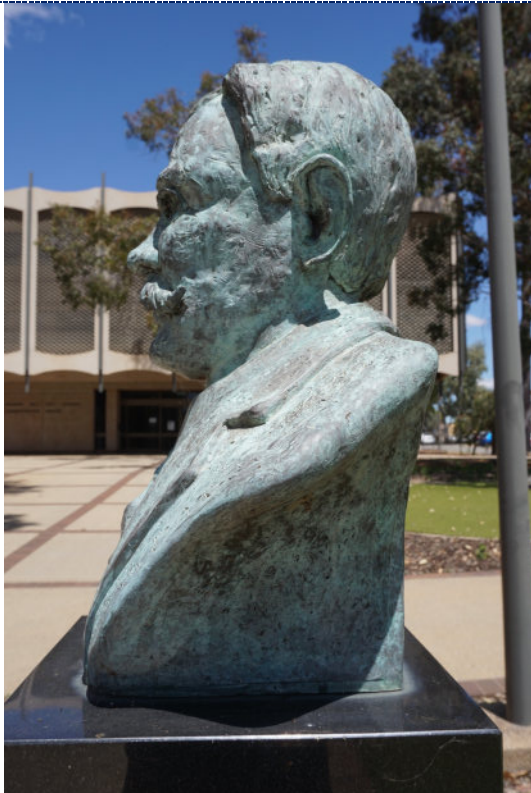
Figure 7: Detail – bust, proper left. Atmospheric pollution-driven copper corrosion product on bronze figure.

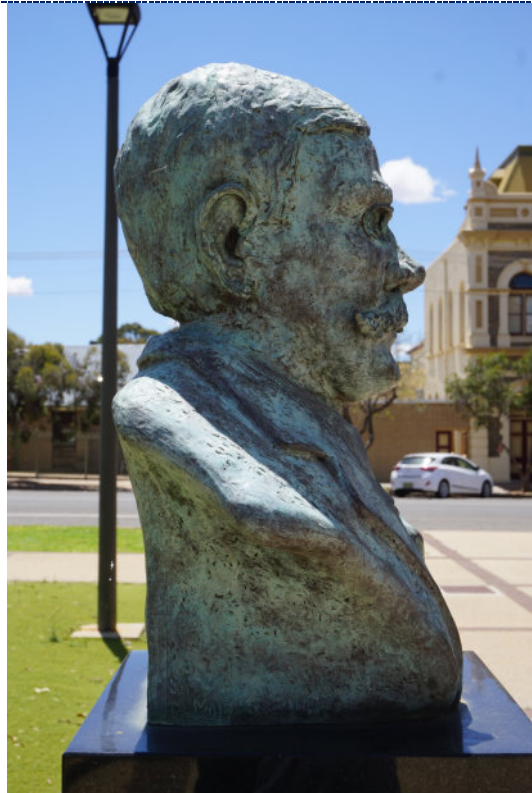
Figure 8: Detail – bust, proper right. Atmospheric pollution-driven copper corrosion product on bronze figure.

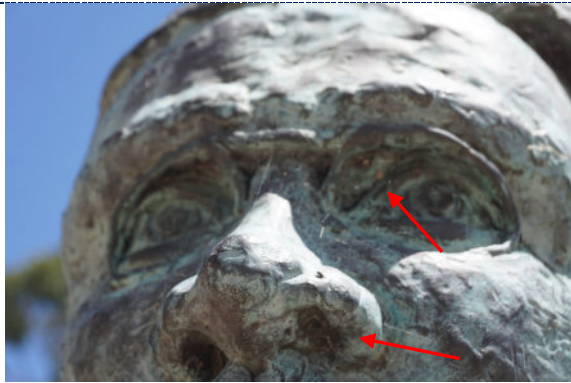
Figure 9: Detail – atmospheric pollution-driven copper corrosion product, dirt particulate, spider webs.

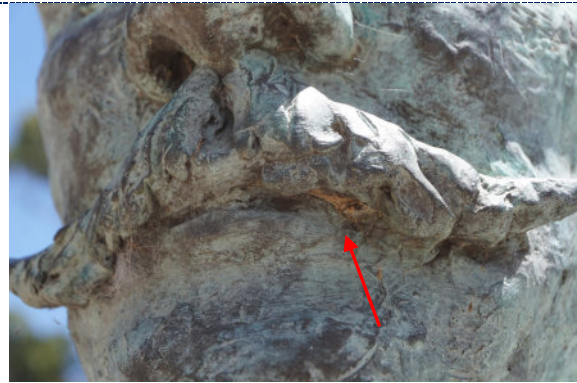
Figure 10: Detail – atmospheric pollution-driven copper corrosion product, dirt particulate, spider webs.

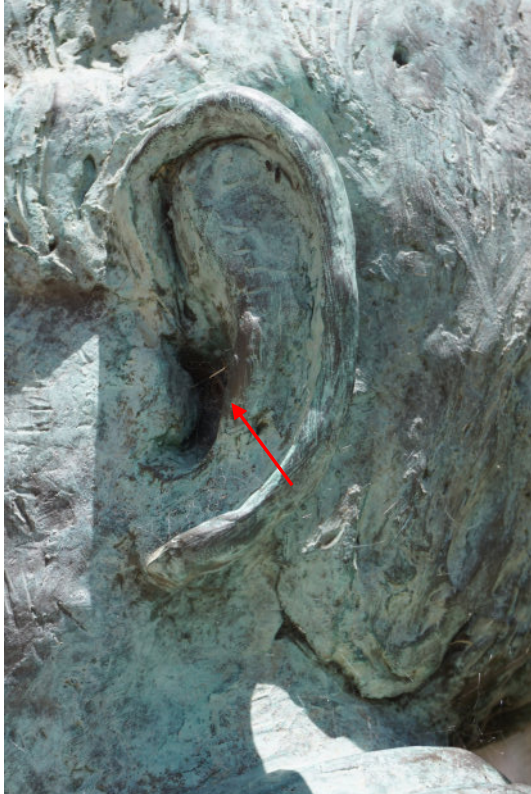
Figure 11: Detail – atmospheric pollution-driven copper corrosion product, dirt particulate, spider webs.

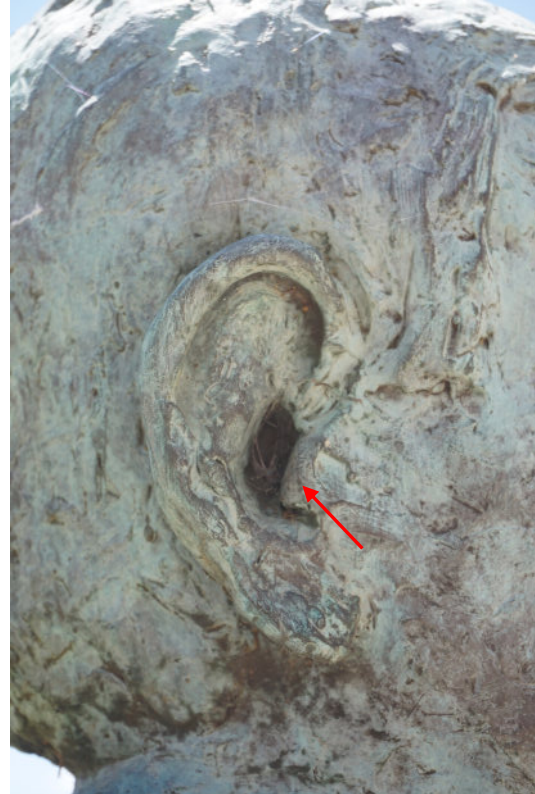
Figure 12: Detail – atmospheric pollution-driven copper corrosion product, dirt particulate, spider webs.

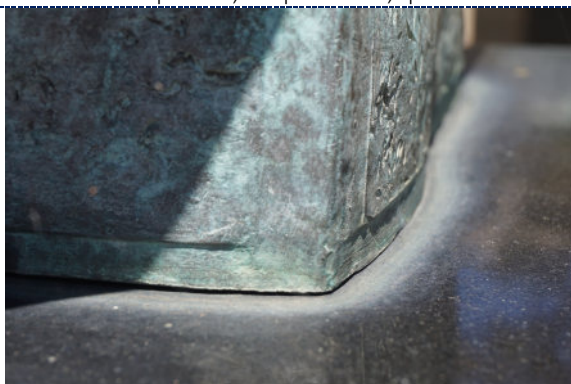
Figure 13: Detail – dirt particulate and increased copper corrosion product stemming from collected water at plinth interface.

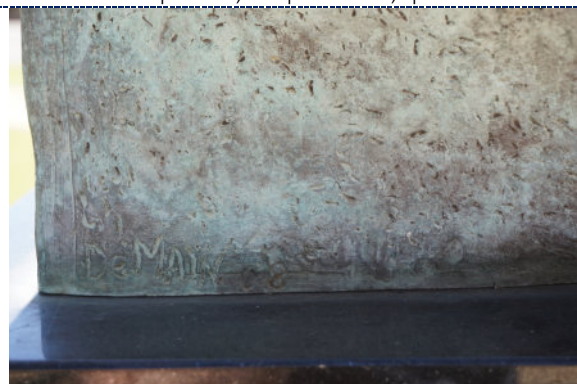
Figure 14: Detail – atmospheric pollution-driven copper corrosion product and artist's signature.

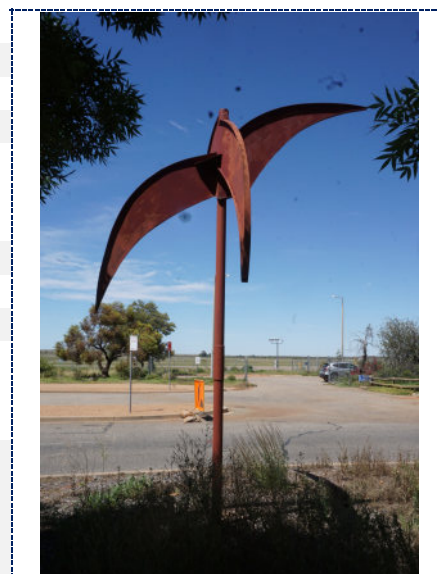
Previous repairs/ modifications?  YES  NO

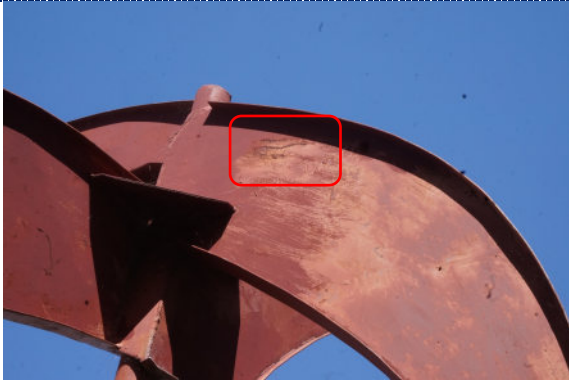
Figure 5: Detail – chalking paint, flaking paint loss, abrasions and corrosion; overpaint.

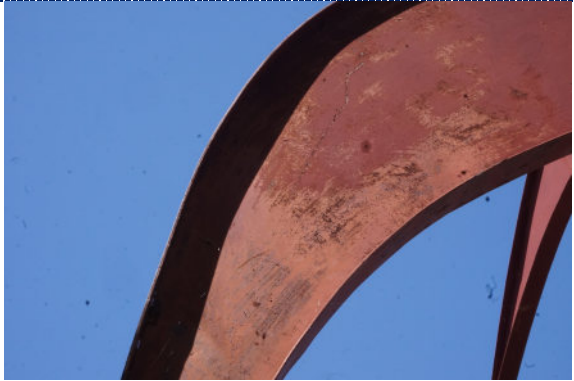
Figure 6: Detail – chalking paint, flaking paint loss, abrasions and corrosion; overpaint.

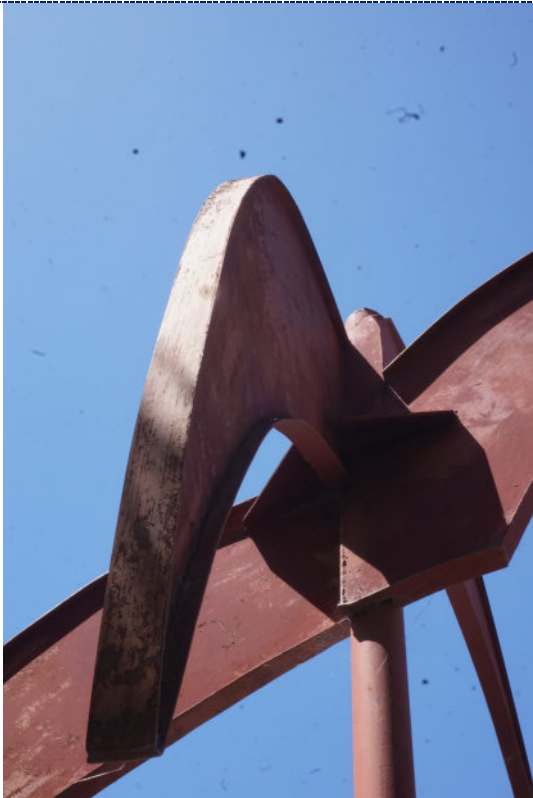
Figure 7: Detail – chalking paint, flaking paint loss, abrasions and corrosion; overpaint.

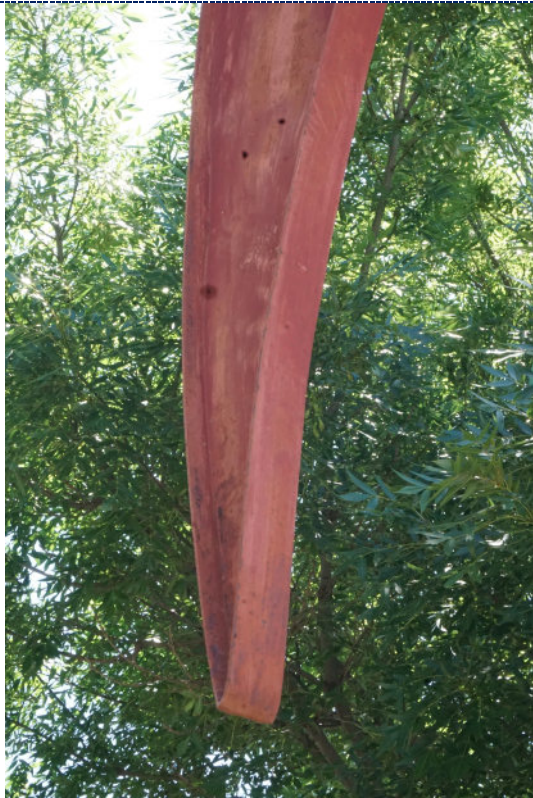
Figure 8: Detail – chalking paint, flaking paint loss, abrasions and corrosion; overpaint.

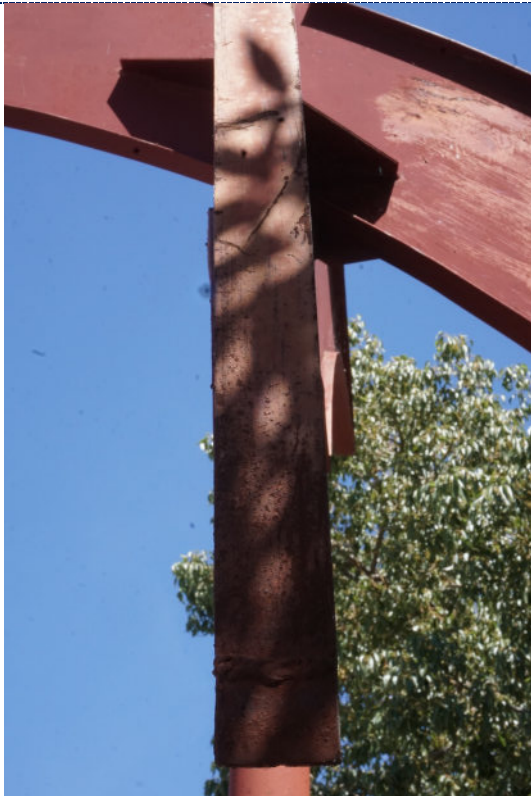
Figure 9: Detail – chalking paint, flaking paint loss, abrasions and corrosion; overpaint.

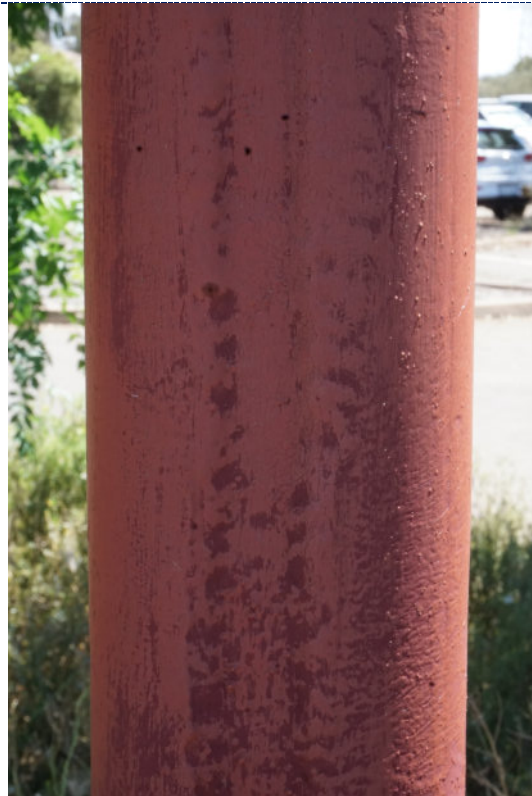
Figure 10: Detail – flaking paint loss with overpaint.

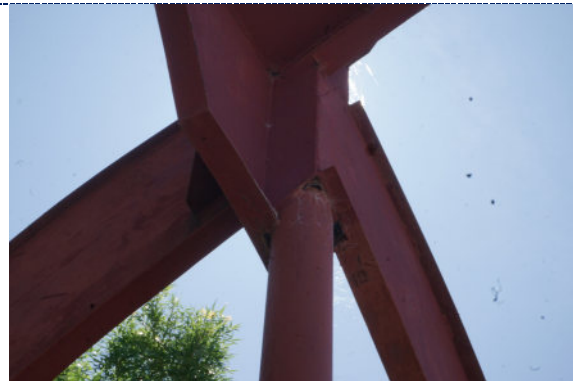
Figure 12: Detail – small holes noted at welding joint and spider webs.

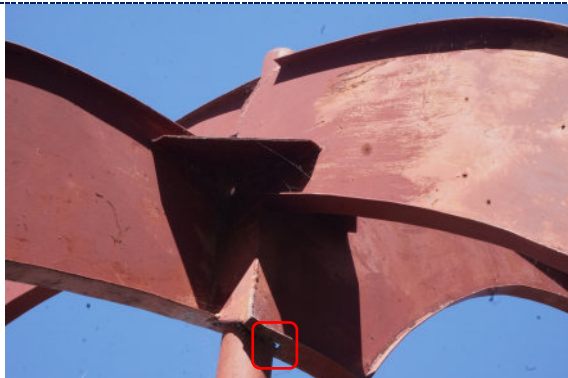
Figure 13: Detail – chalking paint, flaking paint loss, abrasions and corrosion; overpaint; corrosion resulting in perforation of the substrate (small hole).

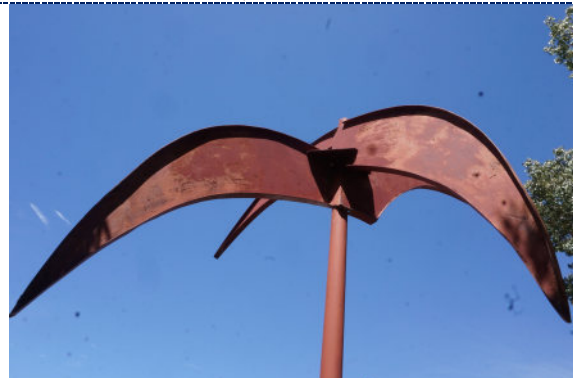
Figure 14: Detail – flaking paint loss with overpaint and abrasions.

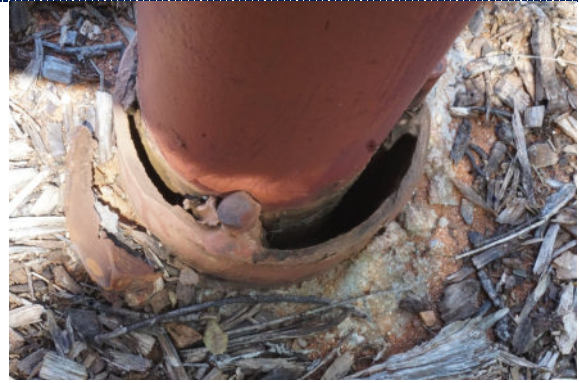
Figure 16: Detail – deteriorated putty with loss throughout base plinth; ingress of water possible, leading to corrosion.

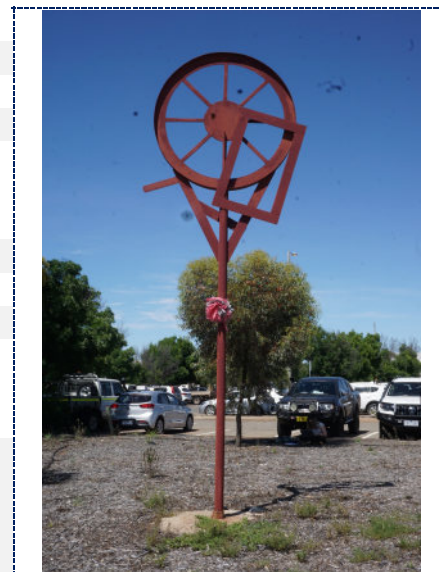
Previous repairs/ modifications?  YES  NO

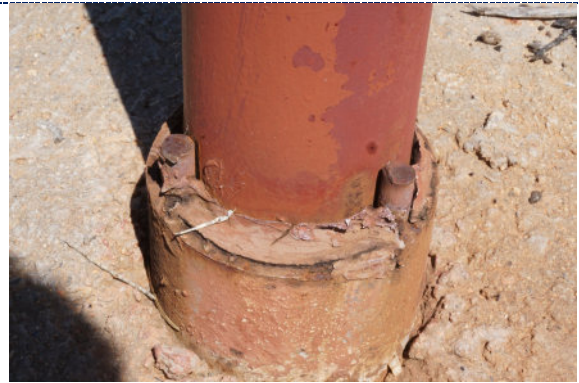
Figure 6: Detail – paint chalking, flaking paint loss with overpaint; corrosion in areas of paint loss; previous repairs (putty/silicone at base).

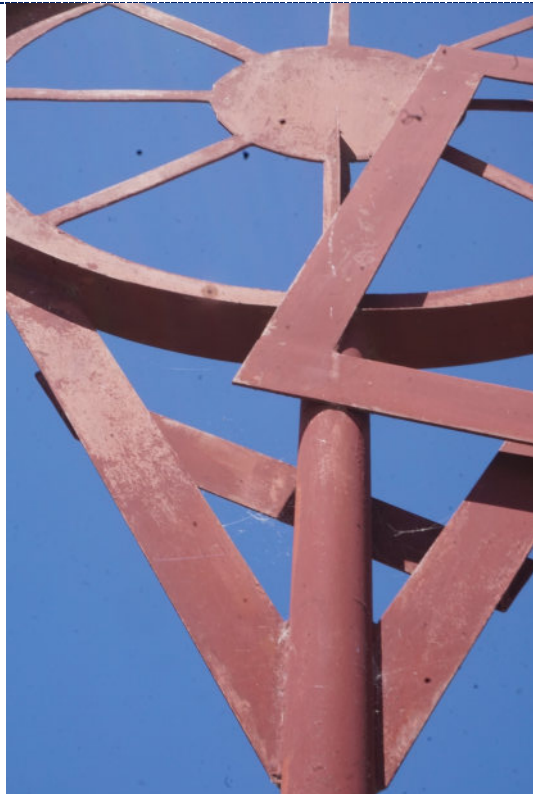
Figure 7: Detail – paint chalking, overpaint; spider webs, bird excrement.

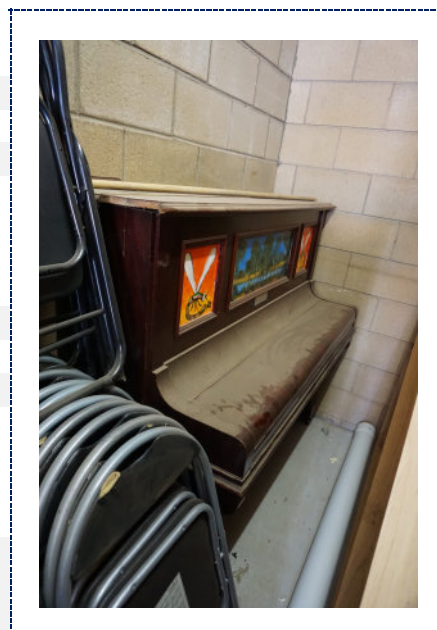
Previous repairs/ modifications?  YES  NO

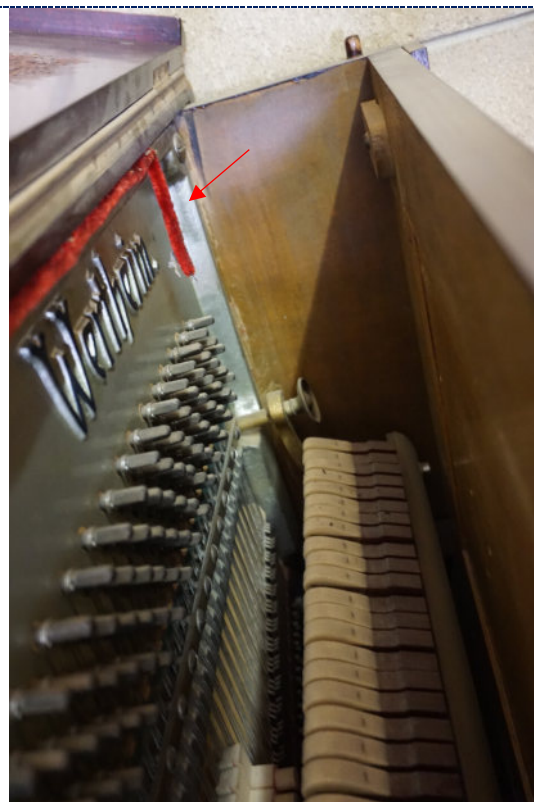
Figure 10: Detail – dirt particulate; loose-hanging felt.

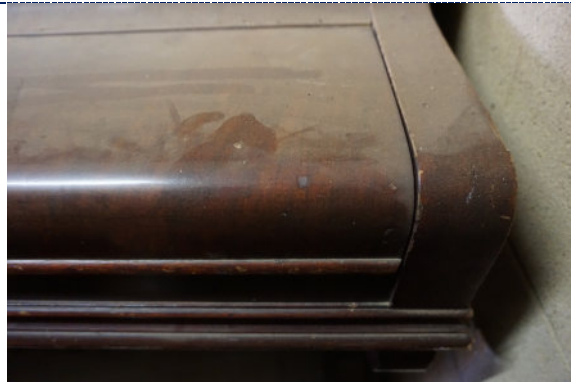
Figure 11: Detail – dirt particulate; surface accretions.

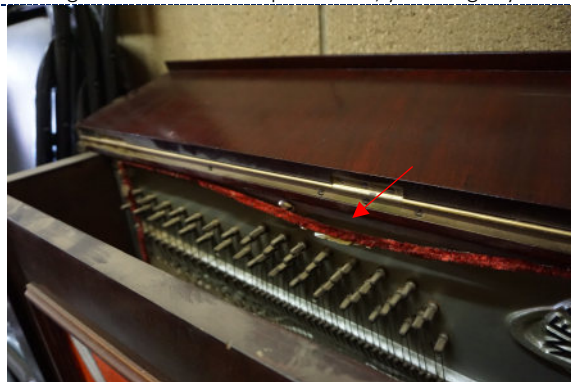
Figure 14: Detail – dirt particulate; loose-hanging felt.

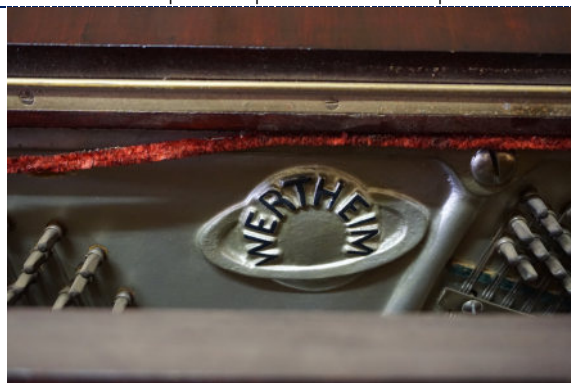
Figure 15: Detail – dirt particulate; loose-hanging felt.

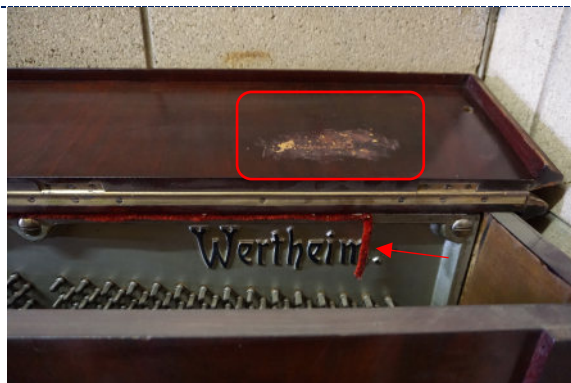
Figure 16: Detail – dirt particulate; loose-hanging felt; large loss to tinted lacquer.

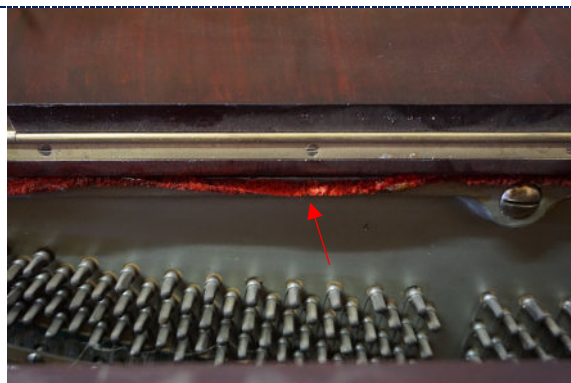
Figure 17: Detail – dirt particulate; loose-hanging felt.

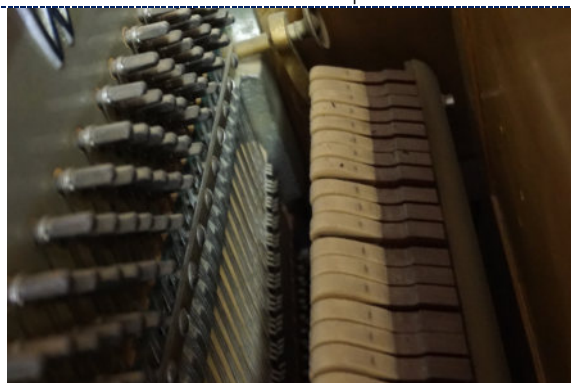
Figure 18: Detail – dirt particulate.

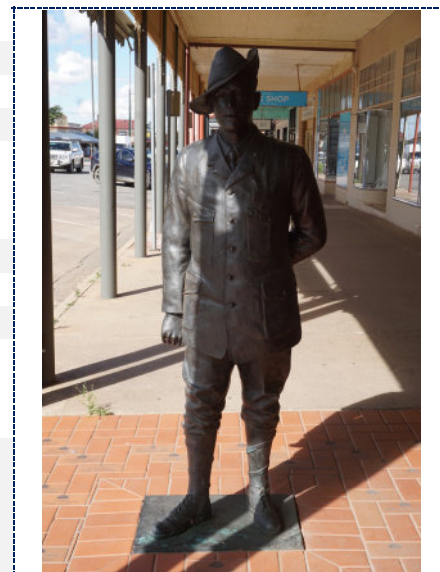
Previous repairs/ modifications?  YES  NO
