# *Broken Hill Public Art Condition Survey and Conservation Plan*

Prepared for: Broken Hill City Council  
Submission Date: February 2023

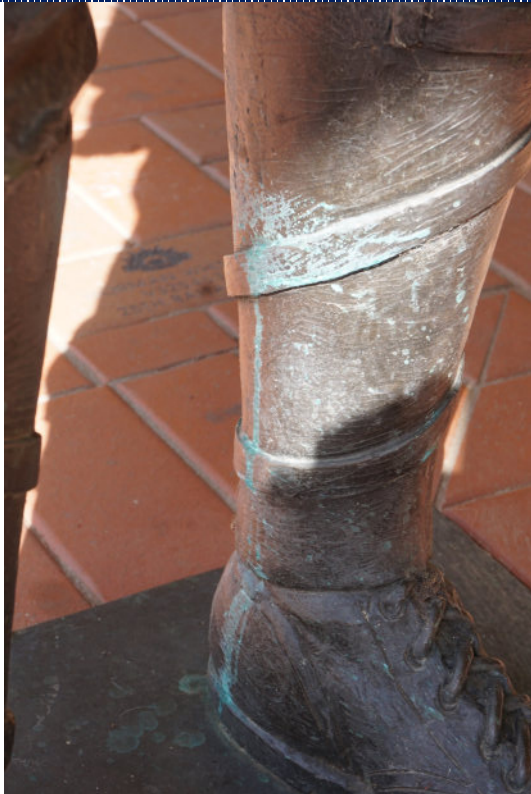
Figure 5: Detail – dirt particulate; corrosion product appearing to stem from acidic dog urine.

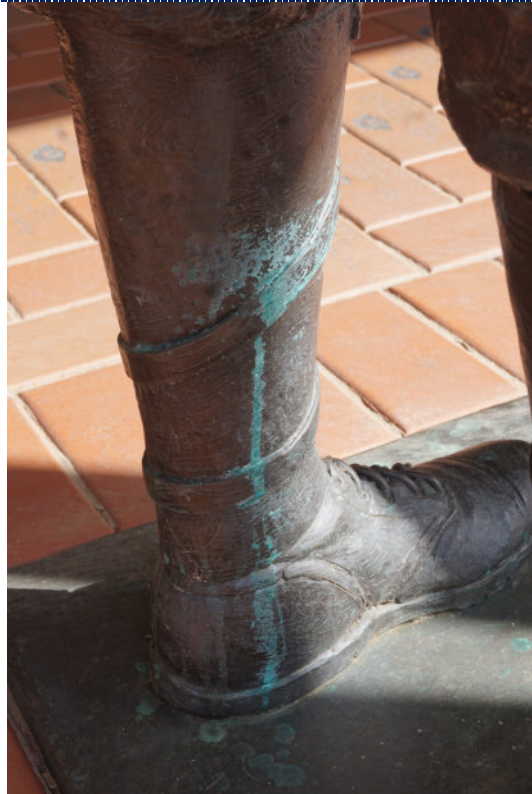
Figure 6: Detail – dirt particulate; corrosion product appearing to stem from acidic dog urine.

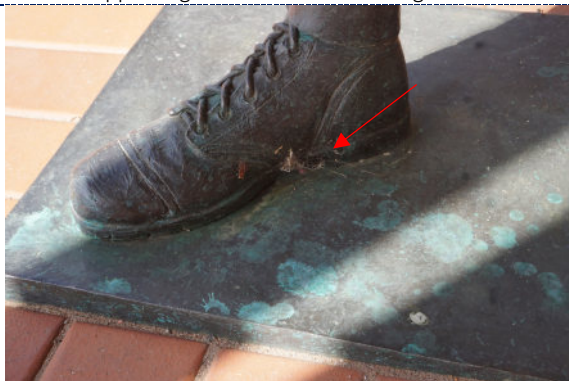
Figure 7: Detail – corrosion product, possibly stemming from acidic dog urine; dirt particulate, spider webs, bird excrement.

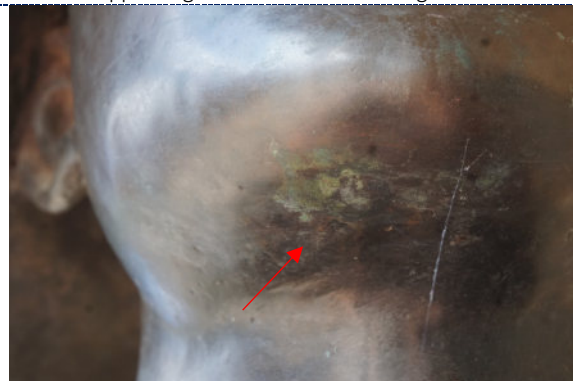
Figure 8: Detail – corrosion product under figure's chin; dirt particulate, spider webs.

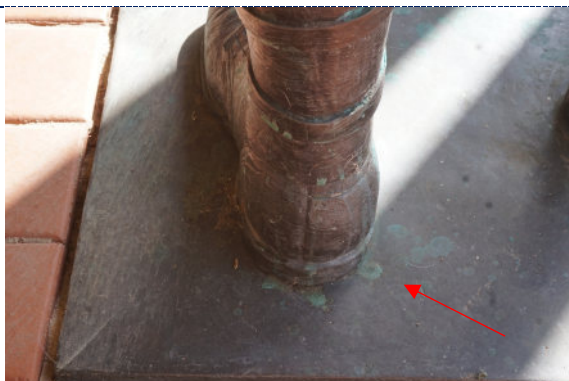
Figure 9: Detail – corrosion product, possibly stemming from acidic dog urine; dirt particulate, spider webs, bird excrement.

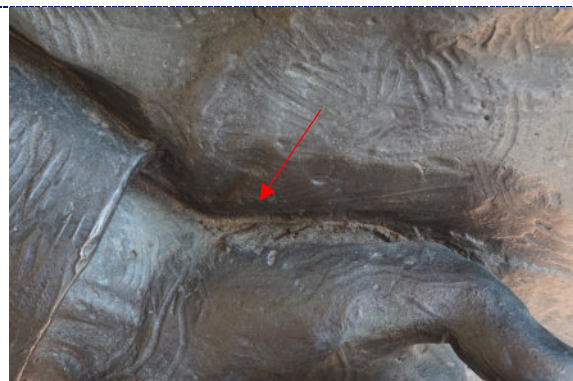
Figure 10: Detail – dirt particulate.

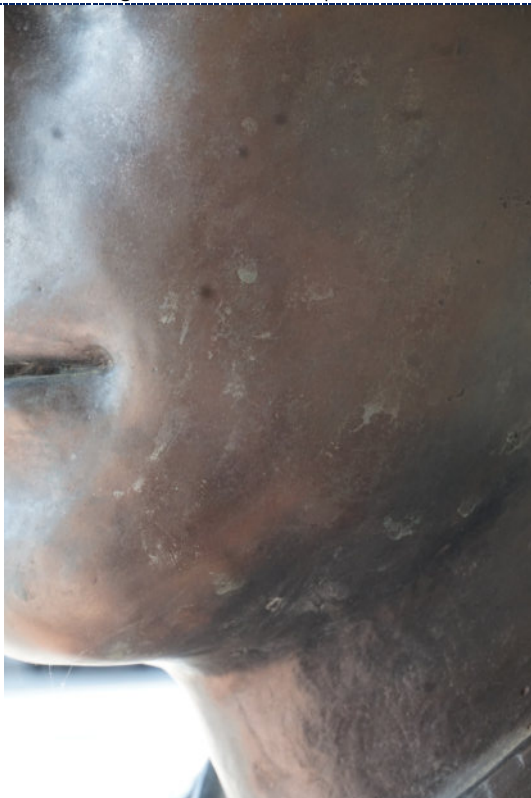
Figure 13: Detail – corrosion product; dirt particulate.

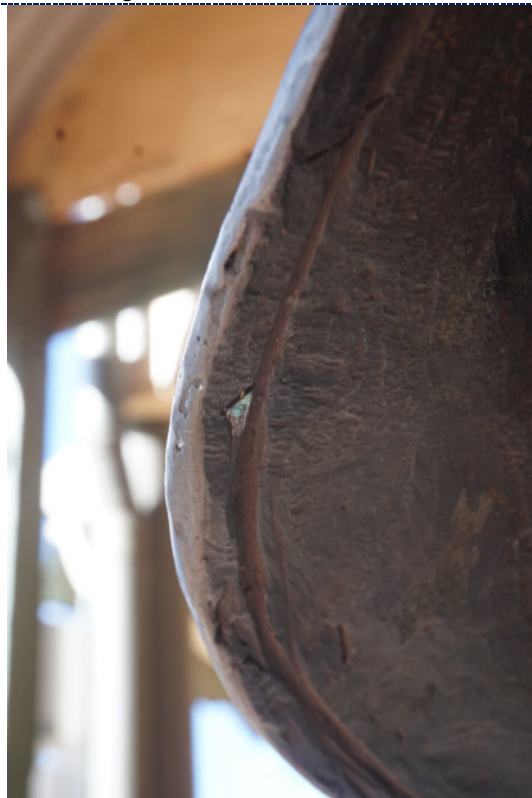
Figure 14: Detail – corrosion product inside small casting defect.

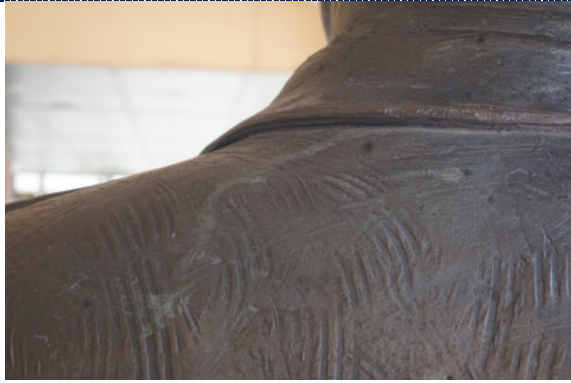
Figure 15: Detail – corrosion product; dirt particulate.

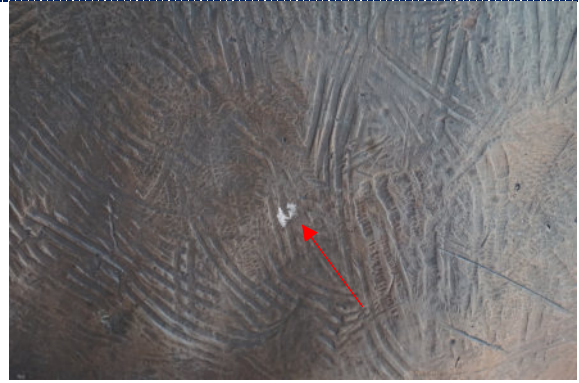
Figure 16: Detail – bird excrement, dirt particulate.

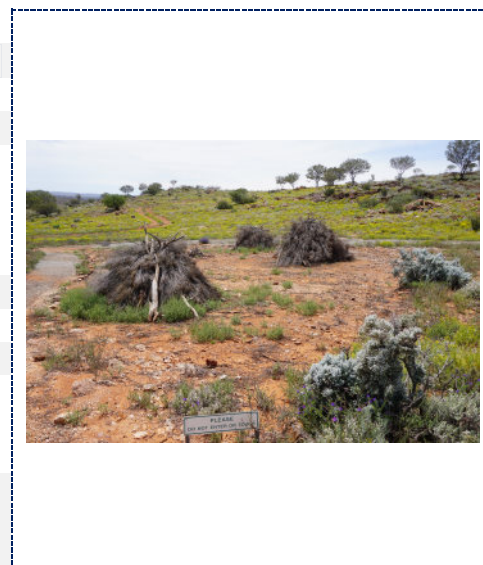
Previous repairs/ modifications?  YES  X NO

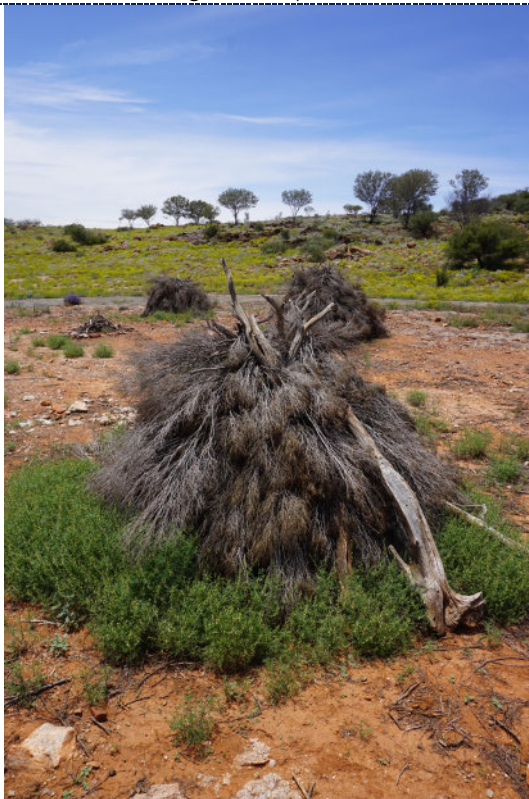
Figure 5: Detail – browning of organic material due to natural degradation processes; biogrowth encircling Yapara shelter.

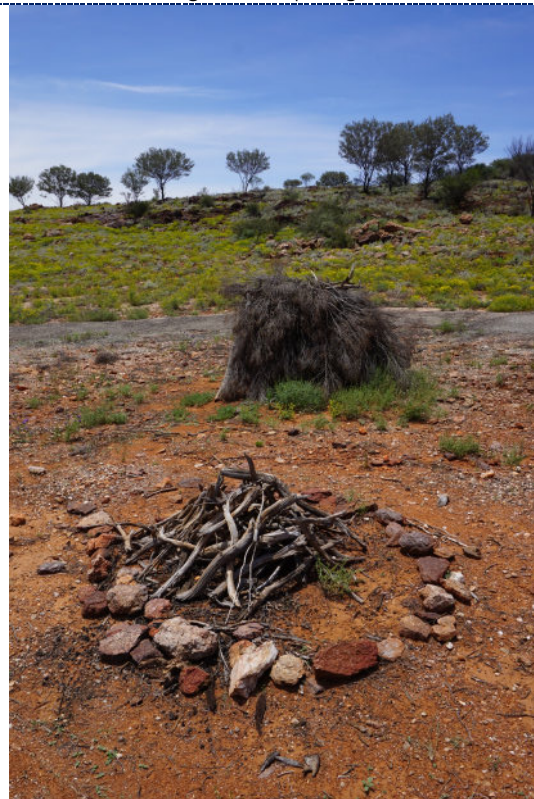
Figure 6: Detail – browning of organic material due to natural degradation processes; biogrowth encircling Yapara shelter.

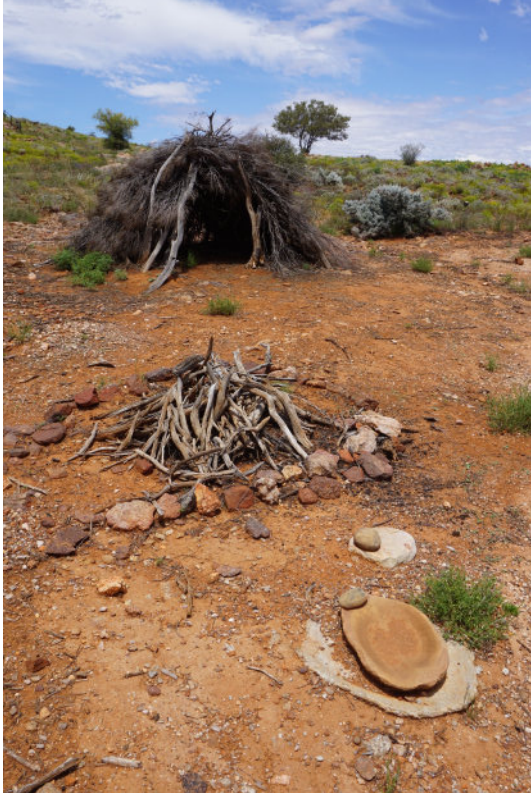
Figure 7: Detail – browning of organic material due to natural degradation processes; biogrowth encircling Yapara shelter.

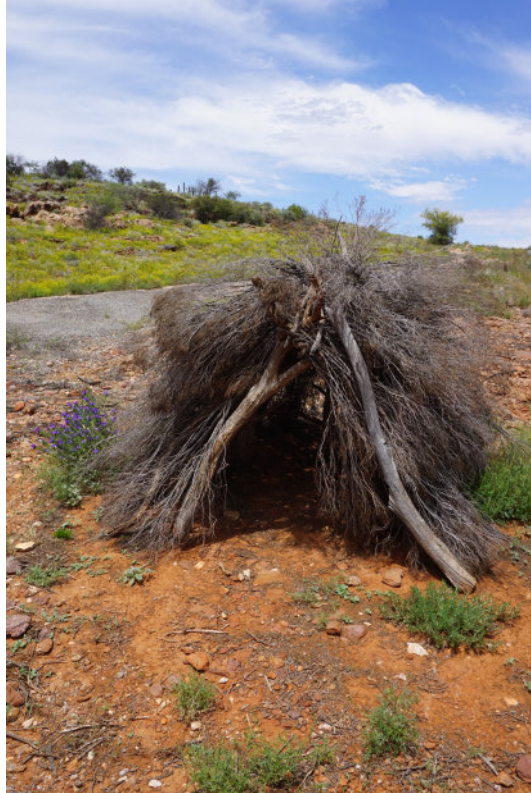
Figure 8: Detail – browning of organic material due to natural degradation processes; biogrowth encircling Yapara shelter.

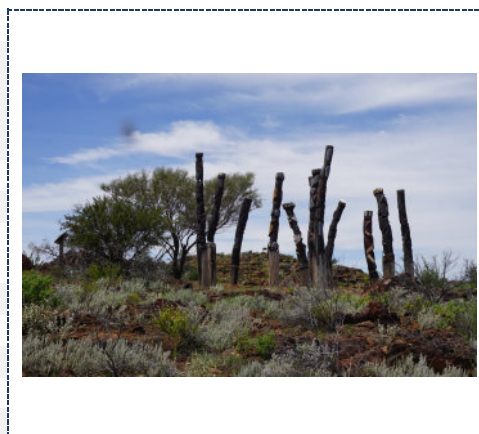
Previous repairs/ modifications?  YES  X NO

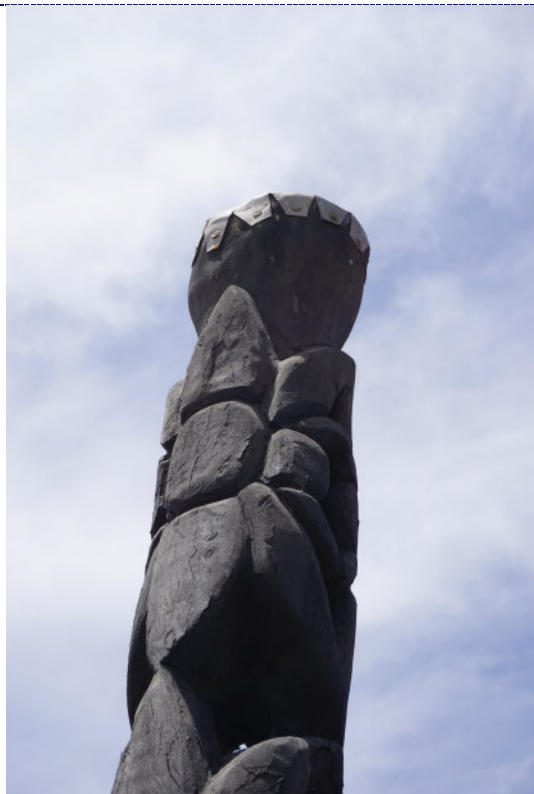
Figure 7: Detail – Pole 1 (temporary conservation number assigned to the object for identification purposes), exterior, UV degradation (darkening) to wood surface. Dirt particulate is present throughout.

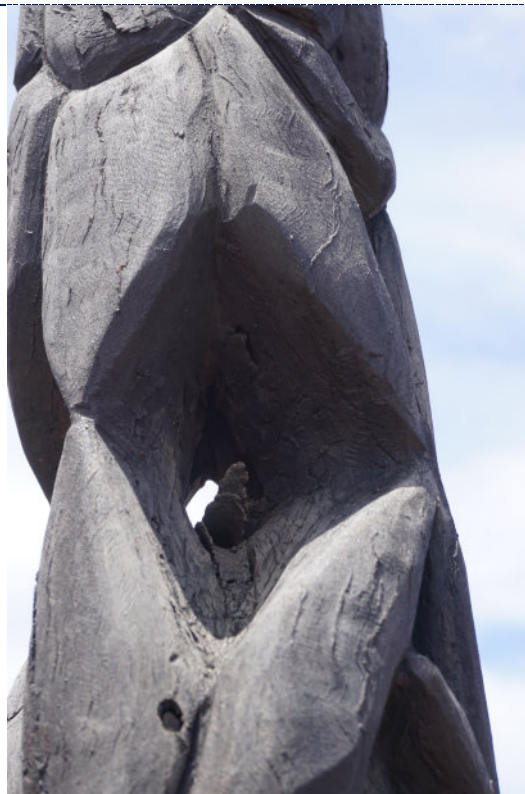
Figure 8: Detail – Pole 1 (temporary conservation number assigned to the object for identification purposes), exterior, UV degradation (darkening) to wood surface, cracks and splitting following the grain of the wood are evident throughout.

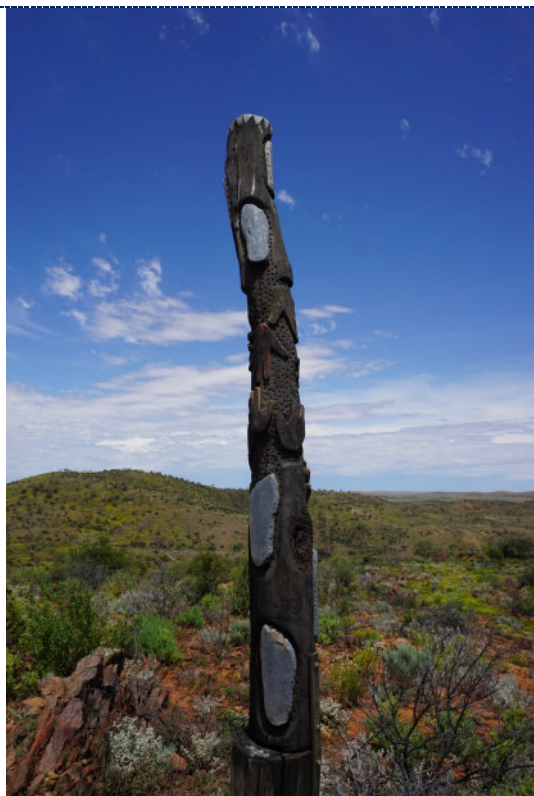
Figure 9: Pole 2 (temporary conservation number assigned to the object for identification purposes), front.

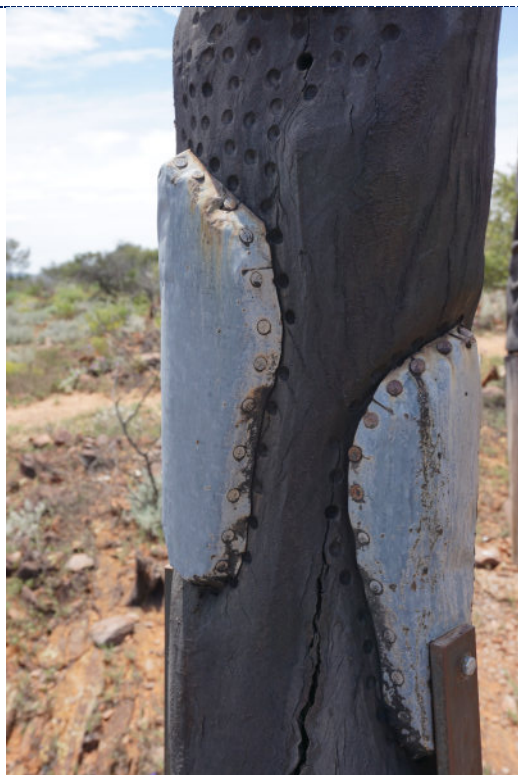
Figure 11: Detail – Pole 2, exterior, UV degradation (darkening) to wood surface, presence of ferric corrosion products on iron components and fittings. Cracks and splitting following the grain of the wood are evident throughout. Dirt particulate is present throughout.

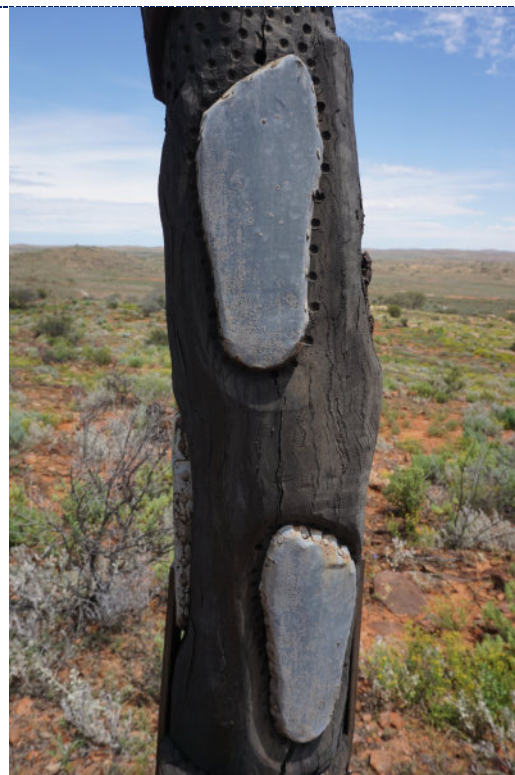
Figure 12: Detail – Pole, exterior, UV degradation (darkening) to wood surface, presence of ferric corrosion products on iron components and fittings. Cracks and splitting following the grain of the wood are evident throughout.

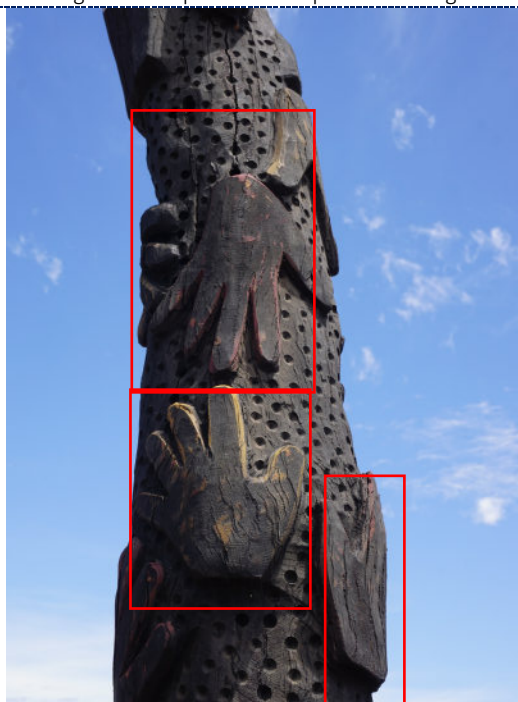
Figure 13: Detail – Pole 2, exterior, UV degradation (darkening) to wood surface, ricks and splitting following the grain of the wood are evident throughout. Extensive paint losses to carve hands (highlighted in red).

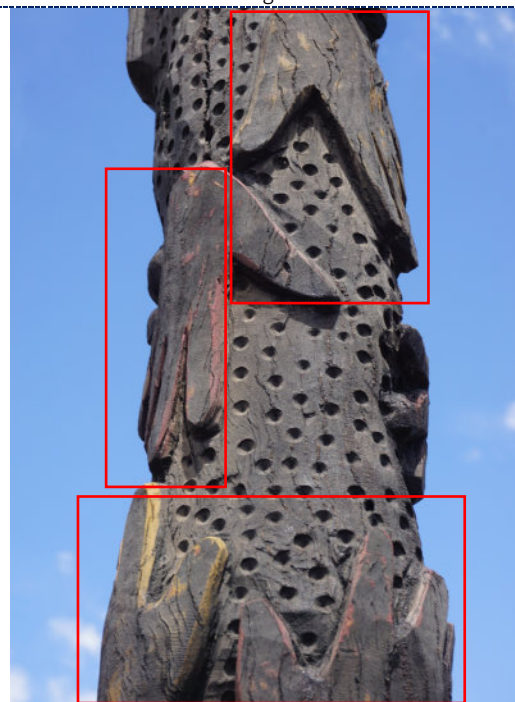
Figure 14: Detail – Pole 2, exterior, UV degradation (darkening) to wood surface, ricks and splitting following the grain of the wood are evident throughout. Extensive paint losses to carve hands (highlighted in red).

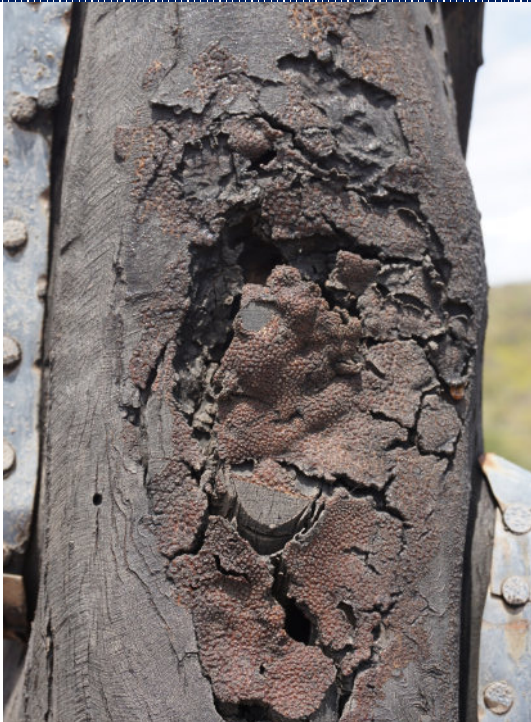
Figure 15: Detail – Pole 2, exterior, UV degradation (darkening) to wood surface, significant cracking of wood, and build-up of sap-like accretions.

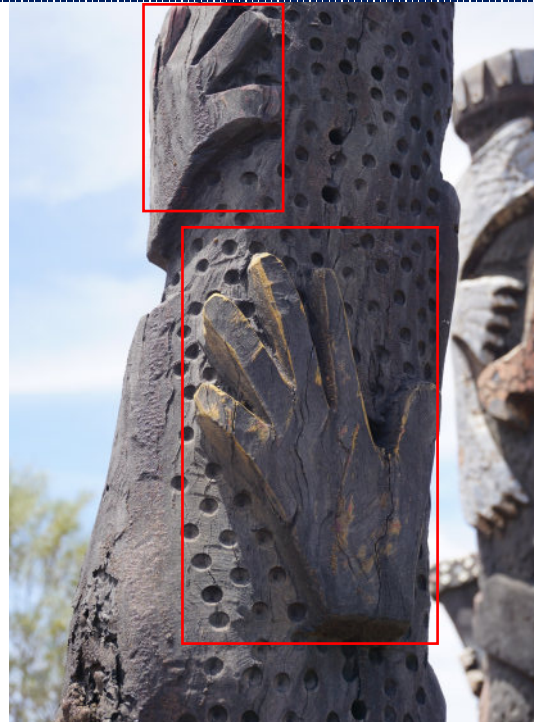
Figure 16: Detail – Pole 2, exterior, UV degradation (darkening) to wood surface, extensive paint losses to carve hands.

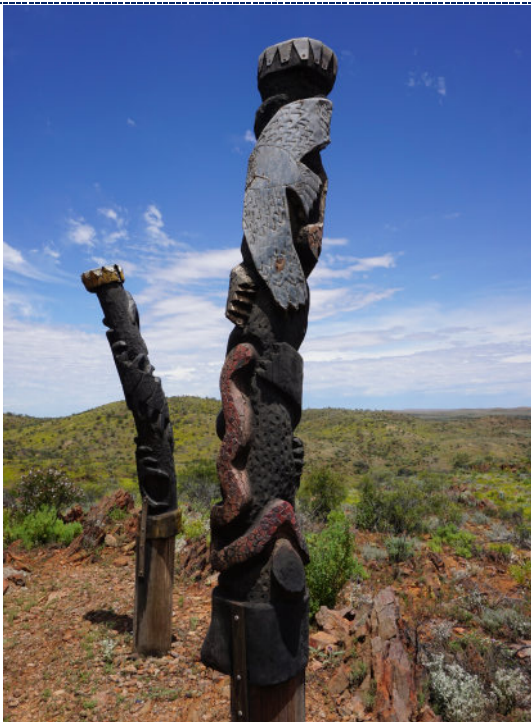
Figure 17: Pole 3 (temporary conservation number assigned to the object for identification purposes), front.

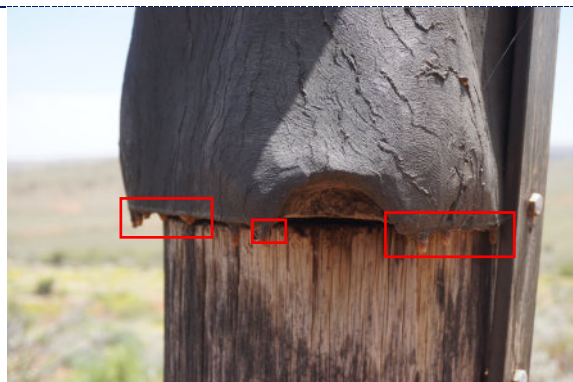
Figure 19: Detail – Pole 3, exterior, UV degradation (darkening) to wood surface, sap-like deposits (accretions) along the lower edge of the pole (highlighted in red). Dirt particulate is present throughout.

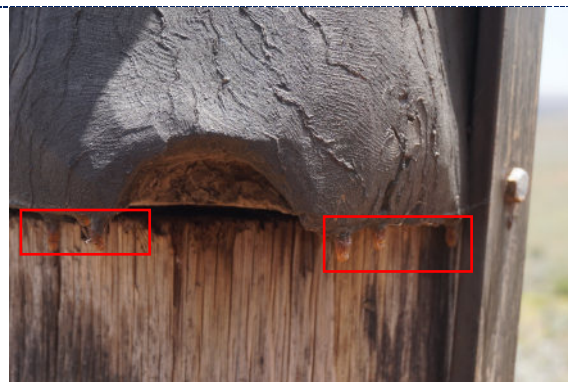
Figure 20: Detail – Pole 3, exterior, UV degradation (darkening) to wood surface, sap-like deposits (accretions) along the lower edge of the pole (highlighted in red).

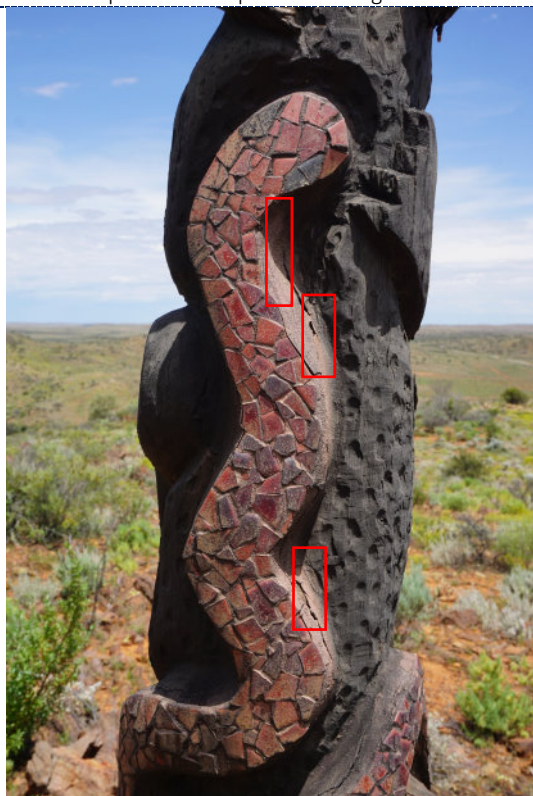
Figure 21: Detail – Pole 3, exterior, UV degradation (darkening) to wood surface, losses to wood surface adjacent to the mosaic tiled serpent (losses highlighted in red).

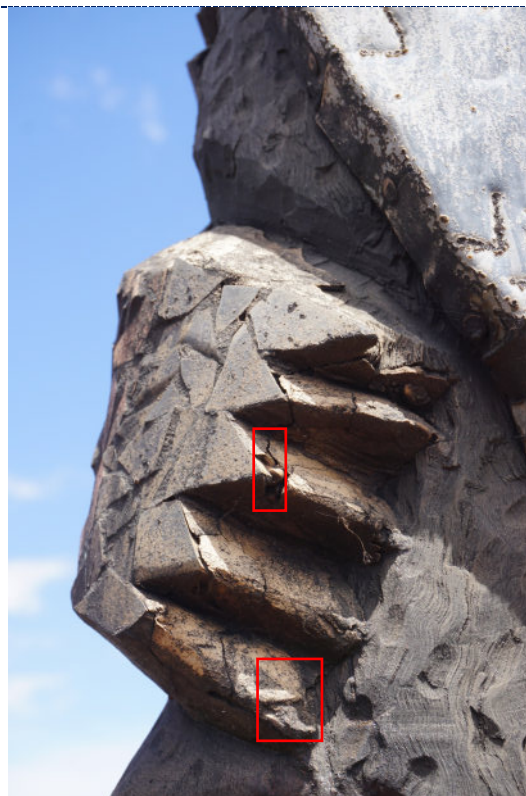
Figure 22: Detail – Pole 3, exterior, UV degradation (darkening) to wood surface, losses to wood surface adjacent to the mosaic tiled serpent (losses highlighted in red).

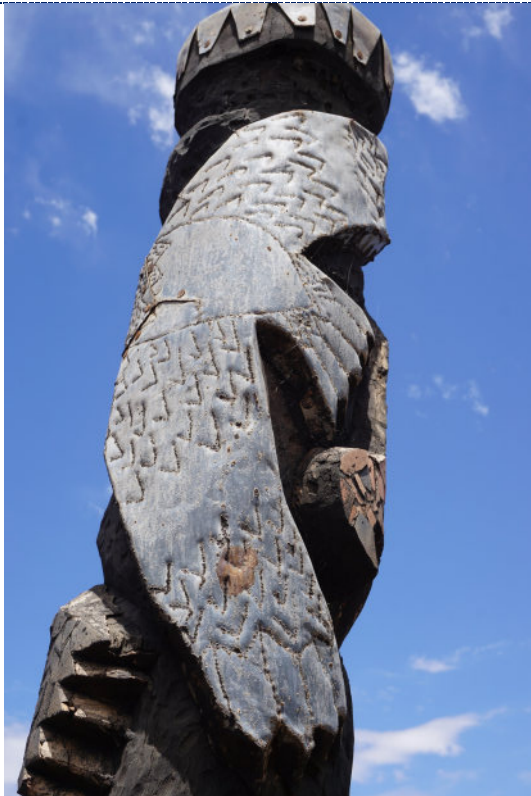
Figure 23: Detail – Pole 3, exterior, UV degradation (darkening) to wood surface, iron corrosion and staining on metal bird and iron nails.

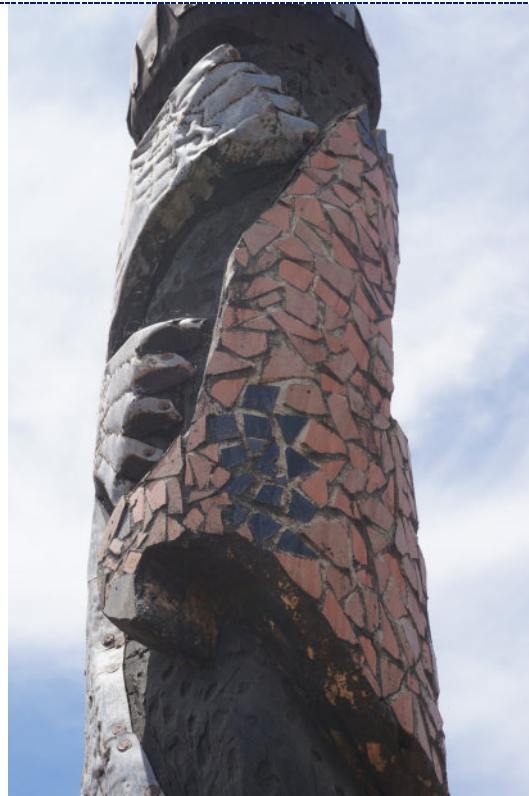
Figure 24: Detail – Pole 3, exterior, UV degradation (darkening) to wood surface, iron corrosion and staining on metal bird and iron nails and UV degradation of mosaic tiles.

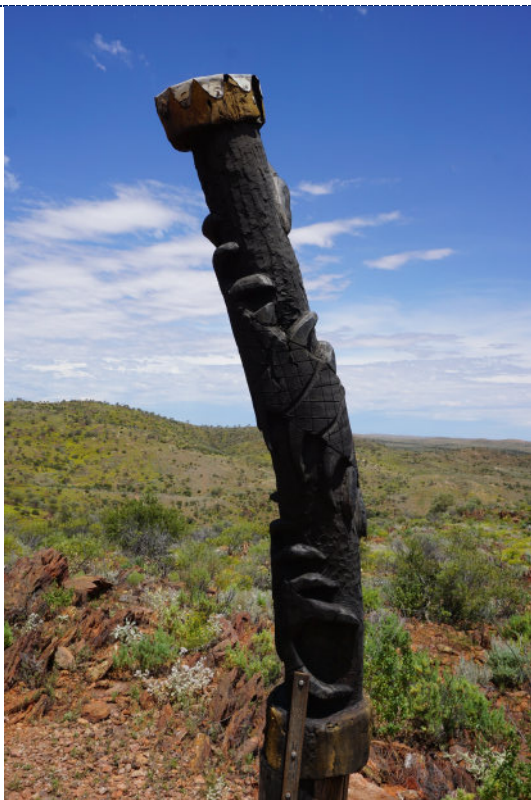
Figure 25: Pole 4 (temporary conservation number assigned to the object for identification purposes), front.

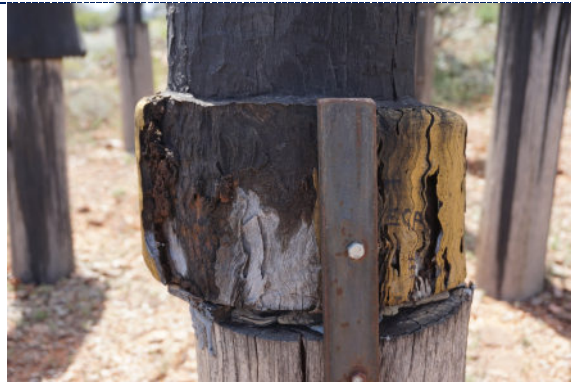
Figure 27: Detail – Pole 4, exterior, UV degradation (darkening) to wood surface, losses to wood likely associated with past insect activity, iron corrosion on metal support brackets. Dirt particulate is present throughout.

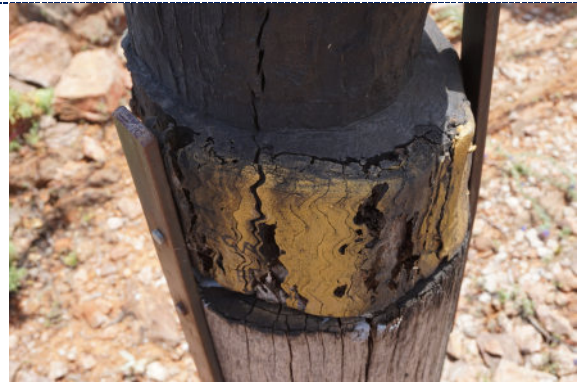
Figure 28: Detail – Pole 4, exterior, UV degradation (darkening) to wood surface, losses to wood likely associated with past insect activity, iron corrosion on metal support brackets.

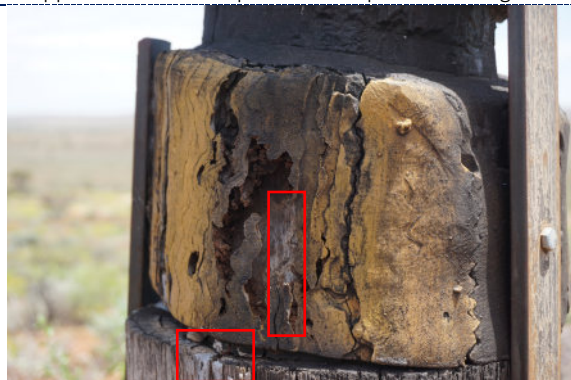
Figure 29: Detail – Pole 4, exterior, UV degradation (darkening) to wood surface, losses to wood likely associated with past insect activity, and presence of bird excrement (highlighted in red).

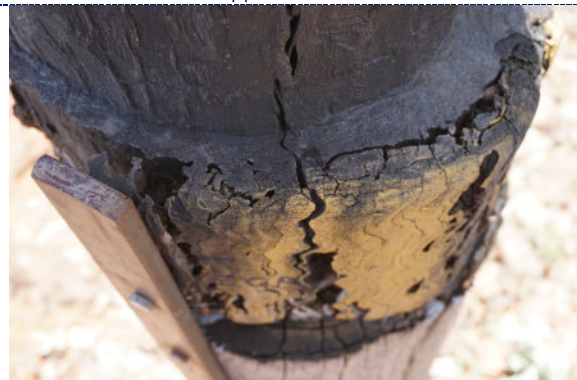
Figure 30: Detail – Pole 4, exterior, UV degradation (darkening) to wood surface, losses to wood likely associated with past insect activity, iron corrosion on metal support brackets.

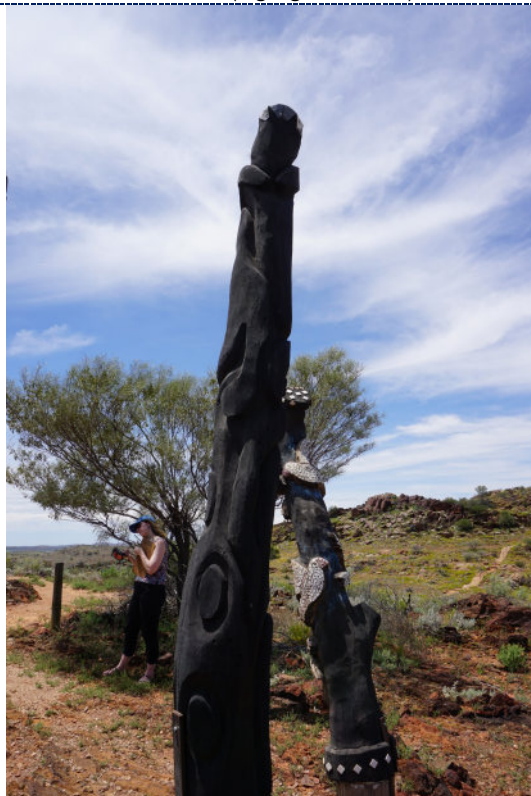
Figure 31: Pole 5 (temporary conservation number assigned to the object for identification purposes), front.

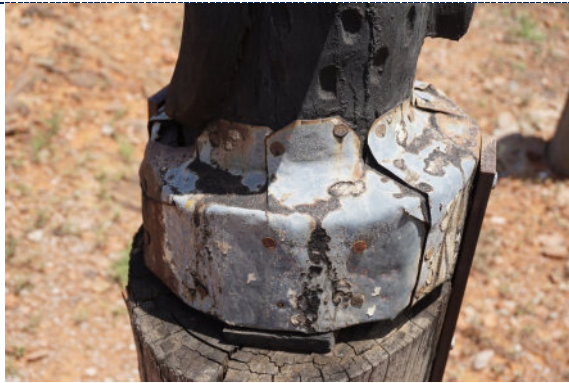
Figure 33: Detail – Pole 5, exterior, UV degradation (darkening) to wood surface, degradation of metal and presence of iron corrosion products. Dirt particulate is present throughout.

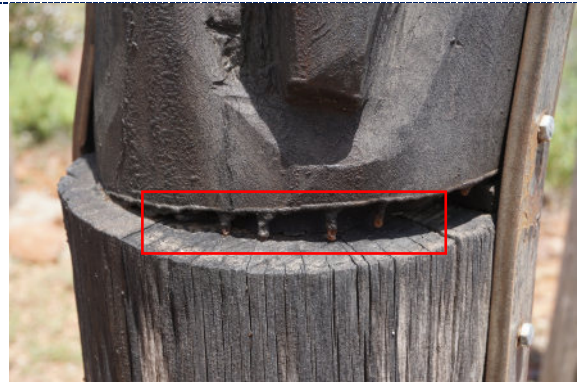
Figure 34: Detail – Pole 5, exterior, UV degradation (darkening) to wood surface, sap-like deposits (accretions) along the lower edge of the pole (highlighted in red).

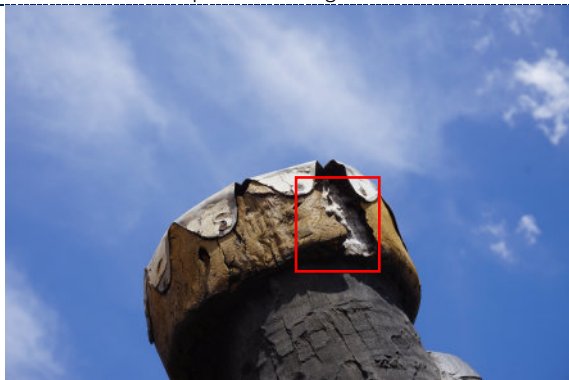
Figure 35: Detail – Pole 5, exterior, UV degradation (darkening) to wood surface, large loss to wood on exterior side of the pole's (top of pole, highlighted in red).

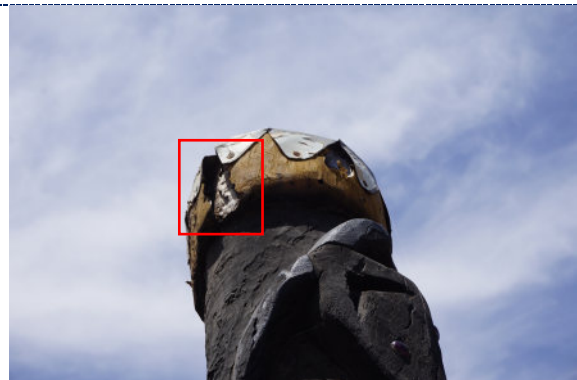
Figure 36: Detail – Pole 5, exterior, UV degradation (darkening) to wood surface, large loss to wood on exterior side of the pole's (top of pole, highlighted in red).

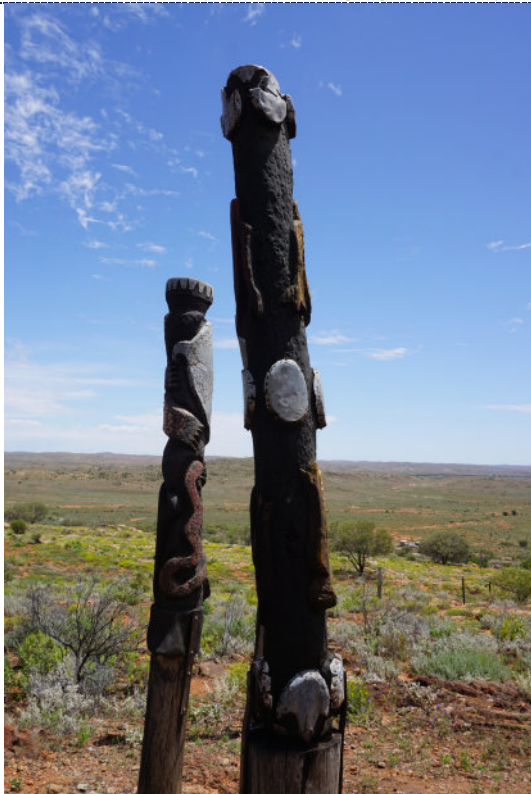
Figure 37: Pole 6 (temporary conservation number assigned to the object for identification purposes), front.

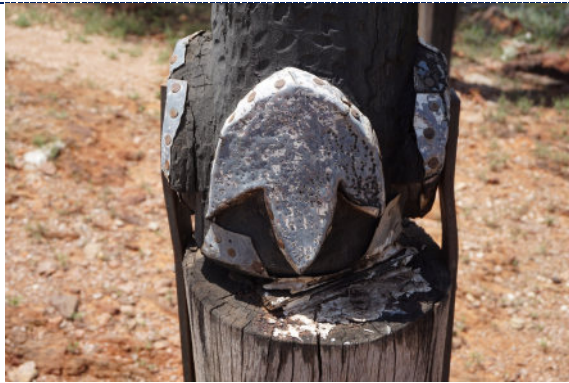
Figure 39: Detail – Pole 6, exterior, UV degradation (darkening) to wood surface, degradation of metal and presence of iron corrosion products. Dirt particulate is present throughout.

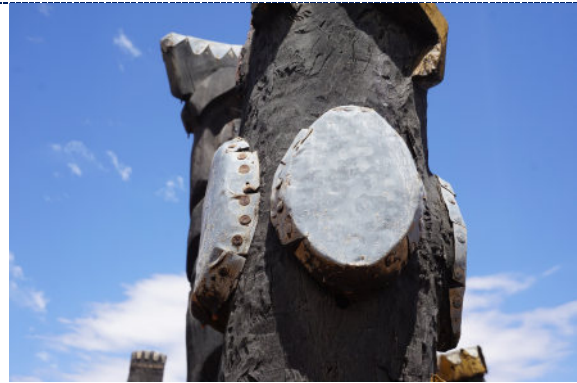
Figure 40: Detail – Pole 6, exterior, UV degradation (darkening) to wood surface, degradation of metal and presence of iron corrosion products on metal components and iron nails.

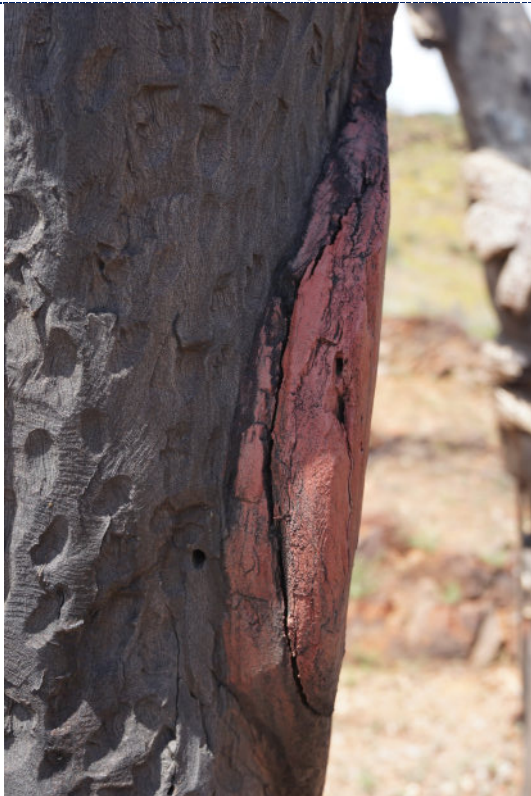
Figure 41: Detail – Pole 6, exterior, UV degradation (darkening) to wood surface, extensive cracking, and losses to raised carved wood designs and associated paint losses likely due UV degradation and full exposure to the elements.

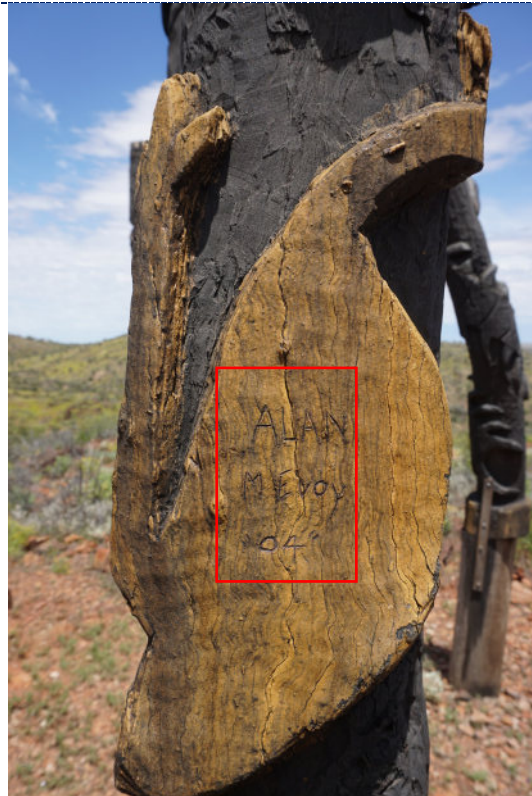
Figure 42: Detail – Pole 6, exterior, UV degradation (darkening) to wood surface, extensive cracking and losses to raised carved wood designs and fading of painted surfaces likely due UV degradation and full exposure to the elements. The artist's name is carved into the wood (highlighted in red).

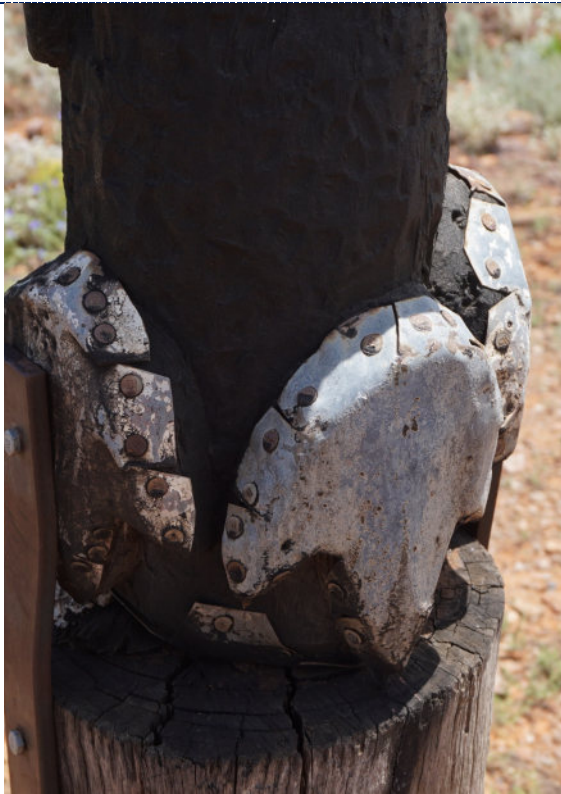
Figure 43: Detail – Pole 6, exterior, UV degradation (darkening) to wood surface, chemical degradation of the spherical metal components, including the presence of pitting and iron corrosion products on the iron nails.

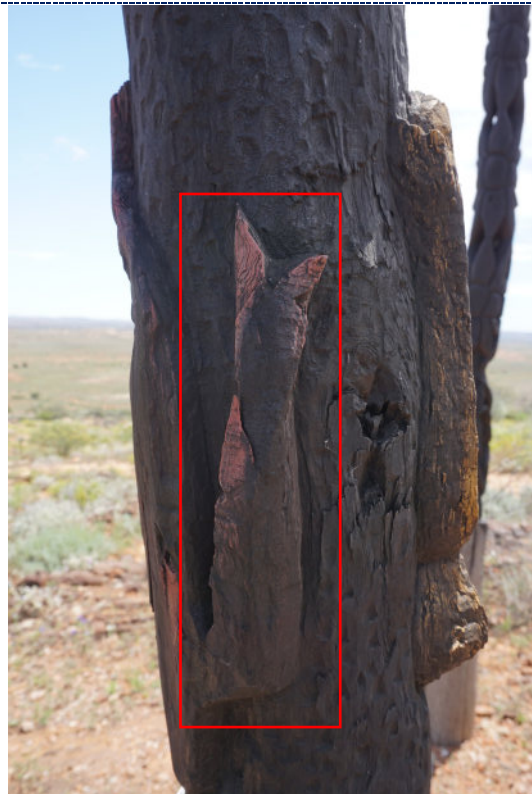
Figure 44: Detail – Pole 6, exterior, UV degradation (darkening) to wood surface, extensive cracking and losses to raised carved wood designs and associated paint losses (highlighted in red) likely due UV degradation and full exposure to the elements.

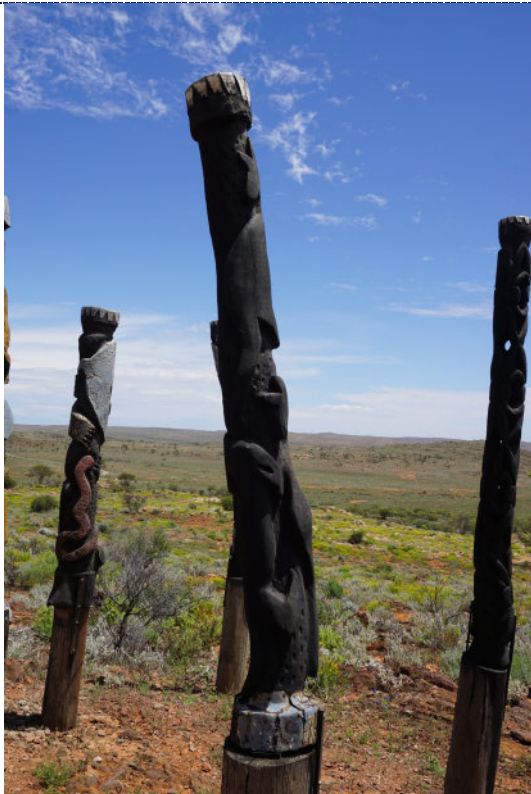
Figure 45: Pole 7 (temporary conservation number assigned to the object for identification purposes), front.

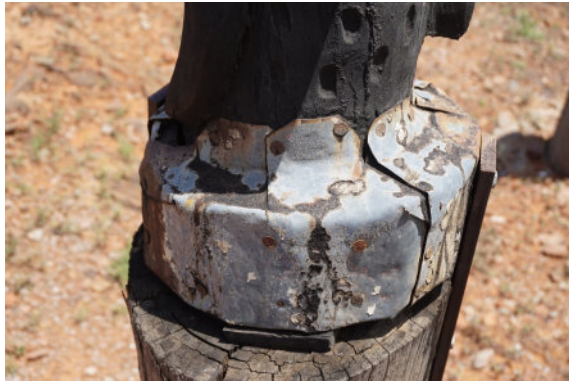
Figure 47: Detail - Pole 7, exterior, UV degradation (darkening) to wood surface, chemical degradation of the spherical metal components, including the presence of pitting and iron corrosion products on the iron nails. Dirt particulate is present throughout.

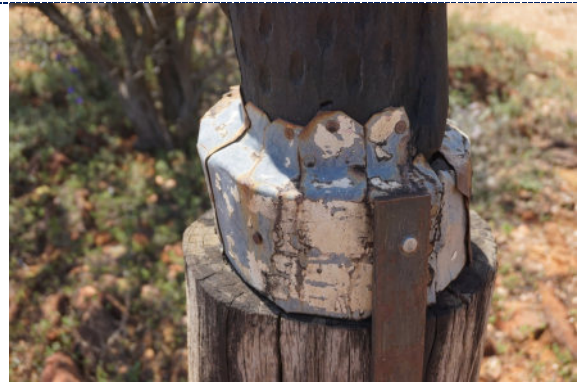
Figure 48: Detail - Pole 7, exterior, UV degradation (darkening) to wood surface, chemical degradation of the spherical metal components, including the presence of pitting and iron corrosion products on the iron nails.

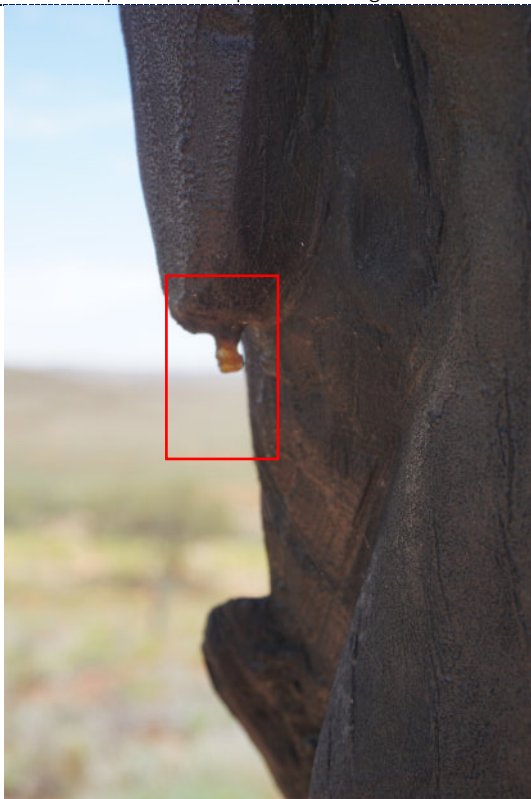
Detail 49: Detail – Pole 7, exterior, UV degradation (darkening) to wood surface, sap-like deposits (accretions) along the lower edge of the pole (highlighted in red).

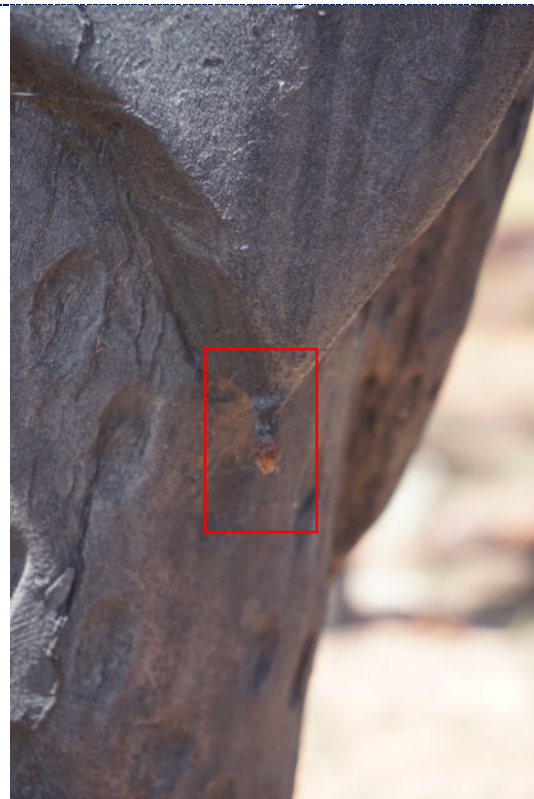
Detail 50: Detail – Pole 7, exterior, UV degradation (darkening) to wood surface, sap-like deposits (accretions) along the lower edge of the pole (highlighted in red).

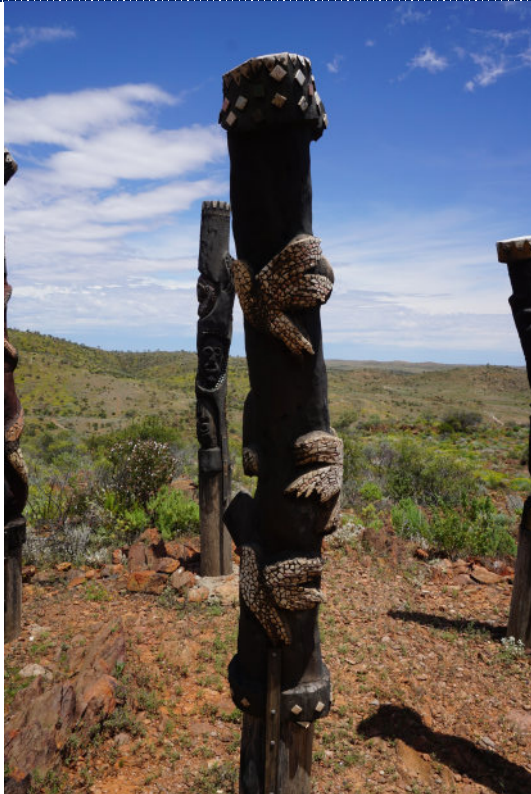
Figure 51: Pole 8 (temporary conservation number assigned to the object for identification purposes), front.

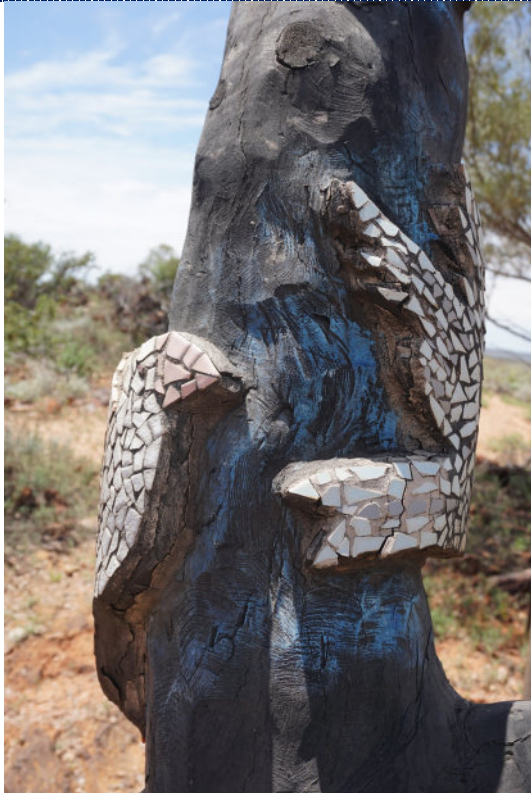
Figure 53: Detail – Pole 8, exterior, UV degradation (darkening) to wood surface, extensive losses to paint and moderate cracking noted on binder securing the mosaic tiles in place. Dirt particulate is present throughout.

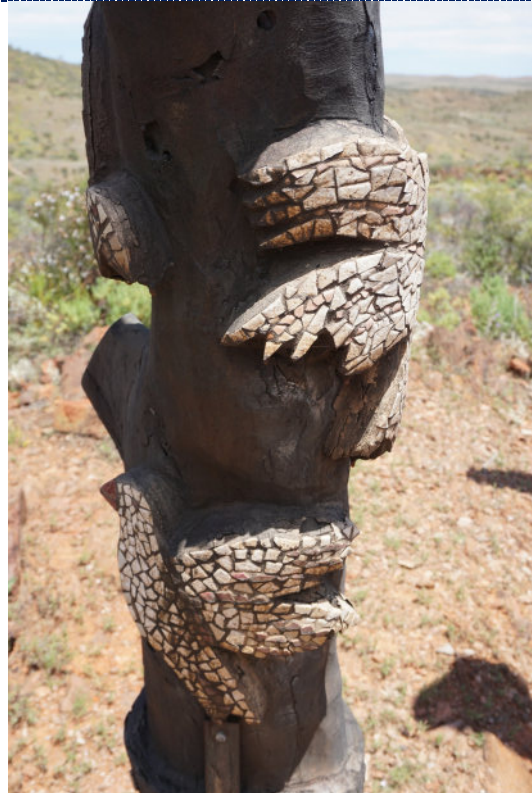
Figure 54: Detail – Pole 8, exterior, UV degradation (darkening) to wood surface, moderate cracking noted on binder securing the mosaic tiles in place. Dirt particulate is present throughout.

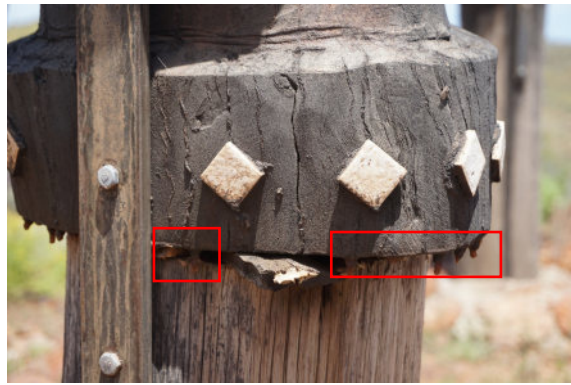
Detail 55: Detail – Pole 8, exterior, UV degradation (darkening) to wood surface, sap-like deposits (accretions) along the lower edge of the pole (highlighted in red). Dirt particulate present on diamond shaped tiles and throughout.

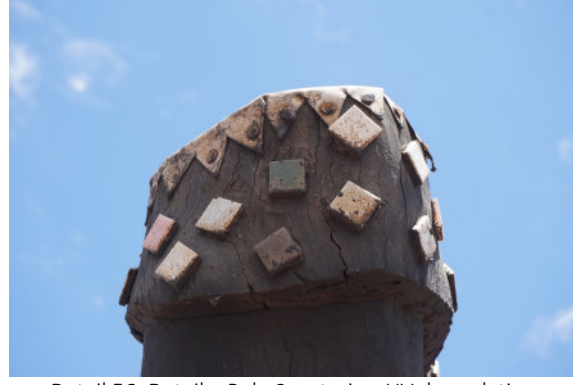
Detail 56: Detail – Pole 8, exterior, UV degradation (darkening) to wood surface, iron corrosion exhibited on metal components at top of pole. Dirt particulate present on diamond shaped tiles and throughout.

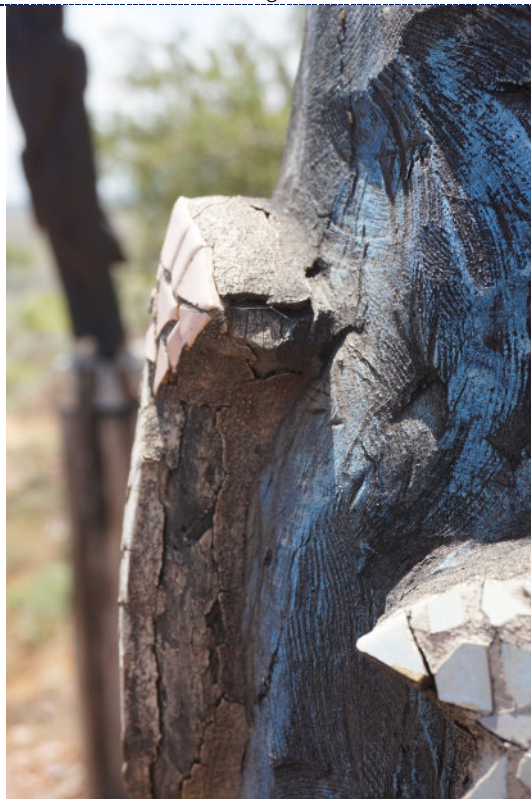
Figure 57: Detail – Pole 8, exterior, UV degradation (darkening) to wood surface, extensive losses to wood and painted surfaces and degradation to the binder securing the mosaic tiles in place.
