# *Broken Hill Public Art Condition Survey and Conservation Plan*

Prepared for: Broken Hill City Council  
Submission Date: February 2023

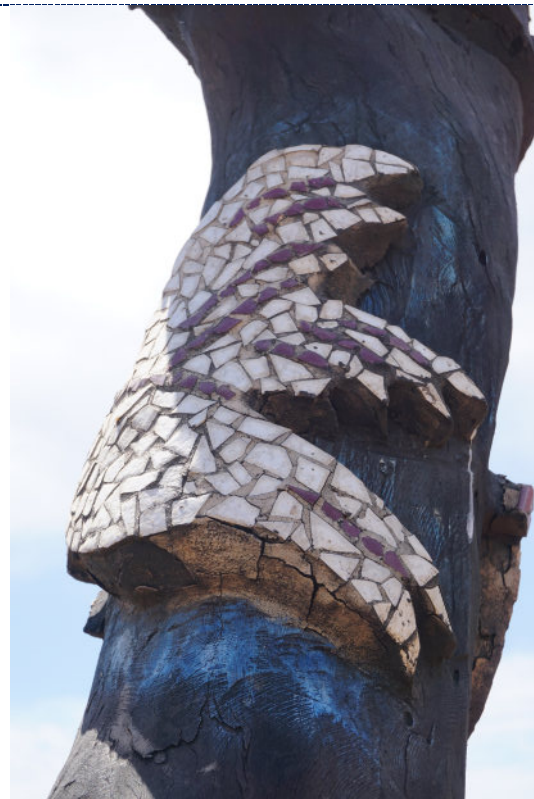
Figure 58: Detail – Pole 8, exterior, UV degradation (darkening) to wood surface, extensive losses to painted surfaces and degradation to the binder securing the mosaic tiles in place.

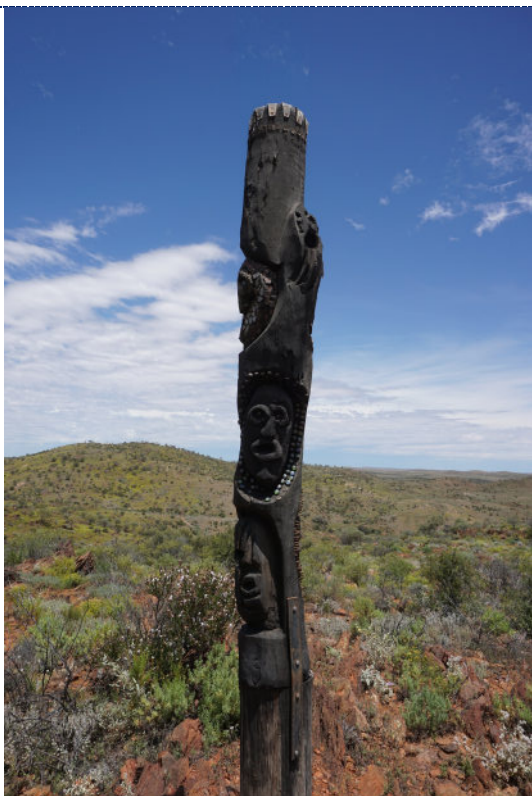
Figure 59: Pole 9 (temporary conservation number assigned to the object for identification purposes), front.

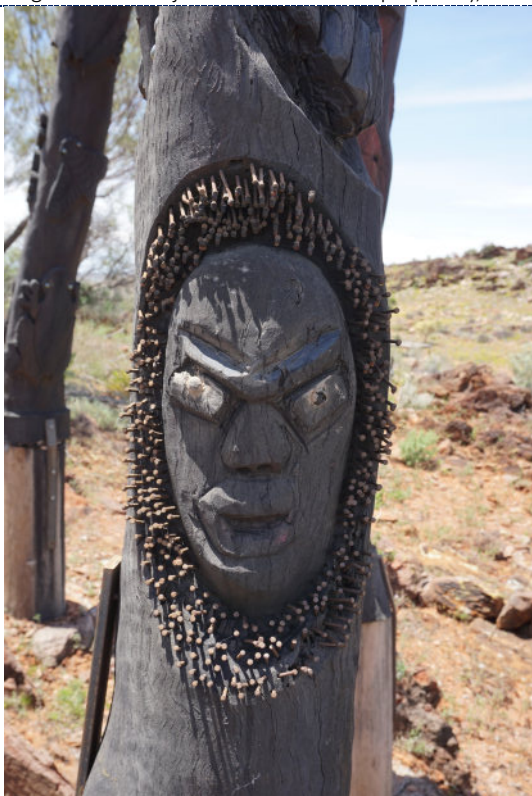
Figure 61: Detail – Pole 9, exterior, UV degradation (darkening) to wood surface, extensive losses to painted surface on carved figure’s eyes. Missing nails noted below and along the periphery of the central figure.

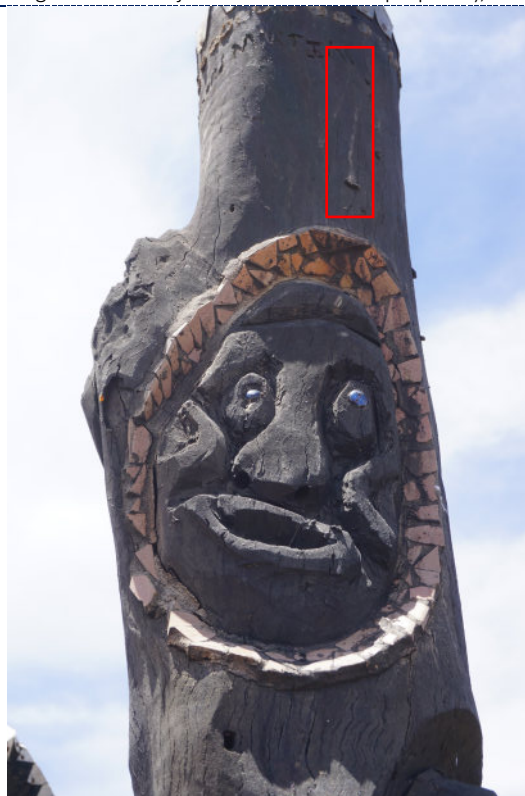
Figure 62: Detail – Pole 9, exterior, UV degradation (darkening) to wood surface, minor losses to the mosaic tiles surrounding the figure. Bird excrement noted above the carved figure (highlighted in red).

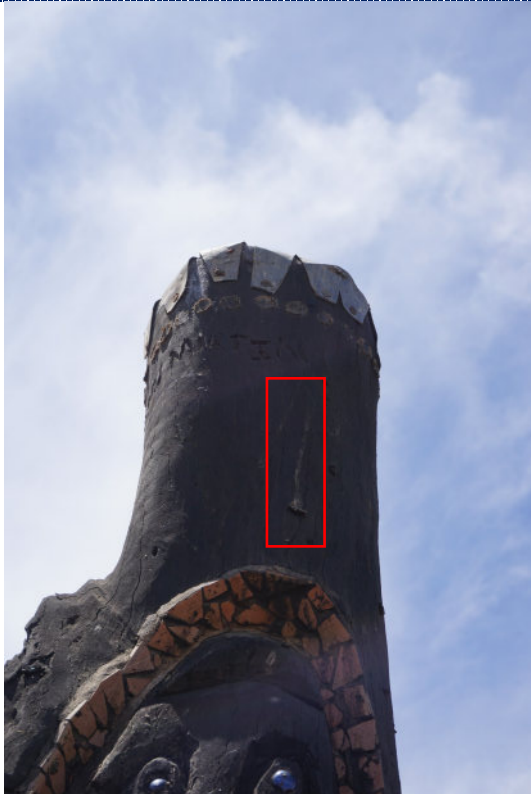
Figure 63: Detail – Pole 9, exterior, UV degradation (darkening) to wood surface, minor losses to the mosaic tiles surrounding the figure. Bird excrement noted above the carved figure (highlighted in red).

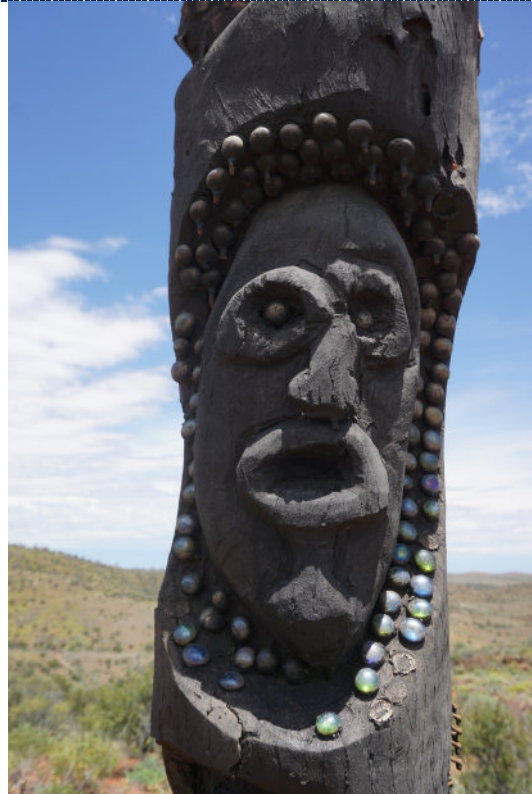
Figure 64: Detail – Pole 9, exterior, UV degradation (darkening) to wood surface, multiple losses to the glass pebbles surrounding the carved figure, particularly below the figure's chin region.

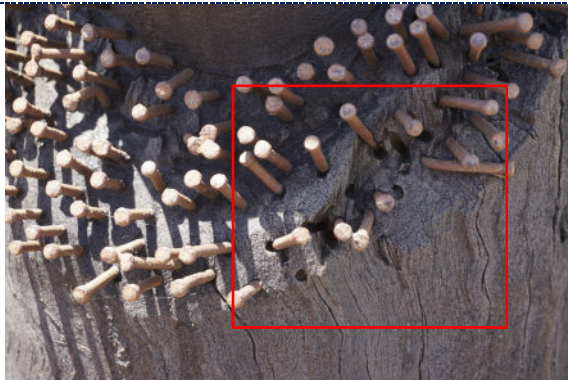
Figure 65: Detail – Pole 9, exterior, UV degradation (darkening) to wood surface, extensive losses to painted surface on carved figure's eyes. Missing nails noted below and along the periphery of the central figure (highlighted in red).

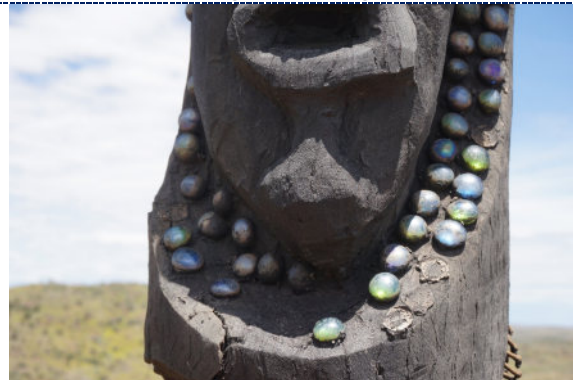
Figure 66: Detail – Pole 9, exterior, UV degradation (darkening) to wood surface, multiple losses to the glass pebbles surrounding the carved figure, particularly below the figure's chin region.

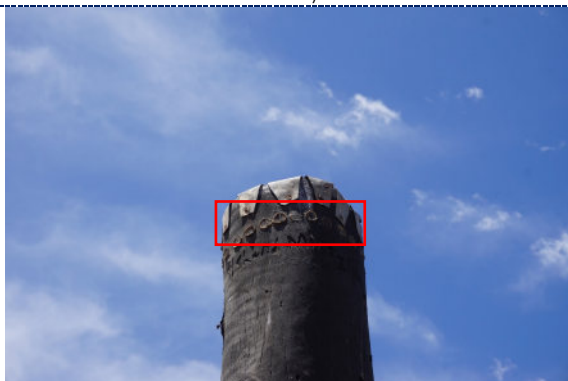
Figure 67: Detail – Pole 9, exterior, UV degradation

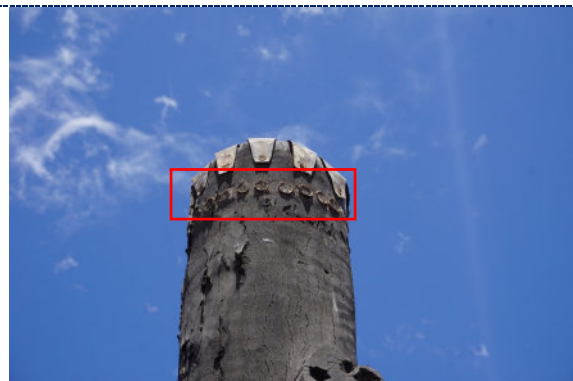
Figure 68: Detail – Pole 9, exterior, UV degradation

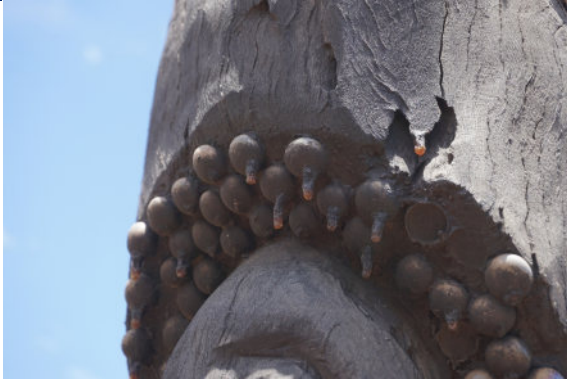
Detail 69: Detail – Pole 9, exterior, UV degradation (darkening) to wood surface, sap-like deposits (accretions) above the carved figure surrounded by glass pebbles.

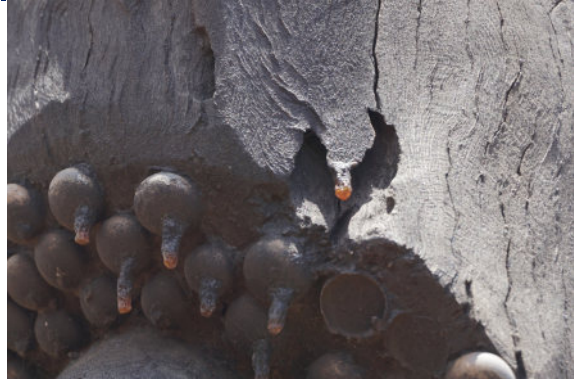
Detail 70: Detail – Pole 9, exterior, UV degradation (darkening) to wood surface, sap-like deposits (accretions) above the carved figure surrounded by glass pebbles.

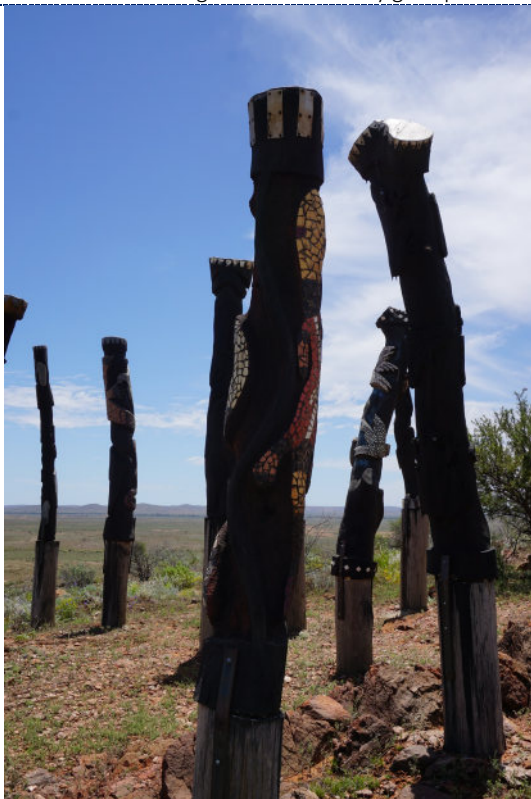
Figure 71: Pole 10 (temporary conservation number assigned to the object for identification purposes), front.

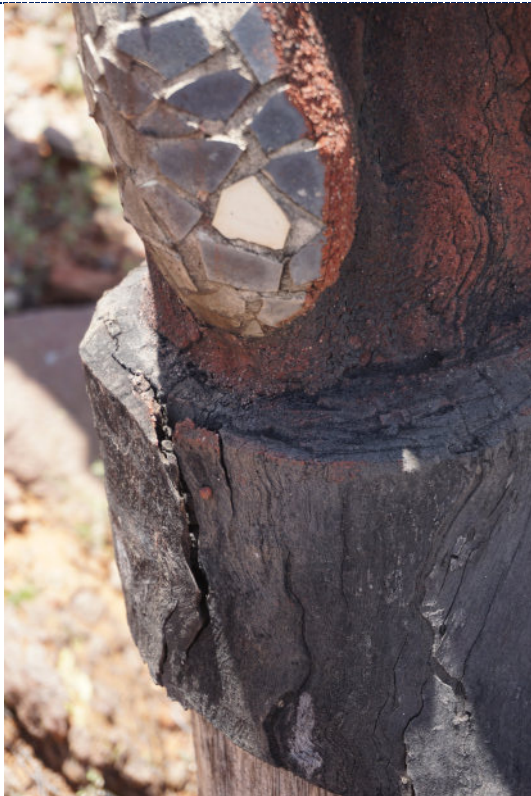
Figure 73: Detail – Pole 10, exterior, UV degradation (darkening) to wood surface, extensive losses to wood and painted surfaces and degradation to the binder securing the mosaic tiles in place.

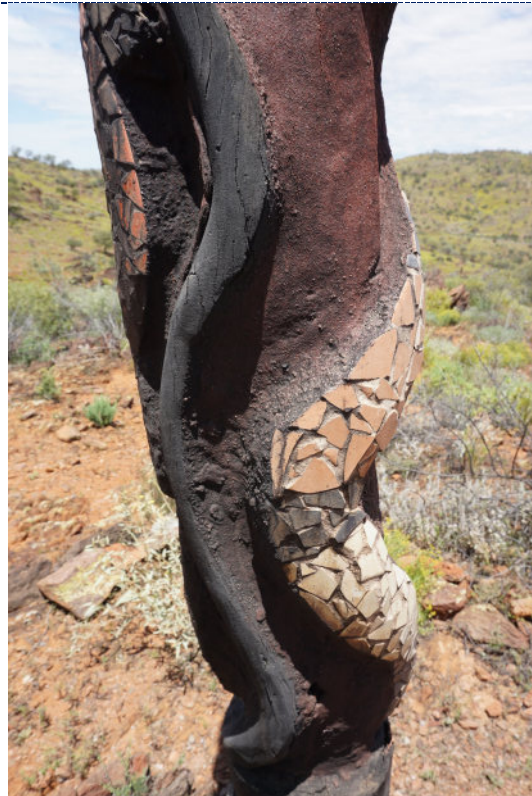
Figure 74: Detail – Pole 10, exterior, UV degradation (darkening) to wood surface, extensive losses to wood and painted surfaces and degradation to the binder securing the mosaic tiles in place.

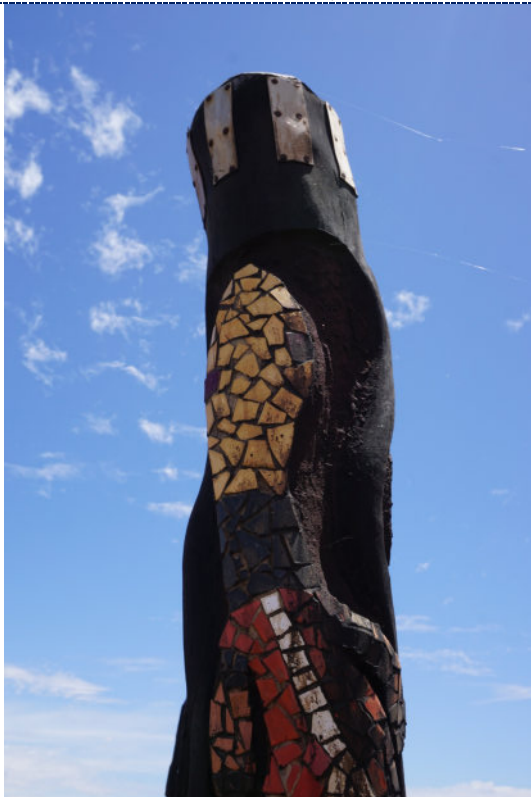
Figure 75: Detail – Pole 10, exterior, UV degradation (darkening) to wood surface, discolouration of the mosaic tiles and buildup of dirt particulate throughout.

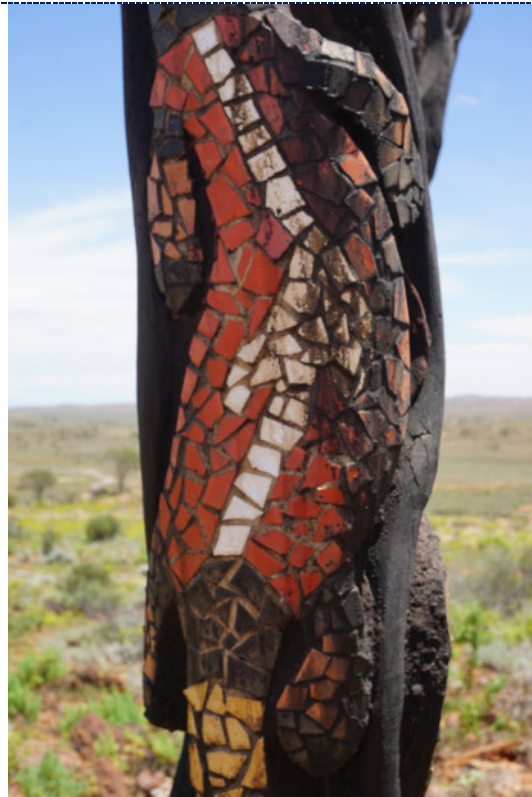
Figure 76: Detail – Pole 10, exterior, UV degradation (darkening) to wood surface, discolouration of the mosaic tiles and buildup of dirt particulate throughout.

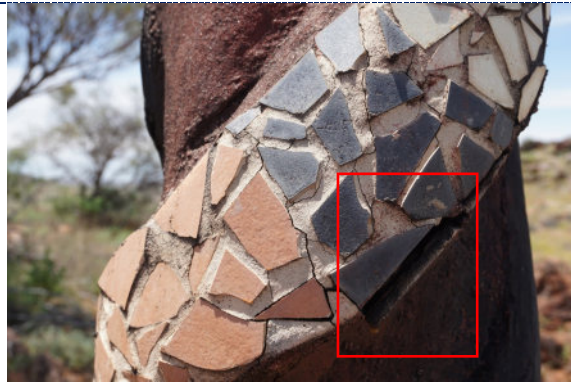
Figure 77: Detail – Pole 10, exterior, UV degradation (darkening) to wood surface, losses to painted surfaces and degradation of binder material securing the mosaic tiles in place (losses highlighted in red).

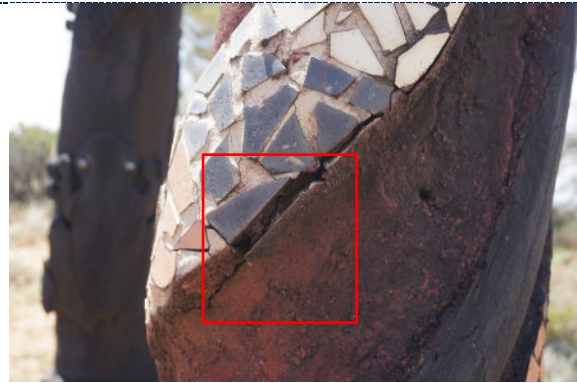
Figure 78: Detail – Pole 10, exterior, UV degradation (darkening) to wood surface, losses to painted surfaces and degradation of binder material securing the mosaic tiles in place (losses highlighted in red).

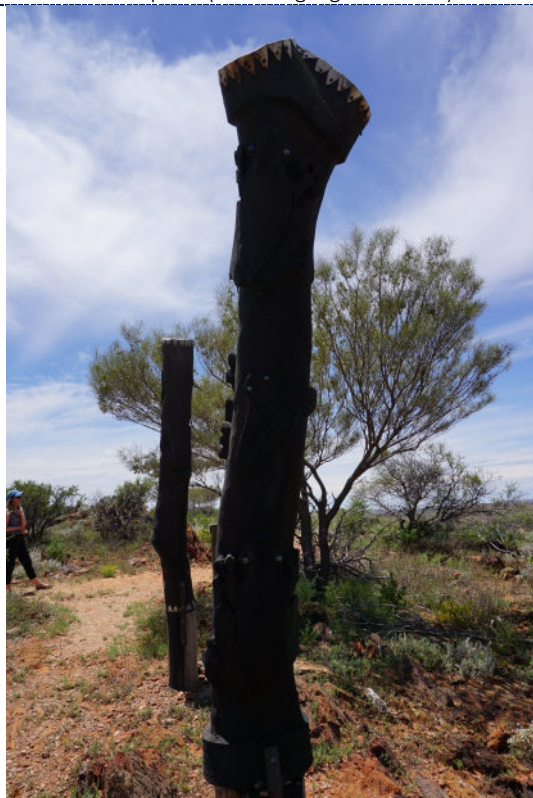
Figure 79: Pole 11 (temporary conservation number assigned to the object for identification purposes), front.

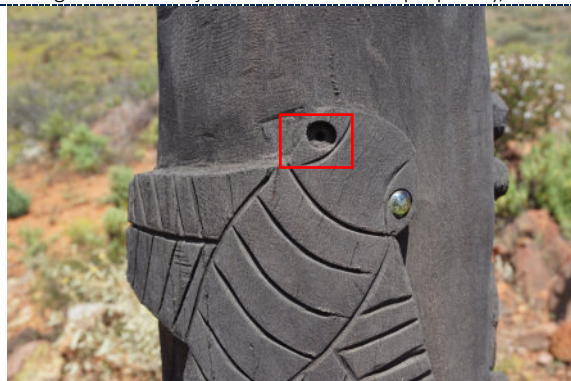
Figure 81: Detail – Pole 11, exterior, UV degradation (darkening) to wood surface, loss to the proper right glass marble eye (loss highlighted in red).

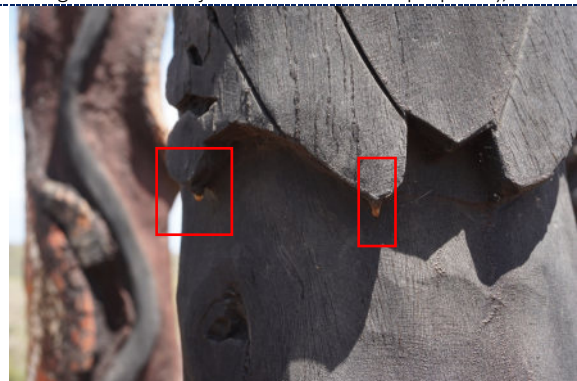
Detail 82: Detail – Pole 11, exterior, UV degradation (darkening) to wood surface, sap-like deposits (accretions) (highlighted in red).

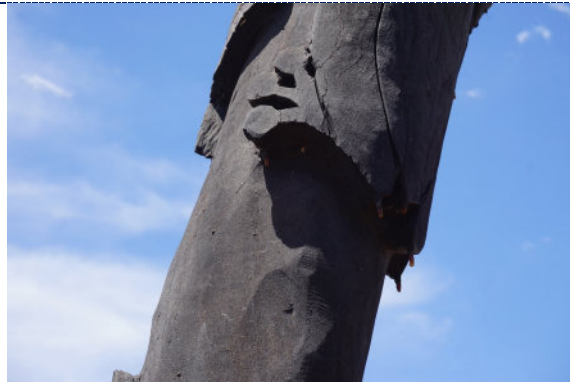
Detail 83: Detail – Pole 11, exterior, UV degradation (darkening) to wood surface, sap-like deposits (accretions).

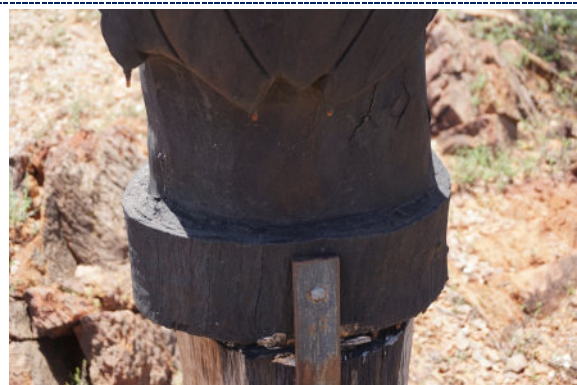
Detail 84: Detail – Pole 11, exterior, UV degradation (darkening) to wood surface, sap-like deposits (accretions) (highlighted in red). Iron corrosion products present on metal components, including the iron nails.

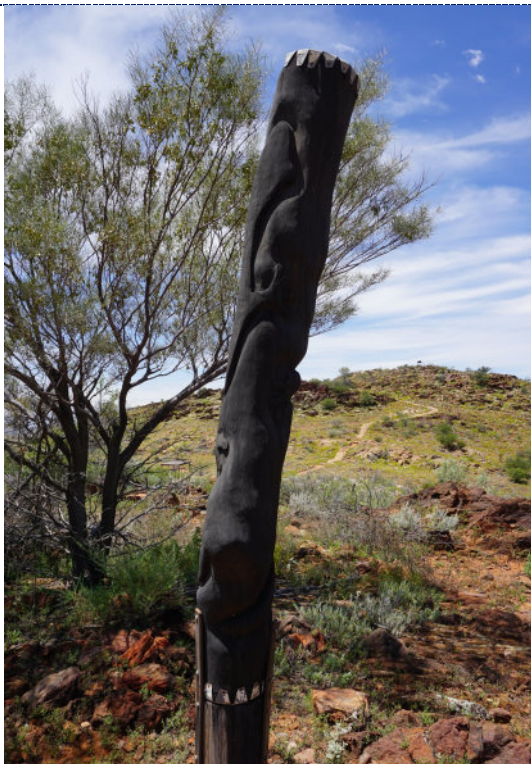
Figure 85: Pole 12 (temporary conservation number assigned to the object for identification purposes), back.

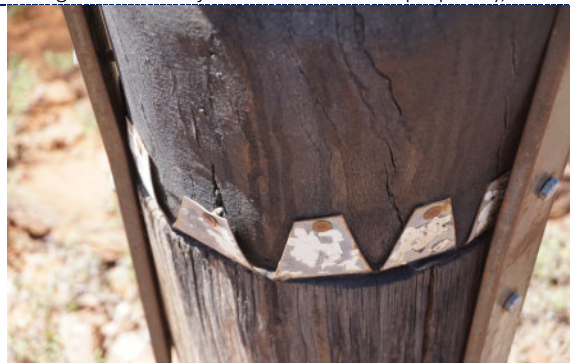
Figure 87: Detail – Pole 12, exterior, UV degradation (darkening) to wood surface, iron corrosion on metal components, including the iron nails.

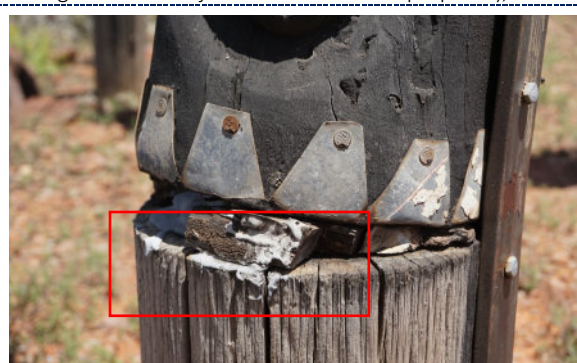
Figure 88: Detail – Pole 12, exterior, UV degradation (darkening) to wood surface, iron corrosion on metal components, including the iron nails, and a build up of loose material on the wood base suggestive of insect activity (highlighted in red).

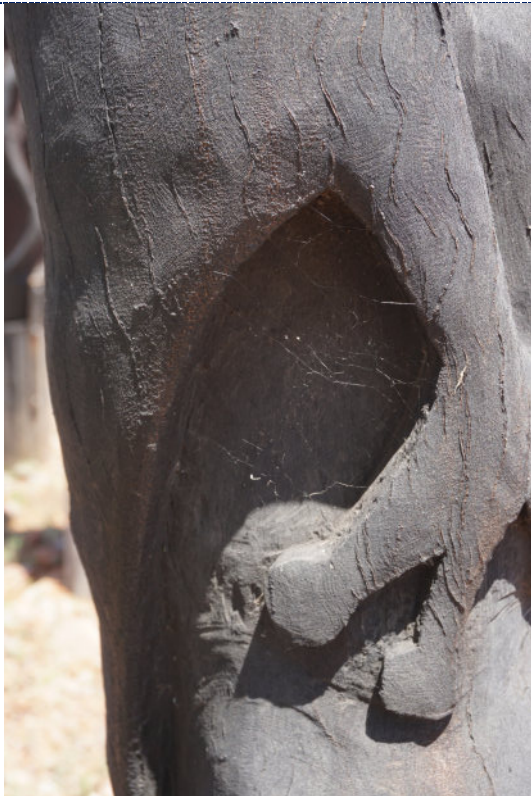
Figure 89: Detail – Pole 12, exterior, UV degradation (darkening) to wood surface, cracks and splitting following the grain of the wood, cobwebs and dirt particulate noted throughout.

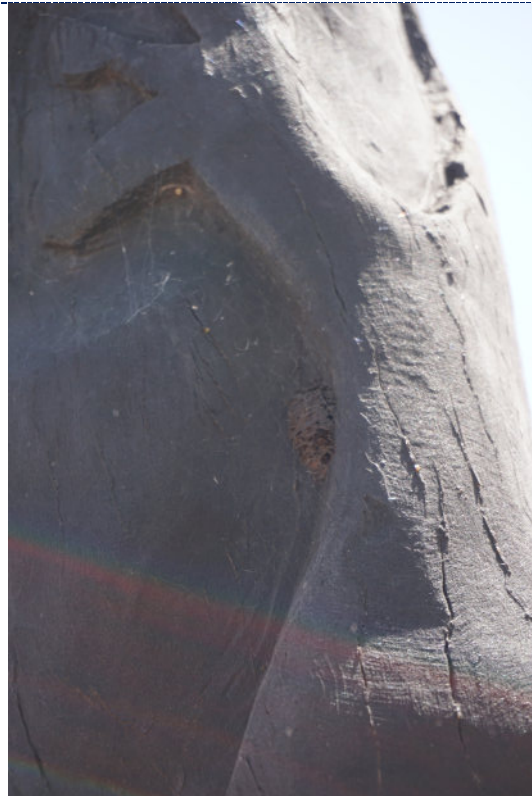
Figure 90: Detail – Pole 12, exterior, UV degradation (darkening) to wood surface, cracks and splitting following the grain of the wood, cobwebs and dirt particulate noted throughout.

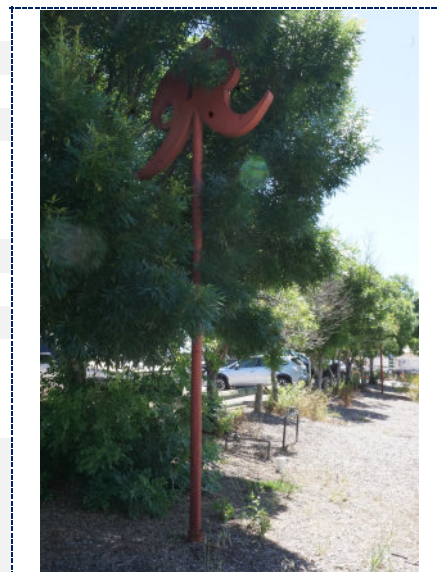
Previous repairs/ modifications?  YES  NO

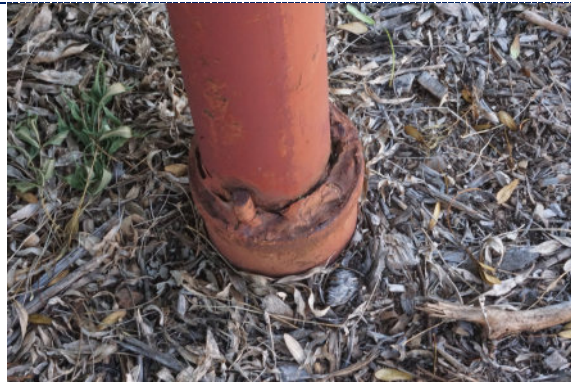
Figure 5: Detail – base plinth, paint chalking, flaking paint loss with corrosion and putty deterioration.

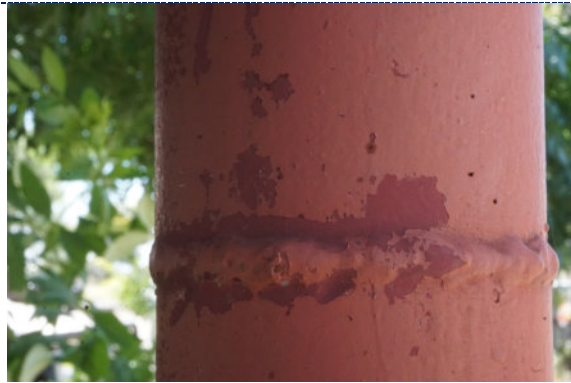
Figure 6: Detail – paint chalking, flaking paint loss with overpaint.

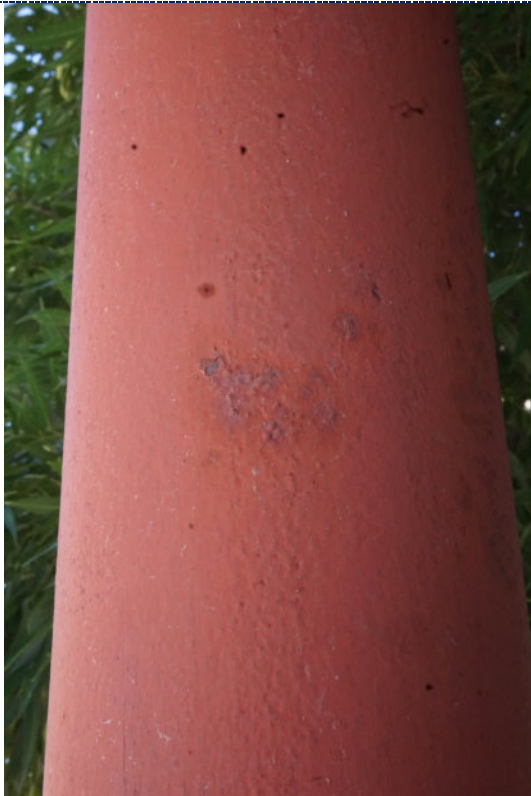
Figure 7: Detail – paint chalking, flaking paint loss with corrosion.

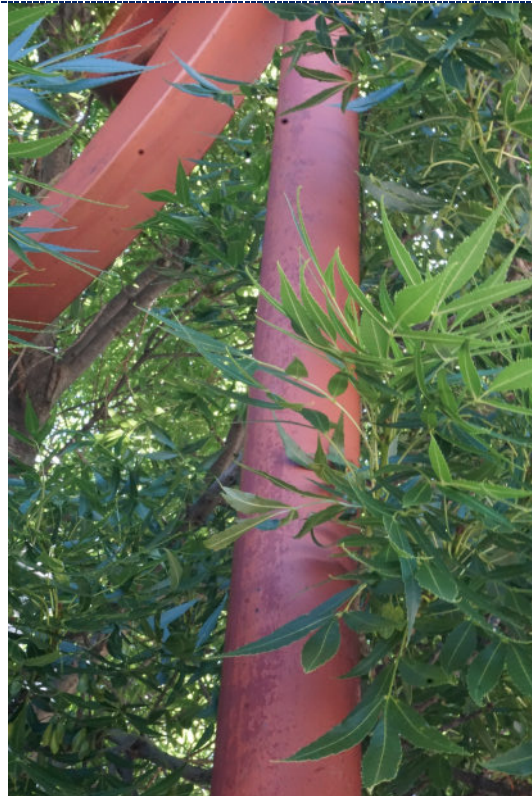
Figure 8: Detail – foliage intrusion; paint chalking, flaking paint loss with overpaint.

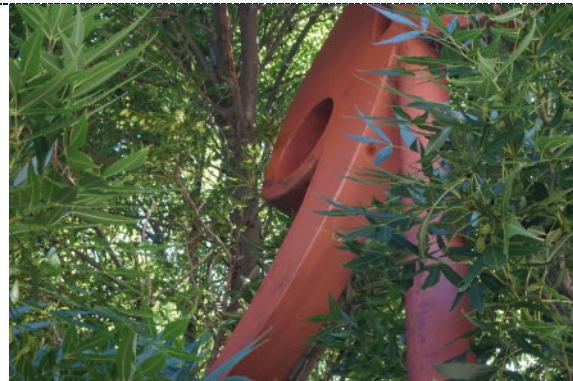
Figure 12: Detail – paint chalking, flaking paint loss with overpaint and corrosion visible.

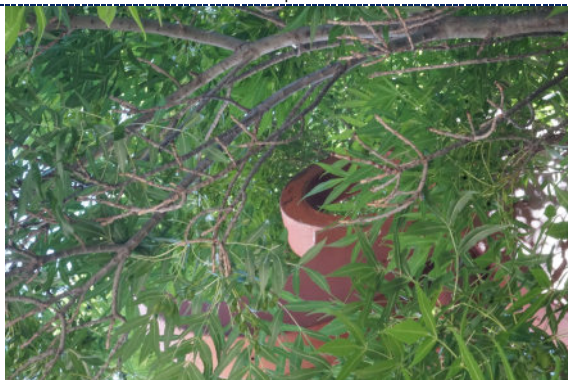
Figure 13: Detail – tree foliage intrusion, risks staining and warping of structure.

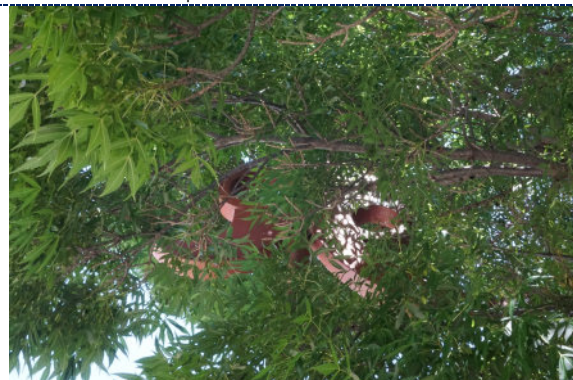
Figure 14: Detail – tree foliage intrusion, risks staining and warping of structure.

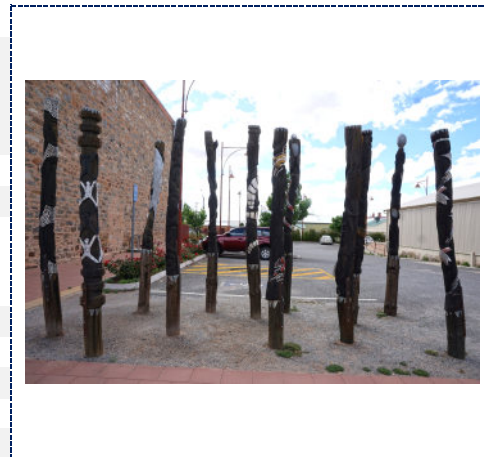
Previous repairs/ modifications?  YES  X NO

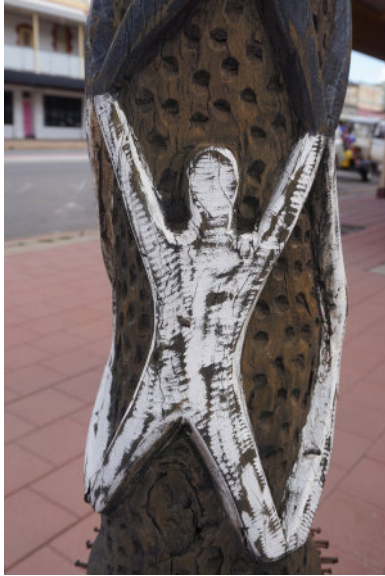
Figure 9: Detail – Pole #2003.0017 *Reconciliation*, proper left exterior, degraded varnish, paint losses, and UV degradation (darkening) to wood surface.

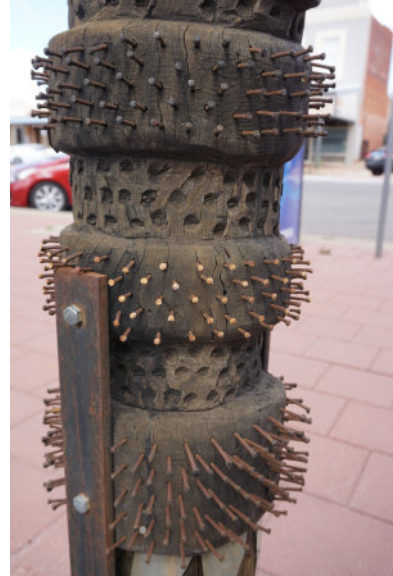
Figure 10: Detail – Pole #2003.0017 *Reconciliation*, proper right exterior, corroded iron nails, degraded varnish and UV degradation (darkening) to wood surface.

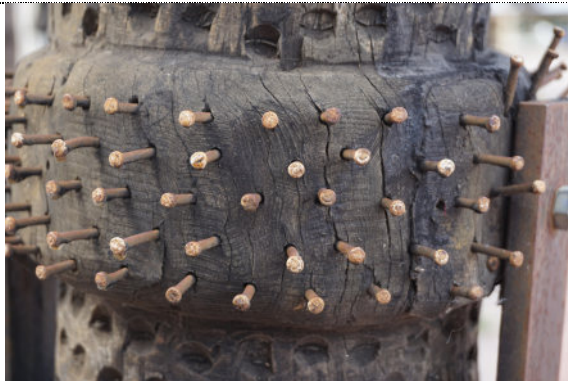
Figure 11: Detail – Pole #2003.0017 *Reconciliation*, proper right exterior, corroded iron nails, sap-like accretions on the iron nails, UV degradation (darkening) to wood surface, and cracks along the grain of the wood.

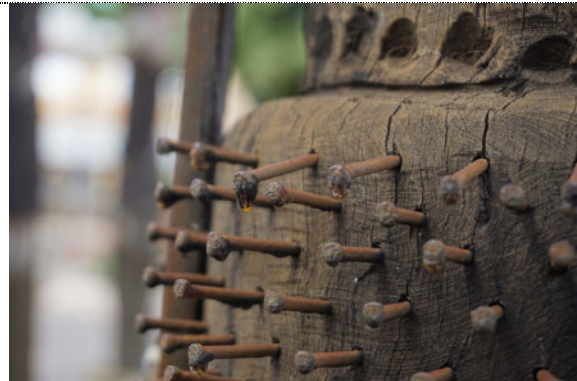
Figure 12: Detail – Pole #2003.0017 *Reconciliation*, proper right exterior, corroded iron nails, sap-like accretions on the iron nails, UV degradation (darkening) to wood surface, and cracks along the grain of the wood.

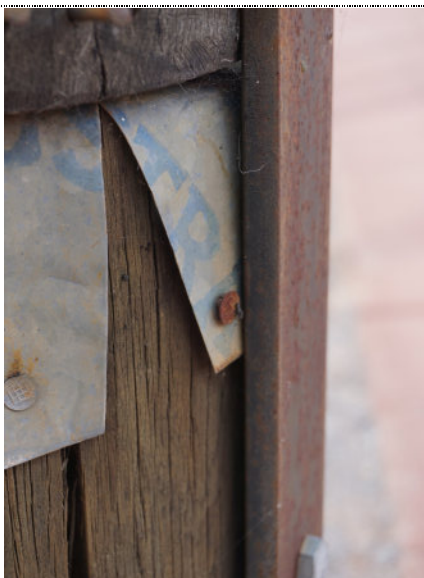
Figure 13: Detail – Pole #2003.0017 *Reconciliation*, exterior, corroded iron nails and metal components, UV degradation (darkening) to wood surface, and fine cracks along the grain of the wood.

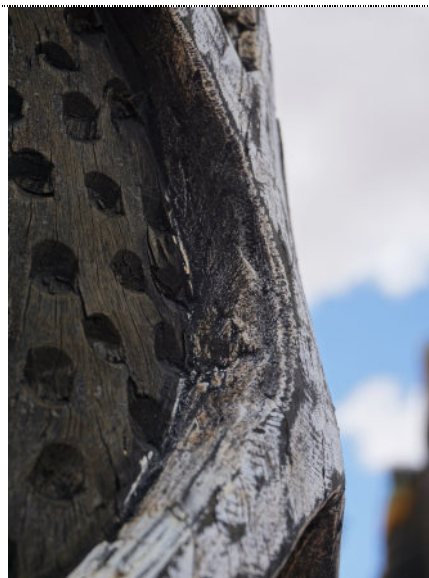
Figure 14: Detail – Pole #2003.0017 *Reconciliation*, exterior, UV degradation (darkening) to wood surface, and fine cracks along the grain of the wood. The surface is also covered in a layer of dirt particulate.

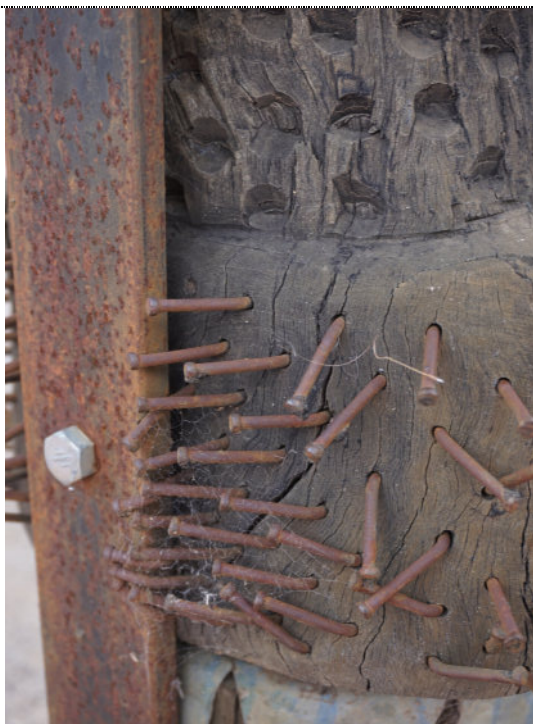
Figure 15: Detail – Pole #2003.0017 *Reconciliation*, exterior, corroded iron nails and metal structural components, UV degradation (darkening) to wood surface, and fine cracks along the grain of the wood. Loose dirt particulate, spider webs and debris also present.

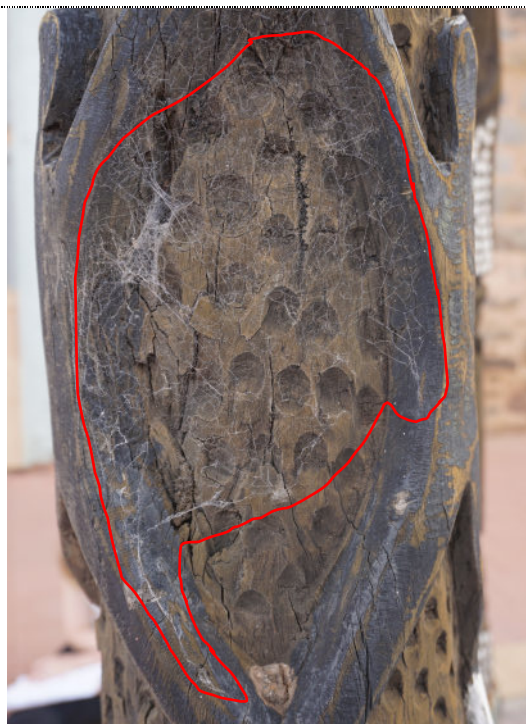
Figure 16: Detail – Pole #2003.0017 *Reconciliation*, exterior, UV degradation (darkening) to wood surface and losses to painted surfaces, and fine cracks along the grain of the wood. Loose dirt particulate, spider webs (highlighted in red) and debris also present.

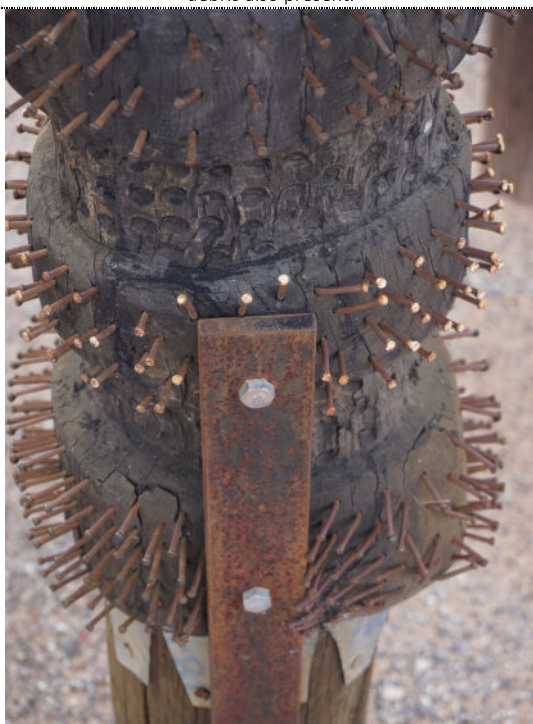
Figure 17: Detail – Pole #2003.0017 *Reconciliation*, exterior, corroded iron nails and metal structural components, UV degradation (darkening) to wood surface, and fine cracks along the grain of the wood.

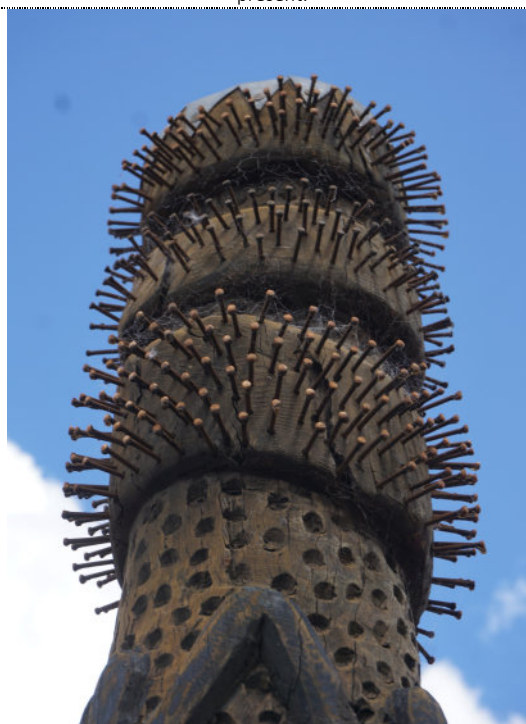
Figure 18: Detail – Pole #2003.0017 *Reconciliation*, exterior, corroded iron nails and metal structural components, UV degradation (darkening) to wood surface, extensive losses to painted surfaces, and extensive cracks along the grain of the wood.

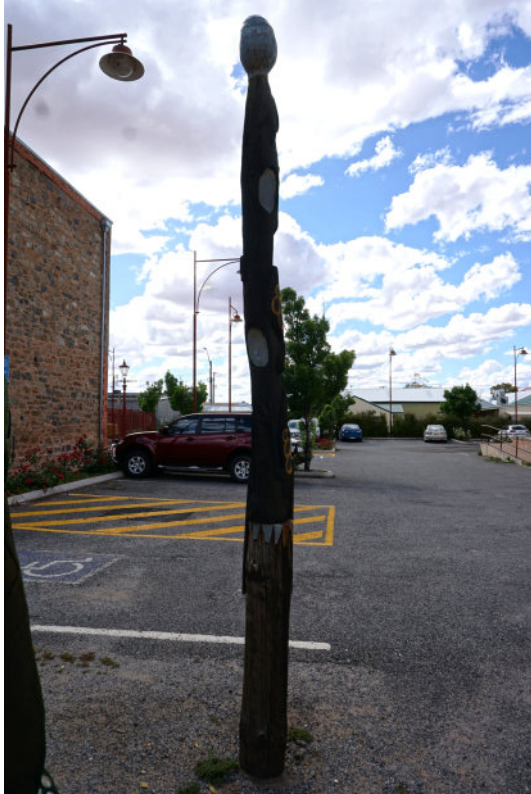
Figure 19: Pole #2003.0018 *Emus and eggs*, Front.

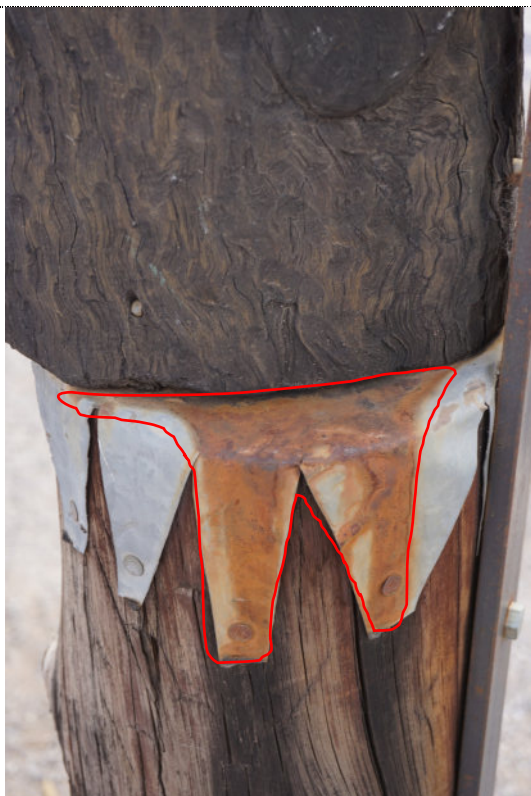
Figure 23: Detail – Pole #2003.0018 *Emus and eggs*, exterior, extensive iron staining to metal components (highlighted in red) and presence of corrosion products on iron nails, associated iron staining on wood below. UV degradation (darkening) to wood surface, and fine cracks along the grain of the wood.

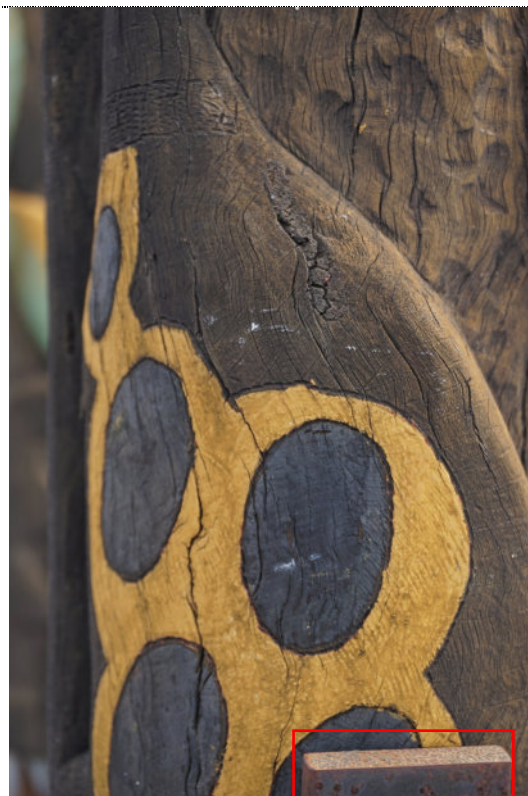
Figure 24: Detail – Pole #2003.0018 *Emus and eggs*, exterior, extensive corrosion products on iron structural support (highlighted in red), UV degradation (darkening) to wood surface, and extensive fine cracks along the grain of the wood.

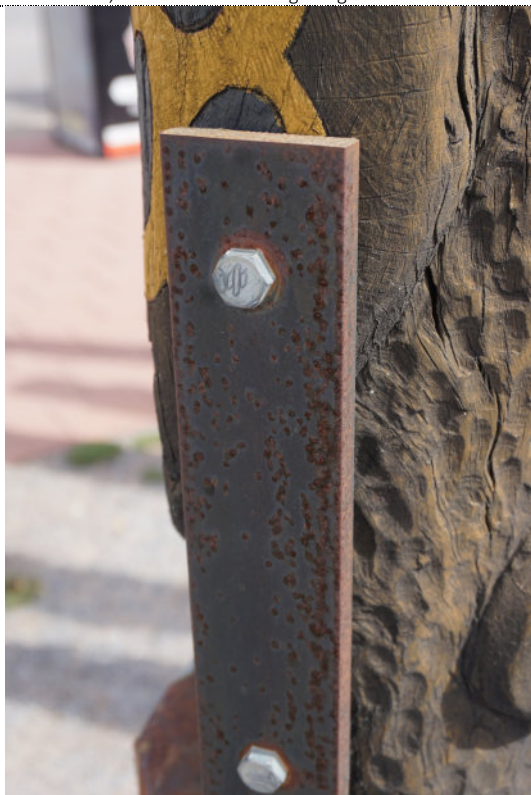
Figure 25: Detail – Pole #2003.0018 *Emus and eggs*, exterior, extensive corrosion products on iron structural support, UV degradation (darkening) to wood surface, and extensive fine cracks along the grain of the wood.

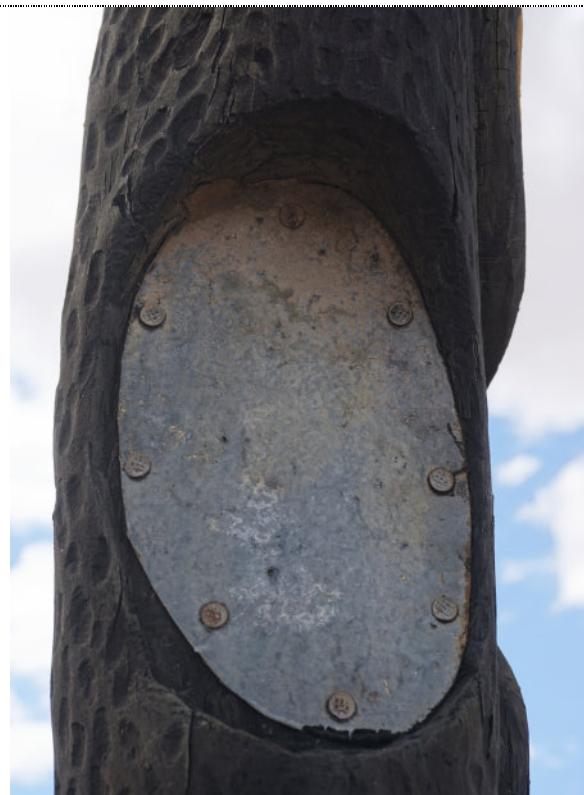
Figure 26: Detail – Pole #2003.0018 *Emus and eggs*, exterior, tarnishing and corrosion noted on the circular metal decorative element and nails affixing the element in place.

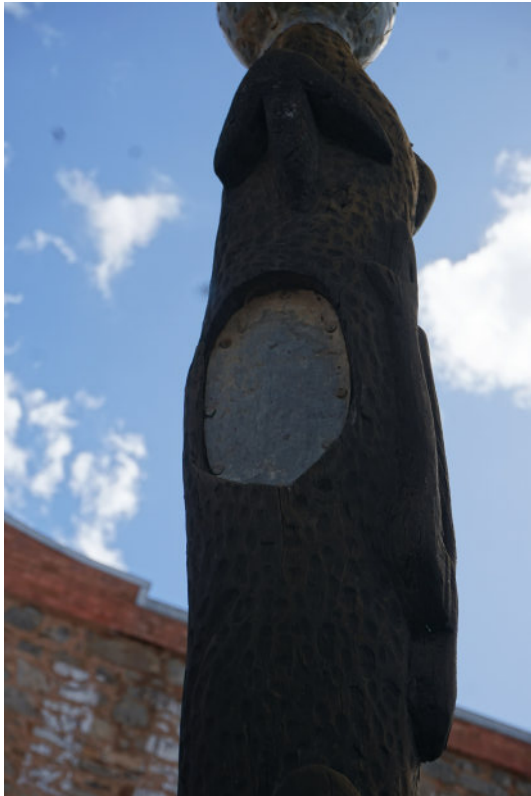
Figure 27: Detail – Pole #2003.0018 *Emus and eggs*, exterior, tarnishing and corrosion noted on the circular metal decorative element and nails affixing the element in place. UV degradation (darkening) to wood surface throughout.

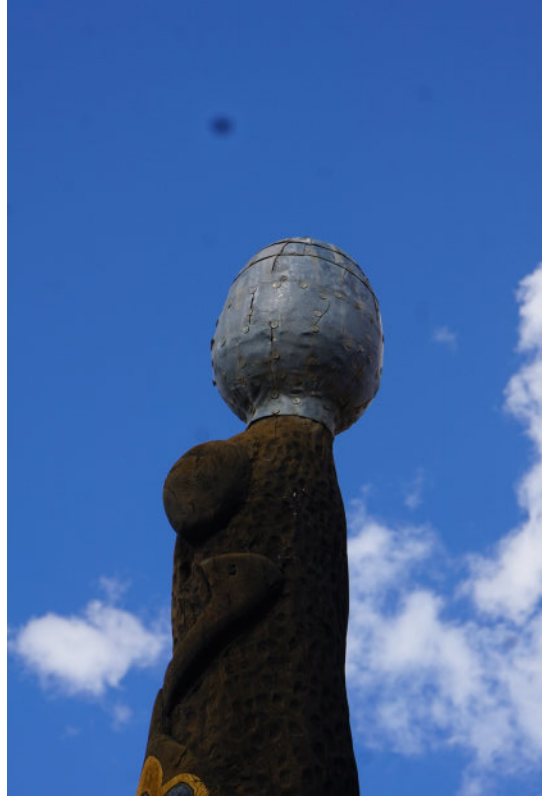
Figure 28: Detail – Pole #2003.0018 *Emus and eggs*, exterior, tarnishing and corrosion noted on the circular metal decorative element and nails affixing the element in place. UV degradation (darkening) to wood surface throughout.

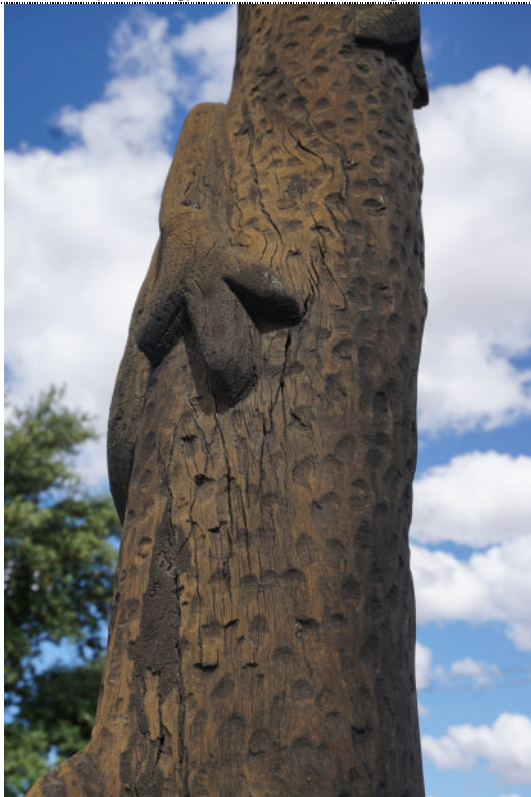
Figure 29: Detail – Pole #2003.0018 *Emus and eggs*, exterior, UV degradation (darkening) to wood surface throughout.

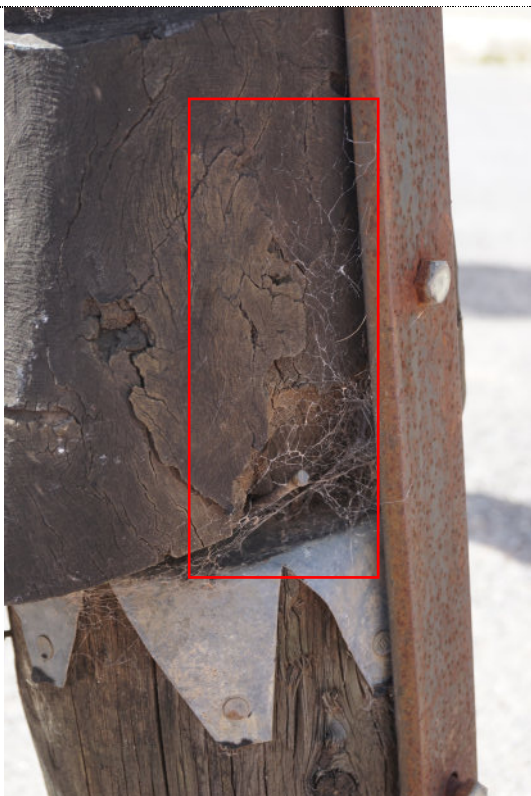
Figure 34: Detail – Pole #2003.0019 *Galahs*, exterior, UV degradation (darkening) to wood surface throughout. Extensive cracking and associated losses to the wood, iron corrosion noted on the iron supports and nails, and surface dirt and insect debris (spider webs, highlighted in red) noted throughout.

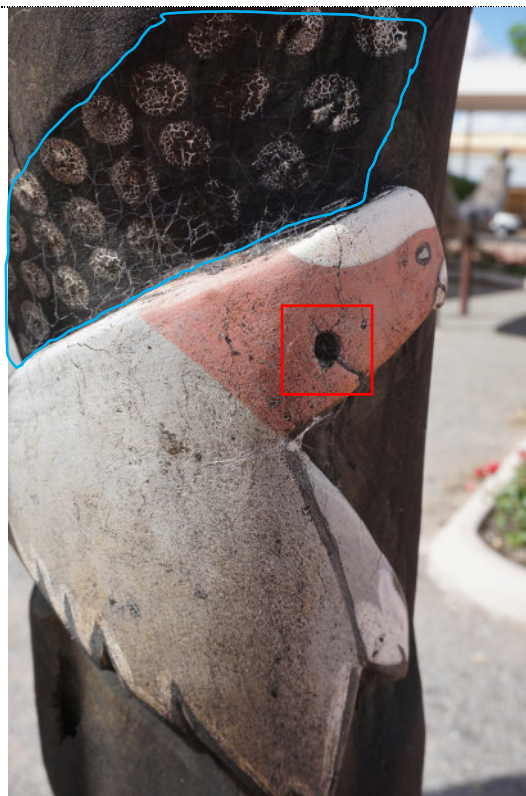
Figure 35: Detail – Pole #2003.0019 *Galahs*, exterior, UV degradation (darkening) to wood surface throughout. Surface dirt and insect debris noted throughout. Fading noted to the painted surfaces, particularly the painted galahs and the surrounding dots (highlighted in blue). Missing nail noted to the neck of the carved galah (highlighted in red).

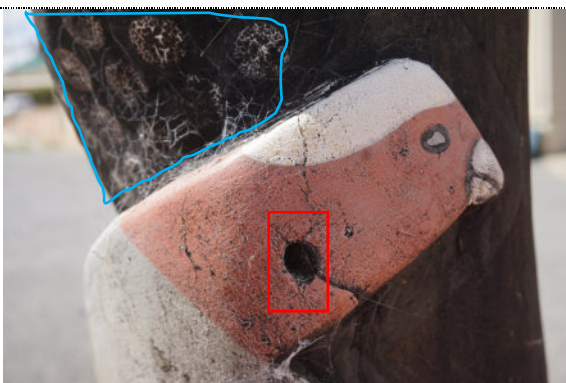
Figure 36: Detail – Pole #2003.0019 *Galahs*, exterior, UV degradation (darkening) to wood surface throughout. Extensive cracking and associated losses to the wood, and surface dirt and insect debris noted throughout. Missing nail noted to the neck of the carved galah (highlighted in red) and extensive loss of paint (highlighted in blue).

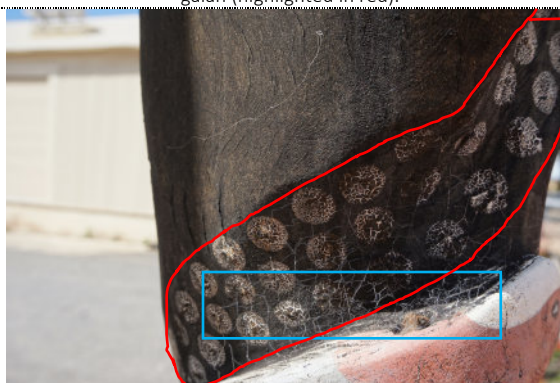
Figure 37: Detail – Pole #2003.0019 *Galahs*, exterior, UV degradation (darkening) to wood surface throughout. Surface dirt and insect debris noted throughout. Extensive loss of paint (highlighted in red) and buildup of spider webs (highlighted in blue).

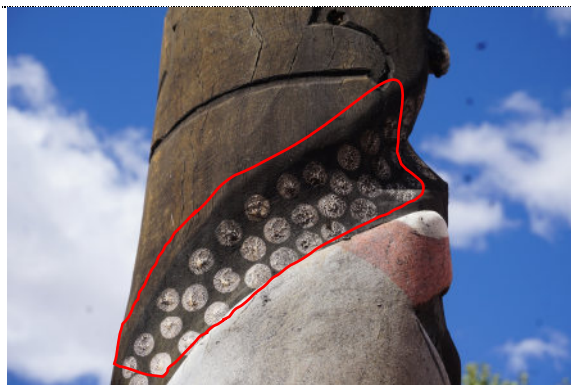
Figure 38: Detail – Pole #2003.0019 *Galahs*, exterior, UV degradation (darkening) to wood surface throughout. Extensive loss of paint (highlighted in red).

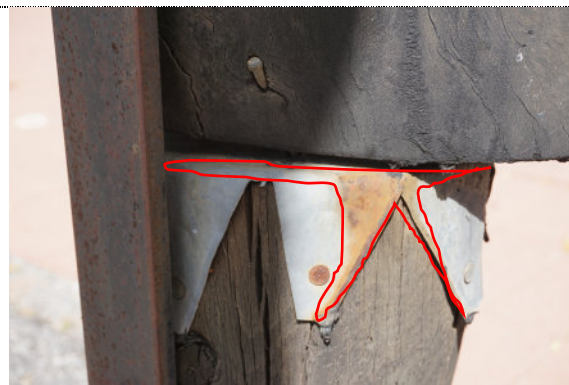
Figure 39: Detail – Pole #2003.0019 *Galahs*, exterior, iron staining to metal components (highlighted in red) and presence of corrosion products on iron nails. UV degradation (darkening) to wood surface, and multiple cracks along the grain of the wood.
