# *Broken Hill Public Art Condition Survey and Conservation Plan*

Prepared for: Broken Hill City Council  
Submission Date: February 2023

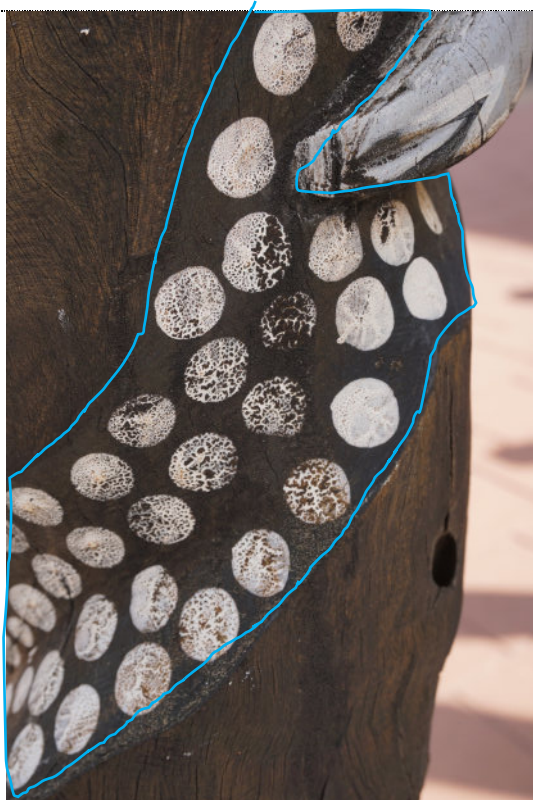
Figure 40: Detail – Pole #2003.0019 *Galahs*, exterior, UV degradation (darkening) to wood surface throughout. Surface dirt and insect debris noted throughout. Fading and losses noted to the painted surfaces, particularly the white painted dots (highlighted in blue).

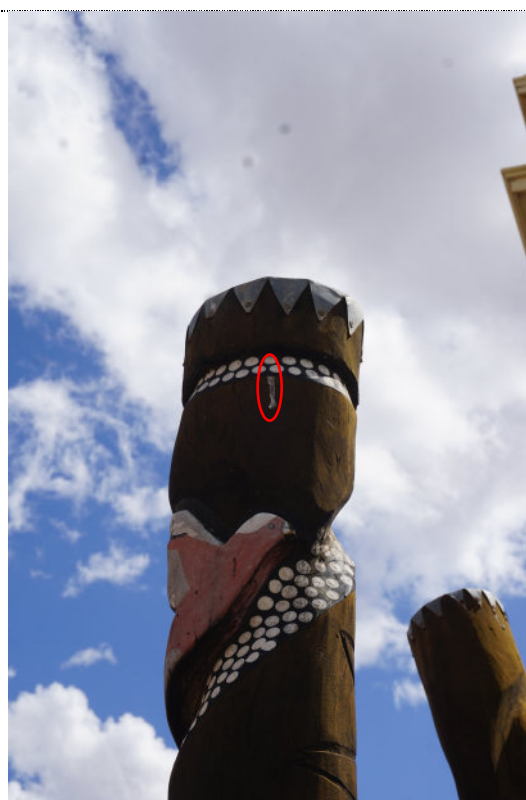
Figure 41: Detail – Pole #2003.0019 *Galahs*, exterior, UV degradation (darkening) to wood surface throughout. Surface dirt and insect debris noted throughout, including the presence of bird excrement (highlighted in red).

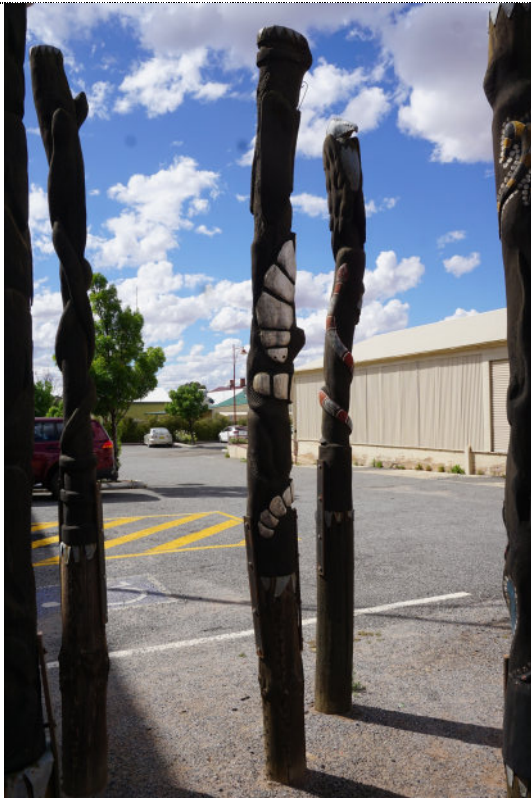
Figure 42: Pole #2003.0020 *Untitled*, Front.

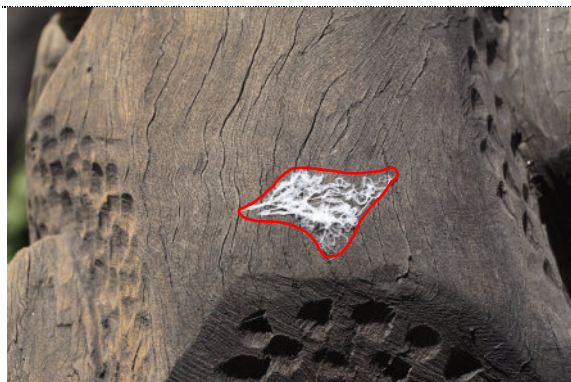
Figure 46: Detail – Pole #2003.0020 *Untitled*, exterior, exterior, UV degradation (darkening) to wood surface throughout. Large spider webbing noted on the wood surface (highlighted in red).

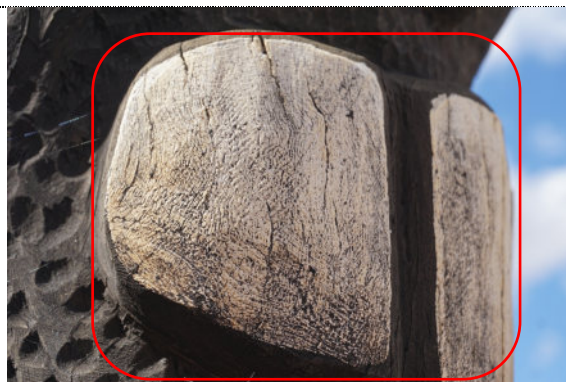
Figure 47: Detail – Pole #2003.0020 *Untitled*, exterior, UV degradation (darkening) to wood surface throughout. Linear cracks noted along the grain of the wood. Discolouration, losses and fading to the white painted decorative elements (highlighted in red).

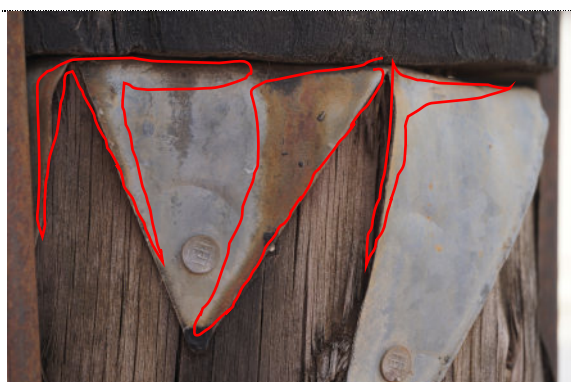
Figure 48: Detail – Pole #2003.0020 *Untitled*, exterior, iron corrosion and staining on the metal components and fastenings (highlighted in red). Linear cracks noted along the grain of the wood.

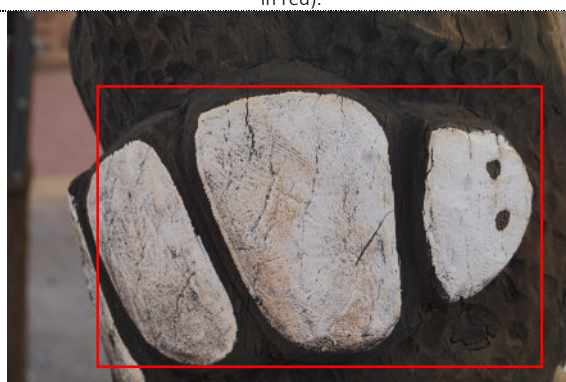
Figure 49: Detail – Pole #2003.0020 *Untitled*, exterior, UV degradation (darkening) to wood surface throughout. Linear cracks noted along the grain of the wood. Discolouration, losses and fading to the white painted decorative elements (highlighted in red).

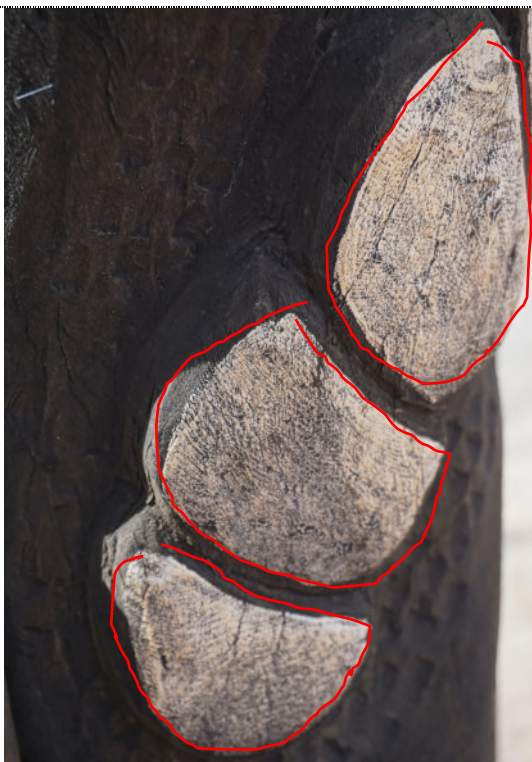
Figure 50: Detail – Pole #2003.0020 *Untitled*, exterior, UV degradation (darkening) to wood surface throughout. Linear cracks noted along the grain of the wood. Discolouration, losses and fading to the white painted decorative elements (highlighted in red).

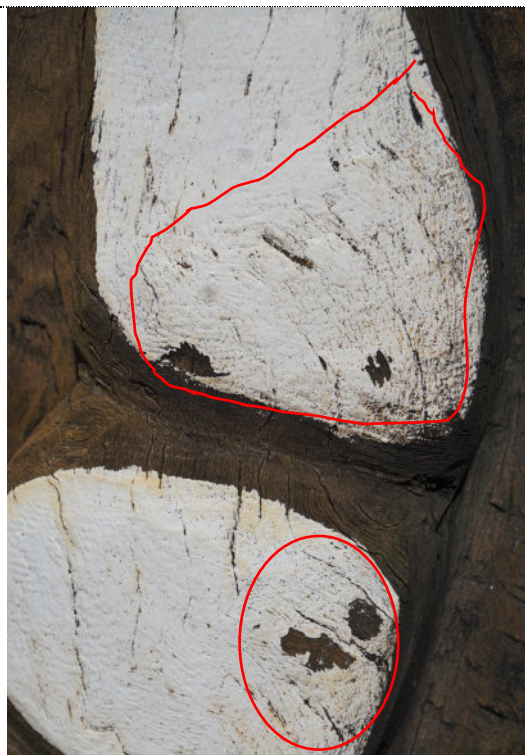
Figure 51: Detail – Pole #2003.0020 *Untitled*, exterior, UV degradation (darkening) to wood surface throughout. Linear cracks noted along the grain of the wood. Discolouration, losses and fading to the white painted decorative elements (highlighted in red).

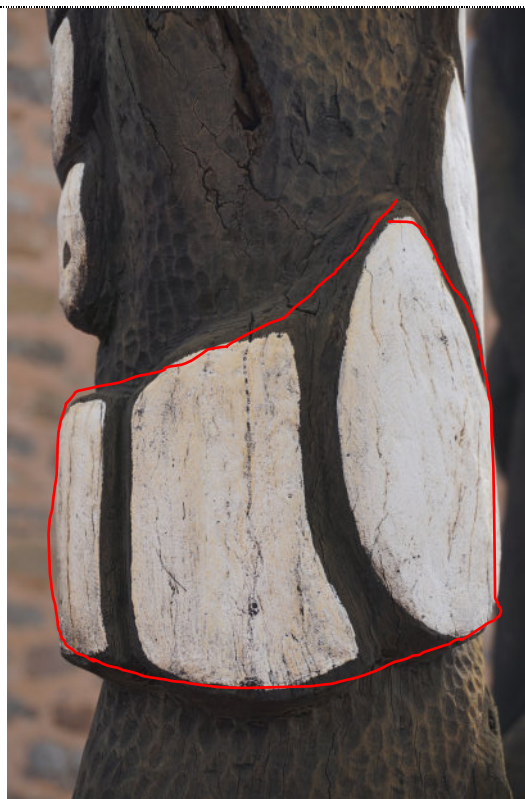
Figure 53: Detail – Pole #2003.0020 *Untitled*, exterior, UV degradation (darkening) to wood surface throughout. Discolouration to the painted white decorative elements (highlighted in red).

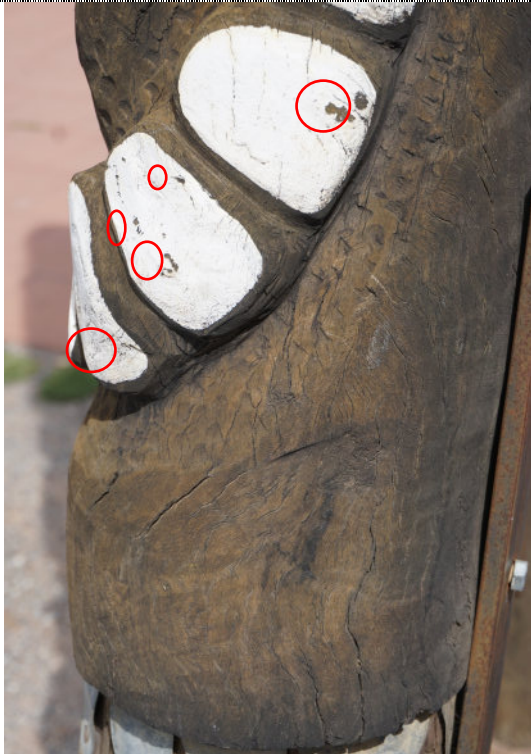
Figure 54: Detail - Pole #2003.0020 *Untitled*, exterior, UV degradation (darkening) to wood surface throughout. Discolouration to the painted white decorative elements (highlighted in red).

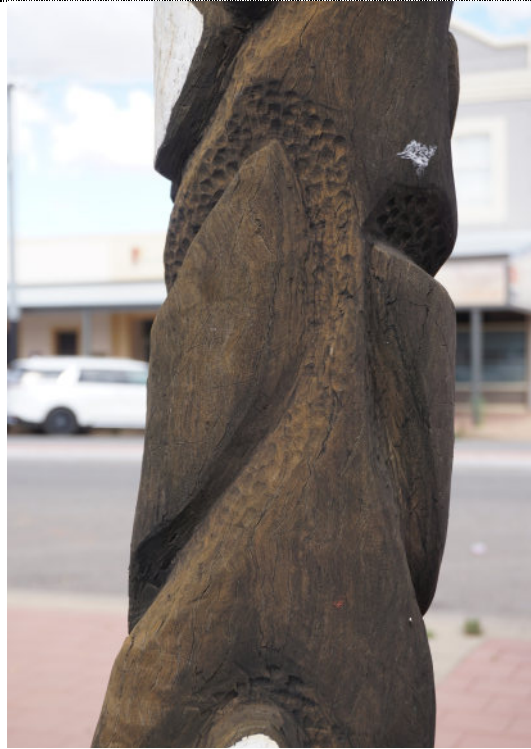
Figure 55: Detail - Pole #2003.0020 *Untitled*, exterior, UV degradation (darkening) to wood surface throughout. Bird excrement present on the wood surface.

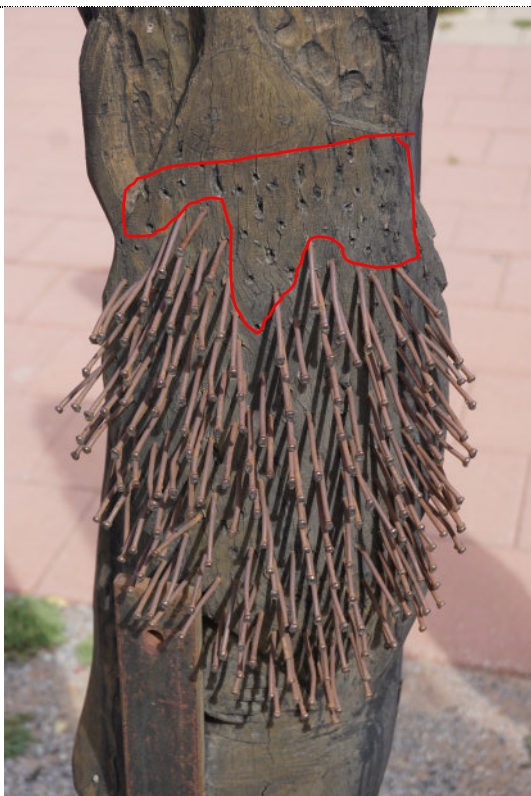
Figure 60: Detail – Pole #2003.0021 *Untitled*, exterior, UV degradation (darkening) to wood surface throughout. Iron corrosion on nails affixed to the timber pole. Missing iron nails are also noted on the exterior sides of the pole (highlighted in red).

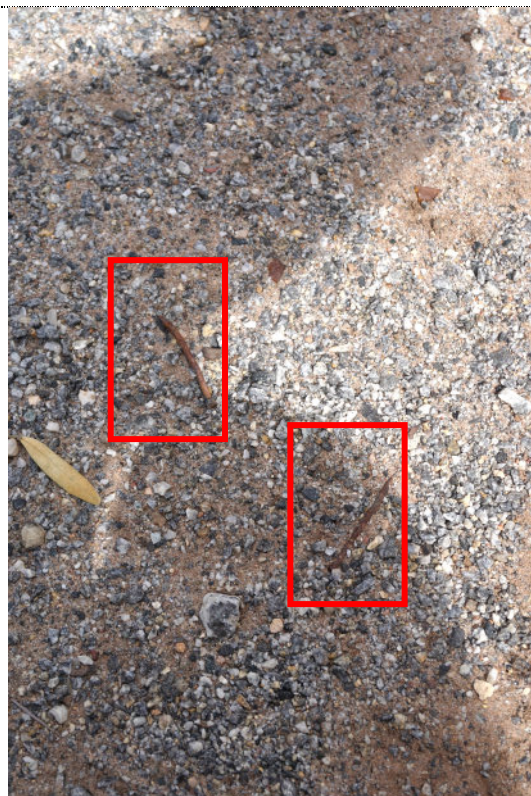
Figure 61: Detail – Pole #2003.0021 *Untitled*, exterior, detached iron nails belonging to artwork found on the ground below the work (highlighted in red).

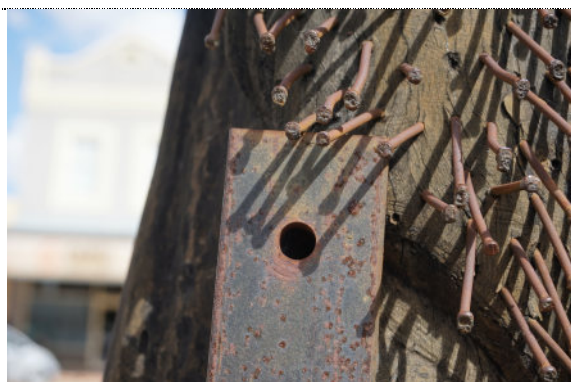
Figure 62: Detail – Pole #2003.0021 *Untitled*, exterior, UV degradation (darkening) to wood surface throughout. Iron corrosion on nails affixed to the timber pole and on iron supports. Missing iron nails are also noted on the exterior sides of the pole.

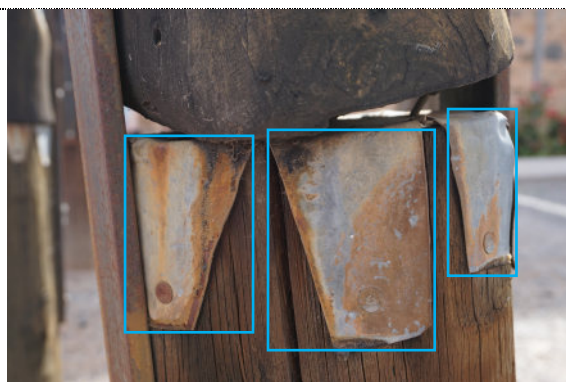
Figure 63: Detail – Pole #2003.0021 *Untitled*, exterior, UV degradation (darkening) to wood surface throughout. Surface dirt also noted throughout. Iron corrosion and staining noted on the metal components below the bands of painted dots (highlighted in blue).

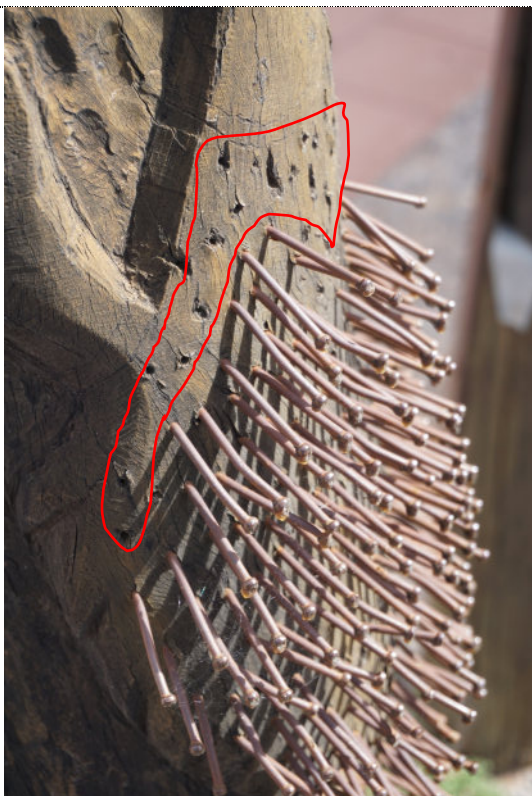
Figure 64: Detail – Pole #2003.0021 *Untitled*, exterior, UV degradation (darkening) to wood surface throughout. Iron corrosion on nails affixed to the timber pole. Missing iron nails are also noted on the exterior sides of the pole (highlighted in red).

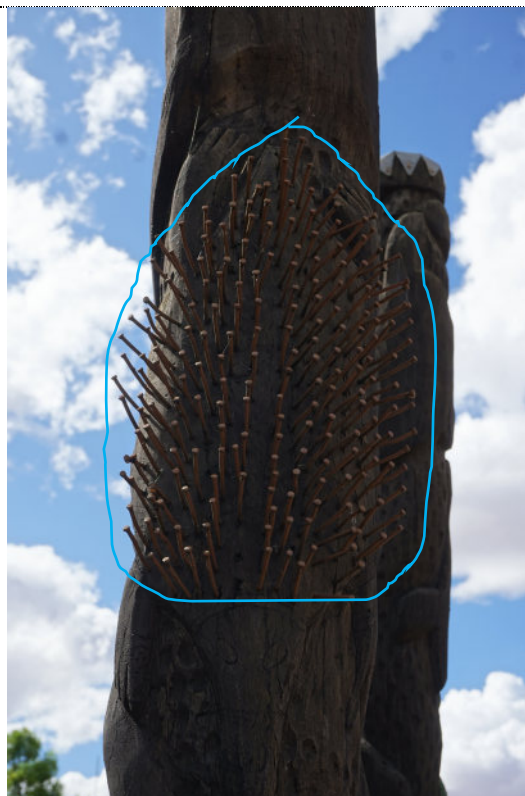
Figure 65: Detail – Pole #2003.0021 *Untitled*, exterior, UV degradation (darkening) to wood surface throughout. Iron corrosion on nails affixed to the timber pole (highlighted in blue).

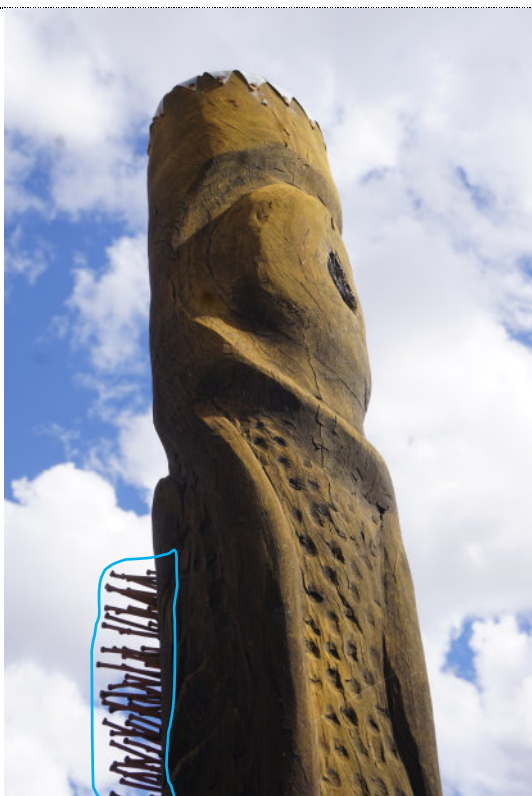
Figure 66: Detail – Pole #2003.0021 *Untitled*, exterior, UV degradation (darkening) to wood surface throughout. Iron corrosion on nails affixed to the timber pole (highlighted in blue).

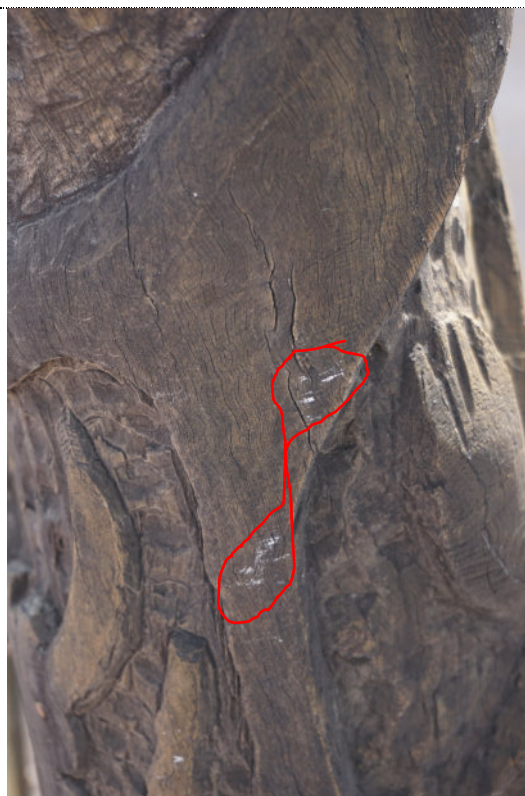
Figure 67: Detail – Pole #2003.0021 *Untitled*, exterior, UV degradation (darkening) to wood surface throughout. Surface dirt and insect debris noted throughout, including the presence of bird excrement (highlighted in red).

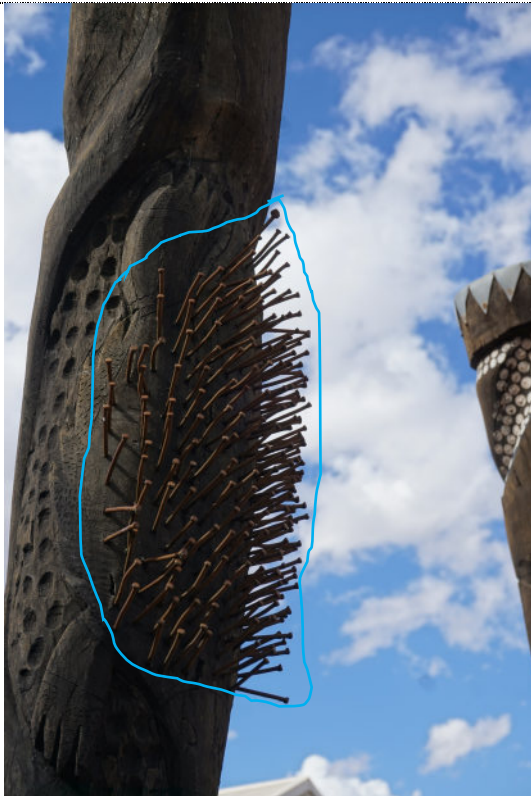
Figure 68: Detail – Pole #2003.0021 *Untitled*, exterior, UV degradation (darkening) to wood surface throughout. Iron corrosion on nails affixed to the timber pole (highlighted in blue).

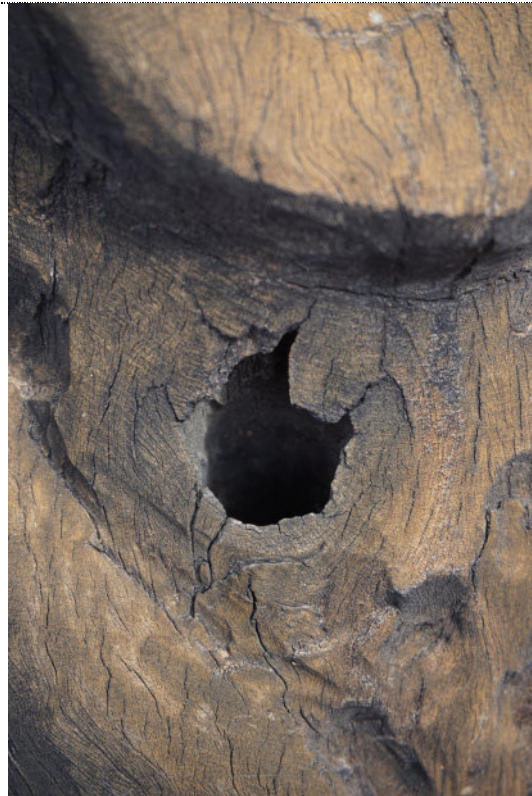
Figure 69: Detail – Pole #2003.0021 *Untitled*, exterior, UV degradation (darkening) to wood surface throughout. Large loss to the timber pole.

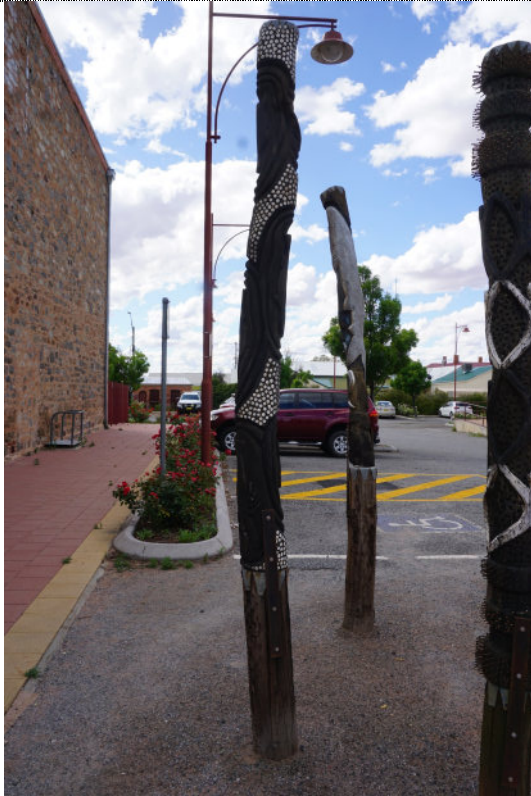
Figure 70: Pole #2003.0022, *Untitled*, Front.

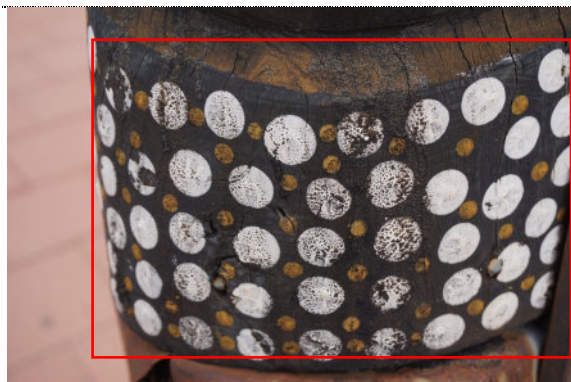
Figure 74: Detail – Pole #2003. 0022, *Untitled*, exterior, UV degradation (darkening) to wood surface throughout. Surface dirt also noted throughout. Fading and losses noted to the painted surfaces, particularly the white and yellow ochre painted dots (highlighted in red).

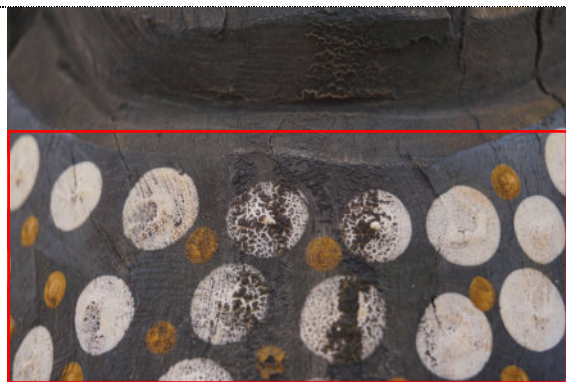
Figure 75: Detail – Pole #2003. 0022, *Untitled*, exterior, UV degradation (darkening) to wood surface throughout. Surface dirt also noted throughout. Fading and losses noted to the painted surfaces, particularly the white and yellow ochre painted dots (highlighted in red).

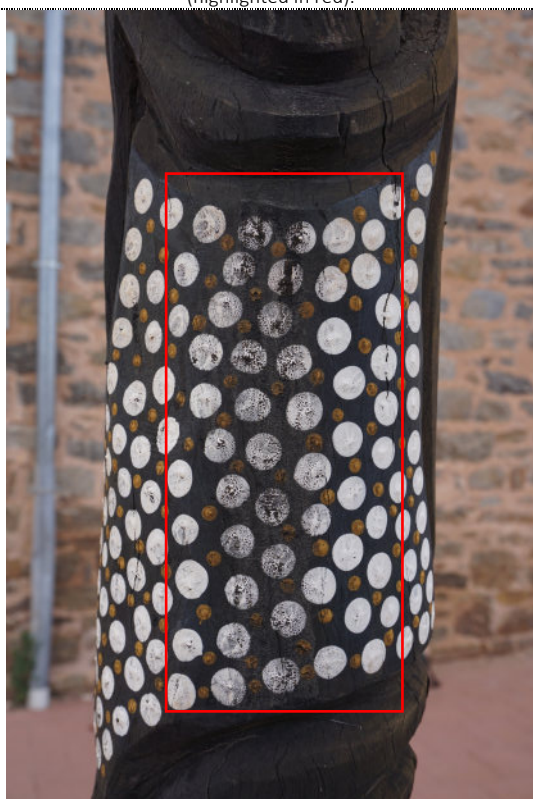
Figure 76: Detail – Pole #2003. 0022, *Untitled*, exterior, UV degradation (darkening) to wood surface throughout. Surface dirt also noted throughout. Fading and losses noted to the painted surfaces, particularly the white and yellow ochre painted dots (highlighted in red).

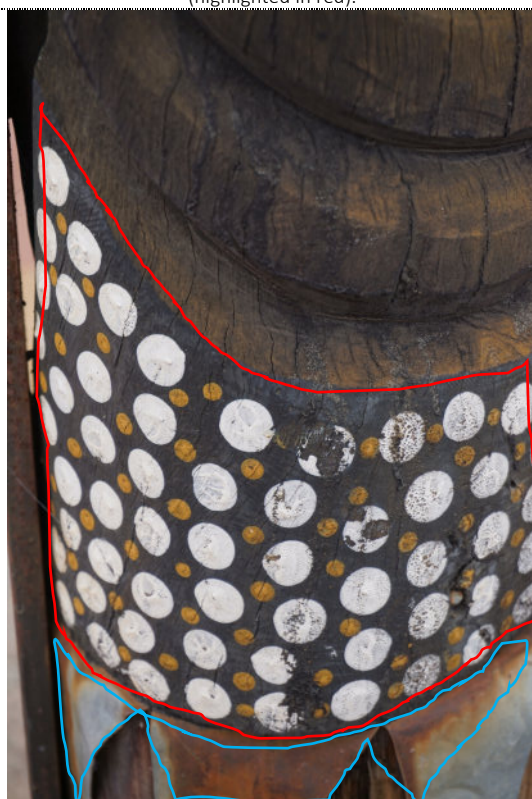
Figure 77: Detail – Pole #2003. 0022, *Untitled*, exterior, UV degradation (darkening) to wood surface throughout. Surface dirt also noted throughout. Fading and losses noted to the painted surfaces, particularly the white and yellow ochre painted dots (highlighted in red). Extensive iron corrosion and staining noted on the metal components below the bands of painted dots (highlighted in blue).

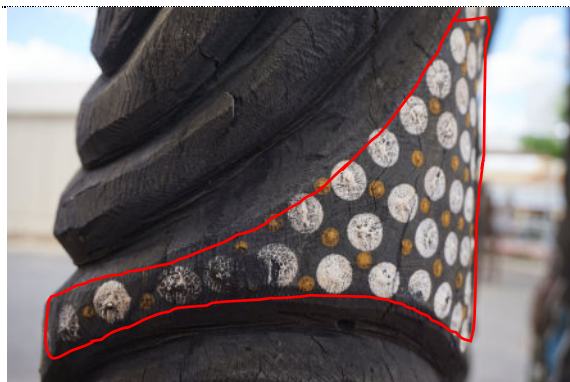
Figure 78: Detail – Pole #2003. 0022, *Untitled*, exterior, UV degradation (darkening) to wood surface throughout. Surface dirt also noted throughout. Fading and losses noted to the painted surfaces, particularly the white and yellow ochre painted dots (highlighted in red).

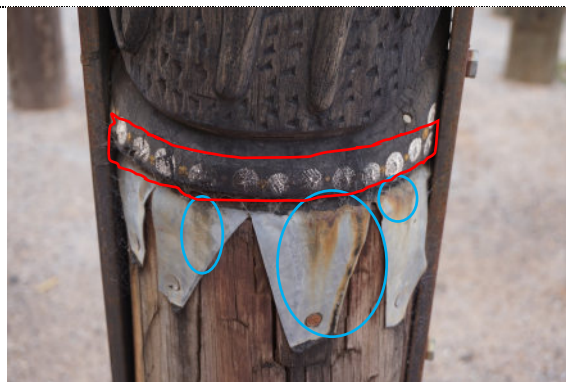
Figure 79: Detail – Pole #2003. 0022, *Untitled*, exterior, UV degradation (darkening) to wood surface throughout. Surface dirt also noted throughout. Fading and losses noted to the painted surfaces, particularly the white and yellow ochre painted dots (highlighted in red). Iron corrosion and staining noted on the metal components below the bands of painted dots (highlighted in blue).

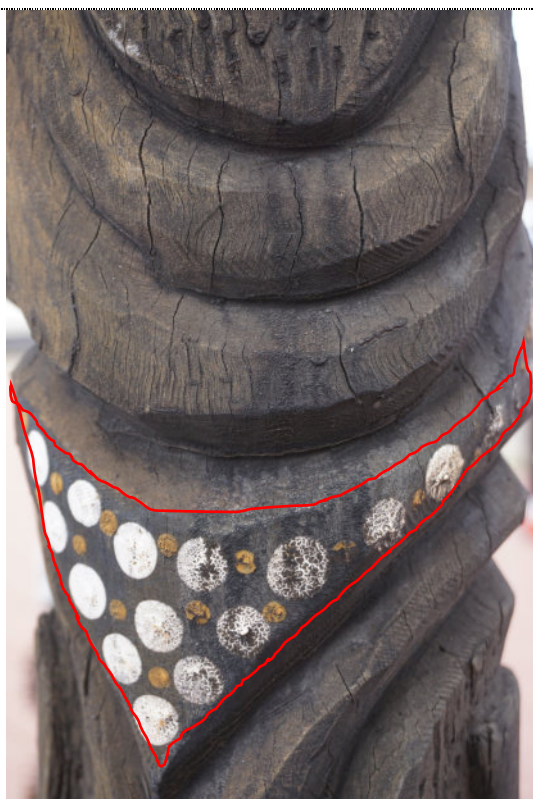
Figure 80: Detail – Pole #2003. 0022, *Untitled*, exterior, UV degradation (darkening) to wood surface throughout. Surface dirt also noted throughout. Fading and losses noted to the painted surfaces, particularly the white and yellow ochre painted dots (highlighted in red).

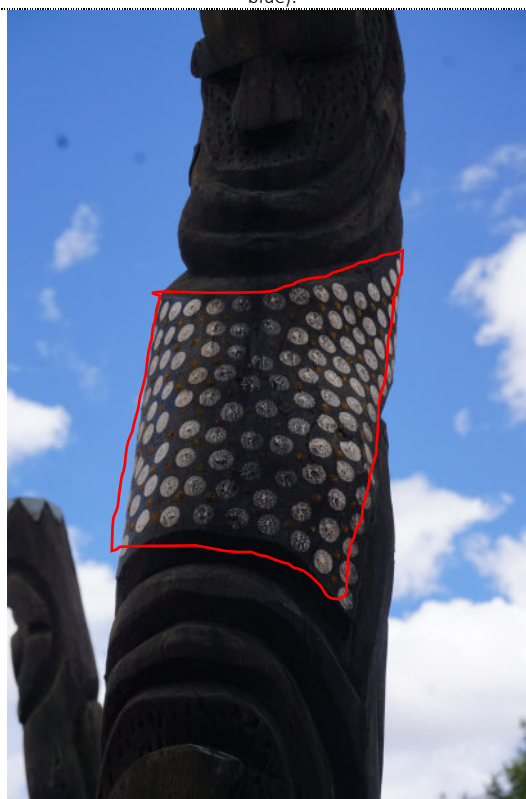
Figure 81: Detail – Pole #2003. 0022, *Untitled*, exterior, UV degradation (darkening) to wood surface throughout. Surface dirt also noted throughout. Fading and losses noted to the painted surfaces, particularly the white and yellow ochre painted dots (highlighted in red).

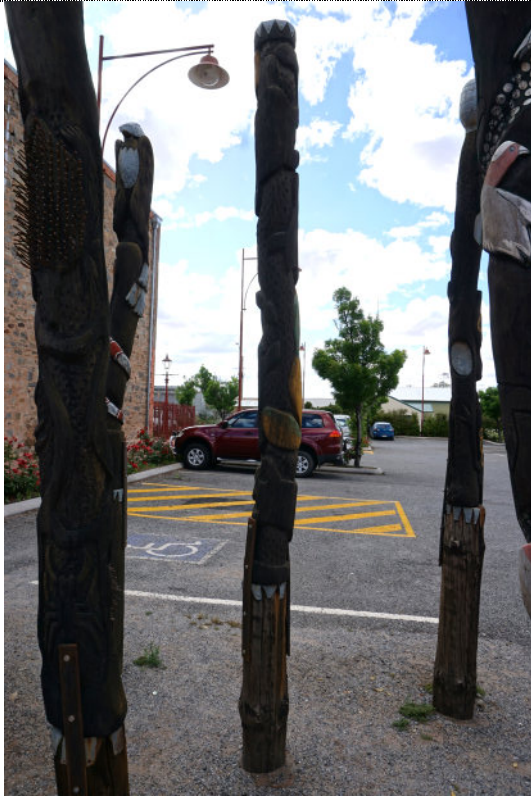
Figure 82: Pole #2003.0023, *Untitled*, Front.

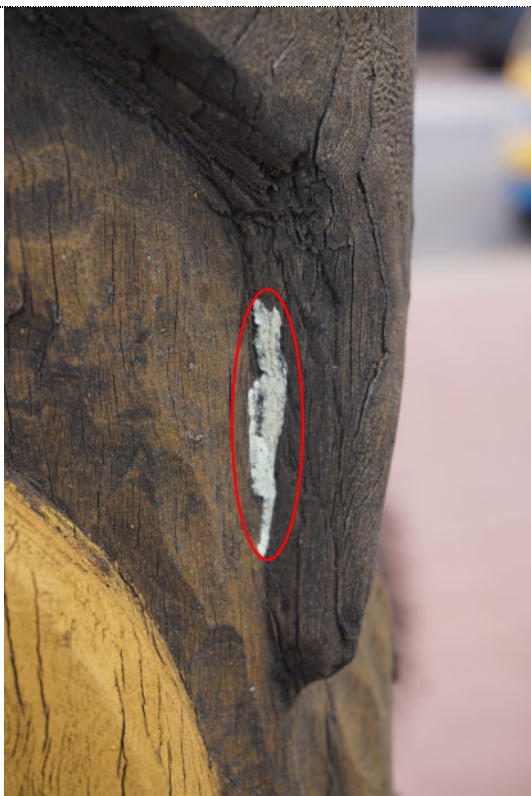
Figure 86: Detail – Pole #2003.0023, *Untitled*, exterior, UV degradation (darkening) to wood surface throughout. Surface dirt and insect debris noted throughout, including the presence of bird excrement (highlighted in red).

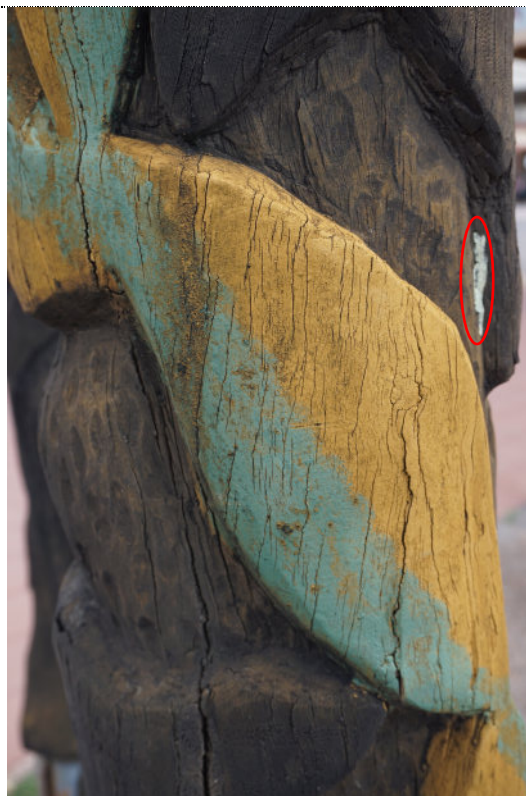
Figure 87: Detail – Pole #2003.0023, *Untitled*, exterior, UV degradation (darkening) to wood surface throughout. Surface dirt and insect debris noted throughout, including the presence of bird excrement (highlighted in red). Linear cracks along the grain of the timber are also noted throughout.

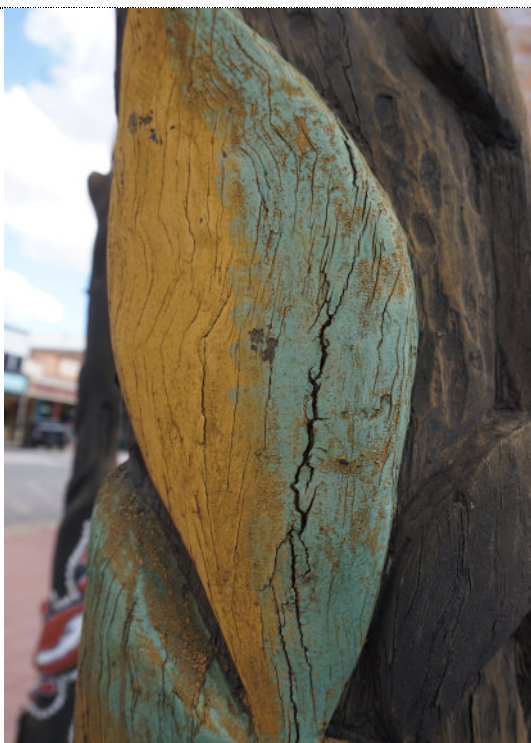
Figure 88: Detail – Pole #2003.0023, *Untitled*, exterior, UV degradation (darkening) to wood surface throughout. Fading and losses noted to the painted surfaces. Cracks and splitting following the grain of the wood are evident throughout. These likely stem from movement in the material as it is exposed to different forces and degradation mechanisms.

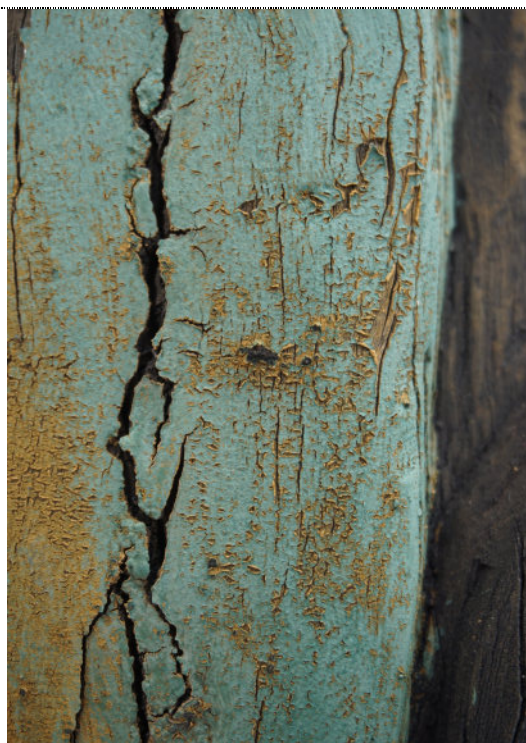
Figure 89: Detail – Pole #2003.0023, *Untitled*, exterior, exterior, UV degradation (darkening) to wood surface throughout. Fading and losses noted to the painted surfaces. Cracks and splitting following the grain of the wood are evident throughout. These likely stem from movement in the material as it is exposed to different forces and degradation mechanisms.

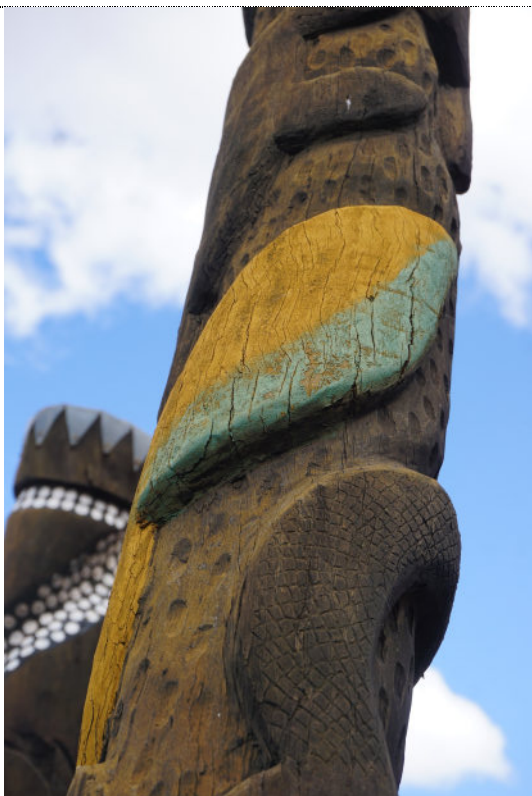
Figure 90: Detail – Pole #2003.0023, *Untitled*, exterior, exterior, UV degradation (darkening) to wood surface throughout. Fading and losses noted to the painted surfaces. Cracks and splitting following the grain of the wood are evident throughout. These likely stem from movement in the material as it is exposed to different forces and degradation mechanisms.

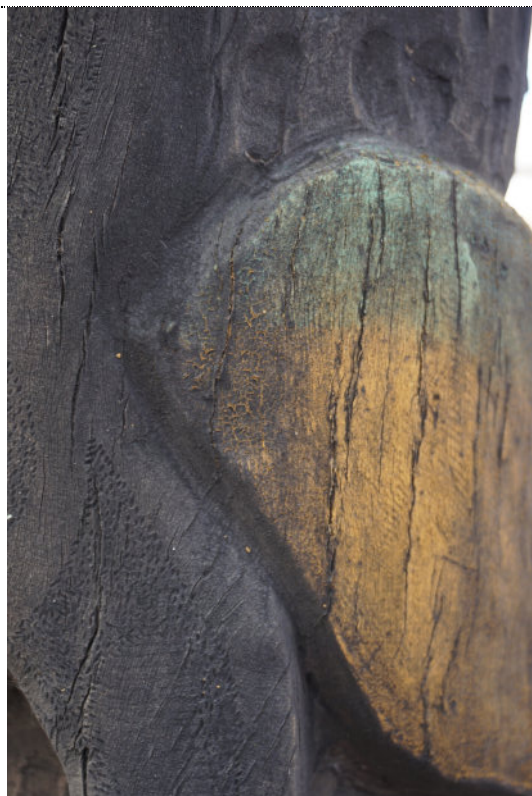
Figure 91: Detail – Pole #2003.0023, *Untitled*, exterior, exterior, UV degradation (darkening) to wood surface throughout. Fading and losses noted to the painted surfaces. Cracks and splitting following the grain of the wood are evident throughout. These likely stem from movement in the material as it is exposed to different forces and degradation mechanisms.

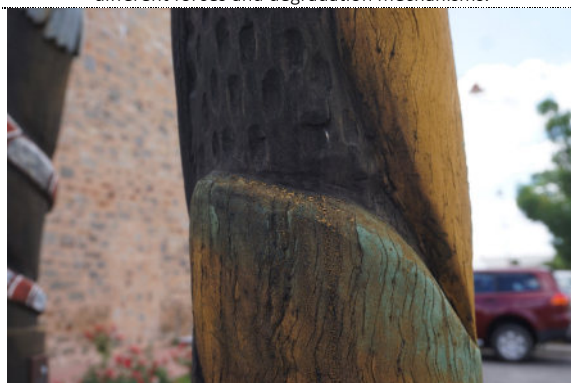
Figure 92: Detail – Pole #2003.0023, *Untitled*, exterior, exterior, UV degradation (darkening) to wood surface throughout. Fading and losses noted to the painted surfaces. Fine cracks and splitting following the grain of the wood are evident throughout.

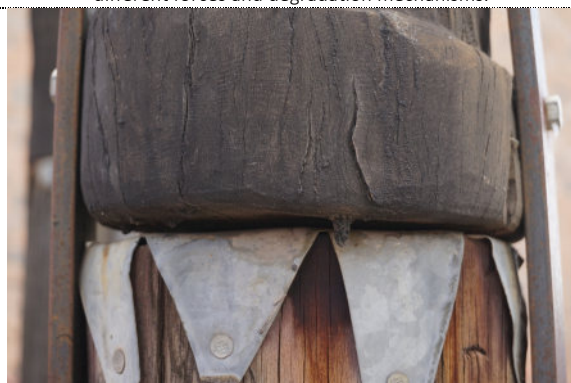
Figure 93: Detail – Pole #2003.0023, *Untitled*, exterior, exterior, UV degradation (darkening) to wood surface throughout. Tarnishing and iron corrosion noted on metal components and fastenings.

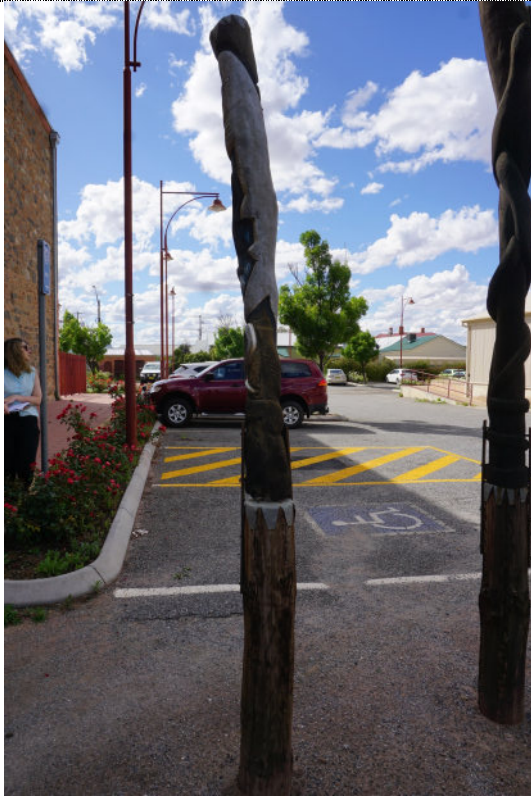
Figure 94: Pole #2003.0024, *Untitled*, Front.

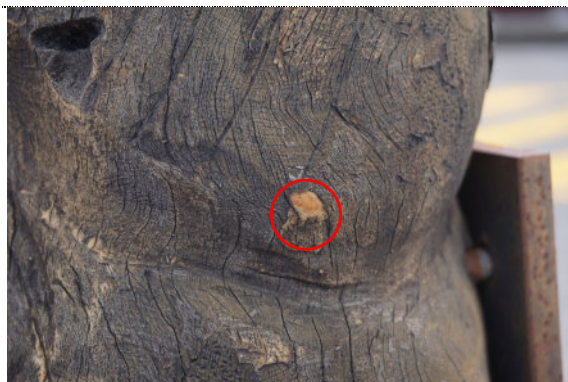
Figure 98: Detail – Pole #2003.0024, *Untitled*, exterior, exterior, UV degradation (darkening) to wood surface throughout. Small yellow accretion affixed to the exterior side of the pole (highlighted in red).

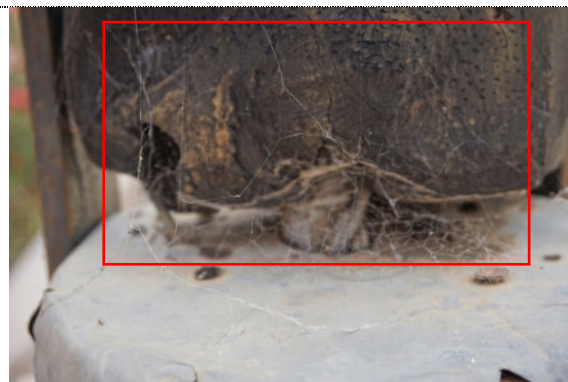
Figure 99: Detail – Pole #2003.0024, *Untitled*, exterior, exterior, UV degradation (darkening) to wood surface throughout. Fading and losses noted to the painted surfaces. Surface dirt and insect debris noted throughout, including the presence of spider webs (highlighted in red).

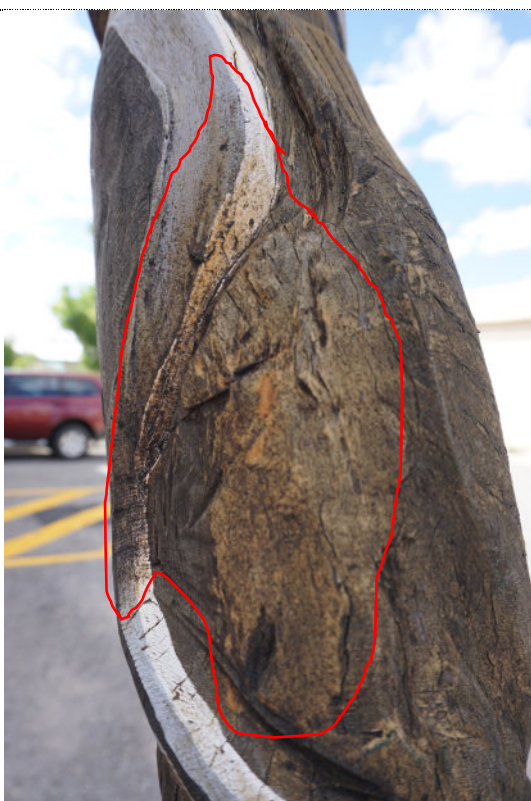
Figure 100: Detail – Pole #2003.0024, *Untitled*, exterior, UV degradation (darkening) to wood surface throughout. Staining, suggestive of iron staining, is noted over the white painted carved designs and surrounding wood surfaces (highlighted in red). The painted areas are also faded, which is consistent with UV degradation and display outdoors.

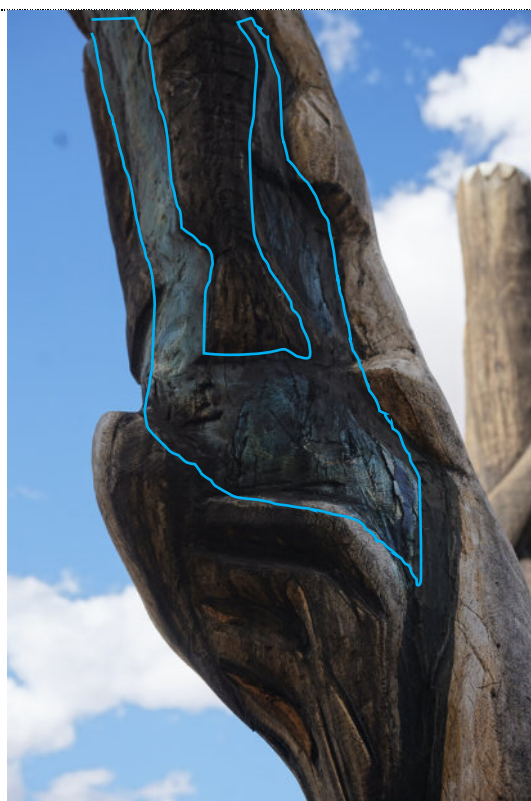
Figure 101: Detail – Pole #2003.0024, *Untitled*, exterior, UV degradation (darkening) to wood surface throughout. Staining, suggestive of iron staining, is noted over the blue painted carved designs and surrounding wood surfaces. The painted areas are also faded and lost (highlighted in blue), which is consistent with UV degradation and display outdoors.

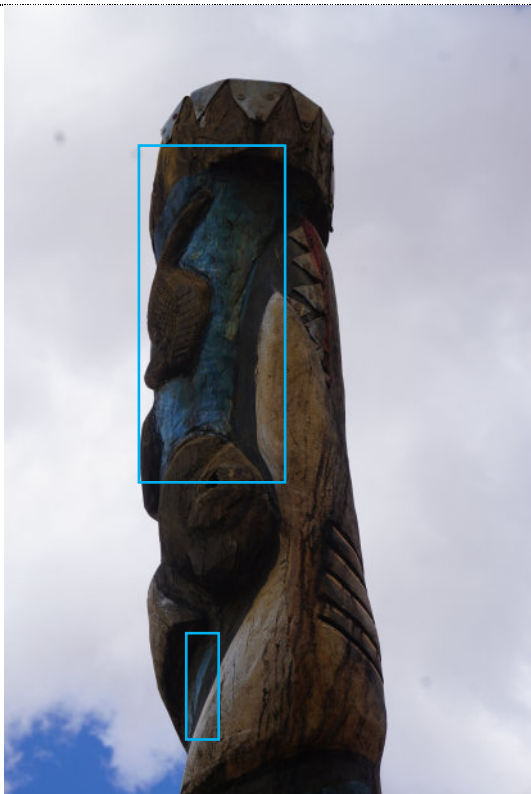
Figure 102: Detail – Pole #2003.0024, *Untitled*, exterior, UV degradation (darkening) to wood surface throughout. The painted areas are also faded and lost (highlighted in blue), which is consistent with UV degradation and display outdoors.

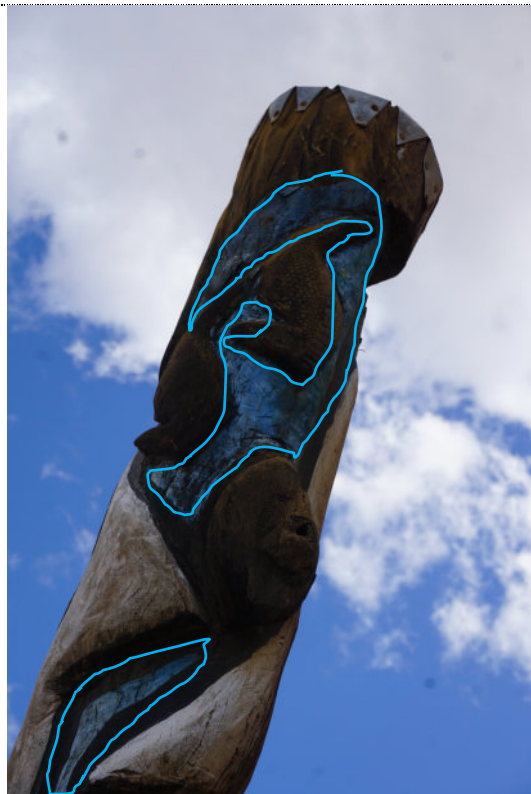
Figure 103: Detail – Pole #2003.0024, *Untitled*, exterior, UV degradation (darkening) to wood surface throughout. The painted areas are also faded and lost (highlighted in blue), which is consistent with UV degradation and display outdoors.

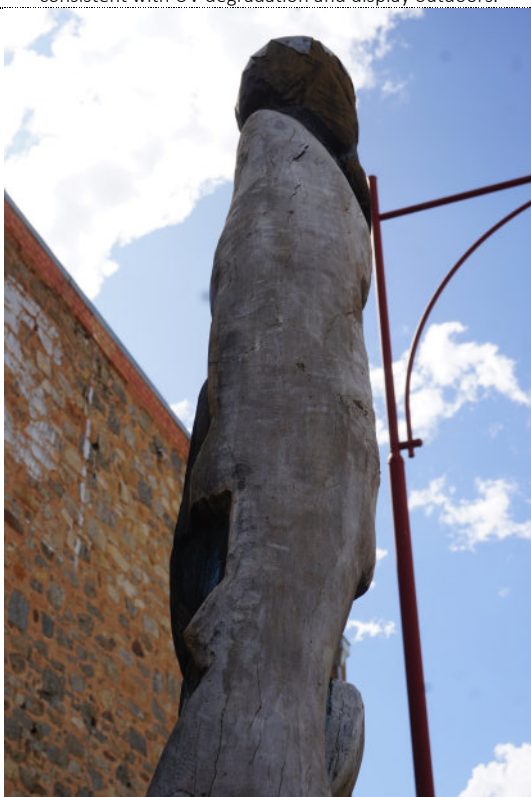
Figure 104: Detail – Pole #2003.0024, *Untitled*, exterior, UV degradation (darkening) to wood surface throughout. The painted surfaces are faded and degraded, which is consistent with UV degradation and display outdoors.

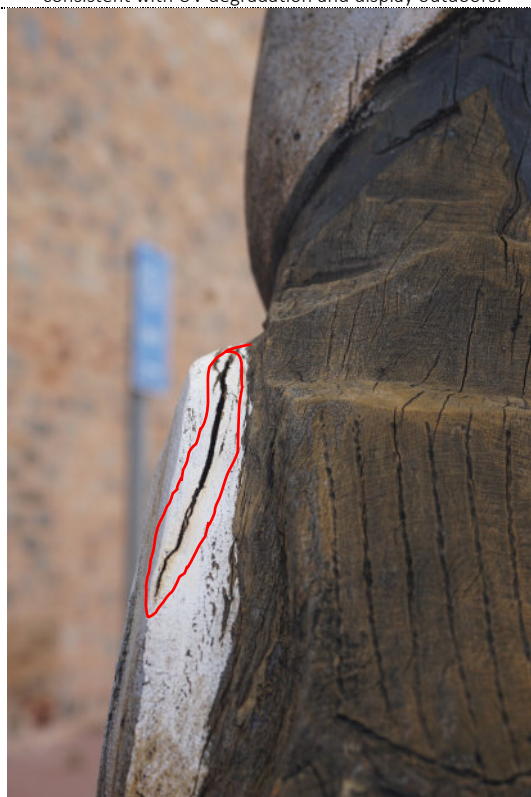
Figure 105: Detail – Pole #2003.0024, *Untitled*, exterior, UV degradation (darkening) to wood surface throughout. Cracks and splitting (highlighted in red) following the grain of the wood are evident throughout. These likely stem from movement in the material as it is exposed to different forces and degradation mechanisms.

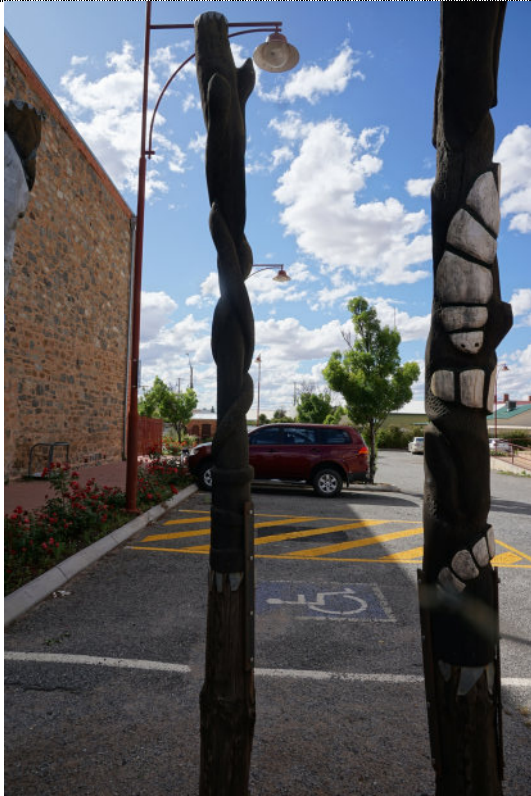
Figure 106: Pole #2003.0025, *Reconciliation*, Front.

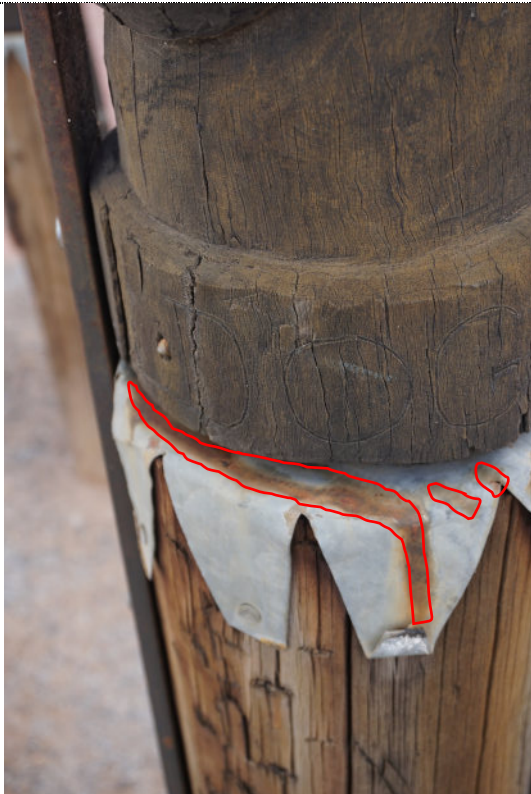
Figure 110: Detail – Pole #2003.0025, *Reconciliation*, exterior, iron staining to metal components (highlighted in red) and presence of corrosion products on iron nails. UV degradation (darkening) to wood surface, and multiple cracks along the grain of the wood.

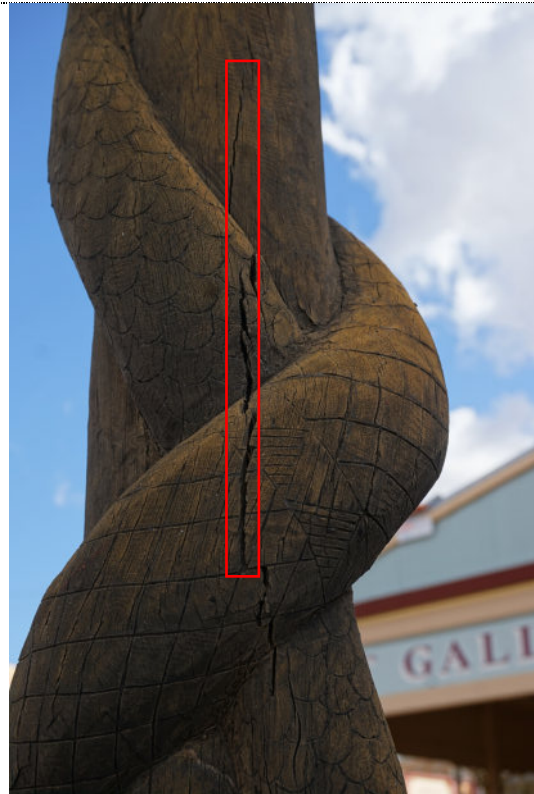
Figure 111: Detail – Pole #2003.0025, *Reconciliation*, exterior, UV degradation (darkening) to wood surface throughout. Cracks and splitting (highlighted in red) following the grain of the wood are evident throughout. These likely stem from movement in the material as it is exposed to different forces and degradation mechanisms.

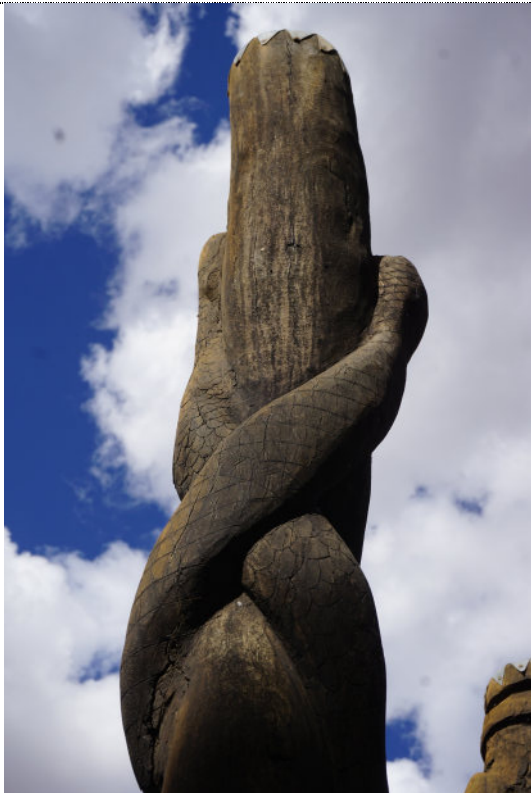
Figure 112: Detail – Pole #2003.0025, *Reconciliation*, exterior, UV degradation (darkening) to wood surface throughout.
