# *Broken Hill Public Art Condition Survey and Conservation Plan*

Prepared for: Broken Hill City Council  
Submission Date: February 2023

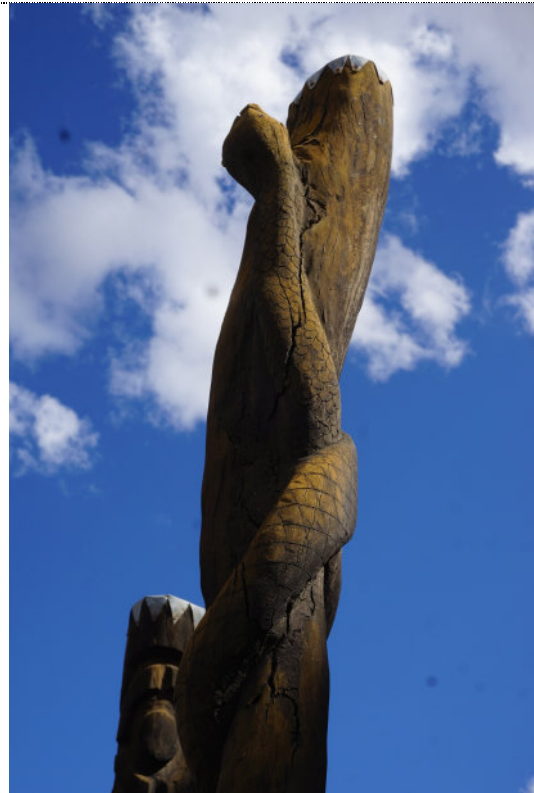
Figure 113: Detail – Pole #2003.0025, *Reconciliation*, exterior, UV degradation (darkening) to wood surface throughout.

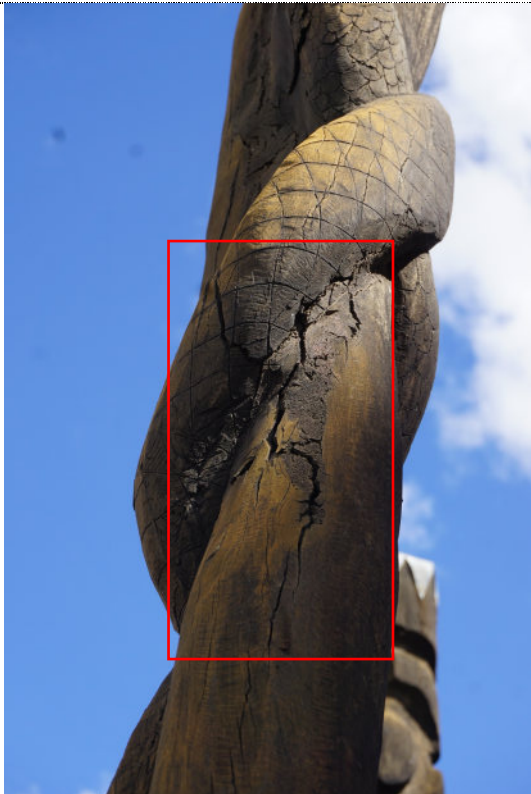
Figure 114: Detail – Pole #2003.0025, *Reconciliation*, exterior, UV degradation (darkening) to wood surface throughout. Cracks and splitting (highlighted in red) following the grain of the wood are evident throughout. These likely stem from movement in the material as it is exposed to different forces and degradation mechanisms.

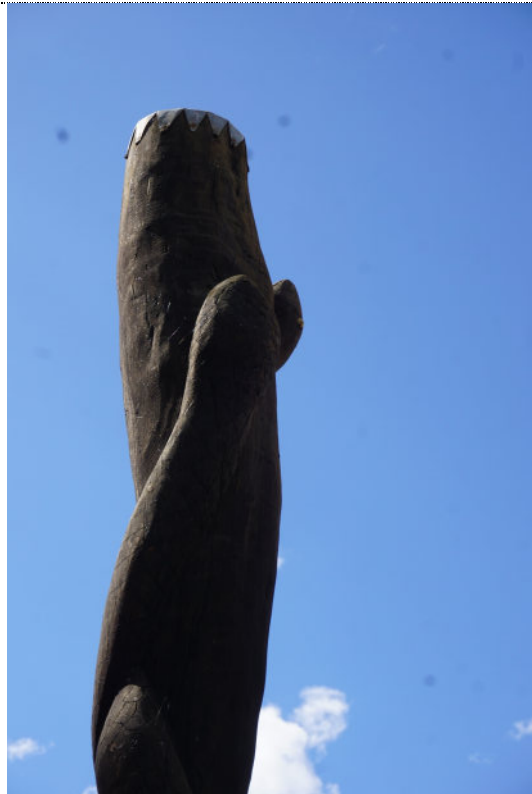
Figure 115: Detail – Pole #2003.0025, *Reconciliation*, exterior, UV degradation (darkening) to wood surface throughout.

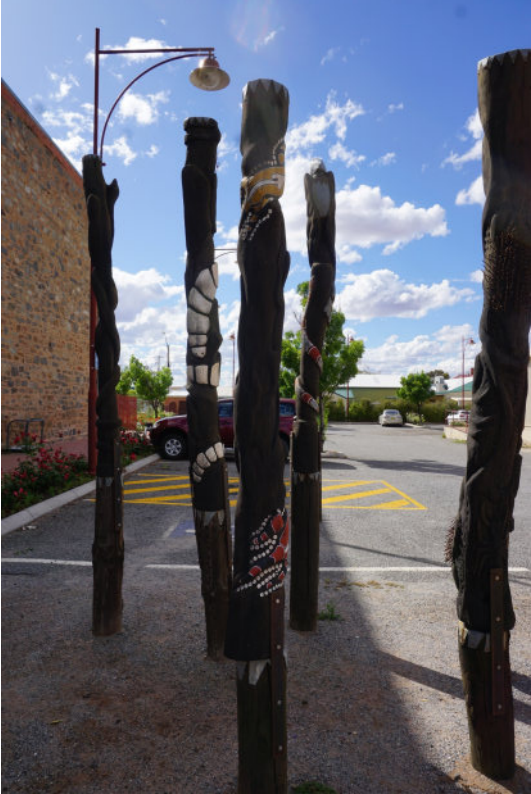
Figure 116: Pole #2003.0026, Reconciliation, Front.

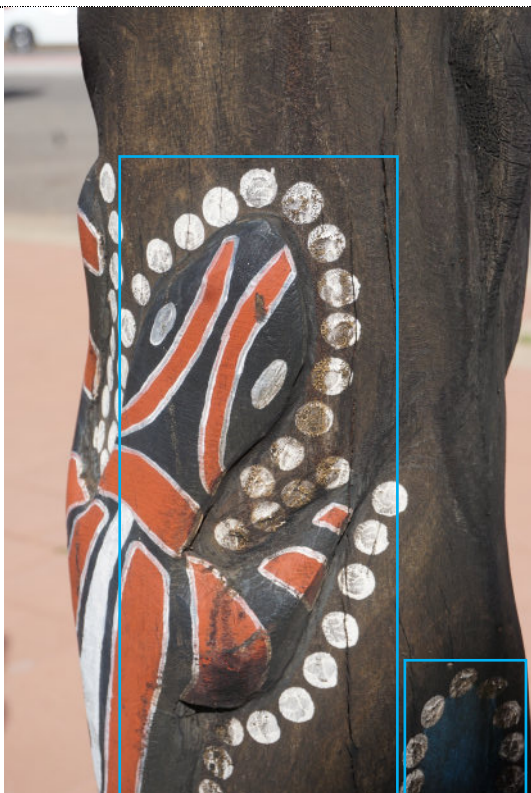
Figure 120: Detail – Pole #2003.0026, *Reconciliation*, exterior, UV degradation (darkening) to wood surface throughout. The painted areas are also faded and lost (highlighted in blue), which is consistent with UV degradation and display outdoors.

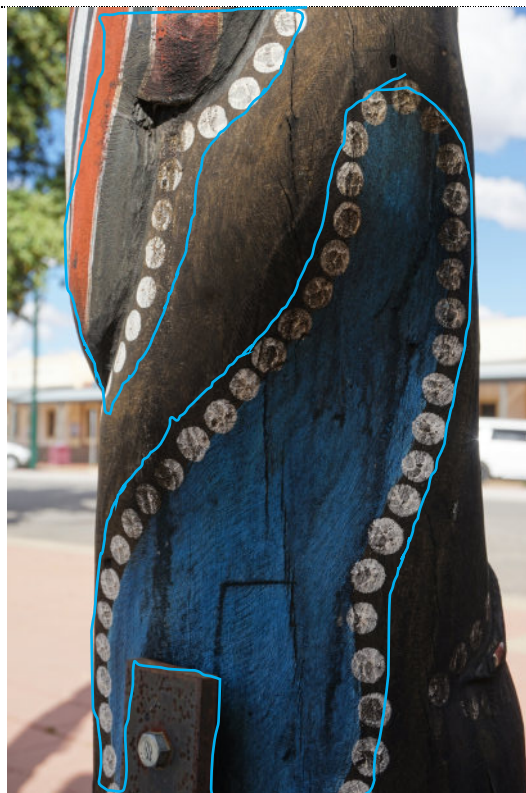
Figure 121: Detail – Pole #2003.0026, *Reconciliation*, exterior, UV degradation (darkening) to wood surface throughout. The painted areas are also faded and lost (highlighted in blue), which is consistent with UV degradation and display outdoors.

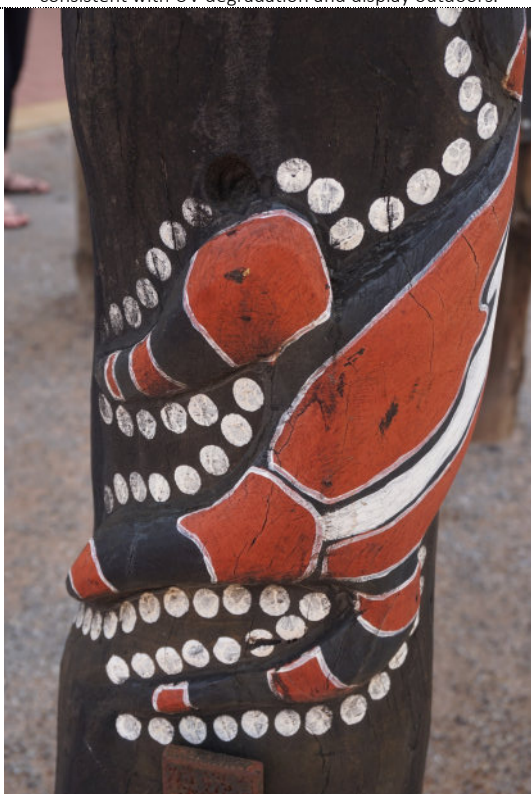
Figure 122: Detail – Pole #2003.0026, *Reconciliation*, exterior, UV degradation (darkening) to wood surface throughout. The painted areas are also faded and lost (highlighted in blue), which is consistent with UV degradation and display outdoors.

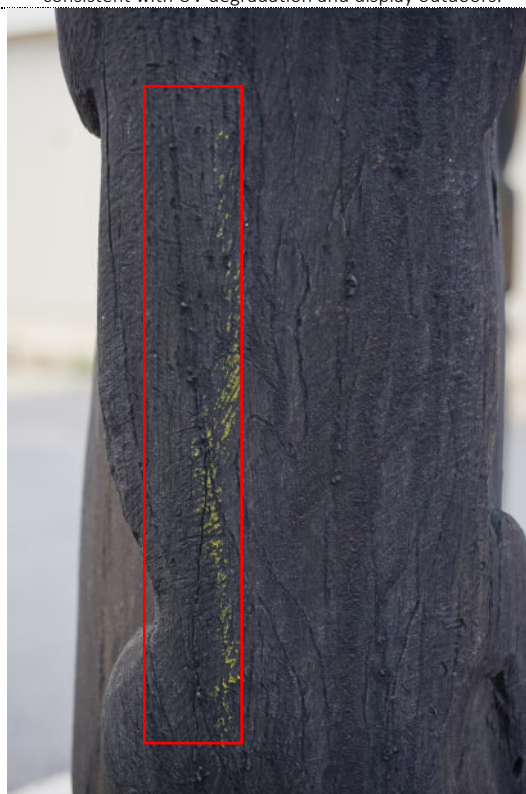
Figure 123: Detail – Pole #2003.0026, *Reconciliation*, exterior, UV degradation (darkening) to wood surface throughout. A large linear accretion, yellow in colour (highlighted in red), is present on the exterior side of the pole.

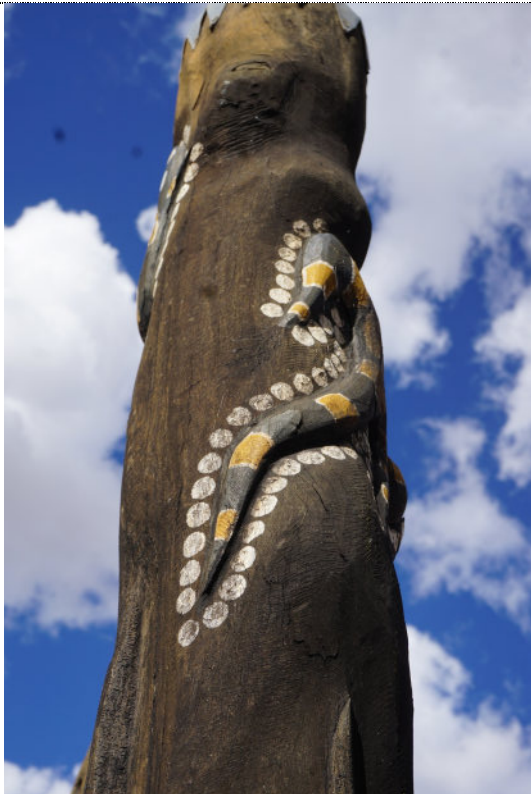
Figure 124: Detail – Pole #2003.0026, *Reconciliation*, exterior, UV degradation (darkening) to wood surface throughout. The painted areas are also faded and lost, which is consistent with UV degradation and display outdoors.

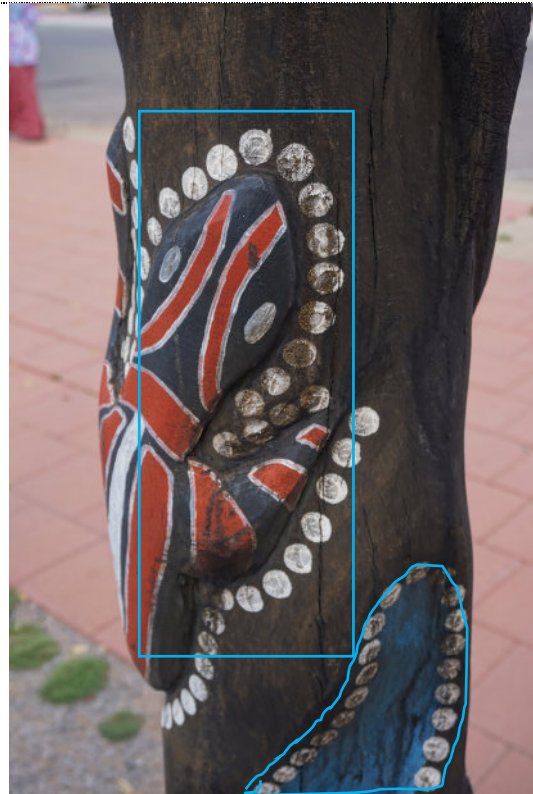
Figure 125: Detail – Pole #2003.0026, *Reconciliation*, exterior, UV degradation (darkening) to wood surface throughout. The painted areas are also faded and lost (highlighted in blue), which is consistent with UV degradation and display outdoors.

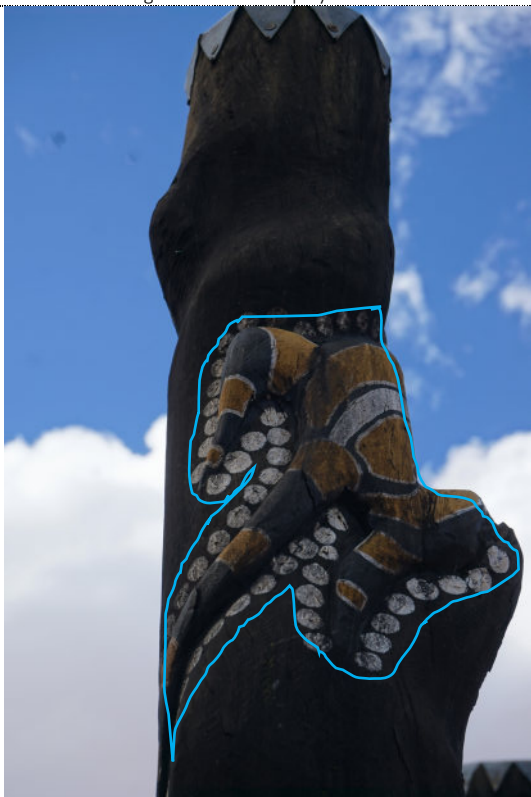
Figure 126: Detail – Pole #2003.0026, *Reconciliation*, exterior, UV degradation (darkening) to wood surface throughout. The painted areas are also faded and lost (highlighted in blue), which is consistent with UV degradation and display outdoors.

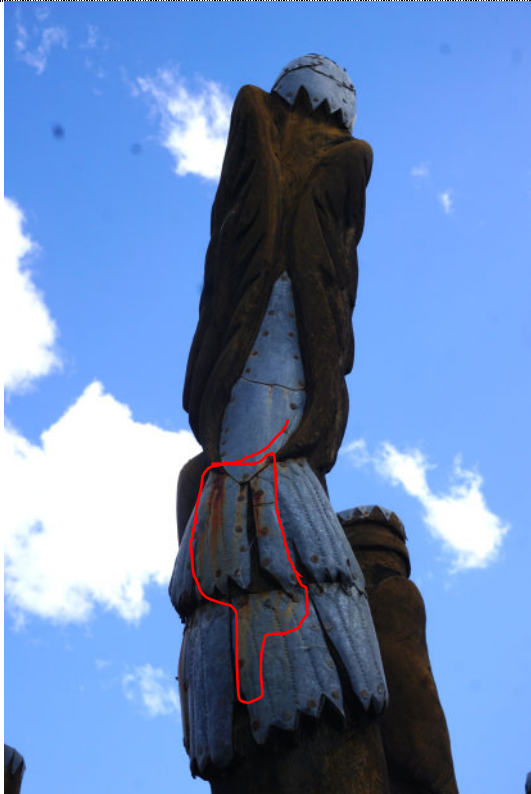
Figure 131: Detail – Pole #2003.0027, *Untitled*, exterior, iron corrosion and associated staining to the metal body and feathers of the carved bird. The iron staining is highlighted in red.

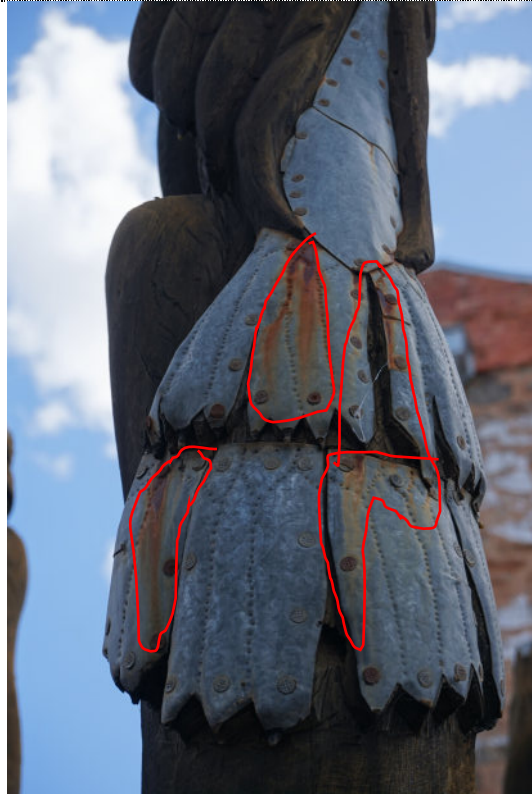
Figure 132: Detail – Pole #2003.0027, *Untitled*, exterior, iron corrosion and associated staining to the metal body and feathers of the carved bird. The iron staining is highlighted in red.

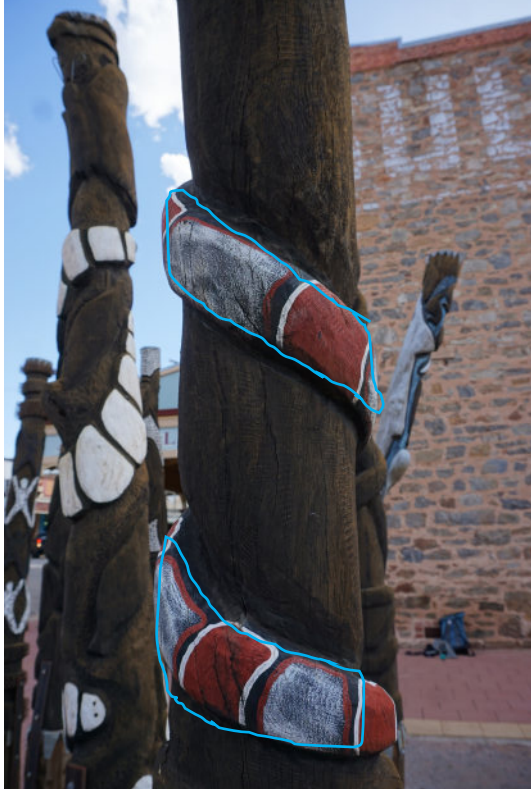
Figure 133: Detail – Pole #2003.0027, *Untitled*, exterior, painted areas/designs have faded with multiple paint losses are also noted (highlighted in blue). This is consistent with UV degradation and display outdoors.

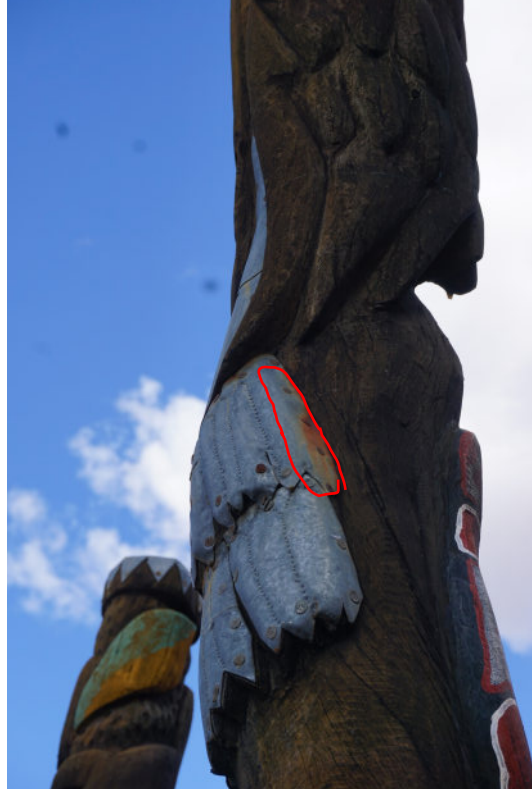
Figure 134: Detail – Pole #2003.0027, *Untitled*, exterior, iron corrosion and associated staining to the metal body and feathers of the carved bird. The iron staining is highlighted in red.

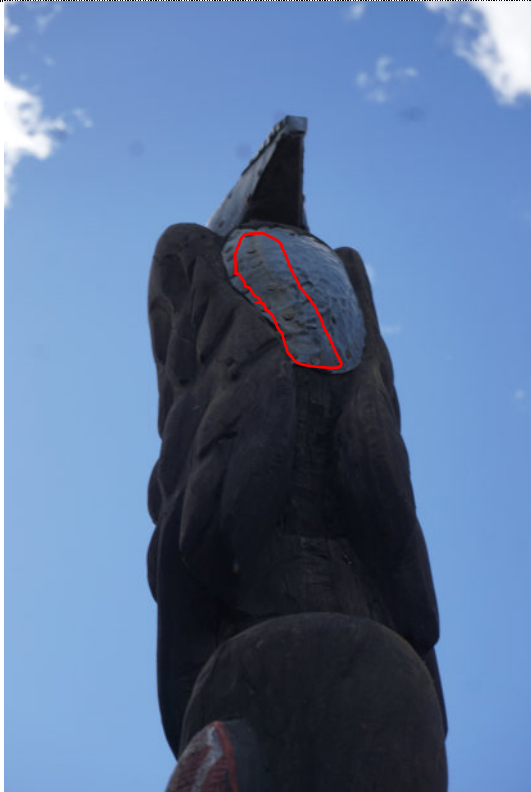
Figure 135: Detail – Pole #2003.0027, *Untitled*, exterior, iron corrosion and associated staining to the metal body and feathers of the carved bird. The iron staining is highlighted in red.

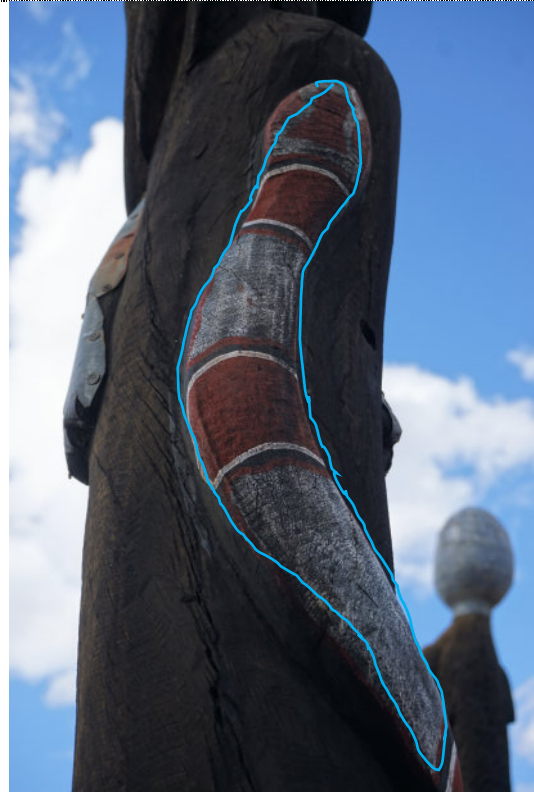
Figure 136: Detail – Pole #2003.0027, *Untitled*, exterior, painted areas/designs are faded with multiple paint losses also noted (highlighted in blue). This is consistent with UV degradation and display outdoors.

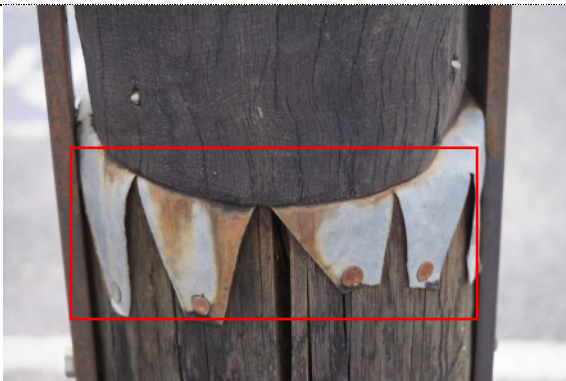
Figure 137: Detail – Pole #2003.0027, *Untitled*, exterior, iron corrosion and associated staining to the metal body and feathers of the carved bird. The iron staining is highlighted in red.

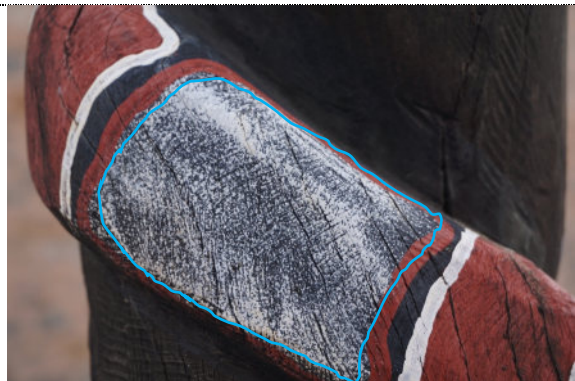
Figure 138: Detail – Pole #2003.0027, *Untitled*, exterior, painted areas/designs are faded with multiple paint losses also noted (highlighted in blue). This is consistent with UV degradation and display outdoors.

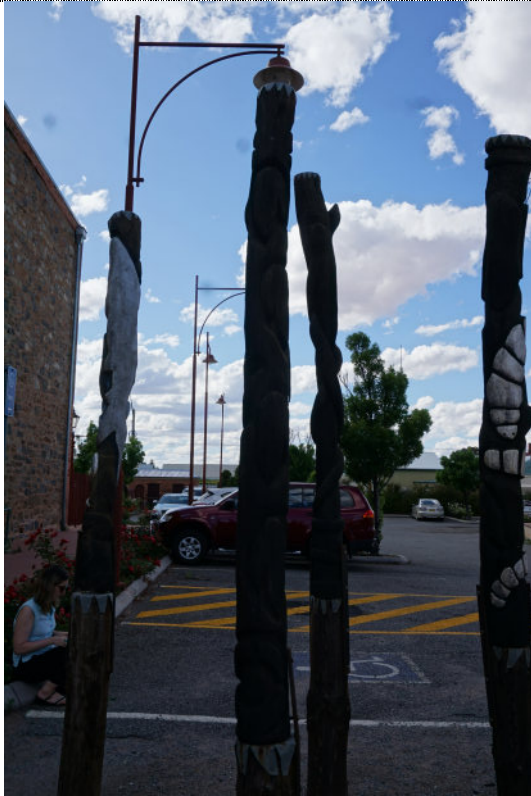
Figure 139: Pole #2003.0028, *Emu and kangaroo tracks*, Front.

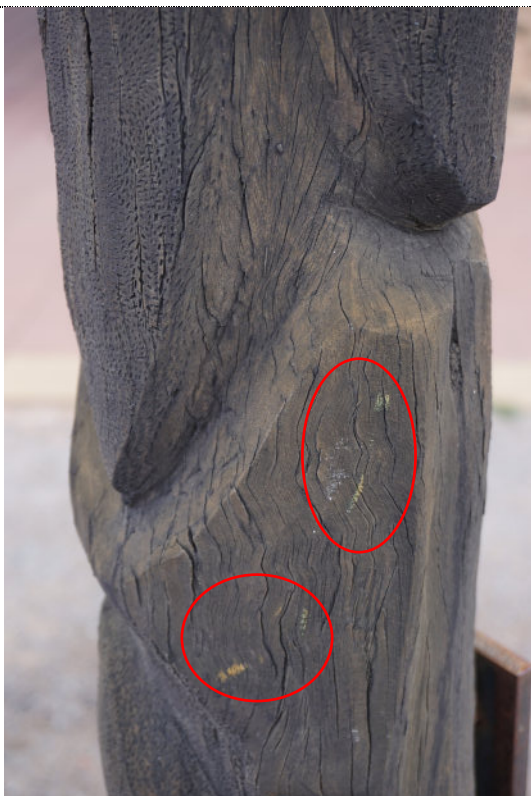
Figure 143: Detail – Pole #2003.0028, *Emu and kangaroo tracks*, exterior, UV degradation (darkening) to wood surface throughout. Yellow accretions noted on the wood surface (highlighted in red).

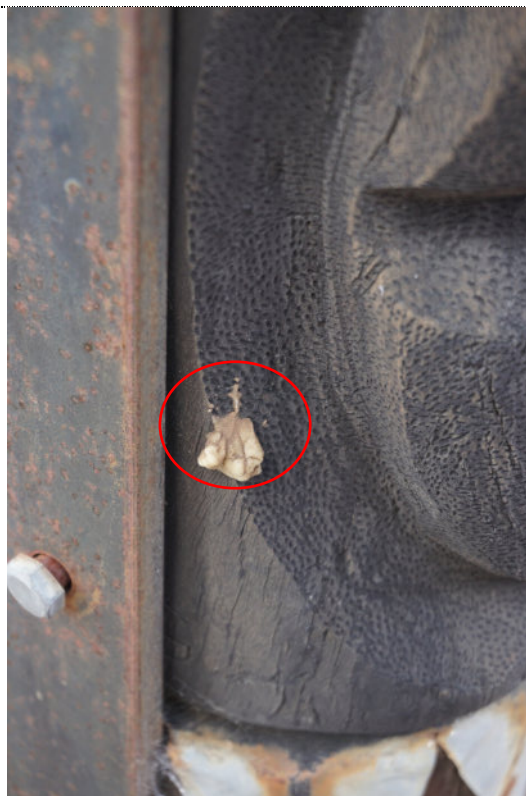
Figure 144: Detail – Pole #2003.0028, *Emu and kangaroo tracks*, exterior, UV degradation (darkening) to wood surface throughout. A large accretion noted on the wood surface (highlighted in red).

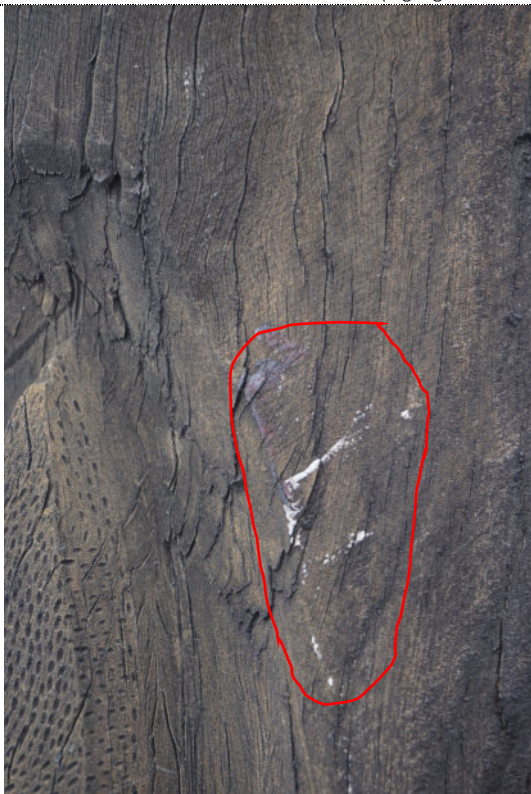
Figure 145: Detail – Pole #2003.0028, *Emu and kangaroo tracks*, exterior, exterior, UV degradation (darkening) to wood surface throughout. White paint accretions noted on the wood surface (highlighted in red).

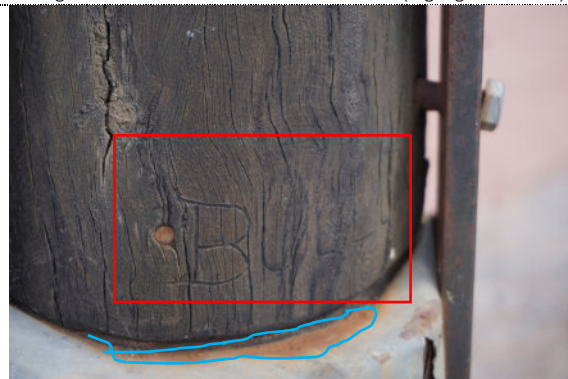
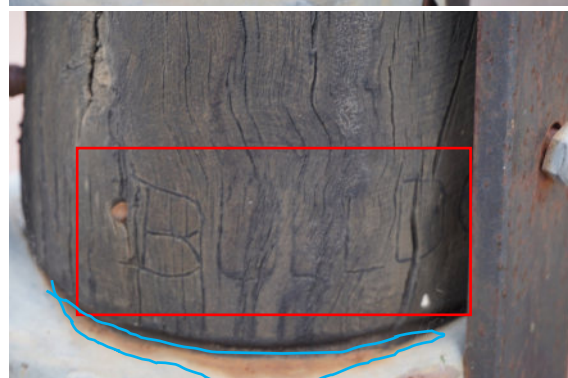
Figure 146 and 147: Detail – Pole #2003.0028, *Emu and kangaroo tracks*, exterior, carved letters written along the base of the pole (highlighted in red in both images). Iron staining on the metal below the base of the pole (highlighted in blue in both images).

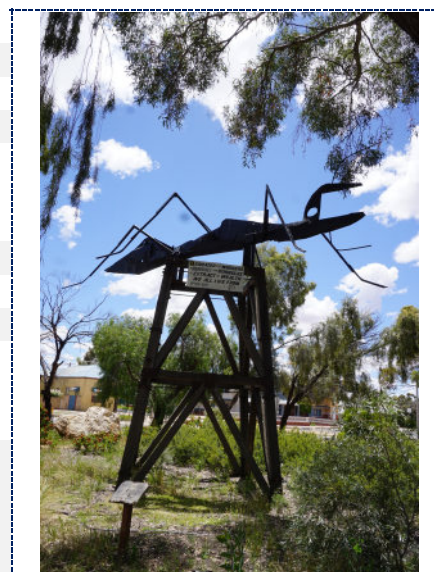
Previous repairs/ modifications?  YES  NO

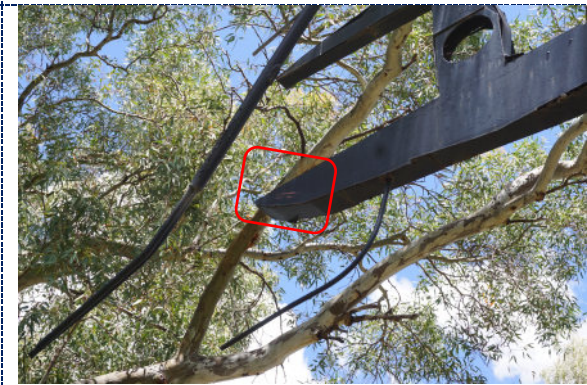
Figure 5: Detail – paint loss and corrosion to iron substrate.

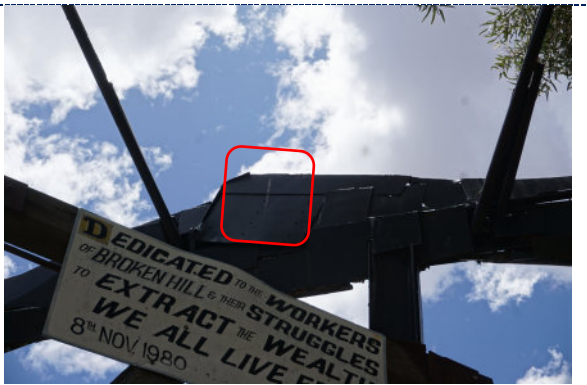
Figure 6: Detail – bird excrement

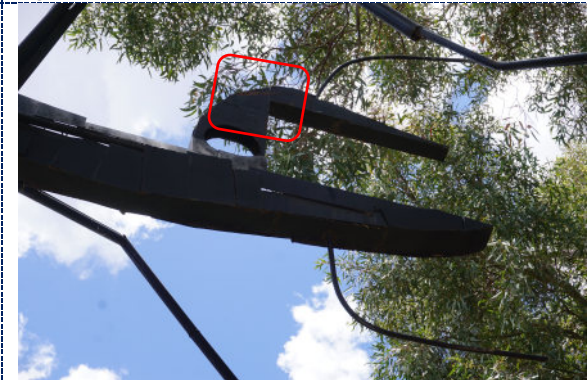
Figure 7: Detail – paint loss and corrosion to iron substrate.

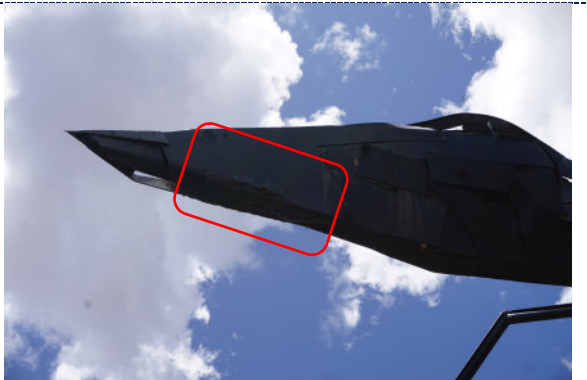
Figure 8: Detail – paint loss and corrosion to iron substrate.

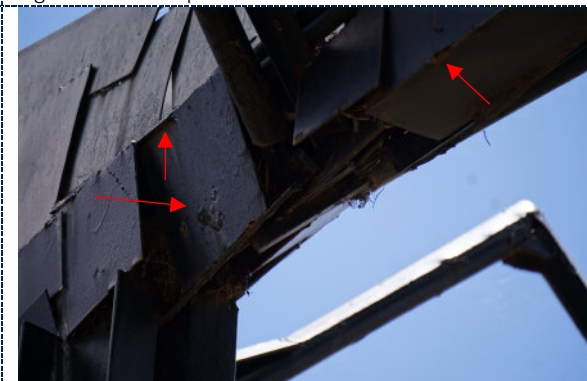
Figure 9: Detail – paint loss and corrosion to iron substrate (arrows); accumulated biomatter and spider webs within.

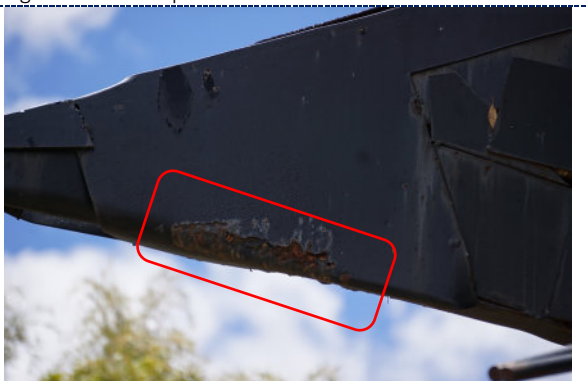
Figure 10: Detail – paint loss and corrosion to iron substrate.

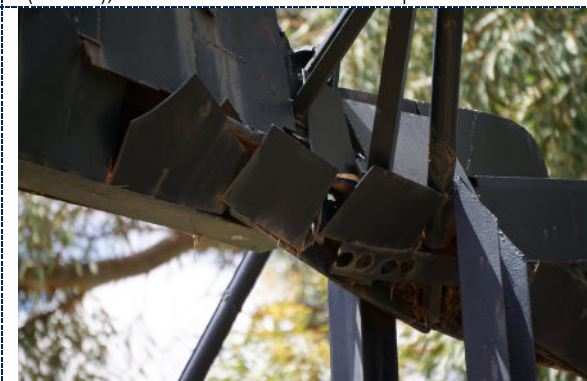
Figure 11: Detail – paint loss and corrosion to iron substrate; accumulated biomatter and spider webs within.

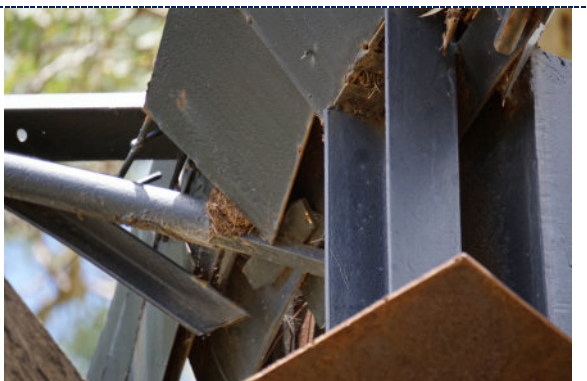
Figure 12: Detail – paint loss and corrosion to iron substrate; accumulated biomatter and spider webs within.

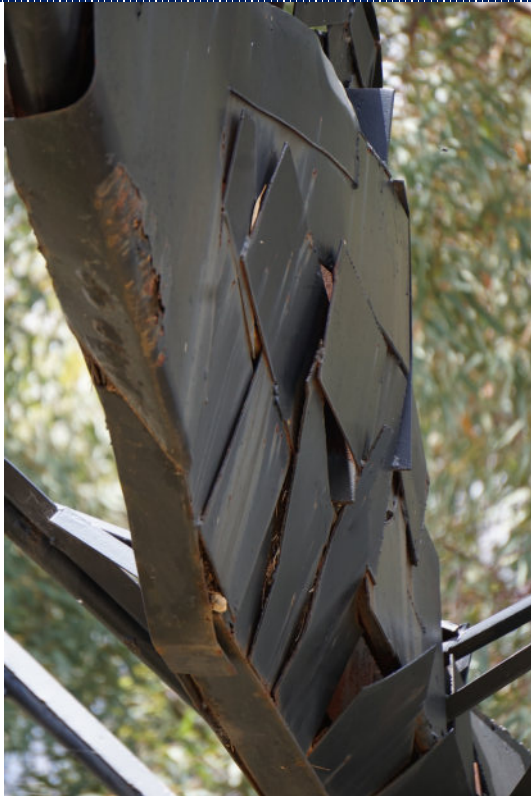
Figure 13: Detail – paint loss and corrosion to iron substrate; accumulated biomatter and spider webs within.

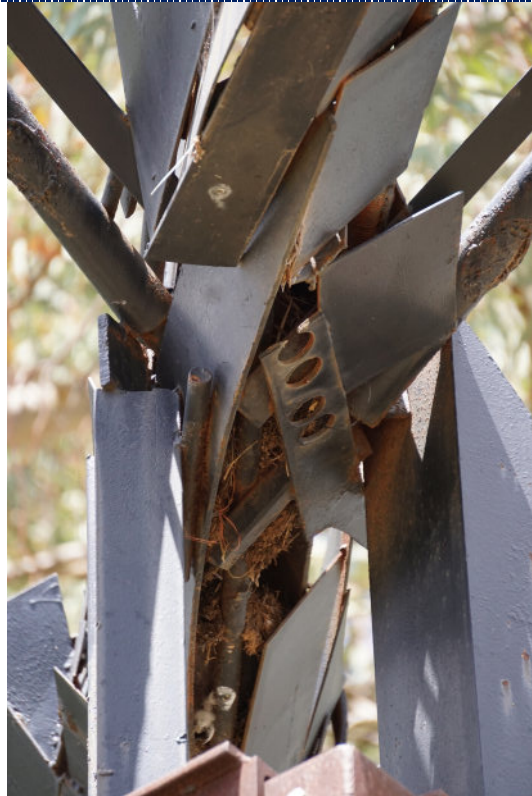
Figure 14: Detail – paint loss and corrosion to iron substrate; accumulated biomatter and spider webs within.

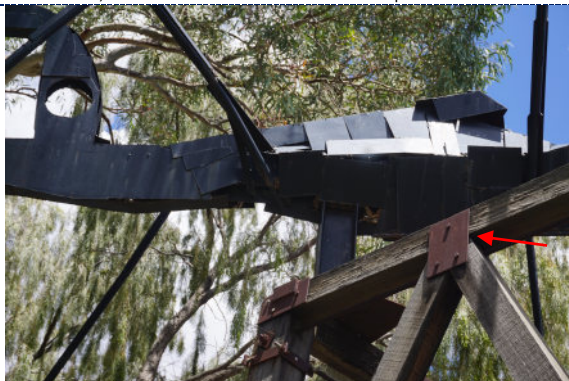
Figure 15: Detail – surface oxidation layer on structural brackets (arrow); UV and water weathering to wooden frame.

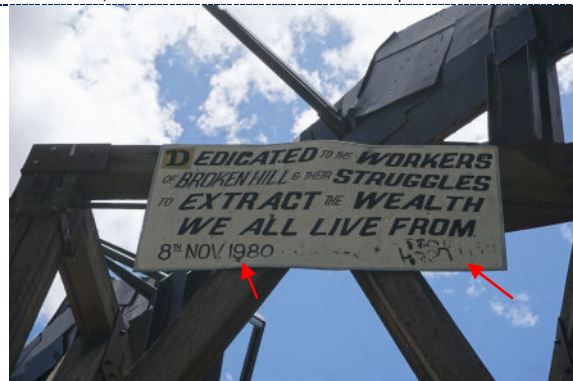
Figure 16: Detail – artist's plaque; surface wear, distortion, paint loss.

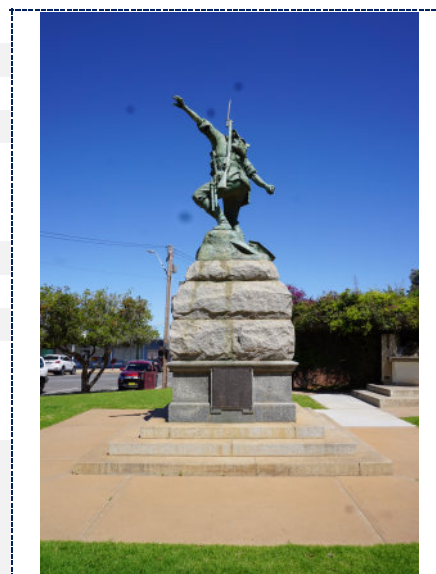
Previous repairs/ modifications?  YES  NO

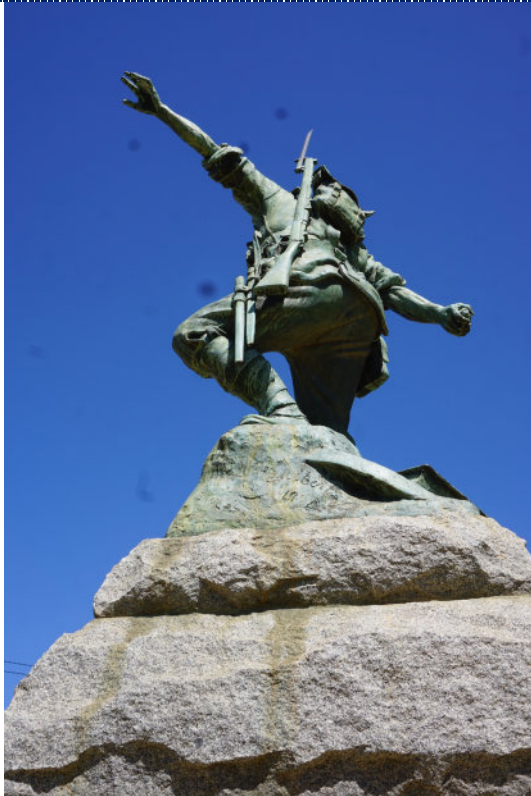
Figure 5: Detail – copper corrosion product and staining to the granite components.

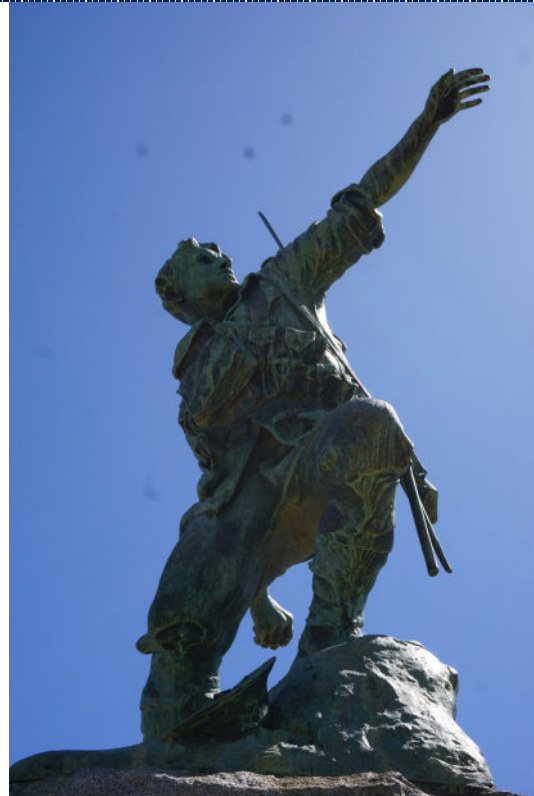
Figure 6: Detail – atmospheric pollution-driven copper corrosion product on figure.

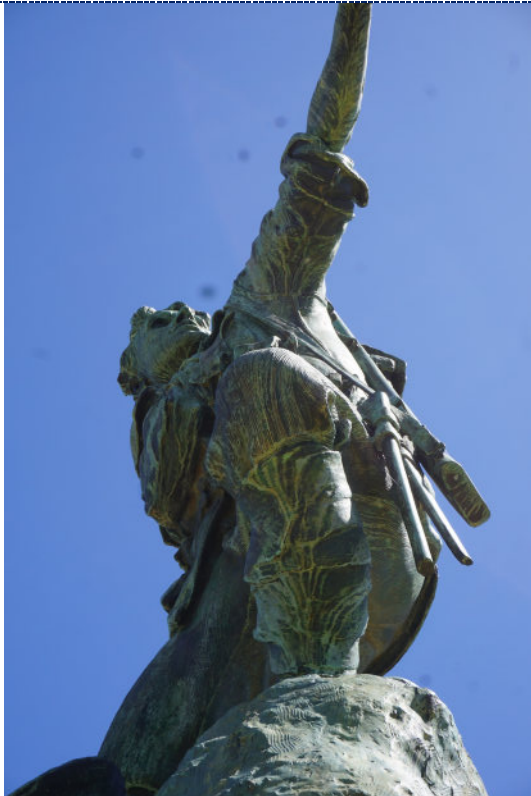
Figure 7: Detail – atmospheric pollution-driven copper corrosion product on figure.

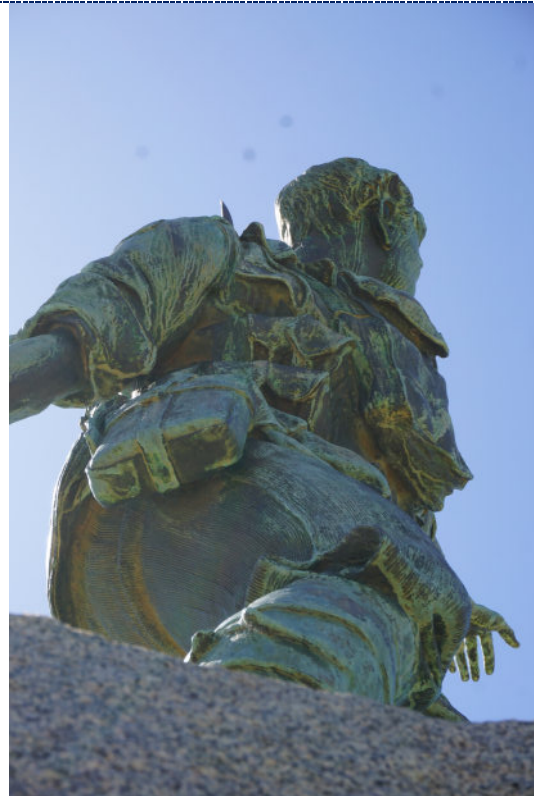
Figure 8: Detail – atmospheric pollution-driven copper corrosion product on figure.

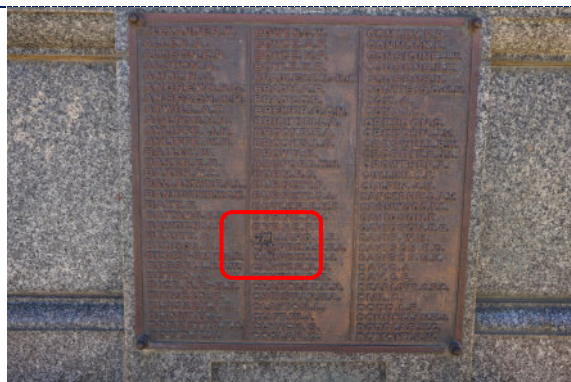
Figure 9: Detail – minor copper corrosion product, surface over cleaning (lighter areas) and surface accretions (rectangle).

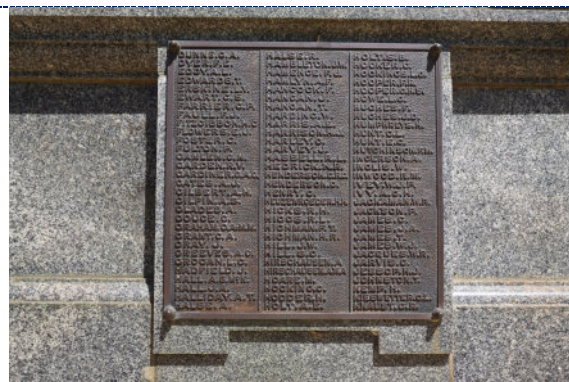
Figure 10: Detail – minor copper corrosion product, surface over cleaning (lighter areas).

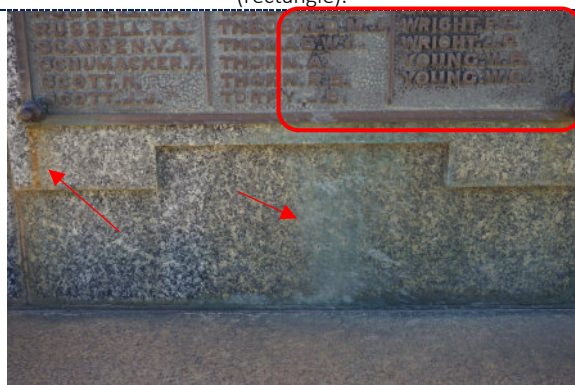
Figure 11: Detail – copper and iron corrosion product staining to granite stone; dirt particulate, black surface accretions on copper-alloy plaque.

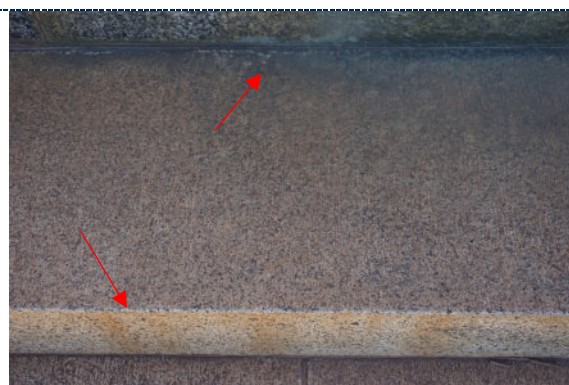
Figure 12: Detail – dirt particulate and copper corrosion product staining to granite stone; red staining at bottom may stem from iron corrosion elsewhere on the object.

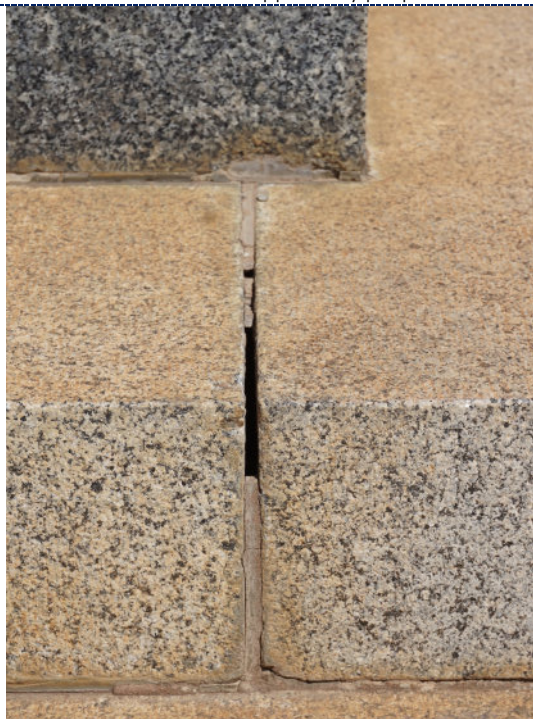
Figure 13: Detail – dirt particulate, red staining (possibly iron corrosion product) and loss to mortar pointing.

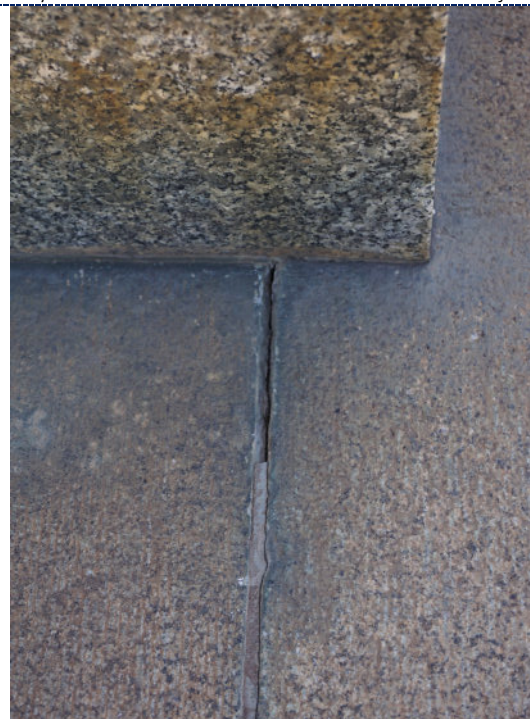
Figure 14: Detail – dirt particulate, red staining (possibly iron corrosion product) and loss to mortar pointing.

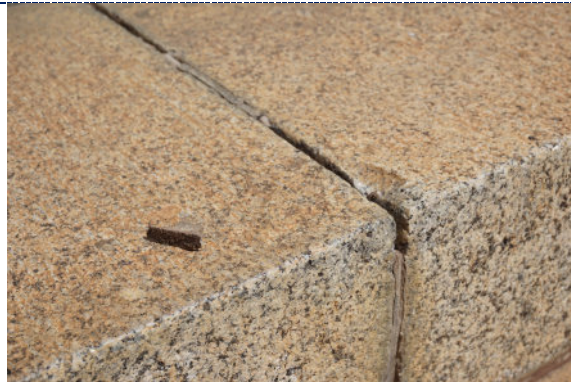
Figure 15: Detail – dirt particulate, red staining (possibly iron corrosion product) and loss to mortar pointing.

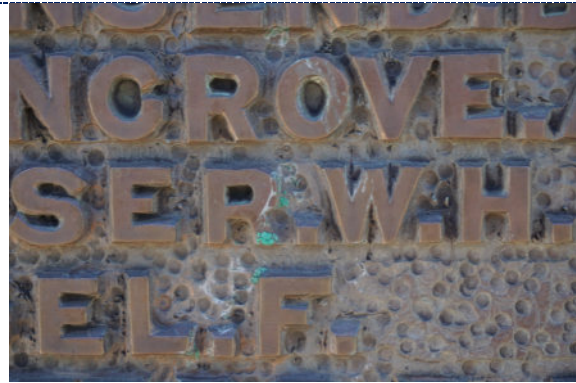
Figure 16: Detail – copper corrosion product on copper alloy plaque.

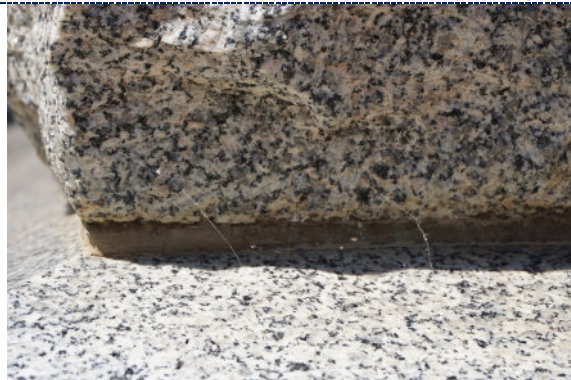
Figure 17: Detail – spider webs.

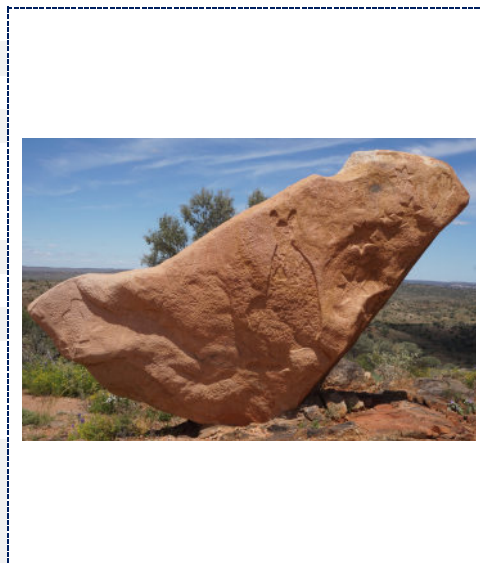
Previous repairs/ modifications?  YES  X NO

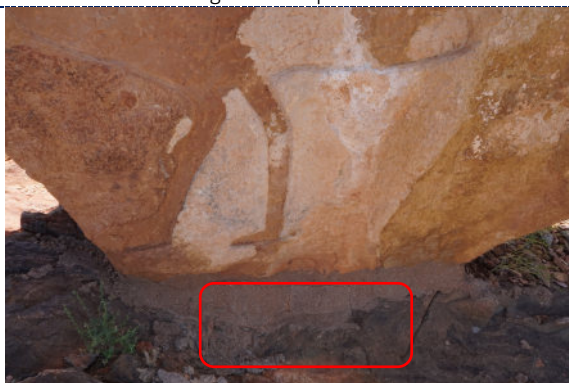
Figure 5: Detail – rear cement/concrete at base; crack in cement.

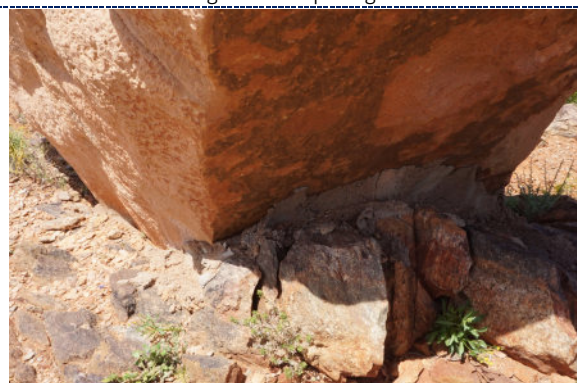
Figure 6: Detail – rear cement/concrete at base.

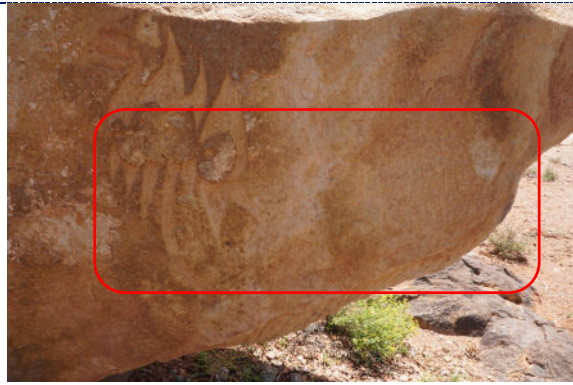
Figure 7: Detail – horizontal crack running through the rear proper right side.

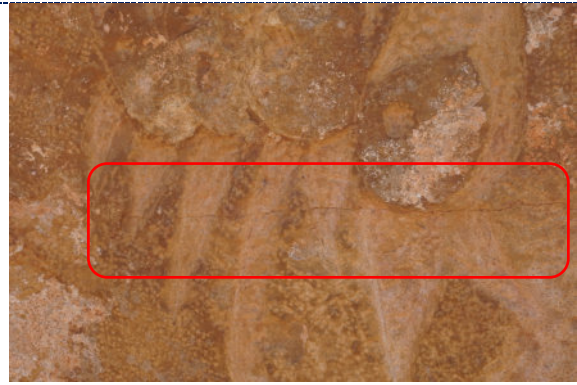
Figure 8: Detail – horizontal crack running through the rear proper right side.

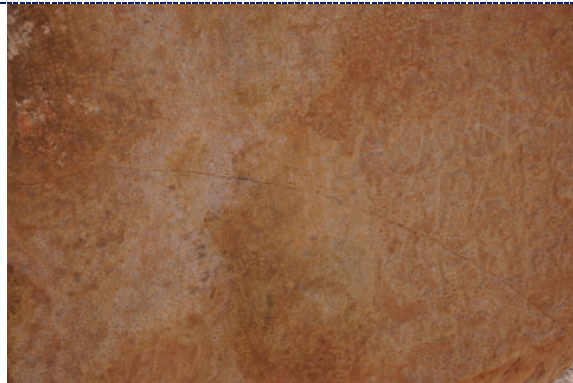
Figure 9: Detail – horizontal crack running through the rear proper right side.

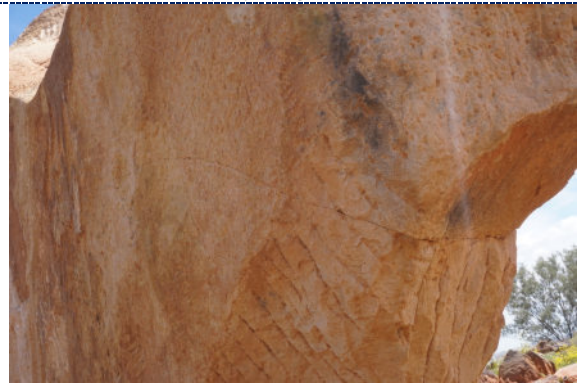
Figure 10: Detail – horizontal crack running through the rear proper right side.

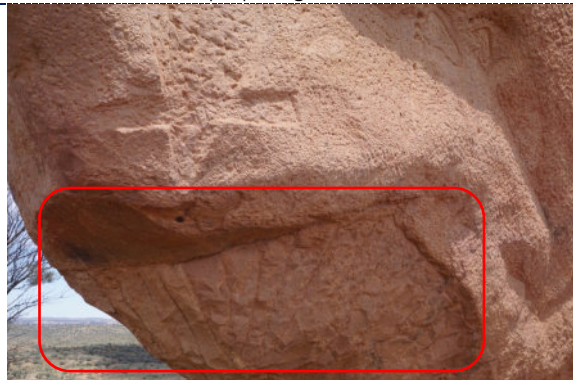
Figure 11: Detail – horizontal crack under lip of the object.

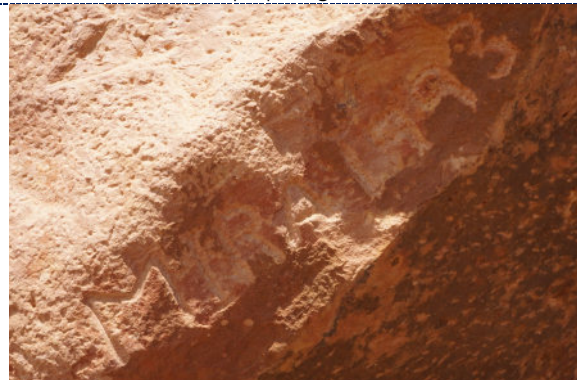
Figure 12: Detail – artist Inscription.

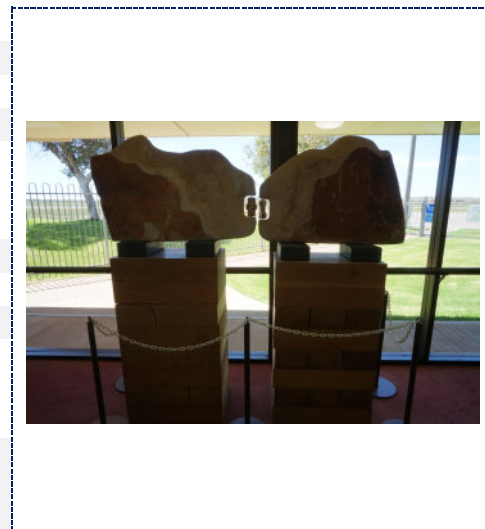
Previous repairs/ modifications?  YES  NO

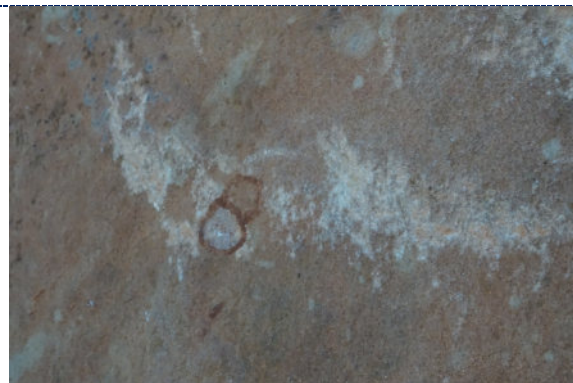
Figure 10: Detail – figure "8" inscription/accretion noted.

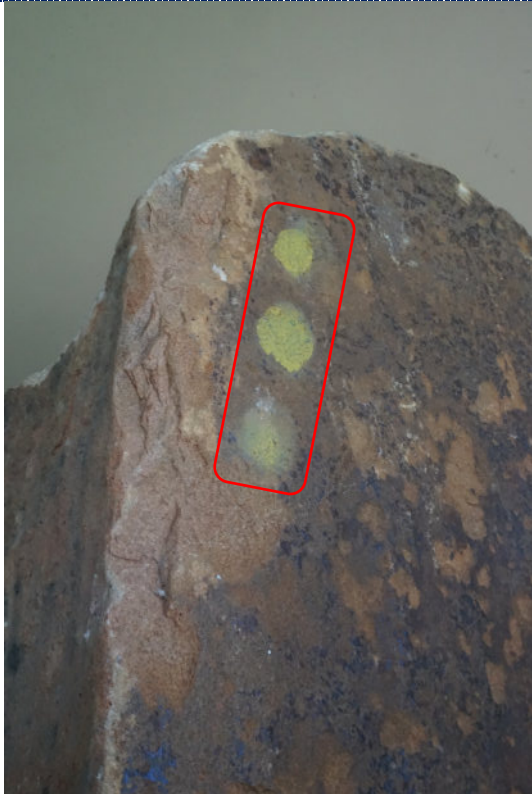
Figure 11: Detail – 3 x yellow accretion deposits.

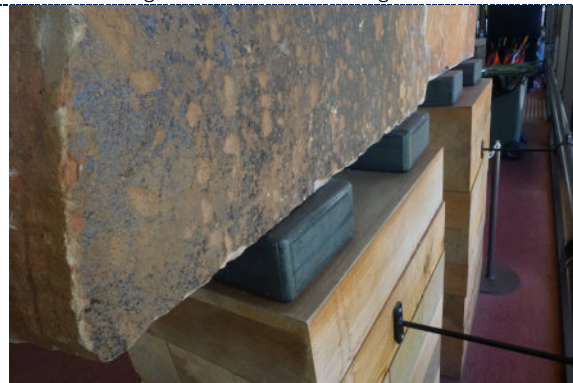
Figure 14: Detail – tidelines on timber, indicating previous exposure to moisture.

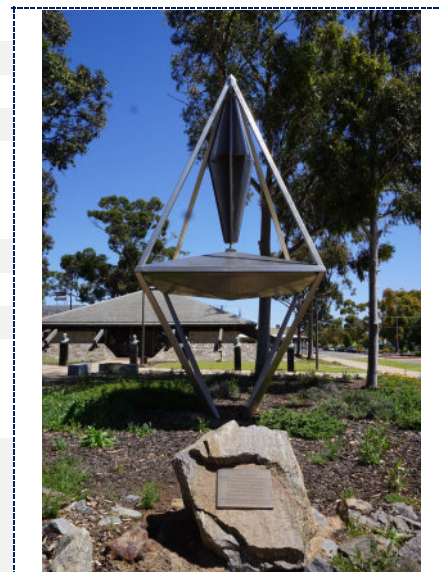
Previous repairs/ modifications?  YES  NO
