# *Broken Hill Public Art Condition Survey and Conservation Plan*

Prepared for: Broken Hill City Council  
Submission Date: February 2023

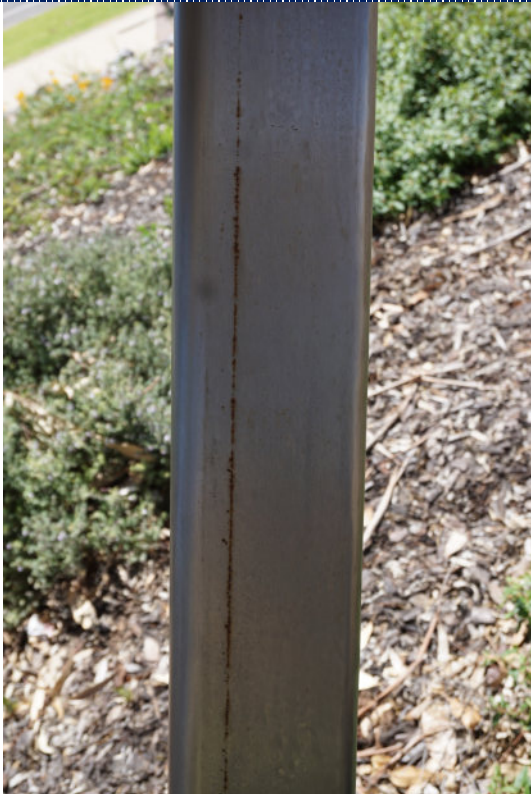
Figure 5: Detail – linear scratch and iron corrosion product.

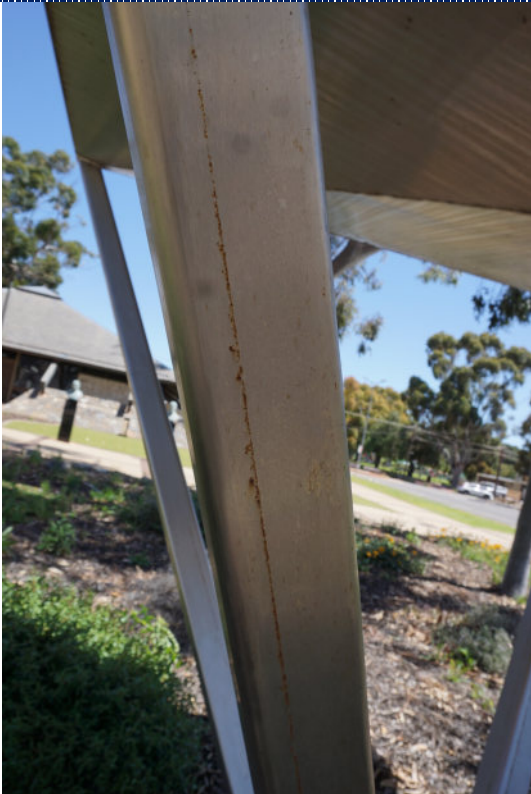
Figure 6: Detail – linear scratch and iron corrosion product.

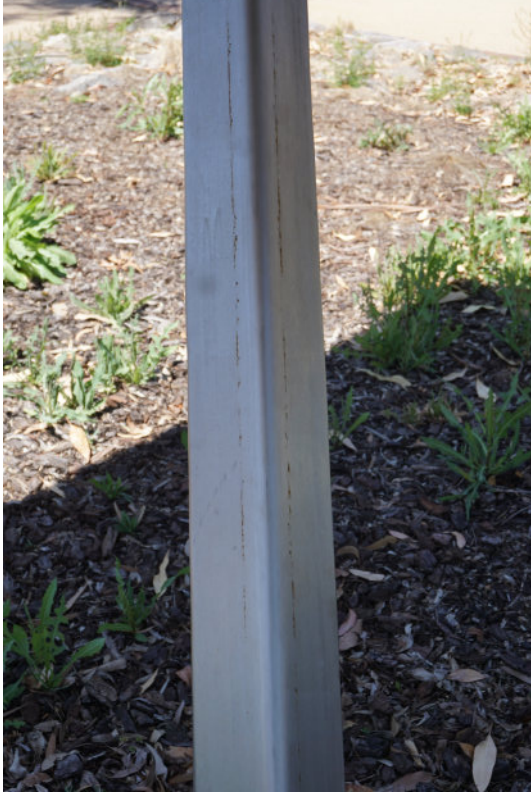
Figure 7: Detail – linear scratch and iron corrosion product.

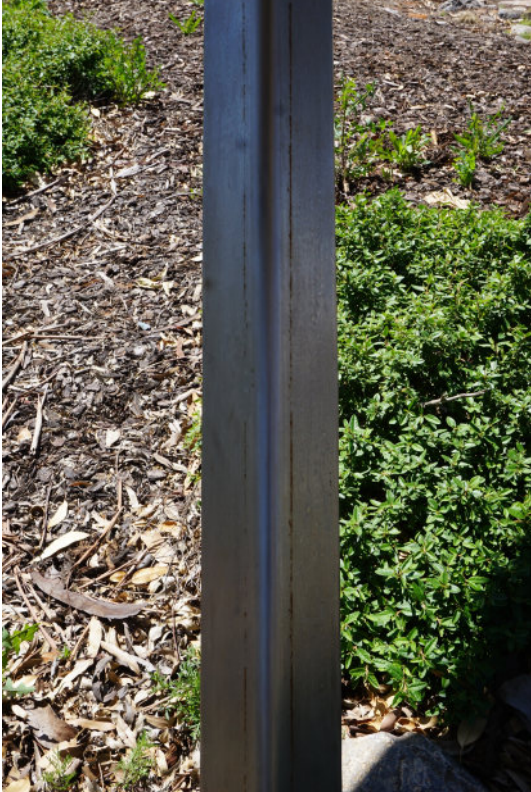
Figure 8: Detail – linear scratch and iron corrosion product.

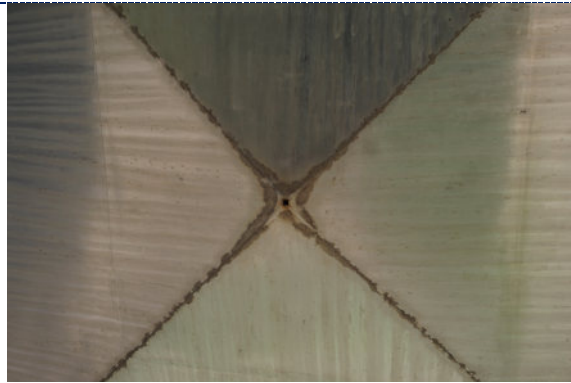
Figure 9: Detail – dirt particulate accumulation along the bottom diamond edges and water streaks.

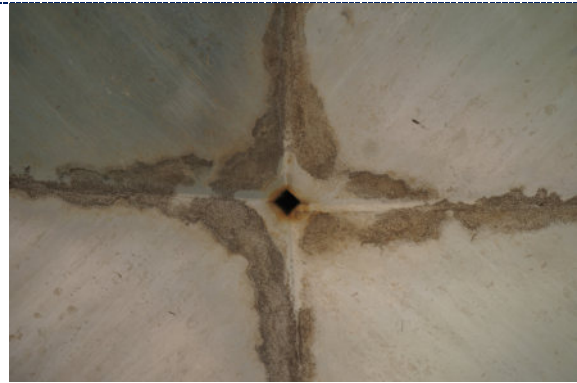
Figure 10: Detail – dirt particulate accumulation along the bottom diamond edges and minor iron corrosion/tea staining around the bottom drain.

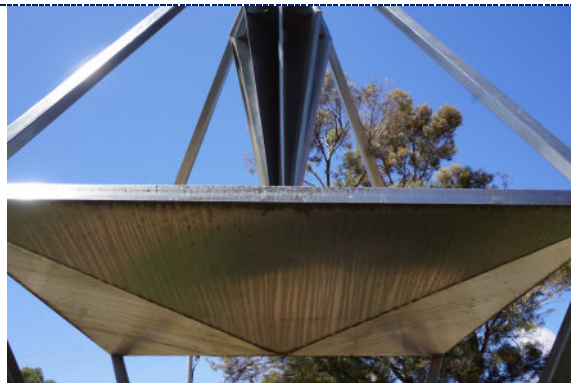
Figure 11: Detail – dirt particulate accumulation along the bottom diamond edges and water streaks.

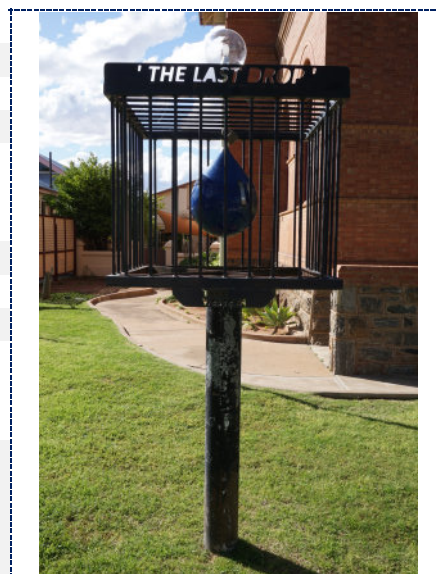
Previous repairs/ modifications?  YES  NO

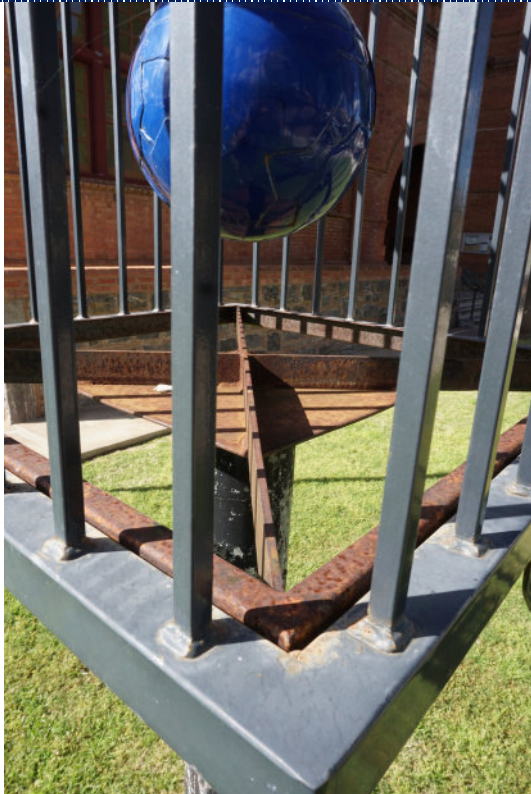
Figure 5: Detail – extensive corrosion of steel in cross-bar mid section base.

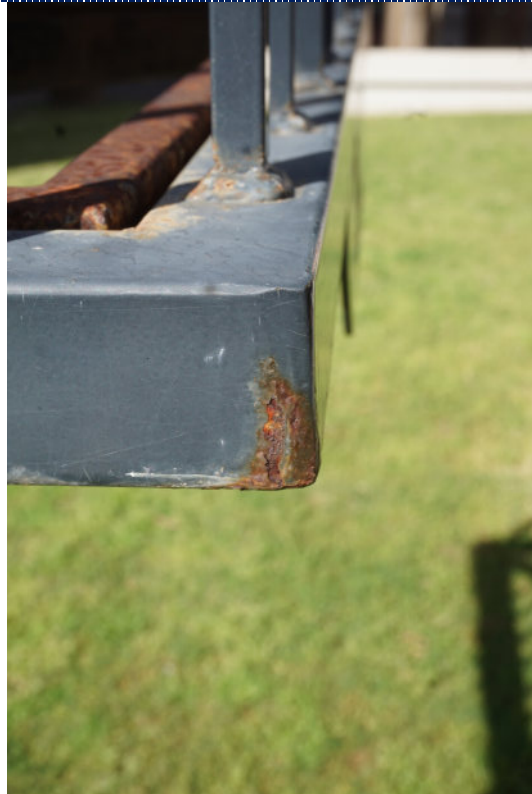
Figure 6: Detail – corrosion occurring at mid-section base piece where paint layer has chipped. Corrosion of the substrate is causing further lifting of the paint in this area.

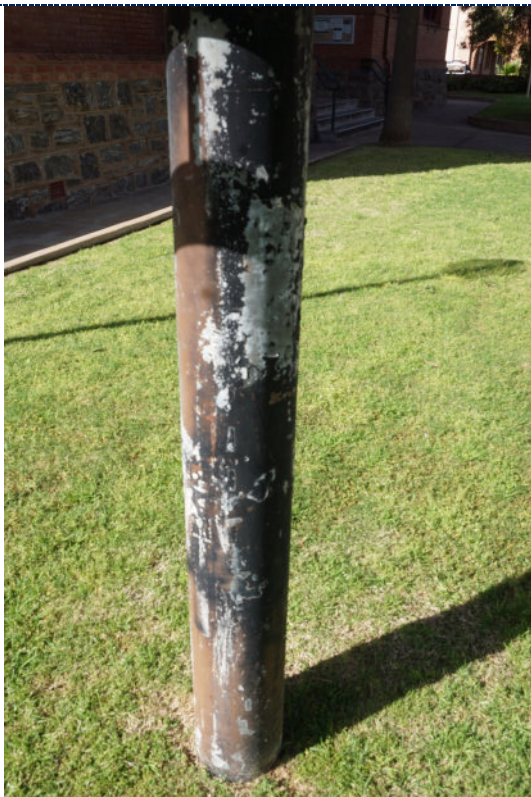
Figure 7: Detail – support pole. Extensive loss of paint layer exposing steel substrate. Surface corrosion occurring.

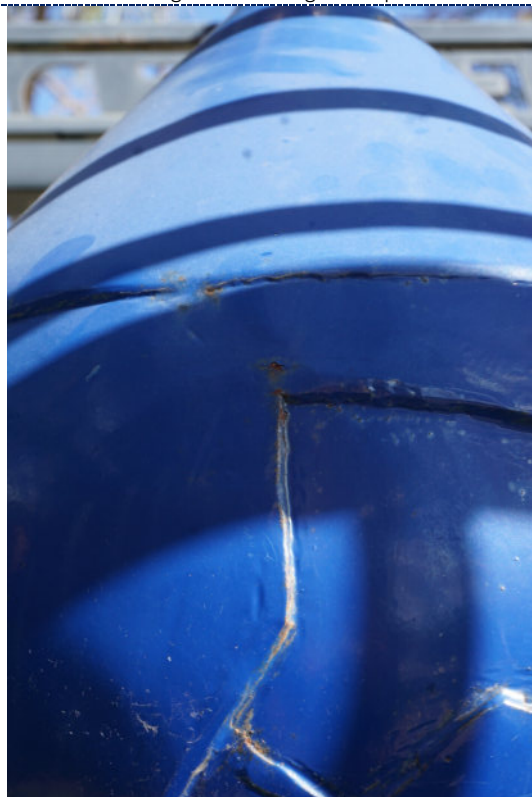
Figure 8: Detail – blanching of blue paint layer, appearing as white hazy bloom on upper section of 'drop' component. Minor losses and areas of corrosion also visible.

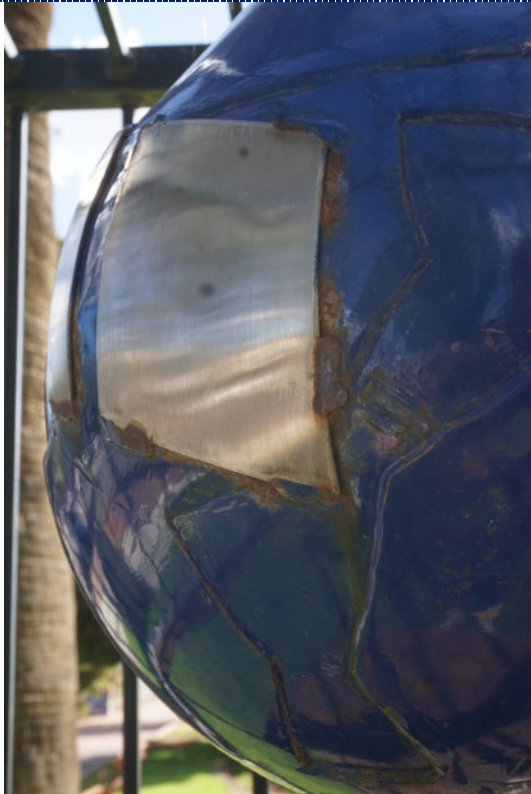
Figure 9: Detail – steel plate on surface of 'drop' (unclear if original or not). Extensive corrosion of welds surrounding the plate

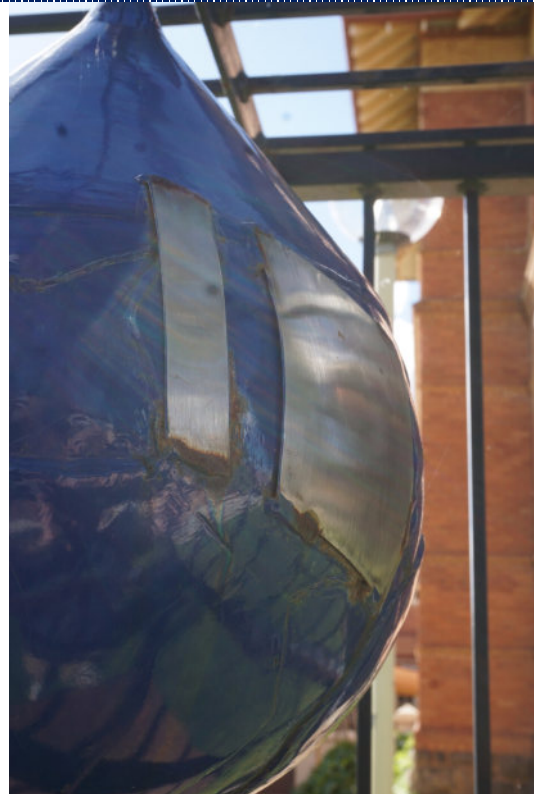
Figure 10: Detail (additional view). Steel plate on surface of 'drop' (unclear if original or not). Extensive corrosion of welds surrounding the plate

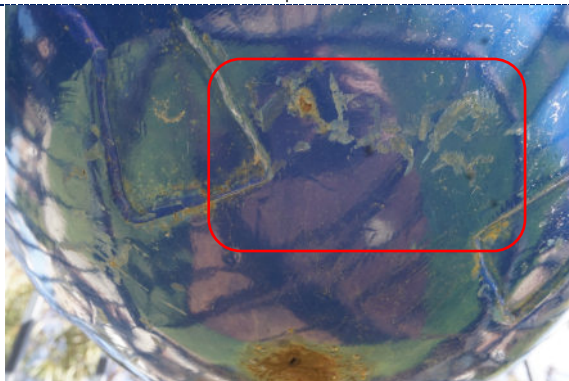
Figure 11: Detail – abrasions of paint on bottom of 'drop' component. Some corrosion occurring where steel substrate has been exposed.

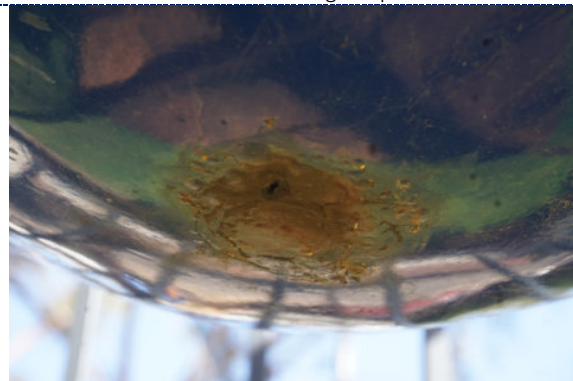
Figure 12: Detail – extensive ferric corrosion, including loss (small hole) of steel at base of 'drop', likely caused partially by water runoff collecting at this point.

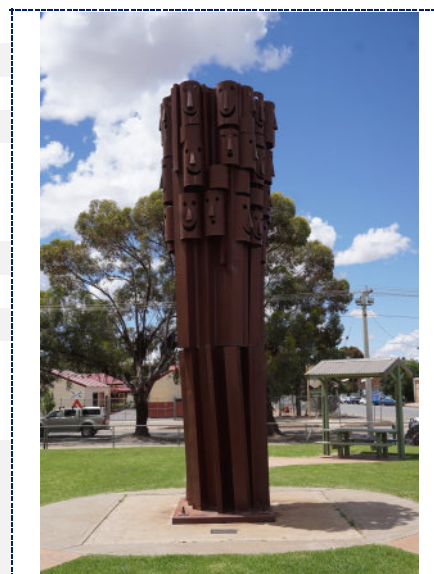
Previous repairs/ modifications?  YES  NO

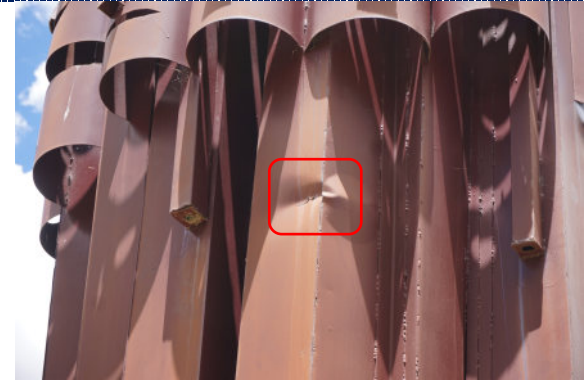
Figure 5: Detail – paint fading and degradation; dirt particulate and spider webs; surface distortion.

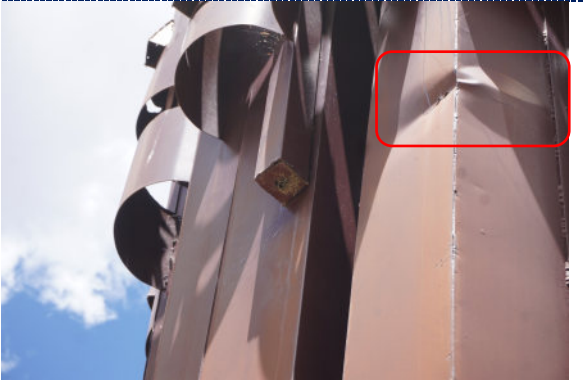
Figure 6: Detail – paint fading and degradation; dirt particulate and spider webs; surface distortion.

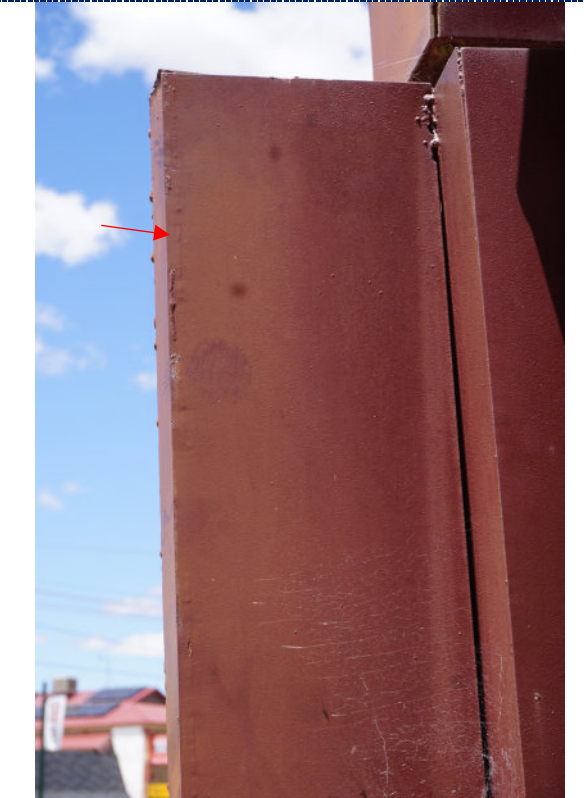
Figure 7: Detail – paint fading and degradation; dirt particulate and spider webs.

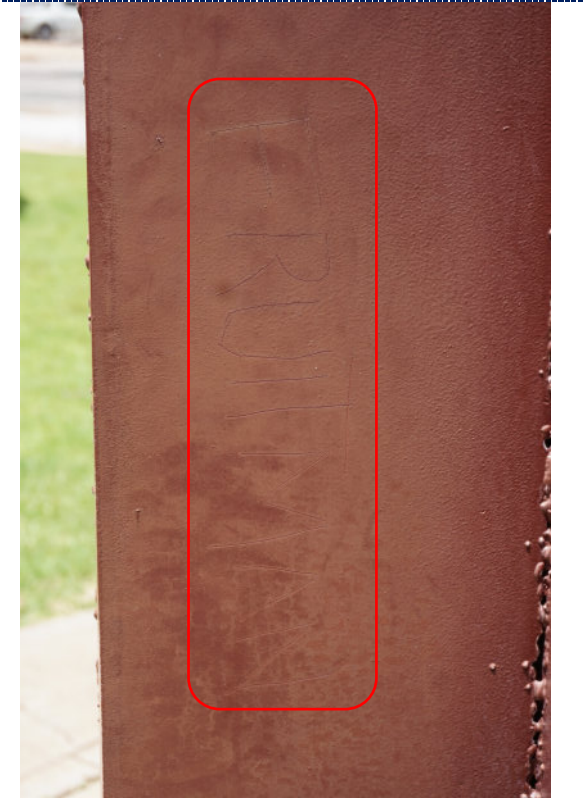
Figure 8: Detail – paint fading and degradation; incised graffiti, "FRUITMAN".

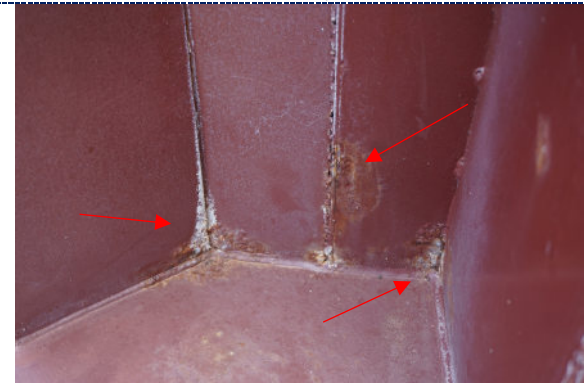
Figure 9: Detail – paint fading and degradation; dirt particulate and surface accretions (white); iron corrosion.

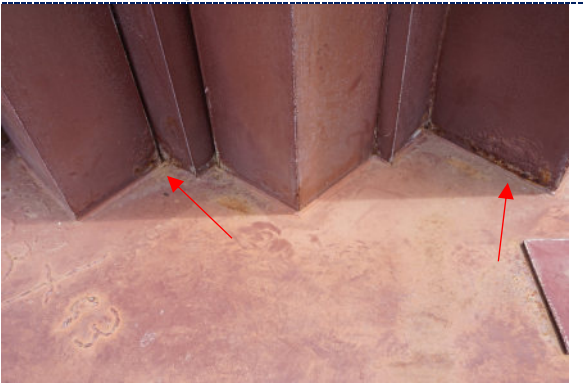
Figure 10: Detail – paint fading and degradation; dirt particulate and surface accretions (white); iron corrosion.

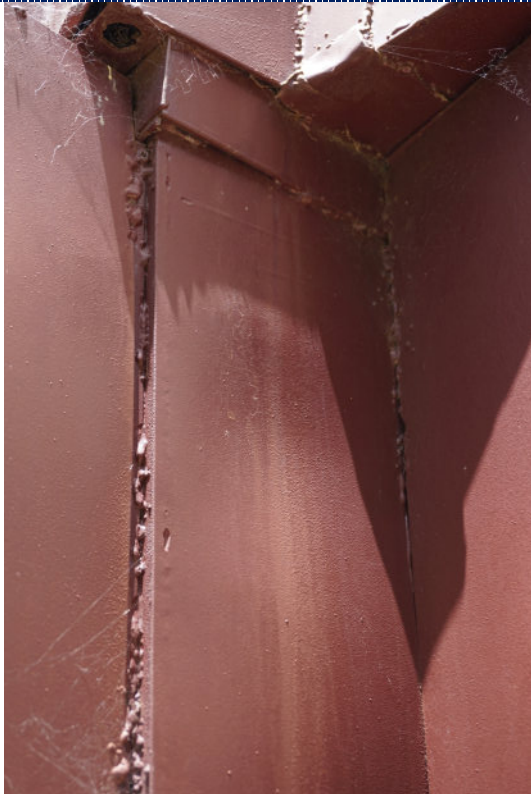
Figure 11: Detail – paint fading and degradation; dirt particulate and spider webs.

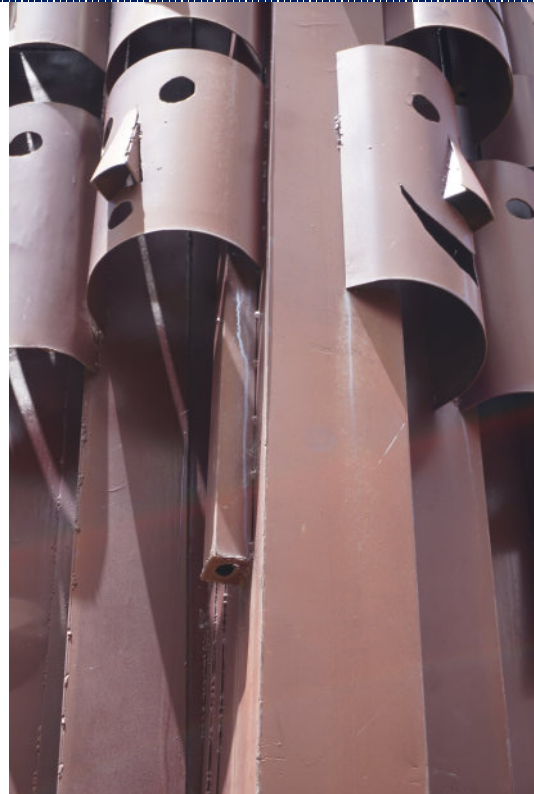
Figure 12: Detail – paint fading and degradation; dirt particulate and spider webs.

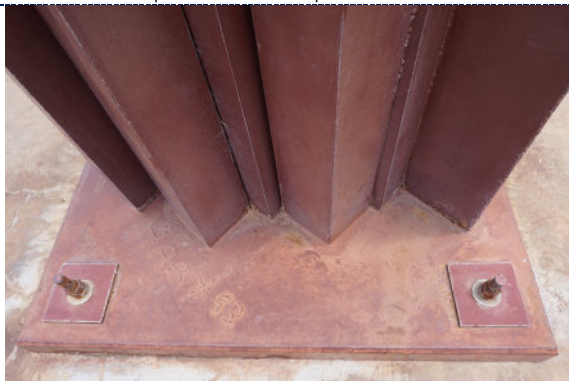
Figure 13: Detail – paint fading and degradation; dirt particulate; iron corrosion; artist's signature.

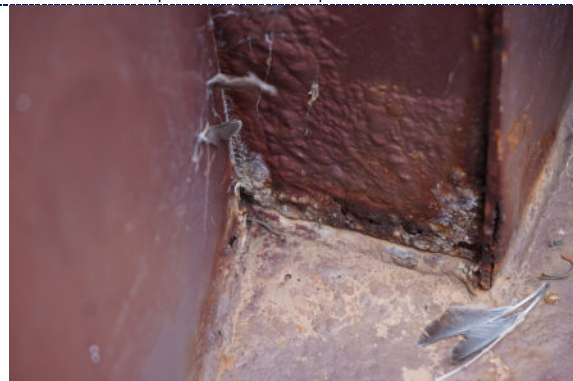
Figure 14: Detail – paint fading and degradation; dirt particulate and surface accretions (white); iron corrosion; dirt particulate, accumulated biomatter and spider webs.

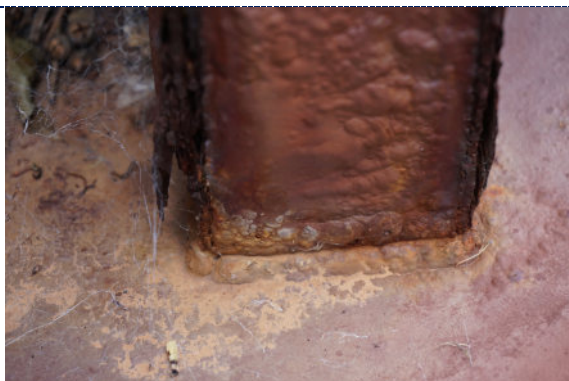
Figure 15: Detail – paint fading and degradation; corrosion to iron substrate; dirt particulate.

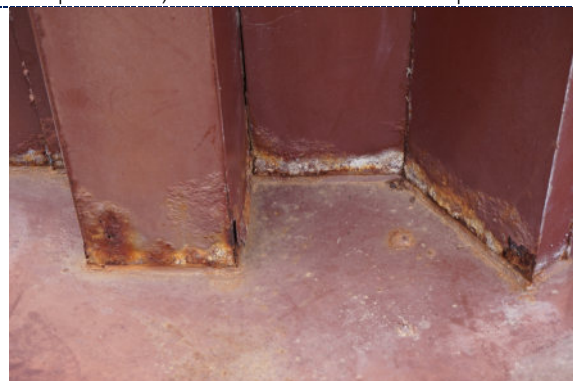
Figure 16: Detail – paint fading and degradation; dirt particulate and surface accretions (white); iron corrosion.

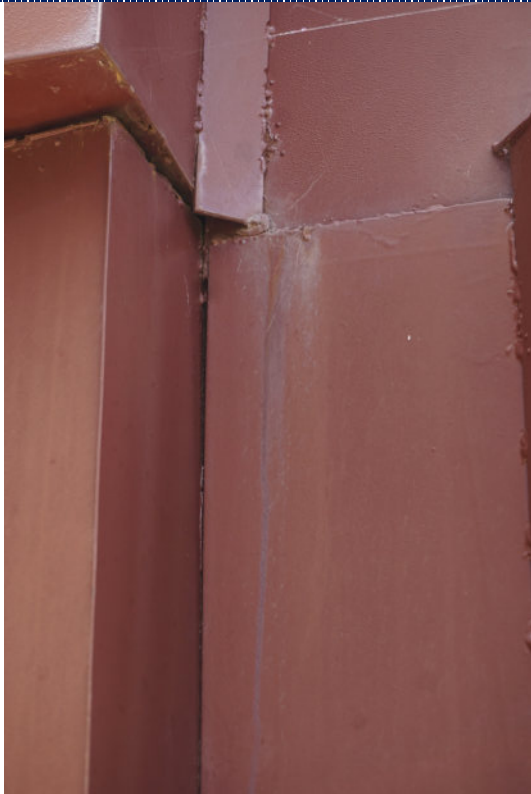
Figure 17: Detail – paint fading and degradation; dirt particulate and spider webs.

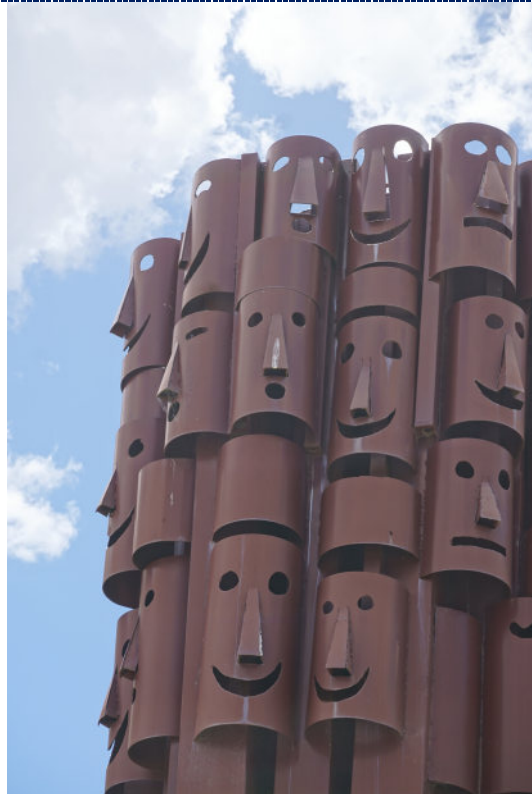
Figure 18: Detail – paint fading and degradation; dirt particulate and bird excrement.

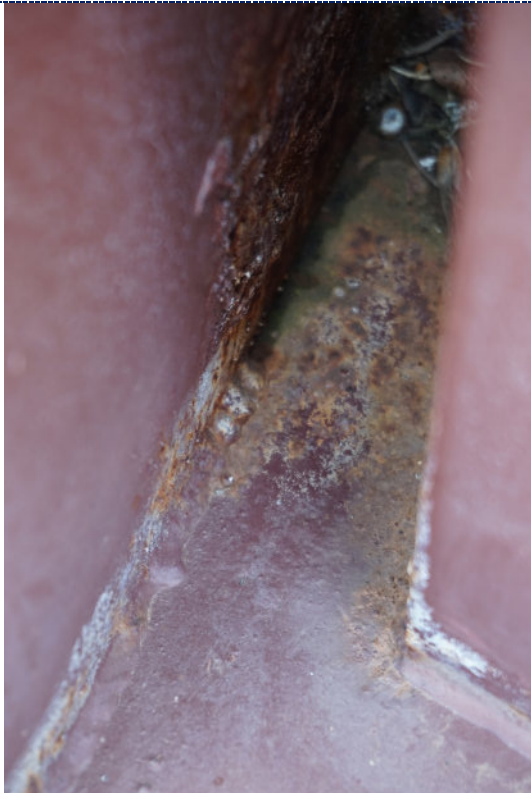
Figure 19: Detail – paint loss and corrosion to iron substrate; accumulation of dirt particulate.

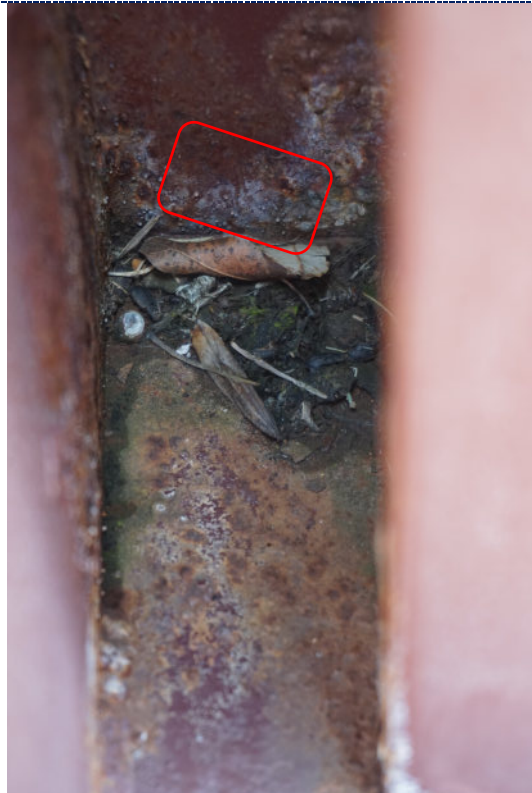
Figure 20: Detail – paint loss and corrosion to iron substrate; accumulation of dirt particulate.

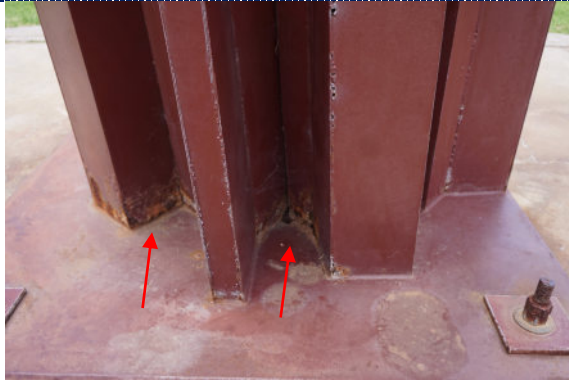
Figure 21: Detail – paint fading and degradation; dirt particulate; iron corrosion.

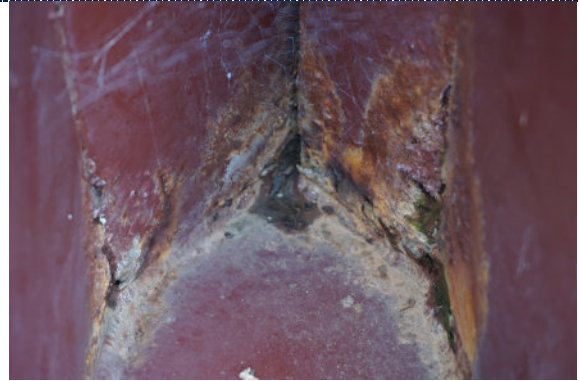
Figure 22: Detail – paint loss and corrosion to iron substrate; dirt particulate.

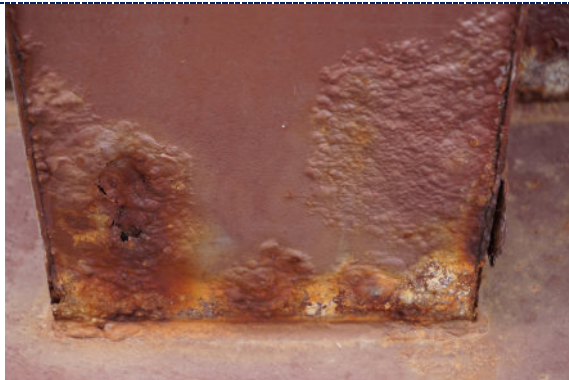
Figure 23: Detail – paint fading and degradation; dirt particulate; iron corrosion.

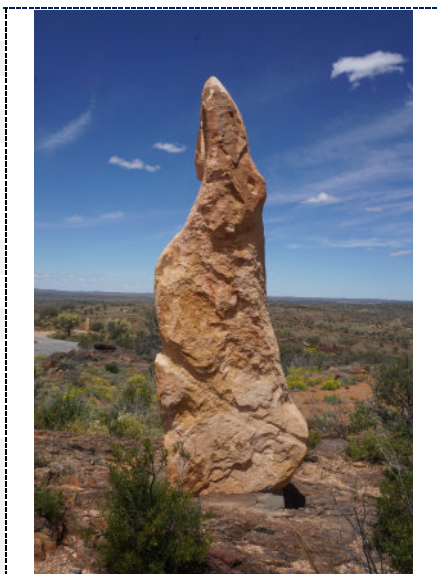
Previous repairs/ modifications?  YES  NO

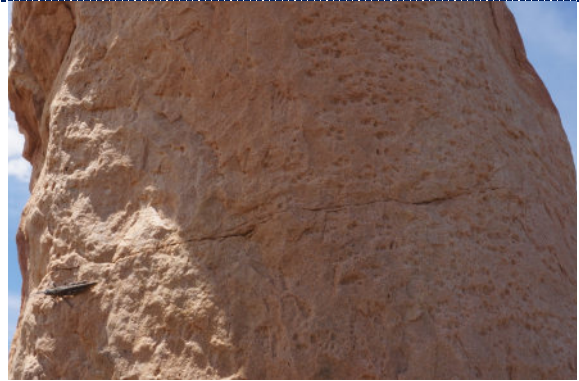
Figure 6: Detail – horizontal crack, likely occurring naturally within the stone.

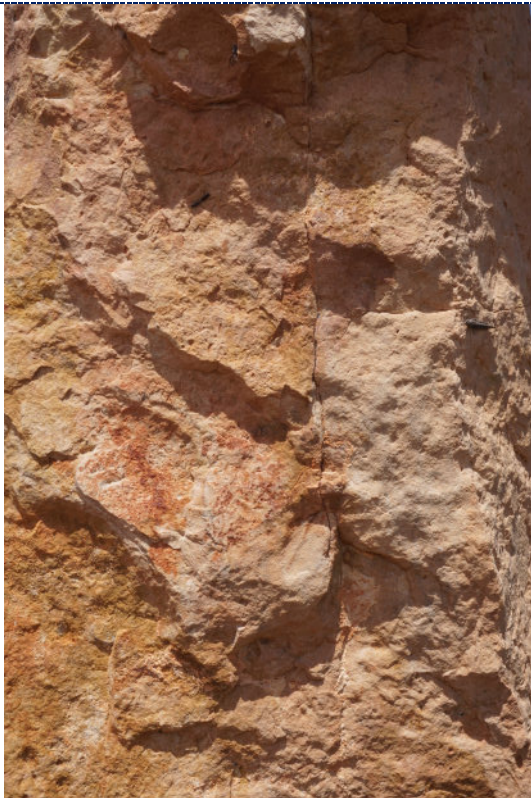
Figure 7: Detail -- vertical crack, likely occurring naturally in the stone.

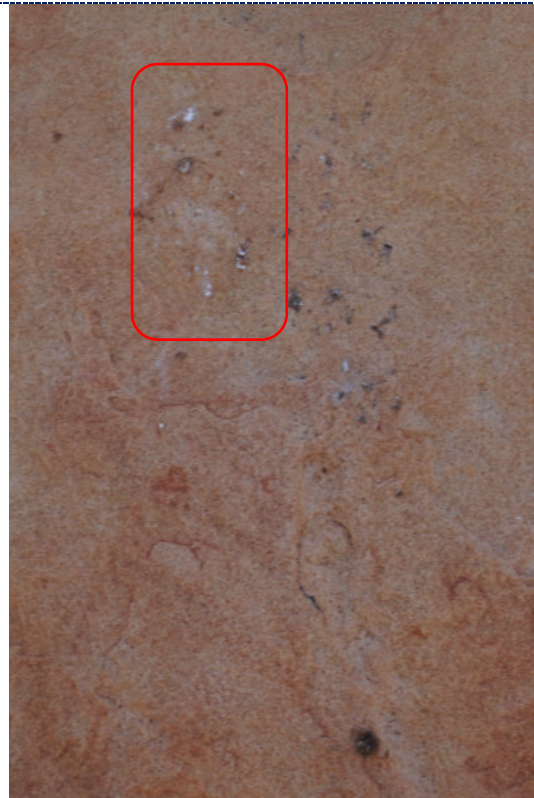
Figure 8: Detail – white surface accretion, possibly remnants of bird excrement.

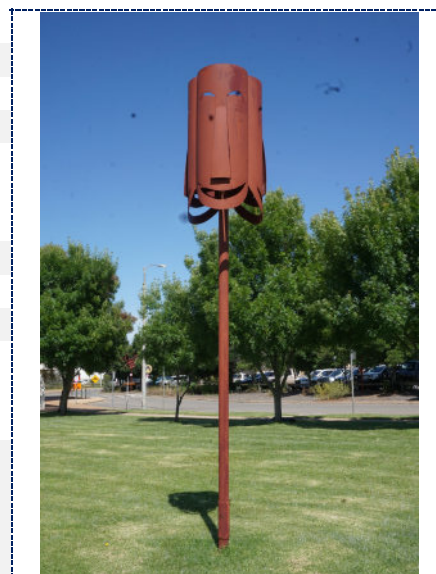
Previous repairs/ modifications?  YES  NO

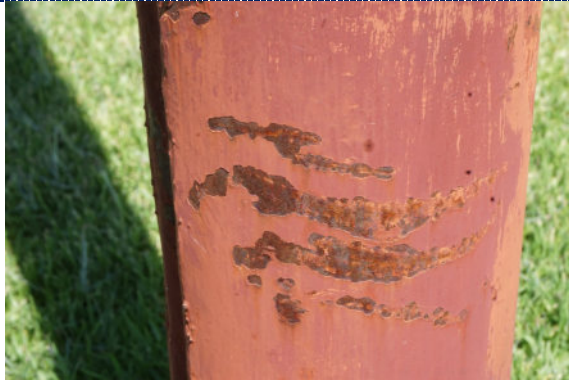
Figure 5: Detail – paint chalking, overpaint; abrasion with loss, likely from contact with foreign object; corrosion in areas of paint loss.

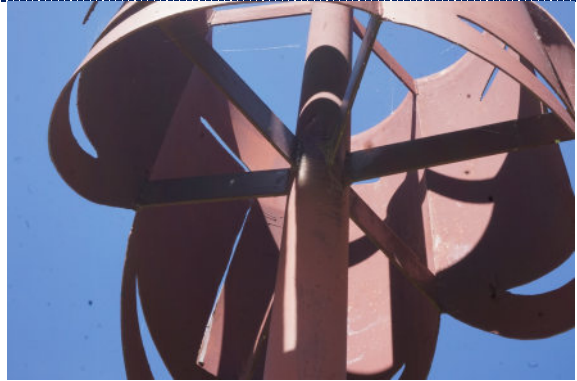
Figure 6: Detail – paint chalking, flaking paint loss with overpaint; spider webs.

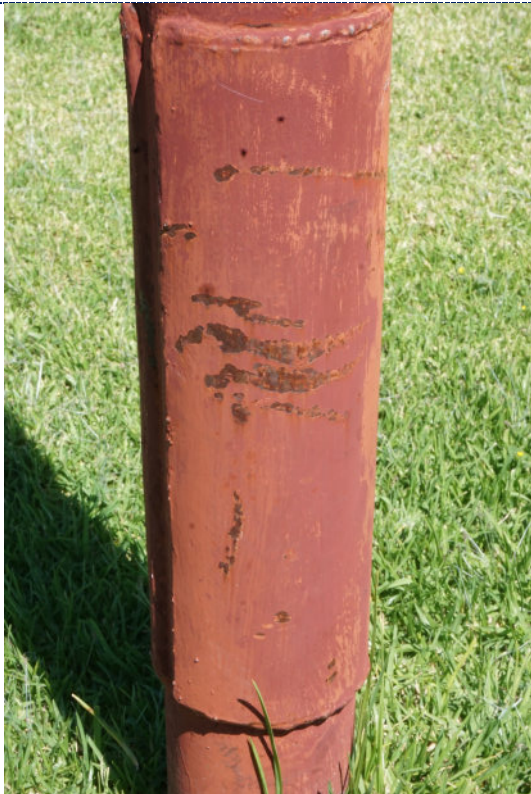
Figure 7: Detail – paint chalking, overpaint; abrasion with loss, likely from contact with foreign object; corrosion in areas of paint loss.

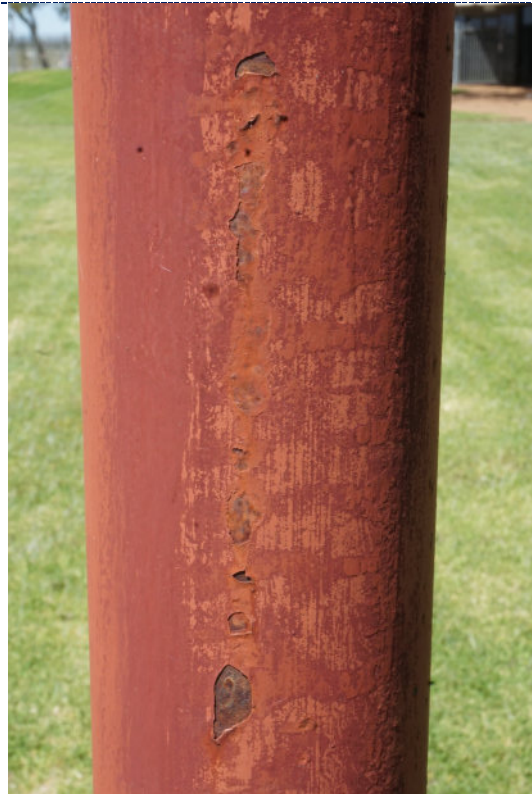
Figure 8: Detail – paint chalking, flaking paint loss with overpaint; corrosion in areas of paint loss.

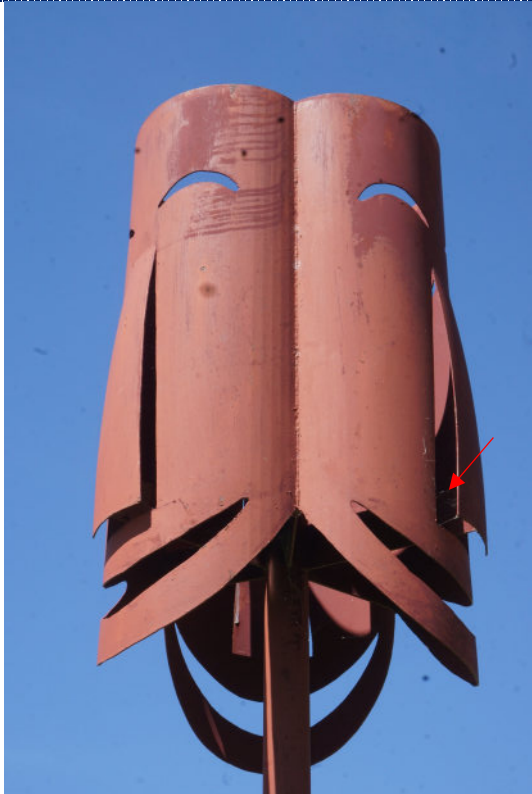
Figure 9: Detail – paint chalking, overpaint; spider webs.

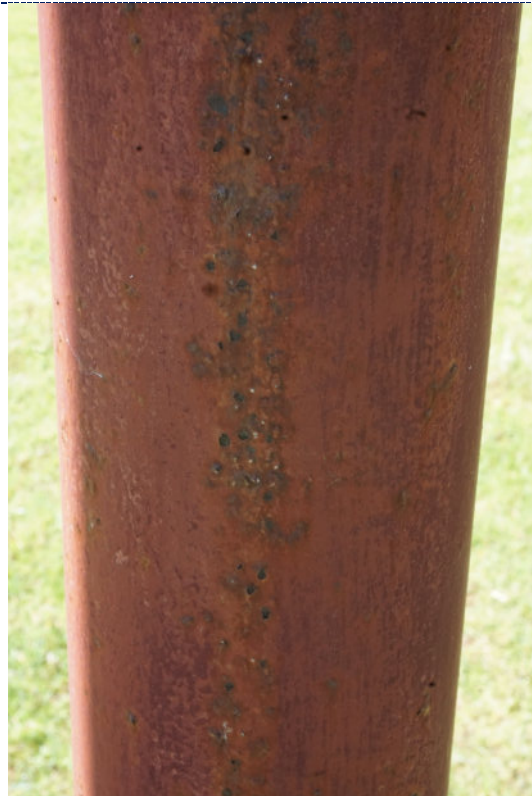
Figure 14: Detail – paint chalking, flaking paint loss with overpaint; corrosion in areas of paint loss.

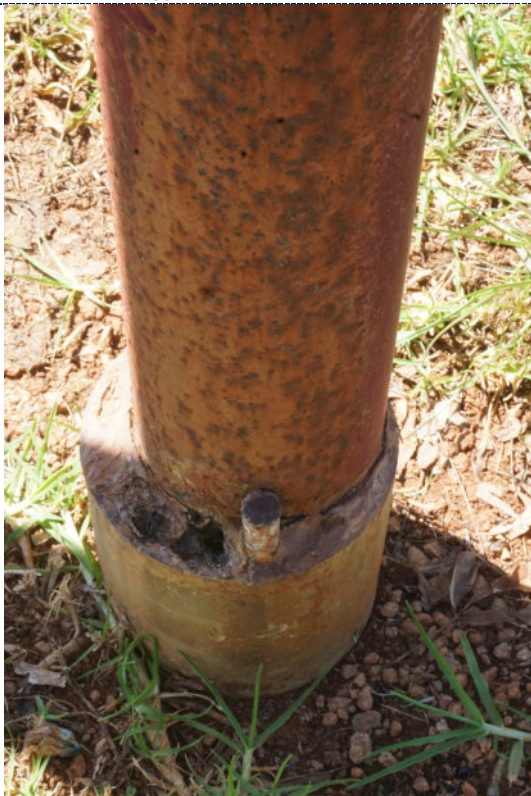
Figure 15: Detail – paint chalking, flaking paint loss with overpaint; corrosion in areas of paint loss; previous repairs (putty/silicone at base).

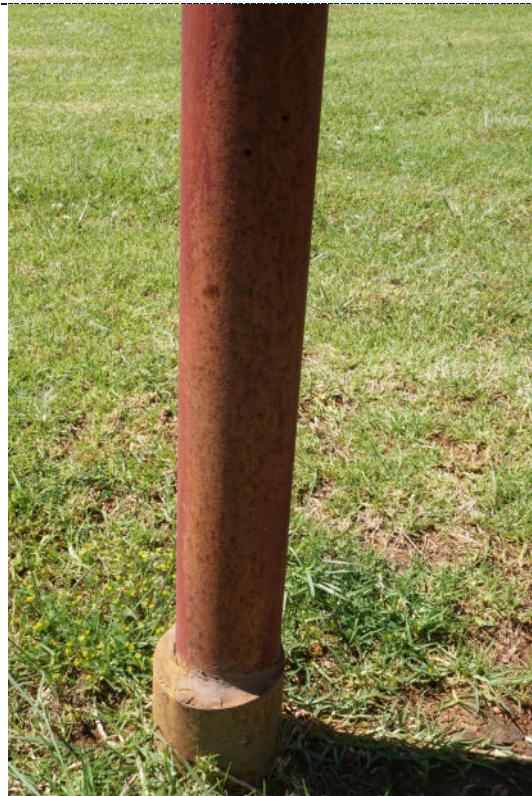
Figure 16: Detail – paint chalking, flaking paint loss with overpaint; corrosion in areas of paint loss; previous repairs (putty/silicone at base).

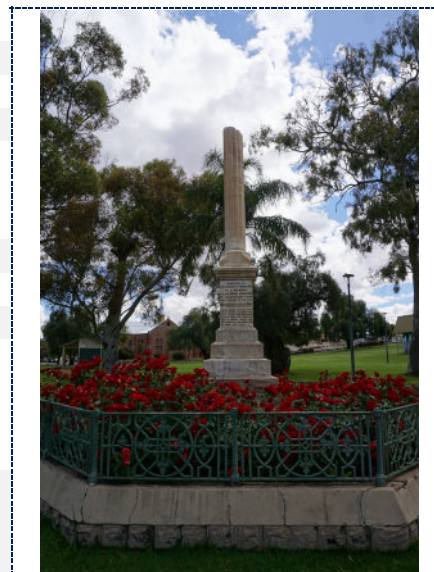
Previous repairs/ modifications?  YES  NO

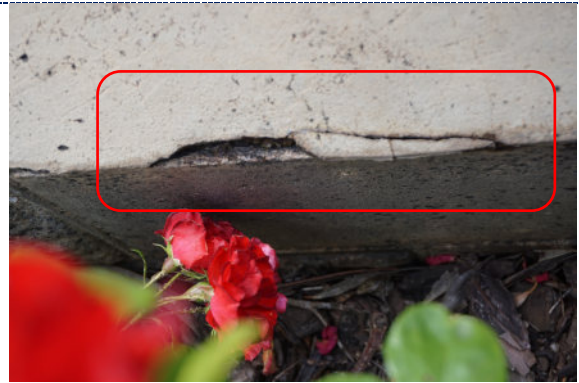
Figure 10: Detail – dirt particulate, crack and loss to plinth render.

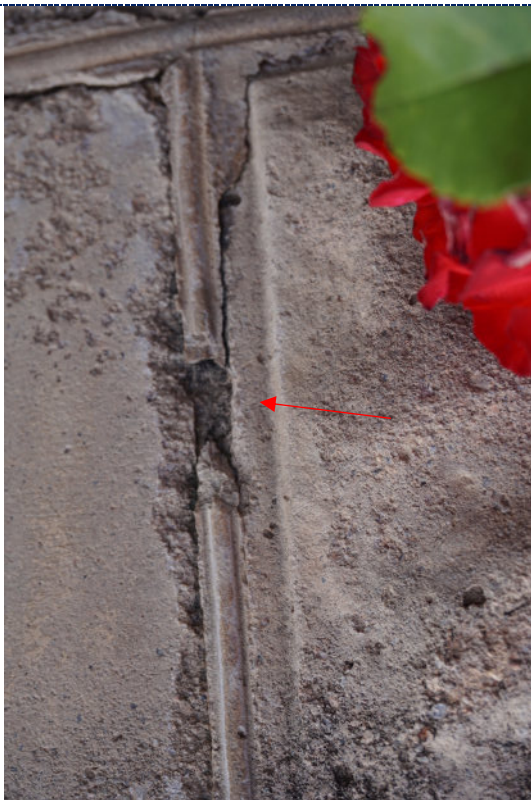
Figure 11: Detail – crack and loss to plinth concrete pointing.

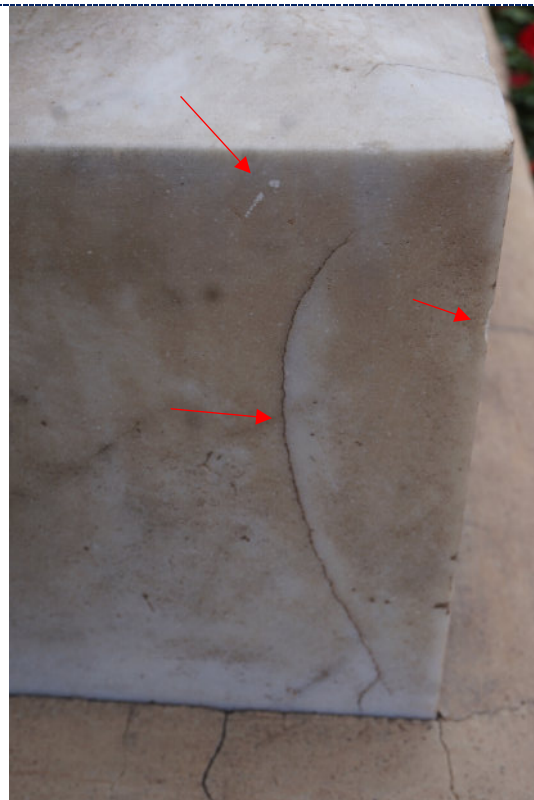
Figure 12: Detail – dirt particulate, small vertical crack in marble substrate; small losses along edge; small surface accretion.

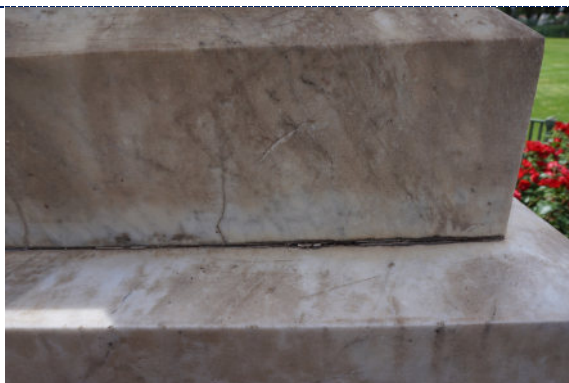
Figure 13: Detail – dirt particulate, small vertical crack in marble substrate; small losses to mortar pointing.

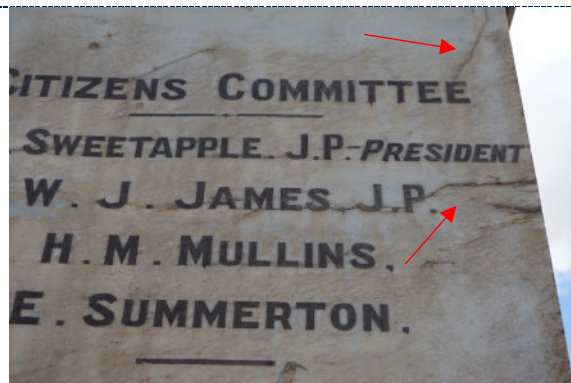
Figure 14: Detail – dirt particulate, small vertical and horizontal cracks in marble substrate.

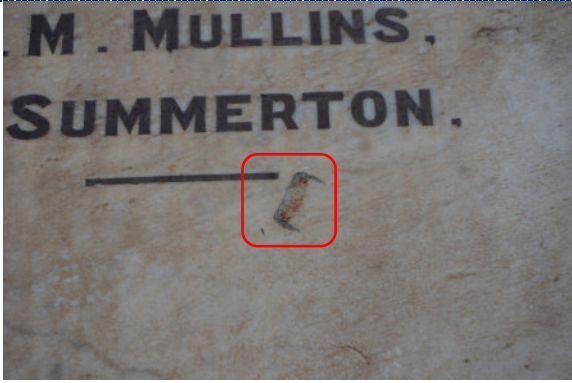
Figure 15: Detail – dirt particulate, surface abrasion with paint transfer.

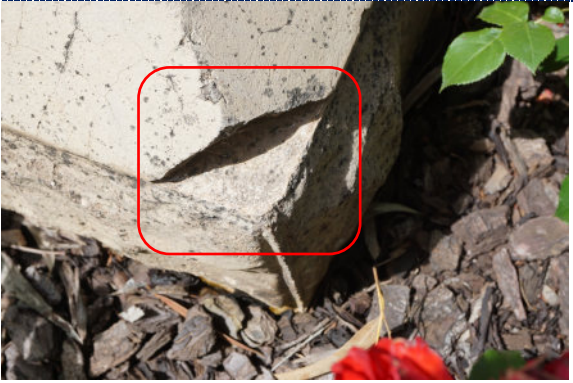
Figure 16: Detail – small cracks and loss to plinth render.

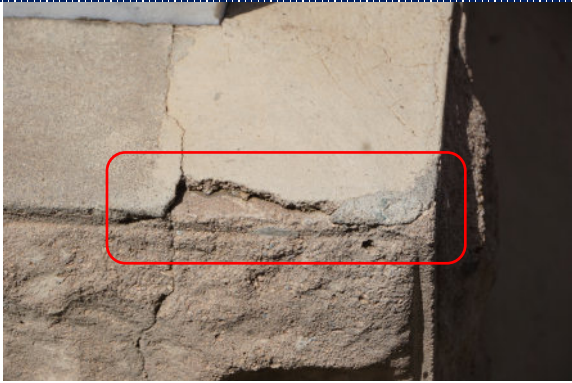
Figure 17: Detail – small cracks and loss to plinth render.

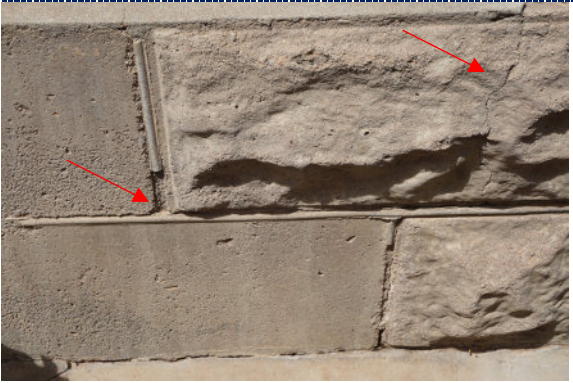
Figure 18: Detail – crack and loss to plinth concrete pointing.

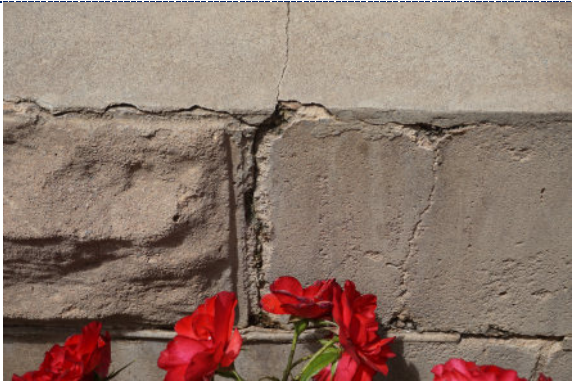
Figure 19: Detail – cracks and small losses to concrete render.

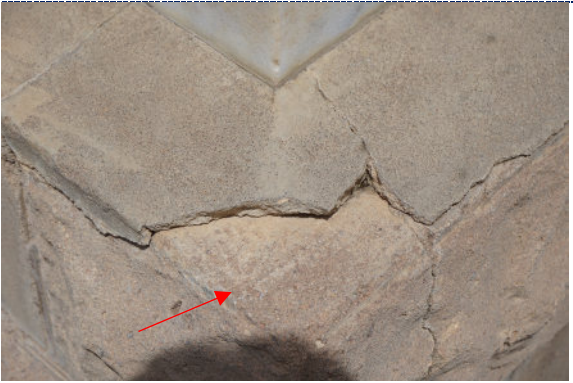
Figure 20: Detail – small cracks and loss to plinth render.

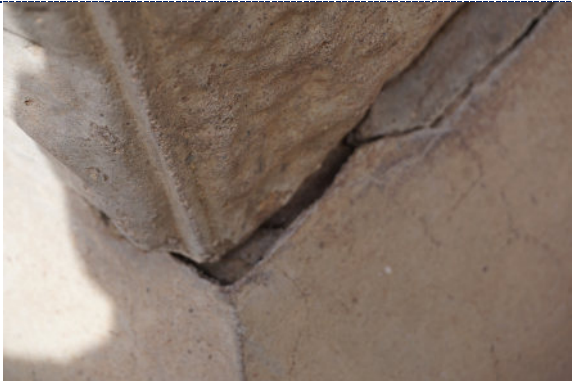
Figure 21: Detail – loss to concrete render.

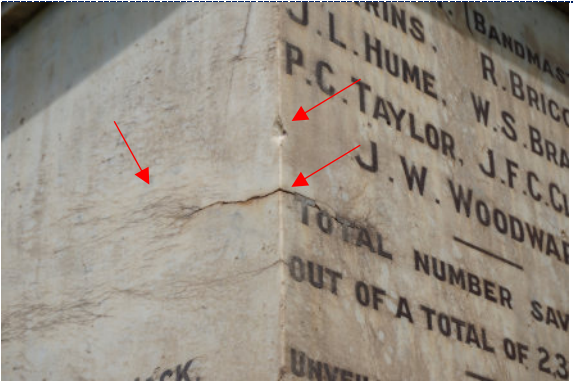
Figure 22: Detail – dirt particulate, small horizontal cracks in marble substrate; loss to marble edge.

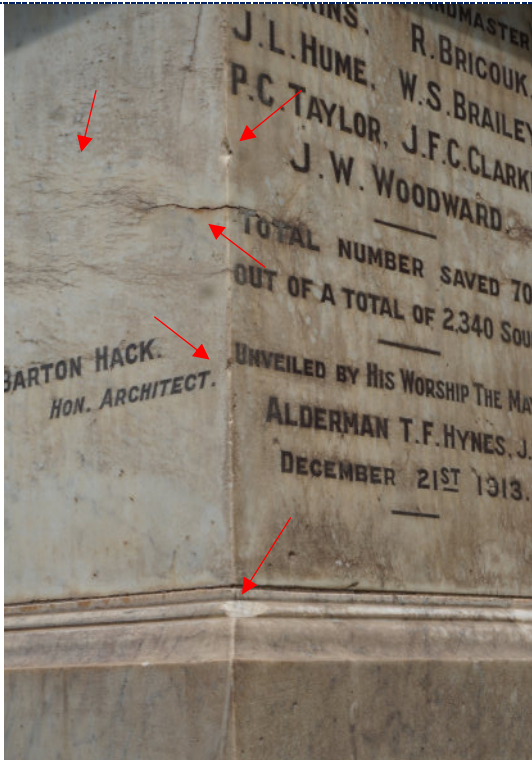
Figure 23: Detail – dirt particulate, small horizontal cracks in marble substrate; losses to marble edge.

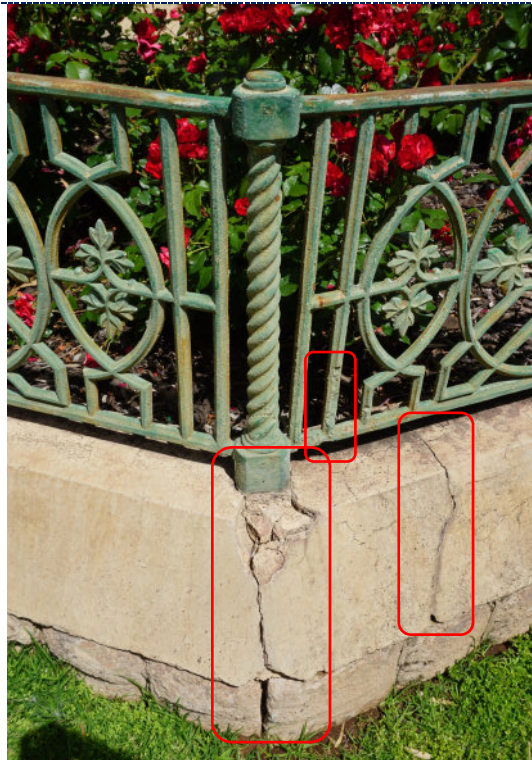
Figure 24: Detail – cracks and loss to plinth render; loss and degradation of green paint on cast iron fencing; iron corrosion product; losses to iron, previously repaired.

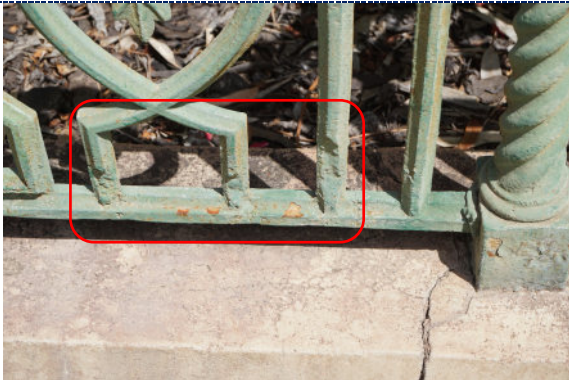
Figure 25: Detail – cracks to plinth render; loss and degradation of green paint on cast iron fencing; iron corrosion product; losses to iron, previously repaired.

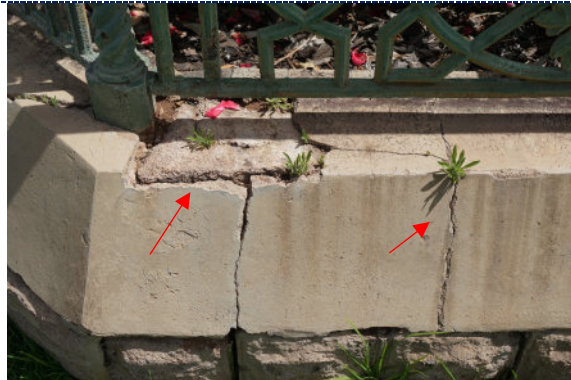
Figure 26: Detail – cracks and loss to plinth render with biogrowth; loss and degradation of green paint on cast iron fencing; iron corrosion product.

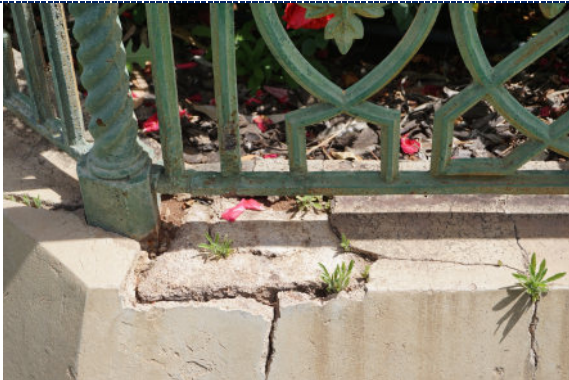
Figure 27: Detail – cracks and loss to plinth render with biogrowth; loss and degradation of green paint on cast iron fencing; iron corrosion product.
