# *Broken Hill Public Art Condition Survey and Conservation Plan*

Prepared for: Broken Hill City Council  
Submission Date: February 2023

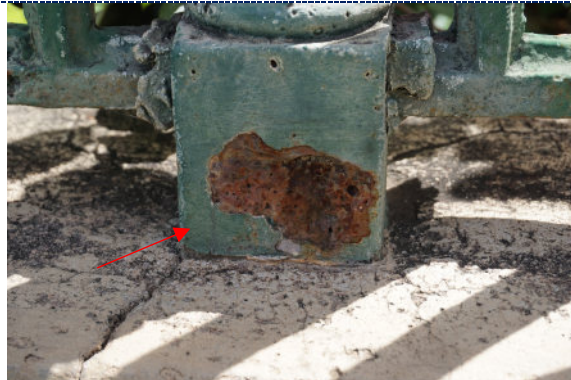
Figure 28: Detail – loss and degradation of green paint on cast iron fencing; iron corrosion product.

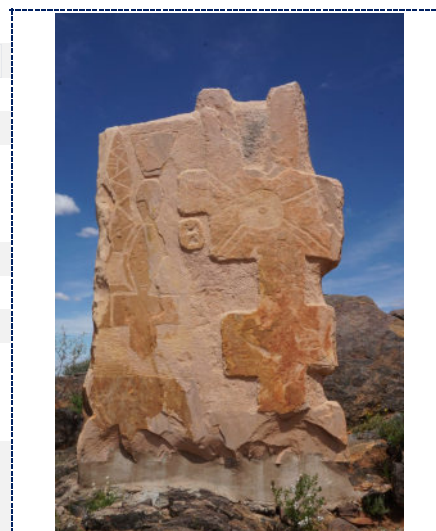
Previous repairs/ modifications?  YES  NO

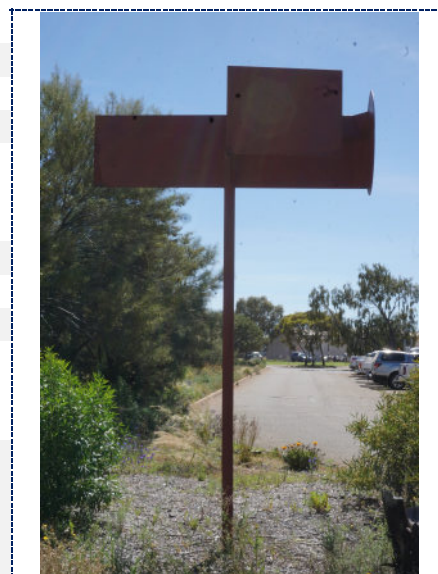
Previous repairs/ modifications?  YES  NO

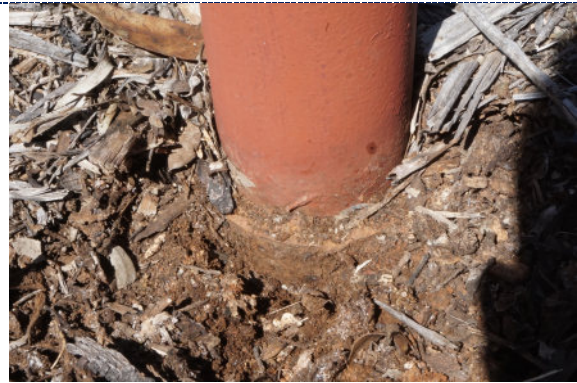
Figure 6: Detail – accumulation of biomatter at base; corrosion to iron.

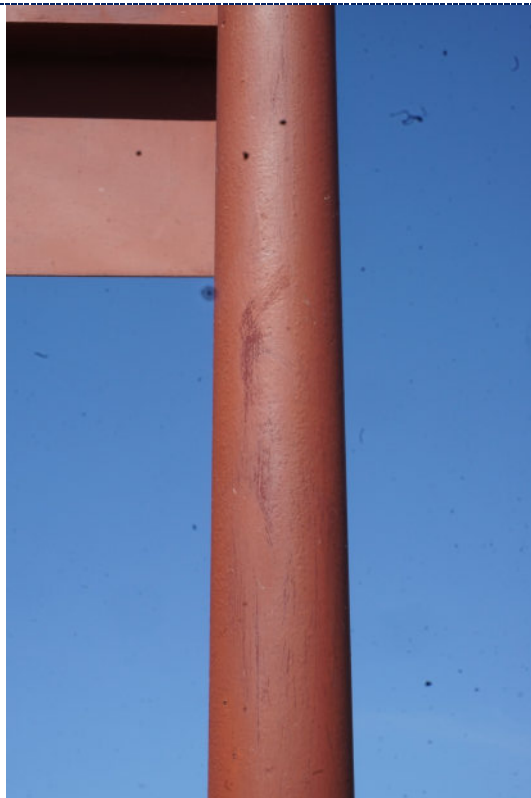
Figure 7: Detail – paint chalking, overpaint.

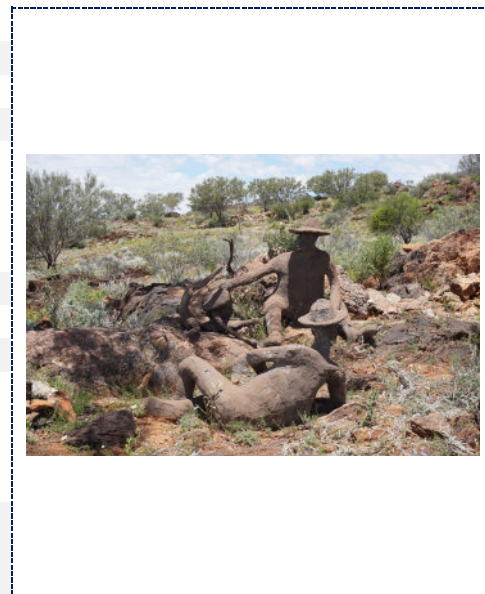
Previous repairs/ modifications?  YES  X NO

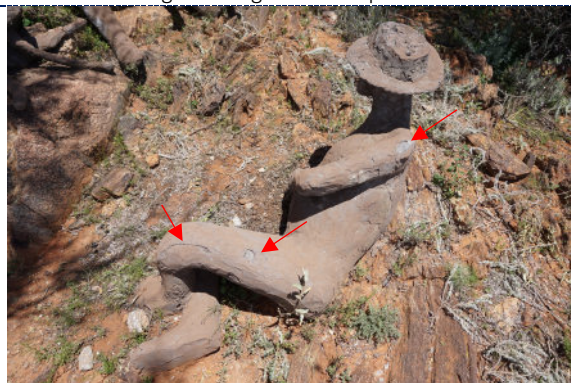
Figure 5: Detail – dirt particulate, large crack and small surface losses.

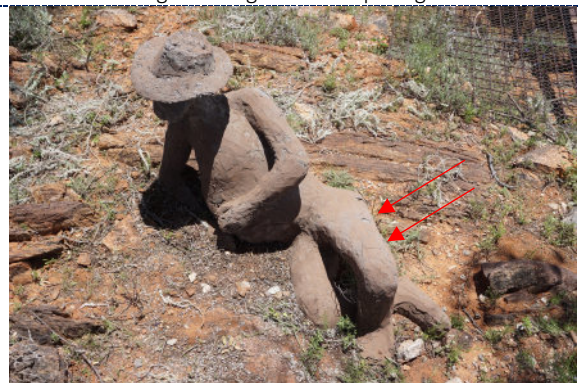
Figure 6: Detail – dirt particulate, large crack and small surface losses.

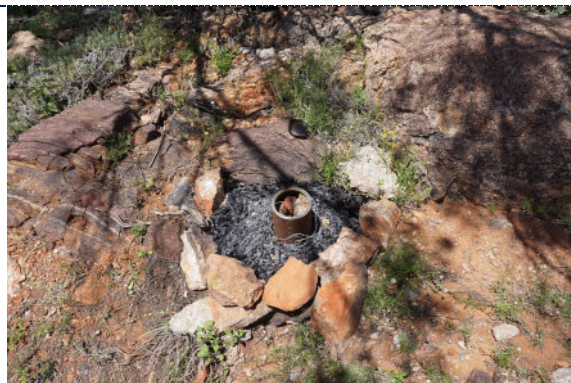
Figure 7: Detail – campsite.

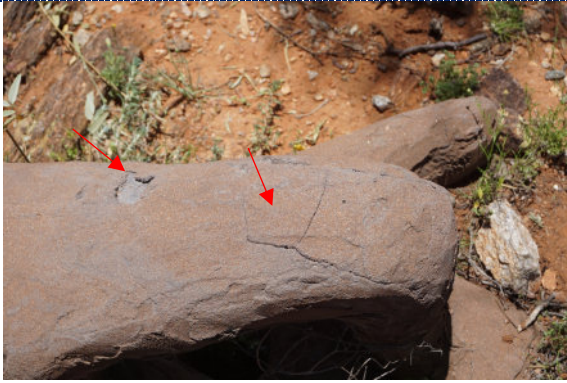
Figure 9: Detail – dirt particulate, large crack and small surface losses.

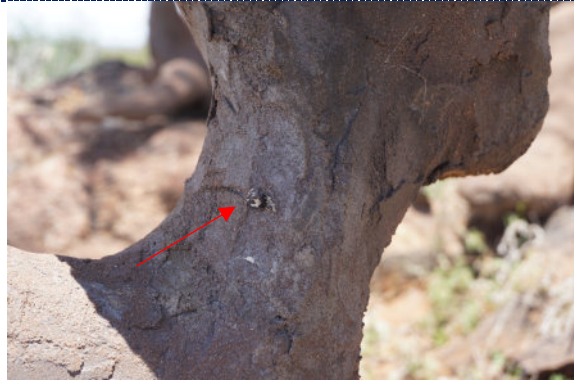
Figure 10: Detail – dirt particulate, bird excrement, spider webs.

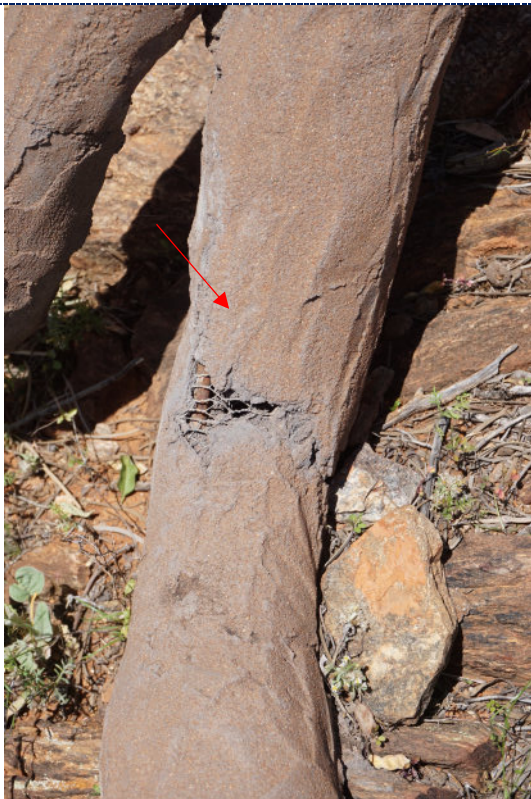
Figure 13: Detail – dirt particulate, large cracks and loss revealing internal iron armature at shoulder.

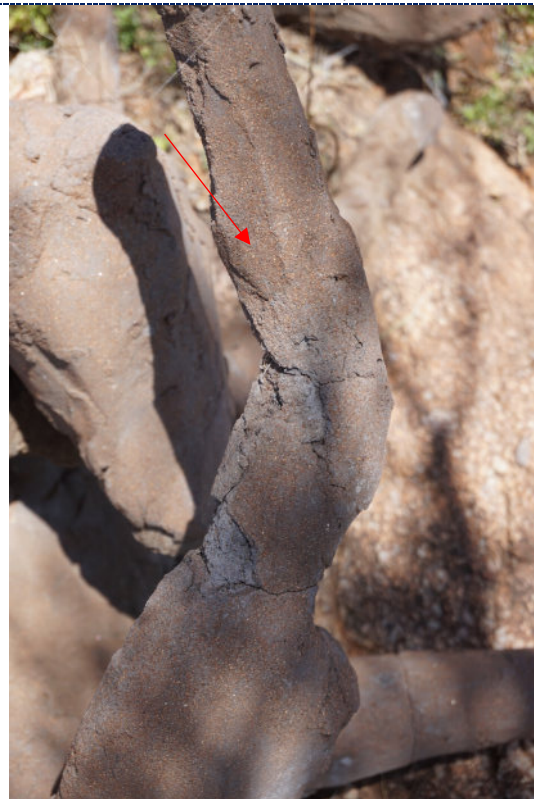
Figure 14: Detail – dirt particulate, large cracks and loss revealing internal iron armature at shoulder.

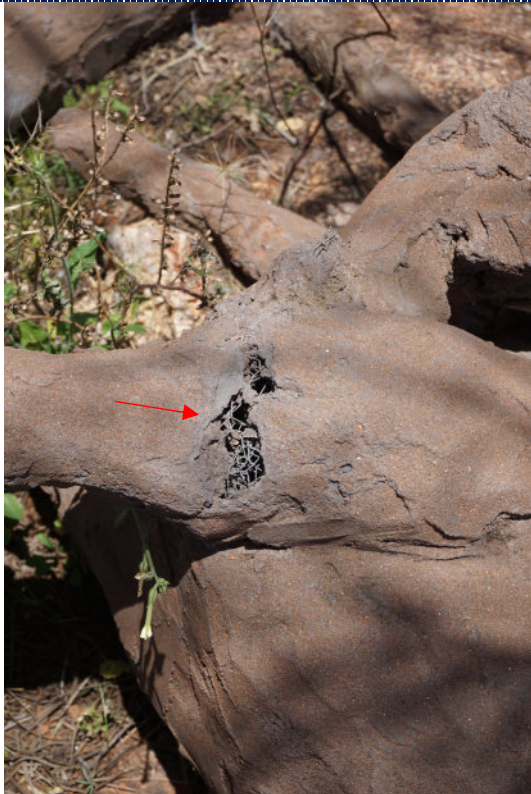
Figure 15: Detail – loss to concrete fondue revealing chicken wire and iron armature.

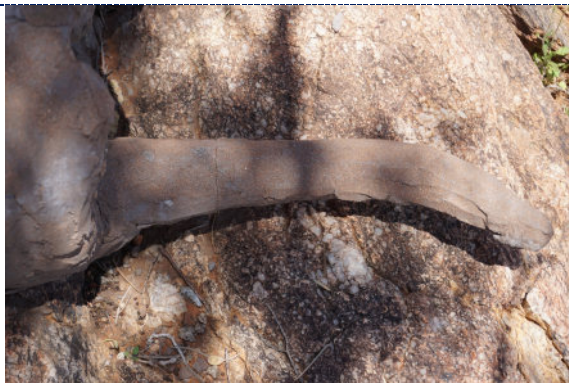
Figure 17: Detail – vertical crack through dog's tail.

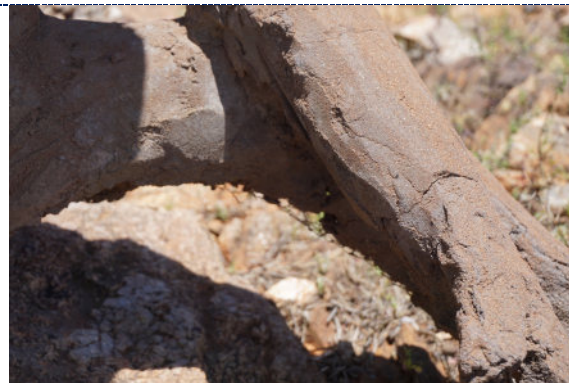
Figure 18: Detail – horizontal crack.

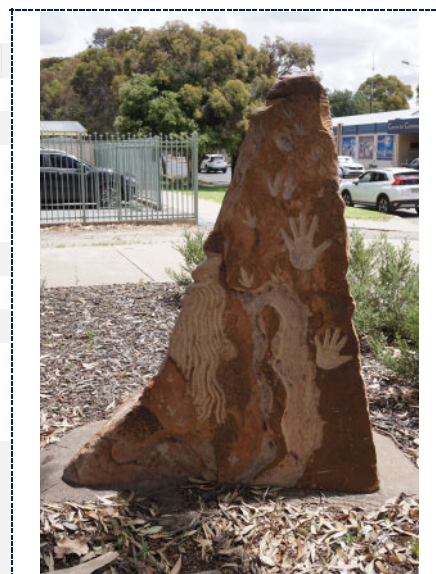
Previous repairs/ modifications?  YES  X NO

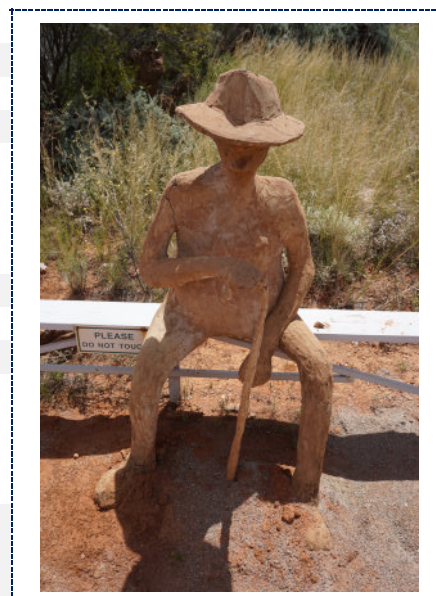
Previous repairs/ modifications?  YES  NO

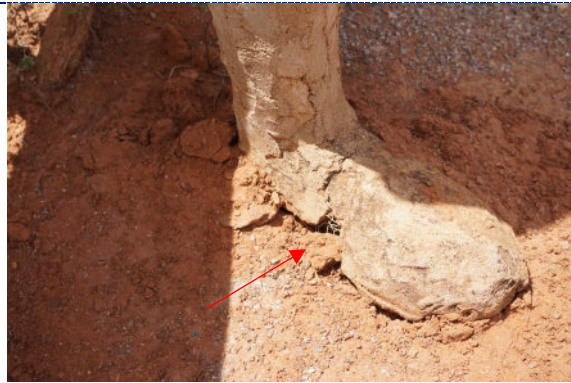
Figure 5: Detail – dirt particulate, large crack and loss revealing internal iron armature at foot.

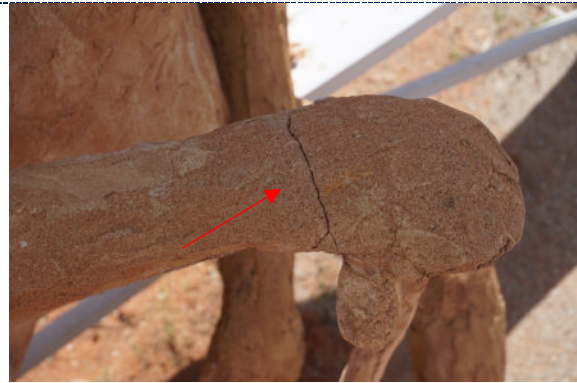
Figure 6: Detail – dirt particulate, crack across hand.

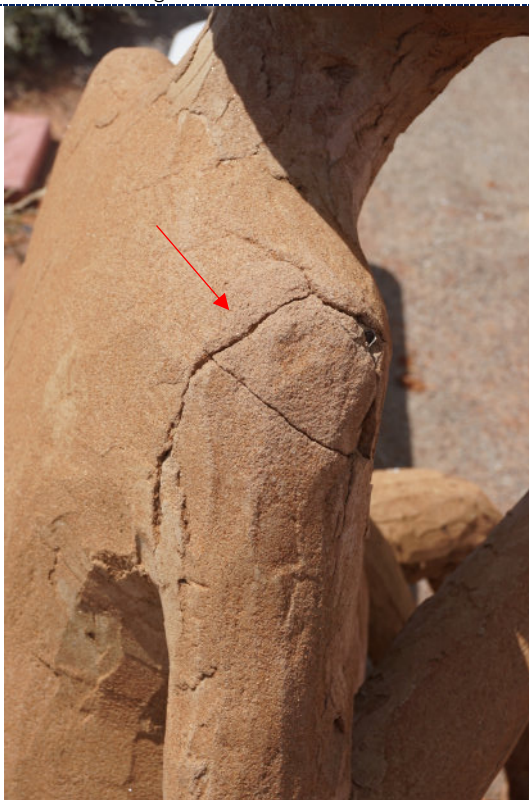
Figure 7: Detail – dirt particulate, large cracks and loss revealing internal iron armature at shoulder.

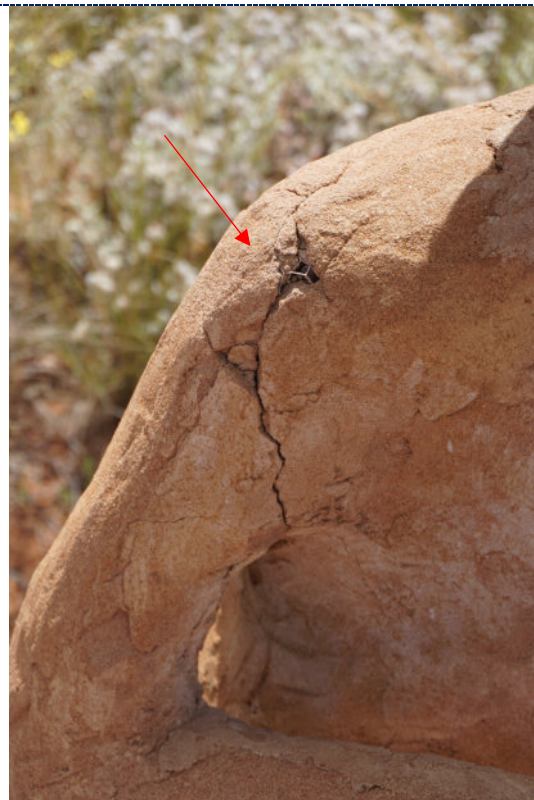
Figure 8: Detail – dirt particulate, large cracks and loss revealing internal iron armature at shoulder.

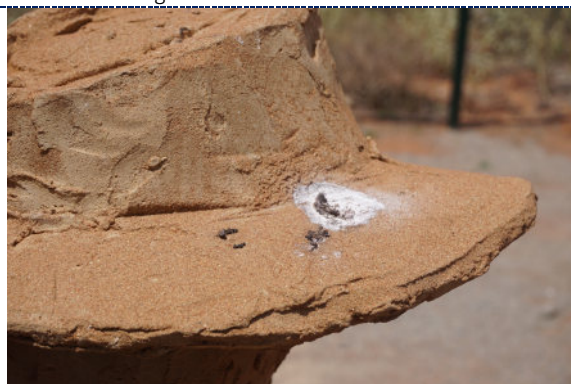
Figure 9: Detail – dirt particulate, bird excrement.

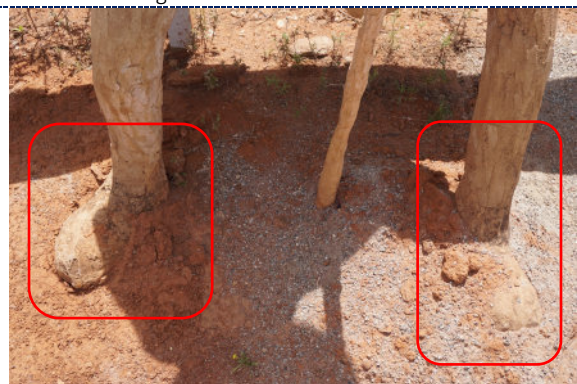
Figure 10: Detail – dirt accumulation at feet, which are partially buried; cracks and small losses at feet.

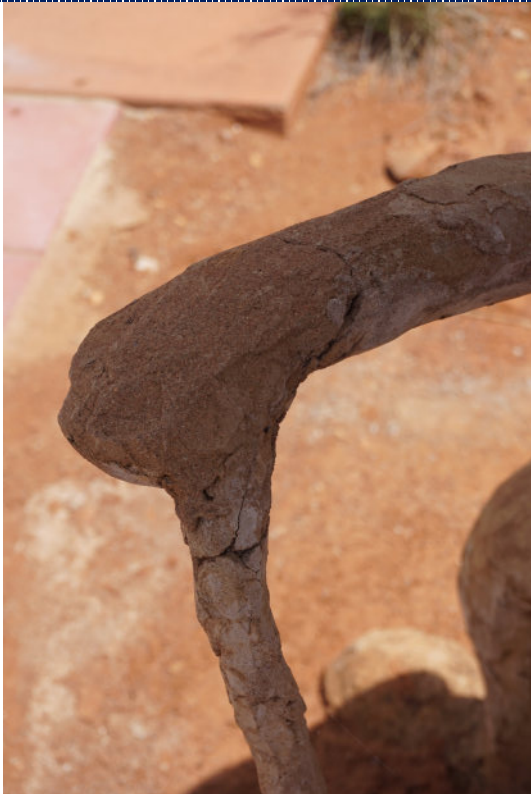
Figure 11: Detail – dirt particulate, large cracks and small losses at hand holding cane.

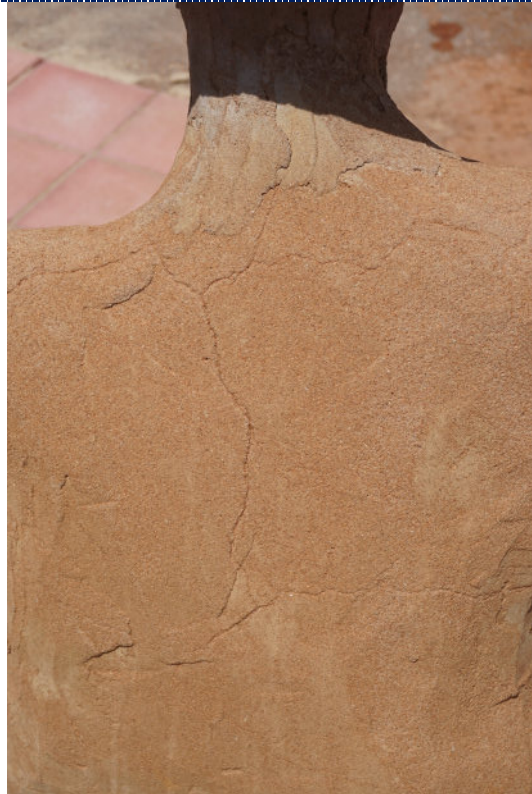
Figure 12: Detail – cracks at figure back.

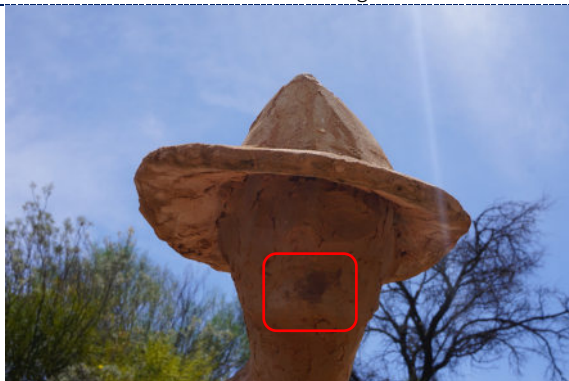
Figure 13: Detail – dirt particulate, abrasion at figure's face.

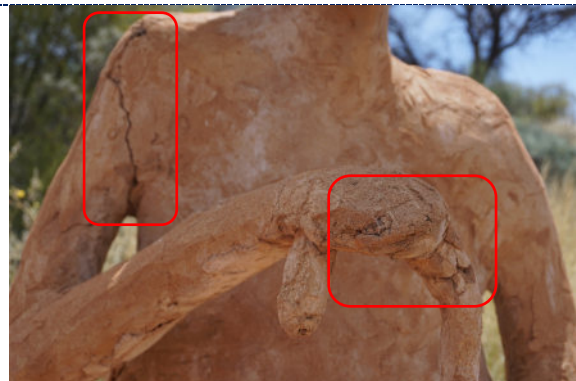
Figure 14: Detail – dirt particulate, large cracks and small losses at hand holding cane; large crack at proper right shoulder.

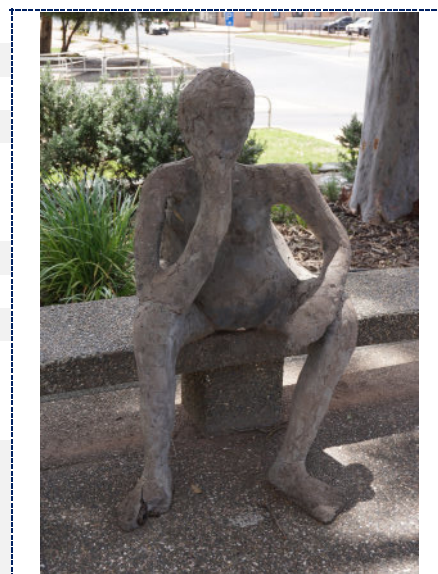
Previous repairs/ modifications?  YES  NO

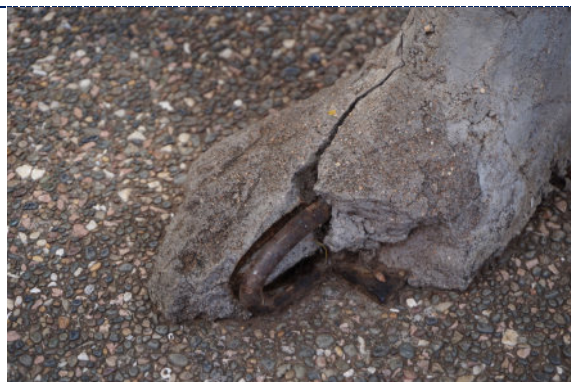
Figure 5: Figure 1 – Detail – dirt particulate, large crack and loss revealing internal iron armature.

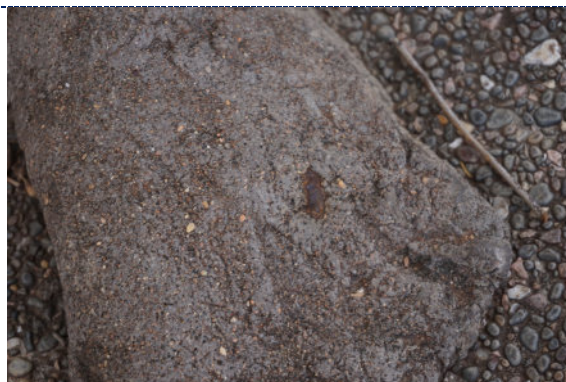
Figure 6: Figure 1 – Detail – dirt particulate, small loss revealing internal iron armature.

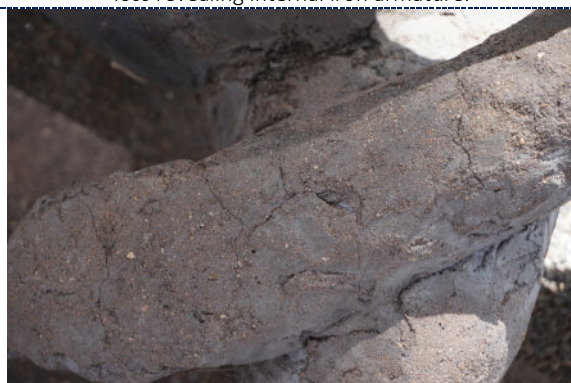
Figure 7: Figure 1 – Detail – dirt particulate, surface cracks

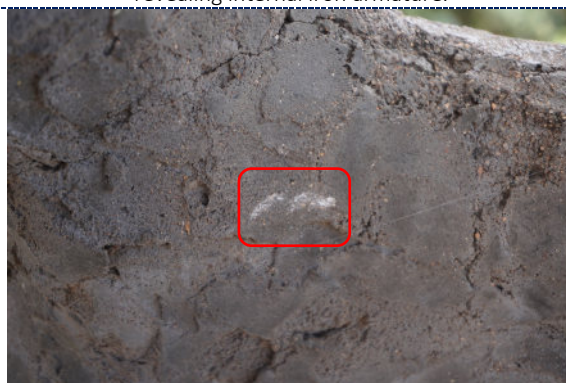
Figure 8: Figure 1 – Detail – dirt particulate, surface cracks and surface abrasion.

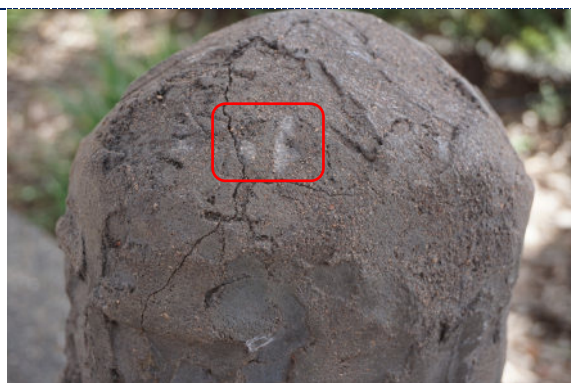
Figure 9: Figure 1 – Detail – dirt particulate, surface cracks and surface abrasion.

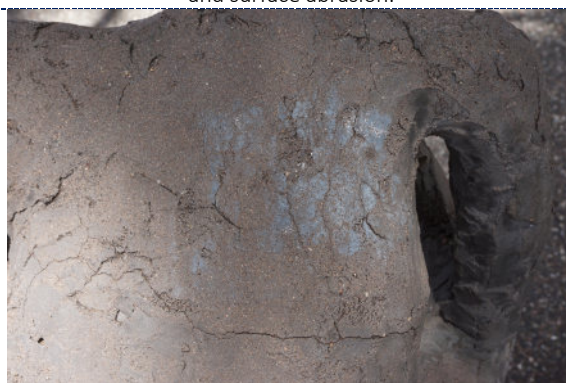
Figure 10: Figure 1 – Detail – dirt particulate, surface cracks and surface paint (likely graffiti).

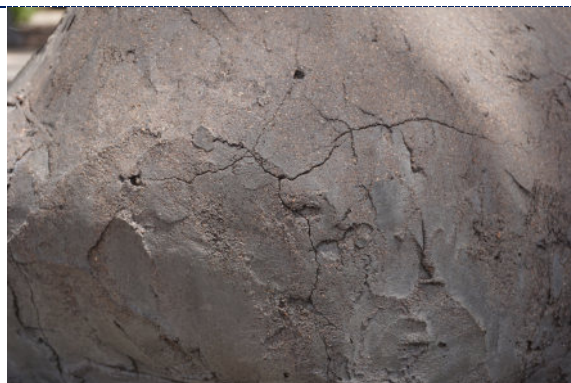
Figure 11: Figure 1 – Detail – dirt particulate, surface cracks.

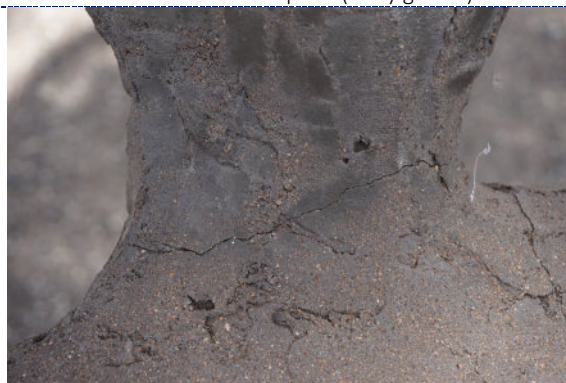
Figure 12: Figure 1 – Detail – dirt particulate, surface cracks.

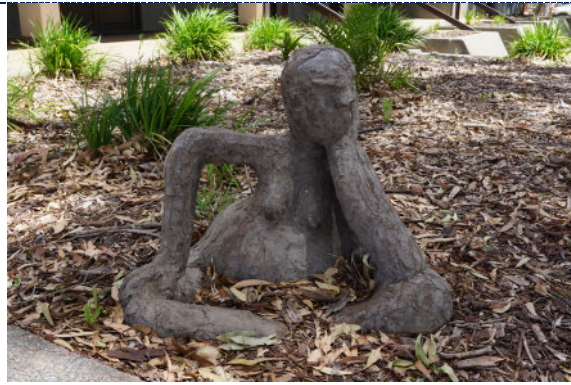
Figure 13: Figure 2 – Front

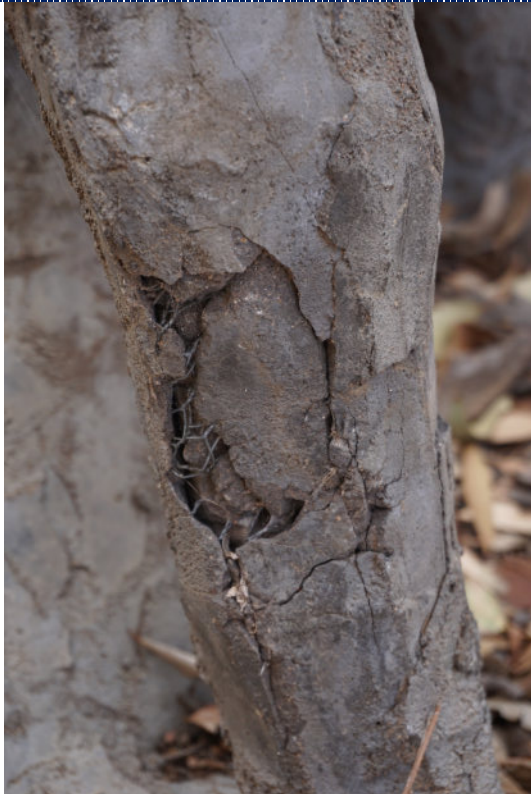
Figure 19: Figure 2 – Detail – dirt particulate, large crack and loss revealing internal 'chicken wire' armature.

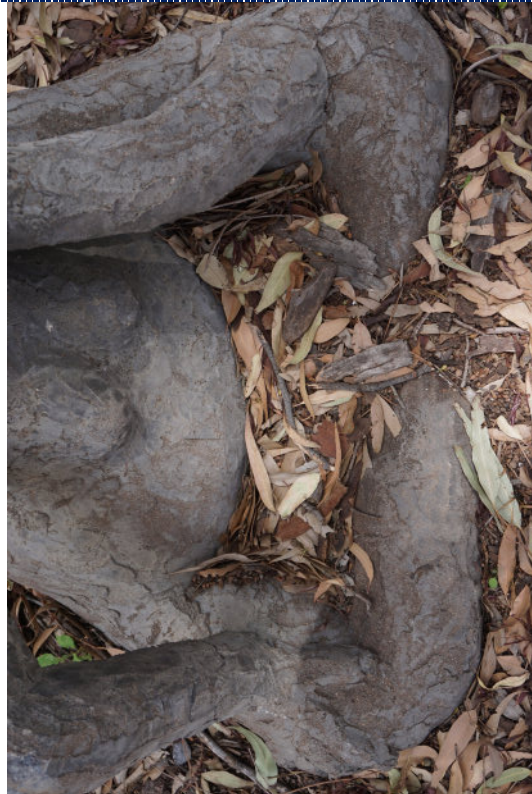
Figure 20: Figure 2 – Detail – dirt particulate, accumulation of biomatter.

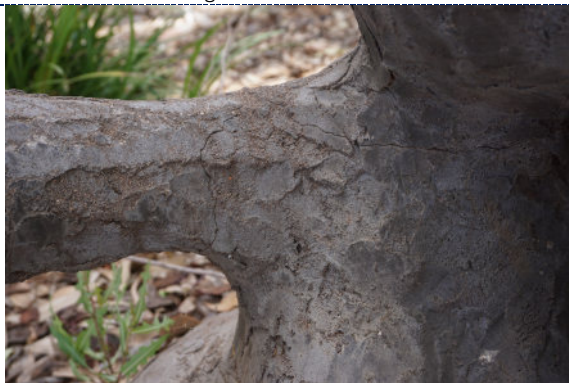
Figure 21: Figure 2 – Detail – dirt particulate, surface cracks.

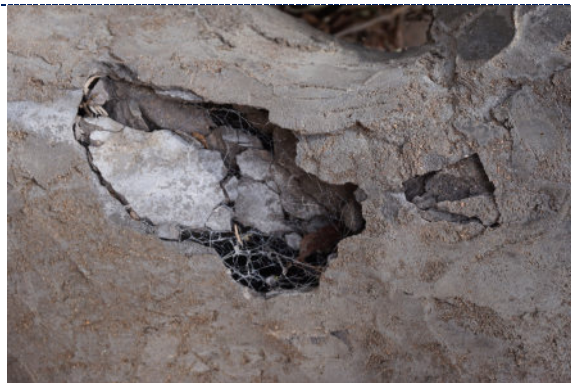
Figure 22: Figure 2 – Detail – dirt particulate, large loss revealing internal 'chicken wire' armature.

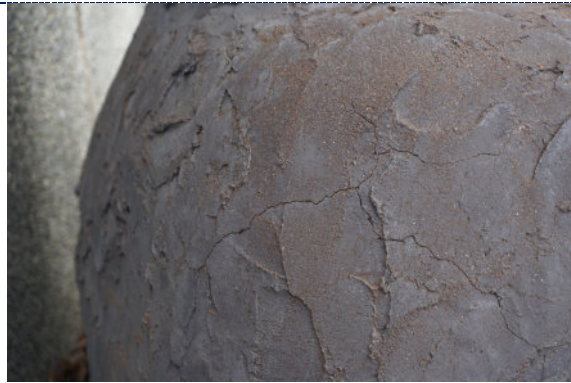
Figure 27: Figure 3 – Detail – dirt particulate, surface cracks.

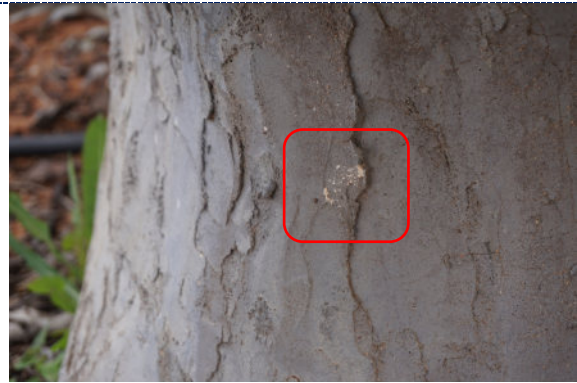
Figure 28: Figure 3 – Detail – dirt particulate, surface accretion.

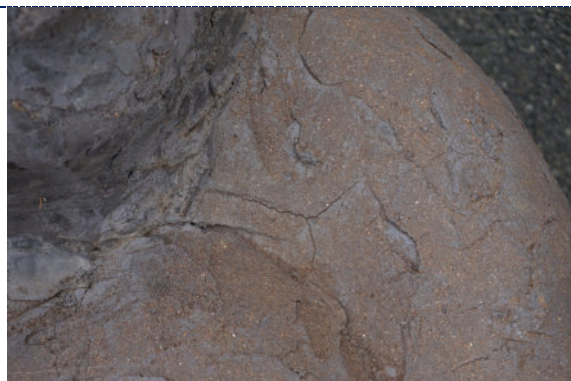
Figure 31: Figure 3 – Detail – dirt particulate, surface cracks.

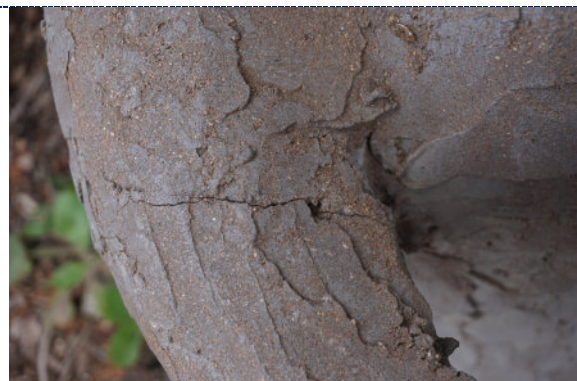
Figure 32: Figure 3 – Detail – dirt particulate, surface cracks and small loss.

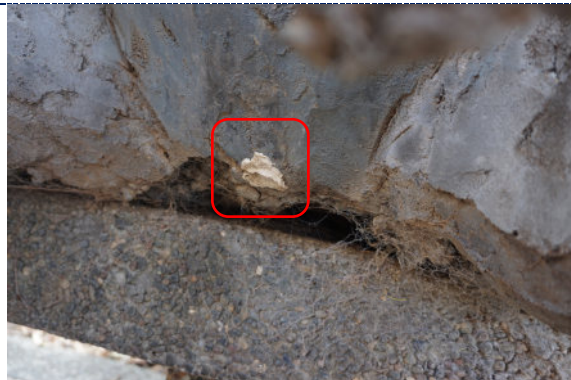
Figure 33: Figure 3 – Detail – dirt particulate, surface cracks and spider webs.

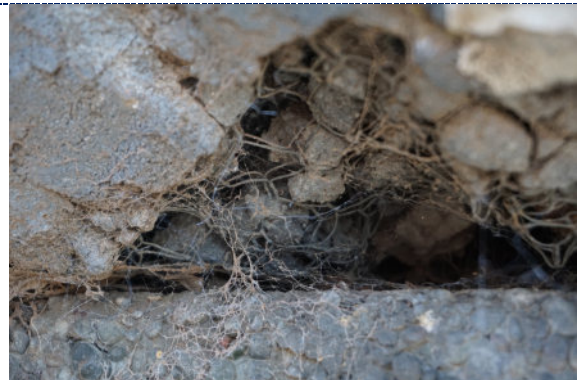
Figure 34: Figure 3 – Detail – dirt particulate, large loss revealing internal 'chicken wire' armature, spider webs.

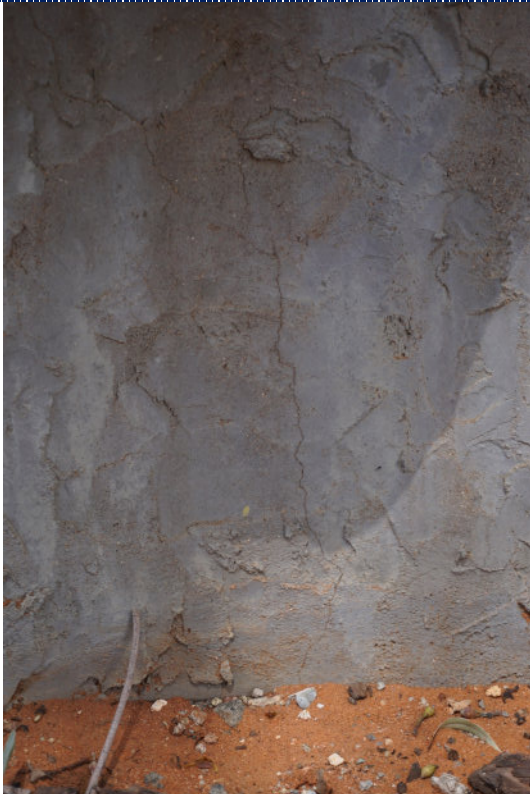
Figure 35: Figure 3 – Detail – dirt particulate, surface cracks.

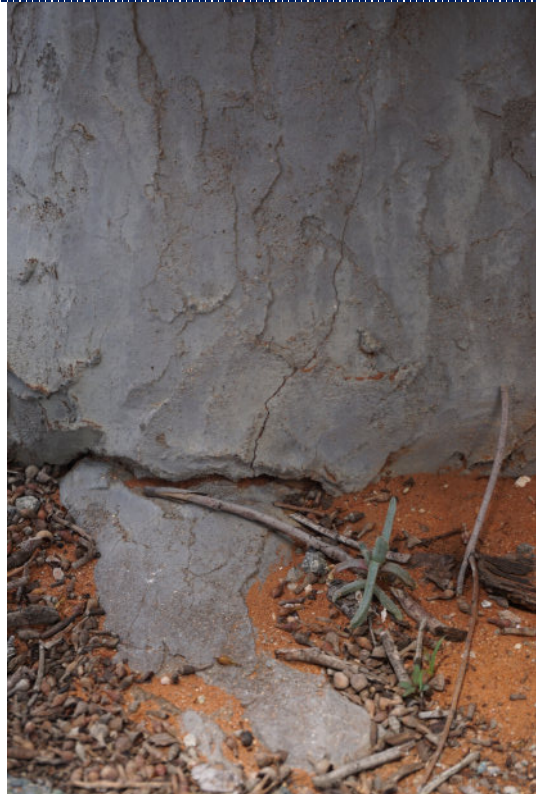
Figure 36: Figure 3 – Detail – dirt particulate, surface cracks.

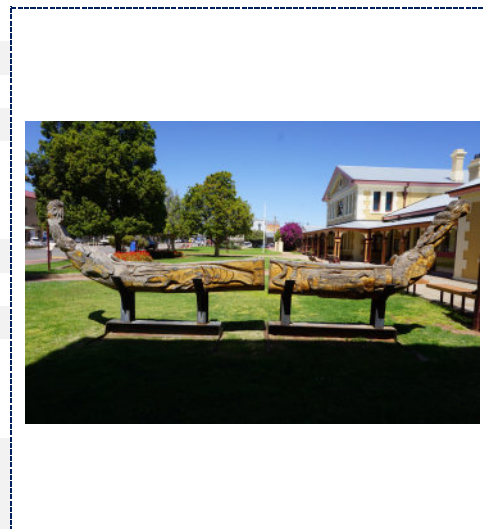
Previous repairs/ modifications?  YES  NO

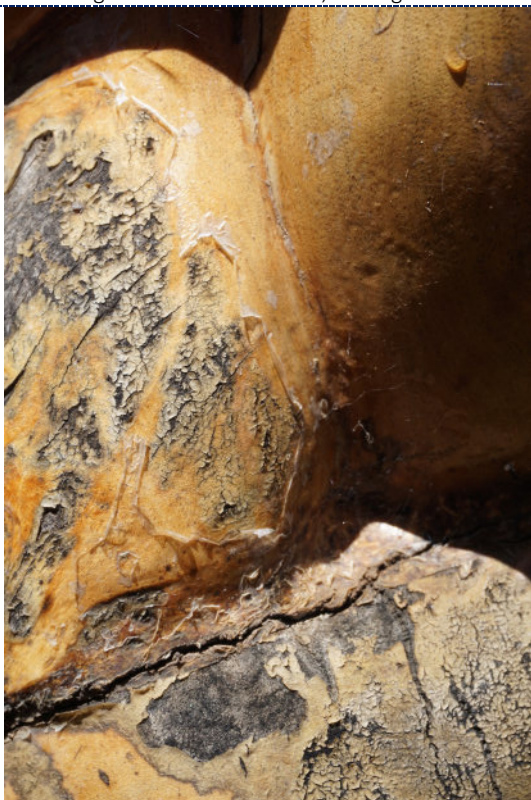
Figure 7: Detail – exterior, degraded and peeling varnish, UV degradation (darkening) to wood surface.

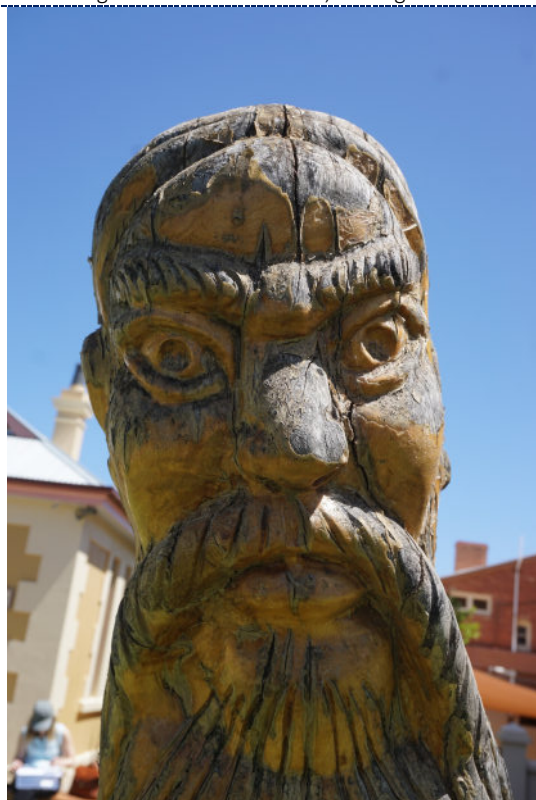
Figure 8: Detail – exterior, degraded and peeling varnish, UV degradation (darkening) to wood surface.

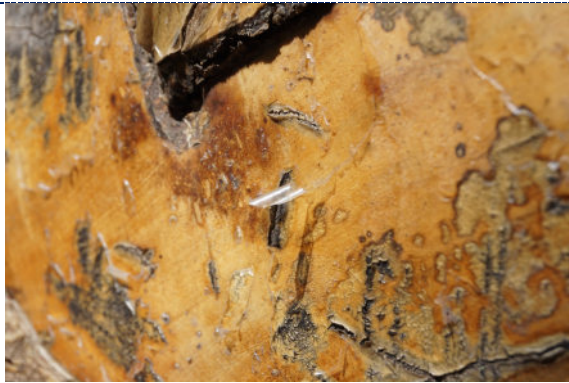
Figure 9: Detail – exterior, degraded and peeling varnish, UV degradation (darkening) to wood surface.

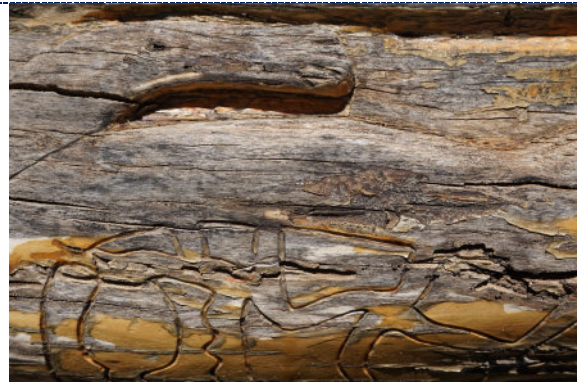
Figure 10: exterior, degraded and peeling varnish, UV degradation (darkening) to wood surface.

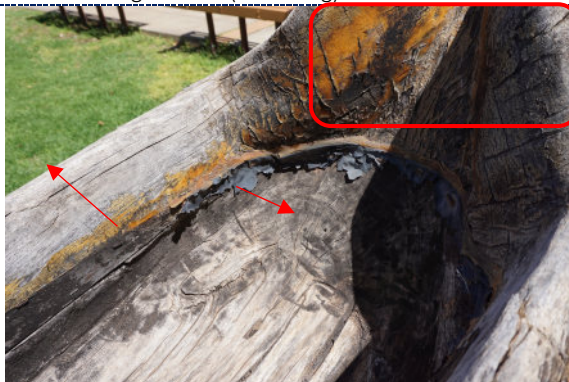
Figure 11: Detail – interior, degraded and peeling varnish, UV degradation (darkening) to wood surface. Interior poly propylene liner, silicon sealant and iron staples heavily degraded.

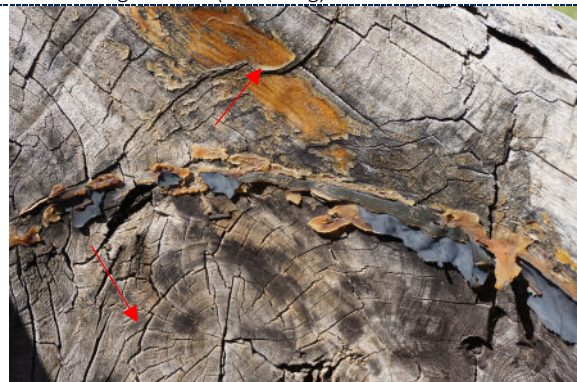
Figure 12: Detail – interior, degraded and peeling varnish, UV degradation (darkening) to wood surface. Interior poly propylene liner, silicon sealant and iron staples heavily degraded.

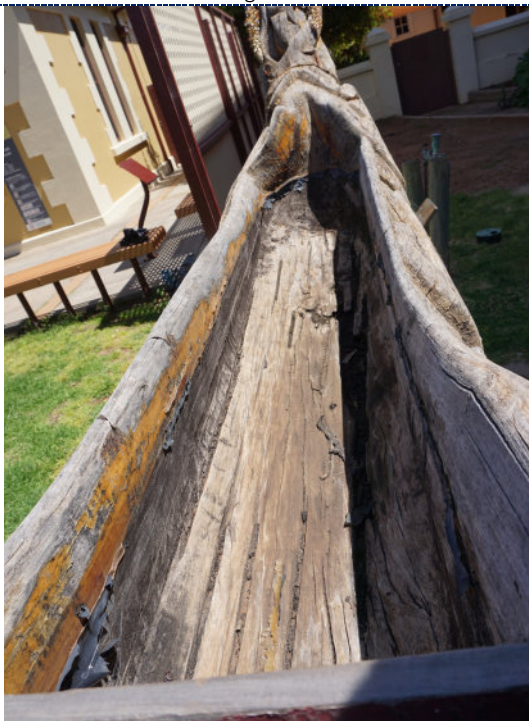
Figure 13: Detail – interior, degraded and peeling varnish, UV degradation (darkening) to wood surface. Interior poly propylene liner, silicon sealant and iron staples heavily degraded. Loose dirt particulate and debris.

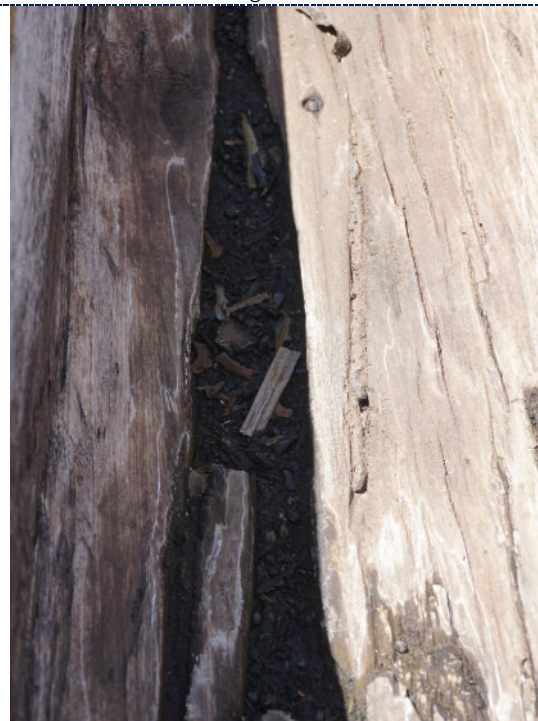
Figure 14: Detail – interior, degraded and peeling varnish, UV degradation (darkening) to wood surface. Interior poly propylene liner, silicon sealant and iron staples heavily degraded. Loose dirt particulate and debris.

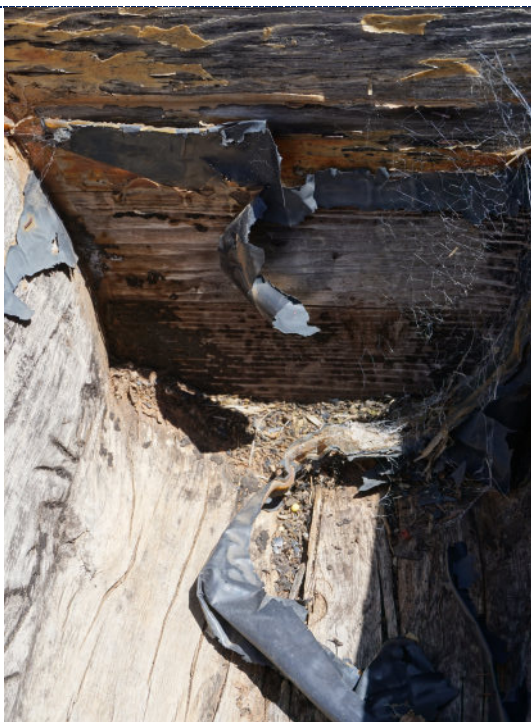
Figure 15: Detail – interior, degraded and peeling varnish, UV degradation (darkening) to wood surface. Interior polypropylene liner, silicon sealant and iron staples heavily degraded. Loose dirt particulate, spider webs and debris.

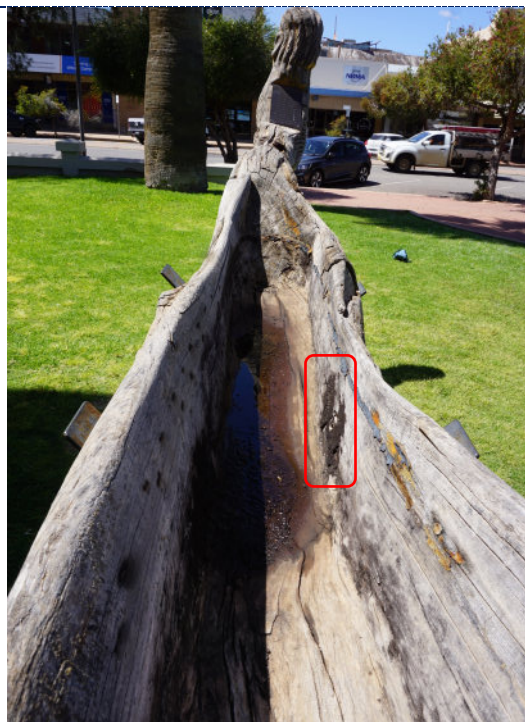
Figure 16: Detail – interior, degraded and peeling varnish, UV degradation (darkening) to wood surface. Interior polypropylene liner, silicon sealant and iron staples heavily degraded. Standing water, loose dirt particulate and debris. A tar-like accretion was visible on the interior surface.

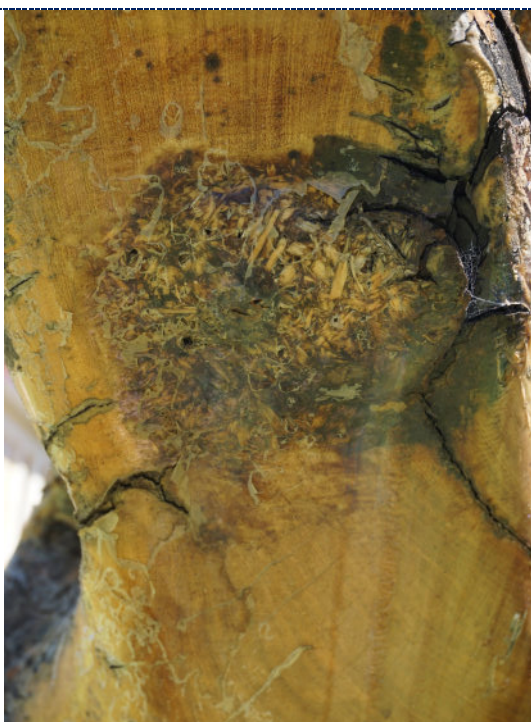
Figure 17: Detail – exterior-bottom, degraded and peeling varnish.

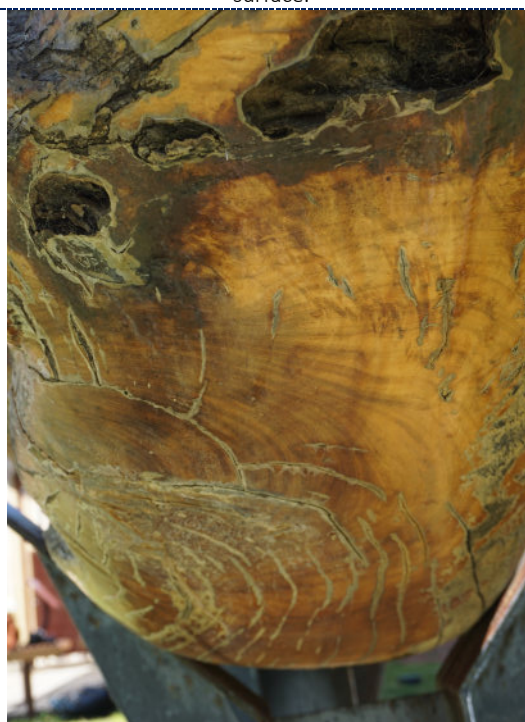
Figure 18: Detail – exterior-bottom, degraded and peeling varnish.

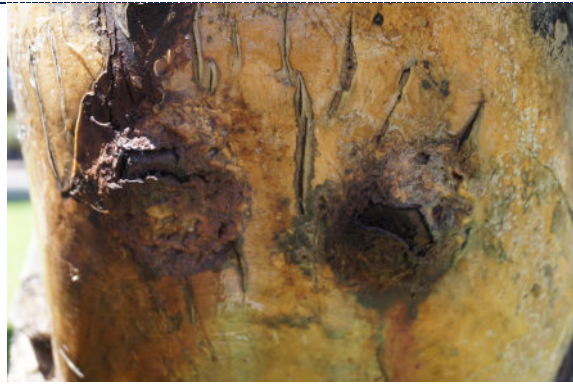
Figure 19: Detail – exterior, corroded iron bolts and peeling varnish.

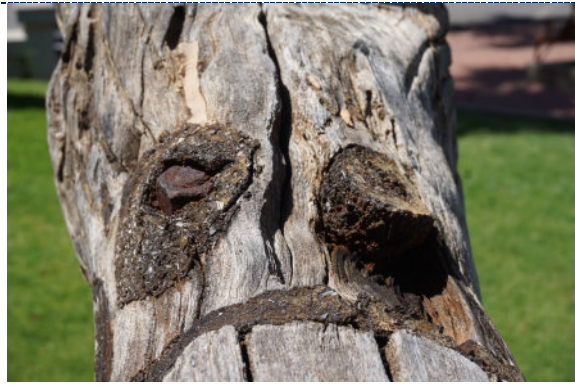
Figure 20: Detail – exterior, corroded iron bolts and peeling varnish. A tar-like accretion is evident within a joint and around the iron bolts.

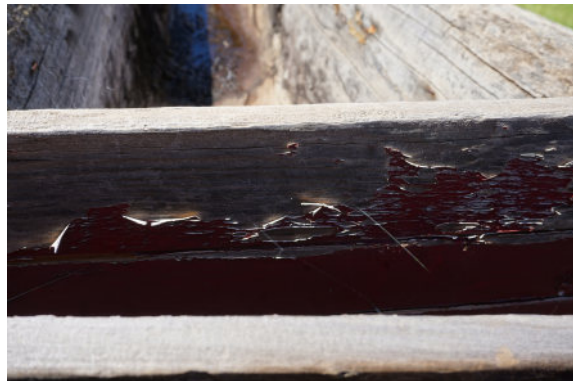
Figure 21: Detail – exterior, degraded and peeling maroon paint, UV degradation (darkening) to wood surface.

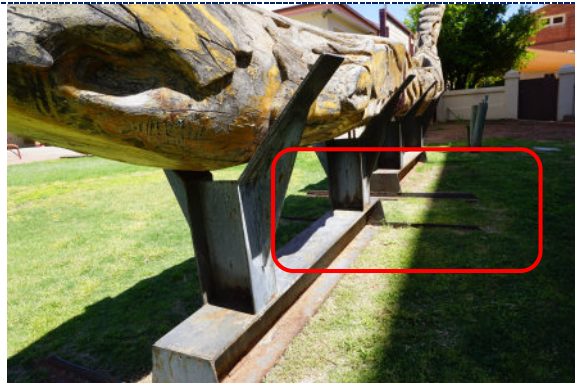
Figure 22: Detail – exterior, degraded and peeling varnish, UV degradation (darkening) to wood surface. Corrosion on mount.

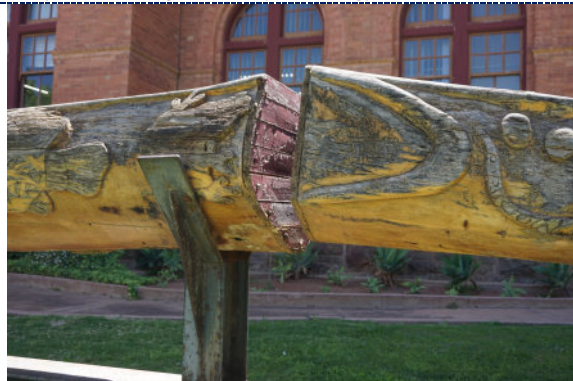
Figure 23: Detail – exterior, degraded and peeling varnish, UV degradation (darkening) to wood surface, degraded and peeling maroon paint. Corrosion on mount.

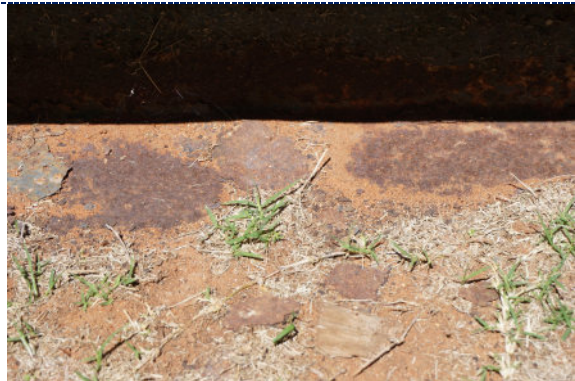
Figure 24: Detail – corrosion product on the ground stemming from the canoe mount.

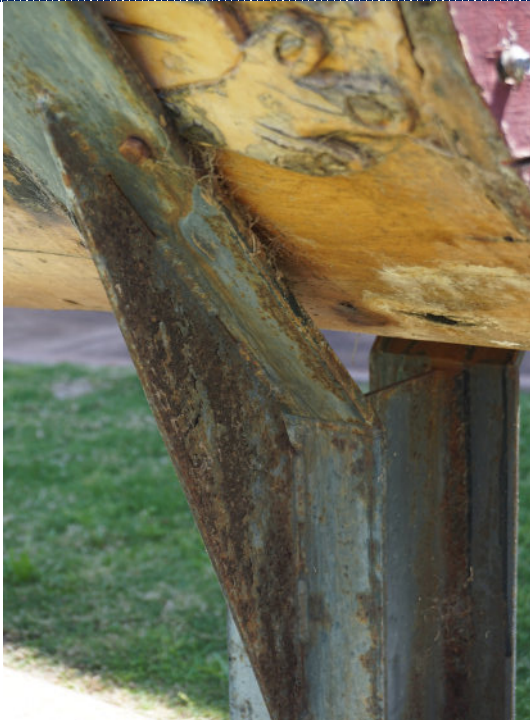
Figure 25: Detail – exterior, degraded and peeling varnish, UV degradation (darkening) to wood surface. Corrosion on mount.

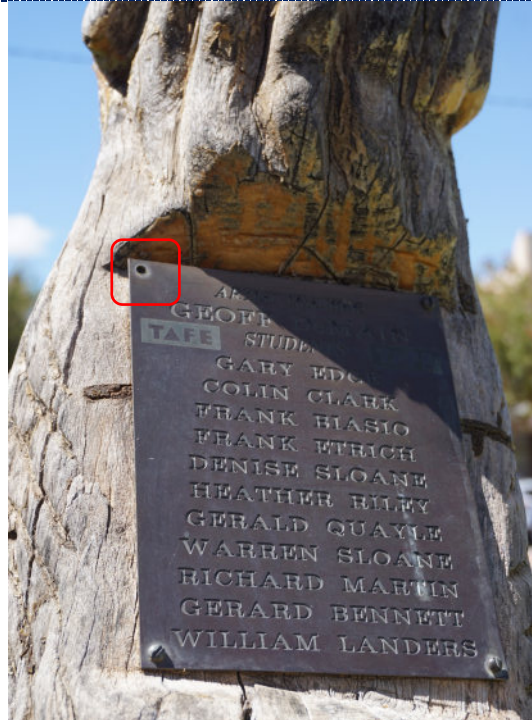
Figure 26: Detail – copper alloy plaque with bird excrement and one screw missing.

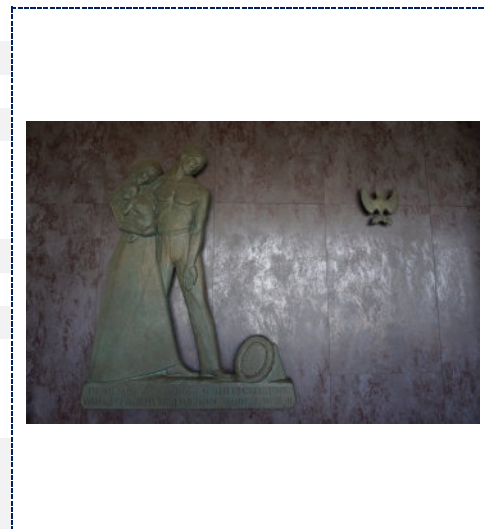
Previous repairs/ modifications?  YES  NO
