Broken Hill Public Art Condition Survey and Conservation Plan

Prepared for: Broken Hill City Council
Submission Date: February 2023

This report presents the results of a condition survey assessing the works held within Broken Hill City Council's public art collection. A total of 56 works were condition assessed.

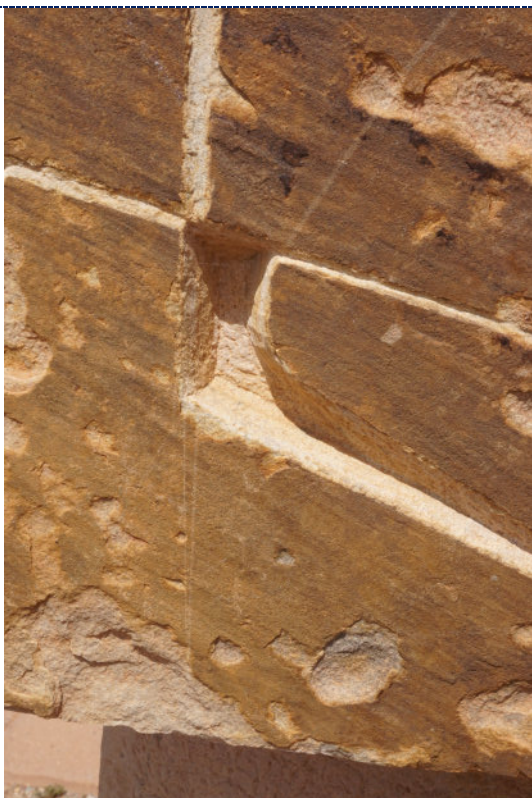
SURFACE/ COATING	MATERIALS:	
CONDITION	✓	NOTES
Abrasions/ dents	✓	Minor abrasions and possible surface losses (figs. 5-6, 14).
Accretion		
Areas of loss		
Corrosion		
Cracks		
Delamination		
Dust/ dirt	✓	Minor dust and dirt visible, inherent to outdoor sculpture.
Fading		
Flaking/Friable		
Mould/ mould damage		
Pest damage		
Pitting		
Previous treatment		
Staining/ discolouration		
OTHER

Figure 5: Details – surface abrasions and delamination.

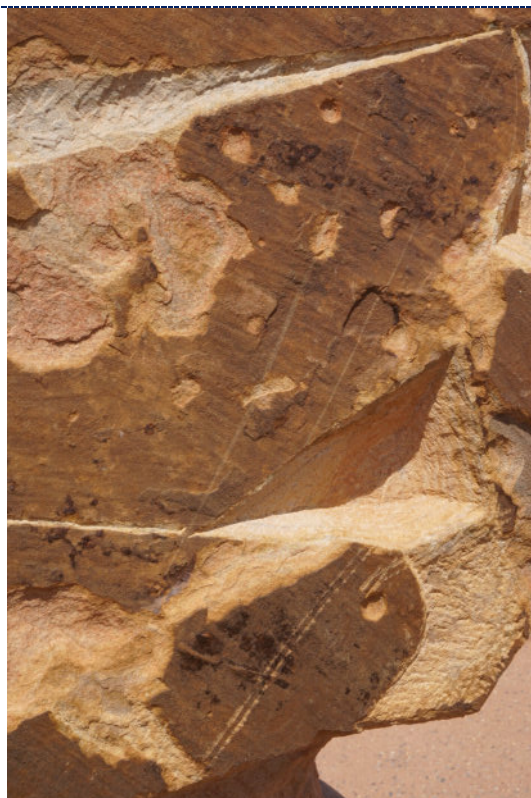
Figure 6: Details – surface abrasions and delamination.

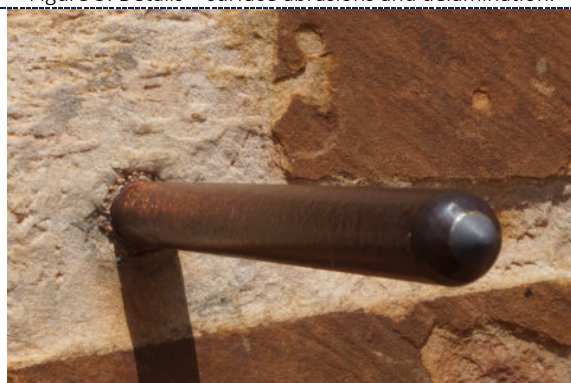
Figure 7: Details – verso, upper center, protruding armature with stable oxidation layer.

Routine Maintenance	Frequency
<ul style="list-style-type: none">Surface clean to remove dirt particulate and avian guano.Monitor iron corrosion and resultant spalling to stone.Monitor stone delamination.Monitor possible stone delamination.Monitor possible soil erosion.	Biennially 1 year 2 years 2 years 2 years

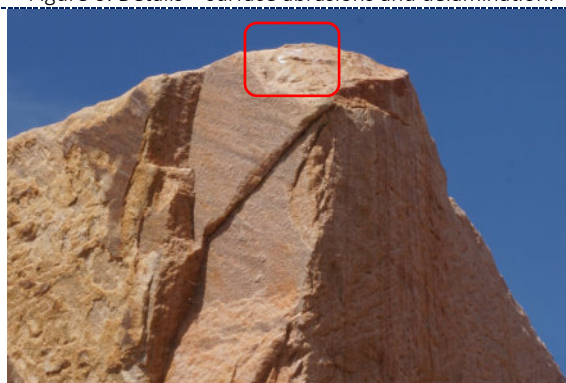
Figure 8: Details – top, stone delamination and weathering; bird excrement.

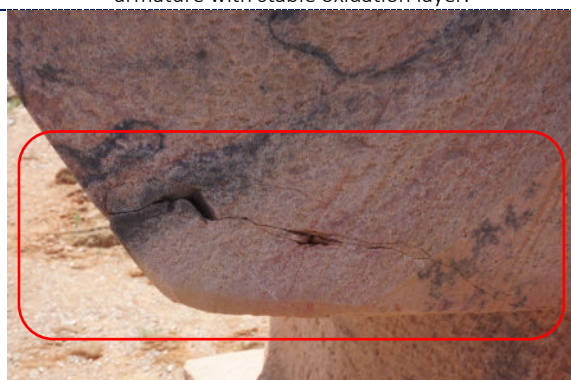
PRIMARY STRUCTURE	MATERIALS:	
CONDITION	✓	NOTES
Abrasions/ dents		
Areas of loss/ detached or missing component	✓	Several areas of loss are evident adjacent to cracks (figs. 9-12).
Corrosion	✓	Stable corrosion product visible on protruding armature (fig. 7).
Cracks/ splitting	✓	Several cracks and splitting at corner visible (figs. 9-13). Elements at the corners are at risk of separating from the work.
Disjoin/ Loose component		
Distortion		
Pest damage		
Previous treatment/ repair		
Rotting		
Wear/ polishing

Figure 9: Details – recto, upper proper right side, horizontal crack and small losses.

Recommended Remedial Treatment Works	Advised Cost
<ul style="list-style-type: none">Consolidate cracks at corners to prevent separation from the work.Fill losses and cracks.	~\$2,000

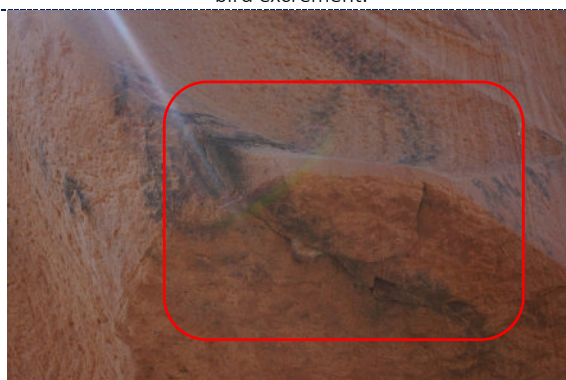
Figure 10: Details – recto, upper proper right side, crack, small losses and insect casing.

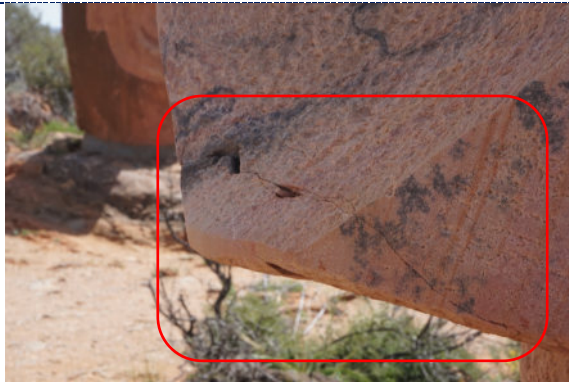
Figure 11: Details – recto, upper proper right side, horizontal crack and small losses.

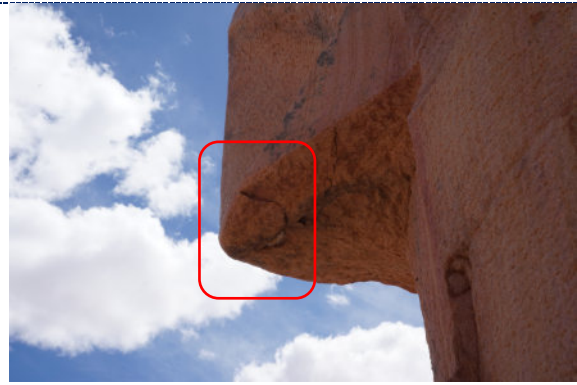
Figure 12: Details – recto, upper proper right side, crack, small losses and insect casing.

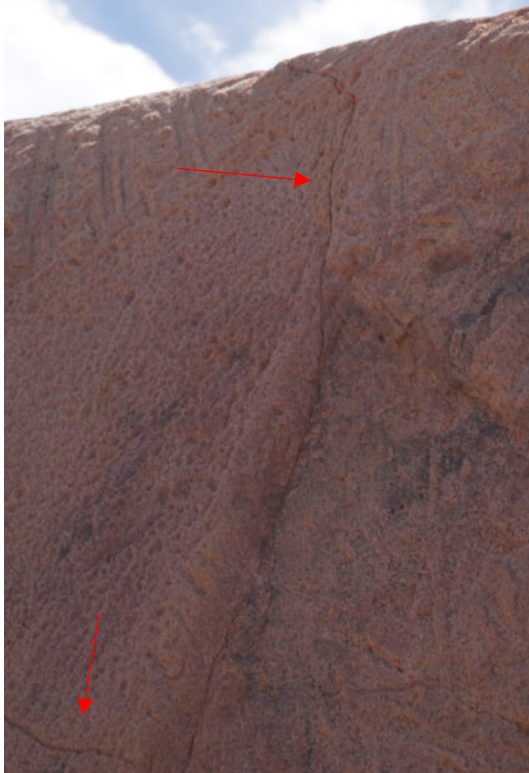
Figure 13: Detail – horizontal and vertical cracks.

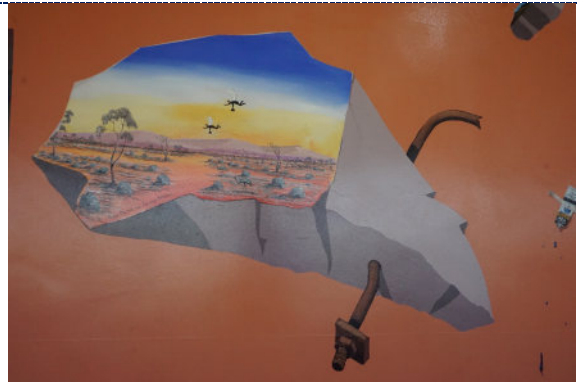
Figure 20: Work 13 – Detail – Flying Doctor and Second Opinion.

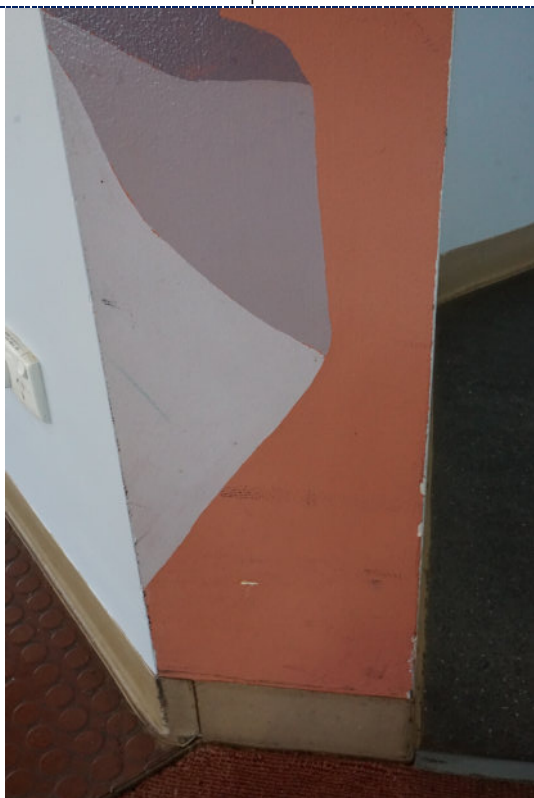
Figure 27: Proper right wall – Detail – surface abrasions with accretions and loss.

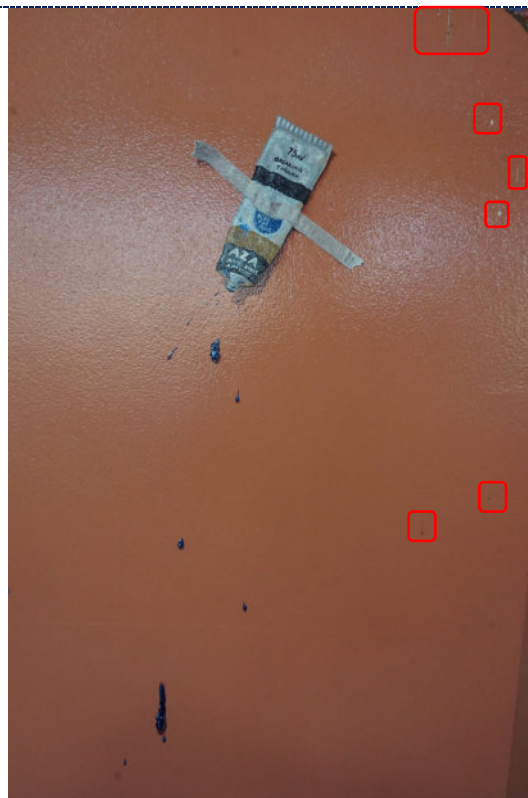
Figure 30: Work 14 – Detail – Surface accretions.

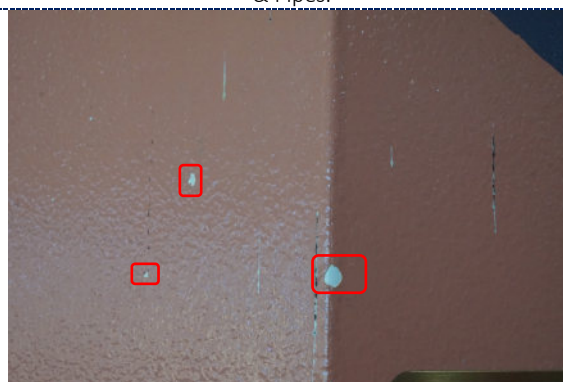
Figure 34: Work 9 – Detail below – 3 x losses with multiple surface accretions.

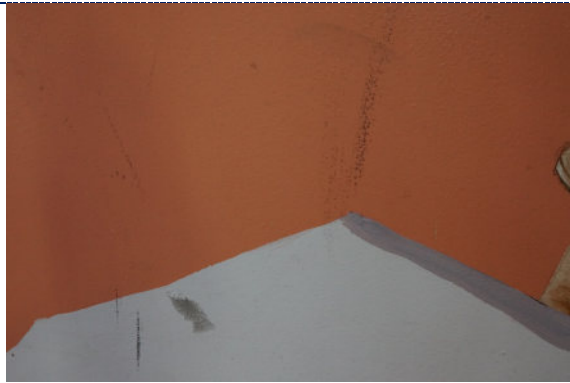
Figure 35: Work 7 – Detail – surface abrasions.

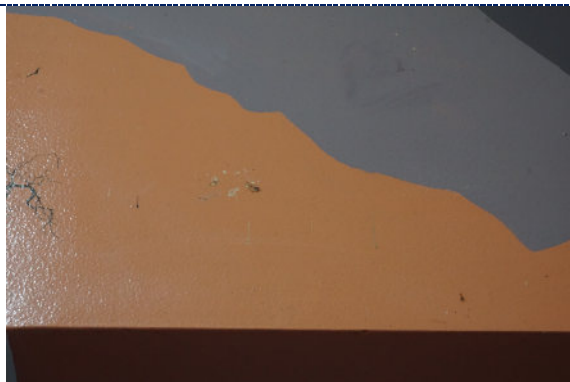
Figure 37: Work 2 – Detail – multiple surface accretions and abrasion.

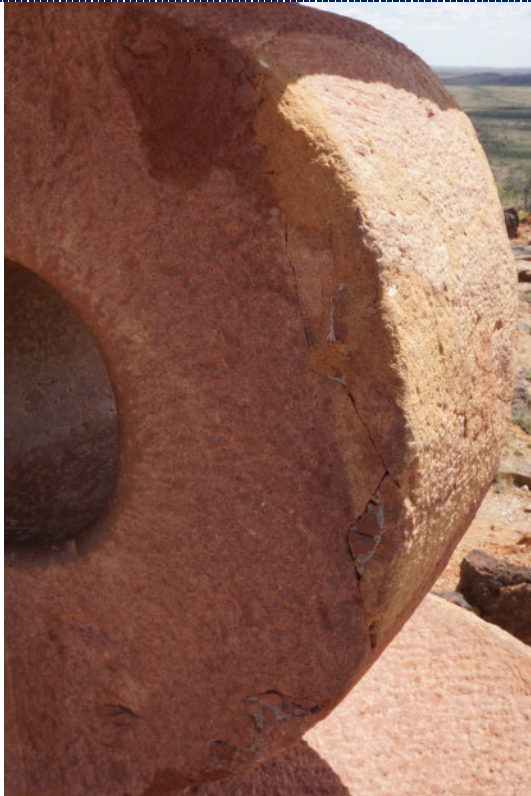
PRIMARY STRUCTURE	MATERIALS:	
CONDITION	<input checked="" type="checkbox"/>	NOTES
Abrasions/ dents	<input type="checkbox"/>	
Areas of loss/ detached or missing component	<input type="checkbox"/>	
Corrosion	<input type="checkbox"/>	
Cracks/ splitting	<input checked="" type="checkbox"/>	Multiple cracks with minor splitting visible. Major cracks and losses appear to have been previous repairs (figs. 5-20).
Disjoin/ Loose component	<input type="checkbox"/>	
Distortion	<input type="checkbox"/>	
Pest damage	<input type="checkbox"/>	
Previous treatment/ repair	<input checked="" type="checkbox"/>	Multiple areas of previous repairs are present. These are concentrated around the loop component and at corners. Repair materials includes an adhesive, colour-matched filler (possibly lime mortar) and concrete (figs. 5-20).
Rotting	<input type="checkbox"/>

Figure 5: Detail – previous repair.

Routine Maintenance	Frequency
<ul style="list-style-type: none">• Surface clean to remove dirt particulate and avian guano.• Monitor condition of material repairs.• Monitor stone delamination.• Monitor possible soil erosion.	Biennially 1 year 2 years 2 years

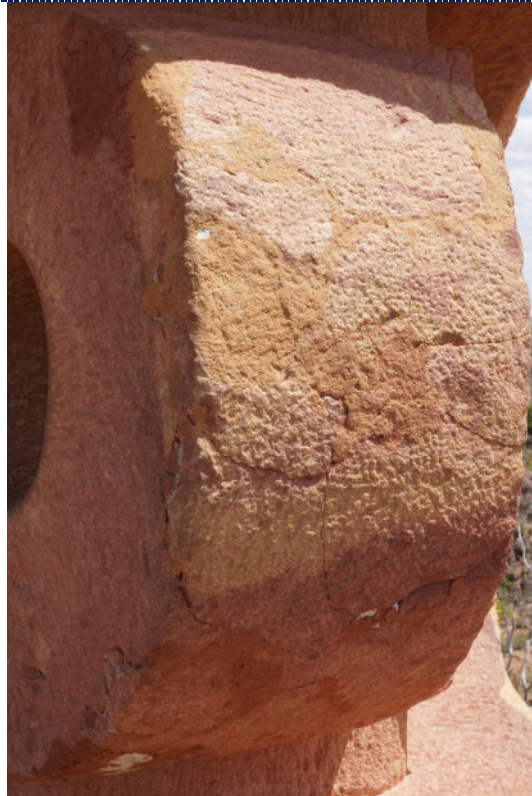
Figure 6: Detail – previous repair.

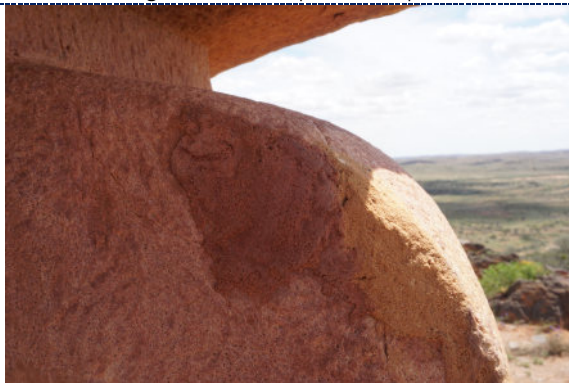
Figure 7: Detail – previous repair.

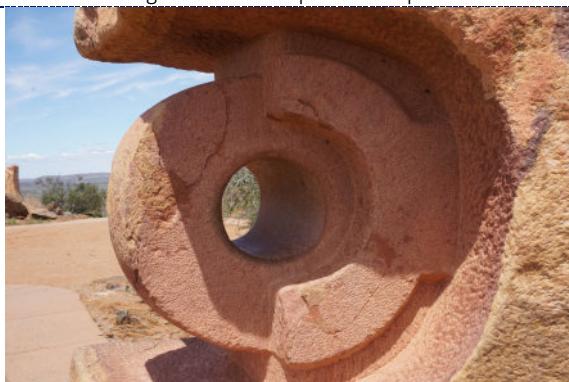
Figure 9: Detail – previous repair.

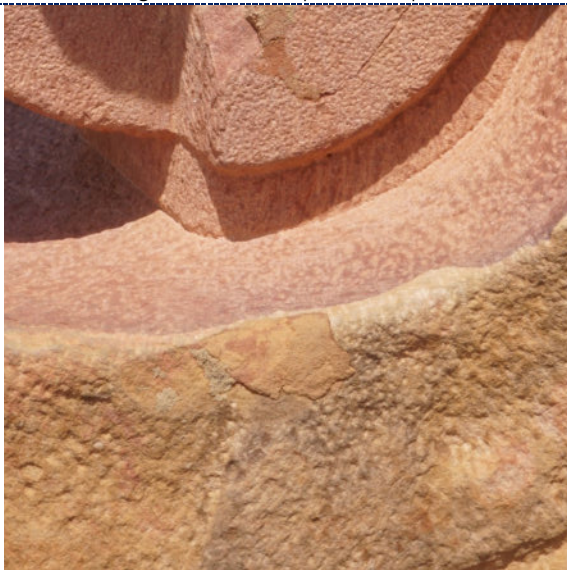
Figure 13: Detail – verso lower, previous repair.

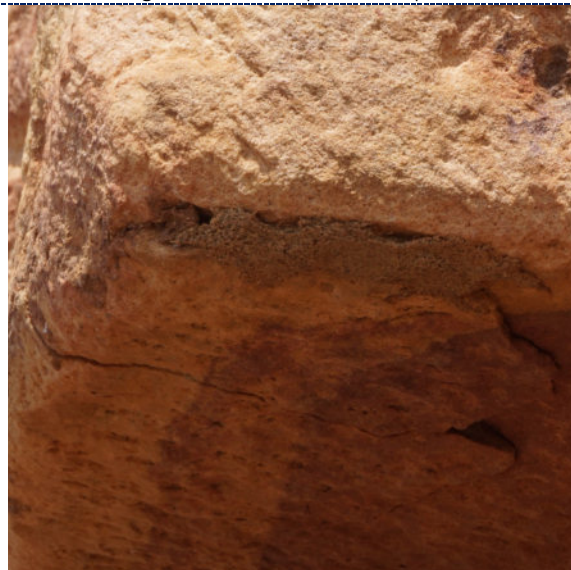
Figure 14: Detail – verso upper, previous repair.

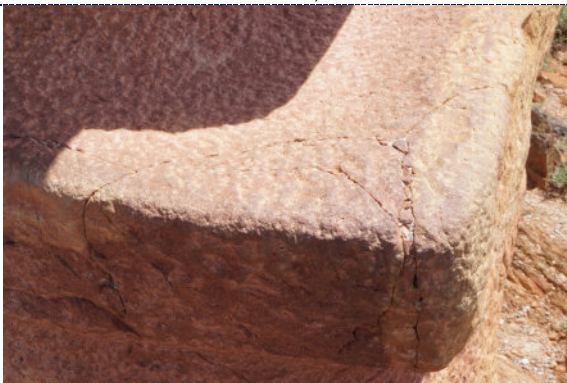
Figure 17: Detail – base, lower corner, cracks.

Recommended Remedial Treatment Works	Advised Cost
<ul style="list-style-type: none">• Consolidate cracks.• Fill areas of loss with colour-matched lime mortar.	~\$5,000

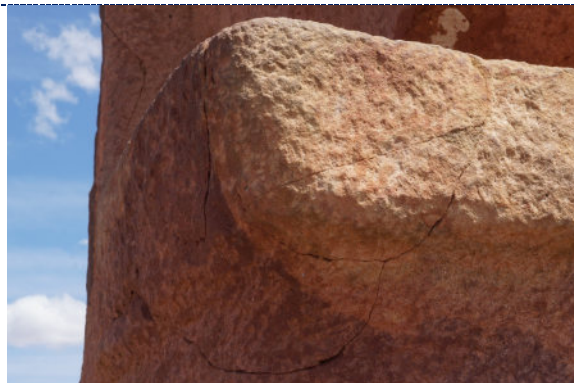
Figure 18: Detail – base, lower corner underside, cracks.

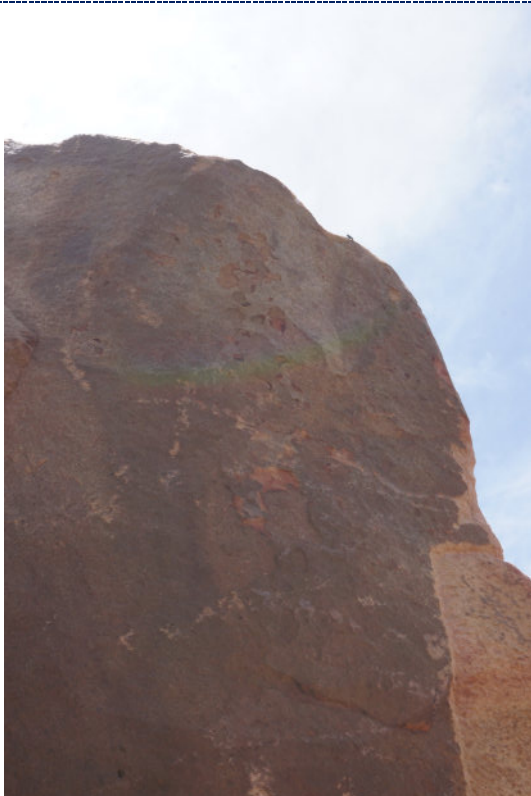
SURFACE/ COATING	MATERIALS:	
CONDITION	✓	NOTES
Abrasions/ dents		
Accretion		
Areas of loss	✓	Small areas of loss are evident throughout, particularly around previous repairs.
Corrosion		
Cracks	✓	Minor surface cracks visible throughout.
Delamination	✓	Stone delamination evident along several edges (fig. 20).
Dust/ dirt	✓	Minor dust and dirt visible, inherent to outdoor sculpture.
Fading		
Flaking/Friable		
Mould/ mould damage		
Pest damage	✓	Pest ootheca's (egg sacs) visibly embedded in recesses of sculpture (fig. 23).
Pitting		
Previous treatment		
Staining/ discolouration		
OTHER

Figure 21: Detail – surface delamination.

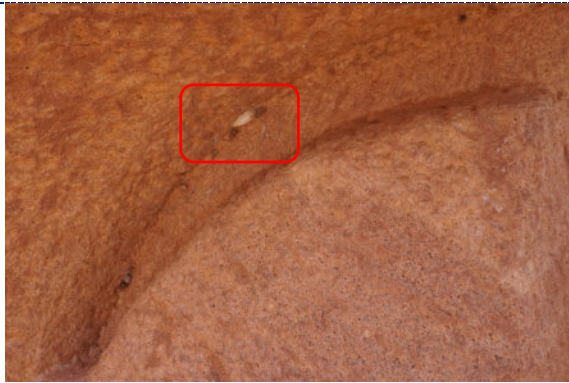
Figure 23: Detail – pest activity.

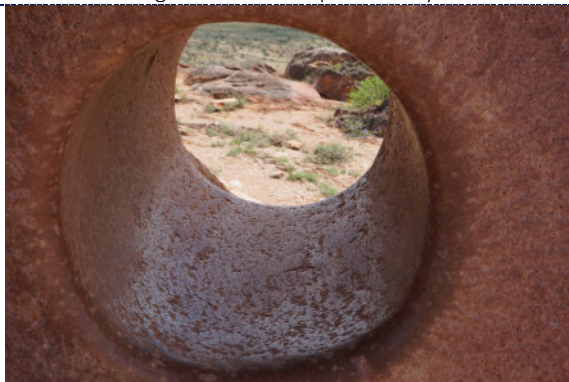
Wear/ polishing	✓	Surface wear is evident within the circular element, likely stemming from human interaction (fig. 25).
OTHER

Figure 25: Detail – surface polishing.

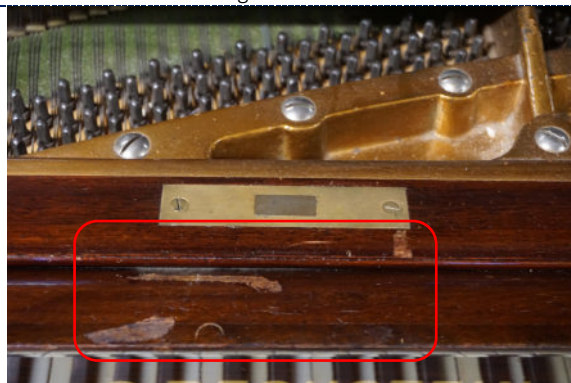
SURFACE/ COATING	MATERIALS:	
CONDITION	✓	NOTES
Abrasions/ dents	✓	Several surface abrasions resulting in loss to clear lacquer (figs. 3, 6).
Accretion		
Areas of loss	✓	Loss to clear lacquer (figs. 3, 6).
Corrosion		
Cracks		
Delamination		
Dust/ dirt	✓	Light dirt particulate observed throughout.
Fading		
Flaking/Friable		
Mould/ mould damage		
Pest damage		
Previous treatment		
Staining/ discolouration		
OTHER

Figure 3: Detail – dirt particulate and loss to clean lacquer coating.

Routine Maintenance	Frequency
<ul style="list-style-type: none">• Surface clean to remove dirt particulate.	1 years

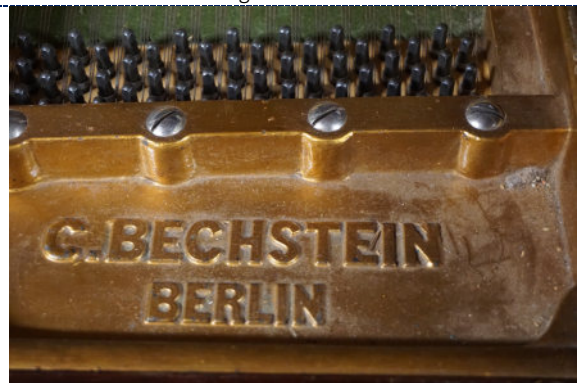
Figure 4: Detail – dirt particulate.

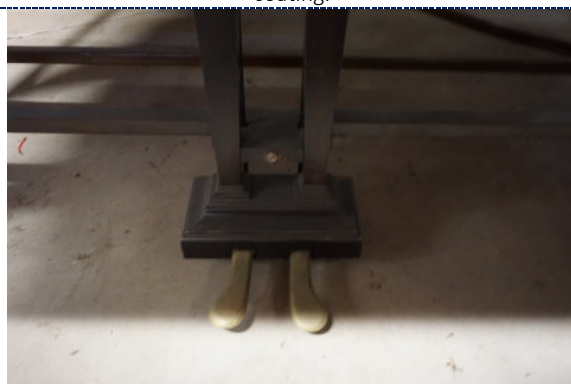
Figure 5: Detail – dirt particulate.

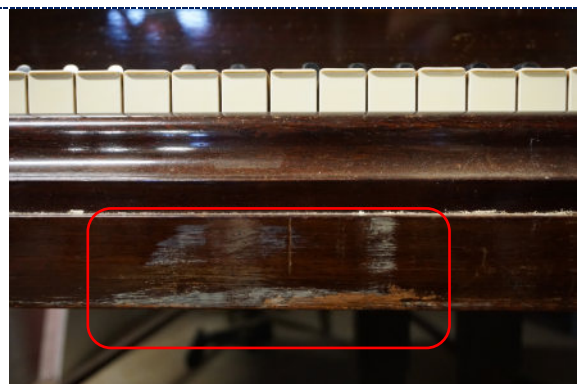
Figure 6: Detail – dirt particulate and loss to clean lacquer coating.

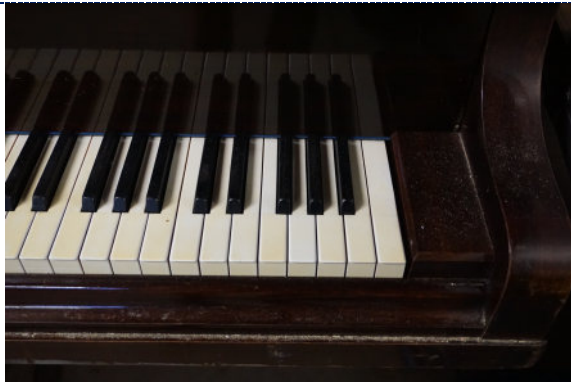
Figure 9: Detail – dirt particulate; yellowing keys.

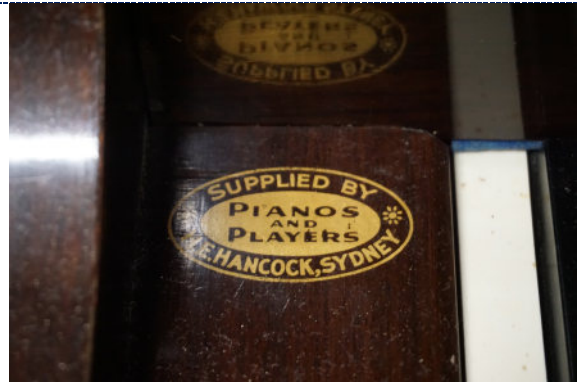
Figure 10: Detail – dirt particulate; piano supplier.

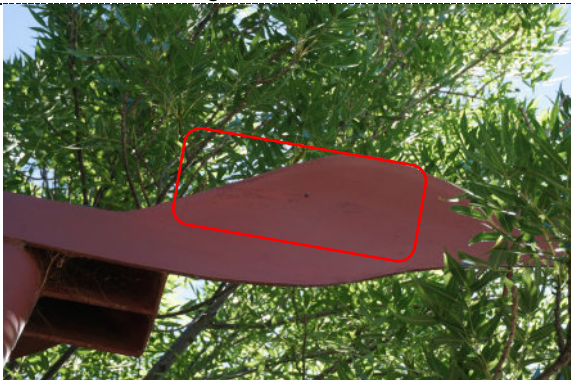
SURFACE/ COATING	MATERIALS:	
CONDITION	✓	NOTES
Abrasions/ dents	✓	Minor small abrasions evident throughout.
Accretion		
Areas of loss	✓	Loss and flaking paint observed throughout (figs. 5-8).
Corrosion	✓	Minor areas of surface corrosion where the paint layer is lost or perforated.
Cracks		
Delamination		
Dust/ dirt	✓	Dirt particulate and spider webs were observed throughout, consistent with display outdoors (fig. 7).
Fading	✓	Chalking and fading to the paint following exposure to sunlight and outdoor conditions (fig. 8).
Flaking/Friable	✓	Flaking and peeling paint (fig. 8).
Mould/ mould damage		
Pest damage		
Previous treatment	✓	The sculpture appears to have been repainted at least once (figs. 7-8) due to the slightly different hue between the two paint layers.
Staining/ discolouration		
OTHER

Figure 5: Detail – flaking paint loss.

Recommended Remedial Treatment Works	Advised Cost
<ul style="list-style-type: none">Remove or reduce failing and flaking paint.Stabilise surface corrosion where needed.Repaint in a paint system rated for use on outdoor metals and colour-matched with the original.	~\$2,500

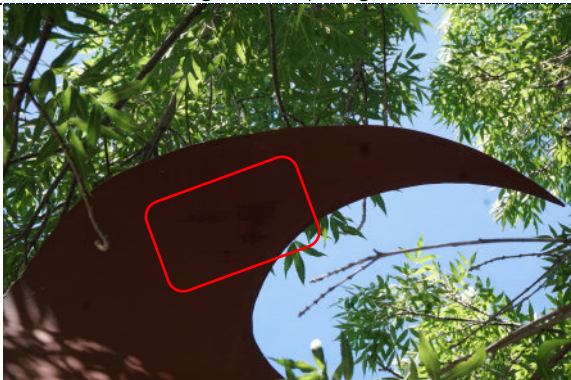
Figure 6: Detail – flaking paint loss.

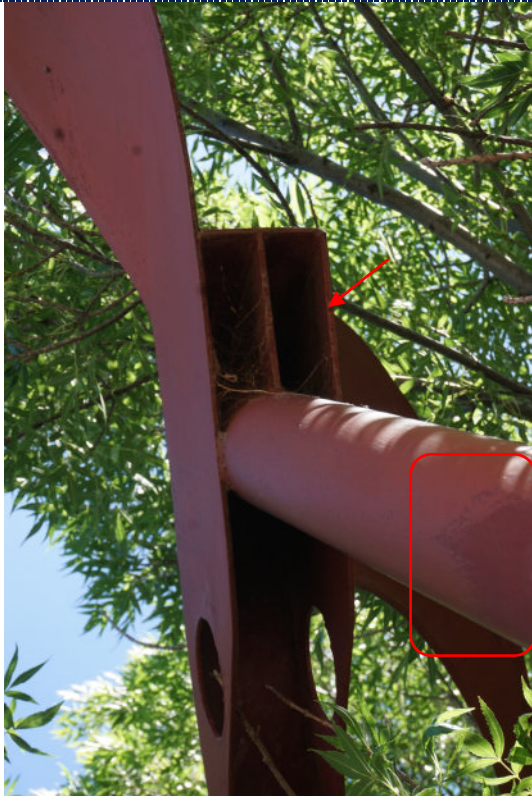
Figure 7: Detail – dirt particulate, spider webs. The two shades of red paint suggest the surface was repainted.

Routine Maintenance	Frequency
<ul style="list-style-type: none">Surface clean to remove dirt particulate and accumulation of biomatter from adjacent trees.	1 year

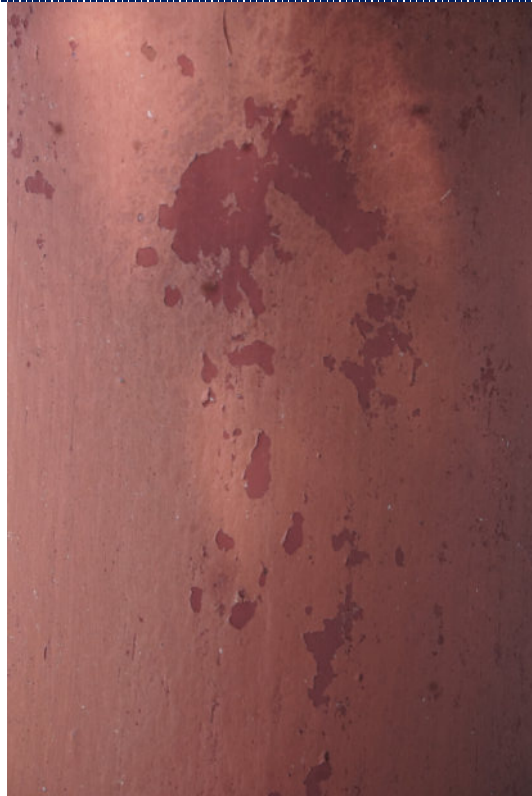
Figure 8: Detail – flaking paint loss; paint chalking. The two shades of red paint suggest the surface was repainted.

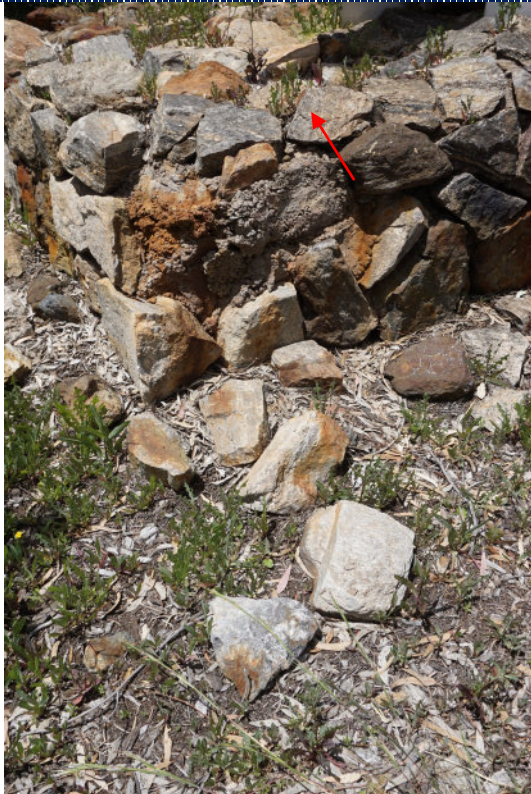
Figure 5: Detail – stones separated from the plinth; biogrowth in crevices (arrow).

Routine Maintenance	Frequency
<ul style="list-style-type: none"> • Surface clean to remove dirt particulate and bird excrement. • Touch up paint as needed. • Keep biomatter and biogrowth in the vicinity curated. 	1 year

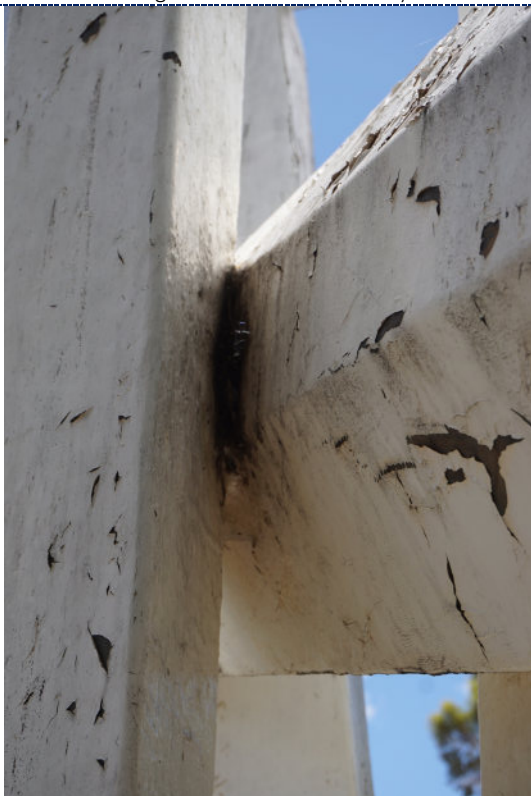
PRIMARY STRUCTURE	MATERIALS:	
CONDITION	✓	NOTES
Abrasions/ dents		
Areas of loss/ detached or missing component	✓	Significant paint loss observed throughout (figs. 6-18). At least one of the iron protruding "spikes" is missing (fig. 18).
Corrosion	✓	Iron corrosion product staining evident on the fiberglass and white painted surfaces indicates corrosion to the internal iron armature around which the figure has been sculpted (figs. 6,12-14,16-17).
Cracks/ splitting		
Disjoin/ Loose component	✓	Several stones comprising the plinth have separated from the concrete binder (fig. 5).
Distortion		
Pest damage		
Previous treatment/ repair		
Rotting		
Wear/ polishing

Figure 7: Detail – dirt particulate and surface paint loss and crazing.

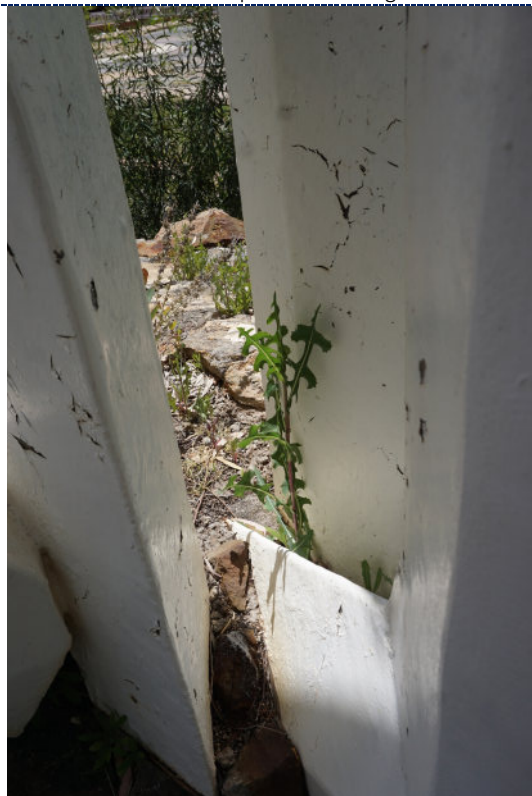
Figure 8: Detail – dirt particulate and surface paint loss and crazing; biogrowth in crevices.

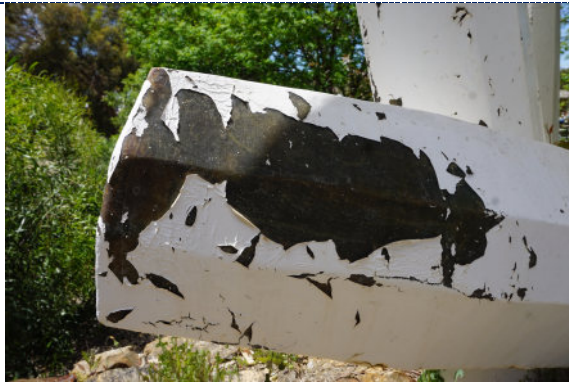
Figure 9: Detail – dirt particulate and significant surface paint loss and crazing.

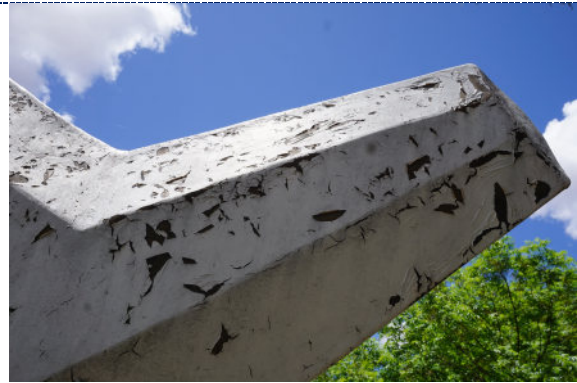
Figure 10: Detail – dirt particulate and significant surface paint loss and crazing.

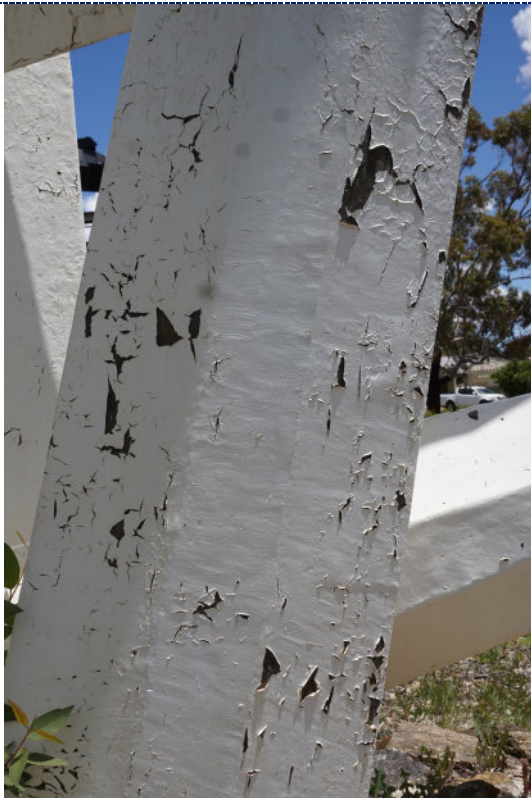
Figure 11: Detail – dirt particulate and significant surface paint loss and crazing.

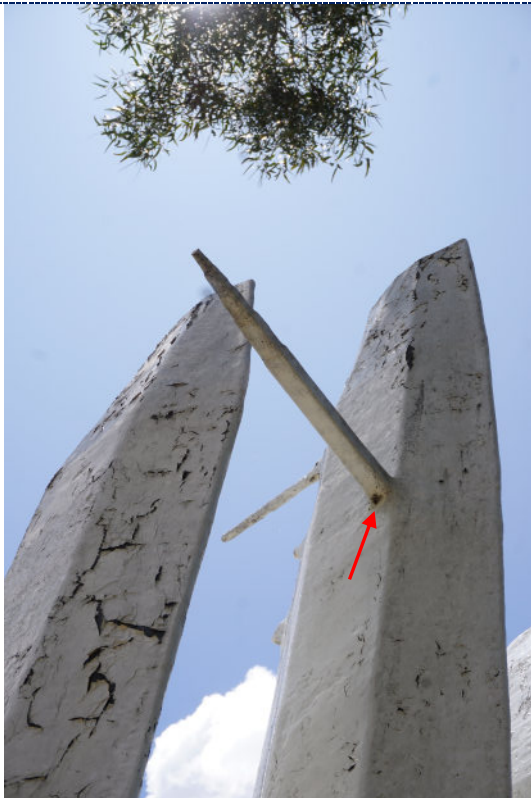
Figure 17: Detail – dirt particulate and significant surface paint loss and crazing; iron corrosion product staining (arrow).

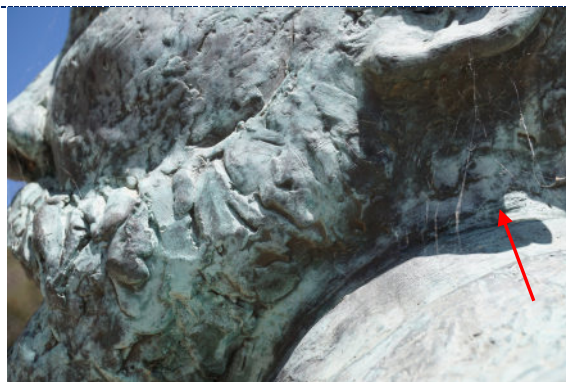
Figure 10: Detail – atmospheric pollution-driven copper corrosion product, dirt particulate, spider webs.

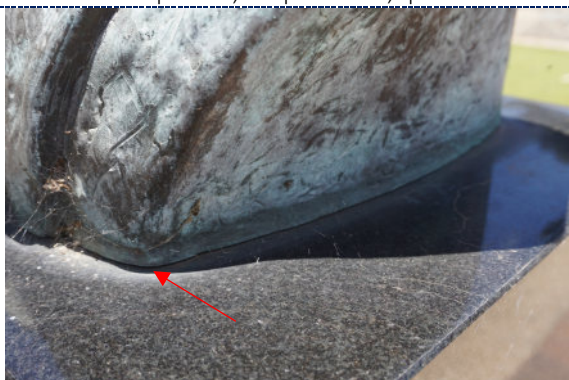
Figure 13: Detail – atmospheric pollution-driven copper corrosion product, dirt particulate, spider webs.

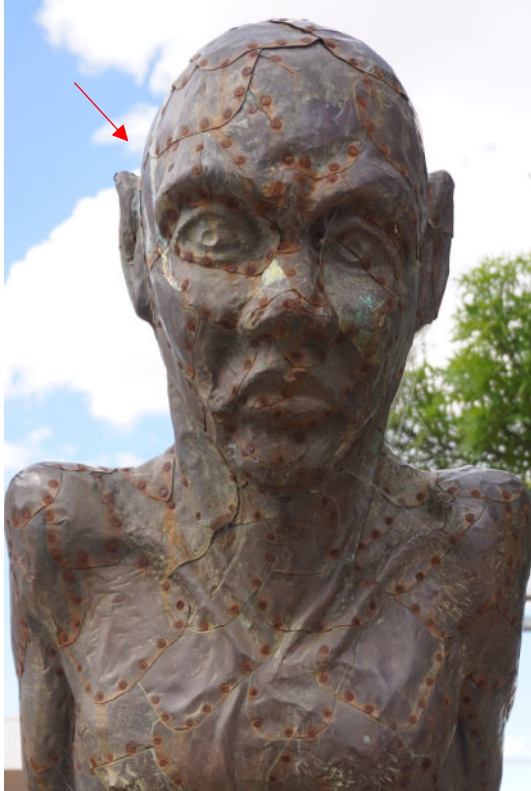
Figure 7: Detail – exterior, isolated surface corrosion products; corroded iron nail heads; bird excrement (arrow).

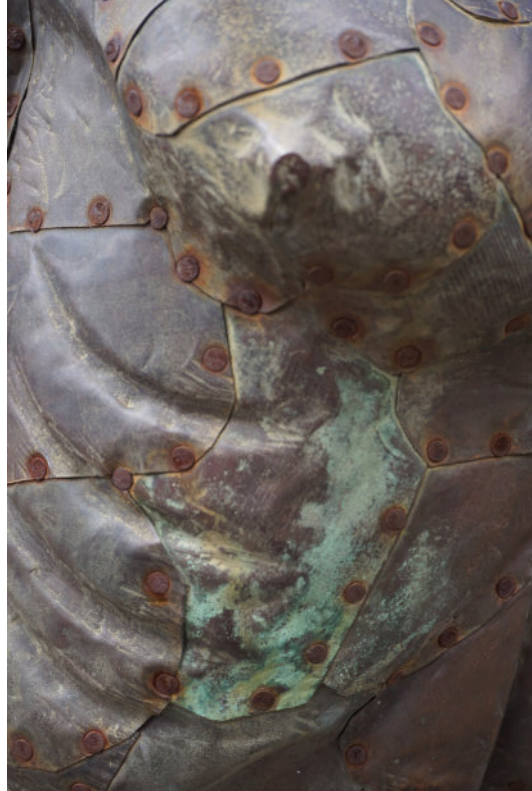
Figure 8: Detail – exterior, surface corrosion products; corroded iron nail heads.

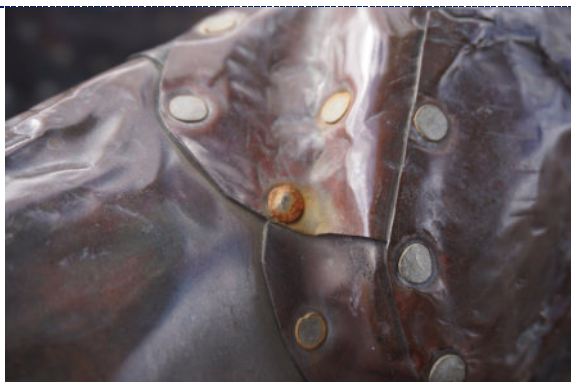
Figure 11: Detail – exterior, corroding zinc-plated nail.

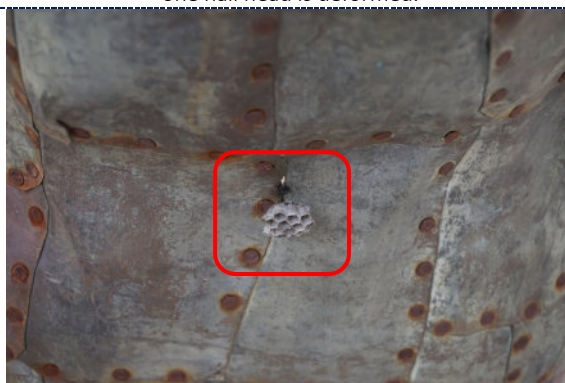
SURFACE/ COATING	MATERIALS:	
CONDITION	✓	NOTES
Abrasions/ dents		
Accretion		Small wasp nest observed on the bottom of the canoe (fig. 14).
Areas of loss		
Corrosion	✓	Minor surface corrosion evident throughout, but particularly in internal areas where water can pool (figs. 16, 19-21, 23-24). Bird excrement, which is acidic, has also etched surfaces where it is found (figs. 6-7, 9-10, 15, 25-26).
Cracks		
Delamination		
Dust/ dirt	✓	Dirt particulate, bird excrement and spider webs were observed throughout, consistent with display outdoors. Biomatter is clogging both drains designed to remove water from the interior of the canoe (figs. 19, 21-22, 29-30).
Fading		
Flaking/Friable		
Mould/ mould damage		
Pest damage		
Previous treatment		
Staining/ discolouration	✓	Iron corrosion product staining stemming from corroding nails (figs. 12, 28, 31, 34).
OTHER

Figure 14: Detail – exterior-bottom, isolated surface corrosion products; corroded iron vs zinc plated nail heads; small wasp nest.

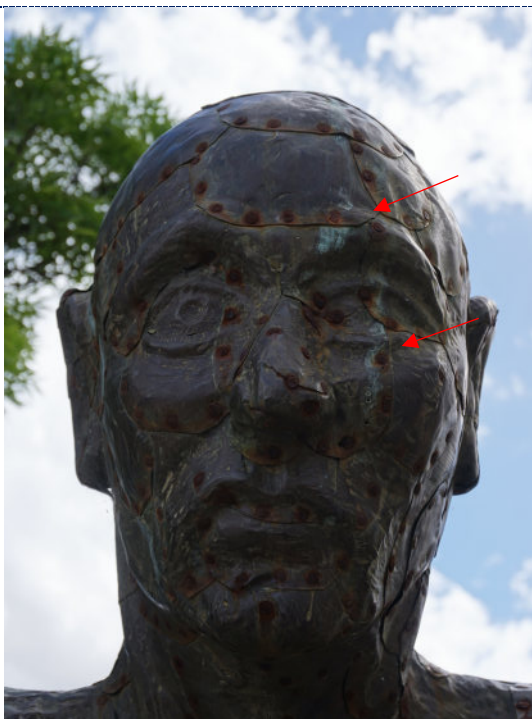
Figure 15: Detail – exterior, isolated surface corrosion products; corroded iron nail heads.

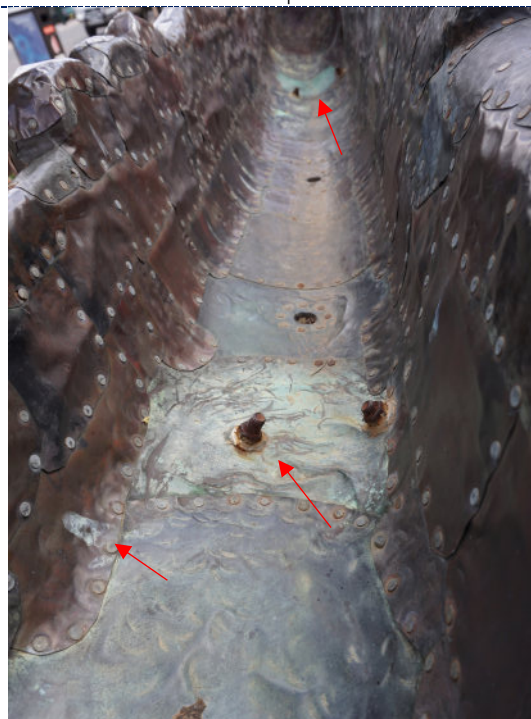
Figure 16: Detail – interior, dirt particulate, green copper corrosion in areas where water pools; corroded bolts where mounts are attached; bird excrement.

Recommended Remedial Treatment Works	Advised Cost
<p>Remedial works should aim to:</p> <ul style="list-style-type: none">• Surface clean to remove dirt particulate.• Remove loose surface corrosion product.• Clear clogged drains.• Replace perforated copper plate.• Replace corroding nails, where failing. <p>It is recommended that artist is contacted, if possible, to discuss their interest in restoring the work.</p>	~\$5,000-\$10,000

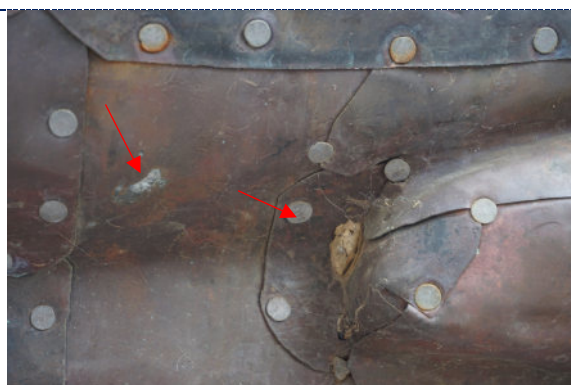
Figure 17: Detail – exterior, dirt particulate, spider webs; minor corrosion to zinc nail heads; isolated surface corrosion.

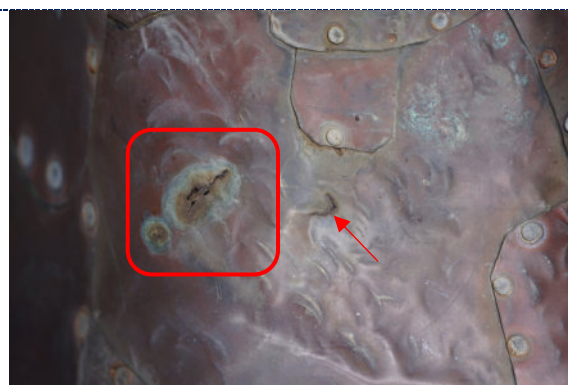
Figure 18: Detail – exterior, corrosion perforating copper plate; minor corrosion to zinc nail heads.

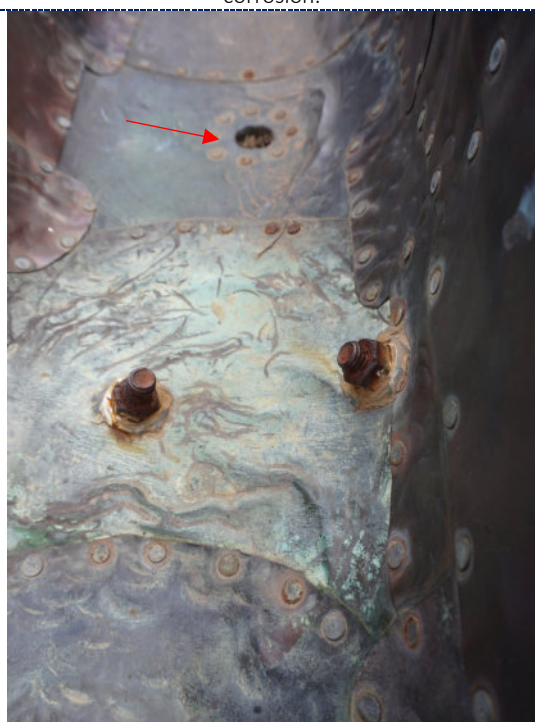
Figure 19: Detail – interior, dirt particulate, green copper corrosion in areas where water pools; corroded bolts where mounts are attached; biomatter clogging drains.

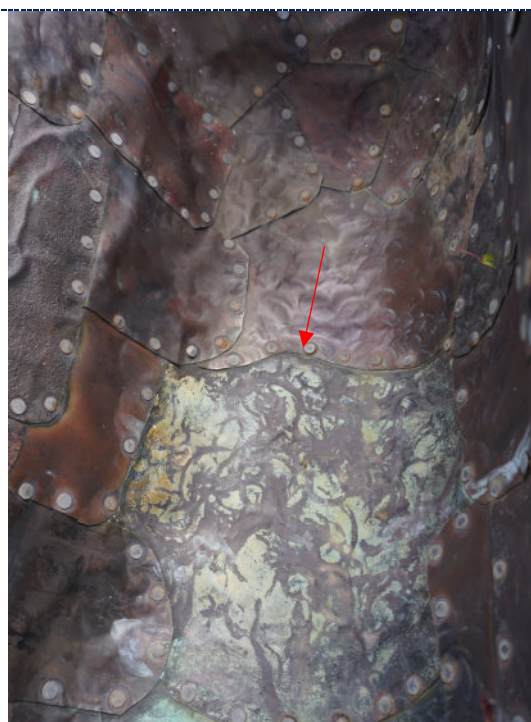
Figure 20: Detail – interior, dirt particulate, green copper corrosion in areas where water pools.

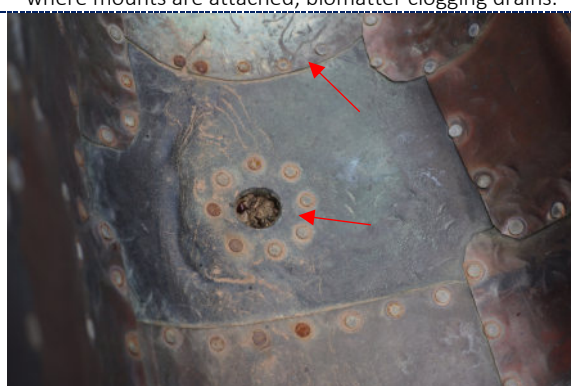
Figure 21: Detail – interior, dirt particulate, green copper corrosion in areas where water pools; biomatter clogging drains.

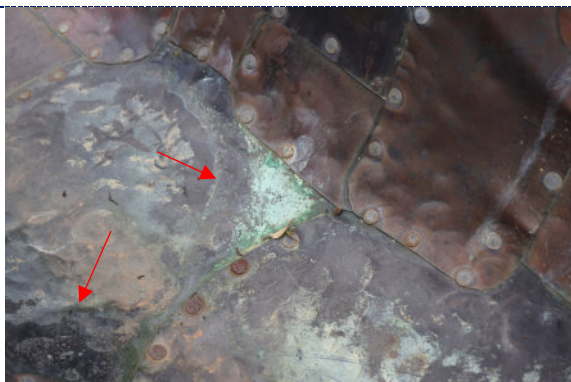
Figure 23: Detail – interior, dirt particulate, green copper corrosion in areas where water pools.

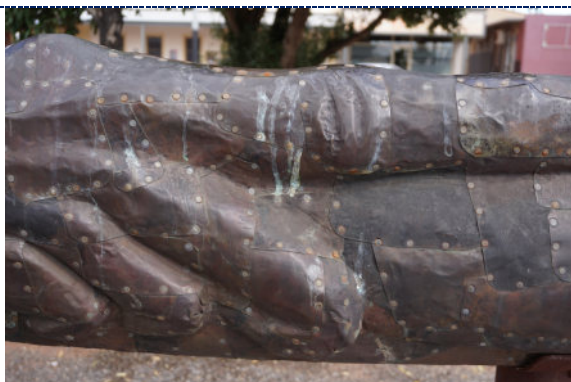
Figure 25: Detail – exterior, dirt particulate; copper corrosion product stemming from bird excrement.

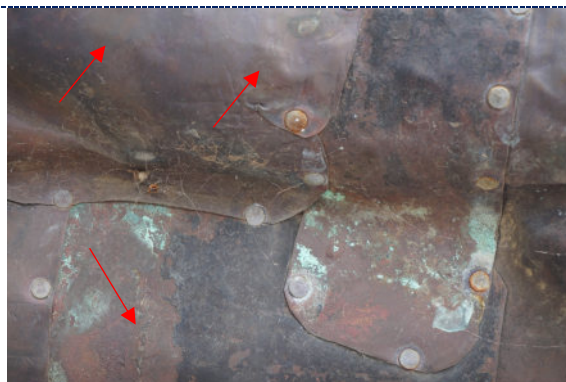
Figure 26: Detail – exterior, dirt particulate, spider webs; minor corrosion to zinc nail heads; isolated surface corrosion.

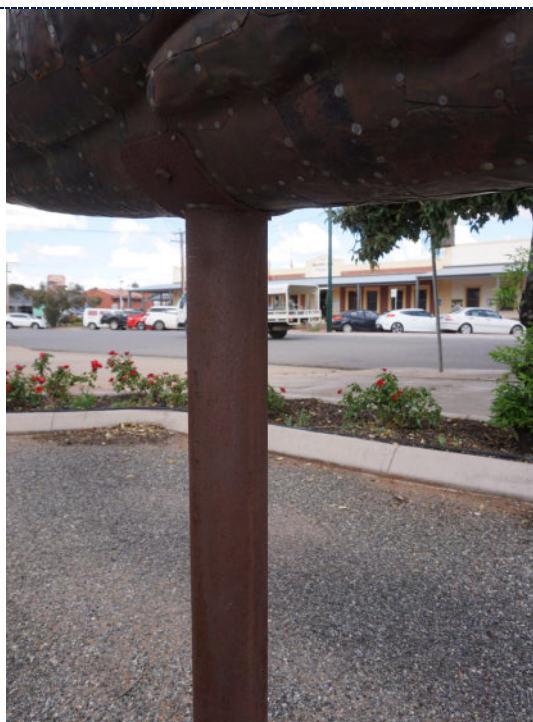
Figure 27: Detail – exterior, surface corrosion on iron mount.

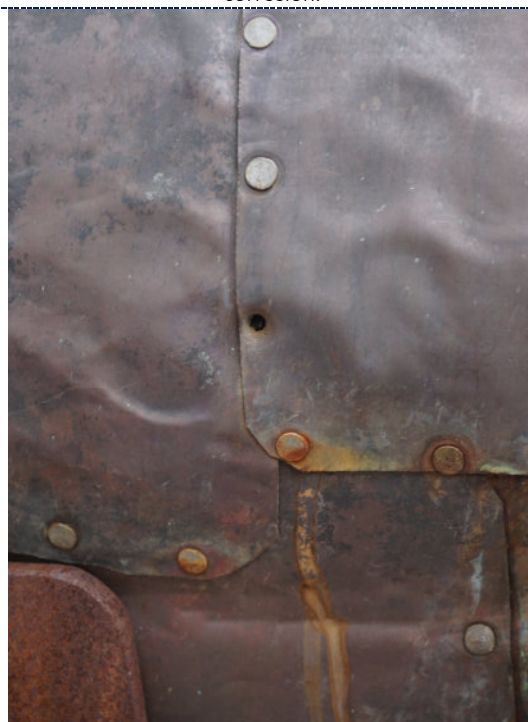
PRIMARY STRUCTURE	MATERIALS:	
CONDITION	✓	NOTES
Abrasions/ dents	✓	Numerous dents are evident throughout, however these appear consistent with shaping of the copper substrate during manufacture.
Areas of loss/ detached or missing component	✓	Missing nails located throughout (figs. 28, 31-32, 34); corrosion product that has perforated thin copper plate (figs. 18). This may stem from the collection of water underneath the copper plate.
Corrosion	✓	Copper corrosion resulting in perforation to one plate is evident (fig. 18). Iron nails fixing the copper plates to the wooden substrate also exhibit significant corrosion (figs. 5, 7-15, 28-34). Iron bolts fixing the canoe to the stands exhibit corrosion (figs. 16, 19, 24).
Cracks/ splitting		
Disjoin/ Loose component		
Distortion	✓	Several of the copper plates exhibit minor distortion as the wooden substrate gradually moves (due to the anisotropic nature of wood).

Figure 28: Detail – exterior, missing nail; corroding zinc-iron nails and iron corrosion staining.

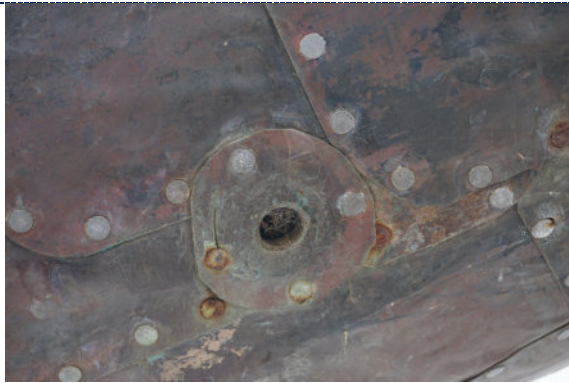
Figure 29: Detail – exterior, dirt particulate, spider webs; corrosion to zinc nail heads; biomatter clogging drains.

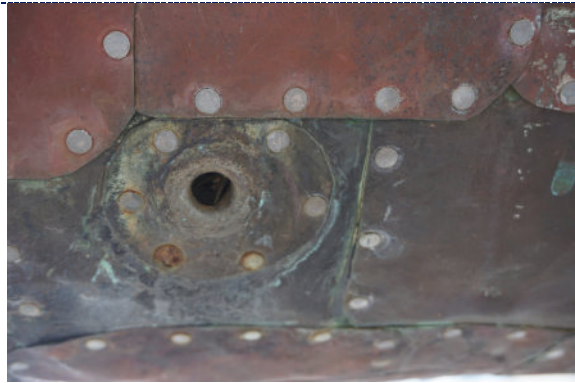
Figure 30: Detail – exterior, dirt particulate, spider webs; corrosion to zinc nail heads; biomatter clogging drains.

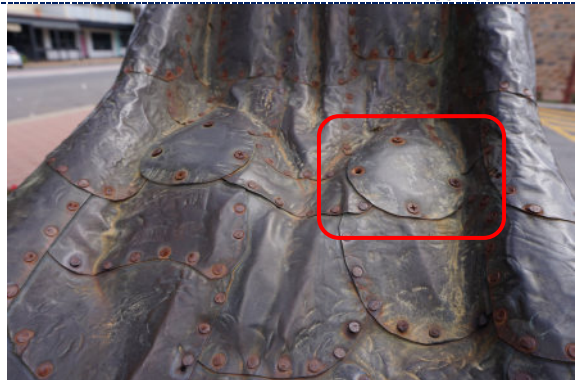
Figure 32: Detail – interior, dirt particulate, corroded iron nails and screws; one screw missing; iron corrosion product staining.
