Broken Hill Public Art Condition Survey and Conservation Plan

Prepared for: Broken Hill City Council
Submission Date: February 2023

This report presents the results of a condition survey assessing the works held within Broken Hill City Council's public art collection. A total of 56 works were condition assessed.

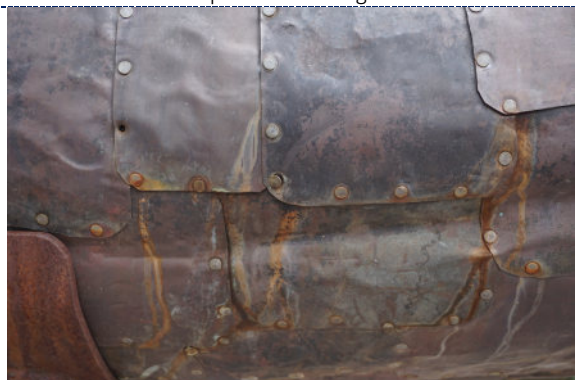
PRIMARY STRUCTURE	MATERIALS:	
CONDITION	✓	NOTES
Abrasions/ dents	✓	Numerous dents are evident throughout, however these appear consistent with shaping of the copper substrate during manufacture.
Areas of loss/ detached or missing component	✓	Missing nails located throughout (figs. 28, 31-32, 34); corrosion product that has perforated thin copper plate (figs. 18). This may stem from the collection of water underneath the copper plate.
Corrosion	✓	Copper corrosion resulting in perforation to one plate is evident (fig. 18). Iron nails fixing the copper plates to the wooden substrate also exhibit significant corrosion (figs. 5, 7-15, 28-34). Iron bolts fixing the canoe to the stands exhibit corrosion (figs. 16, 19, 24).
Cracks/ splitting		
Disjoin/ Loose component		
Distortion	✓	Several of the copper plates exhibit minor distortion as the wooden substrate gradually moves (due to the anisotropic nature of wood).

SURFACE/ COATING	MATERIALS:	
CONDITION	✓	NOTES
Abrasions/ dents		
Accretion		Small wasp nest observed on the bottom of the canoe (fig. 14).
Areas of loss		
Corrosion	✓	Minor surface corrosion evident throughout, but particularly in internal areas where water can pool (figs. 16, 19-21, 23-24). Bird excrement, which is acidic, has also etched surfaces where it is found (figs. 6-7, 9-10, 15, 25-26).
Cracks		
Delamination		
Dust/ dirt	✓	Dirt particulate, bird excrement and spider webs were observed throughout, consistent with display outdoors. Biomatter is clogging both drains designed to remove water from the interior of the canoe (figs. 19, 21-22, 29-30).
Fading		
Flaking/Friable		
Mould/ mould damage		
Pest damage		
Previous treatment		
Staining/ discolouration	✓	Iron corrosion product staining stemming from corroding nails (figs. 12, 28, 31, 34).
OTHER

Figure 34: Detail – exterior, missing and loose nail; corroding zinc-iron nails; significant iron corrosion staining.

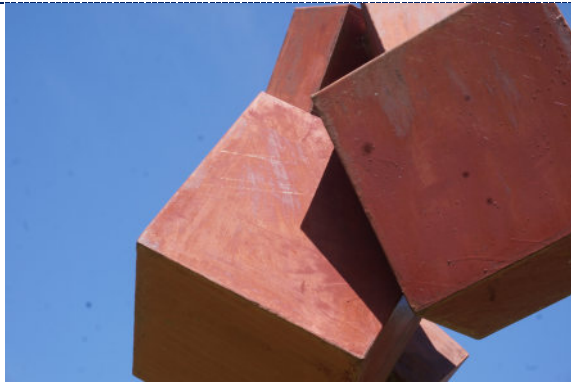
Figure 5: Detail – paint chalking, flaking paint loss with overpaint.

Recommended Remedial Treatment Works	Advised Cost
<ul style="list-style-type: none">Remove or reduce failing and flaking paint.Stabilise surface corrosion where needed.Repaint in a paint system rated for use on outdoor metals and colour-matched with the original.	~\$2,500

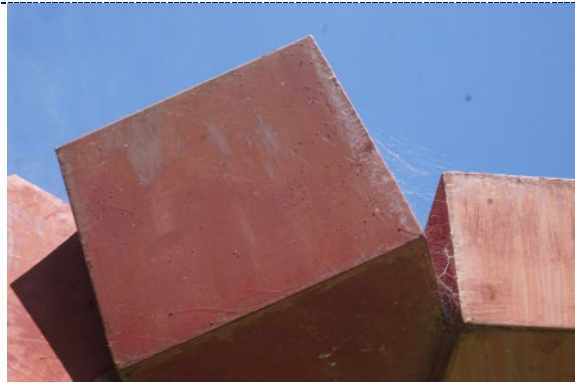
Figure 6: Detail – paint chalking, flaking paint loss with overpaint; spider webs.

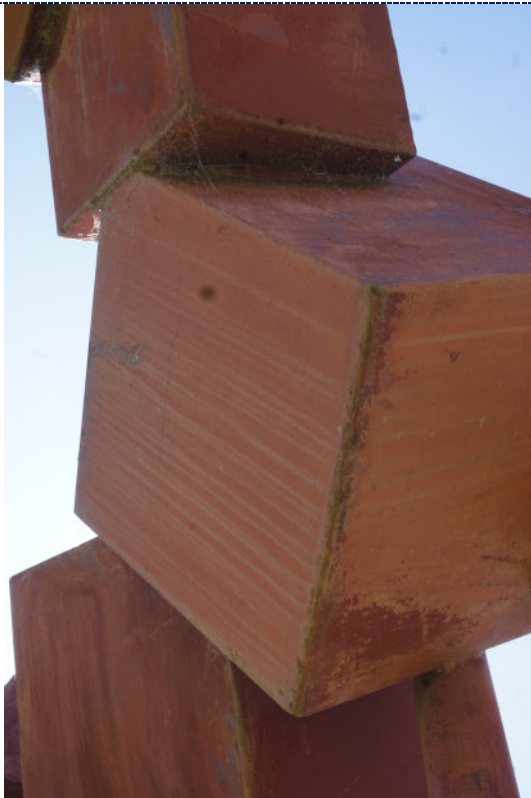
Figure 7: Detail – paint chalking, flaking paint loss with overpaint; dirt particulate and spider webs.

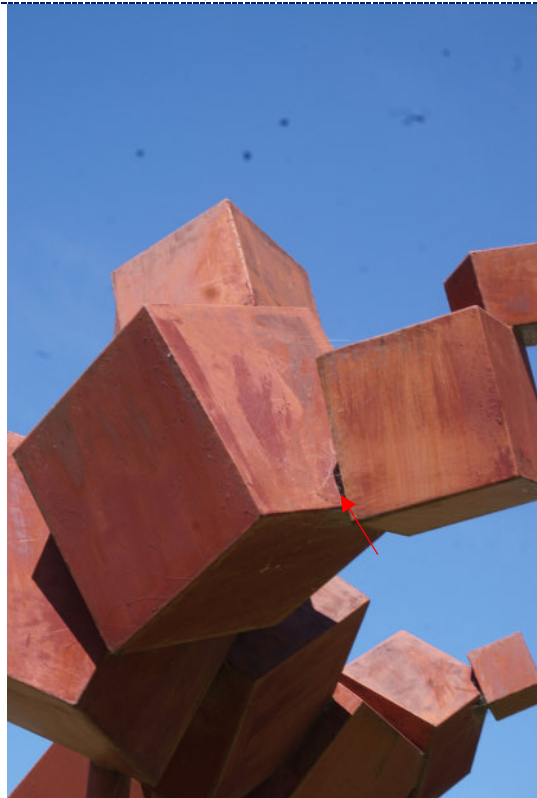
Figure 8: Detail – paint chalking, flaking paint loss with overpaint; dirt particulate and spider webs. The two shades of red paint suggest the surface was repainted.

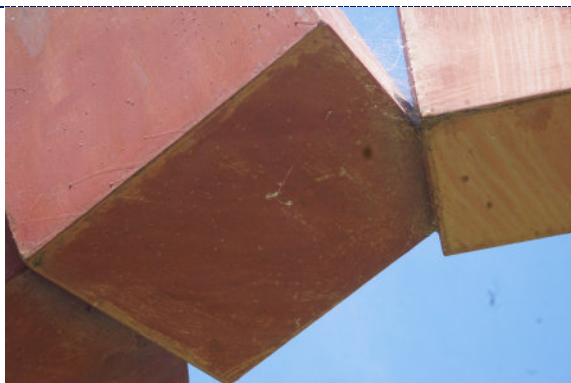
Figure 9: Detail – paint chalking, flaking paint loss with overpaint; dirt particulate and spider webs.

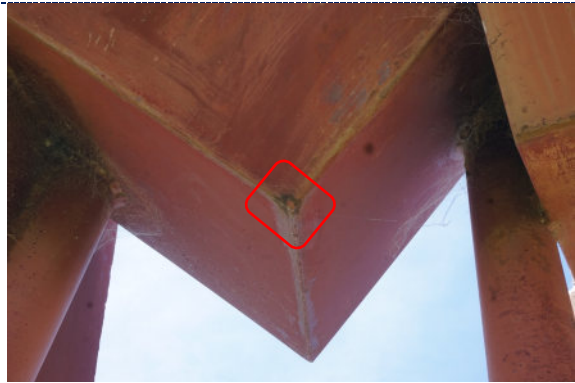
Figure 12: paint chalking, flaking paint loss with overpaint; dirt particulate and spider webs; surface corrosion at corner (circle).

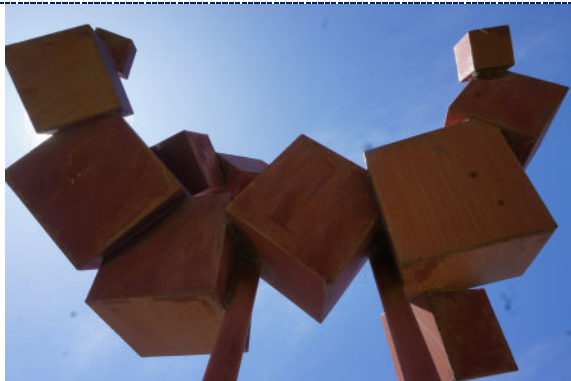
Figure 13: Detail – paint chalking, flaking paint loss with overpaint; dirt particulate and spider webs. The two shades of red paint suggest the surface was repainted.

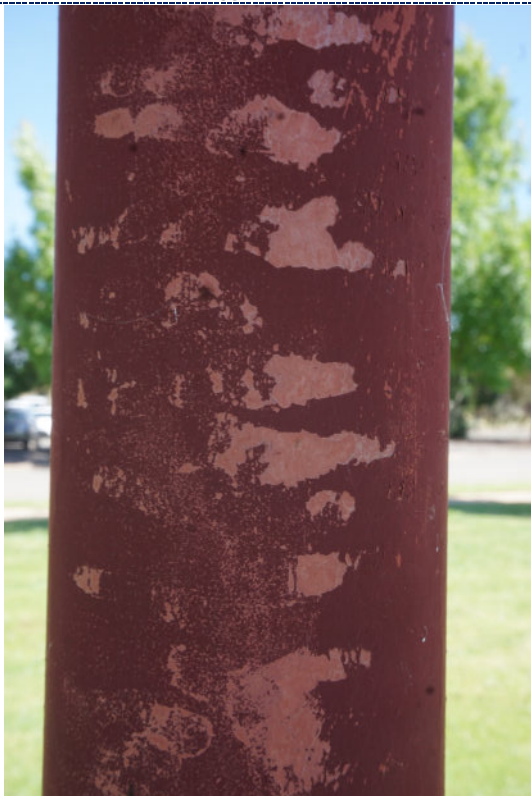
Figure 15: Detail – flaking paint and paint loss.

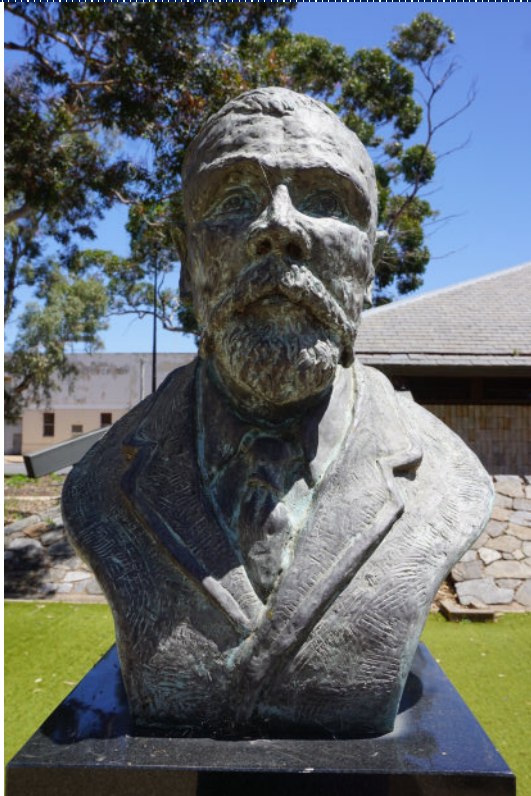
Figure 5: Detail – bust, front. Atmospheric pollution-driven copper corrosion product on bronze figure.

Recommended Remedial Treatment Works	Advised Cost
<ul style="list-style-type: none">• Surface clean to remove dirt particulate and loose corrosion product.• Reduce atmospheric corrosion product.• Wax bronze and copper alloy components.	~\$1,000

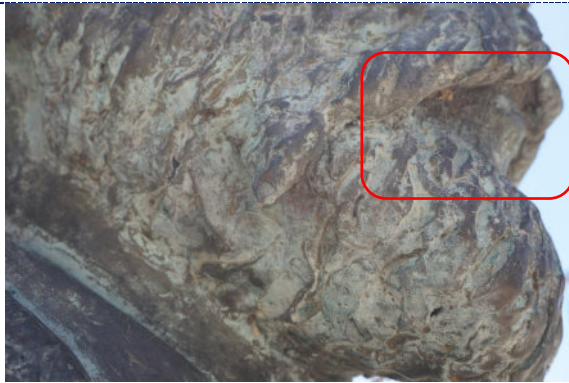
Figure 9: Detail – atmospheric pollution-driven copper corrosion product, dirt particulate, spider webs.

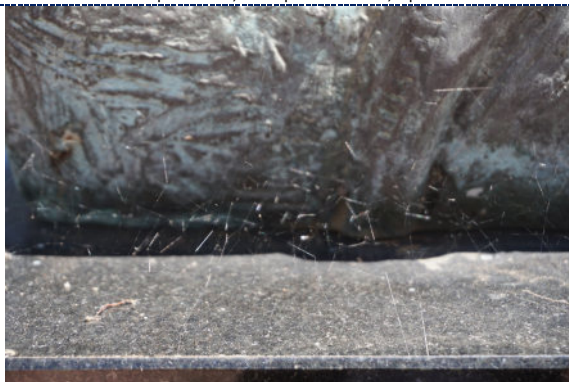
Figure 11: Detail – atmospheric pollution-driven copper corrosion product, dirt particulate, spider webs.

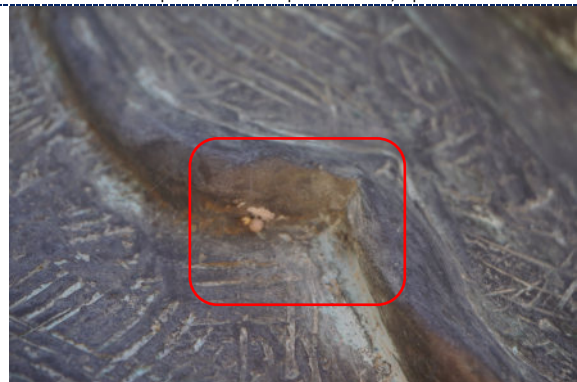
Figure 12: Detail – atmospheric pollution-driven copper corrosion product, dirt particulate, spider webs.

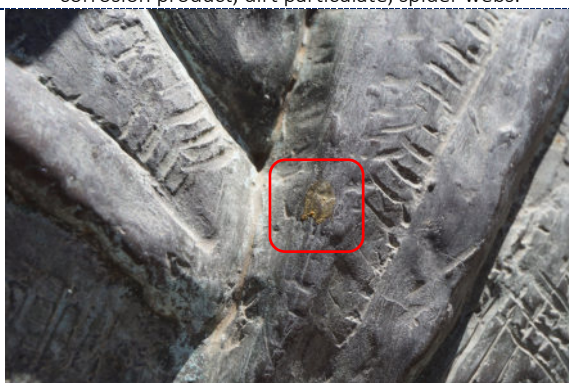
Figure 13: Detail – atmospheric pollution-driven copper corrosion product and bird excrement.

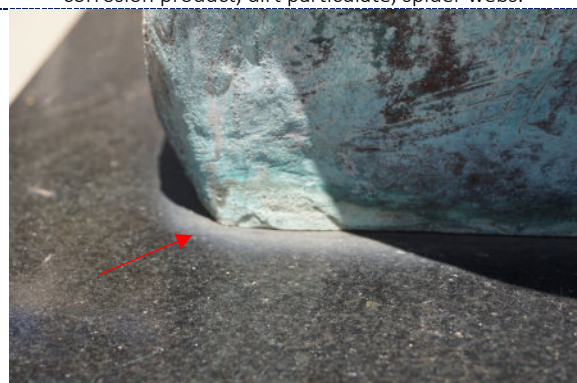
Figure 14: Detail – increased copper corrosion product stemming from collected water at plinth interface.

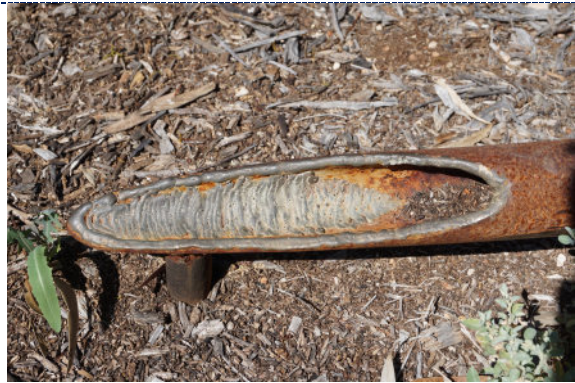
Figure 6: Detail – dirt particulate within tube; surface corrosion.

Routine Maintenance	Frequency
<ul style="list-style-type: none">• Surface clean to remove dirt particulate and accumulation of biomatter from adjacent trees.• Keep biomatter cleaned from object base.• Check for increased corrosion at base due to accumulation of biomatter and where iron is mounted into the ground	<div>1 year</div> <div>1 year</div> <div>1 year</div>

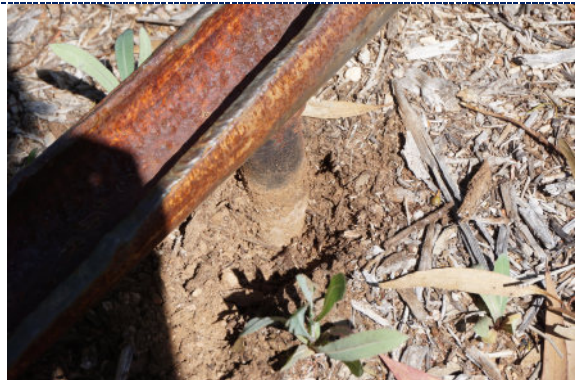
Figure 8: Detail – dirt particulate; rolled steel mounted at ground; accumulation of biomatter.

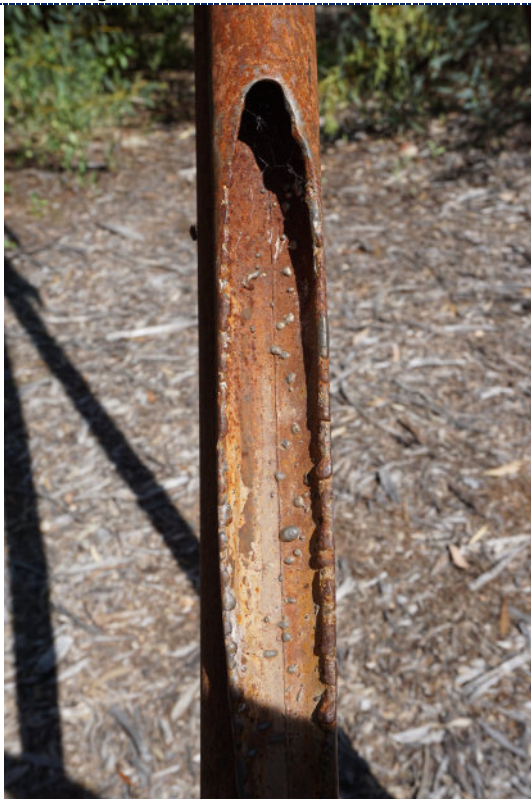
Figure 9: Detail – dirt particulate; surface corrosion.

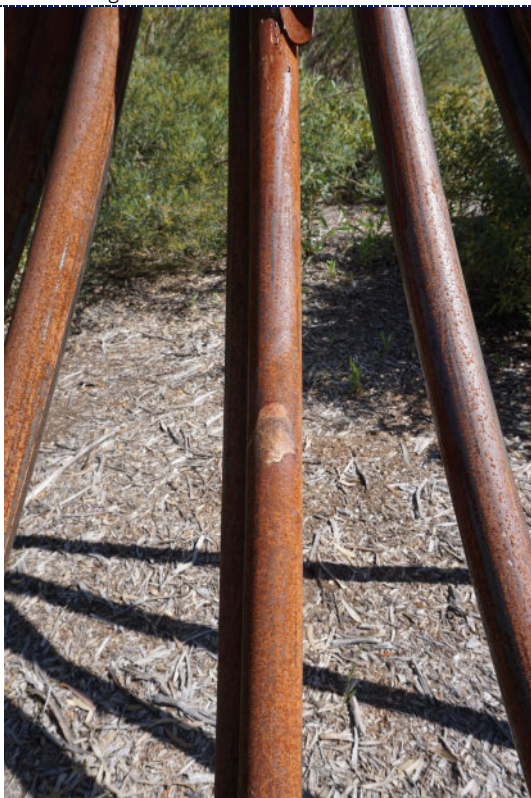
Figure 13: Detail – bird excrement; surface corrosion.

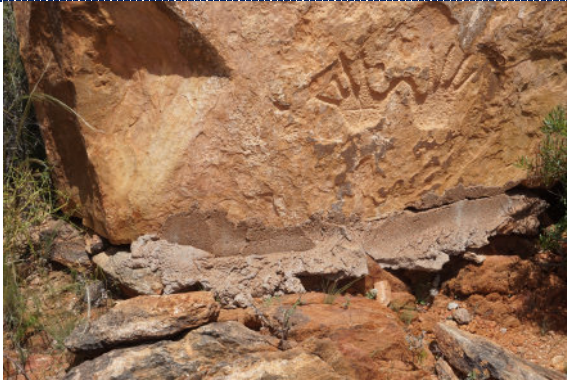
Figure 5: Detail – possible erosion to soil under concrete mortar.

Routine Maintenance	Frequency
<ul style="list-style-type: none">• Surface clean to remove dirt particulate and avian guano.• Monitor possible stone delamination.• Monitor possible soil erosion.	Biennially 2 years 2 years

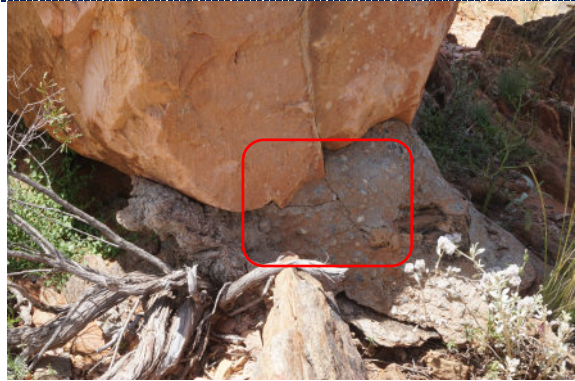
Figure 6: Detail – several small cracks to concrete mortar.

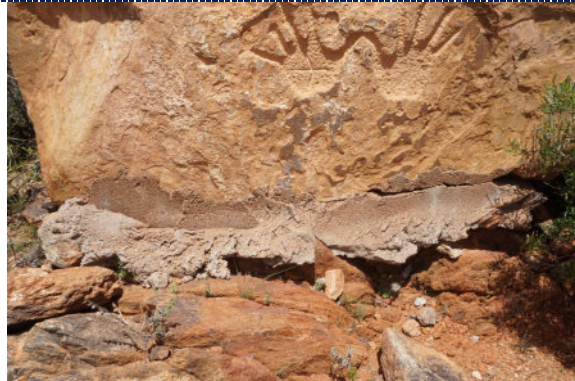
Figure 8: Detail – possible erosion to soil under concrete mortar.

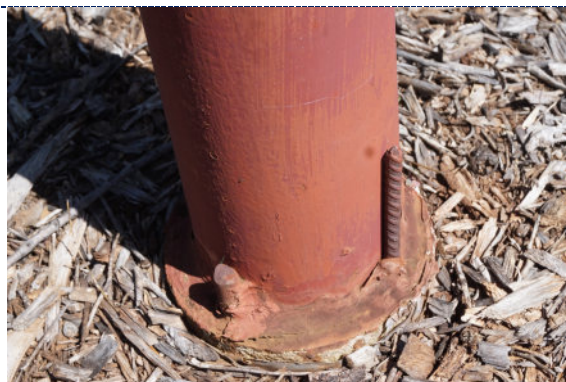
SURFACE/ COATING	MATERIALS:	
CONDITION	✓	NOTES
Abrasions/ dents	✓	Minor small abrasions evident throughout.
Accretion		
Areas of loss	✓	Loss and flaking paint observed throughout (figs. 5-9).
Corrosion	✓	Minor areas of surface corrosion where the paint layer is lost or perforated. Some blistering also noted (figs. 5, 7).
Cracks		
Delamination		
Dust/ dirt	✓	Dirt particulate and spider webs were observed throughout, consistent with display outdoors (fig. 9).
Fading	✓	Chalking and fading to the paint following exposure to sunlight and outdoor conditions (figs. 5-9).
Flaking/Friable	✓	Flaking and peeling paint (fig. 5-9).
Mould/ mould damage		
Pest damage		
Previous treatment	✓	The sculpture appears to have been repainted at least once (figs. 5-9) due to the slightly different hue between the two paint layers.
Staining/ discolouration		
OTHER

Figure 6: Detail – paint chalking, flaking paint loss with overpaint; corrosion at base.

Recommended Remedial Treatment Works	Advised Cost
<ul style="list-style-type: none">Remove or reduce failing and flaking paint.Stabilise surface corrosion where needed.Repaint in a paint system rated for use on outdoor metals and colour-matched with the original.	~\$2,500

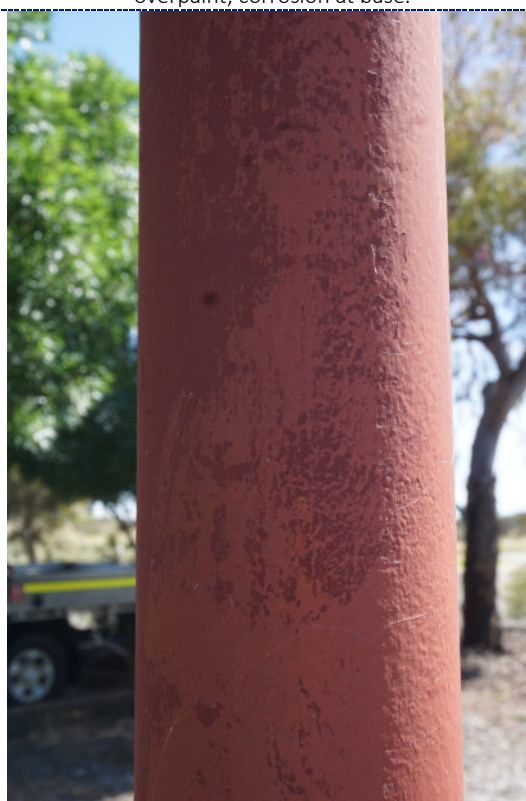
Figure 8: Detail – paint chalking, flaking paint loss with overpaint.

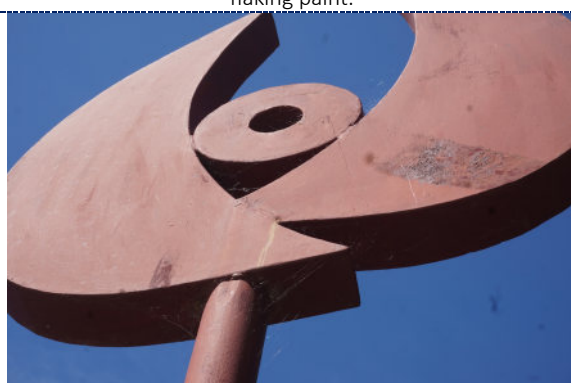
Figure 9: Detail – paint chalking, flaking paint loss with overpaint; dirt particulates and spider webs.

Routine Maintenance	Frequency
<ul style="list-style-type: none">Surface clean to remove dirt particulate and accumulation of biomatter from adjacent trees.	1 year

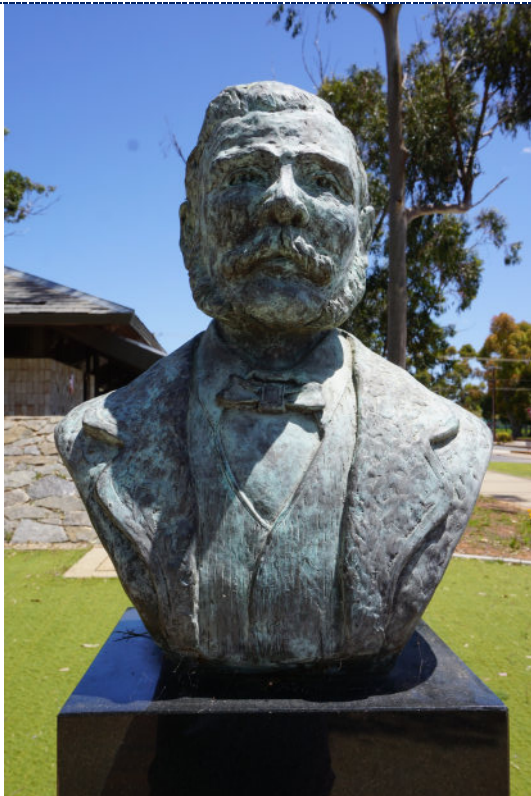
OTHER	
SURFACE/ COATING	MATERIALS:
CONDITION	<div><div>✓</div>NOTES</div>
Abrasions/ dents	
Accretion	
Areas of loss	
Corrosion	<div><div>✓</div>Surface corrosion is evident throughout the bronze figure and appears consistent with atmospheric pollution-driven mechanisms (figs. 5-14).</div>
Cracks	
Delamination	
Dust/ dirt	<div><div>✓</div>Dirt particulate (figs. 9-14) and spider webs were observed throughout, consistent with display outdoors.</div>
Fading	
Flaking/Friable	
Mould/ mould damage	
Pest damage	
Previous treatment	
Staining/ discolouration	
OTHER

Figure 5: Detail – bust, front. Atmospheric pollution-driven copper corrosion product on bronze figure.

Recommended Remedial Treatment Works	Advised Cost
<ul style="list-style-type: none">• Surface clean to remove dirt particulate and loose corrosion product.• Reduce atmospheric corrosion product.• Wax bronze and copper alloy components.	~\$2,000

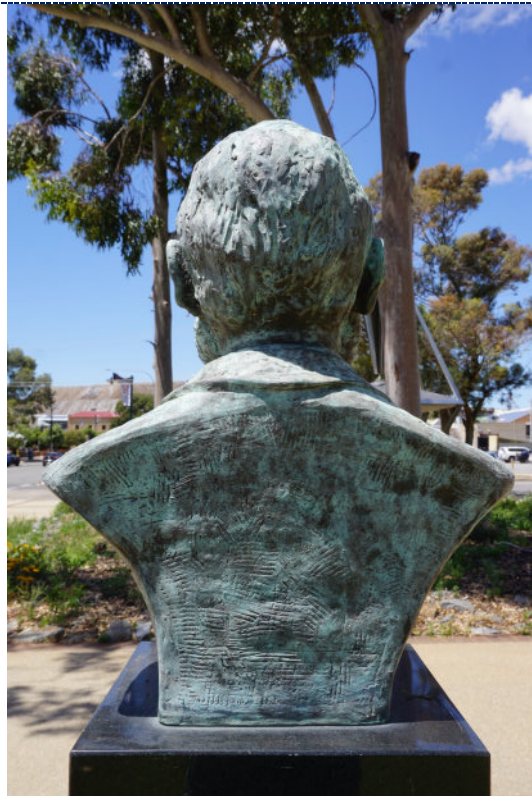
Figure 6: Detail – bust, back. Atmospheric pollution-driven copper corrosion product on bronze figure.

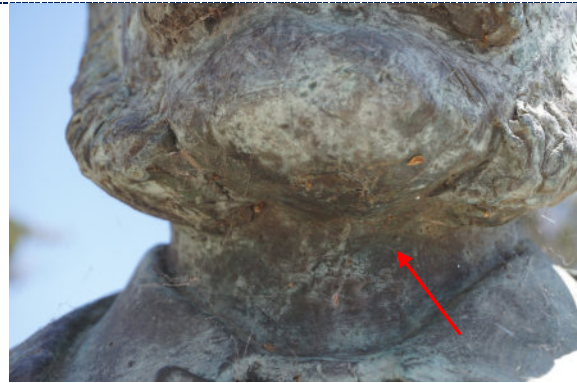
Figure 10: Detail – atmospheric pollution-driven copper corrosion product, dirt particulate, spider webs.

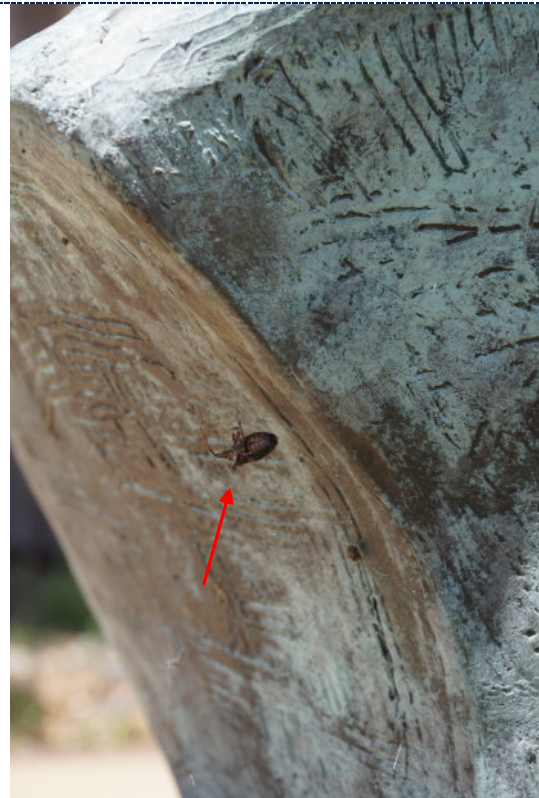
Figure 12: Detail – atmospheric pollution-driven copper corrosion product, dirt particulate, spider webs.

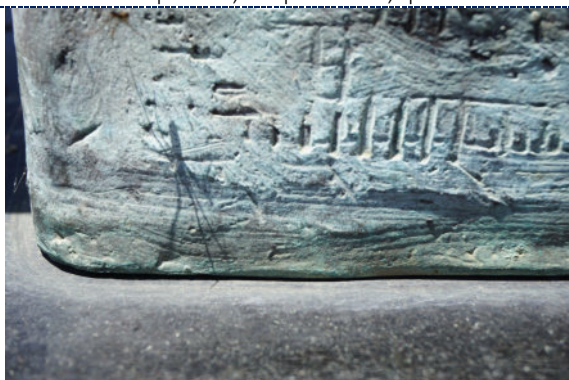
Figure 13: Detail – dirt particulate and increased copper corrosion product stemming from collected water at plinth interface.

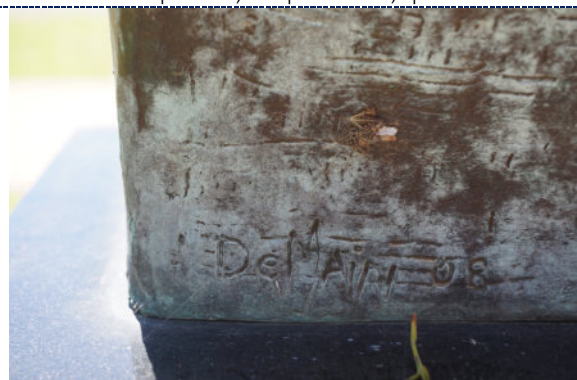
Figure 14: Detail – atmospheric pollution-driven copper corrosion product and artist's signature.

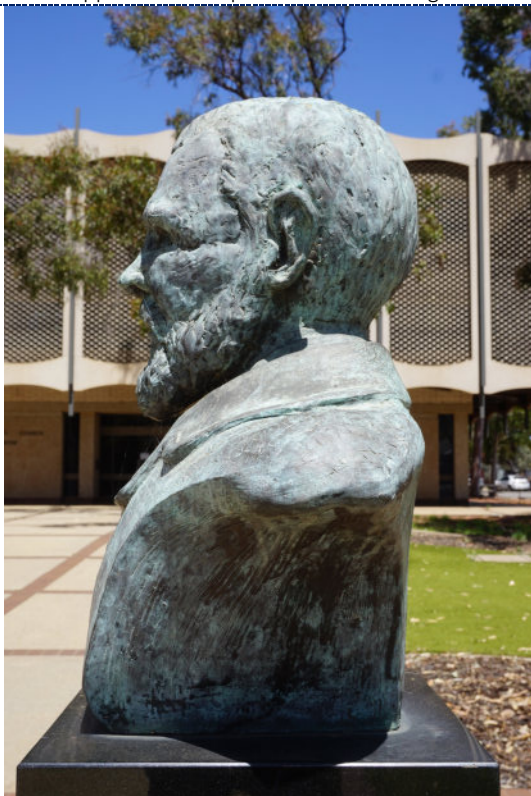
SURFACE/ COATING	MATERIALS:	
CONDITION	✓	NOTES
Abrasions/ dents		
Accretion		
Areas of loss		
Corrosion	✓	Surface corrosion is evident throughout the bronze figure and appears consistent with atmospheric pollution-driven mechanisms (figs. 5-14).
Cracks		
Delamination		
Dust/ dirt	✓	Dirt particulate (figs. 9-13) and spider webs were observed throughout, consistent with display outdoors.
Fading		
Flaking/Friable		
Mould/ mould damage		
Pest damage		
Previous treatment		
Staining/ discolouration		
OTHER

Figure 7: Detail – bust, proper left. Atmospheric pollution-driven copper corrosion product on bronze figure.

Recommended Remedial Treatment Works	Advised Cost
<ul style="list-style-type: none">• Surface clean to remove dirt particulate and loose corrosion product.• Reduce atmospheric corrosion product.• Wax bronze and copper alloy components.	~\$2,000

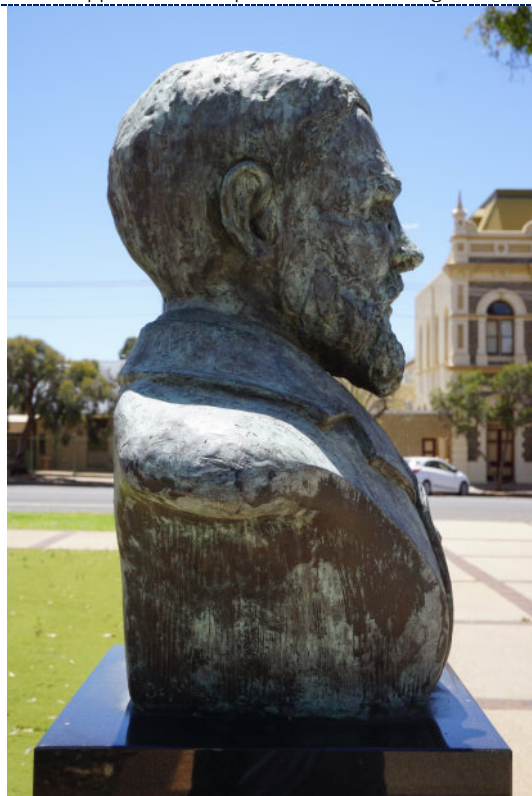
Figure 8: Detail – bust, proper right. Atmospheric pollution-driven copper corrosion product on bronze figure.

SURFACE/ COATING	MATERIALS:	
CONDITION	✓	NOTES
Abrasions/ dents		
Accretion		
Areas of loss		
Corrosion	✓	Surface corrosion is evident throughout the bronze figure and appears consistent with atmospheric pollution-driven mechanisms (figs. 5-14).
Cracks		
Delamination		
Dust/ dirt	✓	Dirt particulate (figs. 9-14) and spider webs were observed throughout, consistent with display outdoors.
Fading		
Flaking/Friable		
Mould/ mould damage		
Pest damage		
Previous treatment		
Staining/ discolouration		
OTHER

Recommended Remedial Treatment Works	Advised Cost
<ul style="list-style-type: none">• Surface clean to remove dirt particulate and loose corrosion product.• Reduce atmospheric corrosion product.• Wax bronze and copper alloy components.	~\$2,000

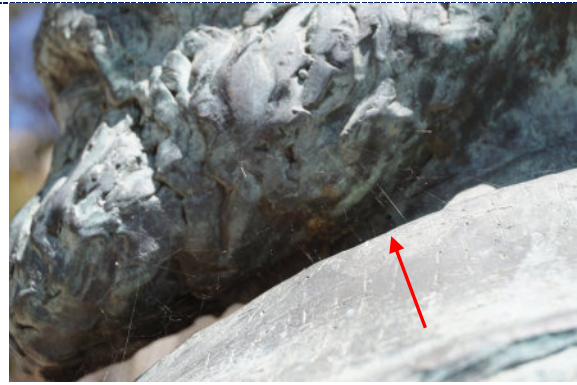
Figure 10: Detail – atmospheric pollution-driven copper corrosion product, dirt particulate, spider webs.

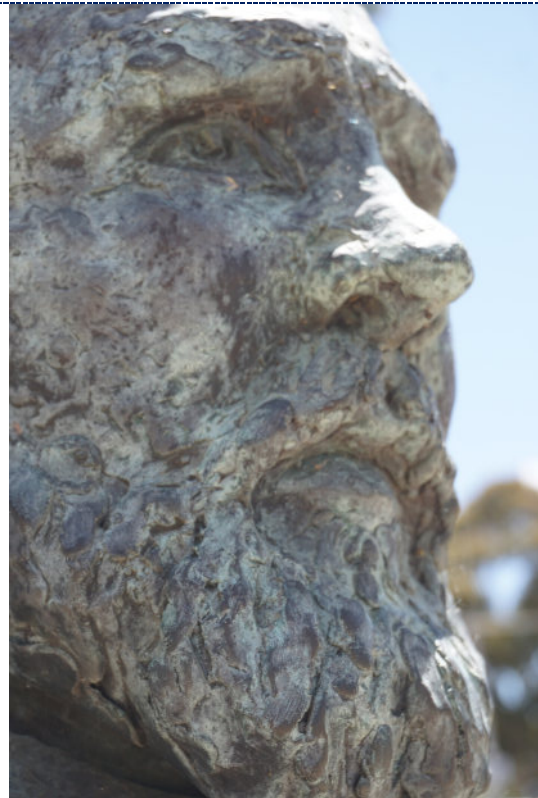
Figure 12: Detail – atmospheric pollution-driven copper corrosion product, dirt particulate, spider webs.

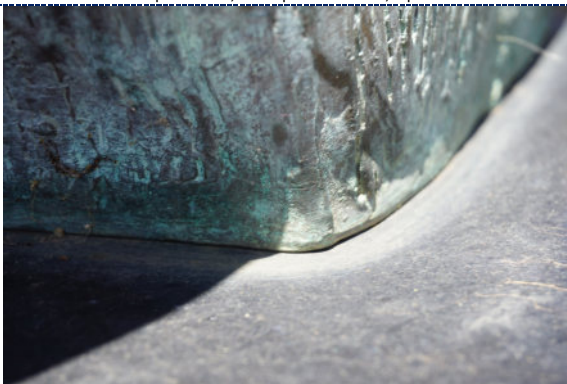
Figure 13: Detail – atmospheric pollution-driven copper corrosion product, dirt particulate, spider webs.

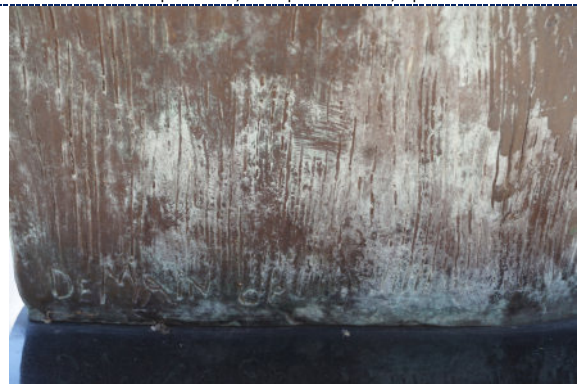
Figure 14: Detail – atmospheric pollution-driven copper corrosion product and artist's signature.

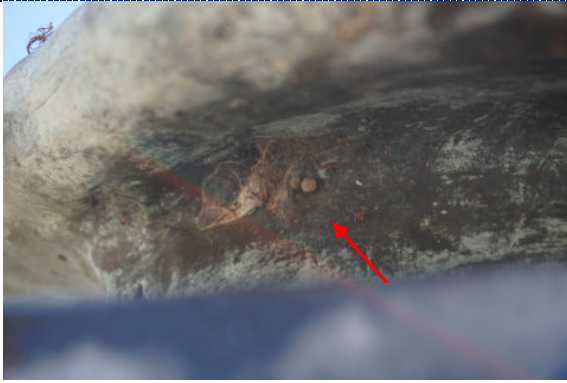
Figure 9: Detail – atmospheric pollution-driven copper corrosion product, dirt particulate, spider webs.

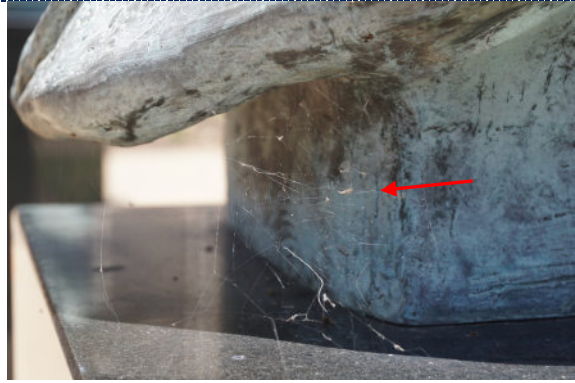
Figure 10: Detail – atmospheric pollution-driven copper corrosion product, dirt particulate, spider webs.

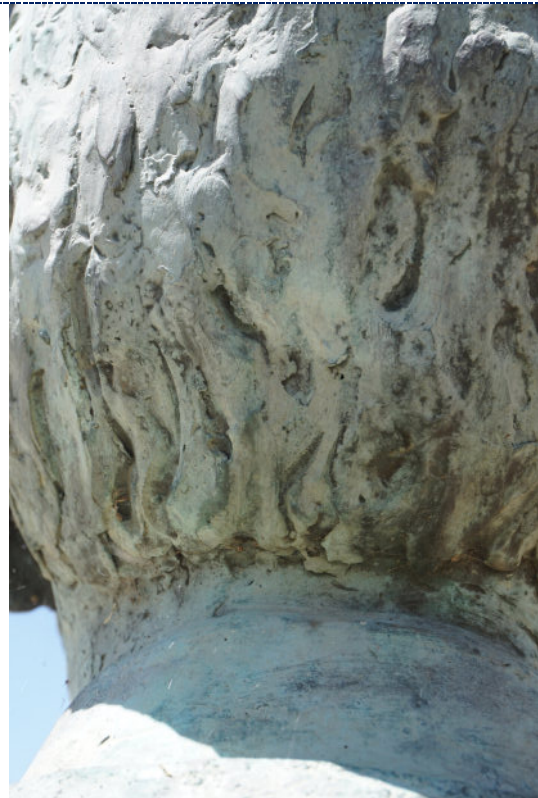
Figure 12: Detail – atmospheric pollution-driven copper corrosion product, dirt particulate, spider webs.

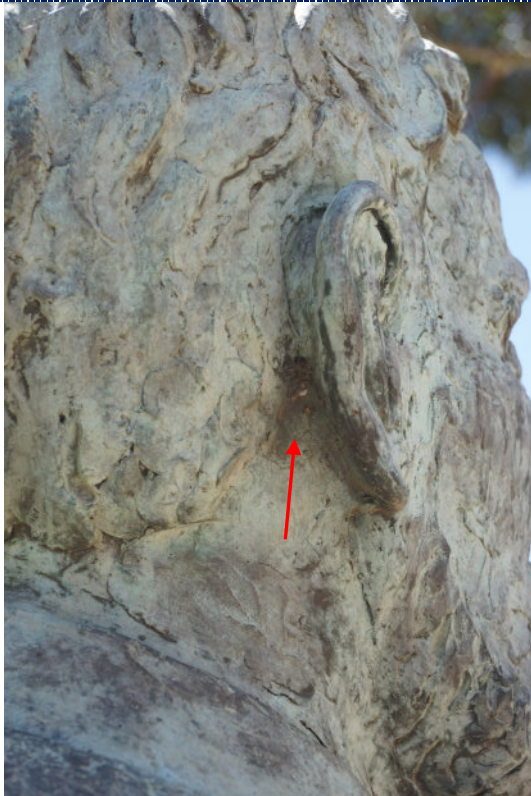
Figure 13: Detail – atmospheric pollution-driven copper corrosion product, dirt particulate, spider webs.

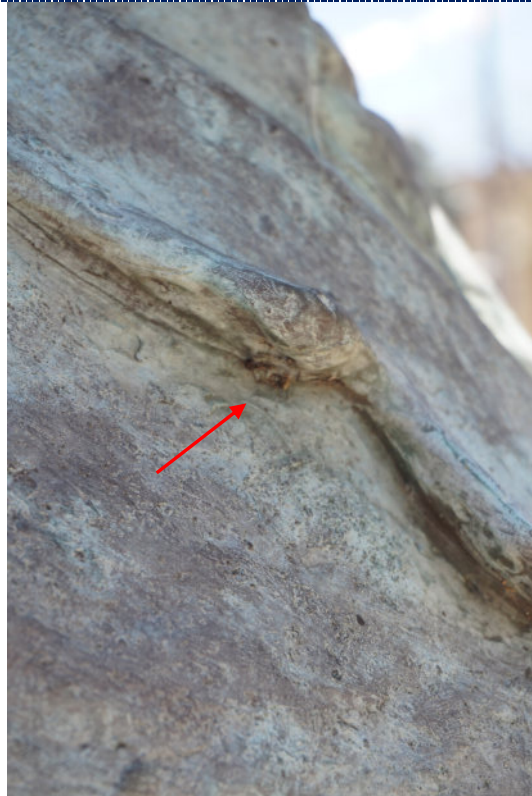
Figure 14: Detail – atmospheric pollution-driven copper corrosion product, dirt particulate, spider webs.

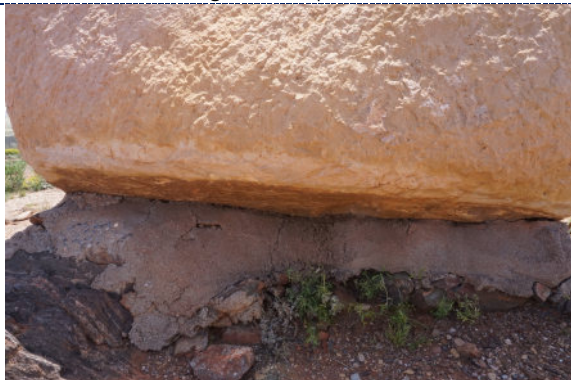
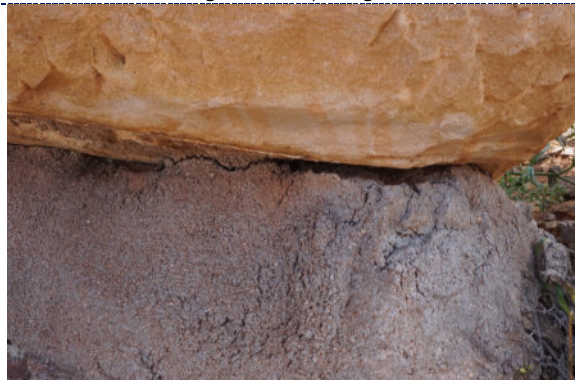
PRIMARY STRUCTURE	MATERIALS:	
CONDITION	✓	NOTES
Abrasions/ dents		
Areas of loss/ detached or missing component		
Corrosion		
Cracks/ splitting	✓	Minor cracks visible through cement/concrete join where sculpture meets rock escarpment (figs. 5-7).
Disjoin/ Loose component	✓	Cement/concrete join has complete separation visible on one corner (fig. 7).
Distortion		
Pest damage		
Previous treatment/ repair		
Rotting		
Wear/ polishing

Figure 5: Detail – concrete plinth supporting sculpture.

Figure 6: Detail – concrete plinth supporting sculpture.

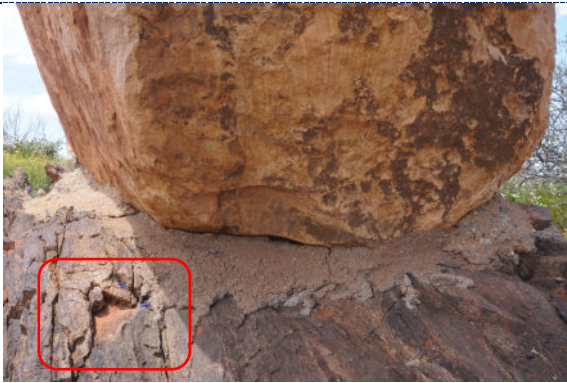
Figure 7: Detail – concrete plinth supporting sculpture with small loss to concrete.

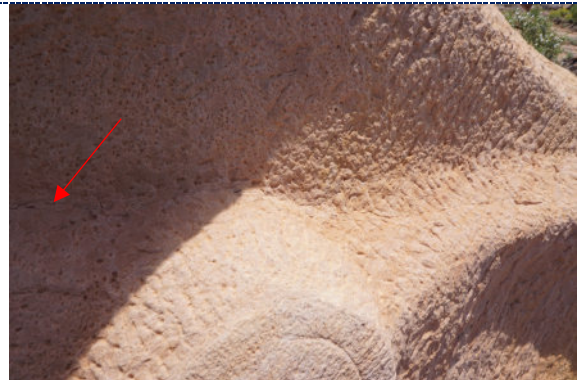
SURFACE/ COATING	MATERIALS:	
CONDITION	✓	NOTES
Abrasions/ dents		
Accretion	✓	Several unknown surface accretions (possibly paint residues) were observed (figs. 13-14).
Areas of loss		
Corrosion		
Cracks	✓	Several surface cracks noted throughout (figs. 8-11).
Delamination	✓	Minor surface delamination associated with several of the surface cracks (figs. 8-11).
Dust/ dirt	✓	Minor dust and dirt visible, inherent to outdoor sculpture.
Fading		
Flaking/Friable		
Mould/ mould damage		
Pest damage		
Pitting		
Previous treatment		
Staining/ discolouration		
OTHER

Figure 10: Detail – horizontal crack with minor stone delamination.

Recommended Remedial Treatment Works	Advised Cost
<ul style="list-style-type: none">Consolidate stone flaking and delamination surrounding surface cracks.	~\$1,000

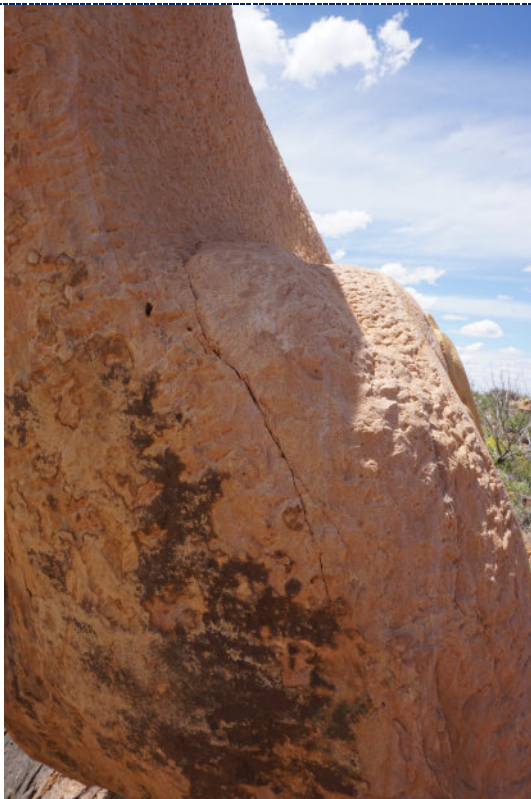
Figure 11: Detail – vertical crack with minor stone delamination.

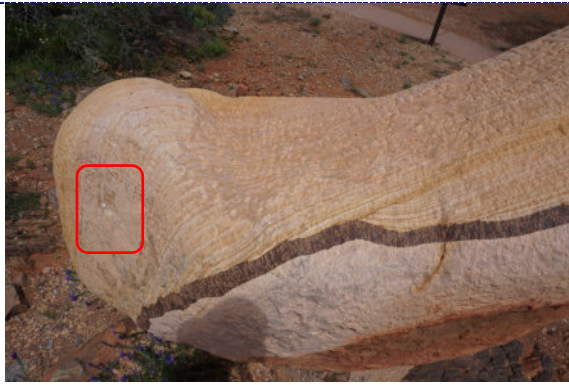
Figure 13: Detail – white accretion, possibly an unknown paint polymer.

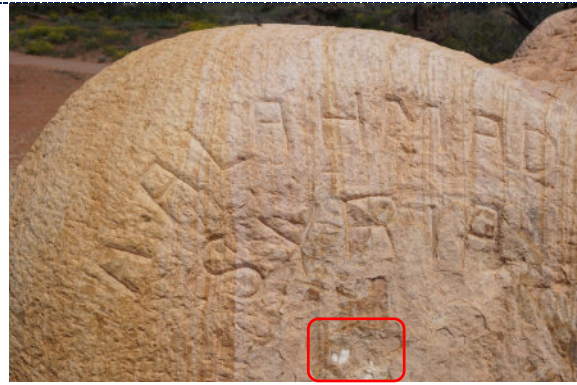
Figure 14: Detail – artist signature and unknown white accretion.

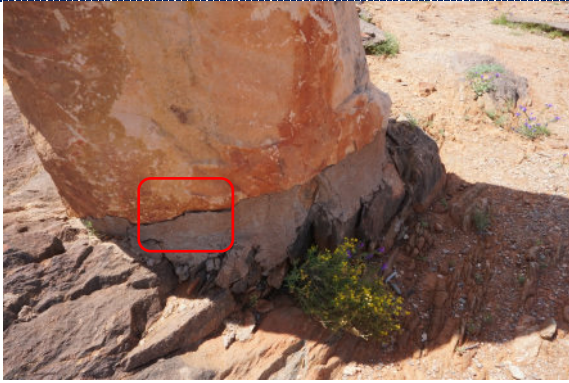
PRIMARY STRUCTURE	MATERIALS:	
CONDITION	✓	NOTES
Abrasions/ dents		
Areas of loss/ detached or missing component	✓	Possible evidence of sandstone delamination (figs. 7-9).
Corrosion		
Cracks/ splitting	✓	Several natural cracks evident within the structure (figs. 8, 10).
Disjoin/ Loose component	✓	Cement/concrete joining sculpture to rock escarpment appears loose and separated from base, possibly due to soil erosion (figs. 5-6).
Distortion		
Pest damage		
Previous treatment/ repair		
Rotting		
Wear/ polishing

Figure 5: Detail – lifting and separation of mortar join.

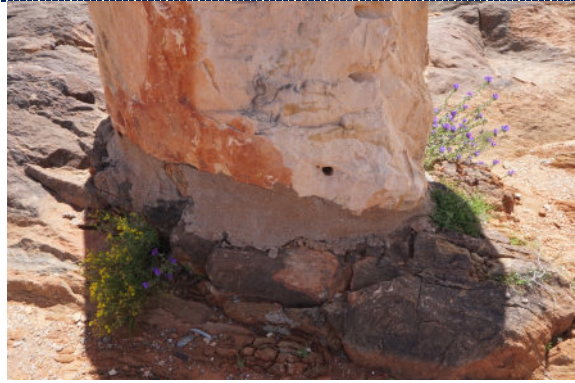
Figure 6: Detail – possible erosion to soil under concrete mortar.

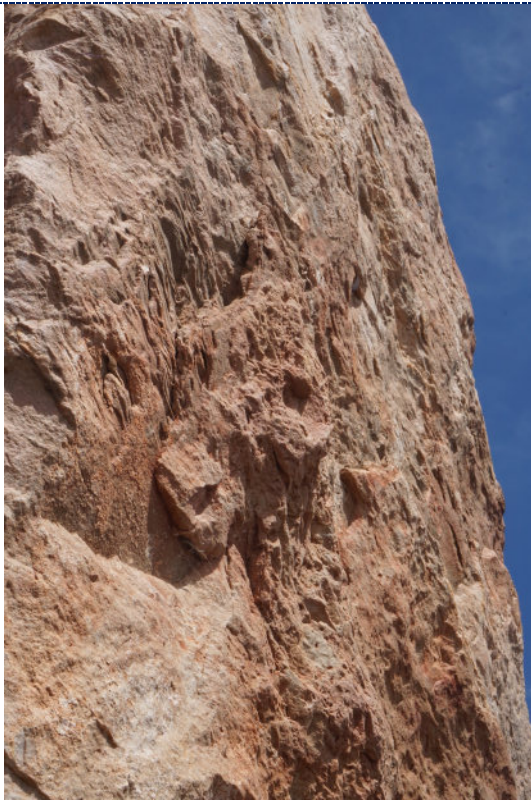
Figure 7: Detail – minor stone delamination.

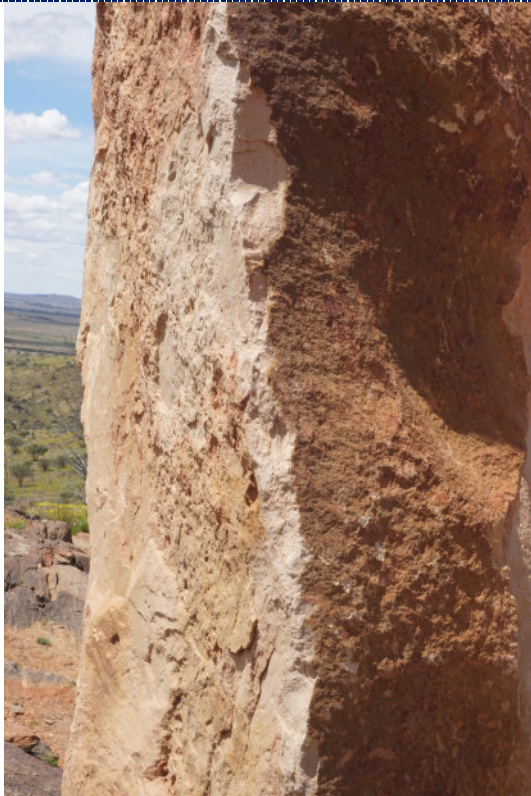
Figure 9: Detail – minor stone delamination.

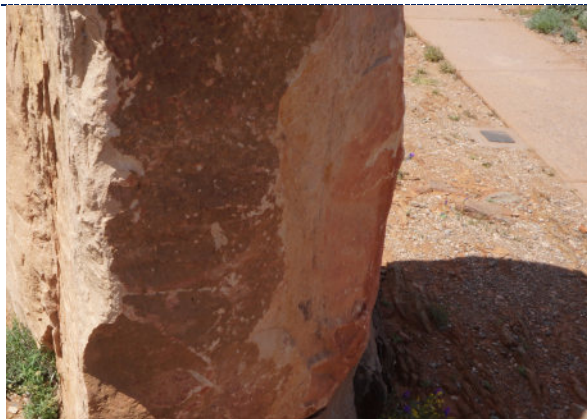
Figure 11: Detail – small surface losses and abrasions.

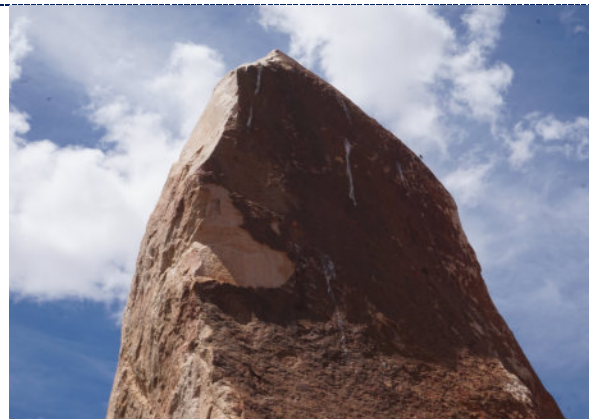
Figure 12: Detail – bird excrement.

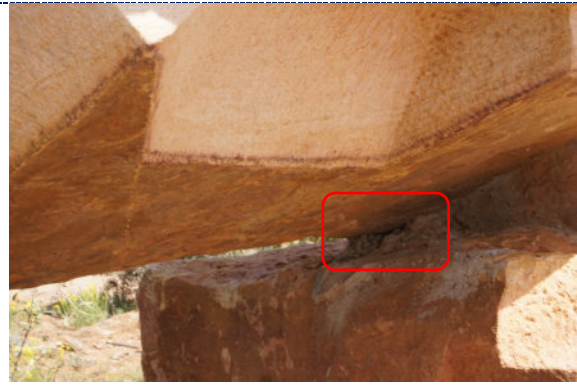
Figure 10: Detail – small gap in mortar.

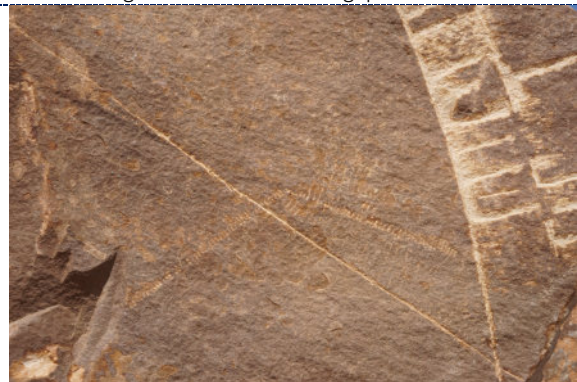
Figure 12: Detail – possible abrasions, but visible in early photo.

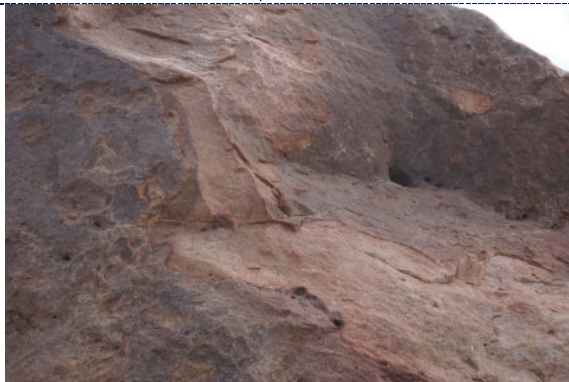
SURFACE/ COATING	MATERIALS:	
CONDITION	✓	NOTES
Abrasions/ dents		
Accretion		
Areas of loss	✓	Possible small losses along horse's mane (fig. 16).
Corrosion		
Cracks		
Delamination	✓	Minor stone delamination present (figs. 13, 15, 17).
Dust/ dirt	✓	Minor dirt particulate observed throughout, inherent to outdoor sculpture.
Fading		
Flaking/Friable		
Mould/ mould damage		
Pest damage		
Pitting		
Previous treatment		
Staining/ discolouration		
OTHER

Figure 13: Detail – possible stone delamination.

Routine Maintenance	Frequency
<ul style="list-style-type: none">• Surface clean to remove dirt particulate and avian guano.• Monitor possible stone delamination.• Monitor possible soil erosion.	Biennially 2 years 2 years

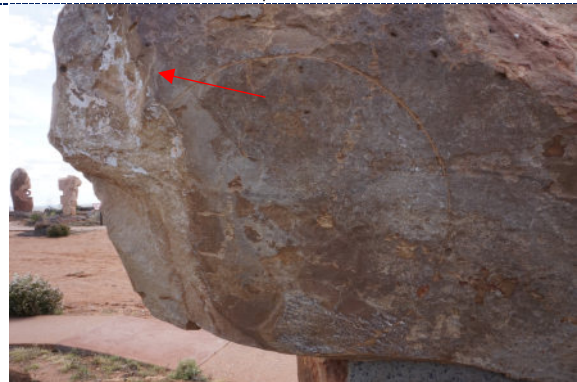
Figure 14: Detail – white surface accretion.

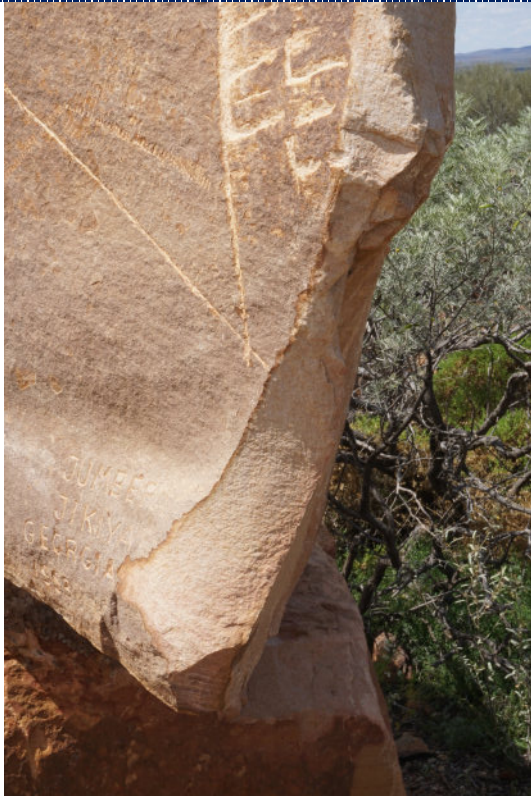
Figure 15: Detail – possible stone delamination.

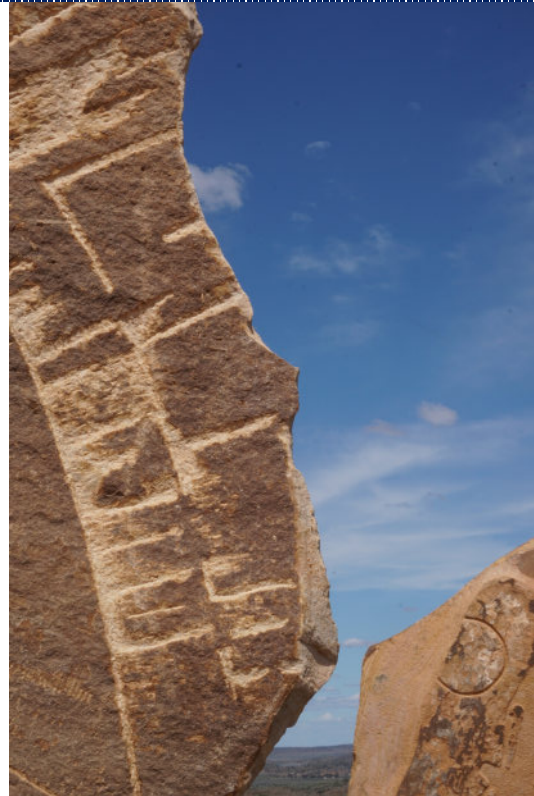
Figure 16: Detail – possible small losses to edge.

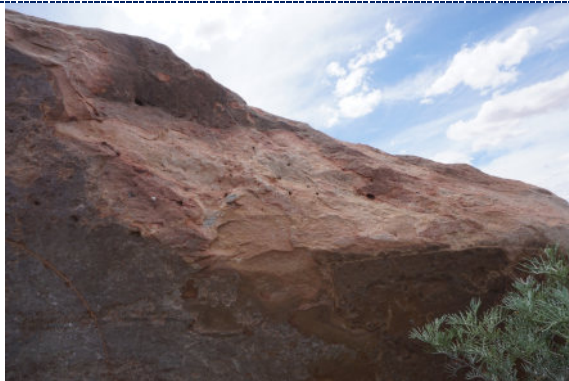
Figure 17: Detail – possible stone delamination.

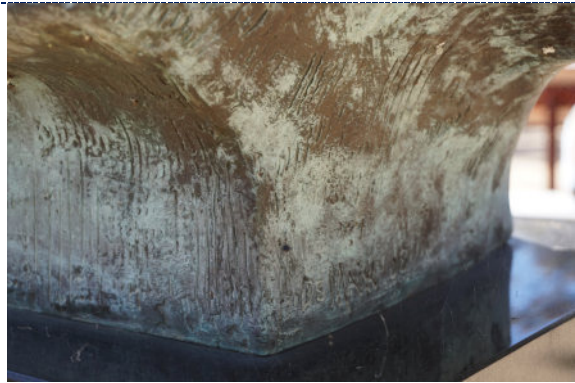
SURFACE/ COATING	MATERIALS:	
CONDITION	✓	NOTES
Abrasions/ dents		
Accretion		
Areas of loss		
Corrosion	✓	Surface corrosion is evident throughout the bronze figure and appears consistent with atmospheric pollution-driven mechanisms (figs. 5-14).
Cracks		
Delamination		
Dust/ dirt	✓	Dirt particulate (figs. 9-13) and spider webs were observed throughout, consistent with display outdoors.
Fading		
Flaking/Friable		
Mould/ mould damage		
Pest damage		
Previous treatment		
Staining/ discolouration		
OTHER

Figure 10: Detail – atmospheric pollution-driven copper corrosion product, dirt particulate, spider webs.

Recommended Remedial Treatment Works	Advised Cost
<ul style="list-style-type: none">• Surface clean to remove dirt particulate and loose corrosion product.• Reduce atmospheric corrosion product.• Wax bronze and copper alloy components.	~\$2,000
