Broken Hill Public Art Condition Survey and Conservation Plan

Prepared for: Broken Hill City Council
Submission Date: February 2023

This report presents the results of a condition survey assessing the works held within Broken Hill City Council's public art collection. A total of 56 works were condition assessed.

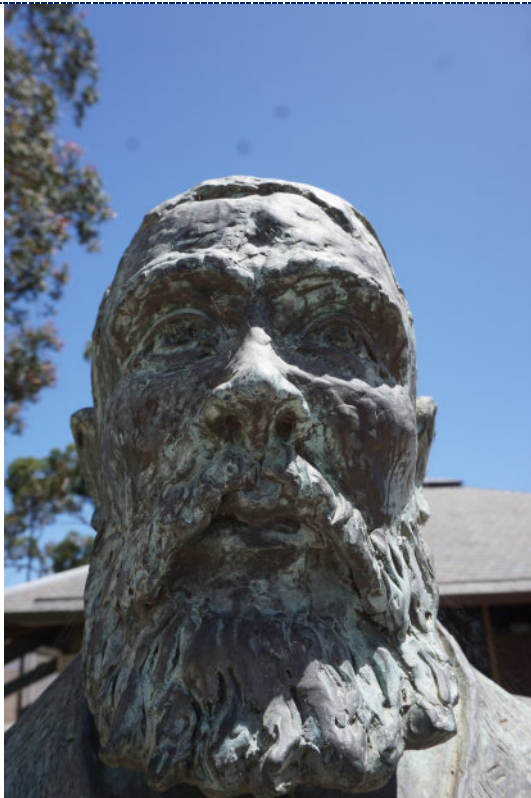
SURFACE/ COATING	MATERIALS:	
CONDITION	✓	NOTES
Abrasions/ dents		
Accretion		
Areas of loss		
Corrosion	✓	Surface corrosion is evident throughout the bronze figure and appears consistent with atmospheric pollution-driven mechanisms (figs. 5-14).
Cracks		
Delamination		
Dust/ dirt	✓	Dirt particulate (figs. 9-13) and spider webs were observed throughout, consistent with display outdoors.
Fading		
Flaking/Friable		
Mould/ mould damage		
Pest damage		
Previous treatment		
Staining/ discolouration		
OTHER

Figure 11: Detail – atmospheric pollution-driven copper corrosion product, dirt particulate, spider webs.

Recommended Remedial Treatment Works	Advised Cost
<ul style="list-style-type: none">• Surface clean to remove dirt particulate and loose corrosion product.• Reduce atmospheric corrosion product.• Wax bronze and copper alloy components.	~\$2,000

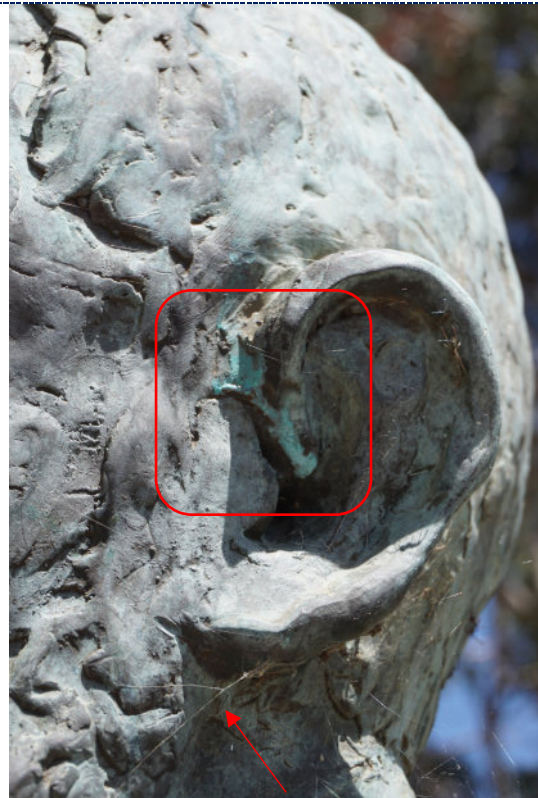
Figure 12: Detail – atmospheric pollution-driven copper corrosion product, dirt particulate, spider webs.

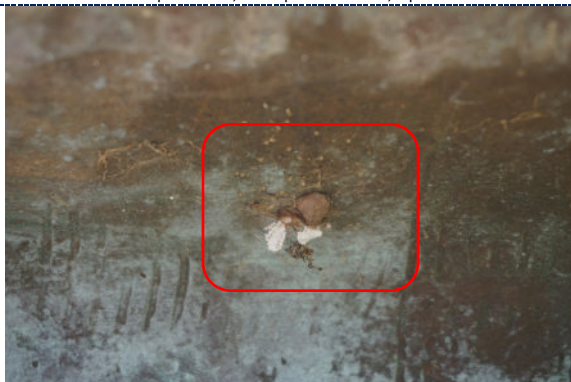
Figure 13: Detail – atmospheric pollution-driven copper corrosion product, dirt particulate, spider webs.

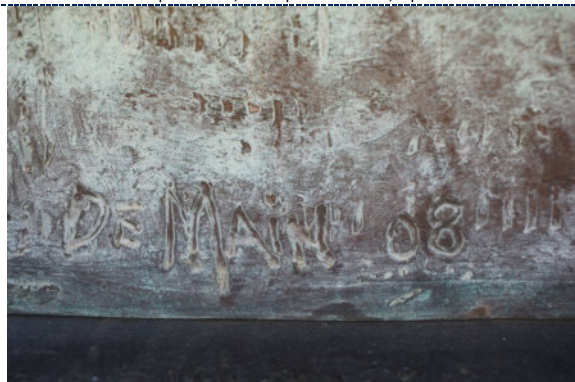
Figure 14: Detail – atmospheric pollution-driven copper corrosion product and artist's signature.

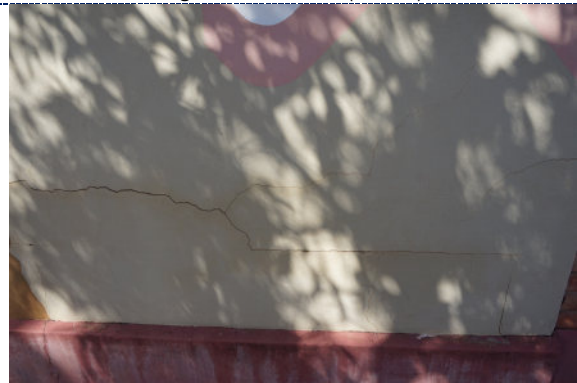
SURFACE/ COATING	MATERIALS:	
CONDITION	✓	NOTES
Abrasions/ dents		
Accretion		
Areas of loss		
Corrosion		
Cracks		
Delamination		
Dust/ dirt	✓	Dirt particulate, bird excrement and spider webs were observed throughout, consistent with display outdoors.
Fading	✓	Fading and chalking to paint layers due to ultraviolet radiation and visible light exposure (figs. 4-20).
Flaking/Friable		
Mould/ mould damage		
Pest damage		
Previous treatment	✓	It's possible this mural has been re-painted over time.
Staining/ discolouration	✓	Staining adjacent to cracks in the mortar (figs. 4-9, 11-18, 20).
OTHER	Inked graffiti (figs. 20-22).

Figure 4: Detail – surface cracks and deformation to the mortar; chalking (UV degradation) and fading of the paint; staining to the exterior of the cracks.

Recommended Remedial Treatment Works	Advised Cost
Currently the work is in a poor condition. Given the extent of damage juxtaposed with its value and significance to the community, Council may consider deaccessioning the work or commissioning a replacement mural. Contact the artist about making repairs in the first instance, if possible.	~\$10,000-\$15,000

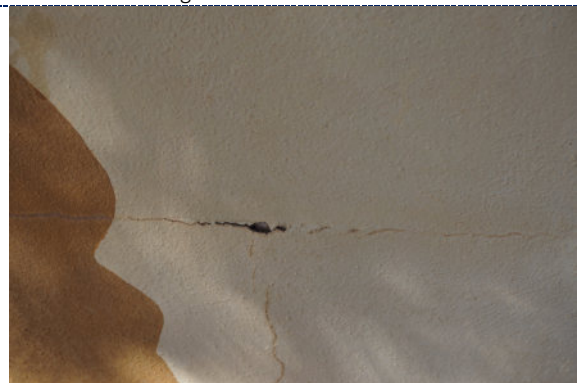
PRIMARY STRUCTURE	MATERIALS:	
CONDITION	✓	NOTES
Abrasions/ dents		
Areas of loss/ detached or missing component	✓	Small areas of loss to the mortar substrate throughout (figs. 6, 11, 13-17).
Corrosion		
Cracks/ splitting	✓	Numerous cracks to the mortar substrate (figs. 4-9, 11-18, 20).
Disjoin/ Loose component		
Distortion	✓	Distortion and lifting to the mortar substrate around cracks (figs. 4-9, 11-18, 20).
Pest damage		
Previous treatment/ repair		
Rotting		
Wear/ polishing		
OTHER

Figure 6: Detail – surface cracks and deformation to the mortar; chalking (UV degradation) and fading of the paint; staining to the exterior of the cracks; small losses.

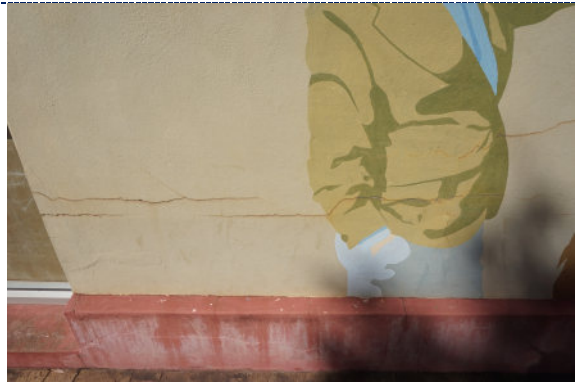
Figure 8: Detail – surface cracks and deformation to the mortar; chalking (UV degradation) and fading of the paint; staining to the exterior of the cracks.

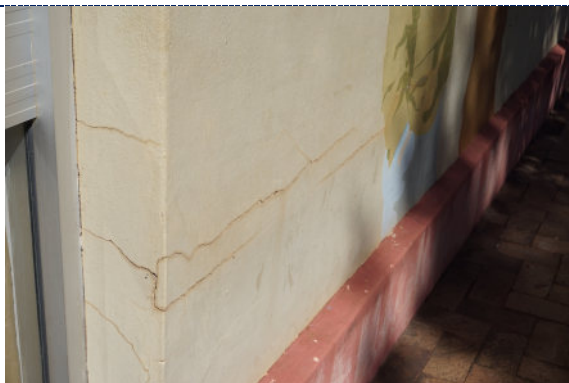
Figure 9: Detail – surface cracks and deformation to the mortar; chalking (UV degradation) and fading of the paint; staining to the exterior of the cracks.

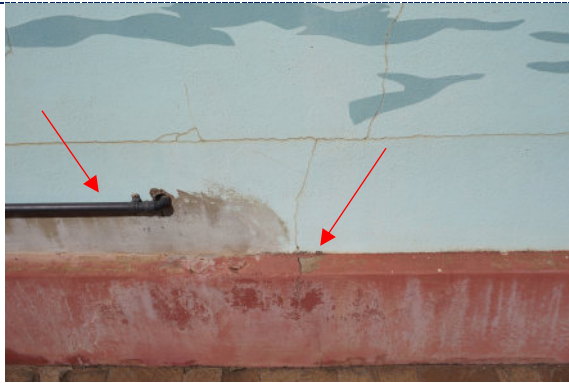
Figure 13: Detail – surface cracks and deformation to the mortar; chalking (UV degradation) and fading of the paint; staining to the exterior of the cracks; large loss to the paint adjacent to the pipe; loss to mortar.

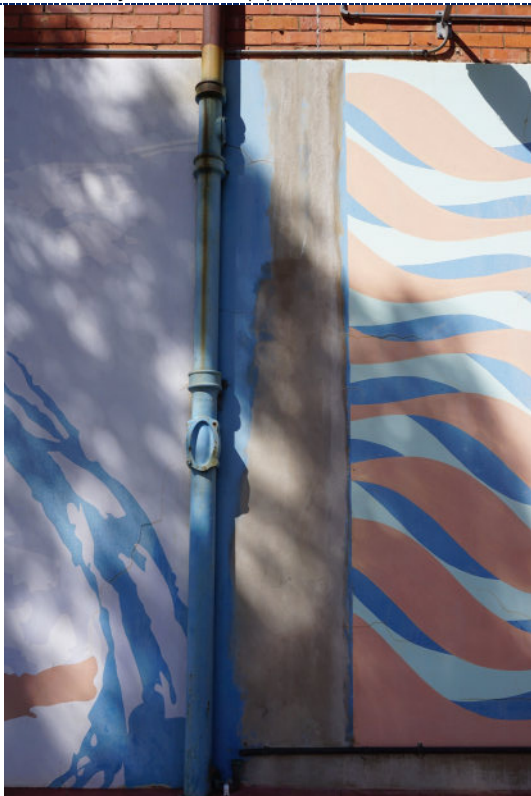
Figure 15: Detail – surface cracks and deformation to the mortar; chalking (UV degradation) and fading of the paint; staining to the exterior of the cracks; large loss to the paint adjacent to the pipe.

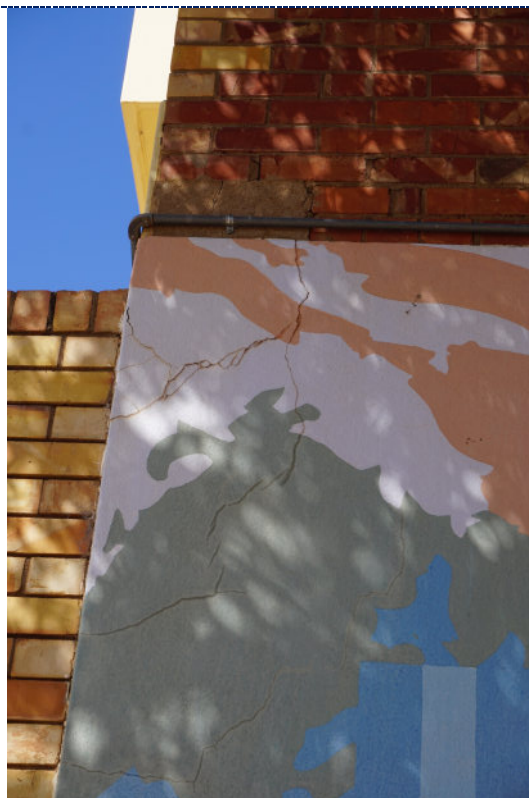
Figure 18: Detail – surface cracks and deformation to the mortar; chalking (UV degradation) and fading of the paint; staining to the exterior of the cracks; small losses.

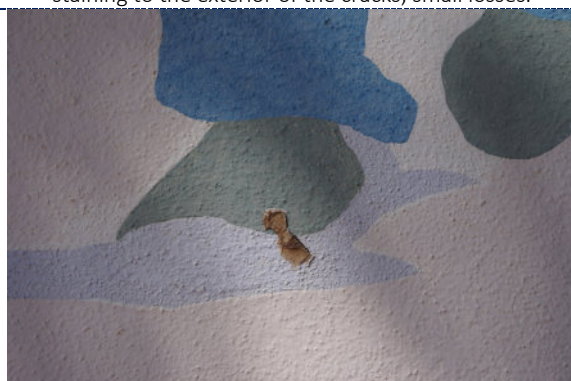
Figure 19: Detail – surface accretion; chalking (UV degradation) and fading of the paint.

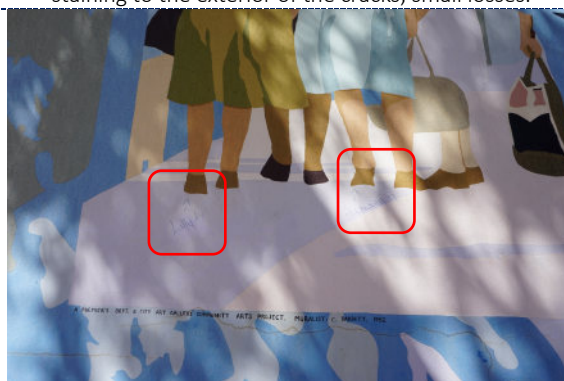
Figure 20: Detail – surface cracks and deformation to the mortar; chalking (UV degradation) and fading of the paint; staining to the exterior of the cracks; inked graffiti.

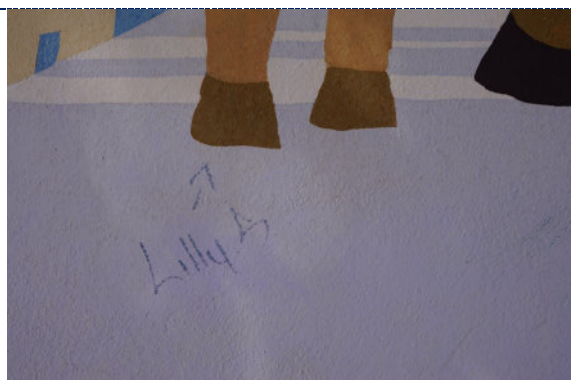
Figure 21: Detail – inked graffiti.

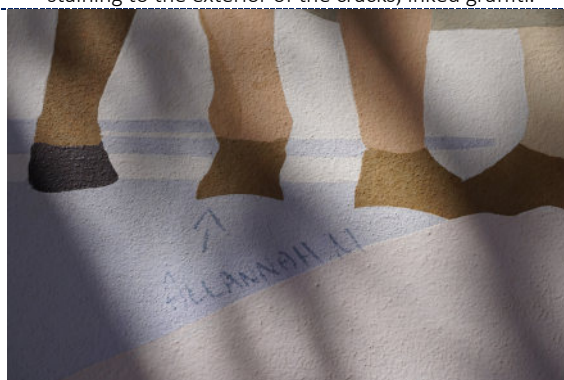
Figure 22: Detail – inked graffiti.

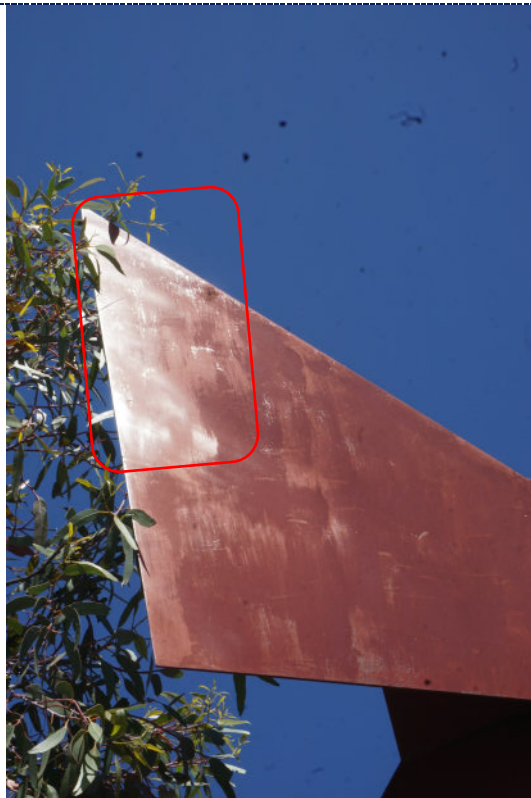
Figure 7: Detail – paint chalking, flaking paint loss with overpaint.

Recommended Remedial Treatment Works	Advised Cost
<ul style="list-style-type: none">Remove or reduce failing and flaking paint.Stabilise surface corrosion where needed.Repaint in a paint system rated for use on outdoor metals and colour-matched with the original.	~\$2,500

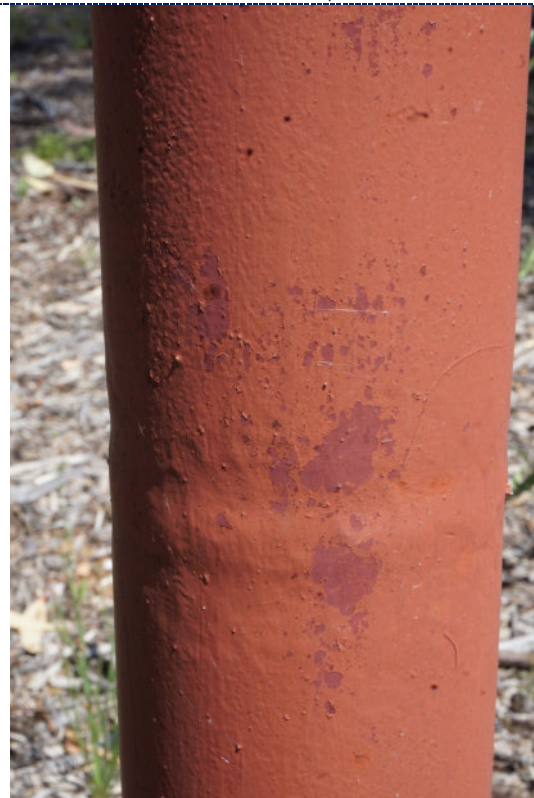
Figure 8: Detail – paint chalking, flaking paint loss with overpaint.

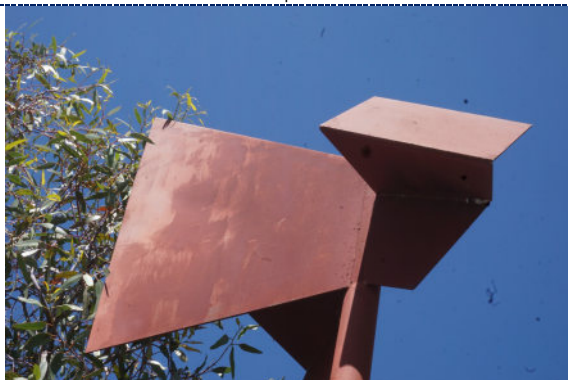
Figure 9: Detail – paint chalking, flaking paint loss with overpaint;

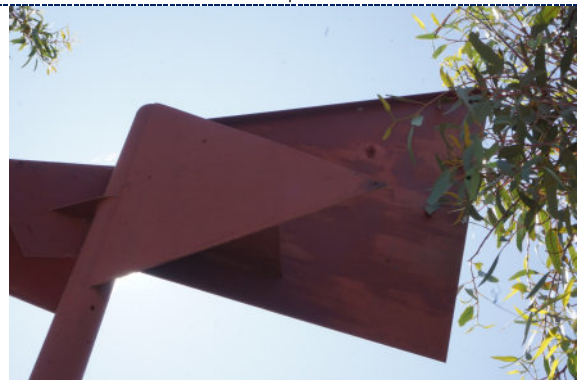
Figure 10: Detail – paint chalking, flaking paint loss with overpaint.

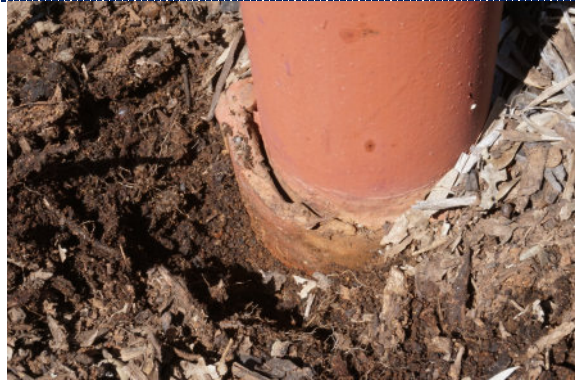
SURFACE/ COATING	MATERIALS:	
CONDITION	✓	NOTES
Abrasions/ dents	✓	Minor small abrasions evident throughout.
Accretion		
Areas of loss		
Corrosion	✓	Corrosion visible where the paint layer is lost or perforated, blistering paint (figs. 6, 11-12).
Cracks		
Delamination		
Dust/ dirt	✓	Dirt particulate and spider webs were observed throughout recesses, consistent with display outdoors.
Fading	✓	Chalking and fading to the paint following exposure to sunlight and outdoor conditions (figs. 5-10).
Flaking/Friable	✓	Flaking and peeling paint (figs. 5-10).
Mould/ mould damage		
Pest damage		
Previous treatment	✓	The sculpture appears to have been repainted at least once due to the slightly different hue between the two paint layers.
Staining/ discolouration		
OTHER

Figure 12: Detail – accumulation of biomatter at base;
corrosion to iron.

Routine Maintenance	Frequency
<ul style="list-style-type: none">Surface clean to remove dirt particulate and accumulation of biomatter from adjacent trees.	1 year

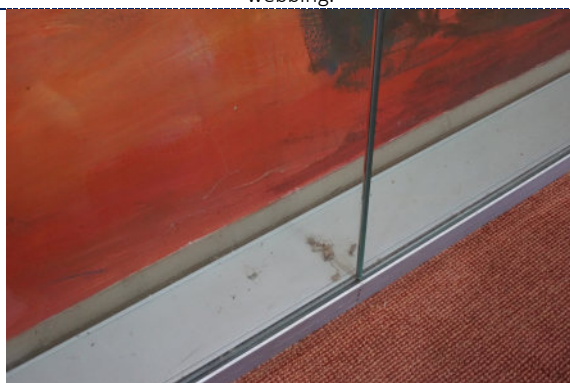
Figure 11: Section 1 – Detail – dirt particulates and spider webs.

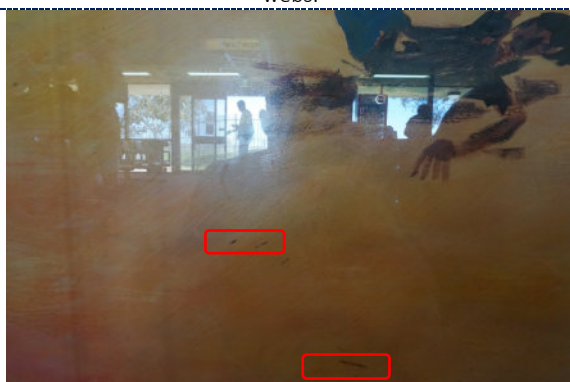
SURFACE/ COATING	MATERIALS:	
CONDITION	✓	NOTES
Abrasions/ dents	✓	Several surface abrasions were observed (figs. 7, 13, 16, 22, 24 and 29).
Accretion	✓	Several surface accretions are present (figs. 6, 13, 15-16, 19, 21-22, 26, 29-35, 39, 42-43.). Many of the white accretions appeared in an elongated splatter/drip line form indicating transfer occurred during previous painting of ceiling/interior walls.
Areas of loss	✓	Multiple areas of minor painted-surface loss were observed (figs. 5, 7, 10, 20, 22 and 29).
Corrosion		
Cracks		
Delamination		
Dust/ dirt	✓	Dirt particulate and spider web accumulation were observed throughout, consistent with permanent display.
Fading		
Flaking/Friable	✓	Lifting of paint layer noted around some edges of mural (fig. 36).
Mould/ mould damage		
Pest damage	✓	Pest activity evident throughout, particularly heavy accumulation of spider webs noted.
Previous treatment		
Staining/ discolouration

Figure 13: Section 1 – Detail – surface abrasions with accretion.

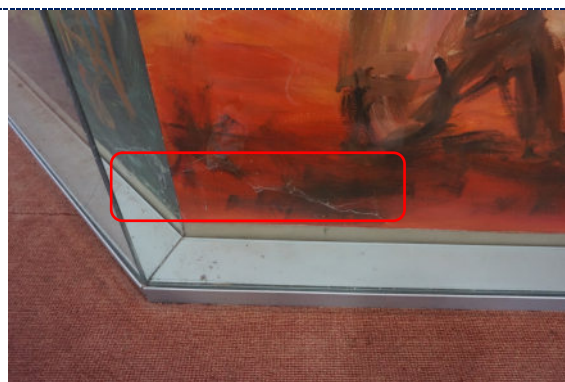
Figure 14: Section 1 – Detail – dirt particulates and spider webs.

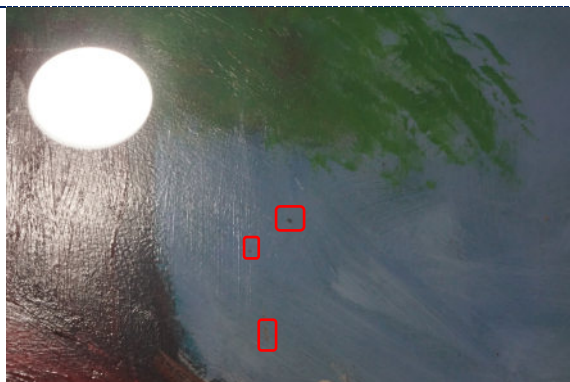
Figure 15: Section 1 – Detail – surface accretions (frass).

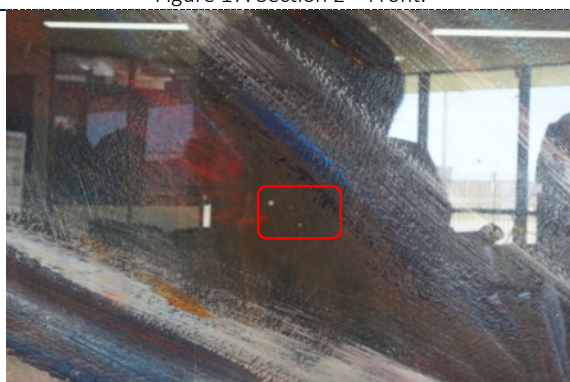
Figure 19: Section 2 – Detail – white surface accretions.

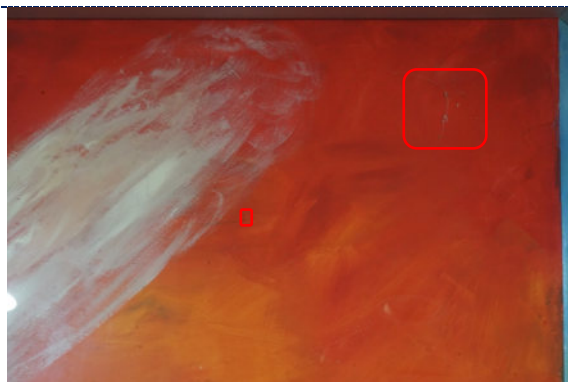
Figure 21: Section 2 – Detail – dirt particulates, surface accretions.

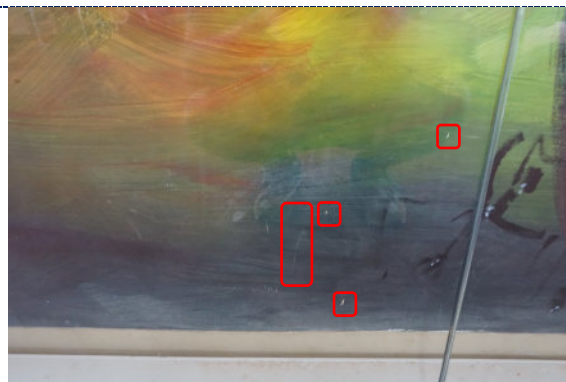
Figure 22: Section 2 – Detail – surface abrasions and accretions with loss.

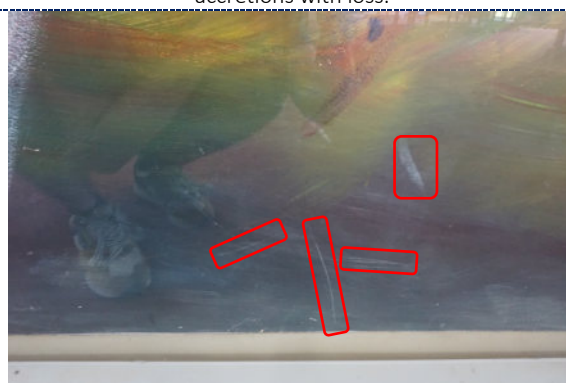
Figure 24: Section 2 – Detail – cluster of localised abrasions.

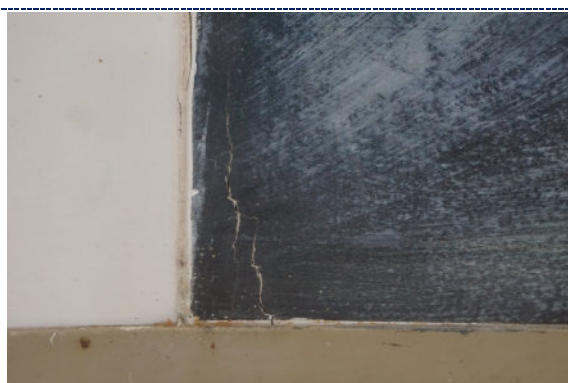
Figure 25: Section 2 – Detail – surface cracks.

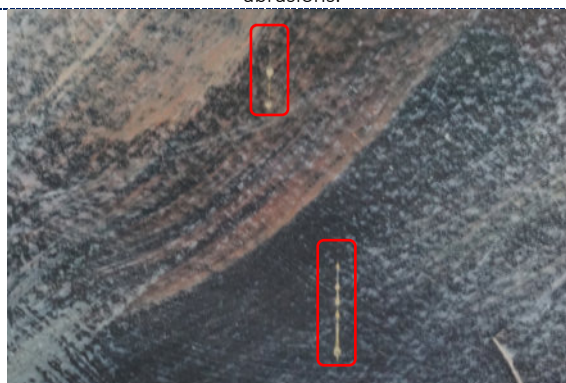
Figure 26: Section 2 – Detail – surface accretions.

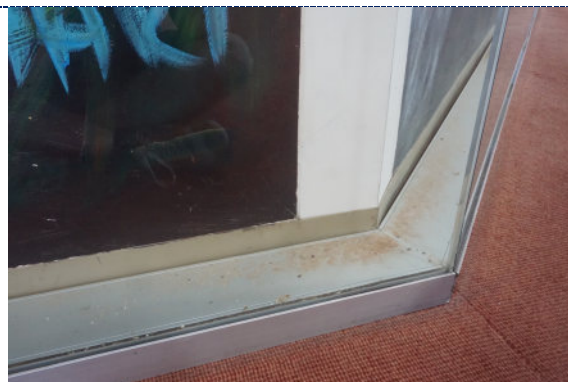
Figure 30: Section 3 – Detail – dirt particulates.

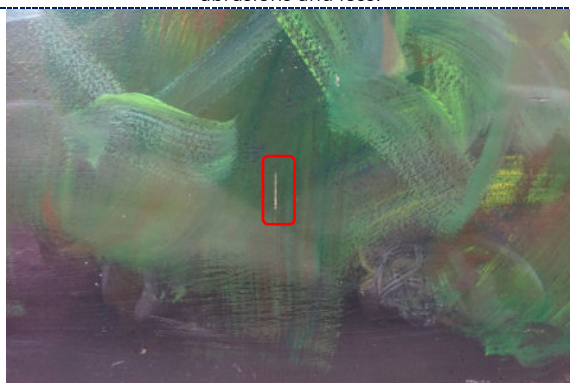
Figure 31: Section 3 – Detail – surface accretion.

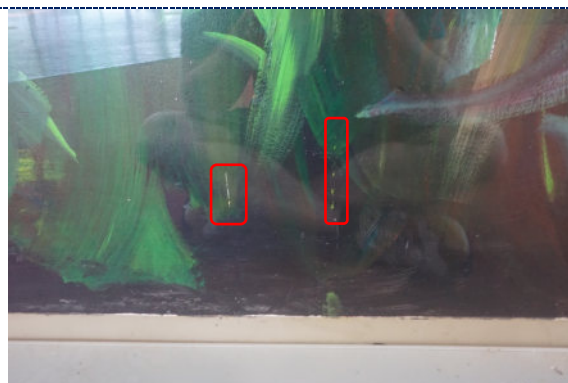
Figure 32: Section 3 – Detail – surface accretions.

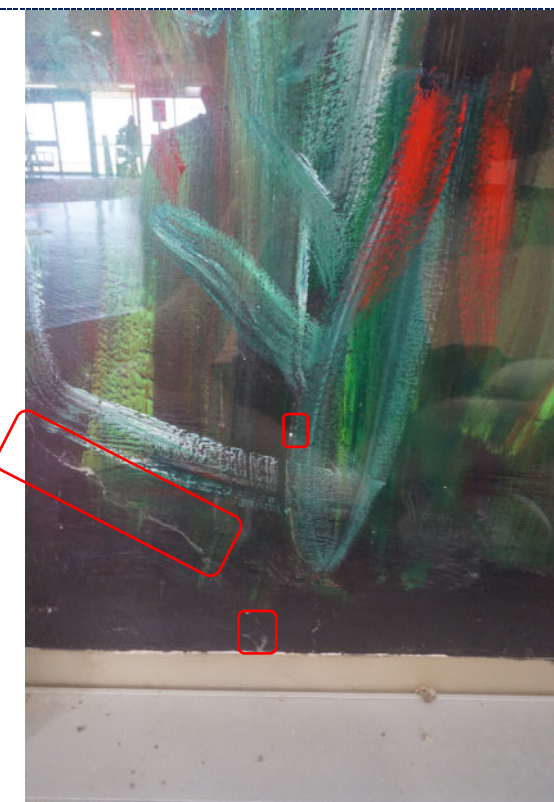
Figure 33: Section 3 – Detail – dirt particulates, spider webs and accretions.

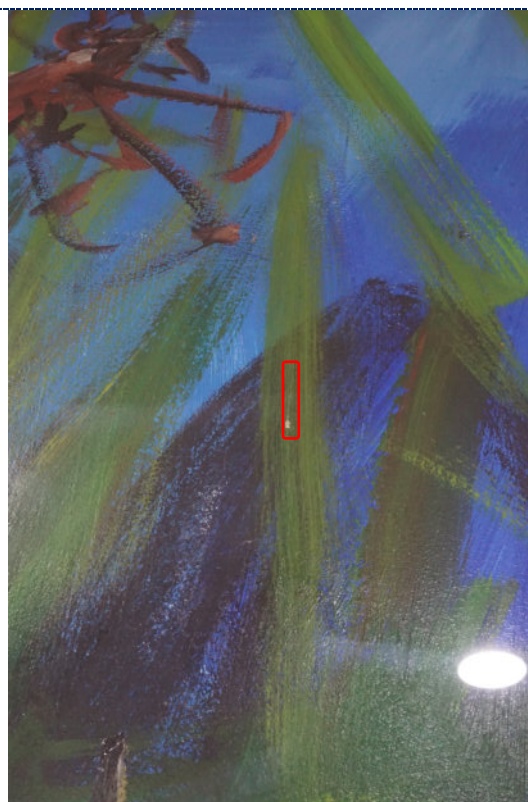
Figure 34: Section 3 – Detail – surface accretion

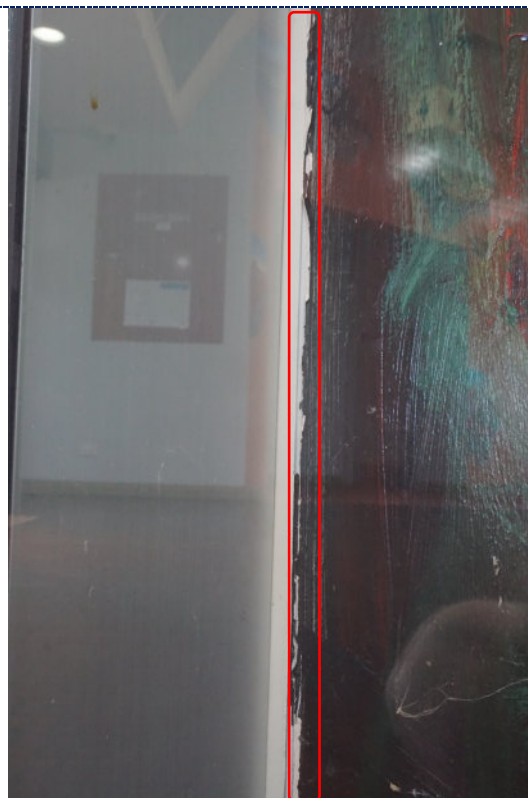
Figure 36: Section 3 – Detail – friable lifting paint layer at edges.

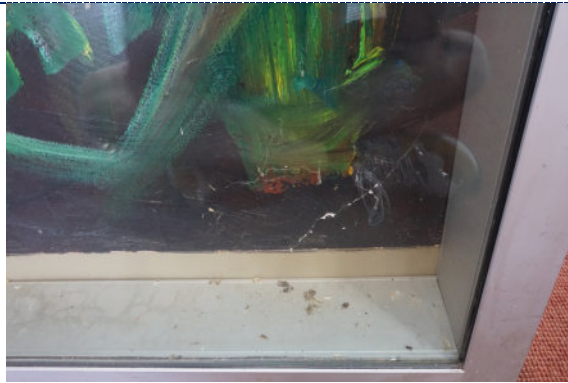
Figure 41: Section 3 – Detail – dirt particulates, surface cracks and spider webs.

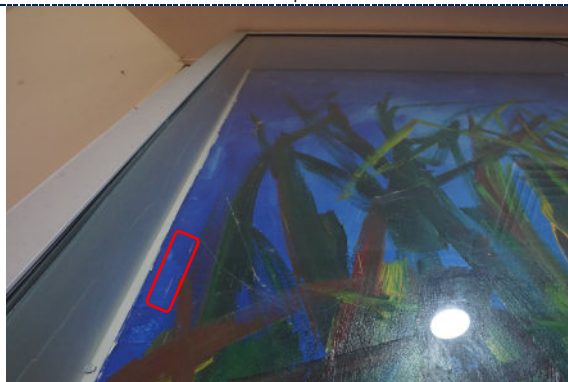
Figure 43: Section 3 – Detail – surface accretions and spider webs.

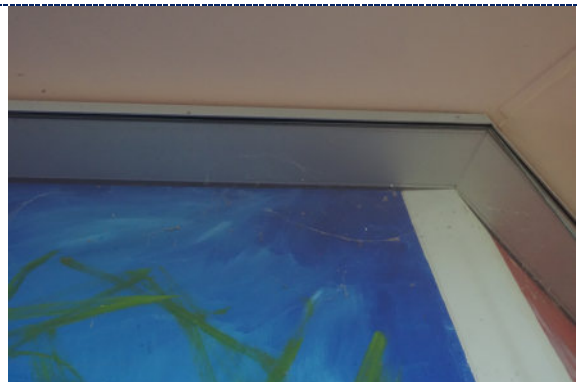
Figure 44: Section 3 – Detail – dirt particulates and spider webs.

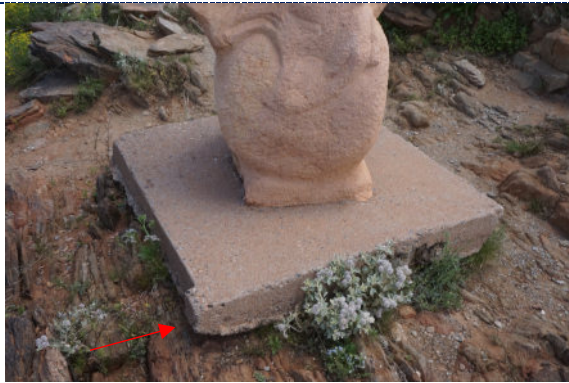
Figure 5: Detail – possible erosion to soil under concrete plinth.

Routine Maintenance	Frequency
<ul style="list-style-type: none">• Surface clean to remove dirt particulate and avian guano.• Monitor stone delamination.• Monitor possible stone delamination.• Monitor soil erosion under plinth.	Biennially 2 years 2 years 2 years

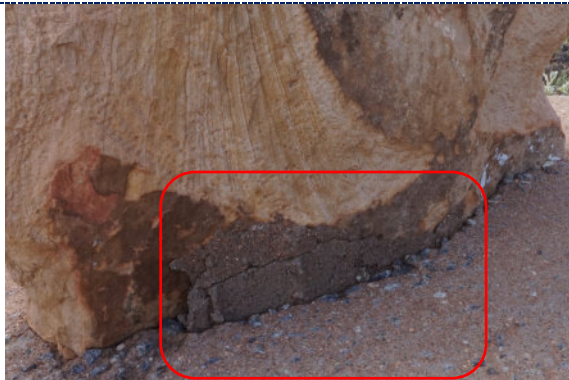
SURFACE/ COATING	MATERIALS:	
CONDITION	✓	NOTES
Abrasions/ dents		
Accretion	✓	Concrete residue on sandstone substrate at base (fig. 7). White paint residues also evident (fig. 6).
Areas of loss		
Corrosion		
Cracks		
Delamination	✓	Minor stone delamination present (fig. 10).
Dust/ dirt	✓	Minor dirt particulate observed throughout.
Fading		
Flaking/Friable		
Mould/ mould damage		
Pest damage		
Pitting		
Previous treatment		
Staining/ discolouration		
OTHER

Figure 7: Detail – concrete residue on sandstone.

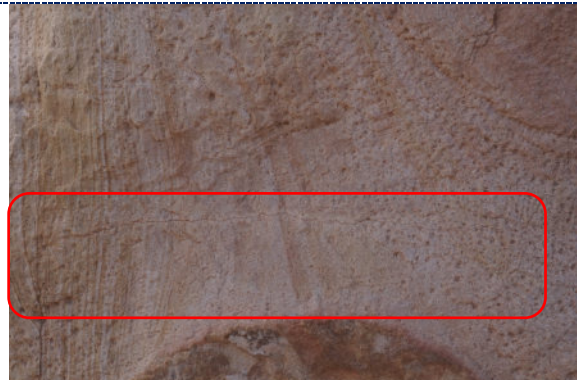
Figure 8: Detail – crack visible through centre.

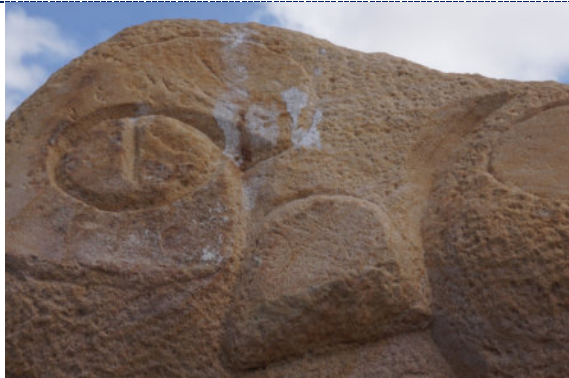
Figure 9: Detail – bird excrement accretion.

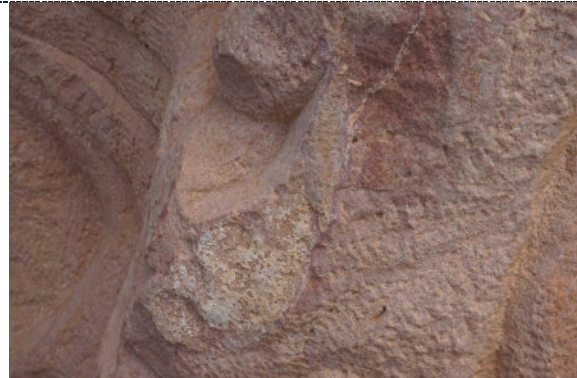
Figure 10: Detail – minor stone delamination.

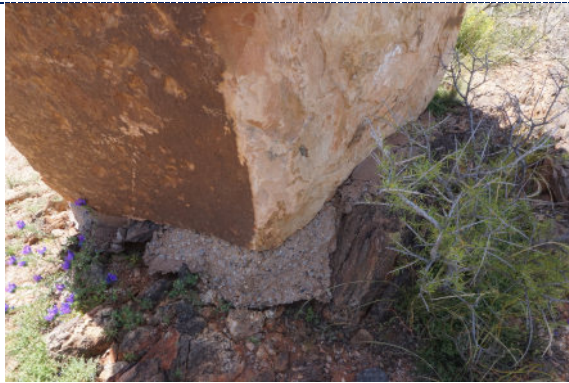
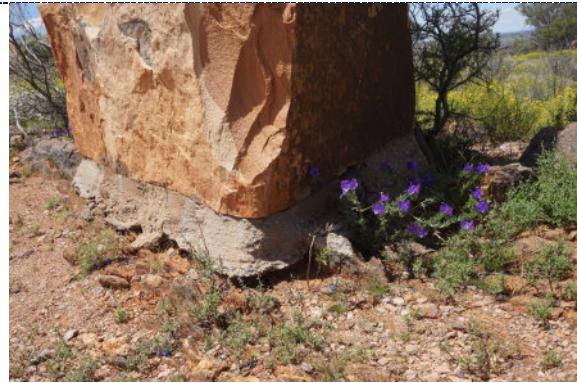
Figure 5: Detail – possible erosion to soil under concrete mortar.

Figure 6: Detail – possible erosion to soil under concrete mortar.

Routine Maintenance	Frequency
<ul style="list-style-type: none">• Surface clean to remove dirt particulate and avian guano.• Monitor stone delamination.• Monitor possible stone delamination.• Monitor possible soil erosion.	Biennially 2 years 2 years 2 years

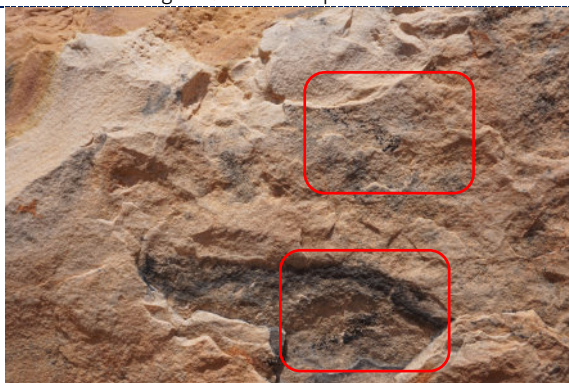
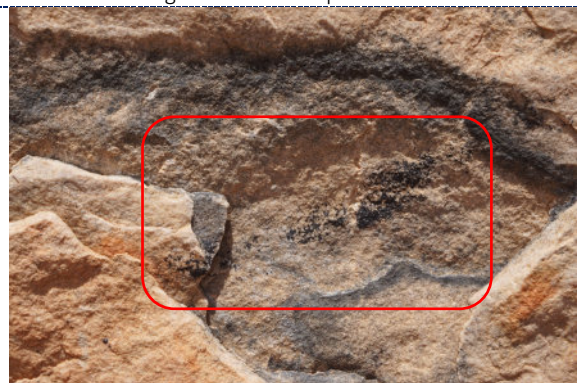
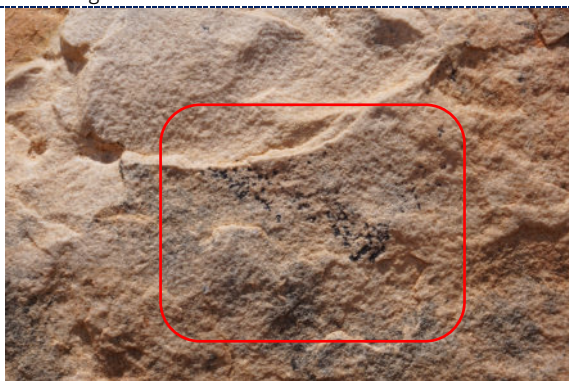
SURFACE/ COATING	MATERIALS:	
CONDITION	✓	NOTES
Abrasions/ dents		
Accretion	✓	Surface accretions present, possible remnants of cleaned graffiti (black paint) (figs. 9-11).
Areas of loss		
Corrosion		
Cracks		
Delamination		
Dust/ dirt	✓	Minor dirt particulate and spider webs (figs. 7-8) observed throughout.
Fading		
Flaking/Friable		
Mould/ mould damage		
Pest damage		
Pitting		
Previous treatment		
Staining/ discolouration		
OTHER

Figure 9: Detail – unknown surface accretion.

Figure 10: Detail – unknown surface accretion.

Figure 11: Detail – unknown surface accretion.

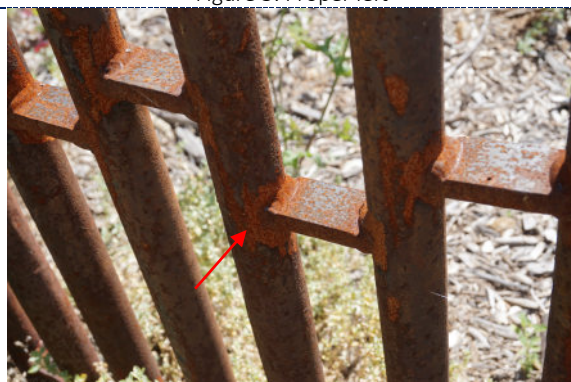
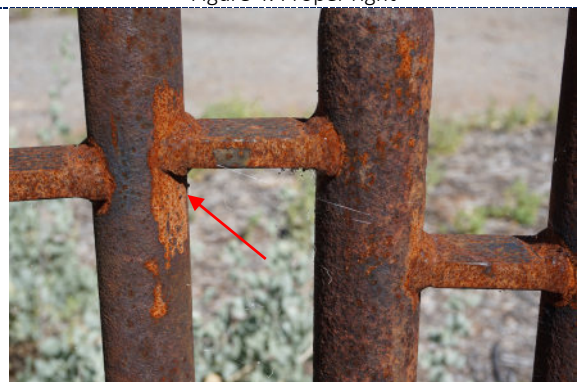
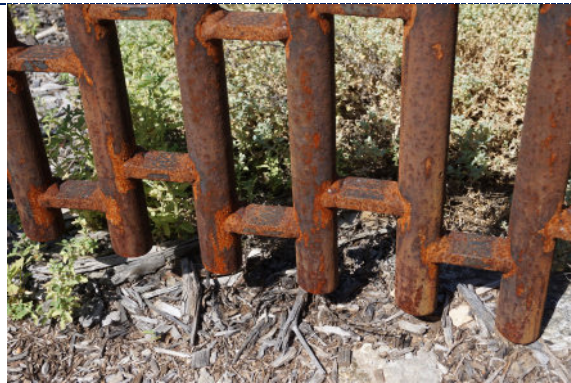
SURFACE/ COATING	MATERIALS:	
CONDITION	✓	NOTES
Abrasions/ dents		
Accretion		
Areas of loss		
Corrosion	✓	Flash rusting/surface corrosion evident throughout but concentrated in areas of fresh welds where the metal had been previously been cleaned for this purpose (figs. 5-14). Iron elements are also embedded into concrete at the ground, and these areas are at most risk for increased corrosion (fig. 8).
Cracks		
Delamination		
Dust/ dirt	✓	Dirt particulate, bird excrement and spider webs were observed throughout, consistent with display outdoors. Biomatter has accumulated in areas at the base.
Fading		
Flaking/Friable		
Mould/ mould damage		
Pest damage		
Previous treatment		
Staining/ discolouration		
OTHER

Figure 5: Detail – dirt particulate; surface flash rusting at new welds created during manufacture of artwork.

Figure 6: Detail – dirt particulate; surface flash rusting at new welds created during manufacture of artwork.

Figure 7: Detail – dirt particulate; surface flash rusting at new welds created during manufacture of artwork.

Routine Maintenance	Frequency
<ul style="list-style-type: none">• Surface clean to remove dirt particulate and accumulation of biomatter from adjacent trees.• Keep biomatter cleaned from object base.• Check for increased corrosion at base due to accumulation of biomatter and where iron is set into concrete.	1 year 1 year 1 year

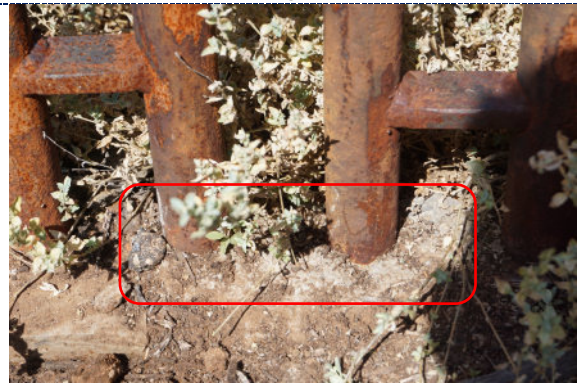
Figure 8: Detail – dirt particulate; surface flash rusting at new welds created during manufacture of artwork; iron inset into concrete.

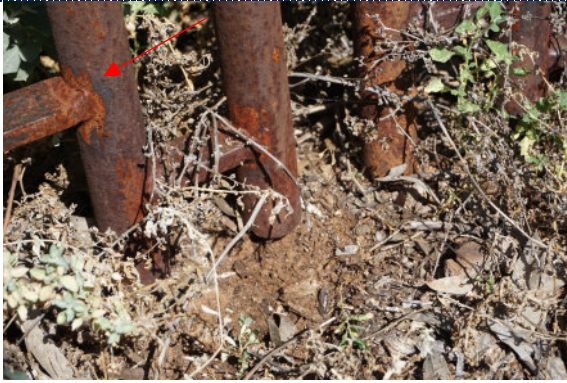
Figure 13: Detail – dirt particulate; surface flash rusting at new welds created during manufacture of artwork.

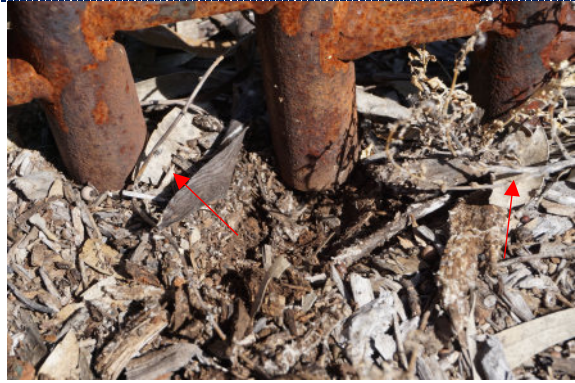
Figure 14: dirt particulate; surface flash rusting at new welds created during manufacture of artwork; biomatter collecting around the base of the work.

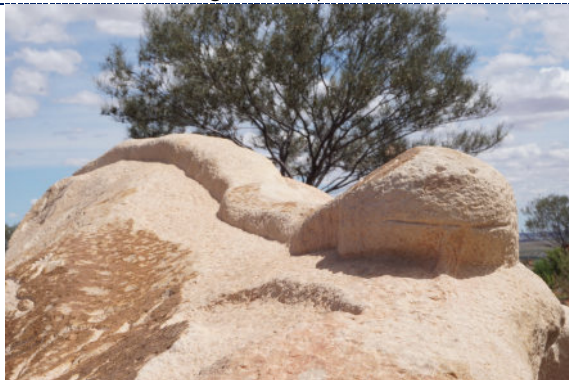
Figure 5: Detail – serpent head.

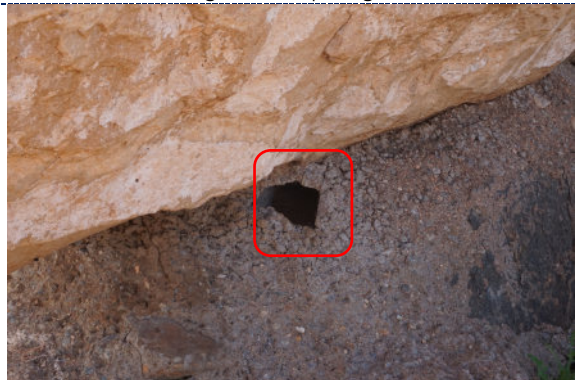
Figure 6: Detail – hole in concrete base.

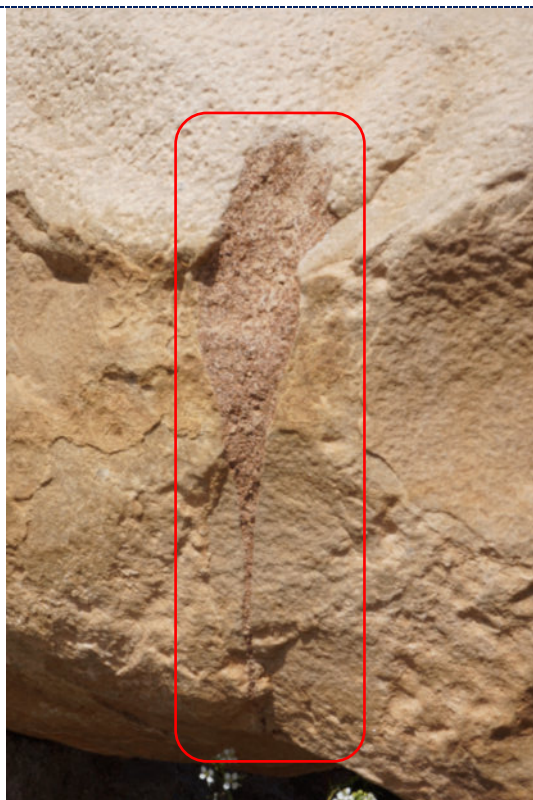
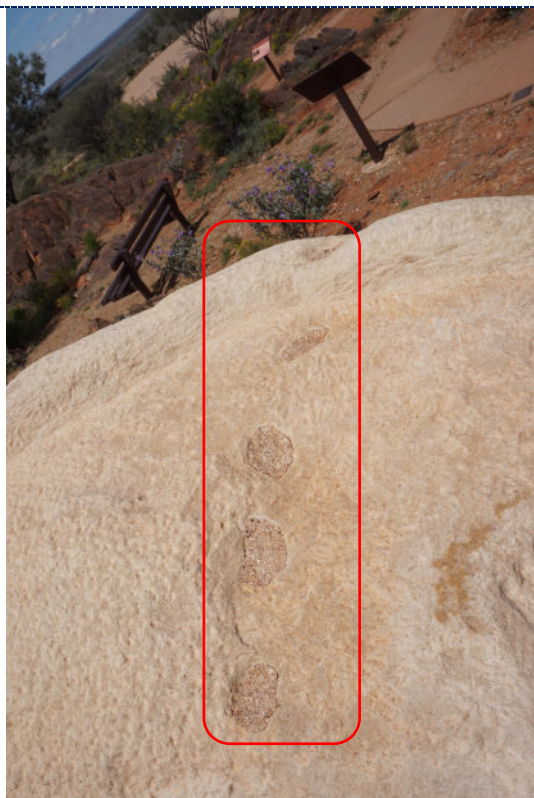
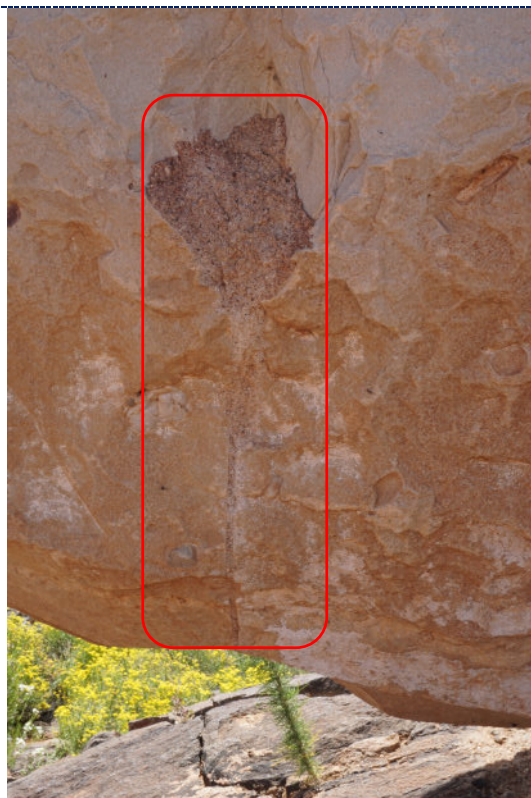
SURFACE/ COATING	MATERIALS:	
CONDITION	✓	NOTES
Abrasions/ dents		
Accretion	✓	Mortar fills visible, likely applied during manufacture to fill voids in the stone (figs. 11-14).
Areas of loss		
Corrosion		
Cracks	✓	Several small natural cracks evident within the structure (fig. 16).
Delamination	✓	Possible stone delamination (fig. 16).
Dust/ dirt	✓	Minor dirt particulate observed throughout, inherent to outdoor sculpture.
Fading		
Flaking/Friable		
Mould/ mould damage		
Pest damage		
Pitting		
Previous treatment		
Staining/ discolouration		
OTHER

Figure 11: Detail – mortar fill.

Figure 12: Detail – mortar fill.

Figure 13: Detail – mortar fill.

Figure 14: Detail – mortar fill.

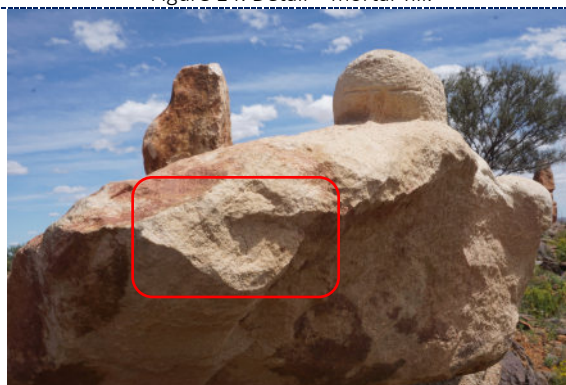
Figure 16: Detail – possible stone delamination.

Routine Maintenance	Frequency
<ul style="list-style-type: none">• Surface clean to remove dirt particulate and avian guano.• Monitor possible stone delamination.• Monitor possible soil erosion.	Biennially 1 year 2 years

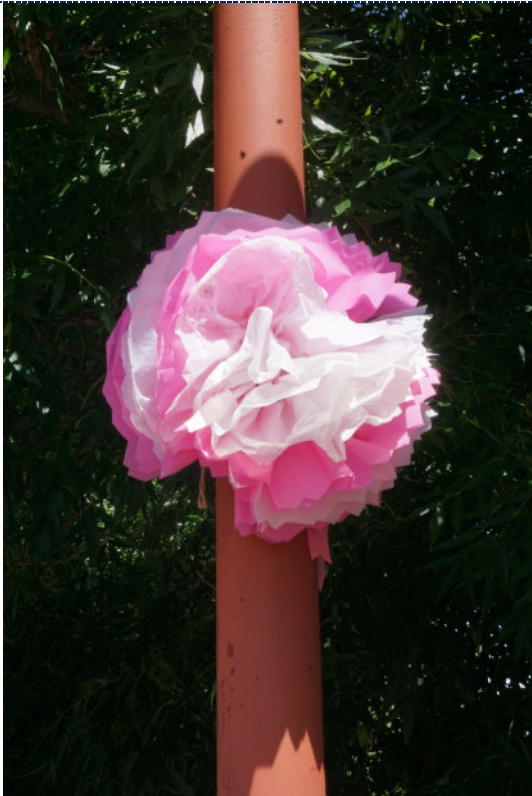
Figure 2: Detail – floral decoration.

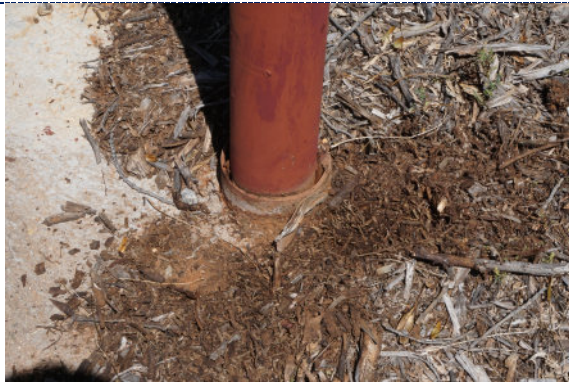
Figure 5: Detail – accumulation of biomatter at base; corrosion to iron.

Routine Maintenance	Frequency
<ul style="list-style-type: none">Surface clean to remove dirt particulate and accumulation of biomatter from adjacent trees.	1 year

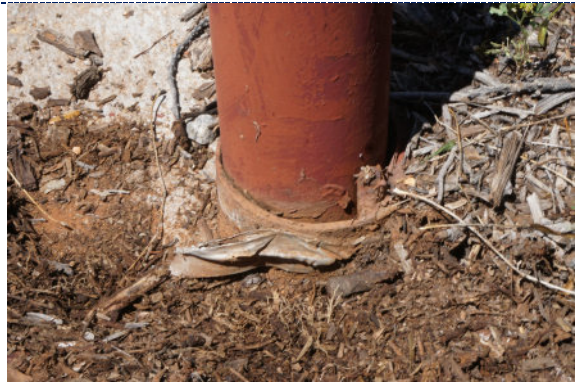
Figure 6: Detail – accumulation of biomatter at base; corrosion to iron.

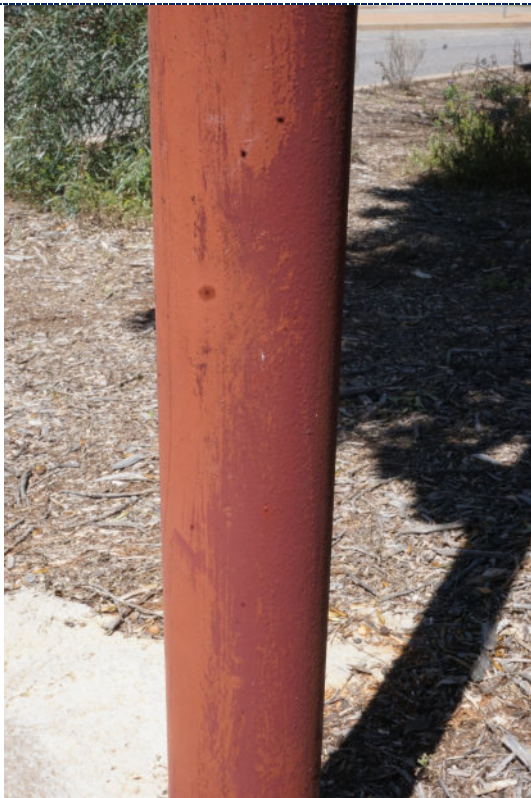
Figure 7: Detail – paint chalking, flaking, overpaint.

Recommended Remedial Treatment Works	Advised Cost
<ul style="list-style-type: none">Remove or reduce failing and flaking paint.Stabilise surface corrosion where needed.Repaint in a paint system rated for use on outdoor metals and colour-matched with the original.	~\$2,500

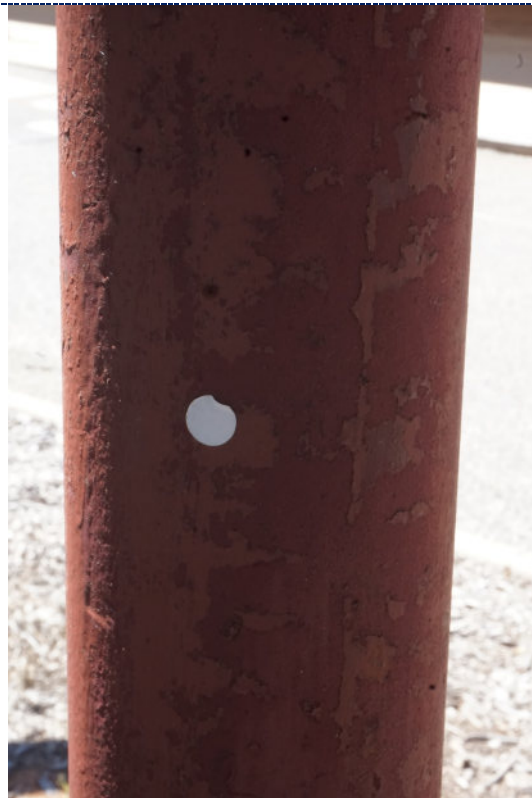
SURFACE/ COATING	MATERIALS:	
CONDITION	✓	NOTES
Abrasions/ dents	✓	Minor small abrasions evident throughout.
Accretion	✓	Small white accretion (sticker) (fig. 8). Floral decoration (fig. 2).
Areas of loss	✓	Flaking paint with loss observed throughout.
Corrosion	✓	Corrosion visible where the paint layer is lost or perforated and visible around base plinth (figs. 5-6).
Cracks		
Delamination		
Dust/ dirt	✓	Dirt particulate and spider webs were observed throughout recesses, consistent with display outdoors. Tree foliage also intruding on sculpture space, risking staining and warping to structure (figs. 11-16).
Fading	✓	Chalking and fading to the paint following exposure to sunlight and outdoor conditions (figs. 7-15).
Flaking/Friable	✓	Flaking and peeling paint (figs. 7-15).
Mould/ mould damage		
Pest damage		
Previous treatment	✓	The sculpture appears to have been repainted at least once due to the slightly different hue between the two paint layers.

Figure 8: Detail – paint chalking, flaking, overpaint; white sticker accretion.

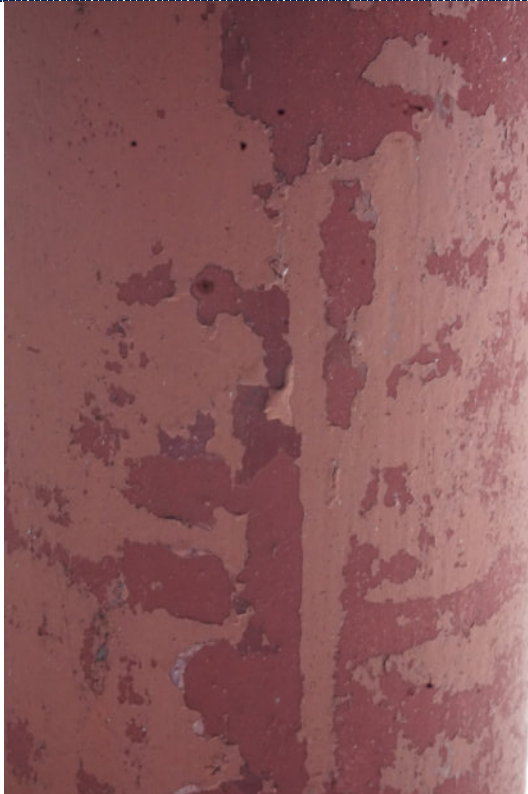
Figure 9: Detail – paint chalking, flaking, overpaint.

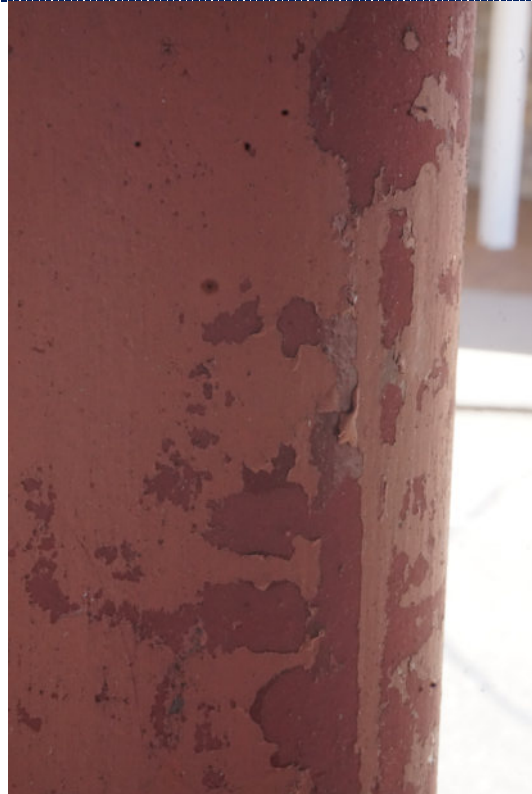
Figure 10: Detail – paint chalking, flaking, overpaint.

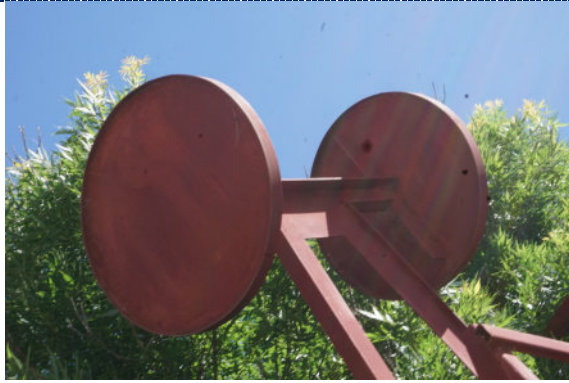
Figure 13: Detail – paint chalking, flaking, overpaint.
