Broken Hill Public Art Condition Survey and Conservation Plan

Prepared for: Broken Hill City Council
Submission Date: February 2023

This report presents the results of a condition survey assessing the works held within Broken Hill City Council's public art collection. A total of 56 works were condition assessed.

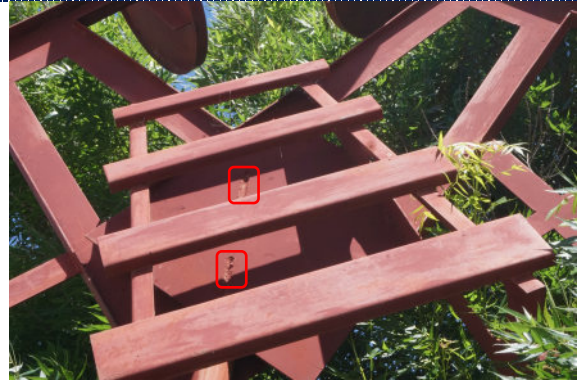
Figure 14: Detail – paint chalking, flaking, overpaint; indentation visible on central panel, likely inherent to artist fabrication.

Recommended Remedial Treatment Works	Advised Cost
<ul style="list-style-type: none">Remove or reduce failing and flaking paint.Stabilise surface corrosion where needed.Repaint in a paint system rated for use on outdoor metals and colour-matched with the original.	~\$2,500

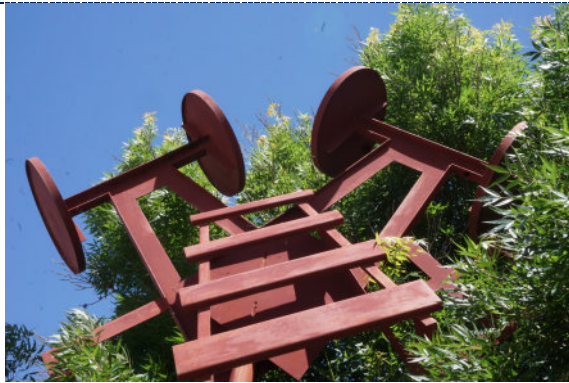
Figure 15: Detail – paint chalking, flaking, overpaint.

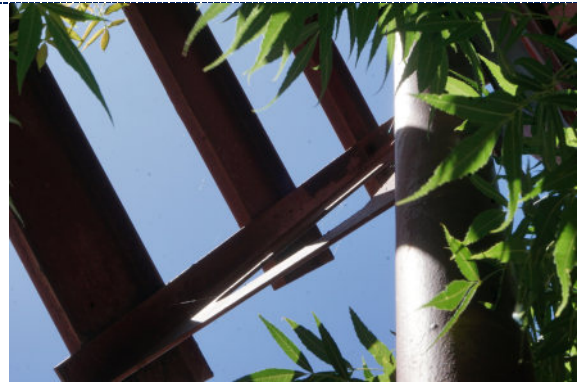
Figure 16: Detail – spider webs.

Routine Maintenance	Frequency
<ul style="list-style-type: none">Surface clean to remove dirt particulate and accumulation of biomatter from adjacent trees.	1 year

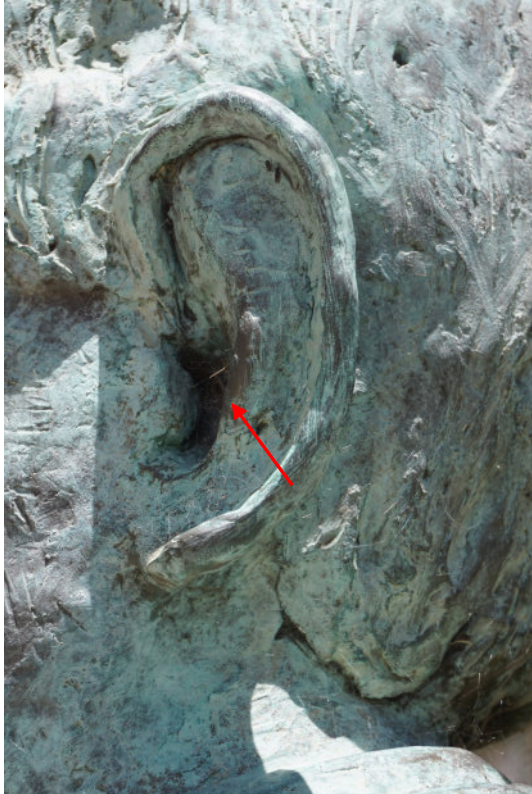
SURFACE/ COATING	MATERIALS:	
CONDITION	✓	NOTES
Abrasions/ dents		
Accretion		
Areas of loss		
Corrosion	✓	Surface corrosion is evident throughout the bronze figure and appears consistent with atmospheric pollution-driven mechanisms (figs. 5-14).
Cracks		
Delamination		
Dust/ dirt	✓	Dirt particulate (figs. 9-13) and spider webs were observed throughout, consistent with display outdoors.
Fading		
Flaking/Friable		
Mould/ mould damage		
Pest damage		
Previous treatment		
Staining/ discolouration		
OTHER

Figure 11: Detail – atmospheric pollution-driven copper corrosion product, dirt particulate, spider webs.

Recommended Remedial Treatment Works	Advised Cost
<ul style="list-style-type: none">• Surface clean to remove dirt particulate and loose corrosion product.• Reduce atmospheric corrosion product.• Wax bronze and copper alloy components.	~\$2,000

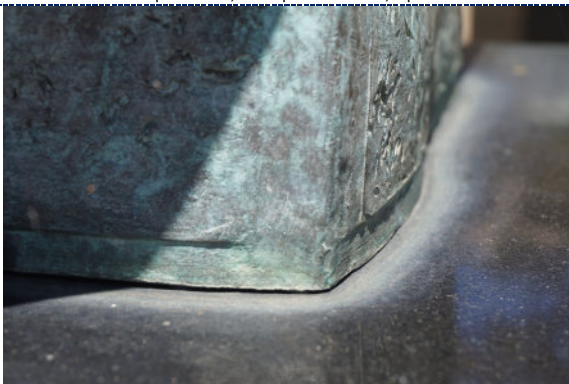
Figure 13: Detail – dirt particulate and increased copper corrosion product stemming from collected water at plinth interface.

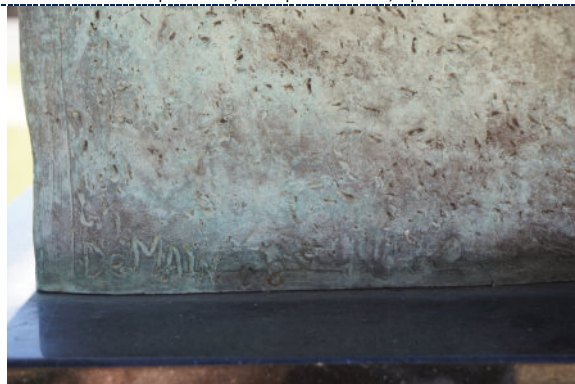
Figure 14: Detail – atmospheric pollution-driven copper corrosion product and artist's signature.

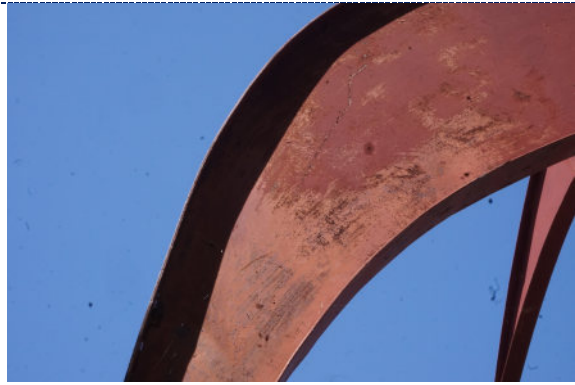
SURFACE/ COATING	MATERIALS:	
CONDITION	✓	NOTES
Abrasions/ dents	✓	Minor small abrasions evident throughout.
Accretion		
Areas of loss		
Corrosion	✓	Corrosion visible where the paint layer is lost or perforated (figs. 5-9, 12-16).
Cracks		
Delamination		
Dust/ dirt	✓	Dirt particulate and spider webs were observed throughout recesses, consistent with display outdoors.
Fading	✓	Chalking and fading to the paint following exposure to sunlight and outdoor conditions (figs. 5-14).
Flaking/Friable	✓	Flaking and peeling paint (figs. 5-14).
Mould/ mould damage		
Pest damage		
Previous treatment	✓	The sculpture appears to have been repainted at least once due to the slightly different hue between the two paint layers.
Staining/ discolouration		
OTHER

Figure 6: Detail – chalking paint, flaking paint loss, abrasions and corrosion; overpaint.

Recommended Remedial Treatment Works	Advised Cost
<ul style="list-style-type: none">Remove or reduce failing and flaking paint.Stabilise surface corrosion where needed.Repaint in a paint system rated for use on outdoor metals and colour-matched with the original.	~\$2,500

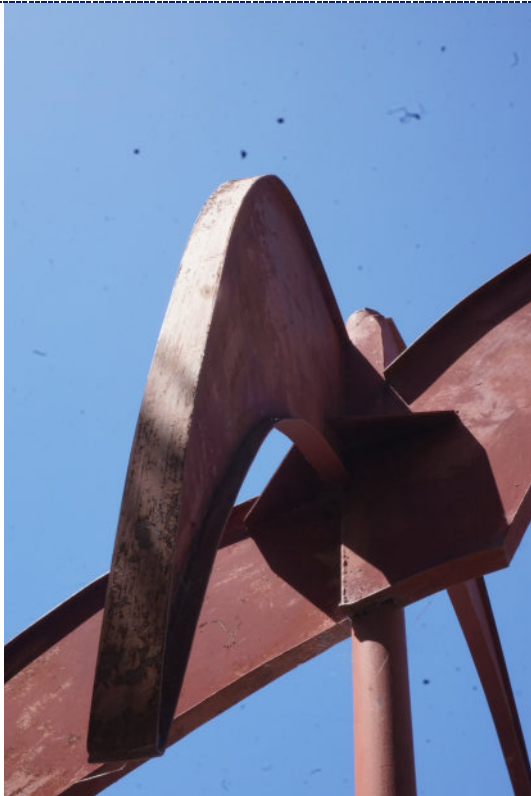
Figure 7: Detail – chalking paint, flaking paint loss, abrasions and corrosion; overpaint.

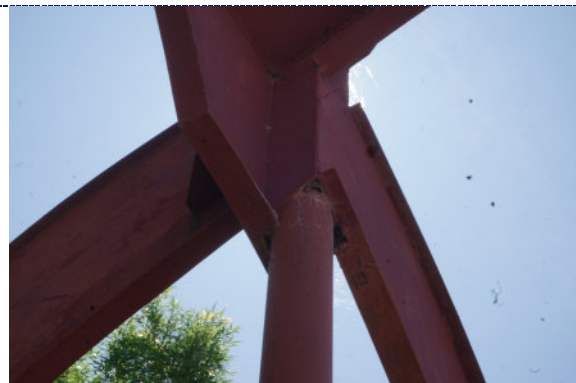
Figure 12: Detail – small holes noted at welding join and spider webs.

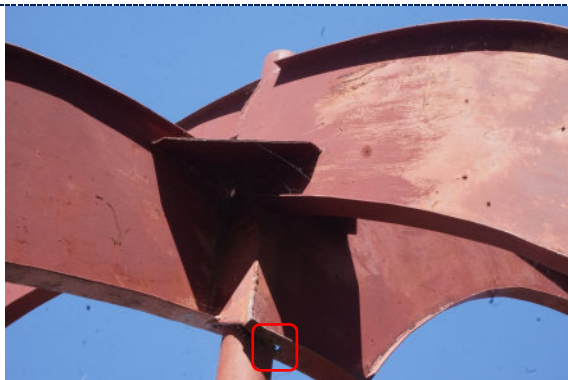
Figure 13: Detail – chalking paint, flaking paint loss, abrasions and corrosion; overpaint; corrosion resulting in perforation of the substrate (small hole).

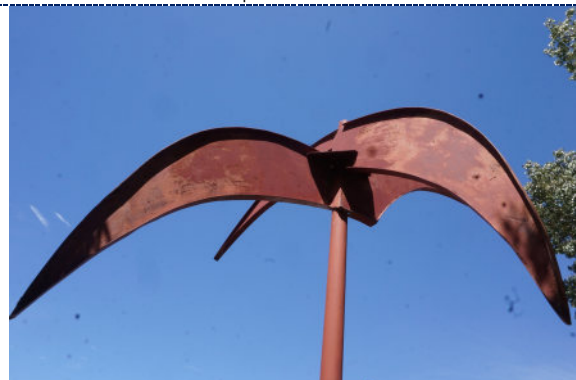
Figure 14: Detail – flaking paint loss with overpaint and abrasions.

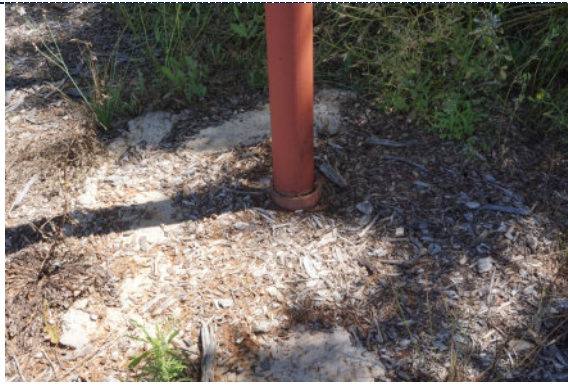
Figure 15: Detail – accumulation of biomatter at base.

Routine Maintenance	Frequency
<ul style="list-style-type: none">Surface clean to remove dirt particulate and accumulation of biomatter from adjacent trees.	1 year

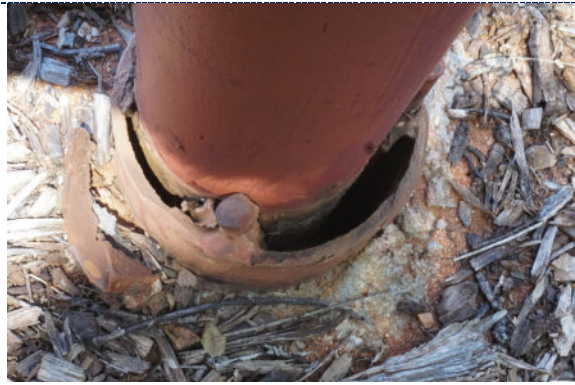
OTHER	Loss of putty/silicon filler at base prevents ingress of water, facilitating corrosion (fig. 16).
-------	---

Figure 16: Detail – deteriorated putty with loss throughout base plinth; ingress of water possible, leading to corrosion.

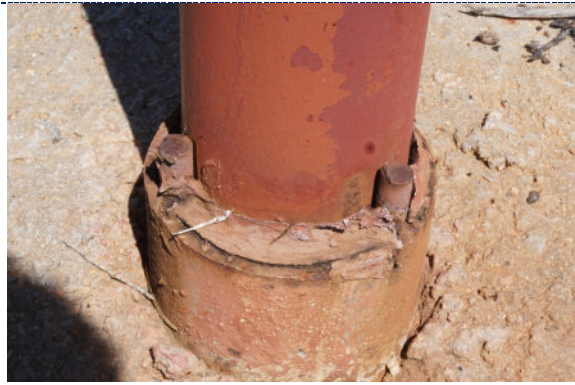
SURFACE/ COATING	MATERIALS:	
CONDITION	✓	NOTES
Abrasions/ dents	✓	Minor small abrasions evident throughout.
Accretion		
Areas of loss	✓	Loss and flaking paint observed throughout.
Corrosion	✓	Corrosion visible where the paint layer is lost or perforated. (fig. 6).
Cracks		
Delamination		
Dust/ dirt	✓	Dirt particulate and spider webs were observed throughout recesses, consistent with display outdoors.
Fading	✓	Chalking and fading to the paint following exposure to sunlight and outdoor conditions (figs. 6-10).
Flaking/Friable	✓	Flaking and peeling paint (fig. 6-10).
Mould/ mould damage		
Pest damage		
Previous treatment	✓	The sculpture appears to have been repainted at least once due to the slightly different hue between the two paint layers. Deteriorated putty/adhesive visible on base plinth (fig. 6).
Staining/ discolouration		
OTHER

Figure 6: Detail – paint chalking, flaking paint loss with overpaint; corrosion in areas of paint loss; previous repairs (putty/silicone at base).

Recommended Remedial Treatment Works	Advised Cost
<ul style="list-style-type: none">Remove or reduce failing and flaking paint.Stabilise surface corrosion where needed.Repaint in a paint system rated for use on outdoor metals and colour-matched with the original.	~\$2,500

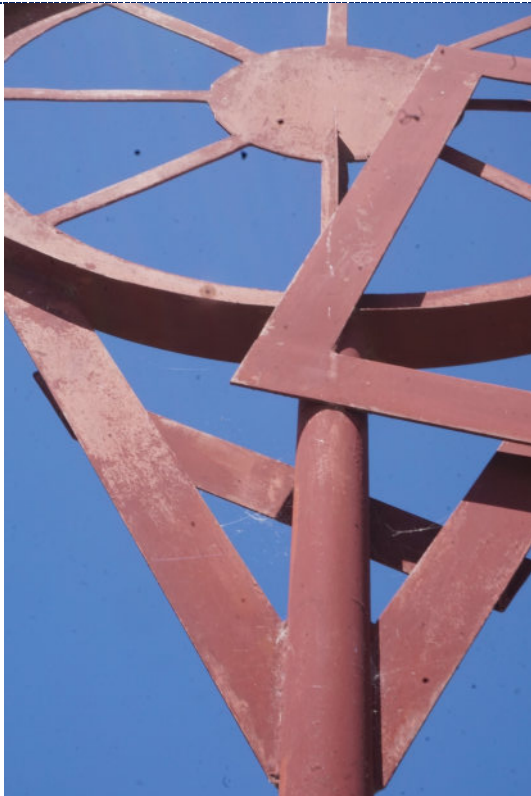
Figure 7: Detail – paint chalking, overpaint; spider webs, bird excrement.

Routine Maintenance	Frequency
<ul style="list-style-type: none">Surface clean to remove dirt particulate and accumulation of biomatter from adjacent trees.	1 year

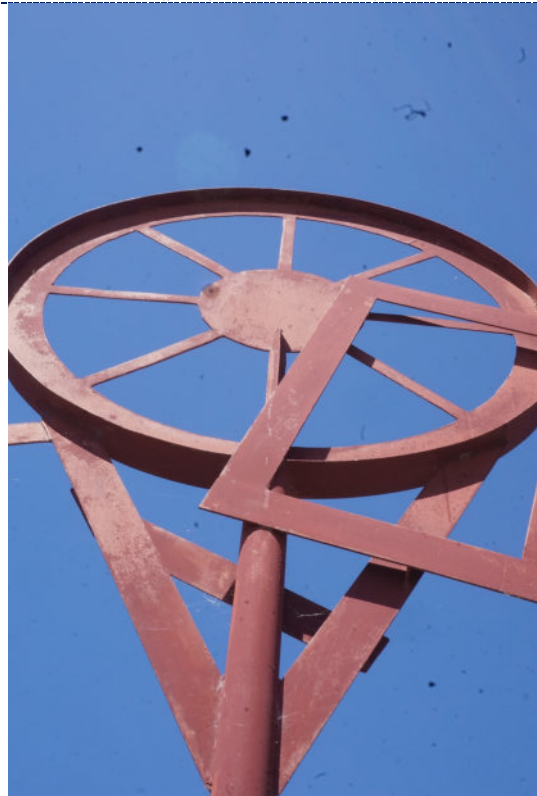
Figure 8: Detail – paint chalking, overpaint; spider webs, bird excrement.

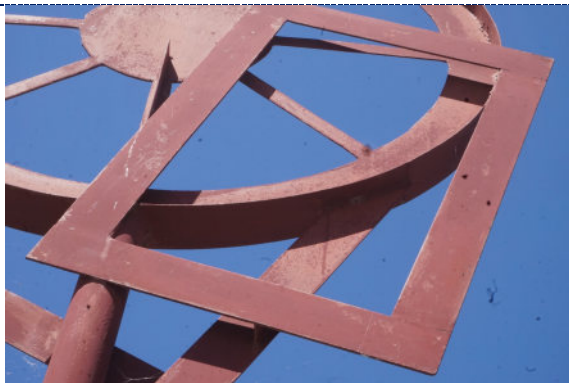
Figure 9: Detail – paint chalking, overpaint; spider webs, bird excrement.

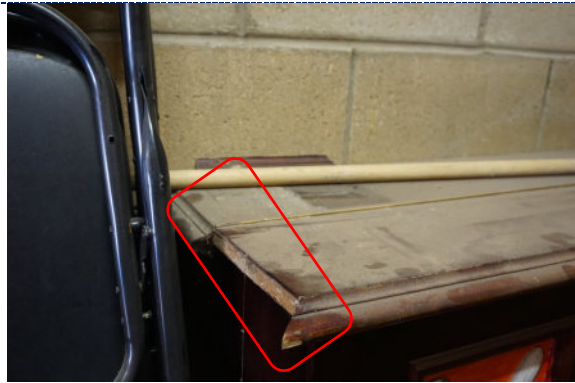
PRIMARY STRUCTURE	MATERIALS:	
CONDITION	✓	NOTES
Abrasions/ dents	✓	Abrasion or sharp contact likely caused separation of wooden component and damage to wood corner (figs. 6-8).
Areas of loss/ detached or missing component	✓	Wooden element on proper right side separated (fig. 6); the missing element is located on top of the piano (fig. 8). Other areas of loss to the wood and lacquer observed throughout (figs. 7, 9, 13, 16).
Corrosion		
Cracks/ splitting		
Disjoin/ Loose component	✓	Felt/textile internal element is loose and partially separated (figs. 10, 14-17).
Distortion		
Pest damage		
Previous treatment/ repair		
Rotting

Figure 6: Detail – dirt particulate and loss of wooden element.

Recommended Remedial Treatment Works	Advised Cost
<ul style="list-style-type: none">• Surface clean to remove dirt particulate.• Reintegrate separated wooden element.• Fill losses to the wooden elements and re-lacquer to match with the original.• Repair loss to lacquer (fig. 16).• If possible, find an alternative storage solution so the object is not at risk of falling chairs, etc.• Store with a cover.	~\$5,000

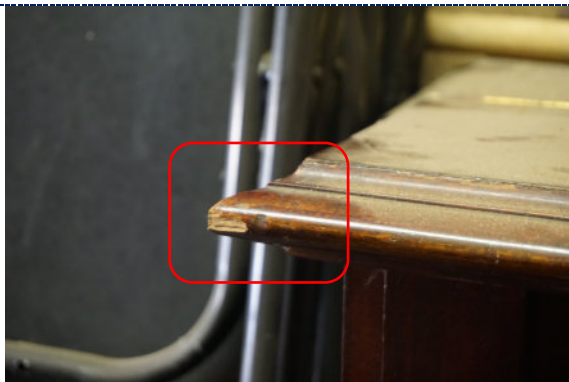
Figure 7: Detail – dirt particulate; loss at corner.

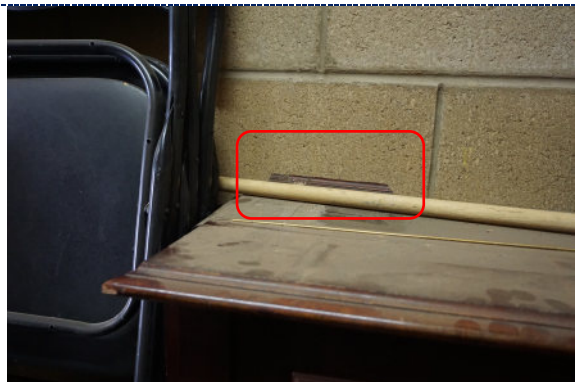
Figure 8: Detail – separated wooden component in figure 6.

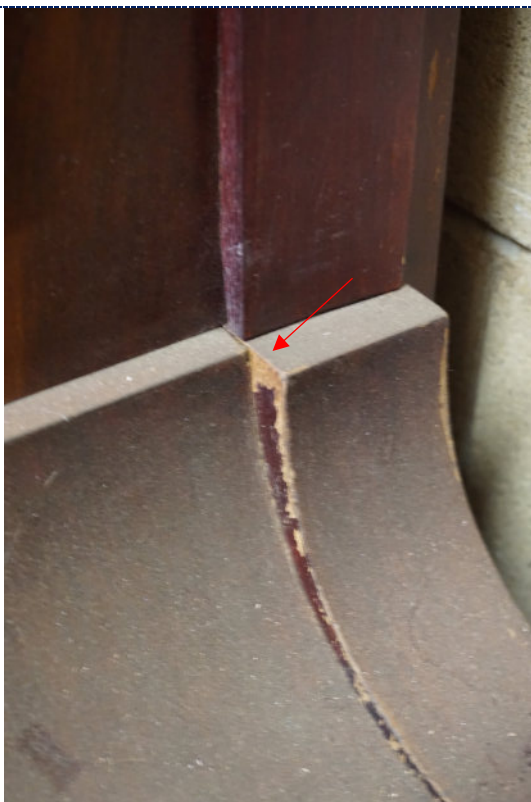
SURFACE/ COATING	MATERIALS:	
CONDITION	✓	NOTES
Abrasions/ dents	✓	Several surface abrasions resulting in loss to clear lacquer (figs. 9, 13, 16).
Accretion		
Areas of loss	✓	Loss to clear lacquer (figs. 9, 13, 16).
Corrosion		
Cracks		
Delamination		
Dust/ dirt	✓	Dirt particulate observed throughout.
Fading		
Flaking/Friable		
Mould/ mould damage		
Pest damage		
Previous treatment		
Staining/ discolouration		
OTHER

Figure 9: Detail – dirt particulate; loss to surface lacquer.

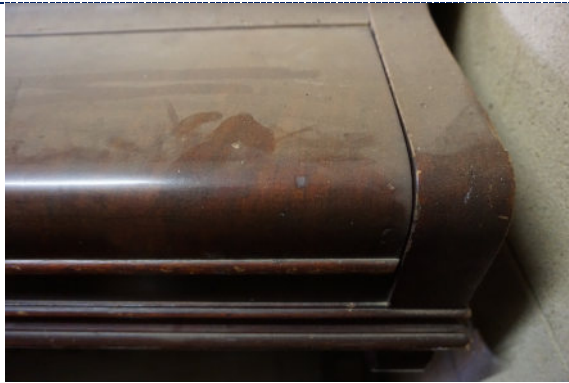
Figure 11: Detail – dirt particulate; surface accretions.

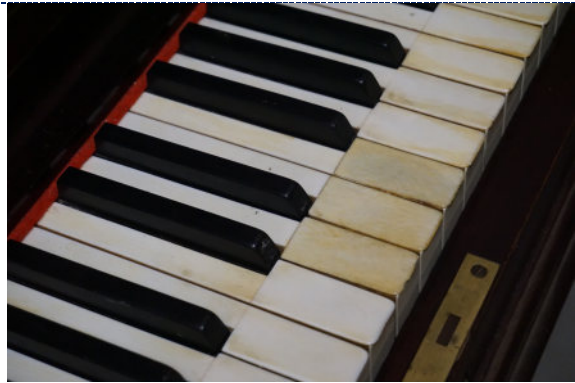
Figure 12: Detail – dirt particulate; yellowing keys.

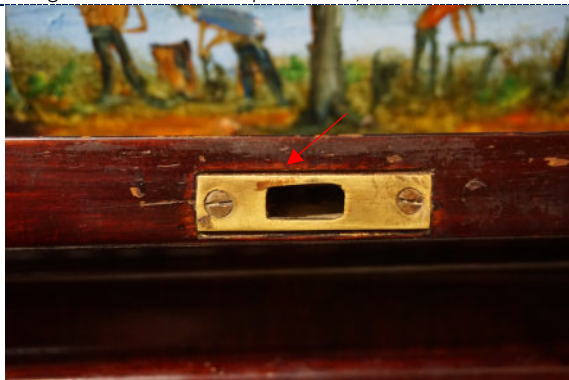
Figure 13: Detail – dirt particulate; small surface losses; tinted lacquer overpaint on brass component.

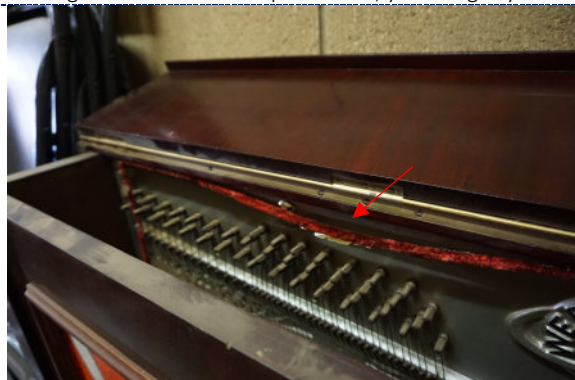
Figure 14: Detail – dirt particulate; loose-hanging felt.

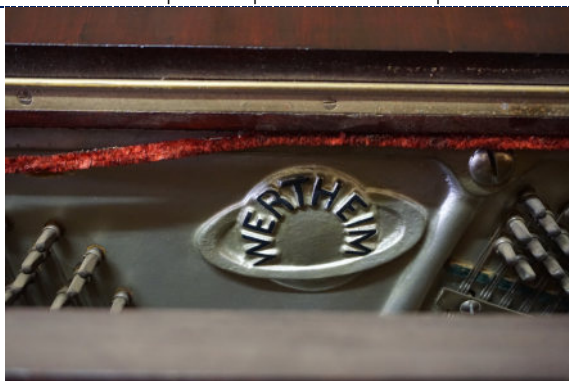
Figure 15: Detail – dirt particulate; loose-hanging felt.

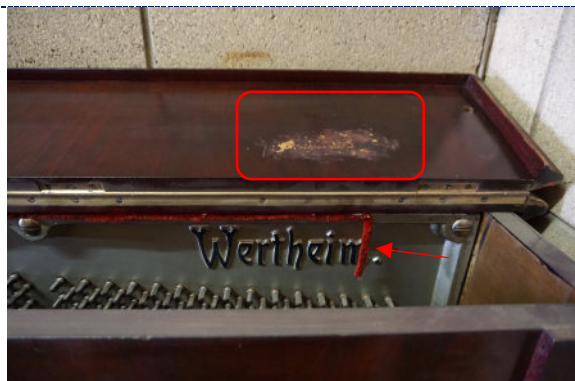
Figure 16: Detail – dirt particulate; loose-hanging felt; large loss to tinted lacquer.

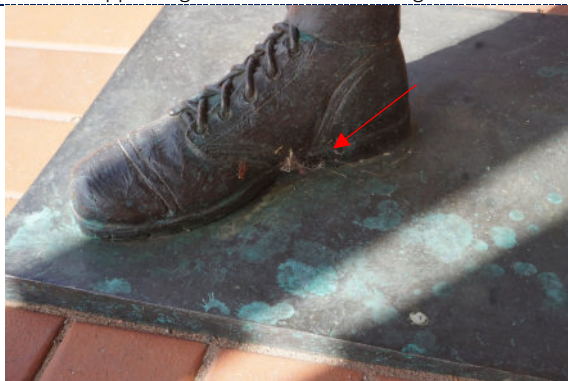
SURFACE/ COATING	MATERIALS:	
CONDITION	✓	NOTES
Abrasions/ dents		
Accretion		
Areas of loss		
Corrosion	✓	Surface corrosion is evident throughout the bronze figure, the worst of which appears to stem from contact with acidic dog urine (figs. 5-14).
Cracks		
Delamination		
Dust/ dirt	✓	Dirt particulate, bird excrement and spider webs were observed throughout, consistent with display outdoors.
Fading		
Flaking/Friable		
Mould/ mould damage		
Pest damage		
Previous treatment		
Staining/ discolouration		
OTHER

Figure 7: Detail – corrosion product, possibly stemming from acidic dog urine; dirt particulate, spider webs, bird excrement.

Recommended Remedial Treatment Works	Advised Cost
<ul style="list-style-type: none">• Surface clean to remove dirt particulate and loose corrosion product.• Reduce atmospheric corrosion product.• Wax bronze and copper alloy components.	~\$3,000

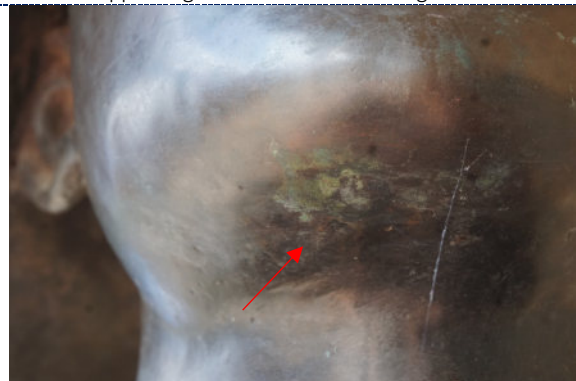
Figure 8: Detail – corrosion product under figure's chin; dirt particulate, spider webs.

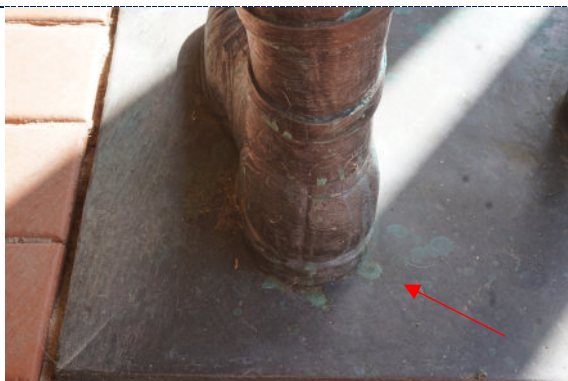
Figure 9: Detail – corrosion product, possibly stemming from acidic dog urine; dirt particulate, spider webs, bird excrement.

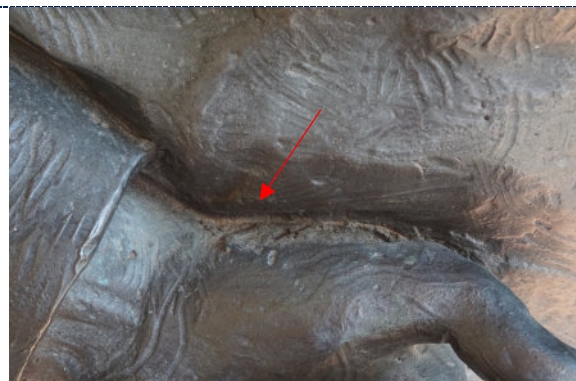
Figure 10: Detail – dirt particulate.

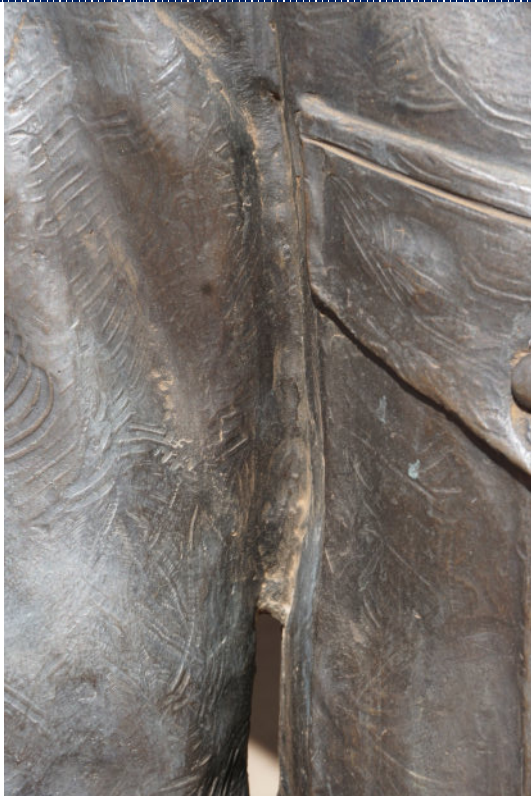
Figure 11: Detail – dirt particulate.

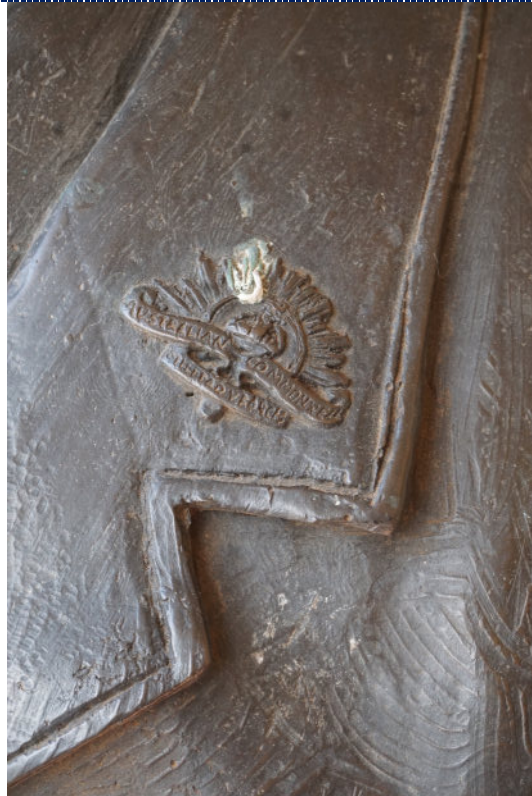
Figure 12: Detail – bird excrement.

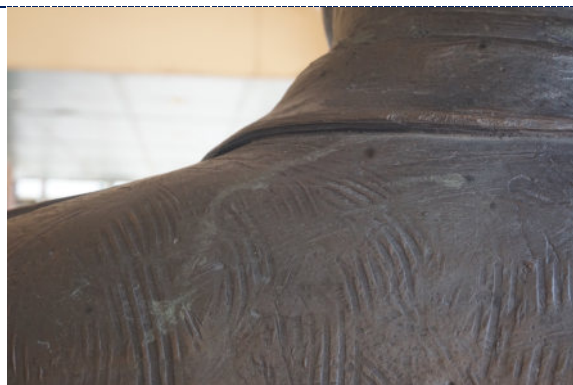
Figure 15: Detail – corrosion product; dirt particulate.

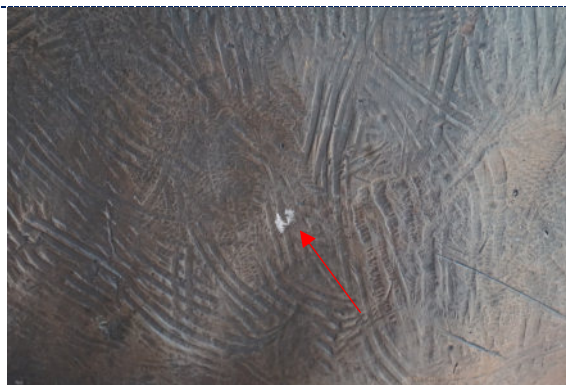
Figure 16: Detail – bird excrement, dirt particulate.

Routine Maintenance	Frequency
<ul style="list-style-type: none">• Surface clean to remove dirt particulate and bird excrement.• Re-apply wax.	2 years

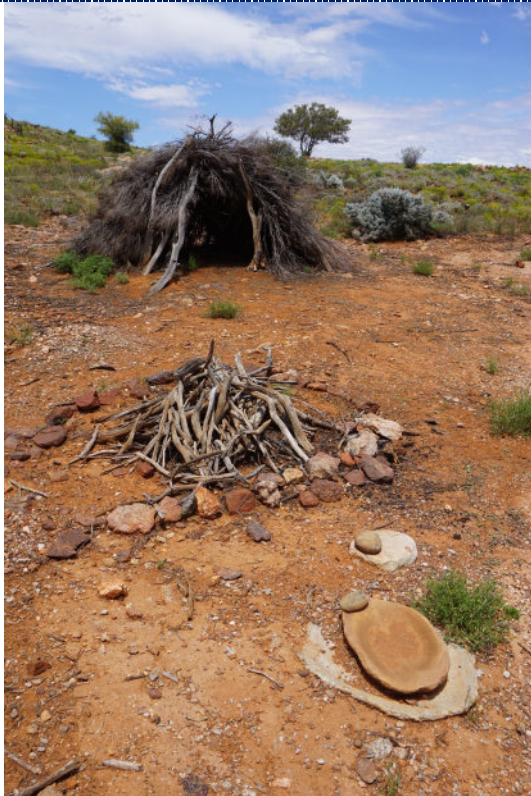
PRIMARY STRUCTURE	MATERIALS:	
CONDITION	✓	NOTES
Abrasions/ dents		
Areas of loss/ detached or missing component		
Corrosion		
Cracks/ splitting	✓	Long crack visible through rear proper right side extending around to front (figs. 7-11). This may stem from a natural fault in the sandstone.
Disjoin/ Loose component	✓	Cement/concrete joining sculpture to rock escarpment appears loose with some cracks (figs. 5-6).
Distortion		
Pest damage		
Previous treatment/ repair		
Rotting		
Wear/ polishing		
OTHER

Figure 7: Detail – browning of organic material due to natural degradation processes; biogrowth encircling Yapara shelter.

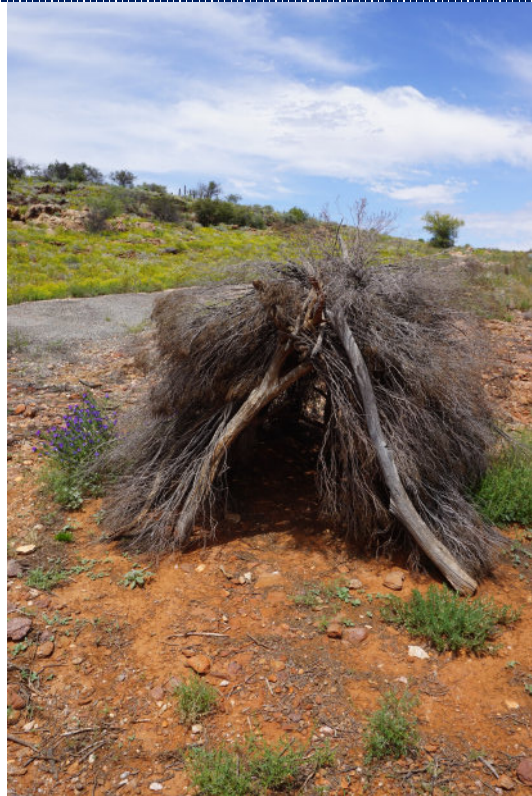
Figure 8: Detail – browning of organic material due to natural degradation processes; biogrowth encircling Yapara shelter.

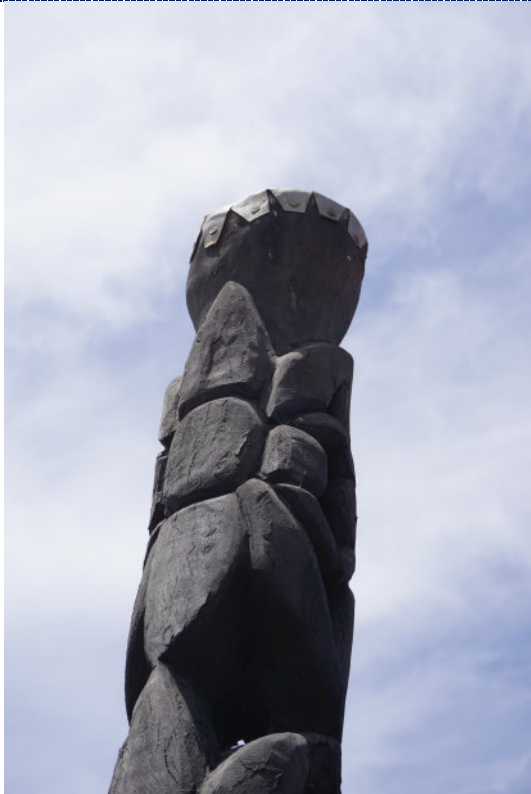
Figure 7: Detail – Pole 1 (temporary conservation number assigned to the object for identification purposes), exterior, UV degradation (darkening) to wood surface. Dirt particulate is present throughout.

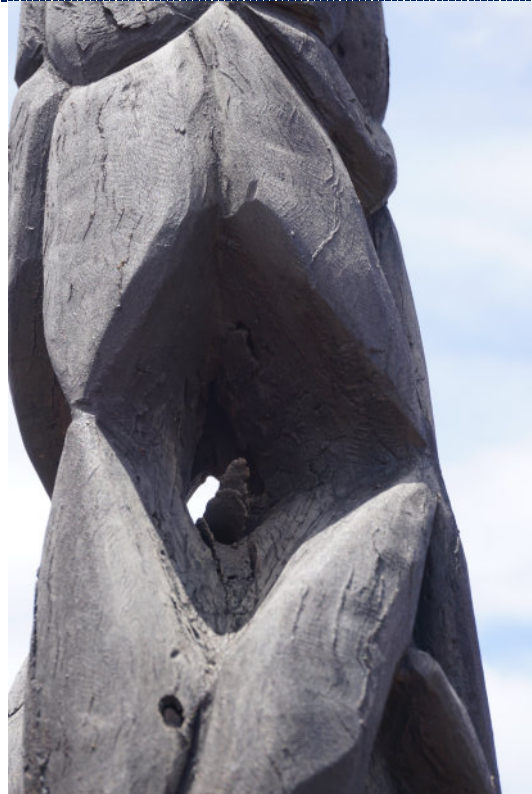
Figure 8: Detail – Pole 1 (temporary conservation number assigned to the object for identification purposes), exterior, UV degradation (darkening) to wood surface, cracks and splitting following the grain of the wood are evident throughout.

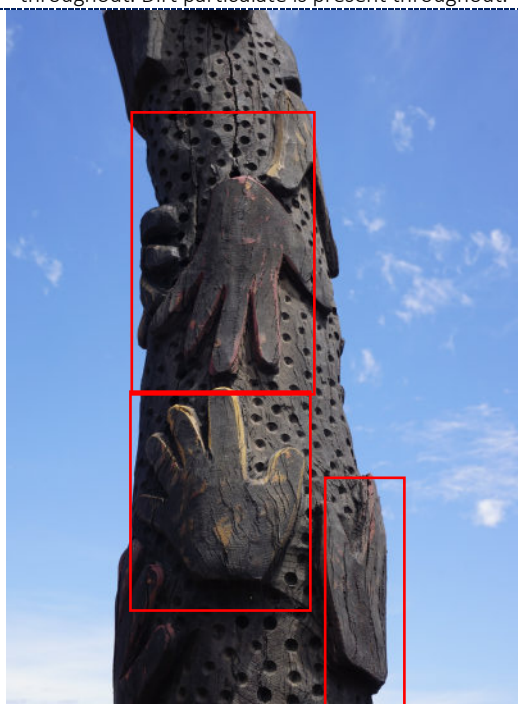
Figure 13: Detail – Pole 2, exterior, UV degradation (darkening) to wood surface, cracks and splitting following the grain of the wood are evident throughout. Extensive paint losses to carve hands (highlighted in red).

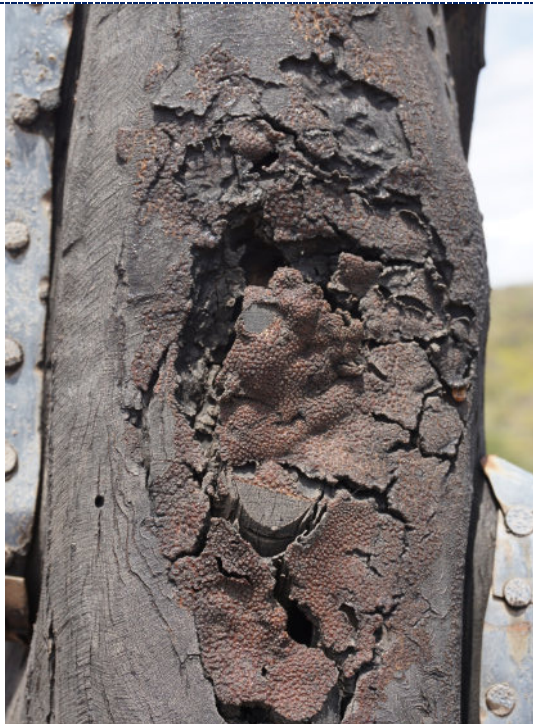
Figure 15: Detail – Pole 2, exterior, UV degradation (darkening) to wood surface, significant cracking of wood, and build-up of sap-like accretions.

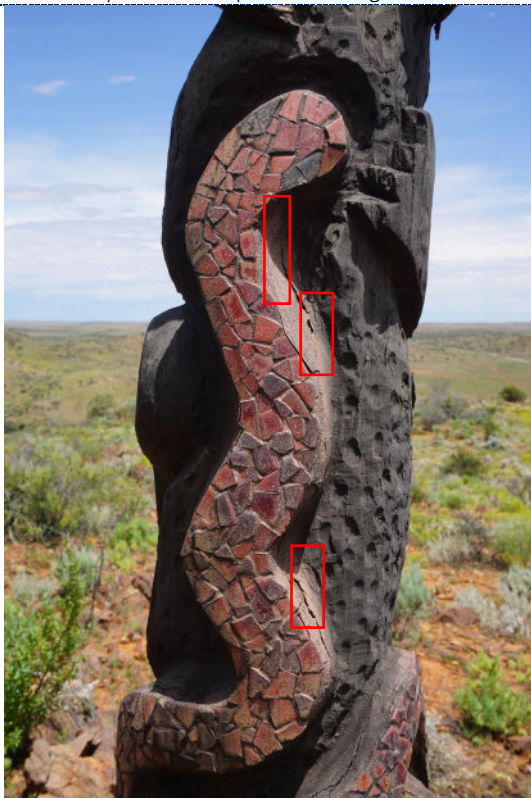
Figure 21: Detail – Pole 3, exterior, UV degradation (darkening) to wood surface, losses to wood surface adjacent to the mosaic tiled serpent (losses highlighted in red).

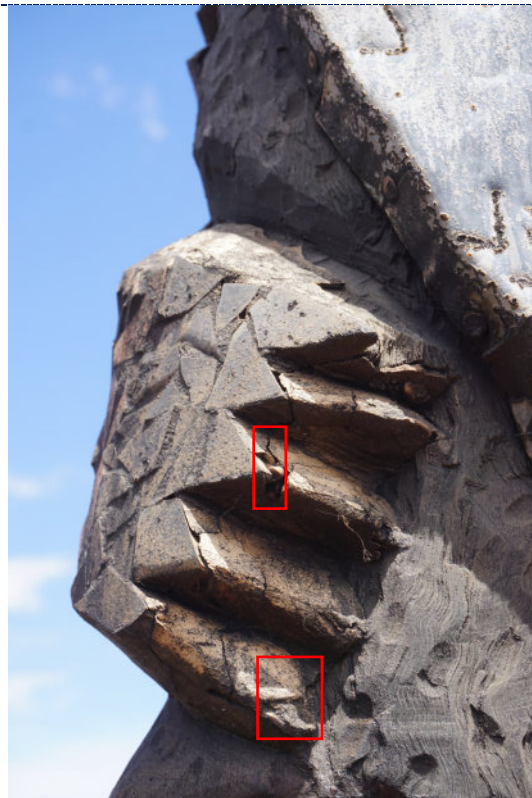
Figure 22: Detail – Pole 3, exterior, UV degradation (darkening) to wood surface, losses to wood surface adjacent to the mosaic tiled serpent (losses highlighted in red) .

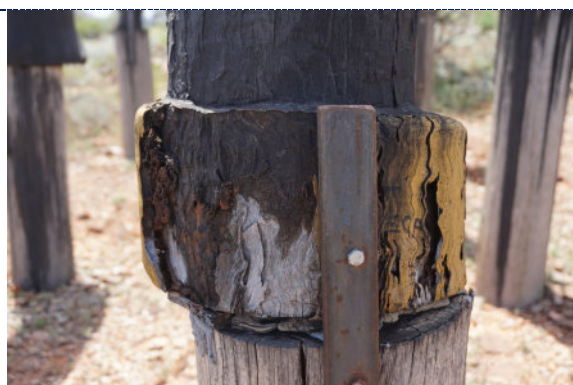
Figure 27: Detail – Pole 4, exterior, UV degradation (darkening) to wood surface, losses to wood likely associated with past insect activity, iron corrosion on metal support brackets. Dirt particulate is present throughout.

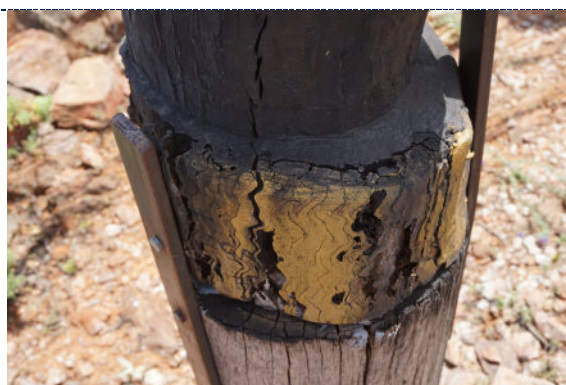
Figure 28: Detail – Pole 4, exterior, UV degradation (darkening) to wood surface, losses to wood likely associated with past insect activity, iron corrosion on metal support brackets.

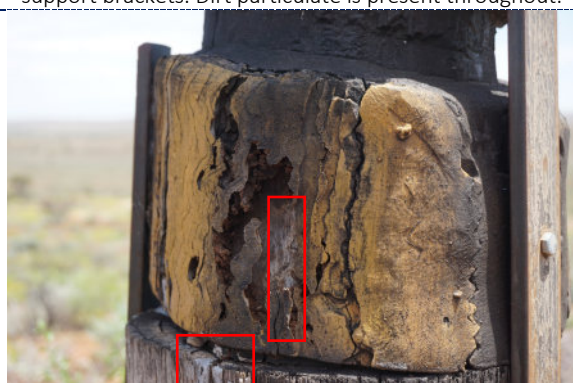
Figure 29: Detail – Pole 4, exterior, UV degradation (darkening) to wood surface, losses to wood likely associated with past insect activity, and presence of bird excrement (highlighted in red).

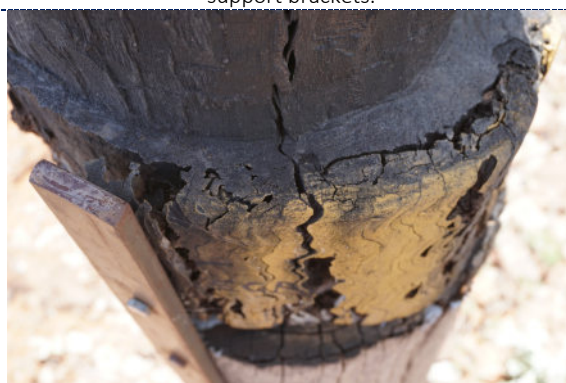
Figure 30: Detail – Pole 4, exterior, UV degradation (darkening) to wood surface, losses to wood likely associated with past insect activity, iron corrosion on metal support brackets.

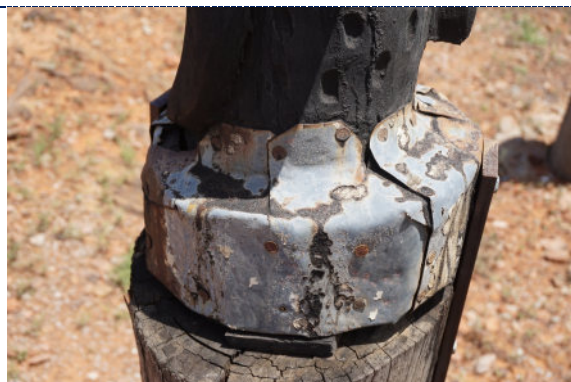
Figure 33: Detail – Pole 5, exterior, UV degradation (darkening) to wood surface, degradation of metal and presence of iron corrosion products. Dirt particulate is present throughout.

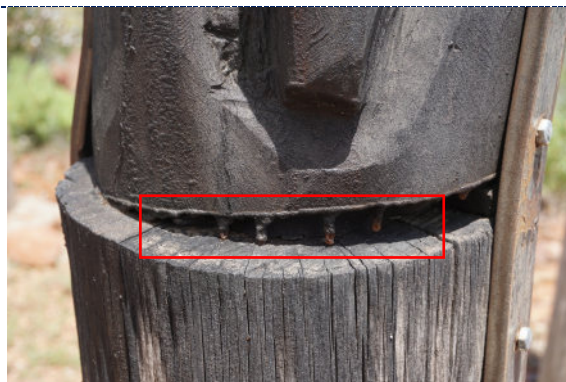
Figure 34: Detail – Pole 5, exterior, UV degradation (darkening) to wood surface, sap-like deposits (accretions) along the lower edge of the pole (highlighted in red).

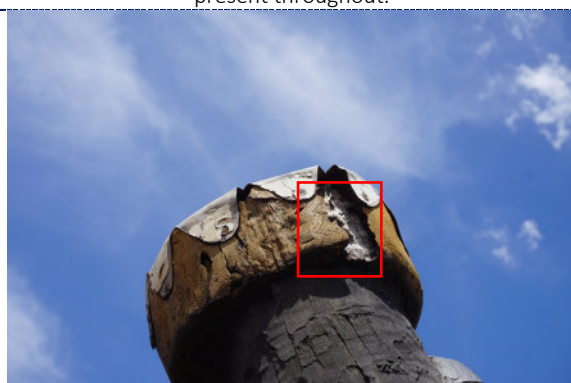
Figure 35: Detail – Pole 5, exterior, UV degradation (darkening) to wood surface, large loss to wood on exterior side of the pole's (top of pole, highlighted in red).

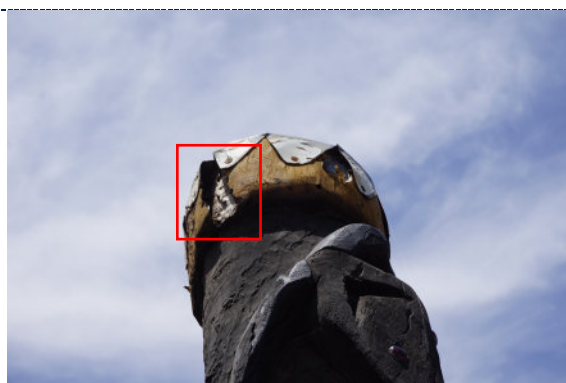
Figure 36: Detail – Pole 5, exterior, UV degradation (darkening) to wood surface, large loss to wood on exterior side of the pole's (top of pole, highlighted in red).

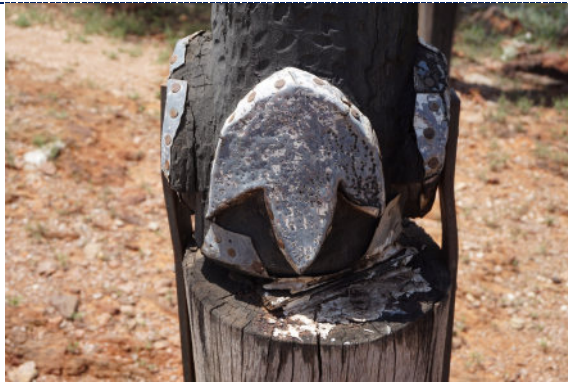
Figure 39: Detail – Pole 6, exterior, UV degradation (darkening) to wood surface, degradation of metal and presence of iron corrosion products. Dirt particulate is present throughout.

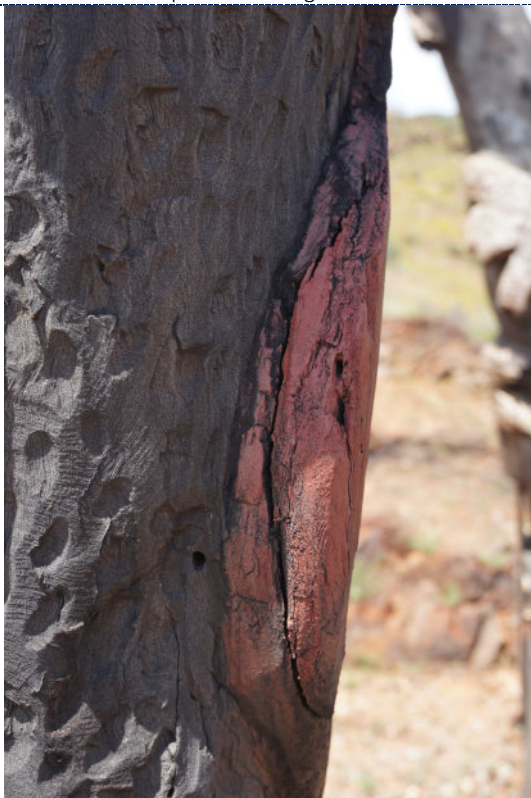
Figure 41: Detail – Pole 6, exterior, UV degradation (darkening) to wood surface, extensive cracking, and losses to raised carved wood designs and associated paint losses likely due to UV degradation and full exposure to the elements.

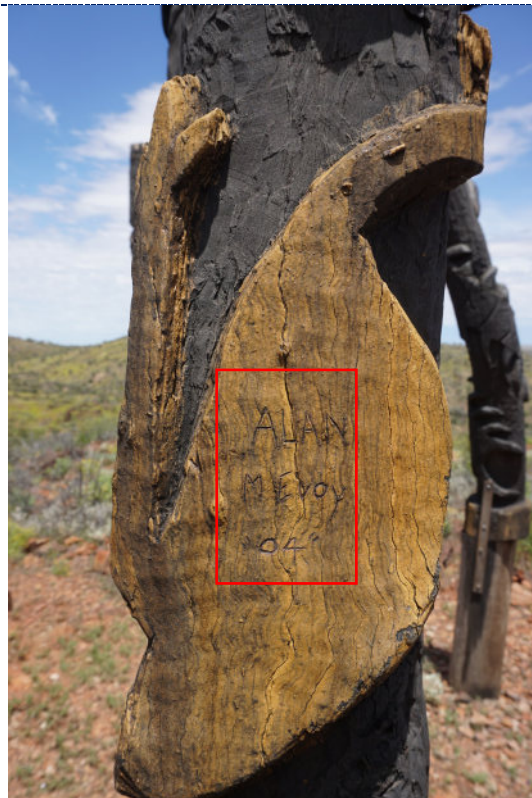
Figure 42: Detail – Pole 6, exterior, UV degradation (darkening) to wood surface, extensive cracking and losses to raised carved wood designs and fading of painted surfaces likely due to UV degradation and full exposure to the elements. The artist's name is carved into the wood (highlighted in red).

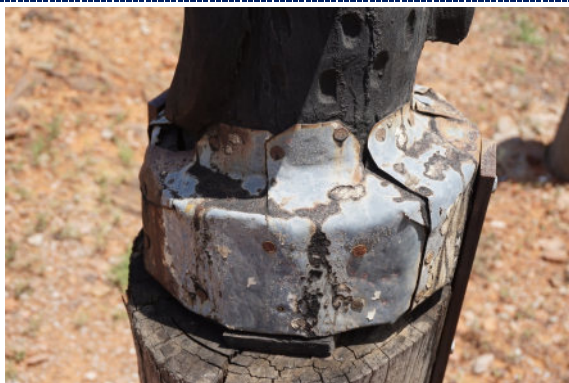
Figure 47: Detail - Pole 7, exterior, UV degradation (darkening) to wood surface, chemical degradation of the spherical metal components, including the presence of pitting and iron corrosion products on the iron nails. Dirt particulate is present throughout.

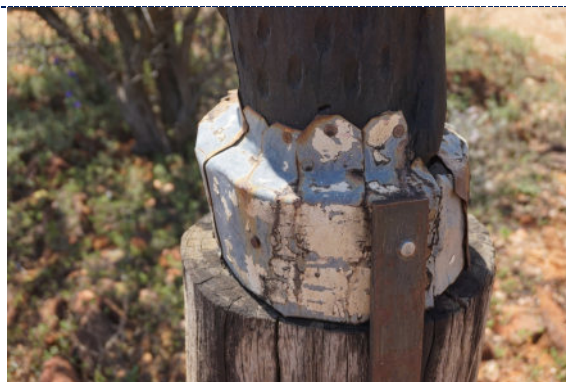
Figure 48: Detail - Pole 7, exterior, UV degradation (darkening) to wood surface, chemical degradation of the spherical metal components, including the presence of pitting and iron corrosion products on the iron nails.

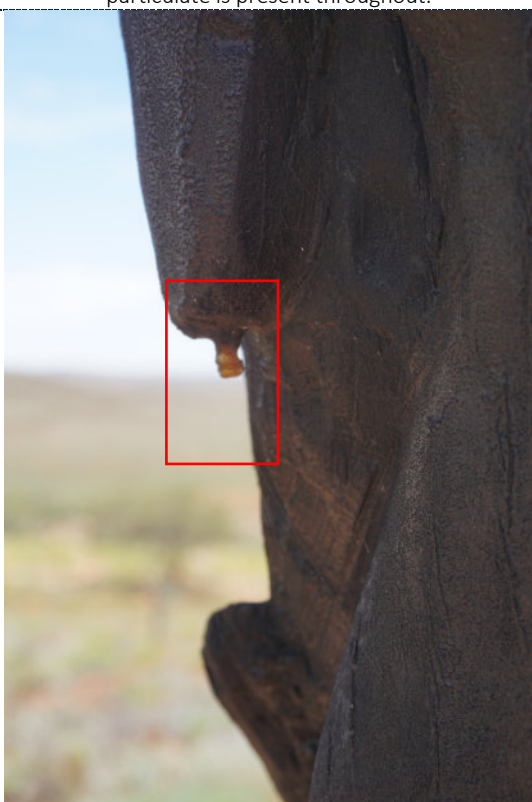
Detail 49: Detail – Pole 7, exterior, UV degradation (darkening) to wood surface, sap-like deposits (accretions) along the lower edge of the pole (highlighted in red).

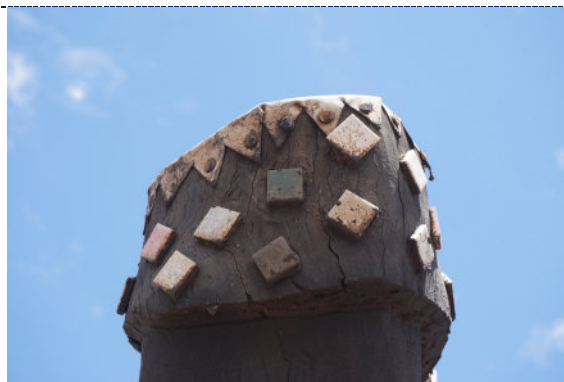
Detail 56: Detail – Pole 8, exterior, UV degradation (darkening) to wood surface, iron corrosion exhibited on metal components at top of pole. Dirt particulate present on diamond shaped tiles and throughout.

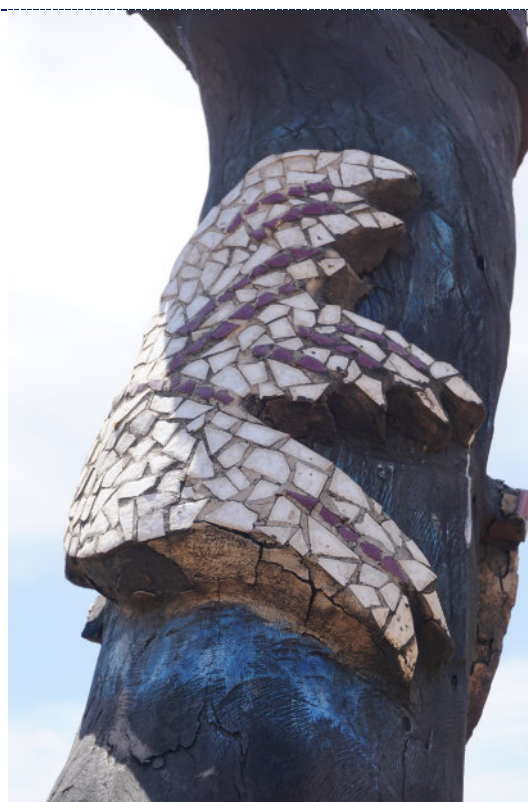
Figure 58: Detail – Pole 8, exterior, UV degradation (darkening) to wood surface, extensive losses to painted surfaces and degradation to the binder securing the mosaic tiles in place.

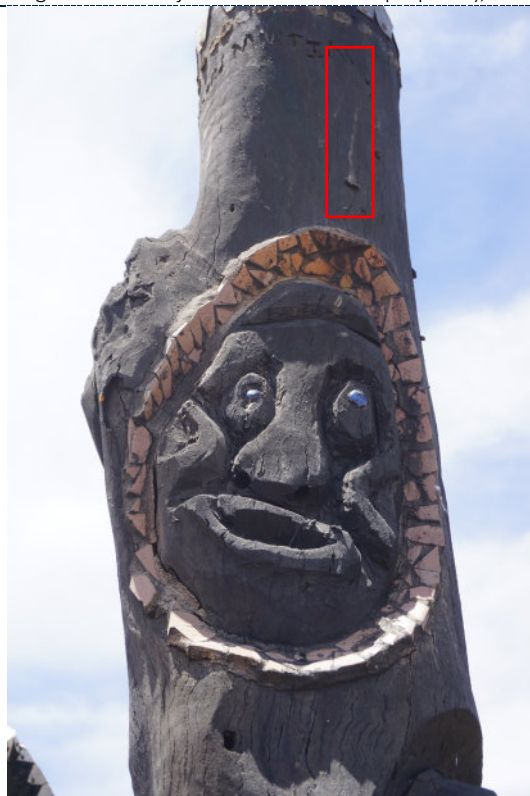
Figure 62: Detail – Pole 9, exterior, UV degradation (darkening) to wood surface, minor losses to the mosaic tiles surrounding the figure. Bird excrement noted above the carved figure (highlighted in red).

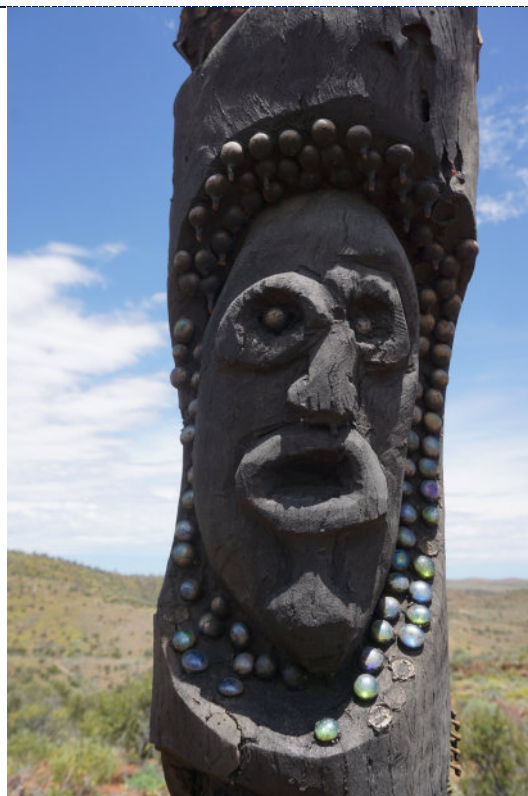
Figure 64: Detail – Pole 9, exterior, UV degradation (darkening) to wood surface, multiple losses to the glass pebbles surrounding the carved figure, particularly below the figure's chin region.

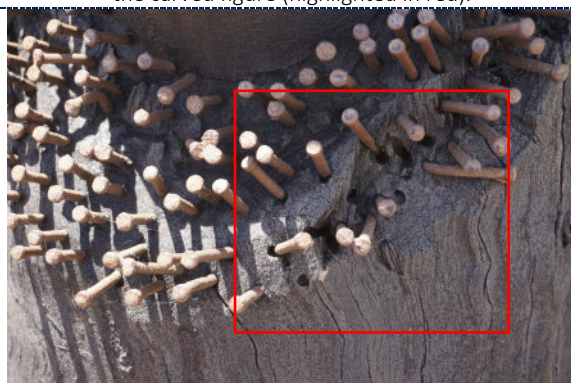
Figure 65: Detail – Pole 9, exterior, UV degradation (darkening) to wood surface, extensive losses to painted surface on carved figure's eyes. Missing nails noted below and along the periphery of the central figure (highlighted in red).

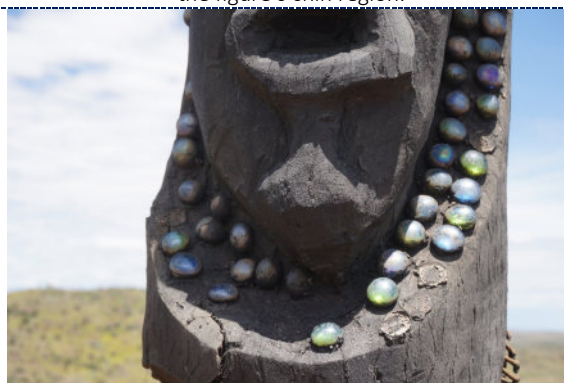
Figure 66: Detail – Pole 9, exterior, UV degradation (darkening) to wood surface, multiple losses to the glass pebbles surrounding the carved figure, particularly below the figure's chin region.

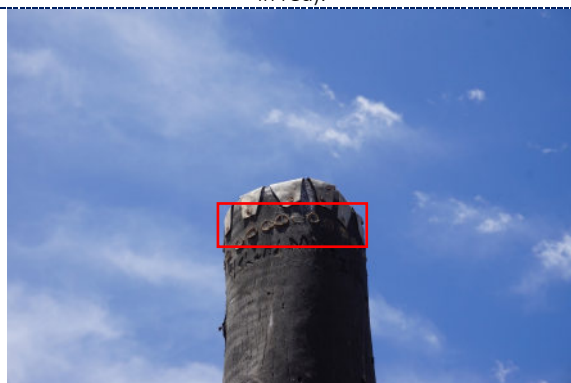
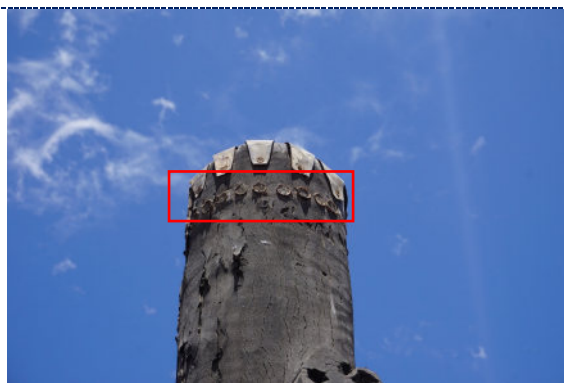
Figure 67: Detail – Pole 9, exterior, UV degradation

Figure 68: Detail – Pole 9, exterior, UV degradation

(darkening) to wood surface, multiple losses to the glass pebbles just below the top of the pole (highlighted in red).
