Broken Hill Public Art Condition Survey and Conservation Plan

Prepared for: Broken Hill City Council
Submission Date: February 2023

This report presents the results of a condition survey assessing the works held within Broken Hill City Council's public art collection. A total of 56 works were condition assessed.

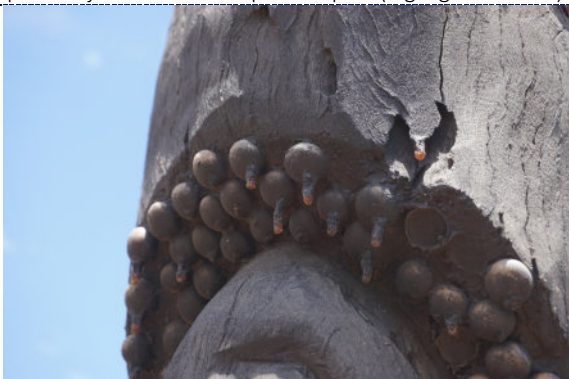
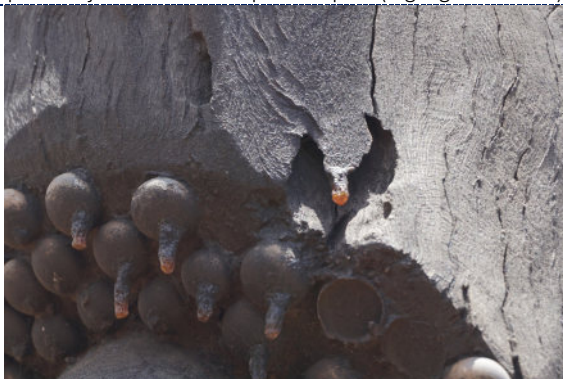
Detail 69: Detail – Pole 9, exterior, UV degradation (darkening) to wood surface, sap-like deposits (accretions) above the carved figure surrounded by glass pebbles.

Detail 70: Detail – Pole 9, exterior, UV degradation (darkening) to wood surface, sap-like deposits (accretions) above the carved figure surrounded by glass pebbles.

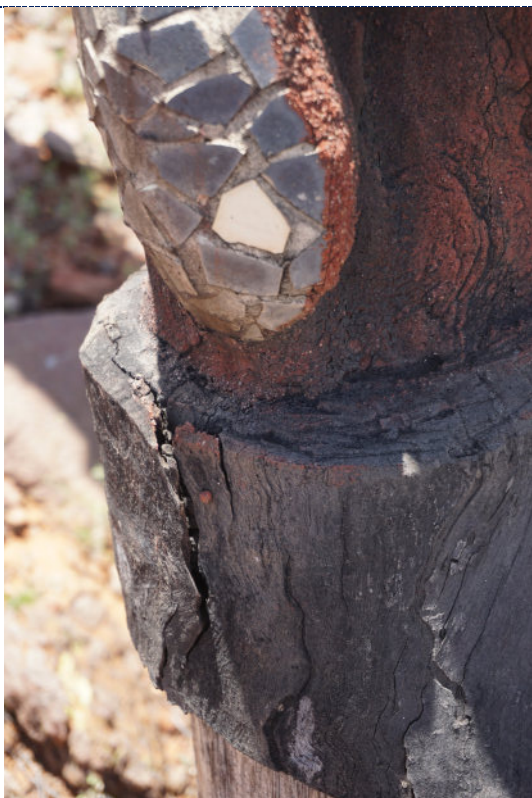
Figure 73: Detail – Pole 10, exterior, UV degradation (darkening) to wood surface, extensive losses to wood and painted surfaces and degradation to the binder securing the mosaic tiles in place.

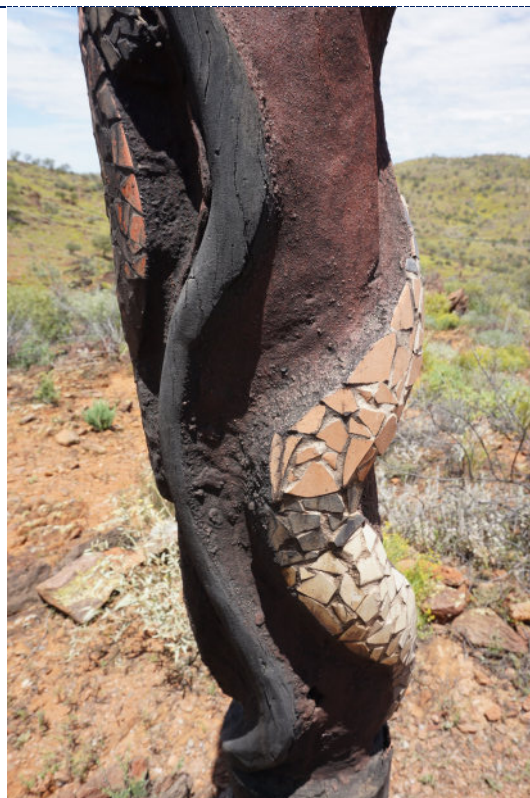
Figure 74: Detail – Pole 10, exterior, UV degradation (darkening) to wood surface, extensive losses to wood and painted surfaces and degradation to the binder securing the mosaic tiles in place.

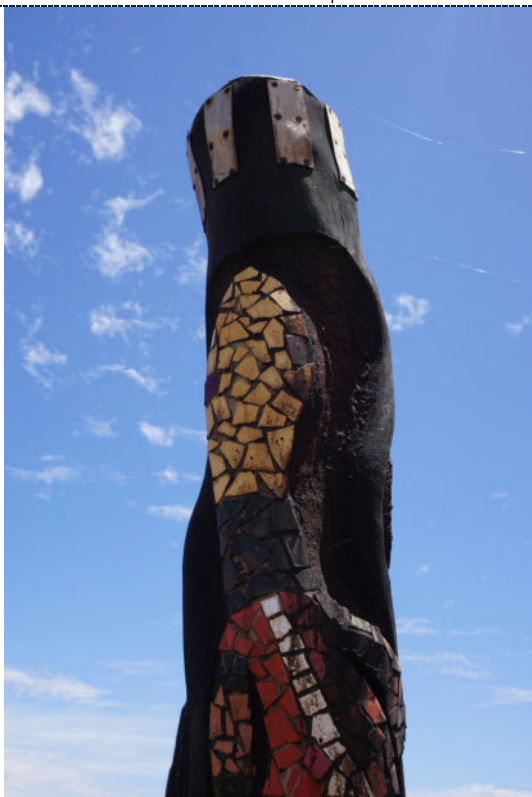
Figure 75: Detail – Pole 10, exterior, UV degradation (darkening) to wood surface, discolouration of the mosaic tiles and buildup of dirt particulate throughout.

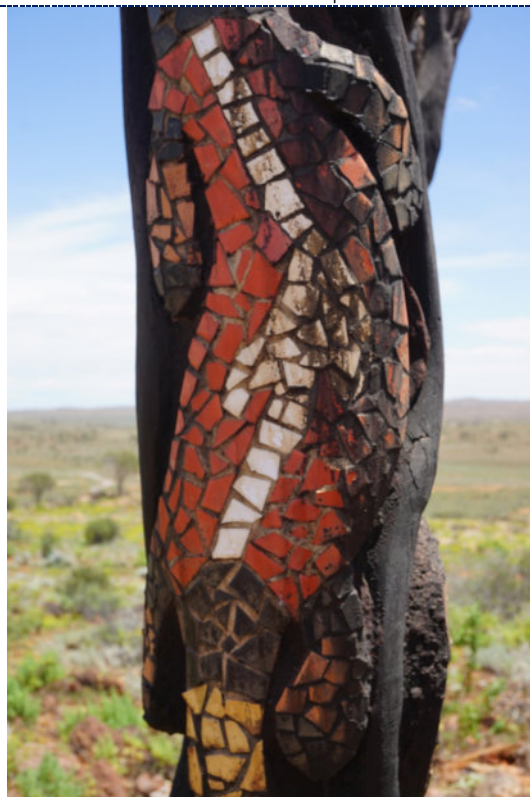
Figure 76: Detail – Pole 10, exterior, UV degradation (darkening) to wood surface, discolouration of the mosaic tiles and buildup of dirt particulate throughout.

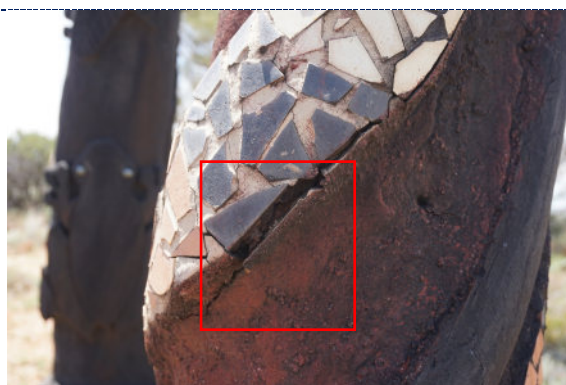
Figure 78: Detail – Pole 10, exterior, UV degradation (darkening) to wood surface, losses to painted surfaces and degradation of binder material securing the mosaic tiles in place (losses highlighted in red).

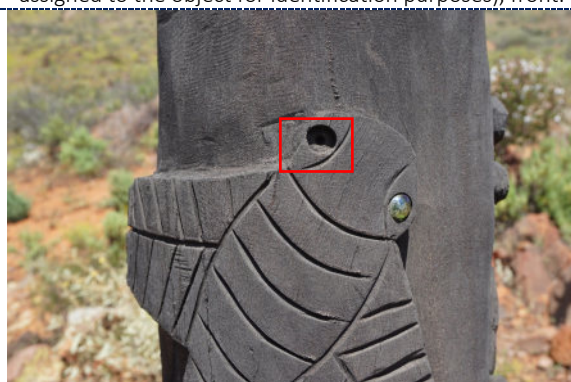
Figure 81: Detail – Pole 11, exterior, UV degradation (darkening) to wood surface, loss to the proper right glass marble eye (loss highlighted in red).

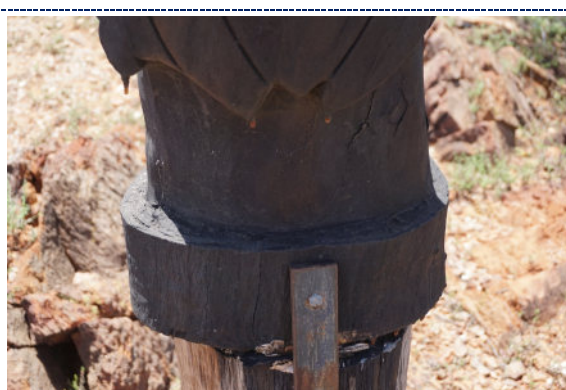
Detail 84: Detail – Pole 11, exterior, UV degradation (darkening) to wood surface, sap-like deposits (accretions) (highlighted in red). Iron corrosion products present on metal components, including the iron nails.

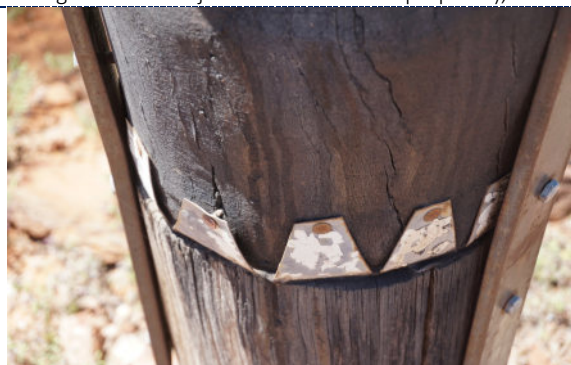
Figure 87: Detail – Pole 12, exterior, UV degradation (darkening) to wood surface, iron corrosion on metal components, including the iron nails.

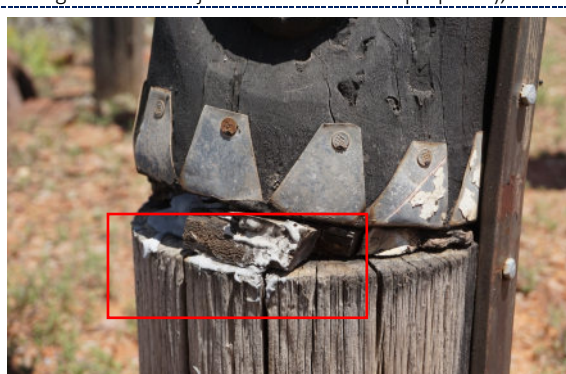
Flaking/Friable		
Mould/ mould damage		
Pest damage	✓	Minor losses likely associated with past insect activity. Insect debris found on Pole 12 (Figure 88).
Previous treatment		
Staining/ discolouration	✓	Iron corrosion product staining is evident on the iron components and fastenings (figs. 11-12, 23, 27-28, 30, 33, 35-36, 39, 43, 65, 84, 87-88). UV degradation (darkening) to wood surface throughout (figs. 7, 8, 11-16, 21-22, 27-28, 35-36, 41-44, 49-50, 53-54, 57-58, 61-64, 69-70, 73-76, 81-84, 89-90).
OTHER		Carved inscriptions (artist names) present on each pole.

Figure 88: Detail – Pole 12, exterior, UV degradation (darkening) to wood surface, iron corrosion on metal components, including the iron nails, and a build up of loose material on the wood base suggestive of insect activity (highlighted in red).

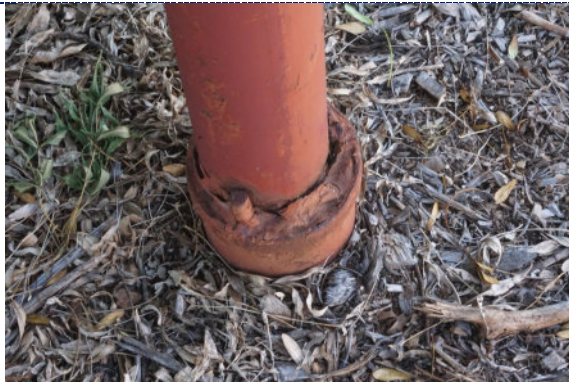
SURFACE/ COATING	MATERIALS:	
CONDITION	✓	NOTES
Abrasions/ dents	✓	Minor small abrasions evident throughout.
Accretion		
Areas of loss	✓	Flaking paint with loss observed throughout.
Corrosion	✓	Corrosion visible where the paint layer is lost or perforated and visible around base plinth (figs. 5-8).
Cracks		
Delamination		
Dust/ dirt	✓	Dirt particulate and spider webs were observed throughout recesses, consistent with display outdoors. Tree foliage also intruding on sculpture space, risking staining and warping to structure (figs. 9-14).
Fading	✓	Chalking and fading to the paint following exposure to sunlight and outdoor conditions (figs. 5-12).
Flaking/Friable	✓	Flaking and peeling paint (figs. 5-12).
Mould/ mould damage		
Pest damage		
Previous treatment	✓	The sculpture appears to have been repainted at least once due to the slightly different hue between the two paint layers.
Staining/ discolouration

Figure 5: Detail – base plinth, paint chalking, flaking paint loss with corrosion and putty deterioration.

Recommended Remedial Treatment Works	Advised Cost
<ul style="list-style-type: none">Remove or reduce failing and flaking paint.Stabilise surface corrosion where needed.Repaint in a paint system rated for use on outdoor metals and colour-matched with the original.	~\$2,500

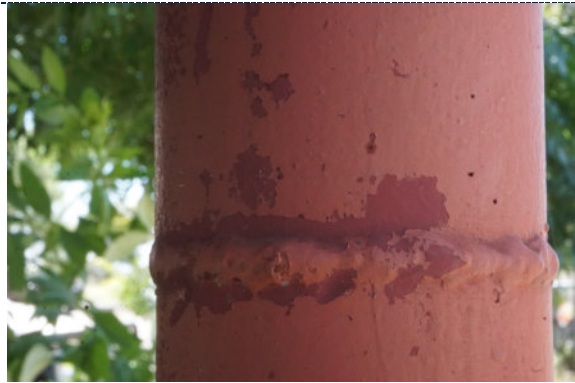
Figure 6: Detail – paint chalking, flaking paint loss with overpaint.

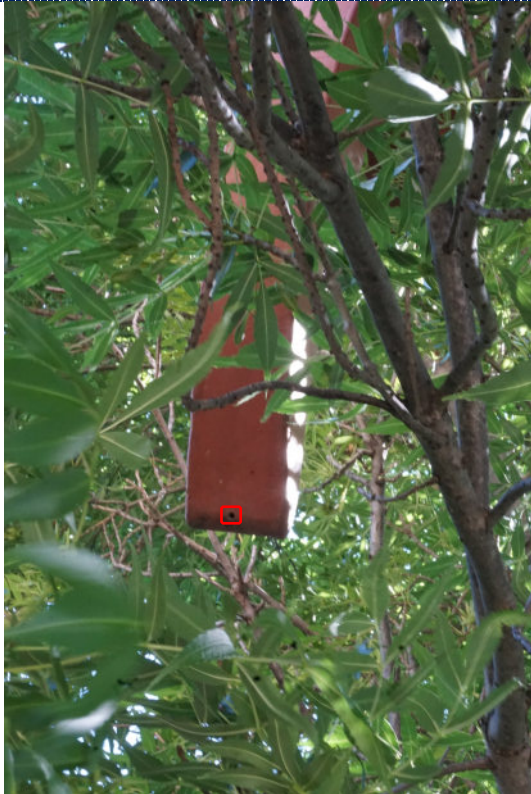
OTHER	2 x small holes noted on structure. Likely inherent by artist to allow draining of excess water build up. (figs. 9-10)
-------	--

Figure 9: Detail – small hole, inherent to fabrication.

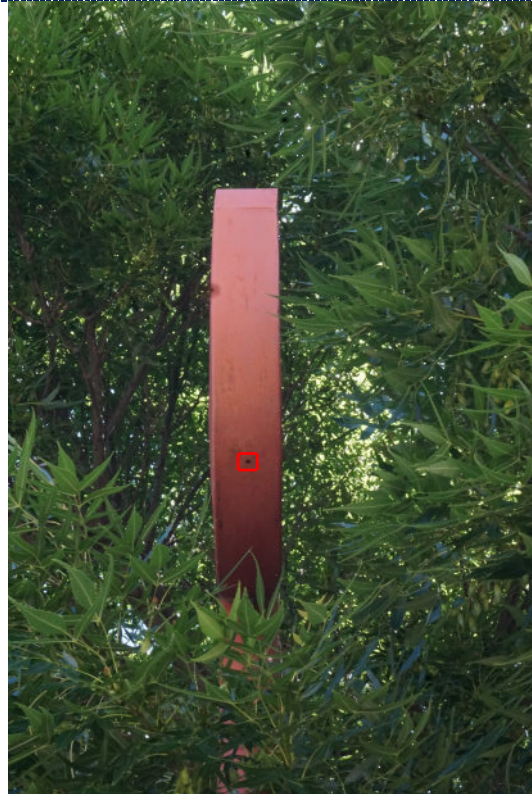
Figure 10: Detail – small hole, inherent to fabrication.

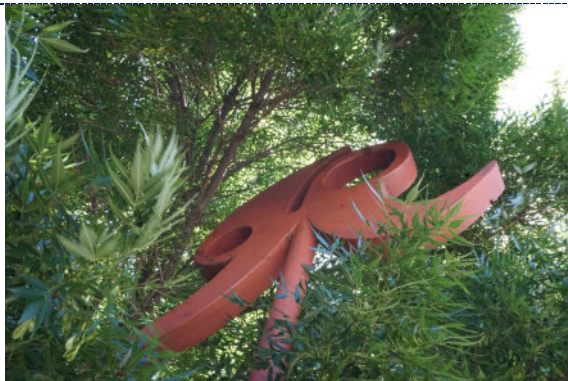
Figure 11: Detail – paint chalking, flaking paint loss with overpaint.

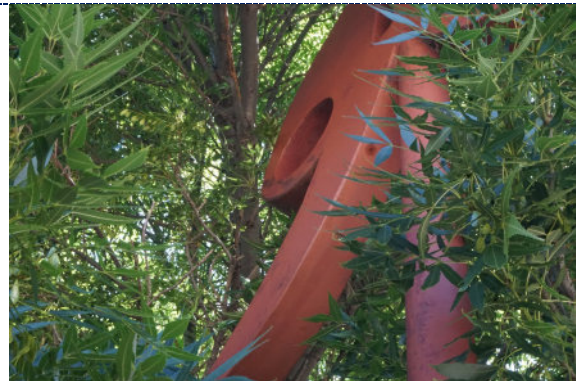
Figure 12: Detail – paint chalking, flaking paint loss with overpaint and corrosion visible.

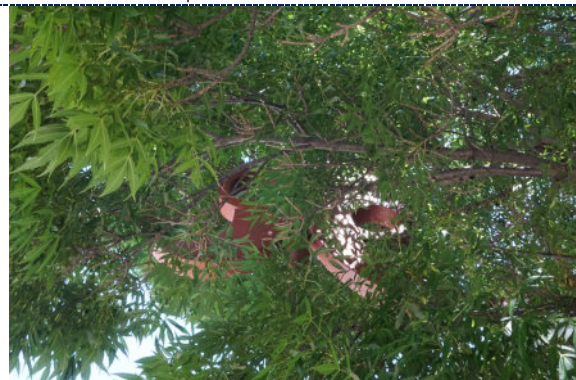
Figure 14: Detail – tree foliage intrusion, risks staining and warping of structure.

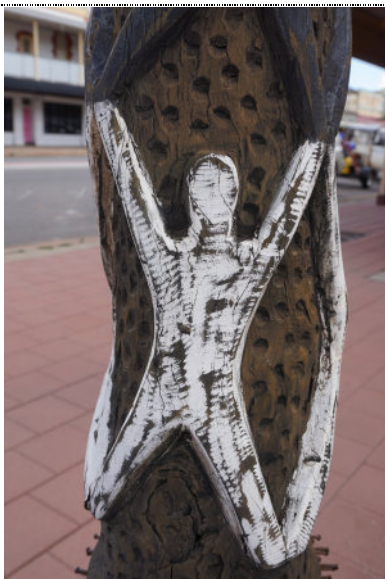
Figure 9: Detail – Pole #2003.0017 *Reconciliation*, proper left exterior, degraded varnish, paint losses, and UV degradation (darkening) to wood surface.

Recommended Remedial Treatment Works	Advised Cost
<p>This work exhibits significant evidence of UV radiation-driven degradation to the varnish and wooden elements. Iron components have also corroded due to exposure to outdoor conditions.</p> <p>Remedial works should aim to:</p> <ul style="list-style-type: none"> • Remove dirt particulate, spider webs, and bird excrement from each pole. • Removed degraded wood surface layers through sanding or microabrasion. • Reintegrate loose iron nails and replace missing iron nails. • Reintegrate areas of paint loss on each pole. • Remove surface corrosion product from metal fastenings. • Application of varnish coating to each pole. <p>It is recommended that artists are contacted, if possible, to discuss their interest in restoring the works.</p>	~\$25,000

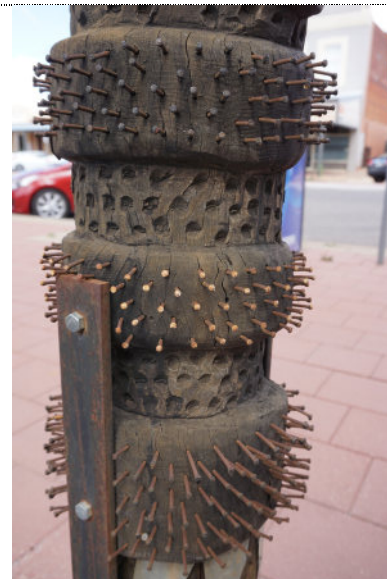
Figure 10: Detail – Pole #2003.0017 *Reconciliation*, proper right exterior, corroded iron nails, degraded varnish and UV degradation (darkening) to wood surface.

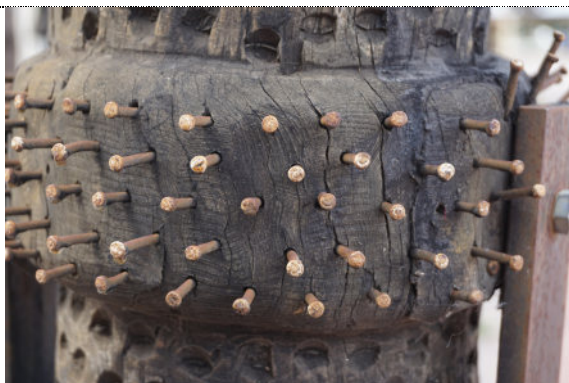
Figure 11: Detail – Pole #2003.0017 *Reconciliation*, proper right exterior, corroded iron nails, sap-like accretions on the iron nails, UV degradation (darkening) to wood surface, and cracks along the grain of the wood.

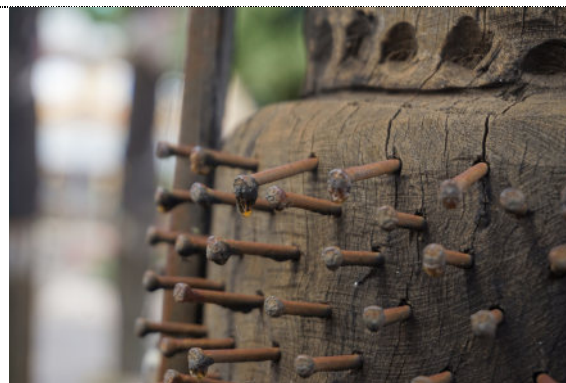
Figure 12: Detail – Pole #2003.0017 *Reconciliation*, proper right exterior, corroded iron nails, sap-like accretions on the iron nails, UV degradation (darkening) to wood surface, and cracks along the grain of the wood.

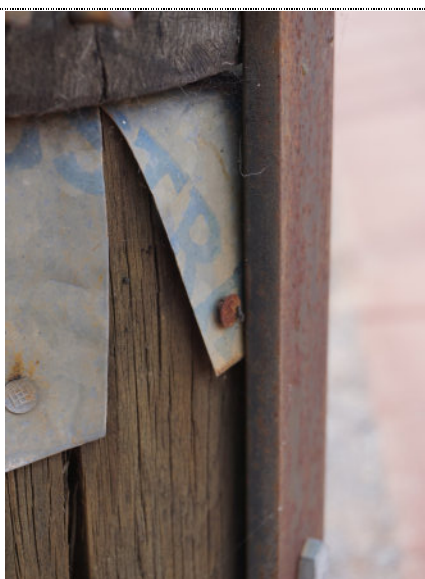
Figure 13: Detail – Pole #2003.0017 *Reconciliation*, exterior, corroded iron nails and metal components, UV degradation (darkening) to wood surface, and fine cracks along the grain of the wood.

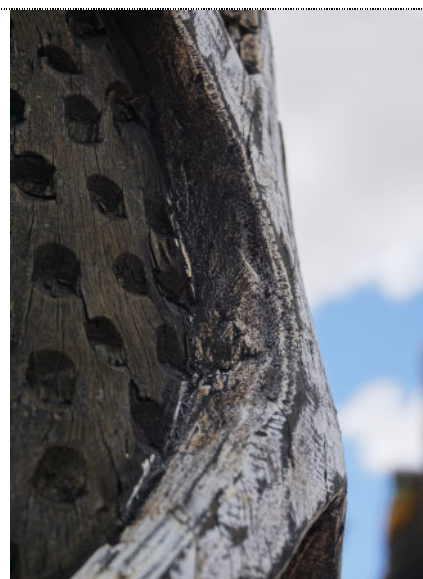
Figure 14: Detail – Pole #2003.0017 *Reconciliation*, exterior, UV degradation (darkening) to wood surface, and fine cracks along the grain of the wood. The surface is also covered in a layer of dirt particulate.

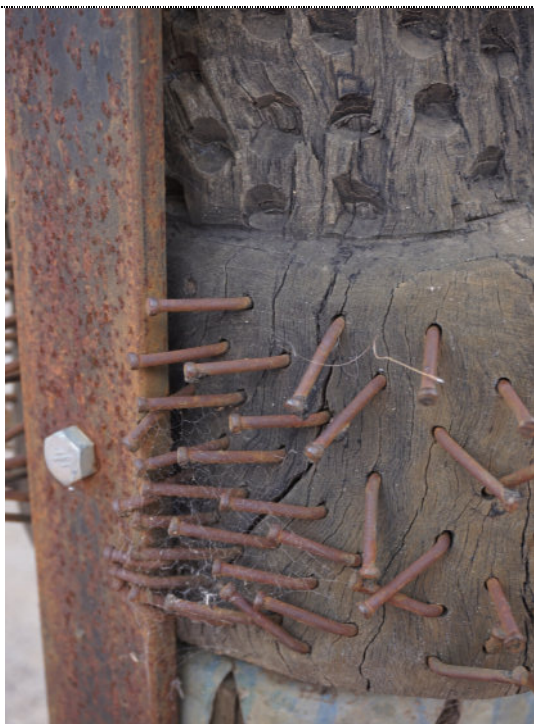
Figure 15: Detail – Pole #2003.0017 *Reconciliation*, exterior, corroded iron nails and metal structural components, UV degradation (darkening) to wood surface, and fine cracks along the grain of the wood. Loose dirt particulate, spider webs and debris also present.

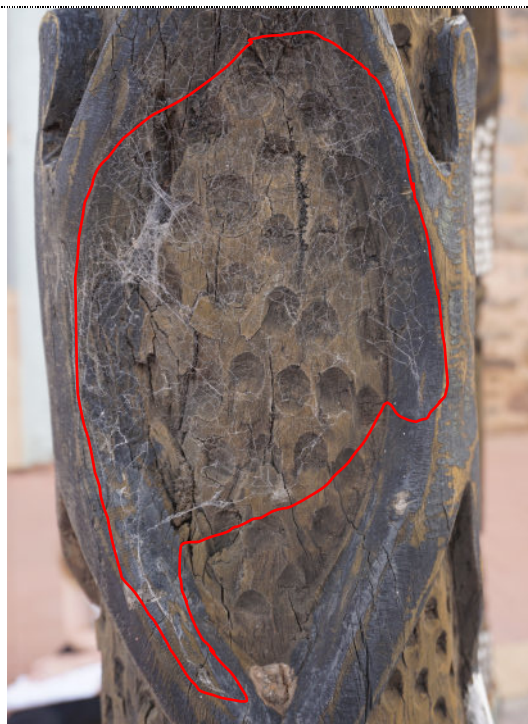
Figure 16: Detail – Pole #2003.0017 *Reconciliation*, exterior, UV degradation (darkening) to wood surface and losses to painted surfaces, and fine cracks along the grain of the wood. Loose dirt particulate, spider webs (highlighted in red) and debris also present.

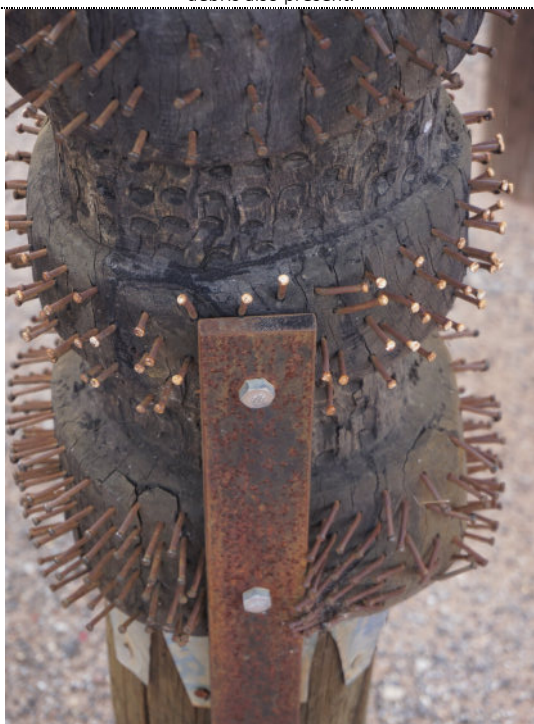
Figure 17: Detail – Pole #2003.0017 *Reconciliation*, exterior, corroded iron nails and metal structural components, UV degradation (darkening) to wood surface, and fine cracks along the grain of the wood.

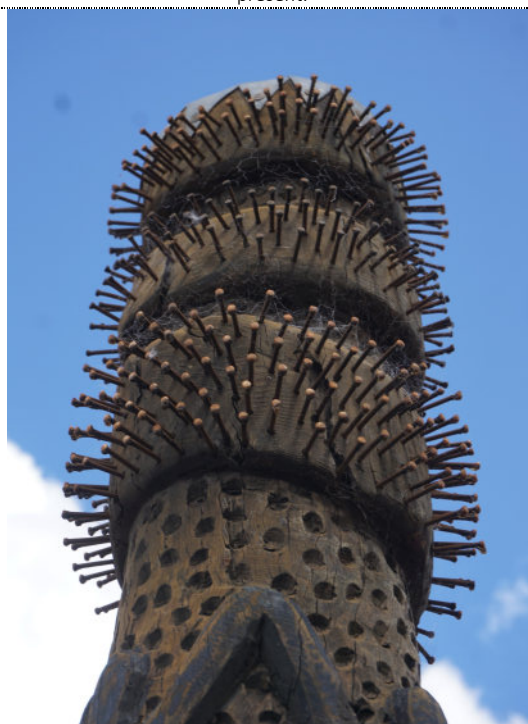
Figure 18: Detail – Pole #2003.0017 *Reconciliation*, exterior, corroded iron nails and metal structural components, UV degradation (darkening) to wood surface, extensive losses to painted surfaces, and extensive cracks along the grain of the wood.

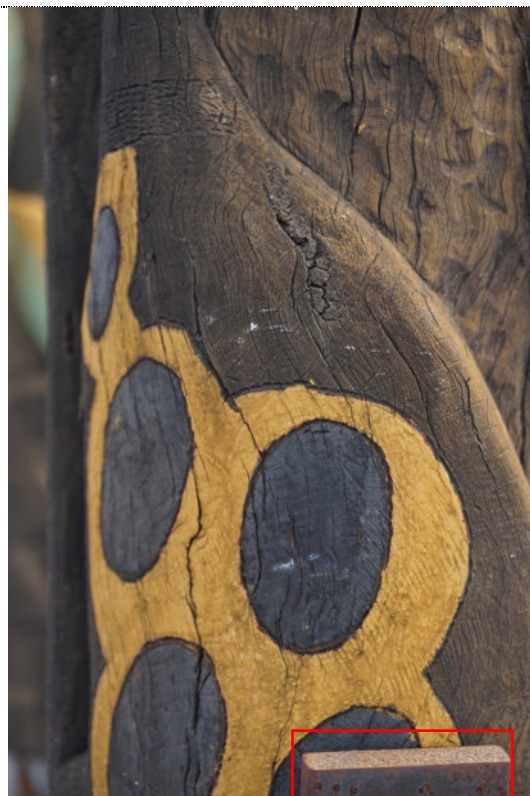
Figure 24: Detail – Pole #2003.0018 *Emus and eggs*, exterior, extensive corrosion products on iron structural support (highlighted in red), UV degradation (darkening) to wood surface, and extensive fine cracks along the grain of the wood.

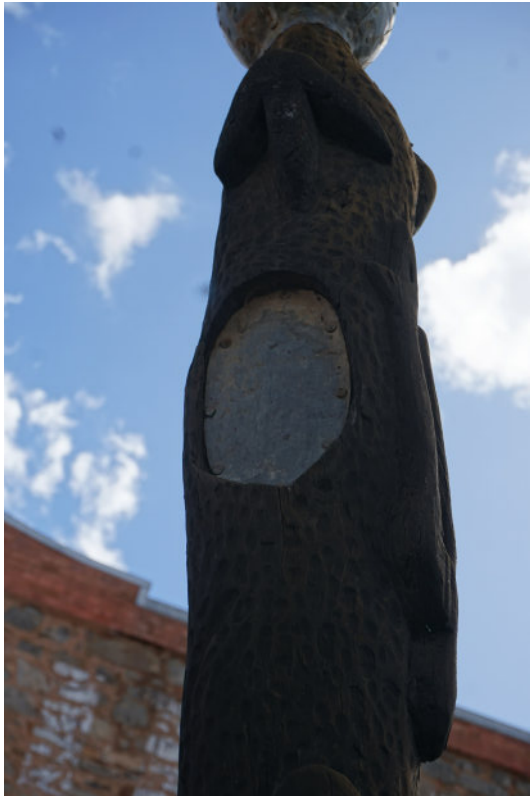
Figure 27: Detail – Pole #2003.0018 *Emus and eggs*, exterior, tarnishing and corrosion noted on the circular metal decorative element and nails affixing the element in place. UV degradation (darkening) to wood surface throughout.

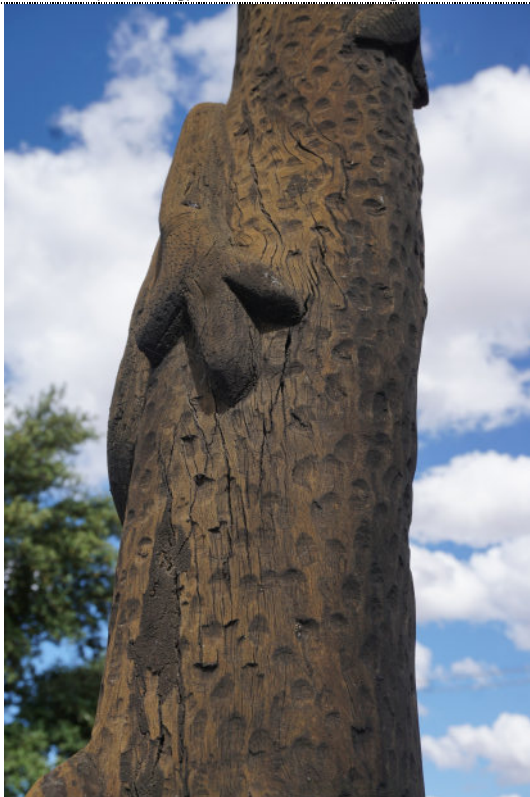
Figure 29: Detail – Pole #2003.0018 *Emus and eggs*, exterior, UV degradation (darkening) to wood surface throughout.

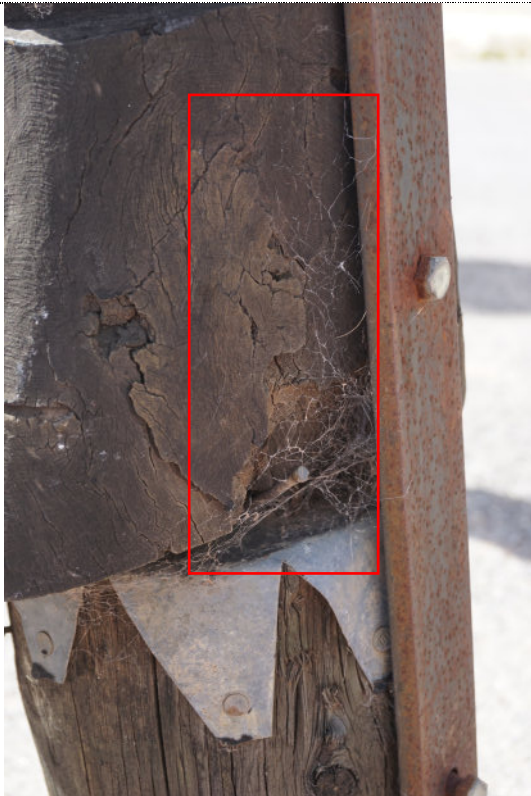
PRIMARY STRUCTURE	MATERIALS:	
CONDITION	<input checked="" type="checkbox"/>	NOTES
Abrasions/ dents	<input type="checkbox"/>	
Areas of loss/ detached or missing component	<input checked="" type="checkbox"/>	<p>Extensive areas of loss to the paint and surface coating are evident throughout, and likely stem from prolonged exposure to UV radiation and outdoor weather condition (figs. 9, 18, 24, 35-37, 38, 40, 47, 49-51, 54, 74-81, 86-89, 91-92, 101-103, 120-122, 125-126, 133, 136, 138).</p> <p>Losses to the timber substrate are evident throughout, and again likely stem from prolonged exposure to UV radiation and outdoor weather conditions (figs. 34, 69).</p> <p>Multiple iron nails are missing from individual poles (figs. 35, 60-61, 64).</p>

Figure 34: Detail – Pole #2003.0019 *Galahs*, exterior, UV degradation (darkening) to wood surface throughout. Extensive cracking and associated losses to the wood, iron corrosion noted on the iron supports and nails, and surface dirt and insect debris (spider webs, highlighted in red) noted throughout.

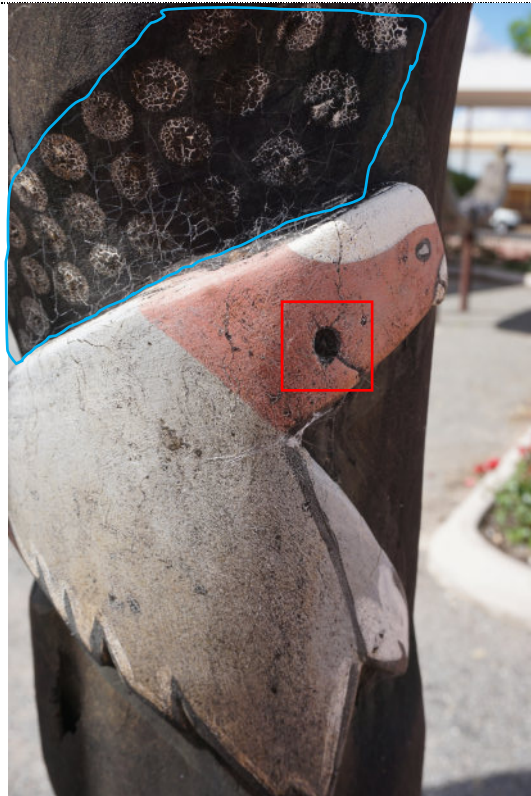
Figure 35: Detail – Pole #2003.0019 *Galahs*, exterior, UV degradation (darkening) to wood surface throughout. Surface dirt and insect debris noted throughout. Fading noted to the painted surfaces, particularly the painted galahs and the surrounding dots (highlighted in blue). Missing nail noted to the neck of the carved galah (highlighted in red).

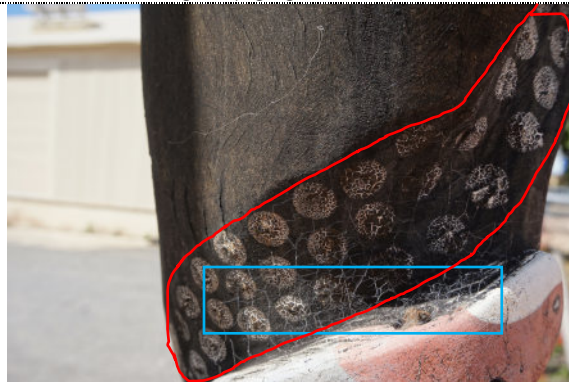
Figure 37: Detail – Pole #2003.0019 *Galahs*, exterior, UV degradation (darkening) to wood surface throughout. Surface dirt and insect debris noted throughout. Extensive loss of paint (highlighted in red) and buildup of spider webs (highlighted in blue).

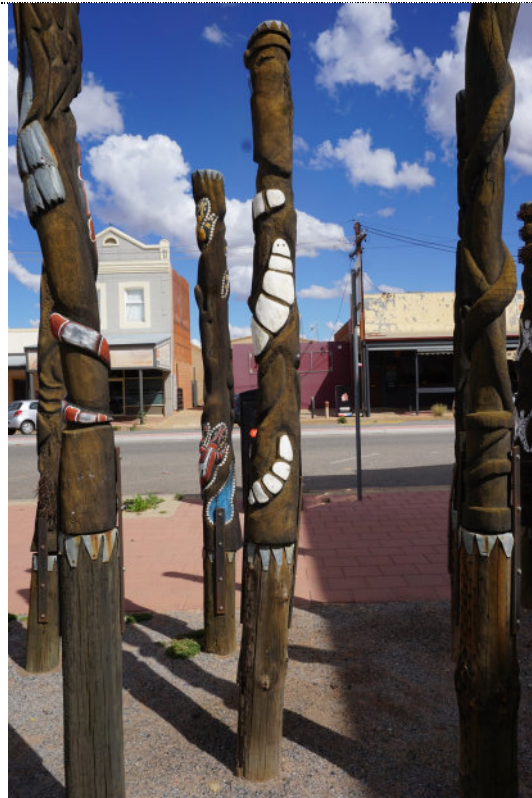
Figure 42: Pole #2003.0020 *Untitled*, Front.

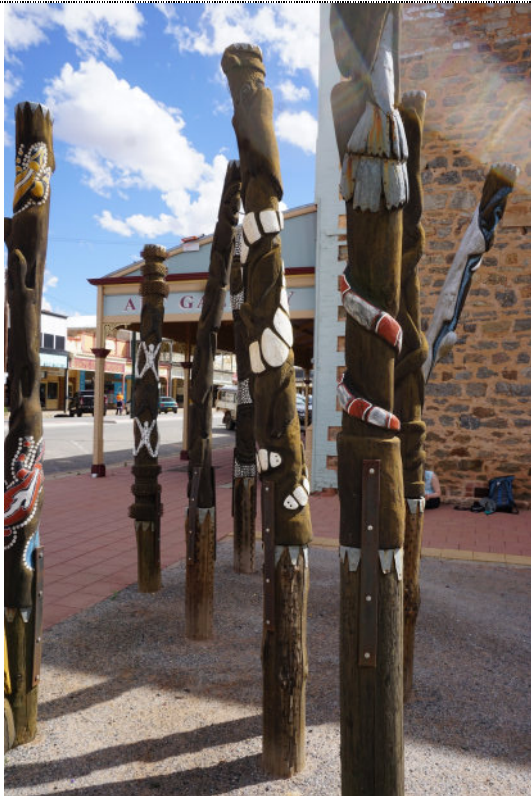
Figure 43: Pole #2003.0020 *Untitled*, Back.

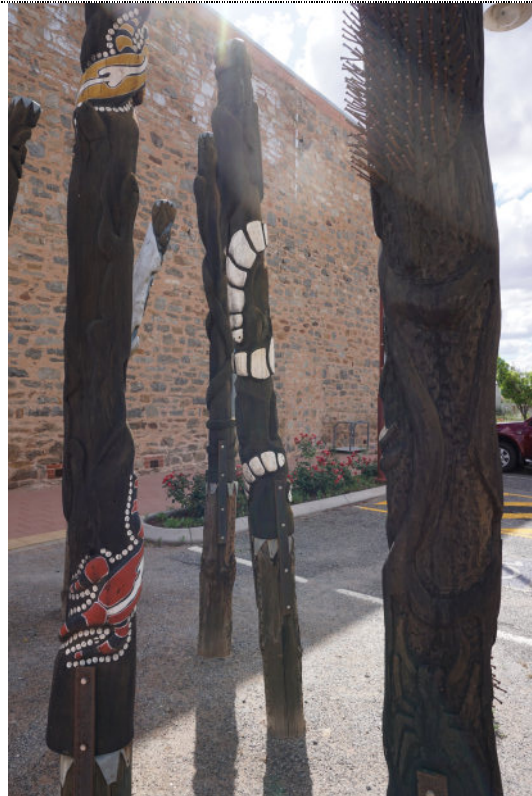
Figure 44: Pole #2003.0020 *Untitled*, Proper Left.

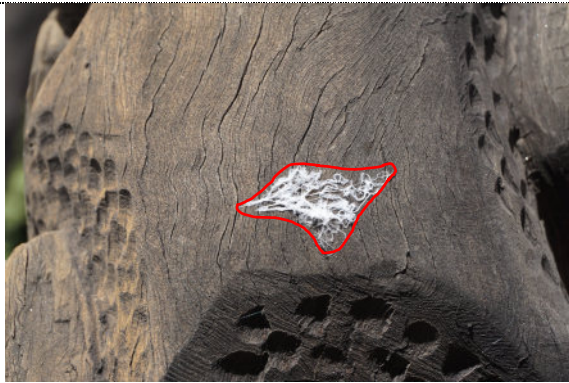
Figure 45: Pole #2003.0020 *Untitled*, Proper Right.

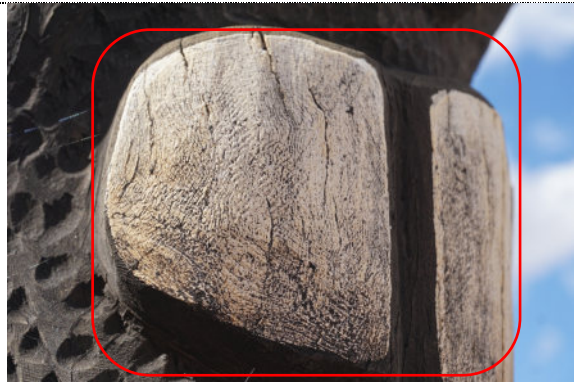
Figure 46: Detail – Pole #2003.0020 *Untitled*, exterior, exterior, UV degradation (darkening) to wood surface throughout. Large spider webbing noted on the wood surface (highlighted in red).

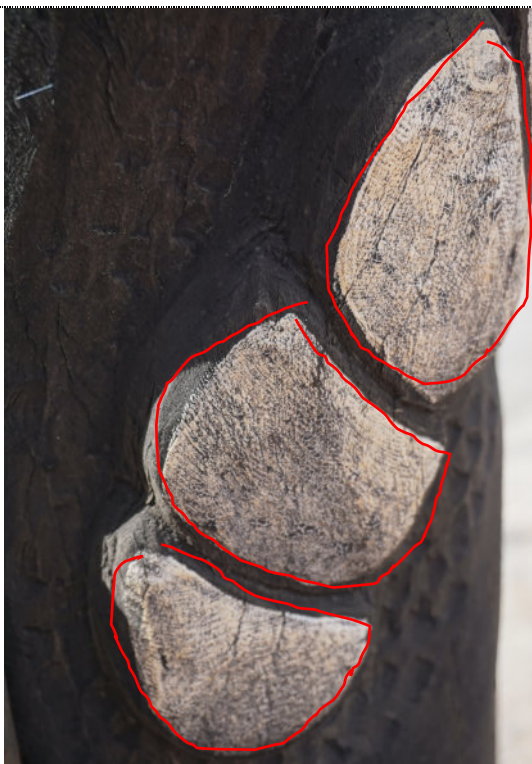
Figure 49: Detail – Pole #2003.0020 *Untitled*, exterior, UV degradation (darkening) to wood surface throughout. Linear cracks noted along the grain of the wood. Discolouration, losses and fading to the white painted decorative elements (highlighted in red).

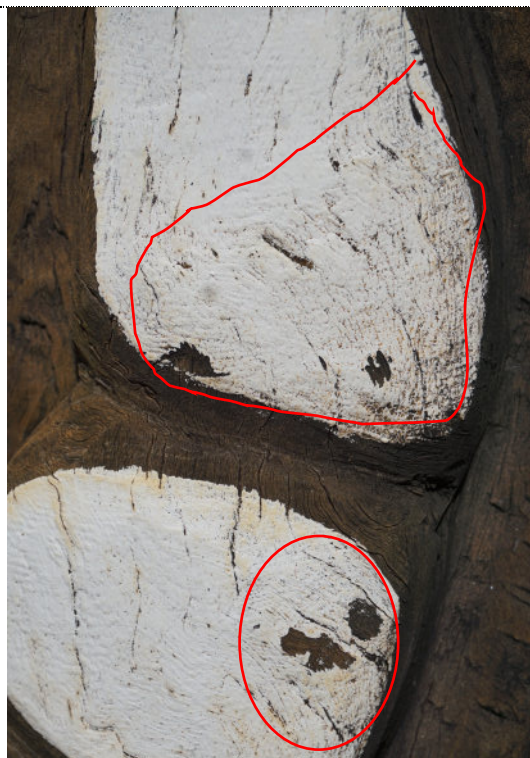
Figure 50: Detail – Pole #2003.0020 *Untitled*, exterior, UV degradation (darkening) to wood surface throughout. Linear cracks noted along the grain of the wood. Discolouration, losses and fading to the white painted decorative elements (highlighted in red).

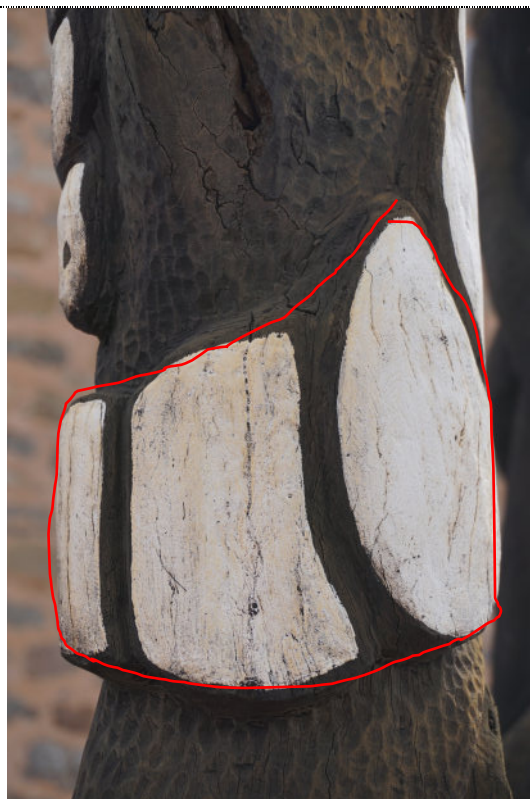
Figure 52: Detail – Pole #2003.0020 *Untitled*, exterior, UV degradation (darkening) to wood surface throughout.

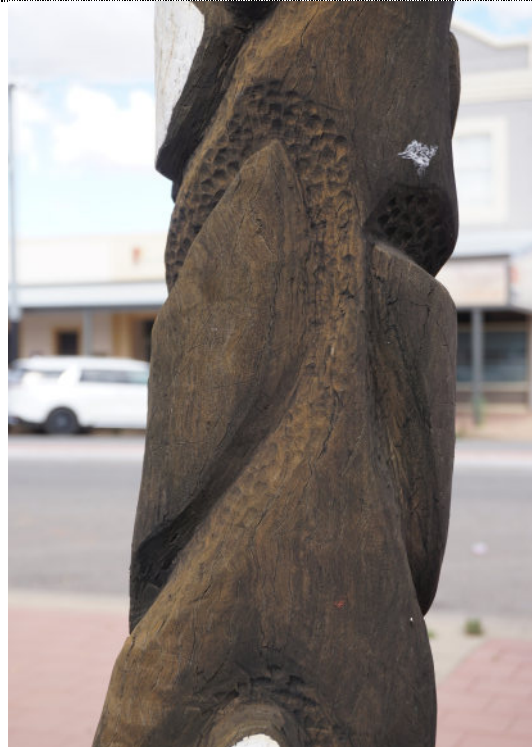
Figure 54: Detail - Pole #2003.0020 *Untitled*, exterior, UV degradation (darkening) to wood surface throughout. Discolouration to the painted white decorative elements (highlighted in red).

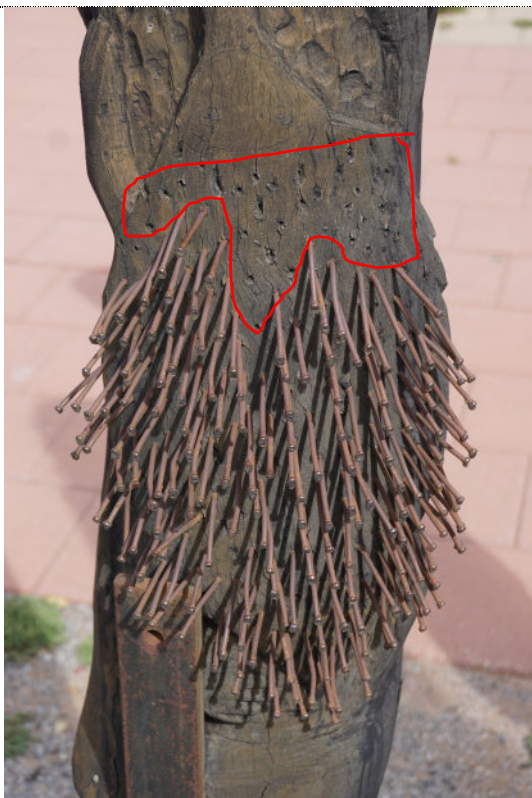
Figure 60: Detail – Pole #2003.0021 *Untitled*, exterior, UV degradation (darkening) to wood surface throughout. Iron corrosion on nails affixed to the timber pole. Missing iron nails are also noted on the exterior sides of the pole (highlighted in red).

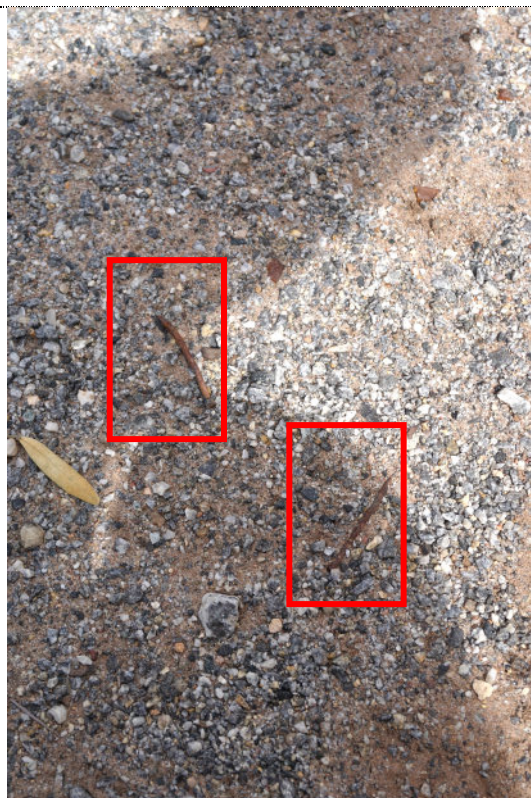
Figure 61: Detail – Pole #2003.0021 *Untitled*, exterior, detached iron nails belonging to artwork found on the ground below the work (highlighted in red).

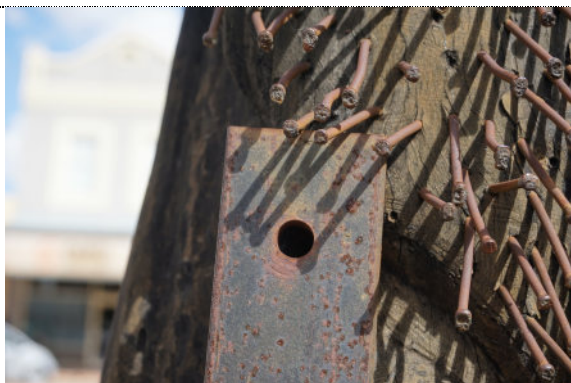
Figure 62: Detail – Pole #2003.0021 *Untitled*, exterior, UV degradation (darkening) to wood surface throughout. Iron corrosion on nails affixed to the timber pole and on iron supports. Missing iron nails are also noted on the exterior sides of the pole.

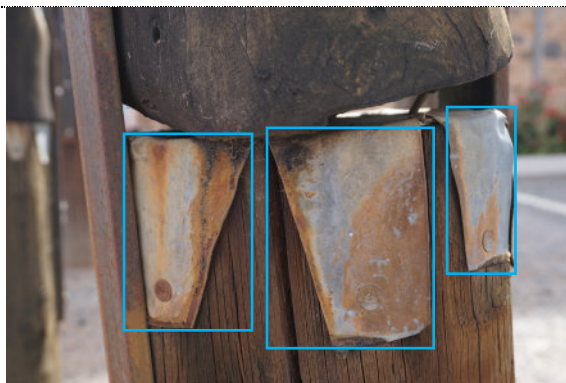
Figure 63: Detail – Pole #2003.0021 *Untitled*, exterior, UV degradation (darkening) to wood surface throughout. Surface dirt also noted throughout. Iron corrosion and staining noted on the metal components below the bands of painted dots (highlighted in blue).

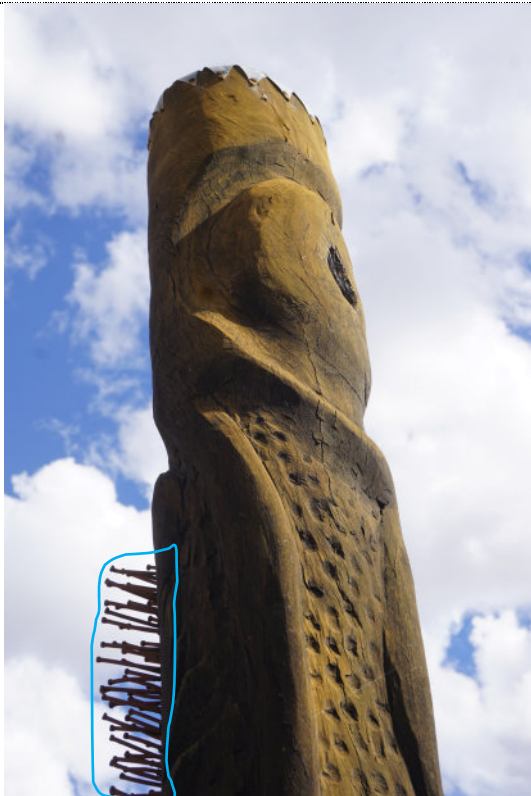
Figure 66: Detail – Pole #2003.0021 *Untitled*, exterior, UV degradation (darkening) to wood surface throughout. Iron corrosion on nails affixed to the timber pole (highlighted in blue).

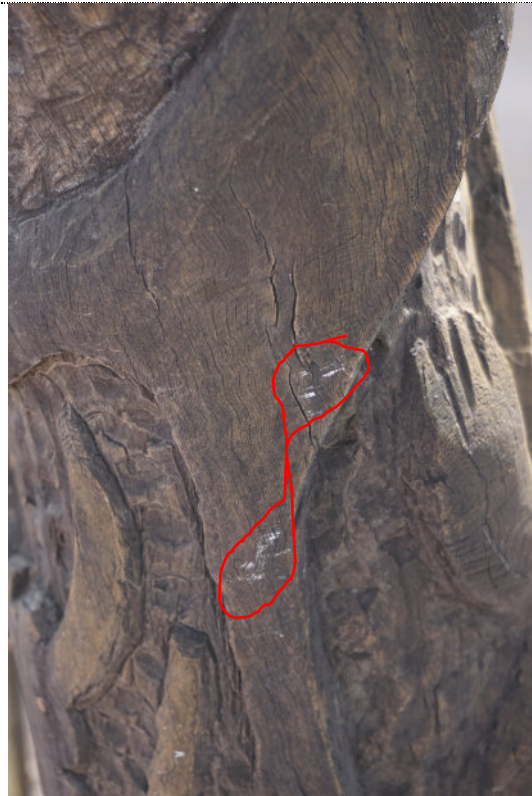
Figure 67: Detail – Pole #2003.0021 *Untitled*, exterior, UV degradation (darkening) to wood surface throughout. Surface dirt and insect debris noted throughout, including the presence of bird excrement (highlighted in red).

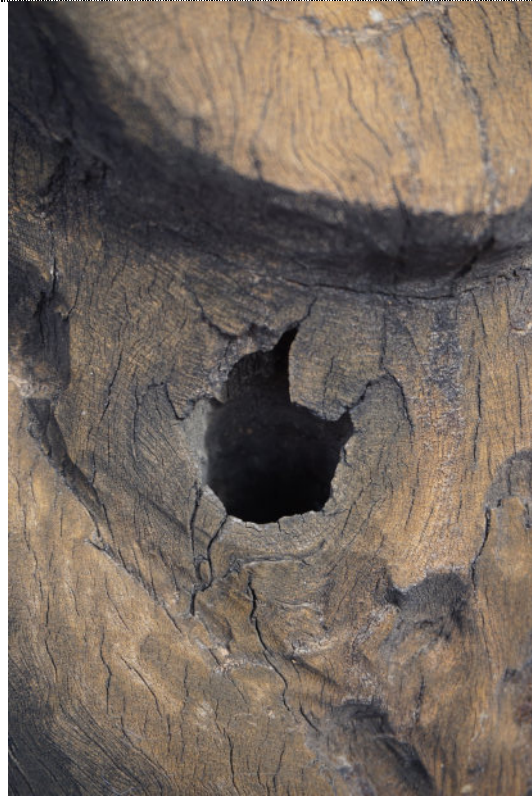
Figure 69: Detail – Pole #2003.0021 *Untitled*, exterior, UV degradation (darkening) to wood surface throughout. Large loss to the timber pole.

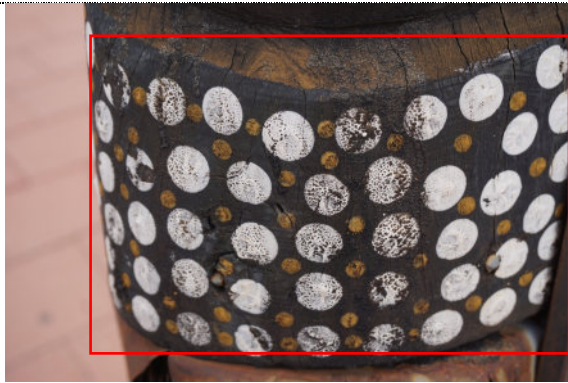
Figure 74: Detail – Pole #2003.0022, *Untitled*, exterior, UV degradation (darkening) to wood surface throughout. Surface dirt also noted throughout. Fading and losses noted to the painted surfaces, particularly the white and yellow ochre painted dots (highlighted in red).

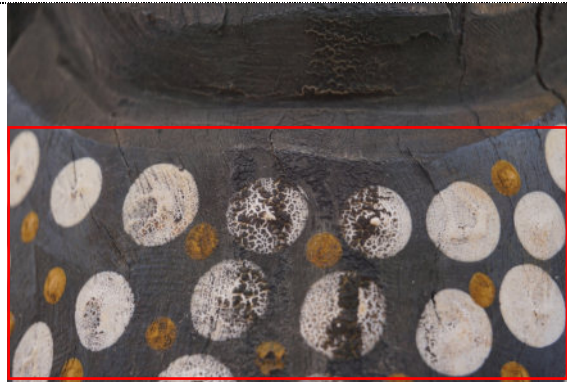
Figure 75: Detail – Pole #2003.0022, *Untitled*, exterior, UV degradation (darkening) to wood surface throughout. Surface dirt also noted throughout. Fading and losses noted to the painted surfaces, particularly the white and yellow ochre painted dots (highlighted in red).

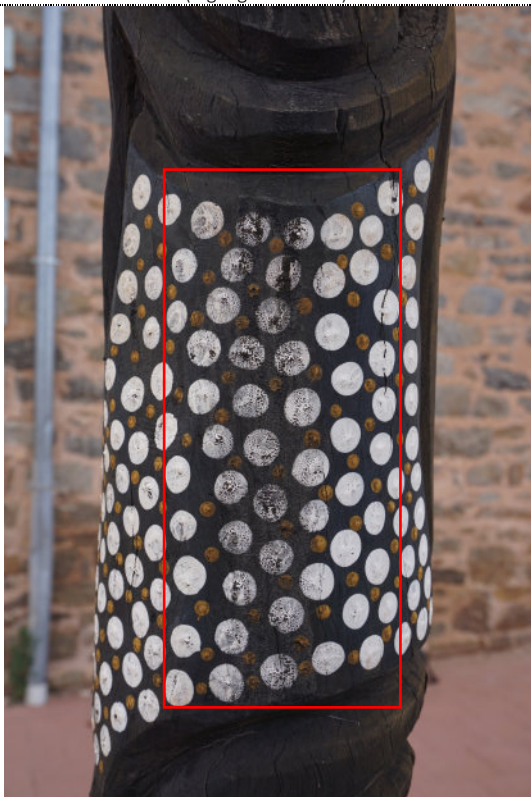
Figure 76: Detail – Pole #2003.0022, *Untitled*, exterior, UV degradation (darkening) to wood surface throughout. Surface dirt also noted throughout. Fading and losses noted to the painted surfaces, particularly the white and yellow ochre painted dots (highlighted in red).

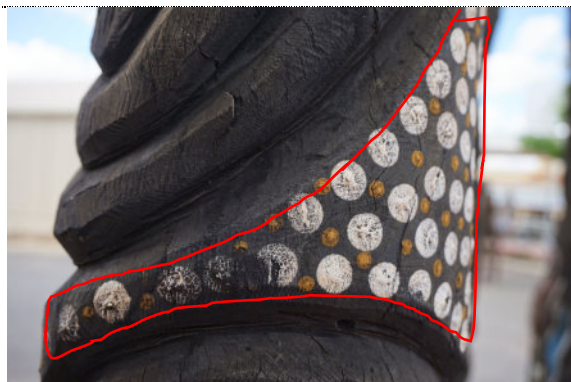
Figure 78: Detail – Pole #2003. 0022, *Untitled*, exterior, UV degradation (darkening) to wood surface throughout. Surface dirt also noted throughout. Fading and losses noted to the painted surfaces, particularly the white and yellow ochre painted dots (highlighted in red).

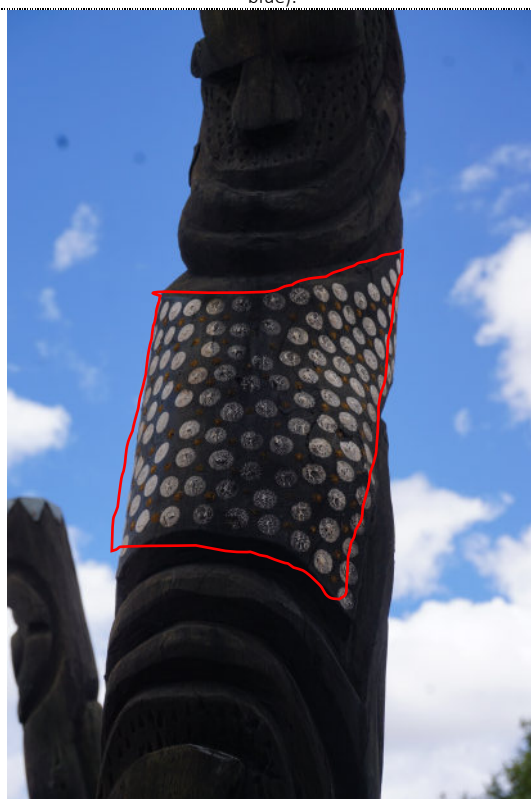
Figure 81: Detail – Pole #2003. 0022, *Untitled*, exterior, UV degradation (darkening) to wood surface throughout. Surface dirt also noted throughout. Fading and losses noted to the painted surfaces, particularly the white and yellow ochre painted dots (highlighted in red).

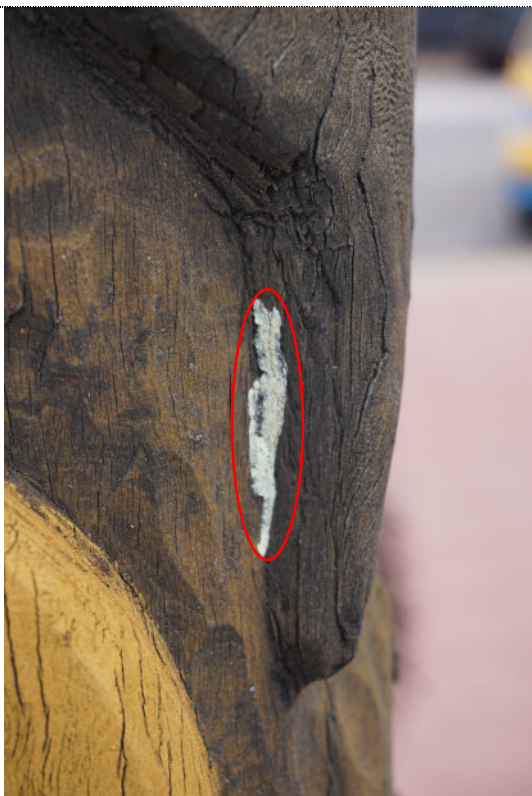
Figure 86: Detail – Pole #2003.0023, *Untitled*, exterior, UV degradation (darkening) to wood surface throughout. Surface dirt and insect debris noted throughout, including the presence of bird excrement (highlighted in red).

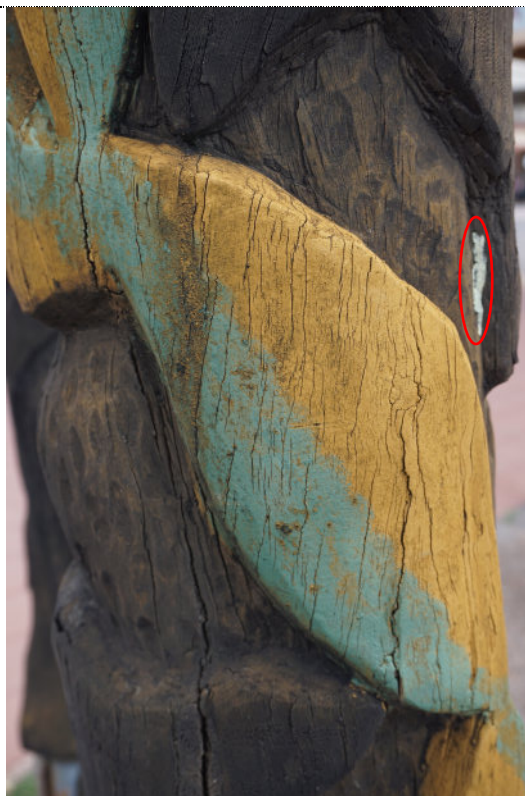
Figure 87: Detail – Pole #2003.0023, *Untitled*, exterior, UV degradation (darkening) to wood surface throughout. Surface dirt and insect debris noted throughout, including the presence of bird excrement (highlighted in red). Linear cracks along the grain of the timber are also noted throughout.
