Broken Hill Public Art Condition Survey and Conservation Plan

Prepared for: Broken Hill City Council
Submission Date: February 2023

This report presents the results of a condition survey assessing the works held within Broken Hill City Council's public art collection. A total of 56 works were condition assessed.

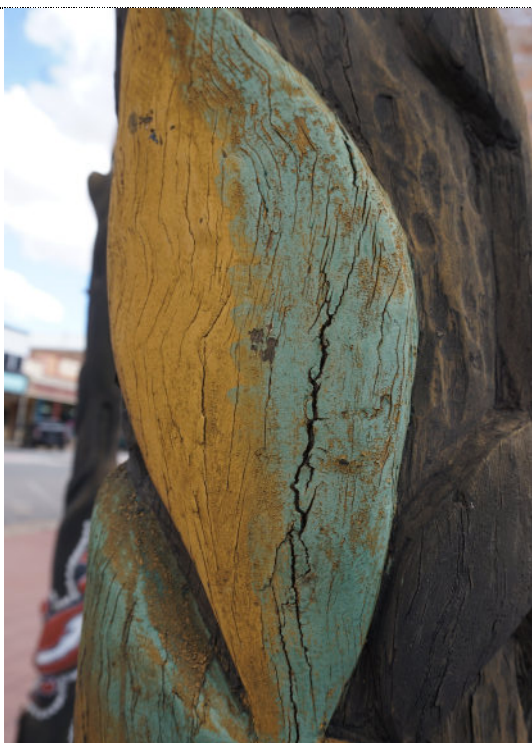
Figure 88: Detail – Pole #2003.0023, *Untitled*, exterior, UV degradation (darkening) to wood surface throughout. Fading and losses noted to the painted surfaces. Cracks and splitting following the grain of the wood are evident throughout. These likely stem from movement in the material as it is exposed to different forces and degradation mechanisms.

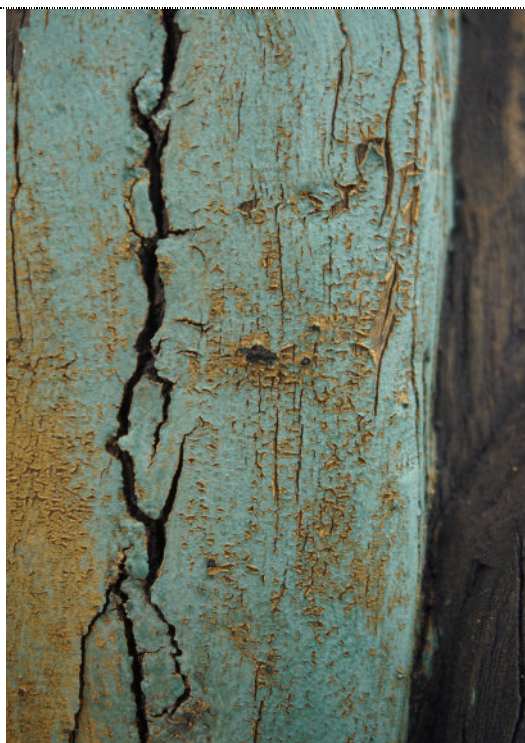
Figure 89: Detail – Pole #2003.0023, *Untitled*, exterior, exterior, UV degradation (darkening) to wood surface throughout. Fading and losses noted to the painted surfaces. Cracks and splitting following the grain of the wood are evident throughout. These likely stem from movement in the material as it is exposed to different forces and degradation mechanisms.

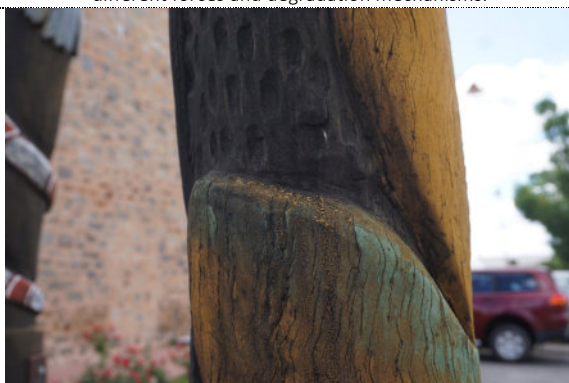
Figure 92: Detail – Pole #2003.0023, *Untitled*, exterior, exterior, UV degradation (darkening) to wood surface throughout. Fading and losses noted to the painted surfaces. Fine cracks and splitting following the grain of the wood are evident throughout.

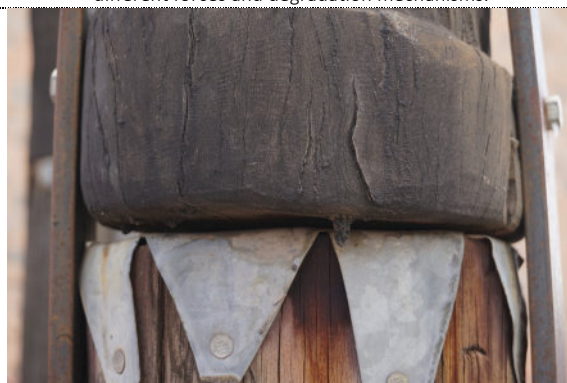
Figure 93: Detail – Pole #2003.0023, *Untitled*, exterior, exterior, UV degradation (darkening) to wood surface throughout. Tarnishing and iron corrosion noted on metal components and fastenings.

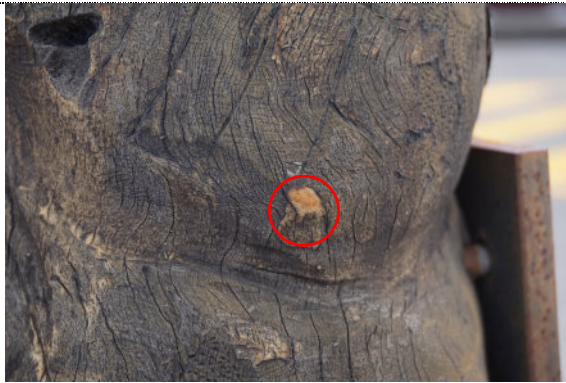
Figure 98: Detail – Pole #2003.0024, *Untitled*, exterior, exterior, UV degradation (darkening) to wood surface throughout. Small yellow accretion affixed to the exterior side of the pole (highlighted in red).

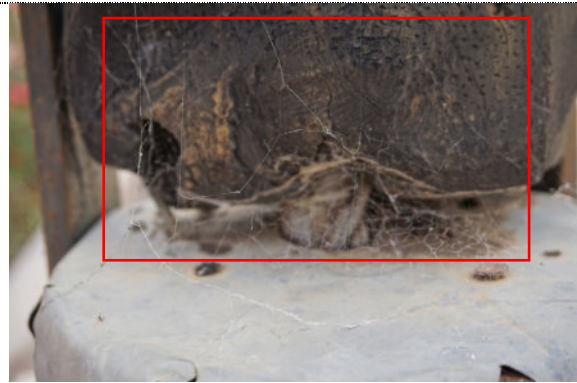
Figure 99: Detail – Pole #2003.0024, *Untitled*, exterior, exterior, UV degradation (darkening) to wood surface throughout. Fading and losses noted to the painted surfaces. Surface dirt and insect debris noted throughout, including the presence of spider webs (highlighted in red).

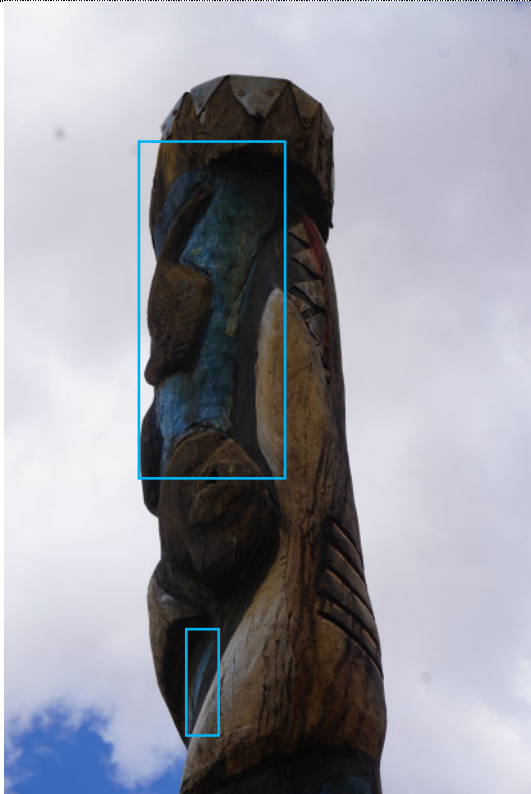
Figure 102: Detail – Pole #2003.0024, *Untitled*, exterior, UV degradation (darkening) to wood surface throughout. The painted areas are also faded and lost (highlighted in blue), which is consistent with UV degradation and display outdoors.

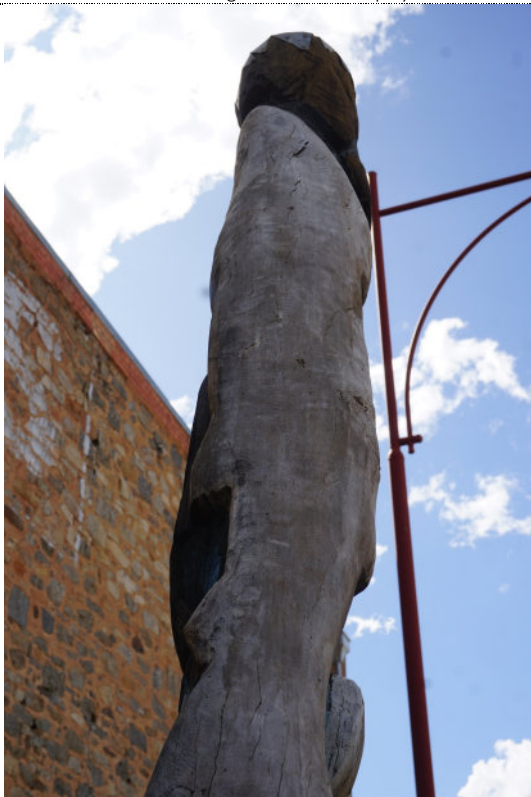
Figure 104: Detail – Pole #2003.0024, *Untitled*, exterior, UV degradation (darkening) to wood surface throughout. The painted surfaces are faded and degraded, which is consistent with UV degradation and display outdoors.

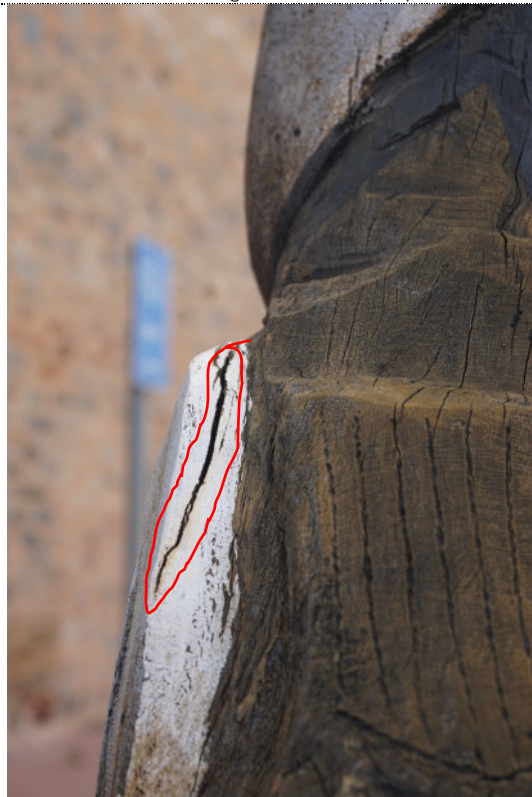
Figure 105: Detail – Pole #2003.0024, *Untitled*, exterior, UV degradation (darkening) to wood surface throughout. Cracks and splitting (highlighted in red) following the grain of the wood are evident throughout. These likely stem from movement in the material as it is exposed to different forces and degradation mechanisms.

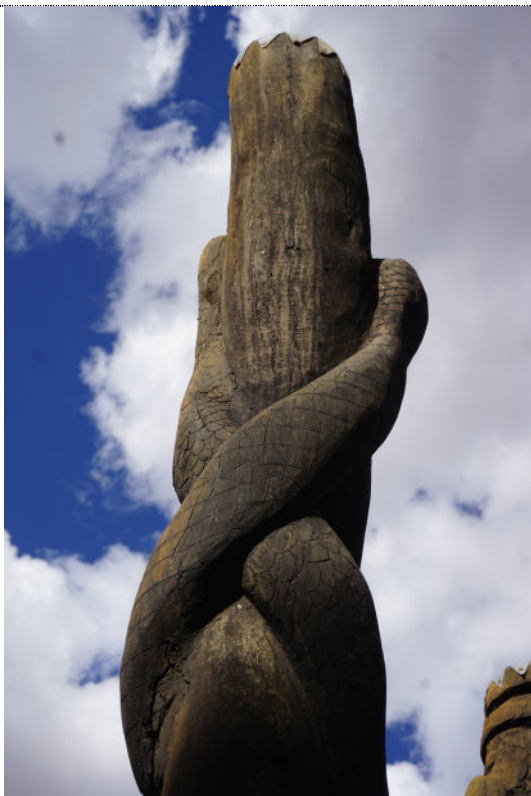
Figure 112: Detail – Pole #2003.0025, *Reconciliation*, exterior, UV degradation (darkening) to wood surface throughout.

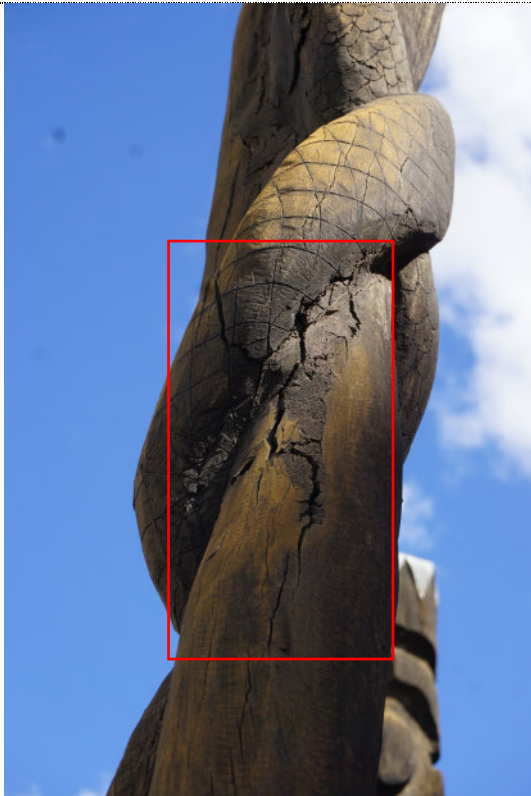
Figure 114: Detail – Pole #2003.0025, *Reconciliation*, exterior, UV degradation (darkening) to wood surface throughout. Cracks and splitting (highlighted in red) following the grain of the wood are evident throughout. These likely stem from movement in the material as it is exposed to different forces and degradation mechanisms.

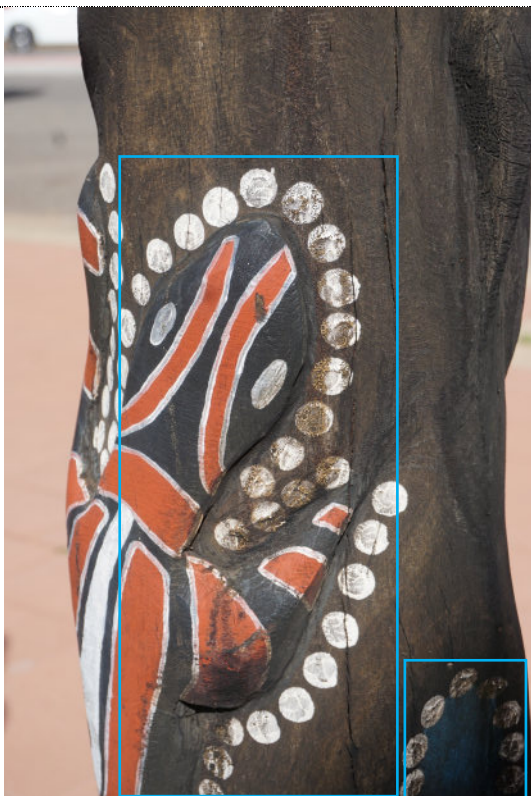
Figure 120: Detail – Pole #2003.0026, *Reconciliation*, exterior, UV degradation (darkening) to wood surface throughout. The painted areas are also faded and lost (highlighted in blue), which is consistent with UV degradation and display outdoors.

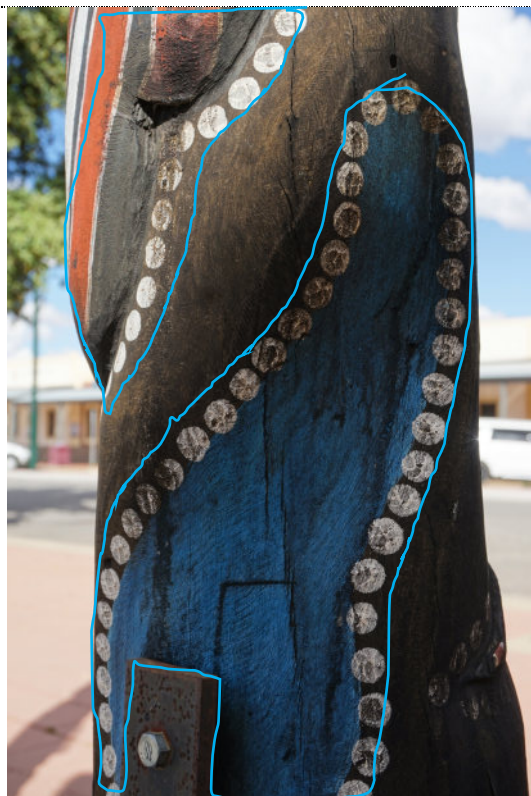
Figure 121: Detail – Pole #2003.0026, *Reconciliation*, exterior, UV degradation (darkening) to wood surface throughout. The painted areas are also faded and lost (highlighted in blue), which is consistent with UV degradation and display outdoors.

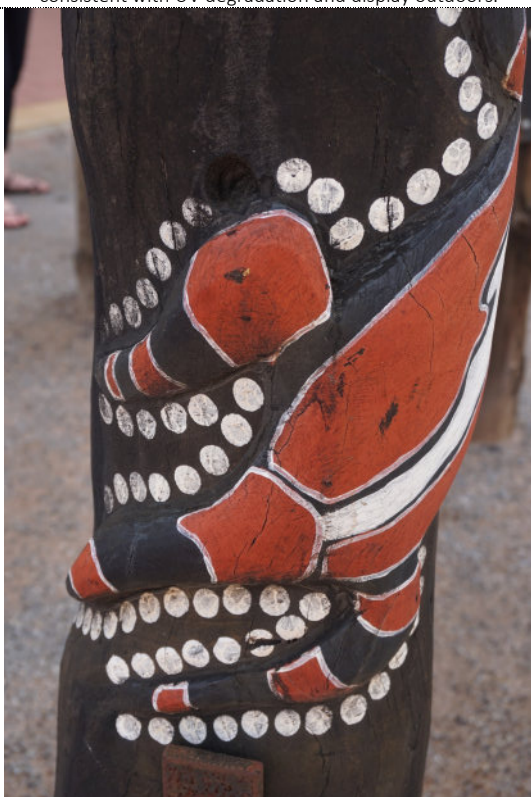
Figure 122: Detail – Pole #2003.0026, *Reconciliation*, exterior, UV degradation (darkening) to wood surface throughout. The painted areas are also faded and lost (highlighted in blue), which is consistent with UV degradation and display outdoors.

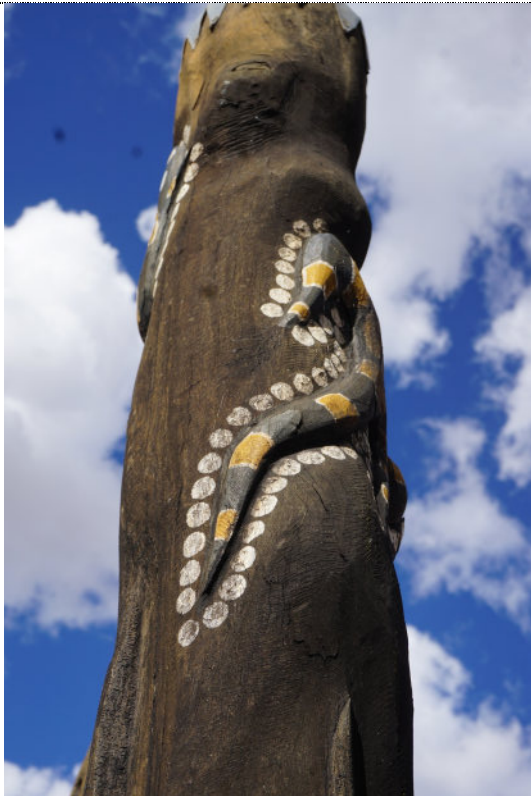
Figure 124: Detail – Pole #2003.0026, *Reconciliation*, exterior, UV degradation (darkening) to wood surface throughout. The painted areas are also faded and lost, which is consistent with UV degradation and display outdoors.

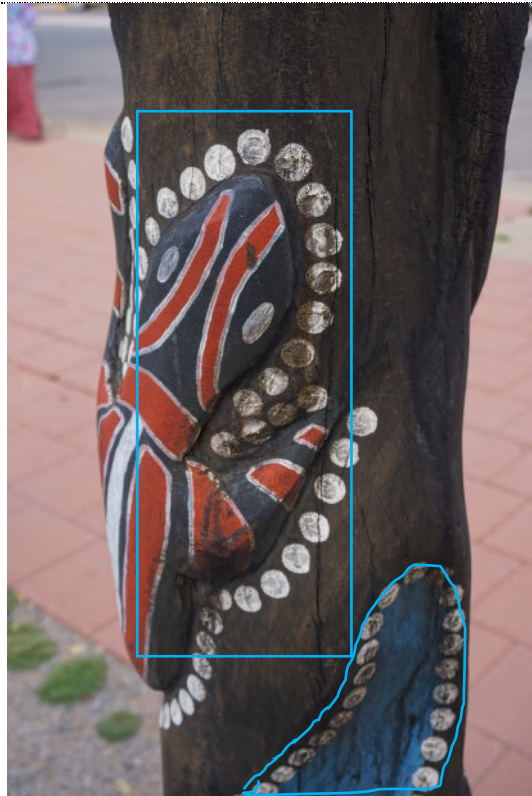
Figure 125: Detail – Pole #2003.0026, *Reconciliation*, exterior, UV degradation (darkening) to wood surface throughout. The painted areas are also faded and lost (highlighted in blue), which is consistent with UV degradation and display outdoors.

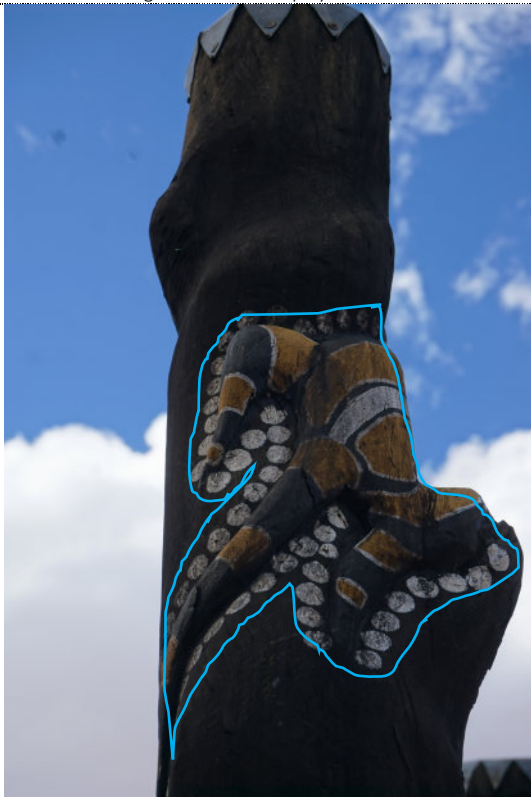
Figure 126: Detail – Pole #2003.0026, *Reconciliation*, exterior, UV degradation (darkening) to wood surface throughout. The painted areas are also faded and lost (highlighted in blue), which is consistent with UV degradation and display outdoors.

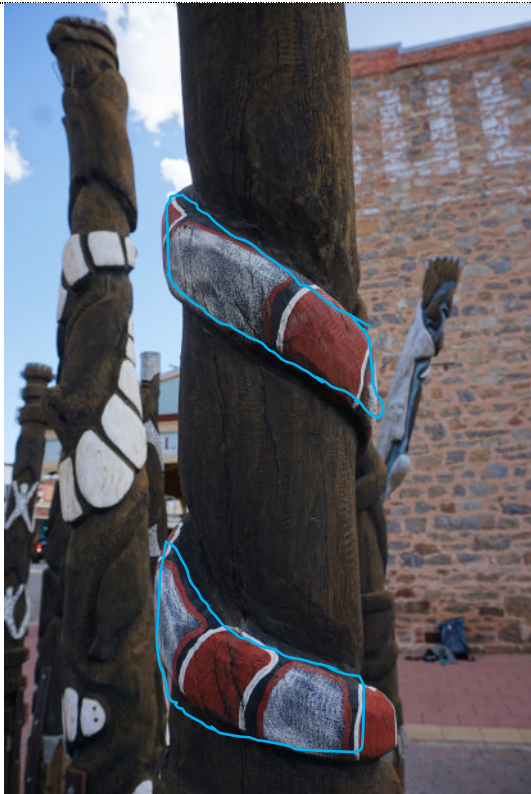
Figure 133: Detail – Pole #2003.0027, *Untitled*, exterior, painted areas/designs have faded with multiple paint losses are also noted (highlighted in blue). This is consistent with UV degradation and display outdoors.

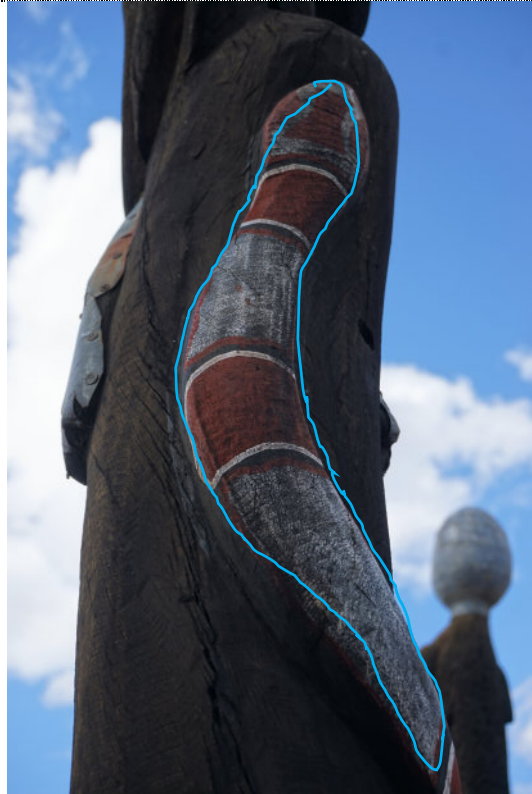
Figure 136: Detail – Pole #2003.0027, *Untitled*, exterior, painted areas/designs are faded with multiple paint losses also noted (highlighted in blue). This is consistent with UV degradation and display outdoors.

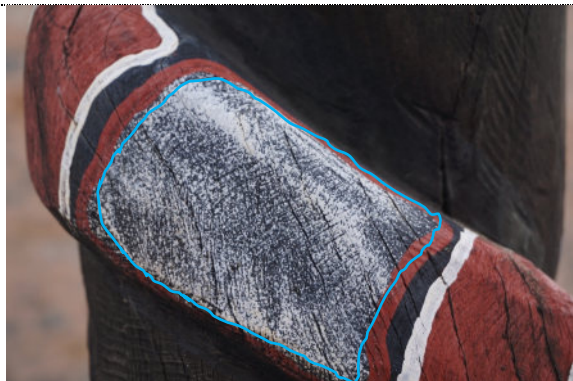
Figure 138: Detail – Pole #2003.0027, *Untitled*, exterior, painted areas/designs are faded with multiple paint losses also noted (highlighted in blue). This is consistent with UV degradation and display outdoors.

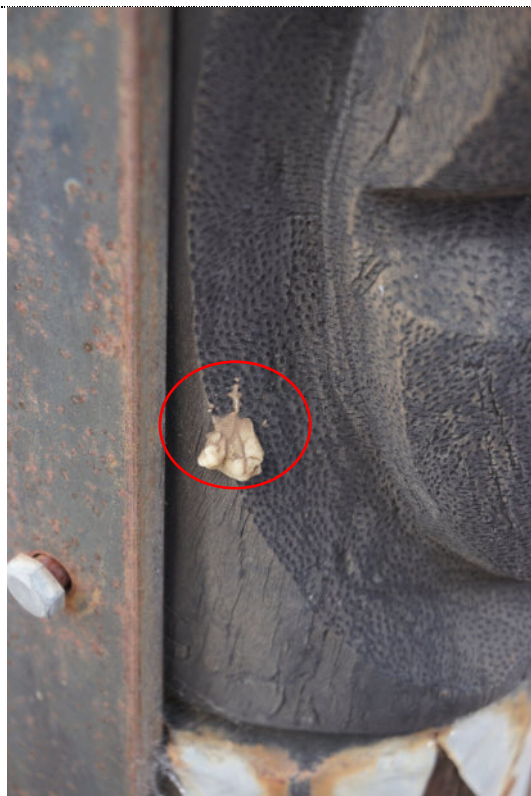
Figure 144: Detail – Pole #2003.0028, *Emu and kangaroo tracks*, exterior, UV degradation (darkening) to wood surface throughout. A large accretion noted on the wood surface (highlighted in red).

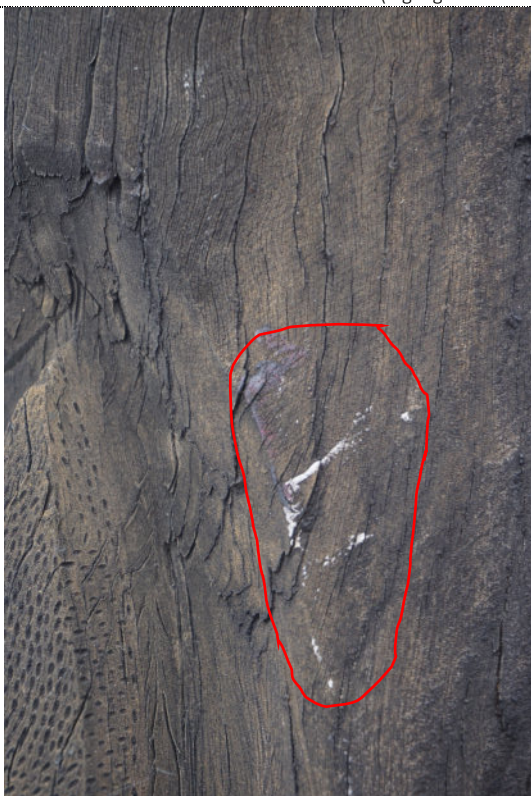
Figure 145: Detail – Pole #2003.0028, *Emu and kangaroo tracks*, exterior, exterior, UV degradation (darkening) to wood surface throughout. White paint accretions noted on the wood surface (highlighted in red).

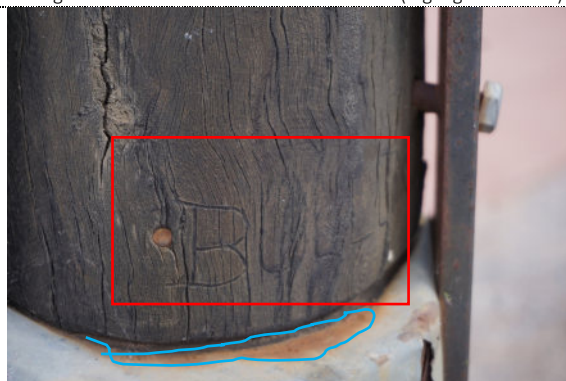
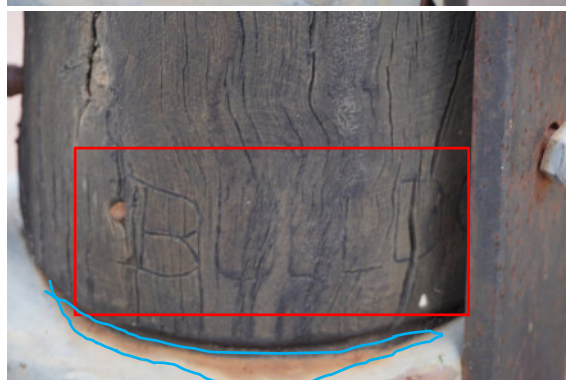
Figure 146 and 147: Detail – Pole #2003.0028, *Emu and kangaroo tracks*, exterior, carved letters written along the base of the pole (highlighted in red in both images). Iron staining on the metal below the base of the pole (highlighted in blue in both images).

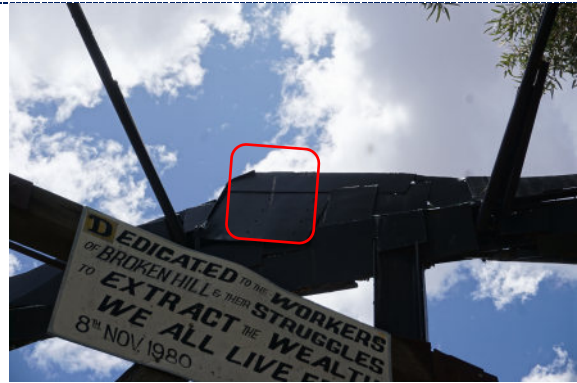
Figure 6: Detail – bird excrement

Routine Maintenance	Frequency
<ul style="list-style-type: none">• Surface clean to remove dirt particulate and accumulation of biomatter from adjacent trees.• Touch up paint as needed.• Keep biomatter and biogrowth in the vicinity curated.	1 year

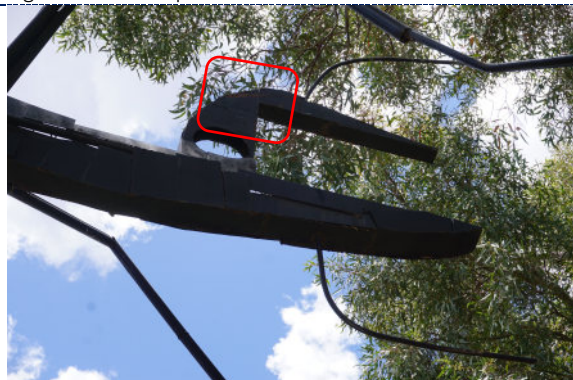
Figure 7: Detail – paint loss and corrosion to iron substrate.

Recommended Remedial Treatment Works	Advised Cost
<ul style="list-style-type: none">• Structural engineer to assess stability.• Remove or reduce failing and flaking paint.• Stabilise surface corrosion where needed.• Fill areas of corrosion loss where needed.• Repaint in a paint system rated for use on outdoor metals and colour-matched with the original.	~\$15,000

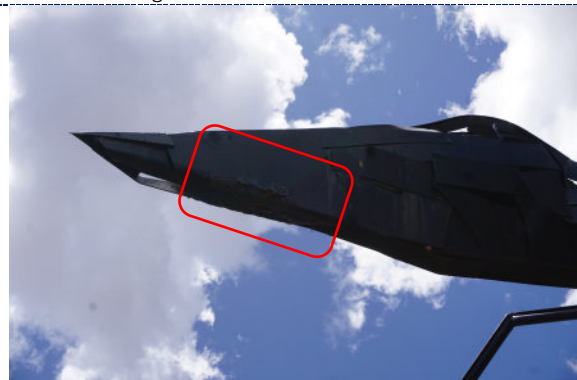
Figure 8: Detail – paint loss and corrosion to iron substrate.

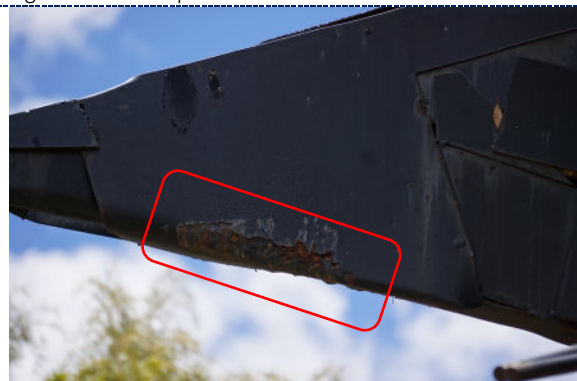
Figure 10: Detail – paint loss and corrosion to iron substrate.

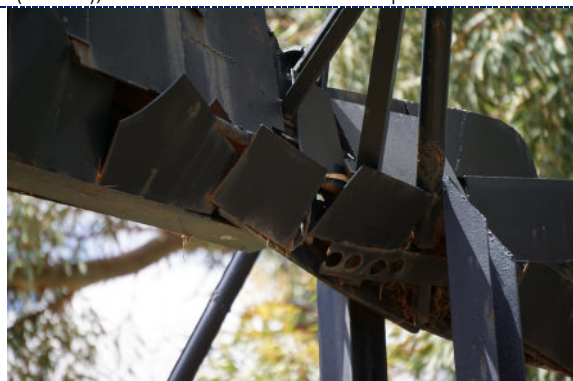
Figure 11: Detail – paint loss and corrosion to iron substrate; accumulated biomatter and spider webs within.

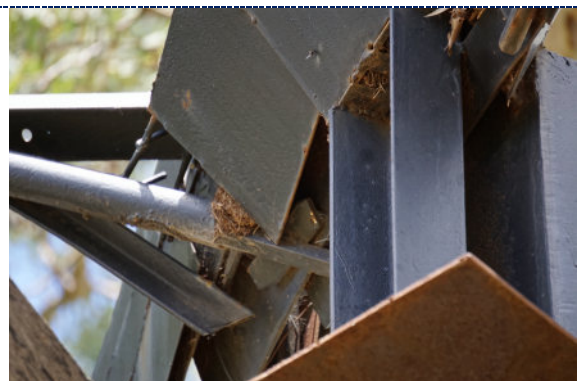
Figure 12: Detail – paint loss and corrosion to iron substrate; accumulated biomatter and spider webs within.

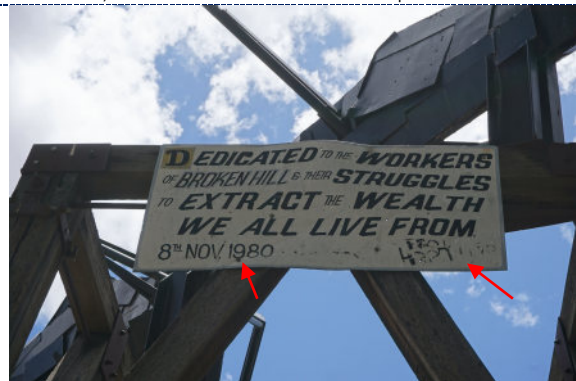
Figure 16: Detail – artist's plaque; surface wear, distortion, paint loss.

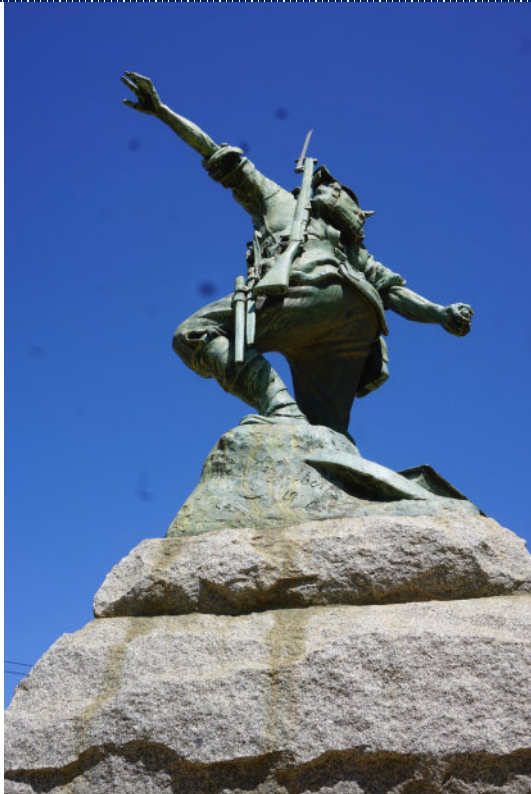
SURFACE/ COATING	MATERIALS:	
CONDITION	✓	NOTES
Abrasions/ dents		
Accretion		
Areas of loss		
Corrosion	✓	Surface corrosion is evident throughout the bronze figure (figs. 5-8) and the copper alloy plaques listing individual names (figs. 9-10, 16). Corrosion to the bronze appears consistent with atmospheric pollution-driven mechanisms. Iron elements fixing the copper-alloy plaques on each side of the work also exhibit evidence of corrosion (fig. 11).
Cracks		
Delamination		
Dust/ dirt	✓	Dirt particulate (figs. 11-15), surface accretions (figs. 9,11), bird excrement (figs. 19-20) and spider webs (figs. 17-18) were observed throughout, consistent with display outdoors.
Fading		
Flaking/Friable		
Mould/ mould damage		
Pest damage		
Previous treatment		
Staining/ discolouration	✓	Copper and iron corrosion product staining to the granite elements is present throughout (figs. 5, 11-15).
OTHER		Small plants were observed growing within voids left by mortar pointing loss (figs. 21-22).

Figure 5: Detail – copper corrosion product and staining to the granite components.

Recommended Remedial Treatment Works	Advised Cost
<ul style="list-style-type: none">• Surface clean to remove dirt particulate and loose corrosion product.• Reduce atmospheric corrosion product.• Remove staining to stone.• Repoint missing mortar.• Wax bronze and copper alloy components.	~\$20,000

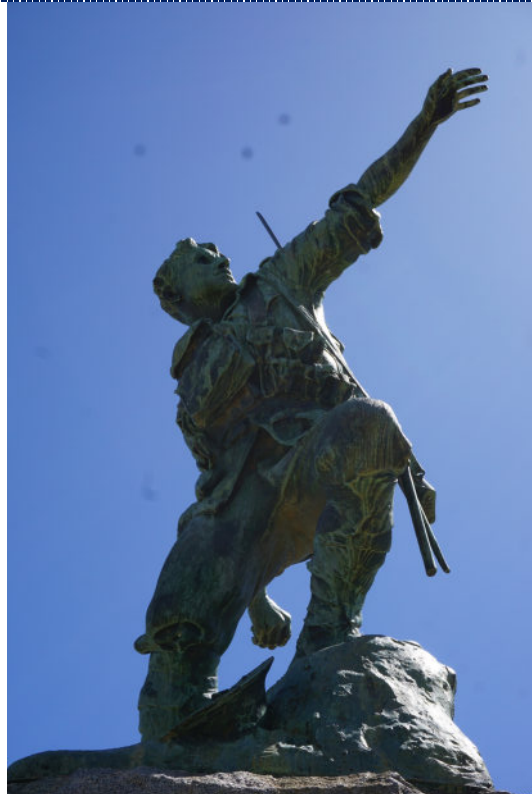
Figure 6: Detail – atmospheric pollution-driven copper corrosion product on figure.

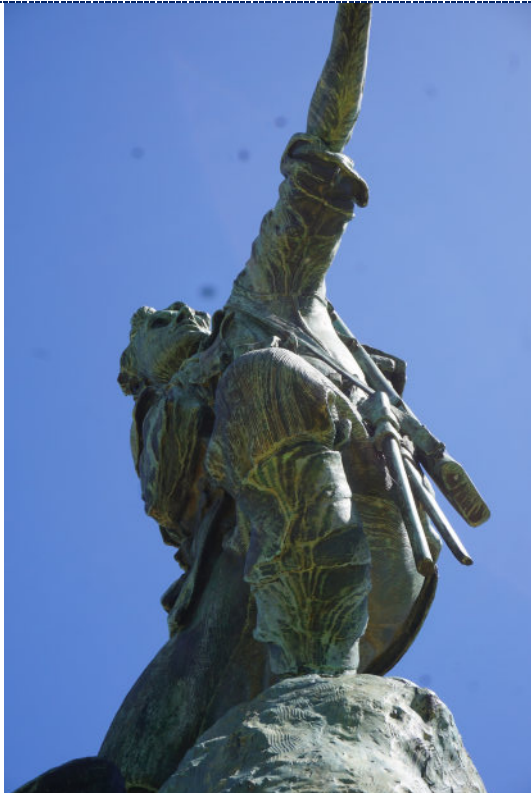
Figure 7: Detail – atmospheric pollution-driven copper corrosion product on figure.

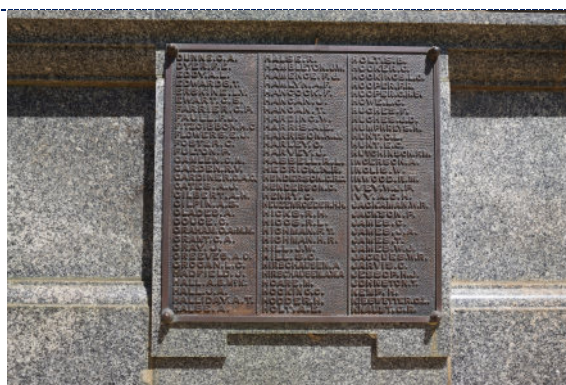
Figure 10: Detail – minor copper corrosion product, surface over cleaning (lighter areas).

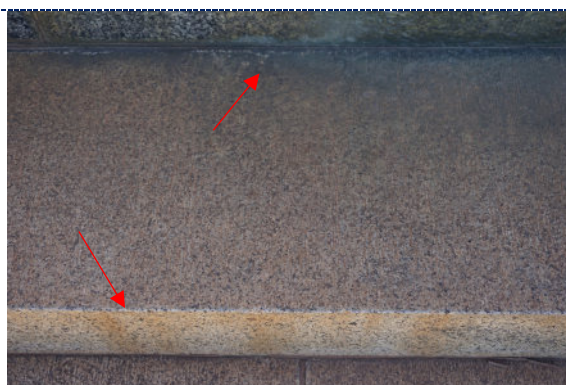
Figure 12: Detail – dirt particulate and copper corrosion product staining to granite stone; red staining at bottom may stem from iron corrosion elsewhere on the object.

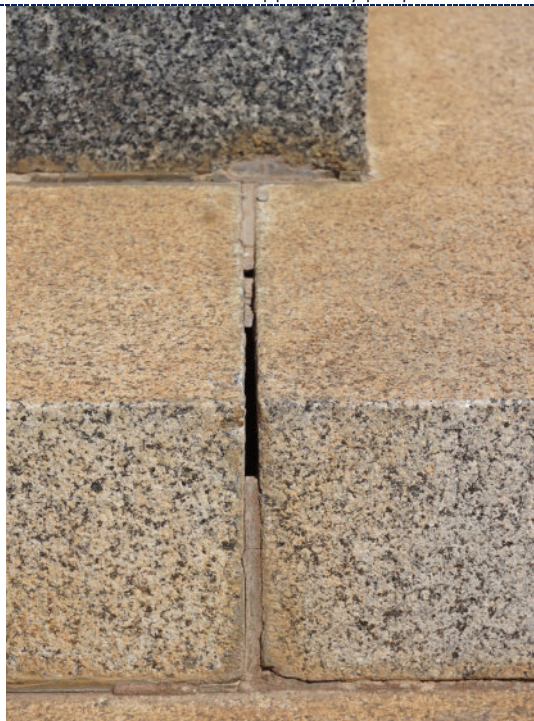
Figure 13: Detail – dirt particulate, red staining (possibly iron corrosion product) and loss to mortar pointing.

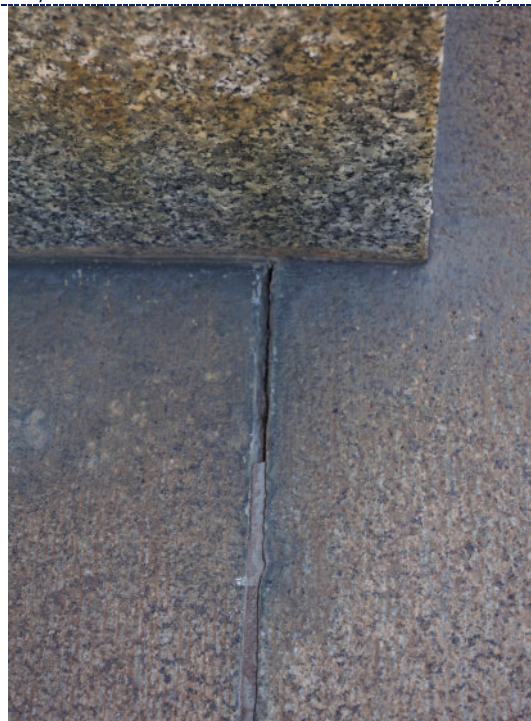
Figure 14: Detail – dirt particulate, red staining (possibly iron corrosion product) and loss to mortar pointing.

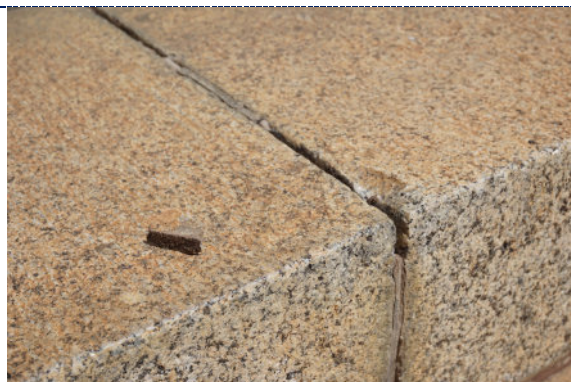
Figure 15: Detail – dirt particulate, red staining (possibly iron corrosion product) and loss to mortar pointing.

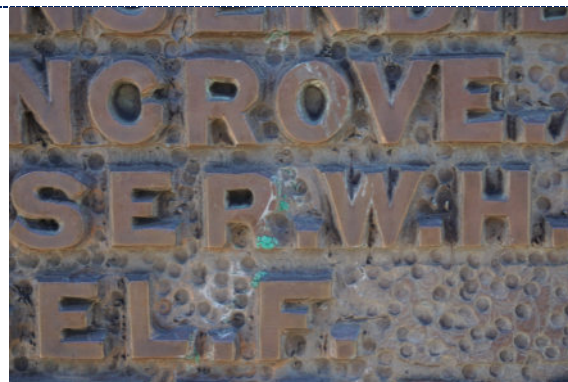
Figure 16: Detail – copper corrosion product on copper alloy plaque.

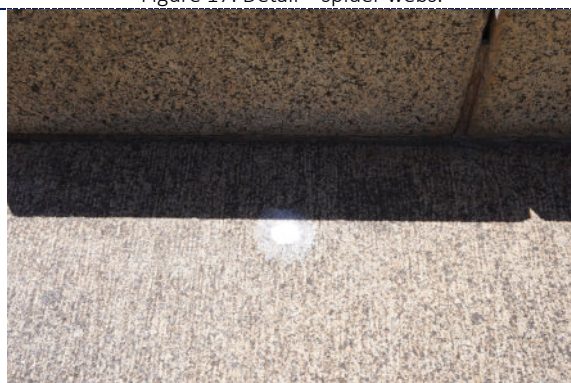
Figure 19: Detail – loss to mortar pointing and bird excrement.

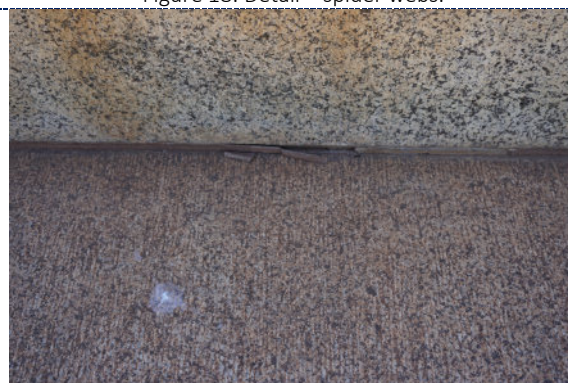
Figure 20: Detail – loss to mortar pointing and bird excrement.

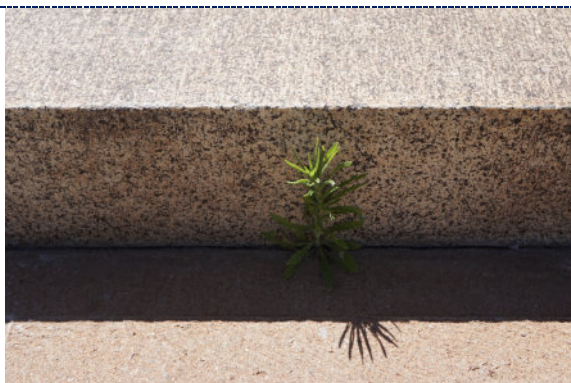
Figure 21: Detail – biogrowth.

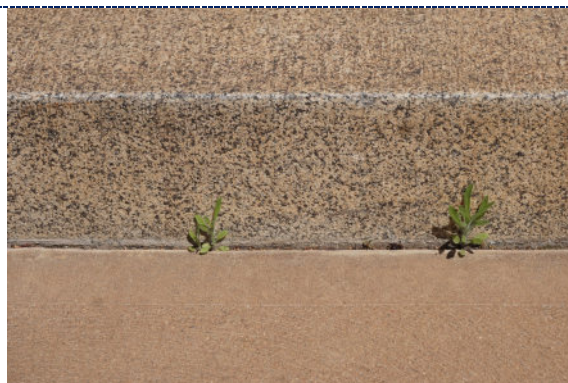
Figure 22: Detail – biogrowth.

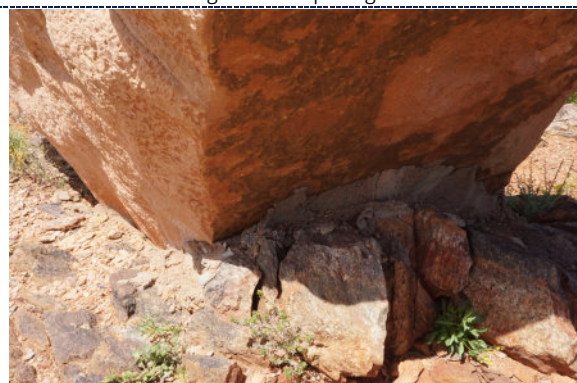
Figure 6: Detail – rear cement/concrete at base.

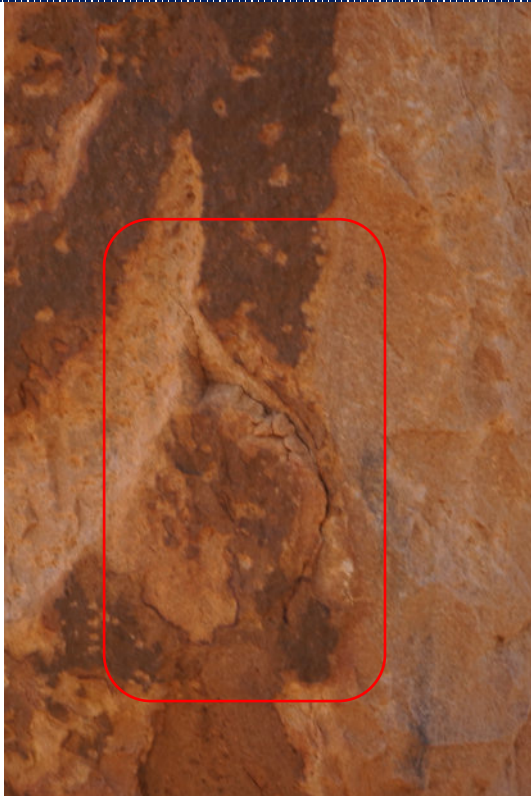
SURFACE/ COATING	MATERIALS:	
CONDITION	✓	NOTES
Abrasions/ dents		
Accretion		
Areas of loss		
Corrosion		
Cracks		
Delamination	✓	Minor stone delamination present.
Dust/ dirt	✓	Minor dirt particulate observed throughout, inherent to outdoor sculpture.
Fading		
Flaking/Friable		
Mould/ mould damage		
Pest damage		
Pitting		
Previous treatment		
Staining/ discolouration		
OTHER

Figure 13: Detail – minor stone delamination.

Routine Maintenance	Frequency
<ul style="list-style-type: none">• Surface clean to remove dirt particulate and avian guano.• Monitor large cracks in the stone and overall structural stability.• Monitor possible stone delamination.• Monitor possible soil erosion.	Biennially 1 year 2 years 2 years

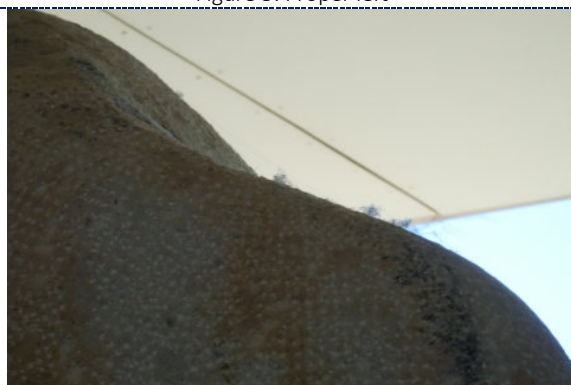
Figure 5: Detail – dirt and dust particulates.

Routine Maintenance	Frequency
<ul style="list-style-type: none">Surface clean to remove dirt particulate and accumulation of arachnid webbing.	1 year

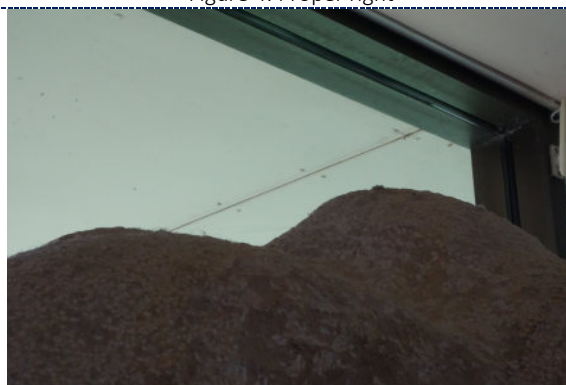
Figure 6: Detail –dirt and dust particulates.

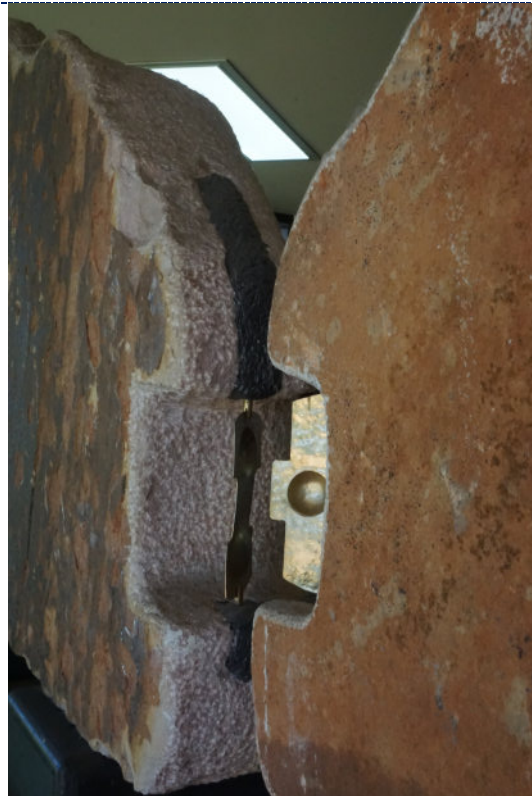
Figure 8: Detail – black accretion, inherent to artist manufacture.

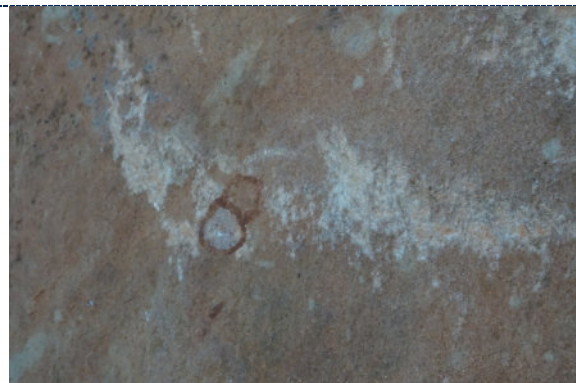
SURFACE/ COATING	MATERIALS:	
CONDITION	✓	NOTES
Abrasions/ dents	✓	Minor abrasions evident throughout (figs. 4, 11-12).
Accretion	✓	3 x yellow deposits visible on verso (fig. 11) and brown figure '8' accretion/inscription noted (fig. 10).
Areas of loss		
Corrosion		
Cracks		
Delamination	✓	Possible small areas of stone delamination noted (figs. 9-14).
Dust/ dirt	✓	Dirt particulates and spider webs were observed on top surfaces and within sculpture recesses (figs. 5-7).
Fading		
Flaking/Friable		
Mould/ mould damage		
Pest damage		
Previous treatment		
Staining/ discolouration	✓	Tidelines noted on timber plinth blocks, indicating prior exposure to moisture.
OTHER

Figure 10: Detail – figure "8" inscription/accretion noted.

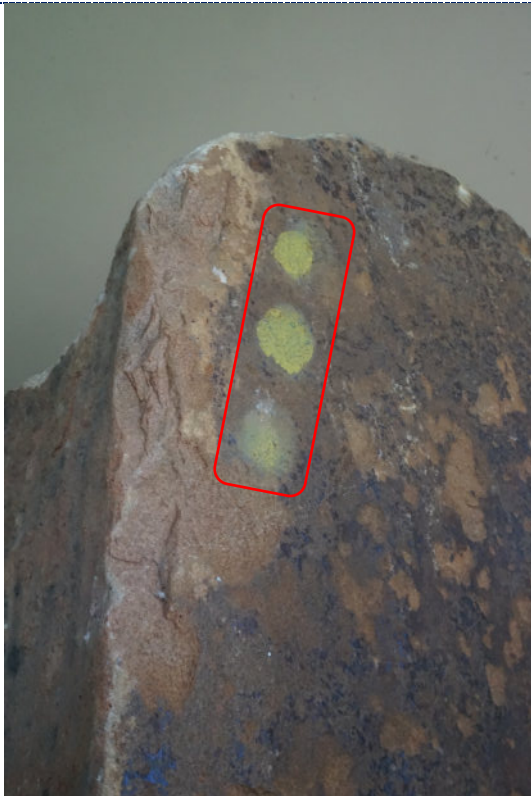
Figure 11: Detail – 3 x yellow accretion deposits.

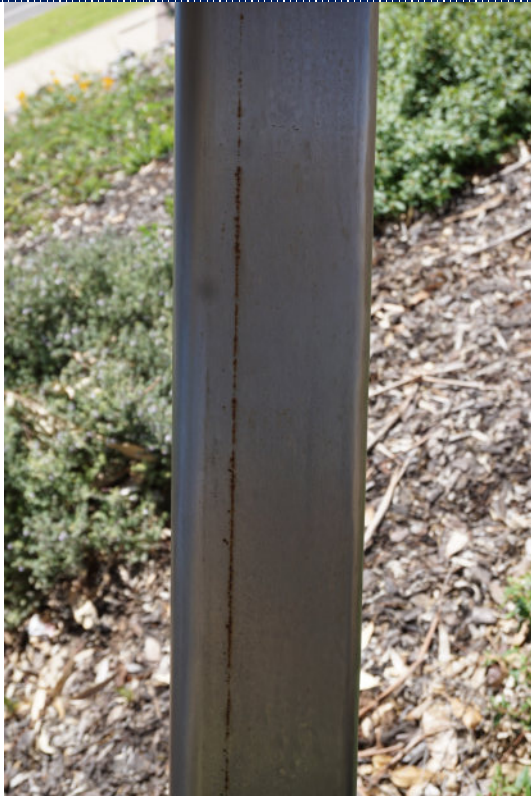
Figure 5: Detail – linear scratch and iron corrosion product.

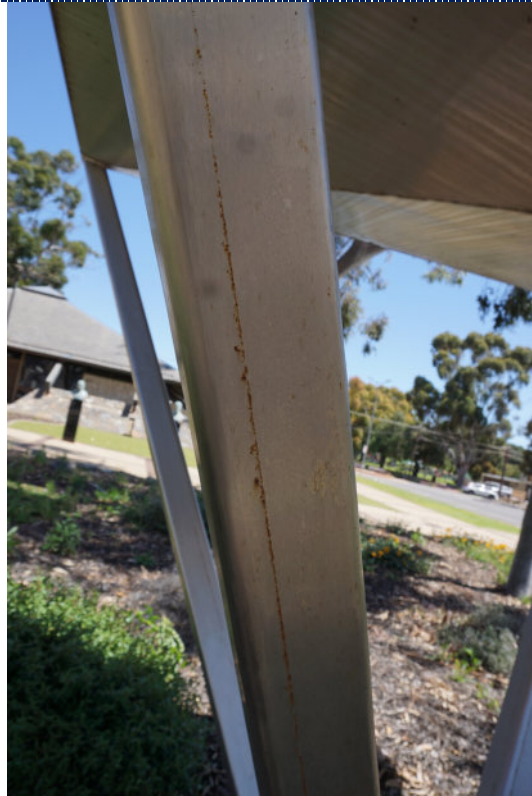
Figure 6: Detail – linear scratch and iron corrosion product.

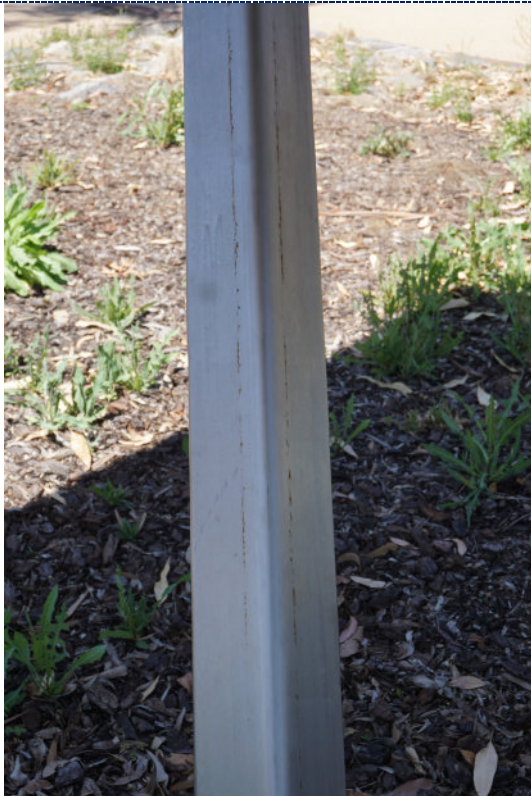
Figure 7: Detail – linear scratch and iron corrosion product.

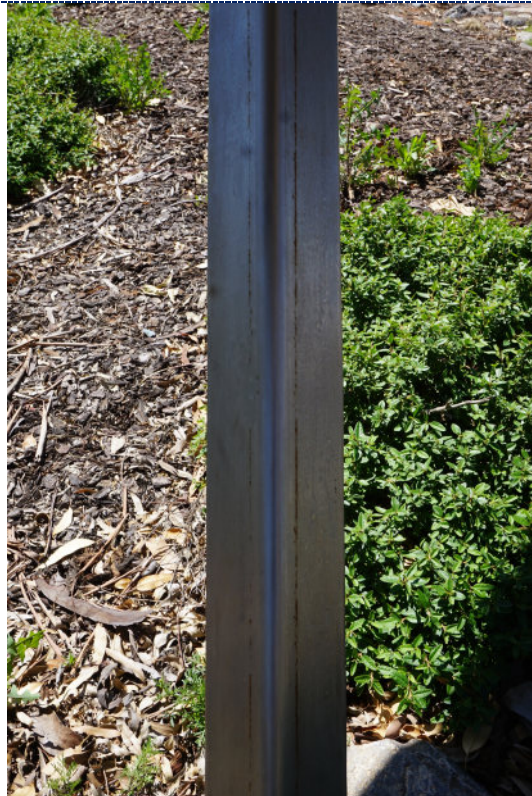
Figure 8: Detail – linear scratch and iron corrosion product.

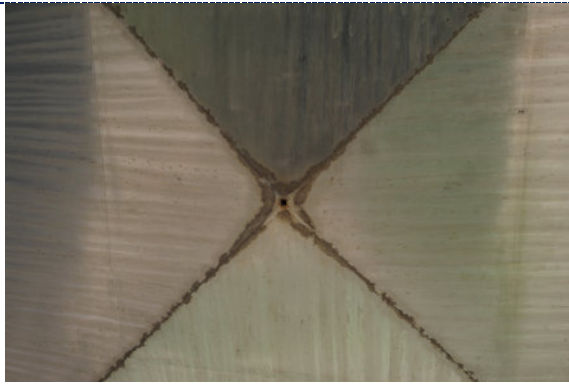
Figure 9: Detail – dirt particulate accumulation along the bottom diamond edges and water streaks.

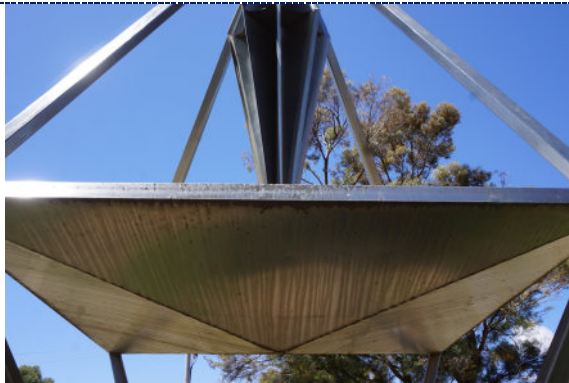
Figure 11: Detail – dirt particulate accumulation along the bottom diamond edges and water streaks.

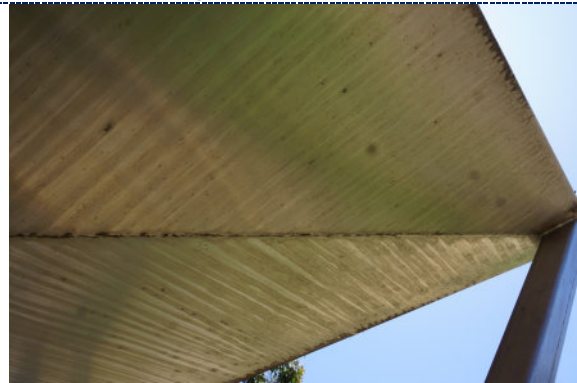
Figure 12: Detail – dirt particulate accumulation along the bottom diamond edges and water streaks.

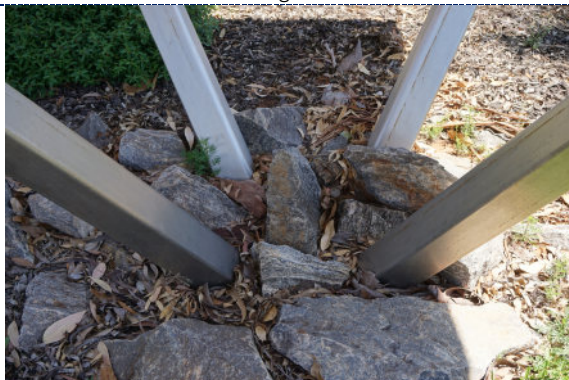
Figure 13: Detail – rocks at base for drainage and the accumulation of biomatter.

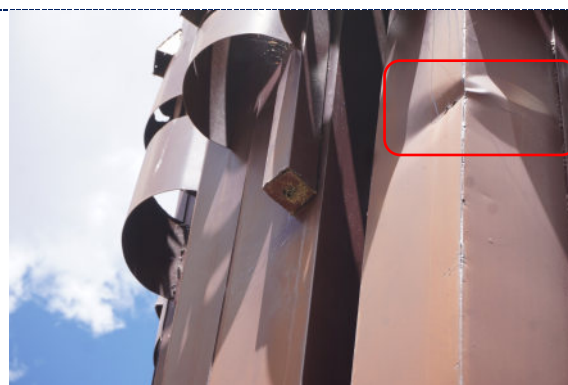
Figure 6: Detail – paint fading and degradation; dirt particulate and spider webs; surface distortion.

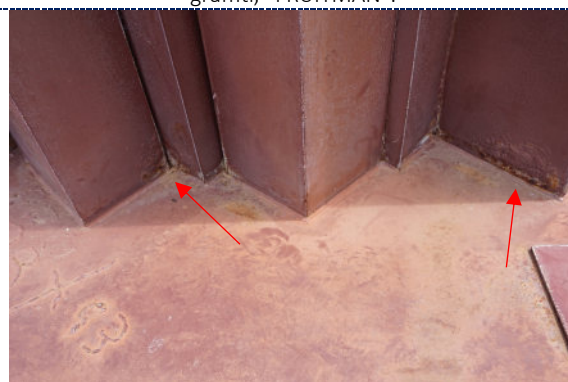
SURFACE/ COATING	MATERIALS:	
CONDITION	✓	NOTES
Abrasions/ dents		
Accretion	✓	White surface accretions evident adjacent to iron corrosion product at base (figs. 9-10, 14, 16, 19-20). This may stem from previous applications of a phosphoric-acid-based corrosion converter.
Areas of loss	✓	Loss and flaking paint observed throughout, particularly at the base.
Corrosion	✓	Surface corrosion where the paint layer is lost or perforated (figs. 9-10, 13-16, 19-23).
Cracks		
Delamination		
Dust/ dirt	✓	Dirt particulate, bird excrement and spider webs were observed throughout, consistent with display outdoors. Biomatter has accumulated in areas at the base (figs. 19-20).
Fading	✓	UV-degraded paint following outdoor exposure (7-23).
Flaking/Friable		
Mould/ mould damage		
Pest damage		
Previous treatment	✓	The artwork appears to have been previously painted.
Staining/ discolouration		
OTHER	Incised graffiti in paint layer (fig. 8).

Figure 10: Detail – paint fading and degradation; dirt particulate and surface accretions (white); iron corrosion.
