Broken Hill Public Art Condition Survey and Conservation Plan

Prepared for: Broken Hill City Council
Submission Date: February 2023

This report presents the results of a condition survey assessing the works held within Broken Hill City Council's public art collection. A total of 56 works were condition assessed.

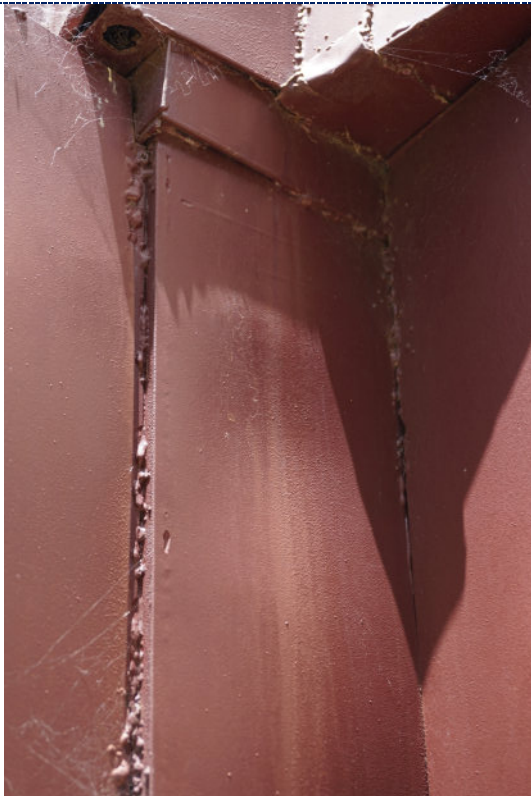
Figure 11: Detail – paint fading and degradation; dirt particulate and spider webs.

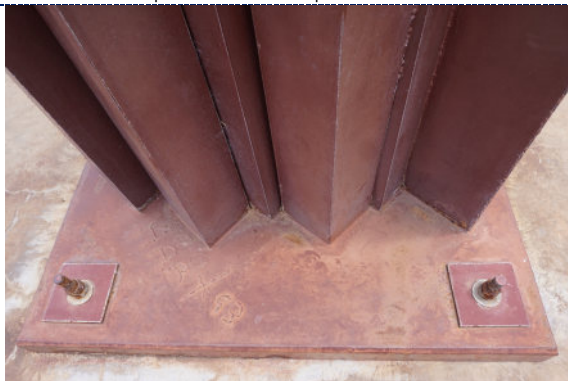
Figure 13: Detail – paint fading and degradation; dirt particulate; iron corrosion; artist's signature.

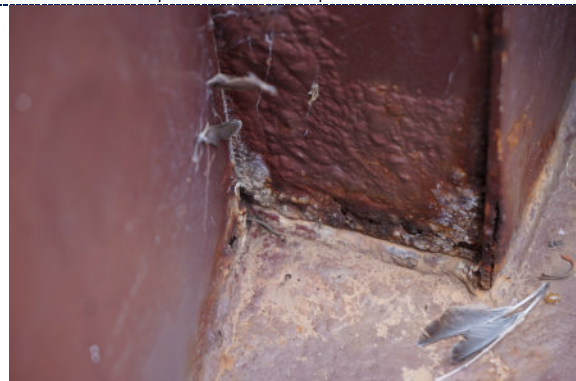
SURFACE/ COATING	MATERIALS:	
CONDITION	✓	NOTES
Abrasions/ dents		
Accretion	✓	White surface accretions evident adjacent to iron corrosion product at base (figs. 9-10, 14, 16, 19-20). This may stem from previous applications of a phosphoric-acid-based corrosion converter.
Areas of loss	✓	Loss and flaking paint observed throughout, particularly at the base.
Corrosion	✓	Surface corrosion where the paint layer is lost or perforated (figs. 9-10, 13-16, 19-23).
Cracks		
Delamination		
Dust/ dirt	✓	Dirt particulate, bird excrement and spider webs were observed throughout, consistent with display outdoors. Biomatter has accumulated in areas at the base (figs. 19-20).
Fading	✓	UV-degraded paint following outdoor exposure (7-23).
Flaking/Friable		
Mould/ mould damage		
Pest damage		
Previous treatment	✓	The artwork appears to have been previously painted.
Staining/ discolouration		
OTHER	Incised graffiti in paint layer (fig. 8).

Figure 14: Detail – paint fading and degradation; dirt particulate and surface accretions (white); iron corrosion; dirt particulate, accumulated biomatter and spider webs.

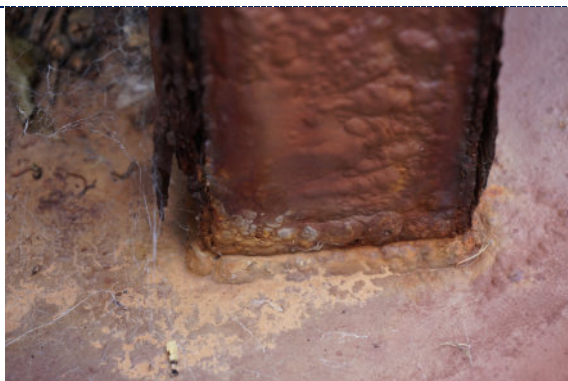
Figure 15: Detail – paint fading and degradation; corrosion to iron substrate; dirt particulate.

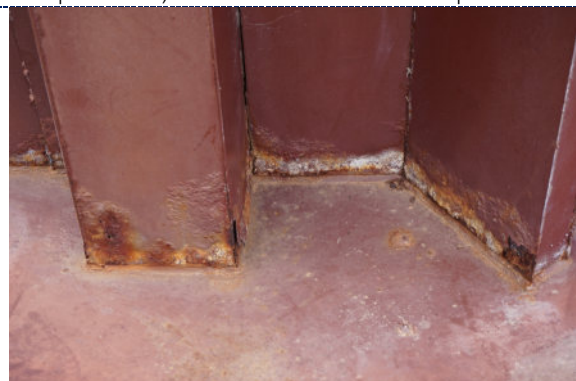
Figure 16: Detail – paint fading and degradation; dirt particulate and surface accretions (white); iron corrosion.

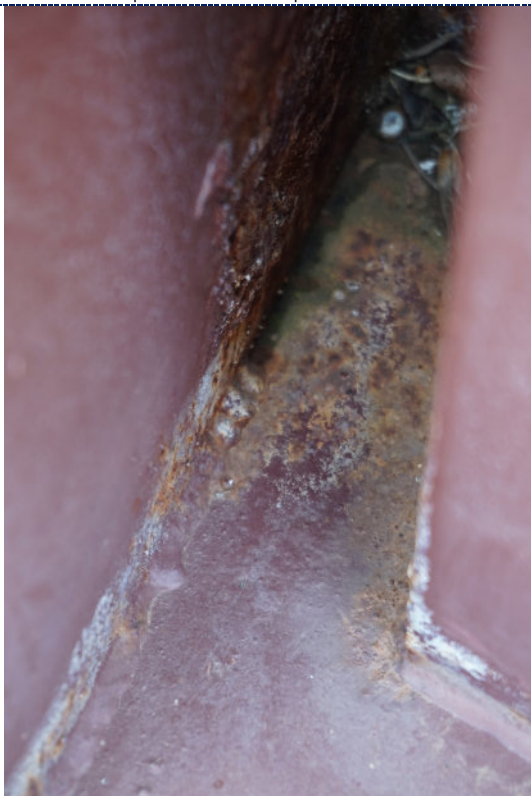
Figure 19: Detail – paint loss and corrosion to iron substrate; accumulation of dirt particulate.

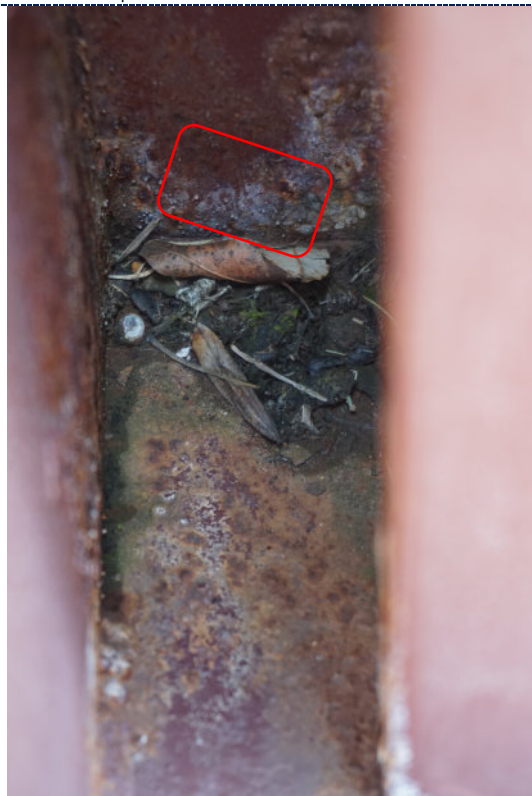
Figure 20: Detail – paint loss and corrosion to iron substrate; accumulation of dirt particulate.

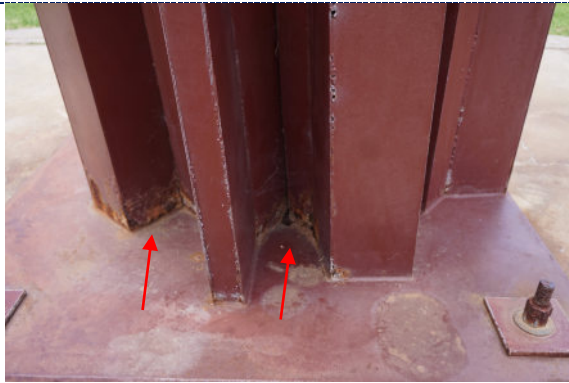
Figure 21: Detail – paint fading and degradation; dirt particulate; iron corrosion.

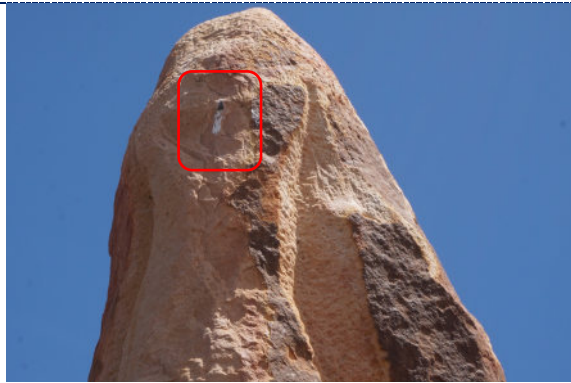
Figure 5: Detail – bird excrement.

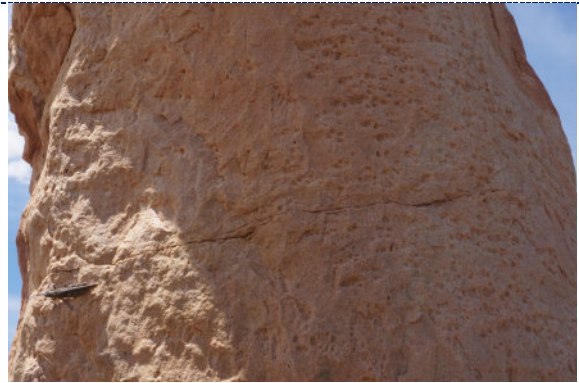
Figure 6: Detail – horizontal crack, likely occurring naturally within the stone.

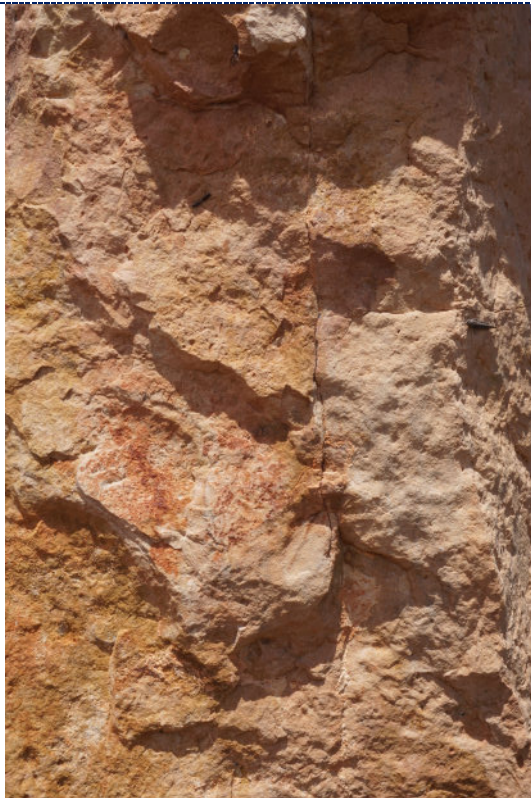
Figure 7: Detail -- vertical crack, likely occurring naturally in the stone.

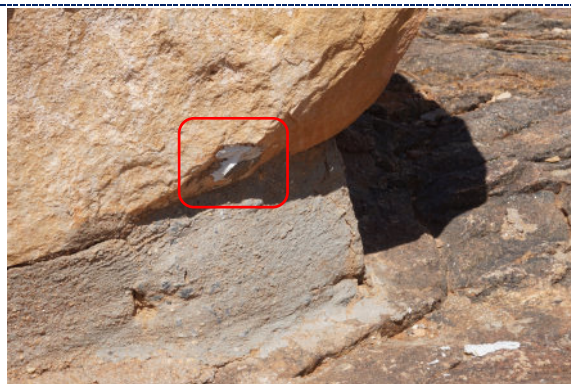
Figure 9: Detail – unknown polymer surface accretion.

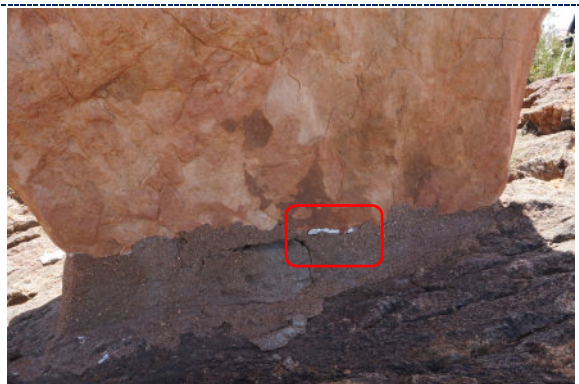
Figure 10: Detail – unknown polymer surface accretion.

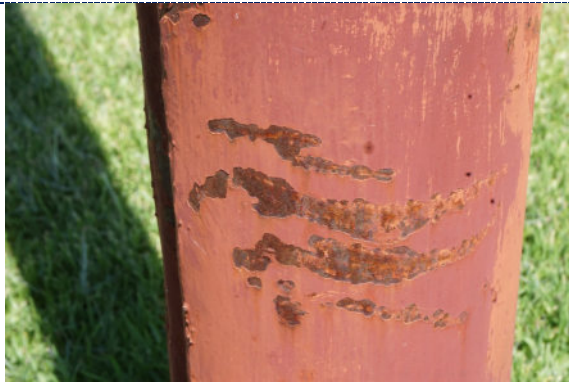
SURFACE/ COATING	MATERIALS:	
CONDITION	✓	NOTES
Abrasions/ dents	✓	Minor small abrasions evident throughout (figs. 5,7-8).
Accretion		
Areas of loss	✓	Loss and flaking paint observed throughout.
Corrosion	✓	Corrosion visible where the paint layer is lost or perforated (figs. 5, 7-8, 14-16).
Cracks		
Delamination		
Dust/ dirt	✓	Dirt particulate and spider webs were observed throughout, consistent with display outdoors.
Fading	✓	Chalking and fading to the paint following exposure to sunlight and outdoor conditions (figs. 5-16).
Flaking/Friable	✓	Flaking and peeling paint (figs. 5-16).
Mould/ mould damage		
Pest damage		
Previous treatment	✓	The sculpture appears to have been repainted at least once due to the slightly different hue between the two paint layers. Putty/silicone visible at (figs 15-16).
Staining/ discolouration		
OTHER

Figure 5: Detail – paint chalking, overpaint; abrasion with loss, likely from contact with foreign object; corrosion in areas of paint loss.

Recommended Remedial Treatment Works	Advised Cost
<ul style="list-style-type: none">Remove or reduce failing and flaking paint.Stabilise surface corrosion where needed.Repaint in a paint system rated for use on outdoor metals and colour-matched with the original.	~\$2,500

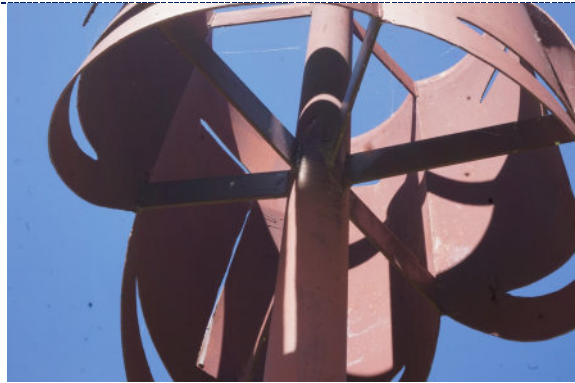
Figure 6: Detail – paint chalking, flaking paint loss with overpaint; spider webs.

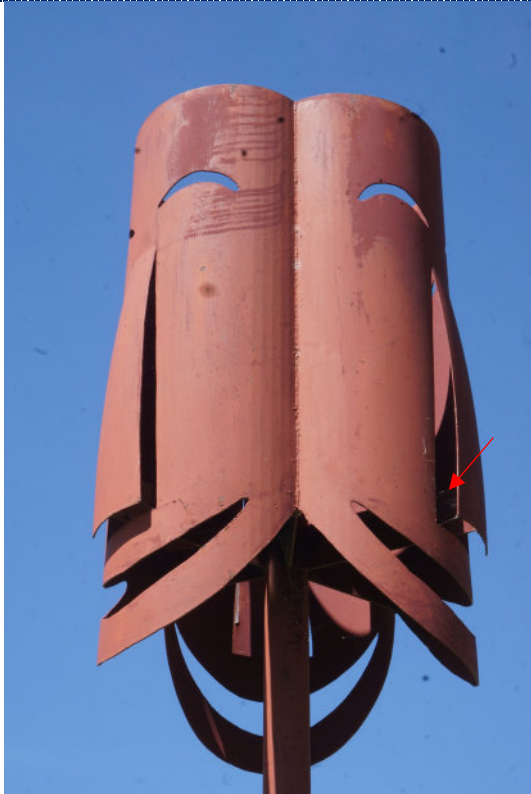
Figure 9: Detail – paint chalking, overpaint; spider webs.

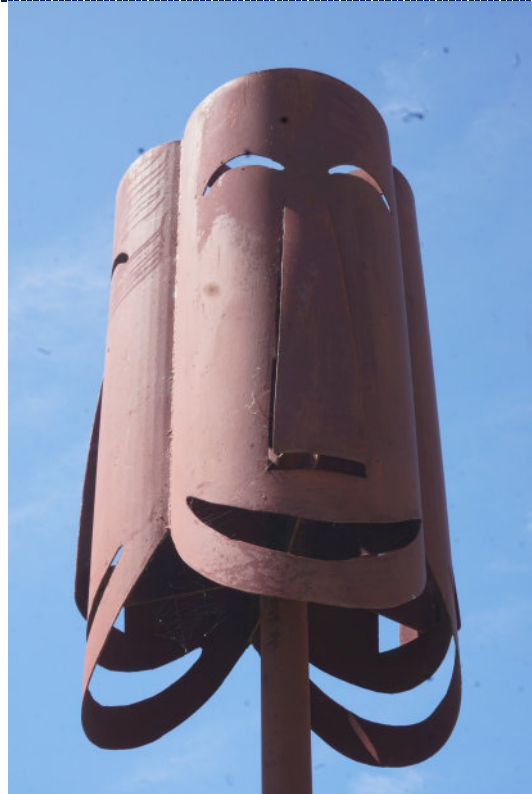
Figure 10: Detail – paint chalking, overpaint; spider webs.

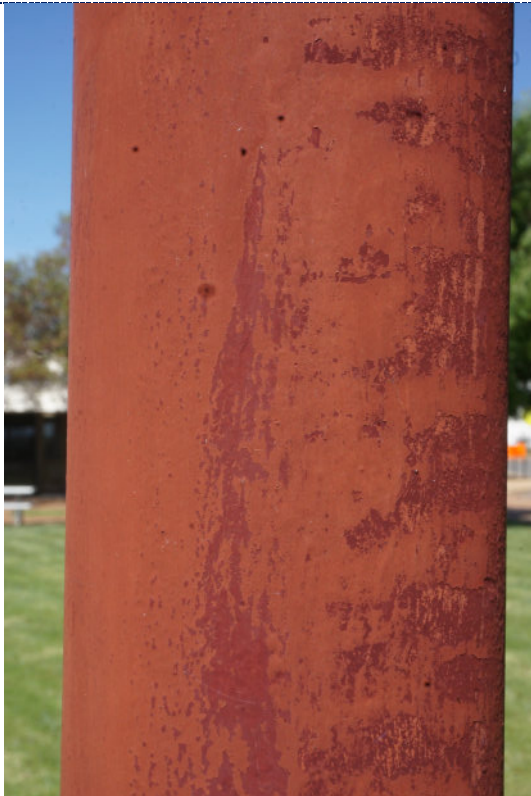
Figure 13: Detail – paint chalking. The two shades of red paint suggest the surface was repainted.

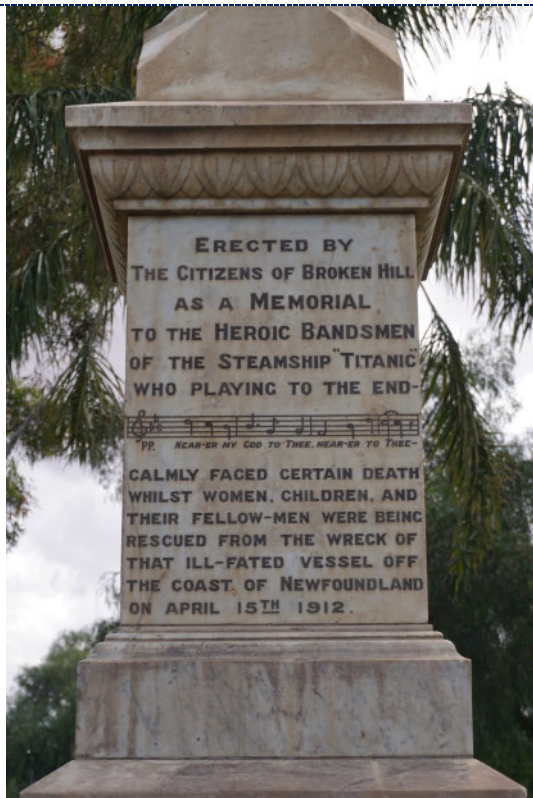
Figure 5: Detail – front, dirt particulate and stone discolouration.

Routine Maintenance	Frequency
<ul style="list-style-type: none">• Surface clean to remove dirt particulate and bird excrement.• Touch up paint as needed.	1 year

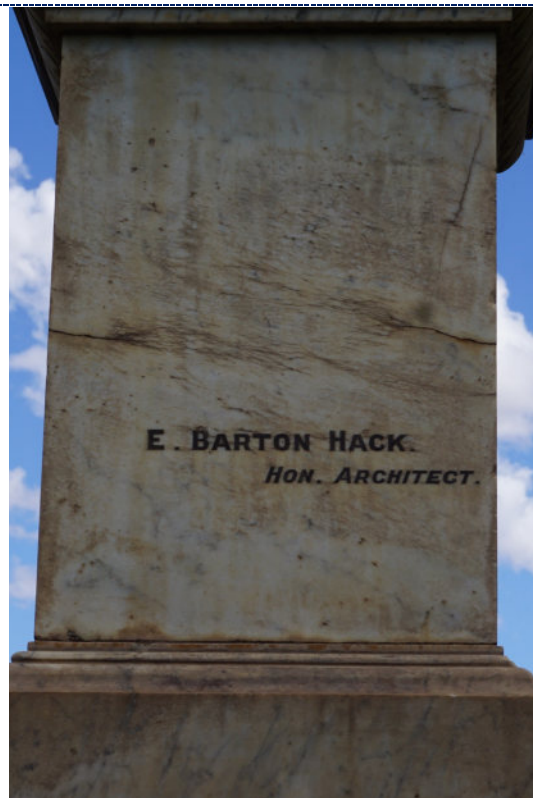
Figure 6: Detail – proper left, dirt particulate and stone discolouration.

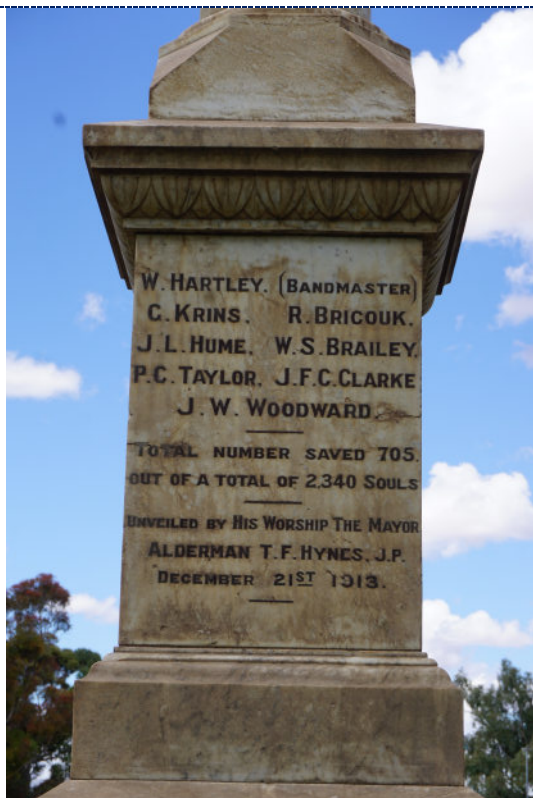
Figure 7: Detail – back, dirt particulate and stone discolouration.

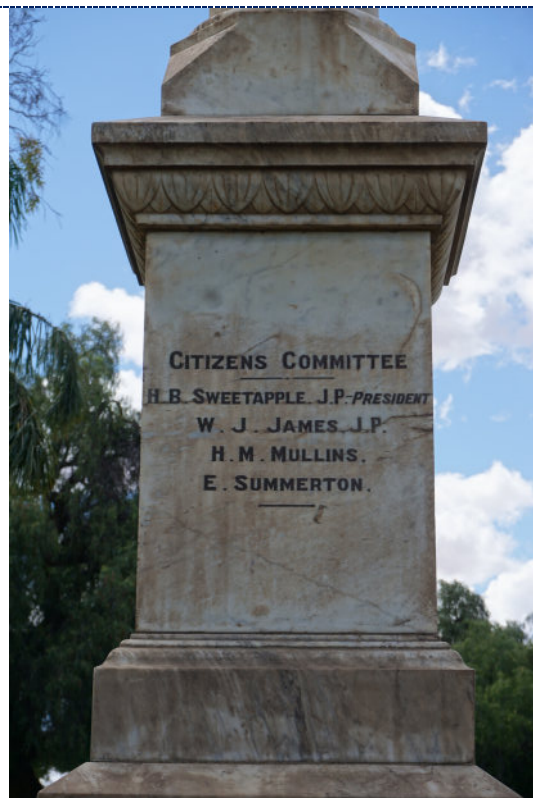
Figure 8: Detail – proper right, dirt particulate and stone discolouration.

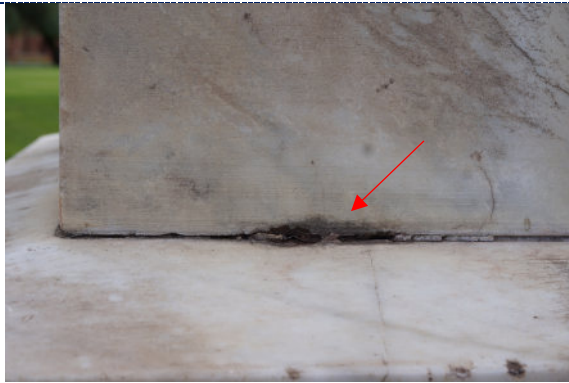
Figure 9: Detail – dirt particulate, pointing loss at join.

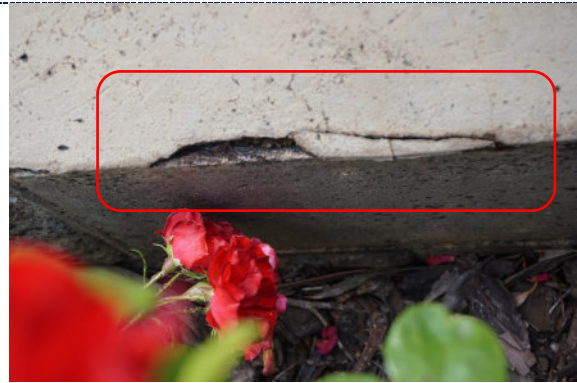
Figure 10: Detail – dirt particulate, crack and loss to plinth render.

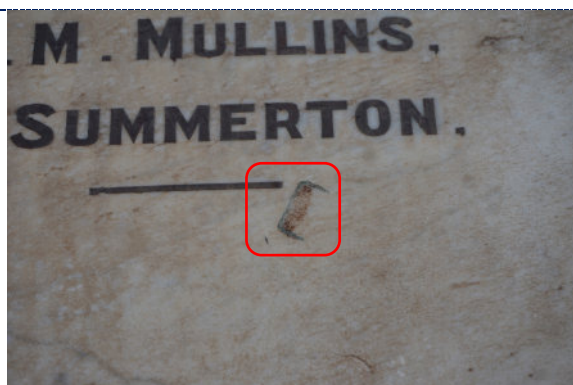
Figure 15: Detail – dirt particulate, surface abrasion with paint transfer.

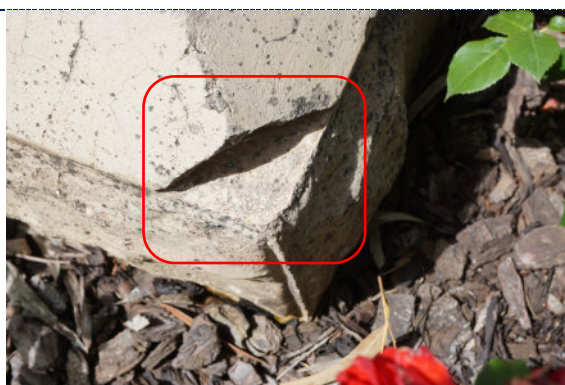
Figure 16: Detail – small cracks and loss to plinth render.

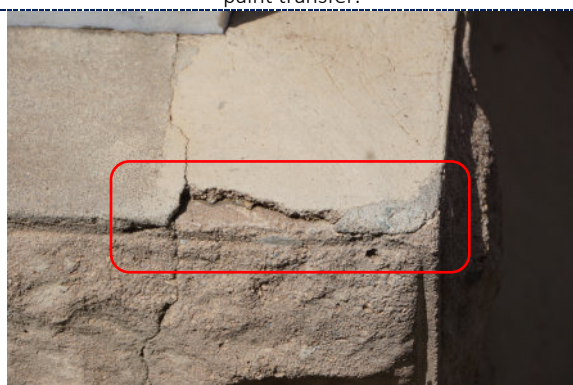
Figure 17: Detail – small cracks and loss to plinth render.

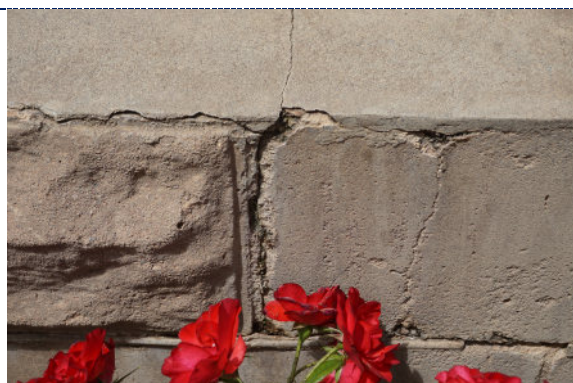
Figure 19: Detail – cracks and small losses to concrete render.

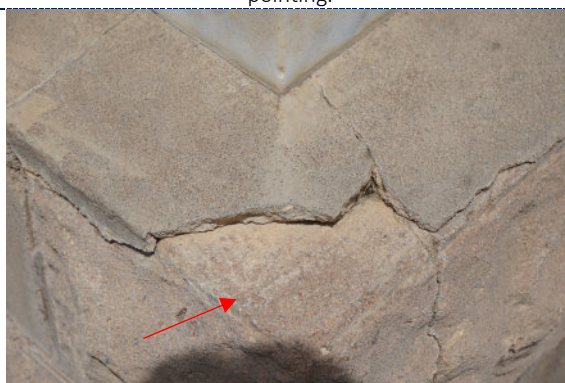
Figure 20: Detail – small cracks and loss to plinth render.

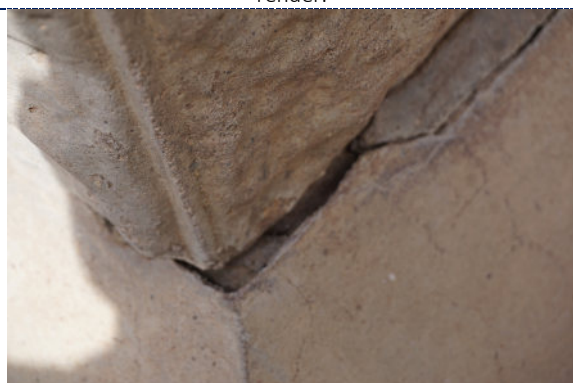
Figure 21: Detail – loss to concrete render.

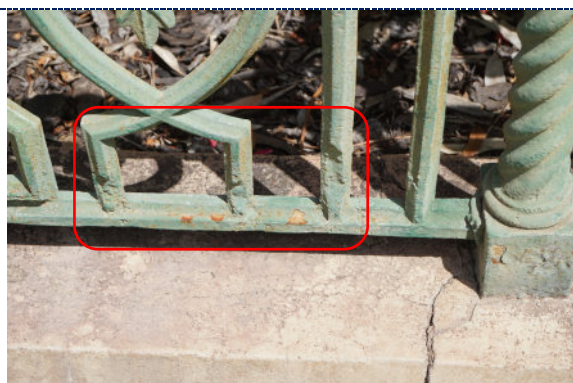
Figure 25: Detail – cracks to plinth render; loss and degradation of green paint on cast iron fencing; iron corrosion product; losses to iron, previously repaired.

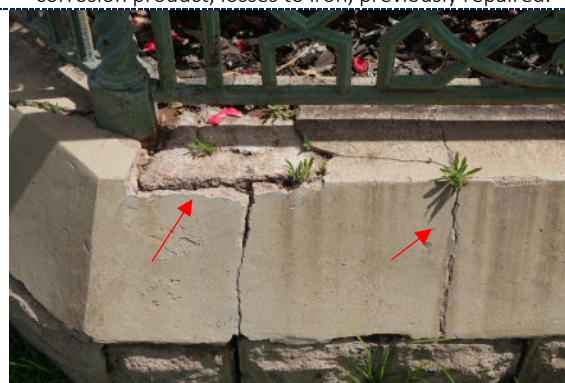
Figure 26: Detail – cracks and loss to plinth render with biogrowth; loss and degradation of green paint on cast iron fencing; iron corrosion product.

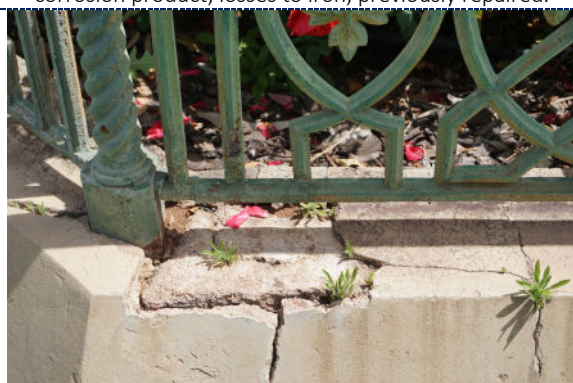
Figure 27: Detail – cracks and loss to plinth render with biogrowth; loss and degradation of green paint on cast iron fencing; iron corrosion product.

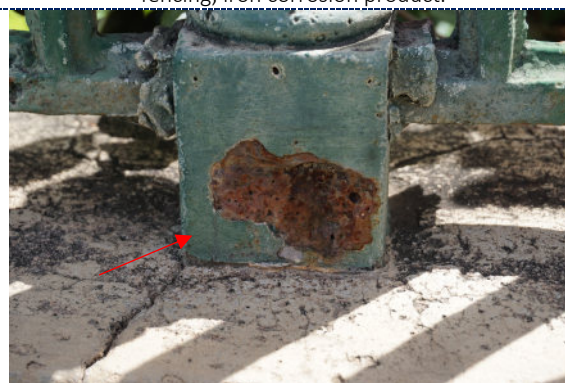
Figure 28: Detail – loss and degradation of green paint on cast iron fencing; iron corrosion product.

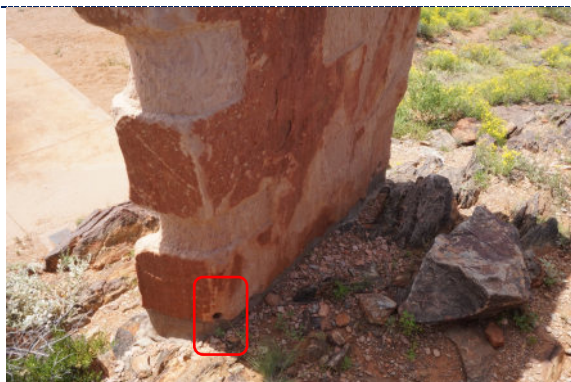
SURFACE/ COATING	MATERIALS:	
CONDITION	✓	NOTES
Abrasions/ dents	✓	Minor abrasions and pitting visible throughout, likely the cause of natural weathering (fig. 5).
Accretion		
Areas of loss		
Corrosion		
Cracks		
Delamination	✓	Possible surface delamination (figs. 6-7, 9-10).
Dust/ dirt	✓	Minor dust and dirt visible, inherent to outdoor sculpture
Fading		
Flaking/Friable		
Mould/ mould damage		
Pest damage	✓	Spider webs visible on top proper left edges (fig. 8).
Previous treatment		
Staining/ discolouration		
OTHER

Figure 5: Detail – hole at base; minor surface abrasions.

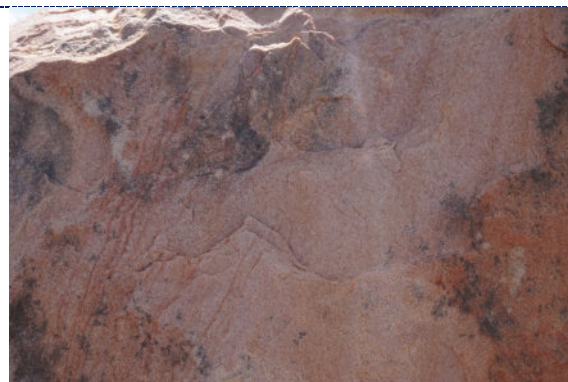
Figure 6: Detail – possible surface delamination.

Routine Maintenance	Frequency
<ul style="list-style-type: none">• Surface clean to remove dirt particulate and avian guano.• Monitor stone delamination.• Monitor possible soil erosion.	Biennially 1 year 2 years

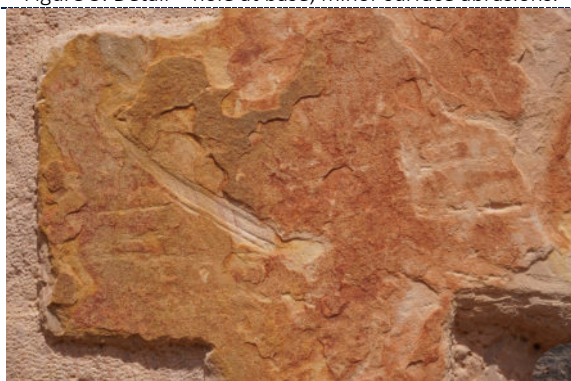
Figure 7: Detail – possible surface delamination.

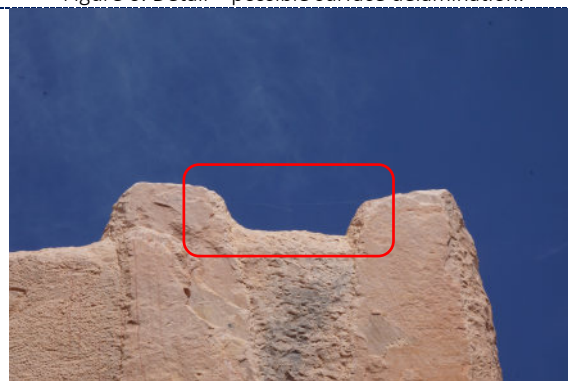
Figure 8: Detail – spider webs.

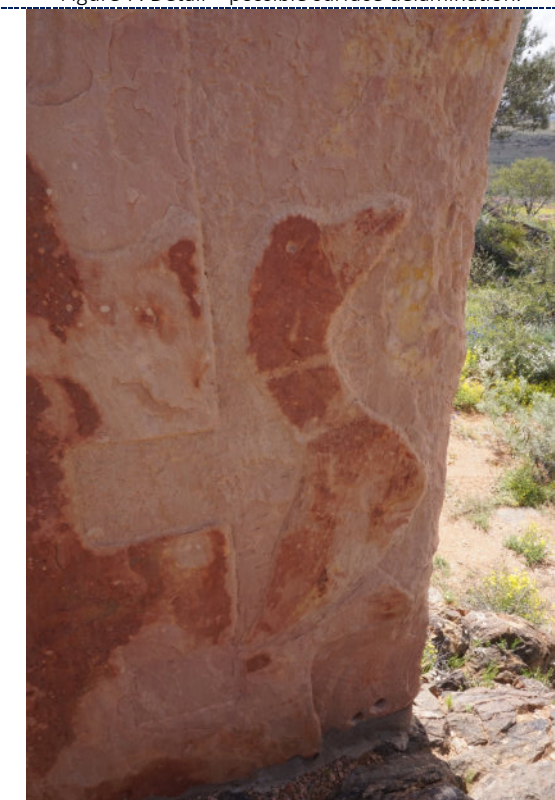
Figure 9: Detail – possible surface delamination.

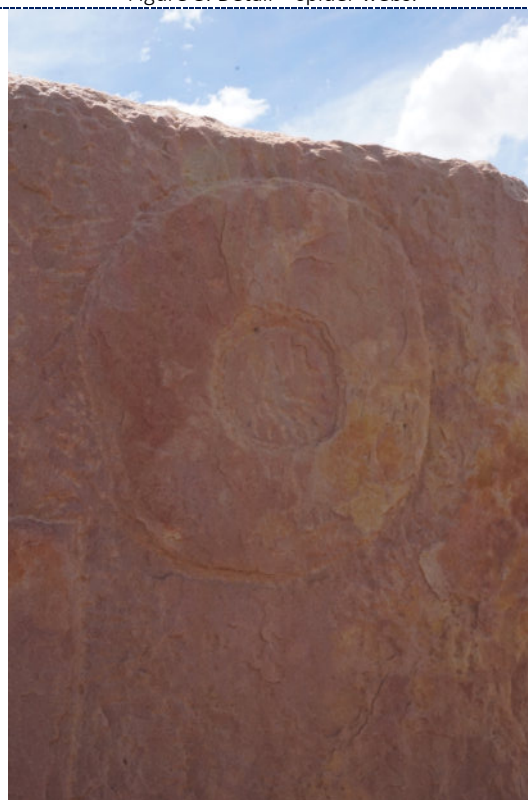
Figure 10: Detail – possible surface delamination.

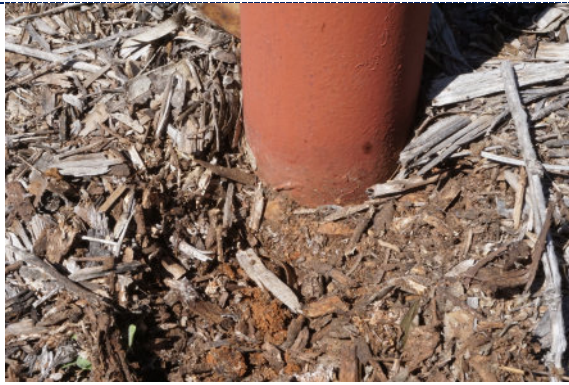
Figure 5: Detail – accumulation of biomatter at base.

Routine Maintenance	Frequency
<ul style="list-style-type: none">Surface clean to remove dirt particulate and accumulation of biomatter from adjacent trees.	1 year

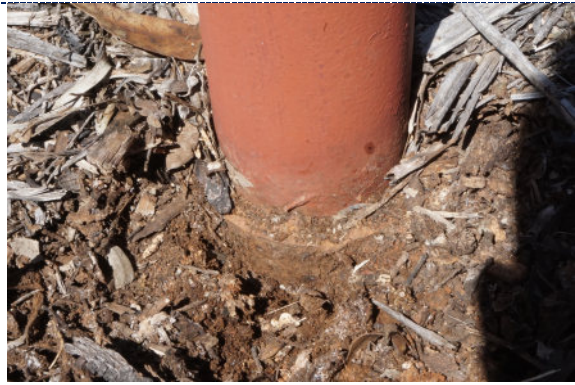
Figure 6: Detail – accumulation of biomatter at base; corrosion to iron.

Recommended Remedial Treatment Works	Advised Cost
<ul style="list-style-type: none">Remove or reduce failing and flaking paint.Stabilise surface corrosion where needed.Repaint in a paint system rated for use on outdoor metals and colour-matched with the original.	~\$2,500

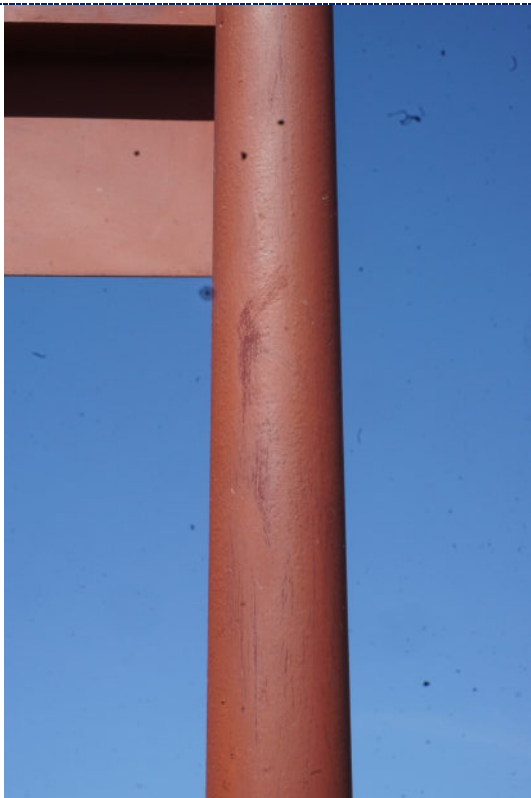
Figure 7: Detail – paint chalking, overpaint.

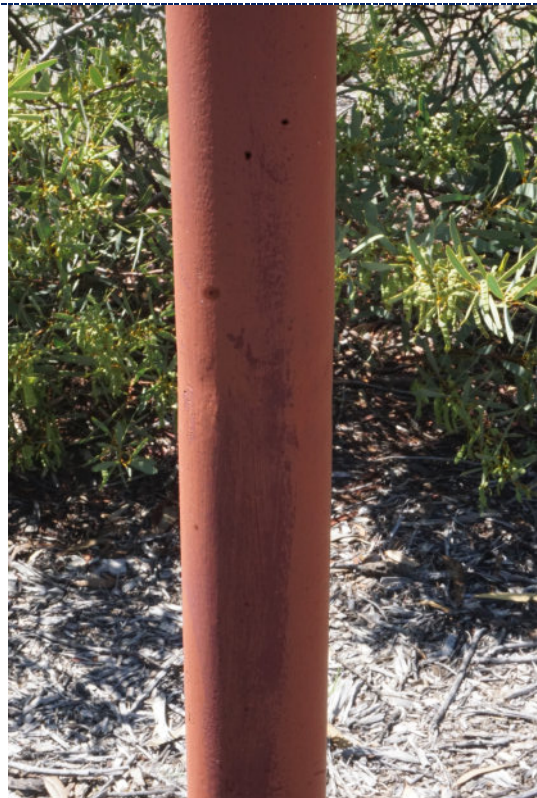
Figure 8: Detail – paint chalking, overpaint.

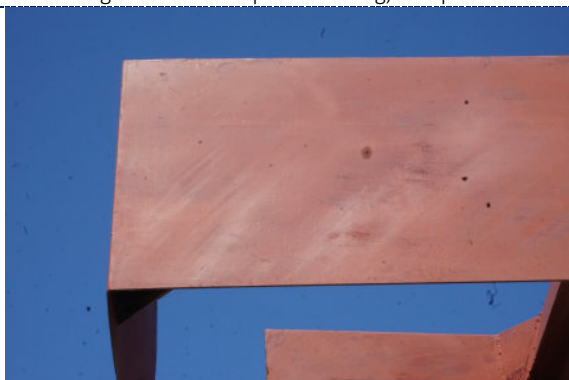
Figure 9: Detail – paint chalking, overpaint.

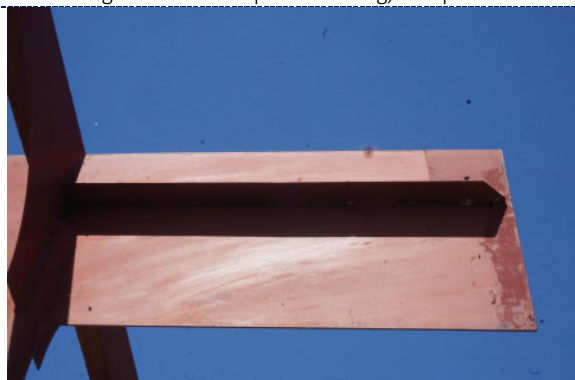
Figure 10: Detail – paint chalking, overpaint.

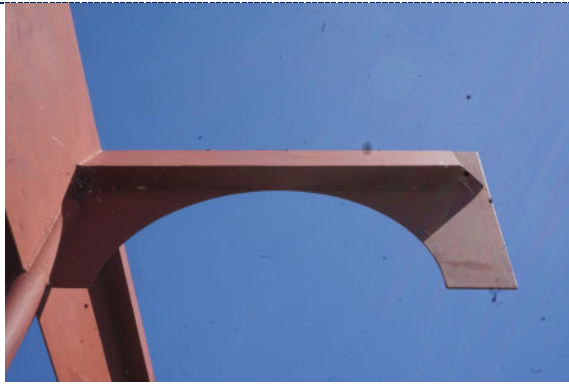
Figure 11: Detail – paint chalking, overpaint.

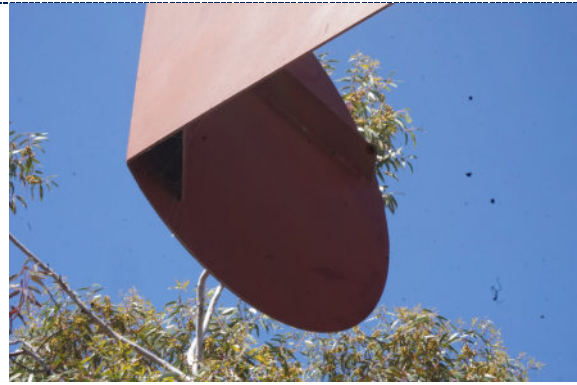
Figure 12: Detail – f paint chalking, overpaint.

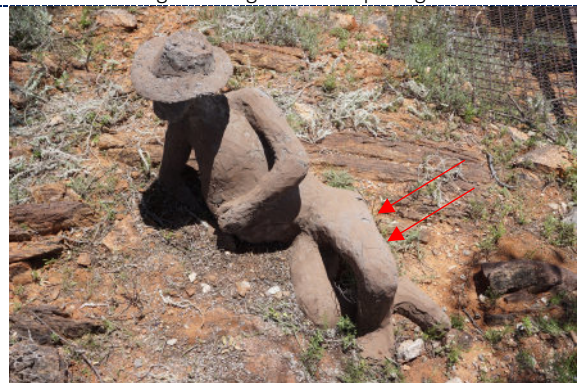
Figure 6: Detail – dirt particulate, large crack and small surface losses.

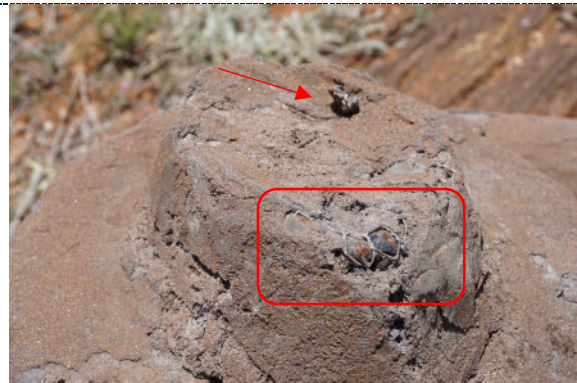
Figure 8: Detail – loss to concrete fondue revealing chicken wire and iron armature; bird excrement.

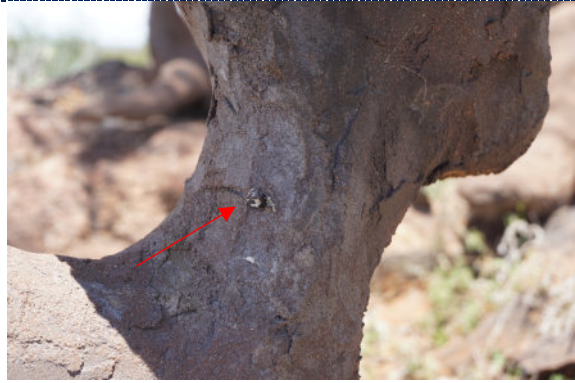
Figure 10: Detail – dirt particulate, bird excrement, spider webs.

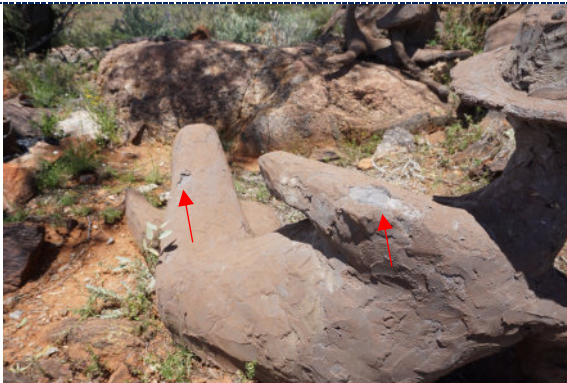
Figure 11: Detail – dirt particulate, small surface losses.

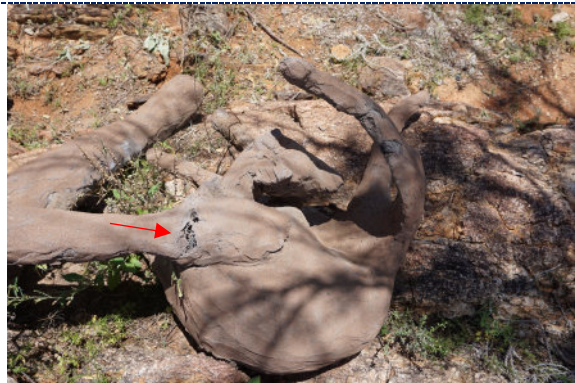
Figure 12: Detail – loss to concrete fondue revealing chicken wire and iron armature; bird excrement.

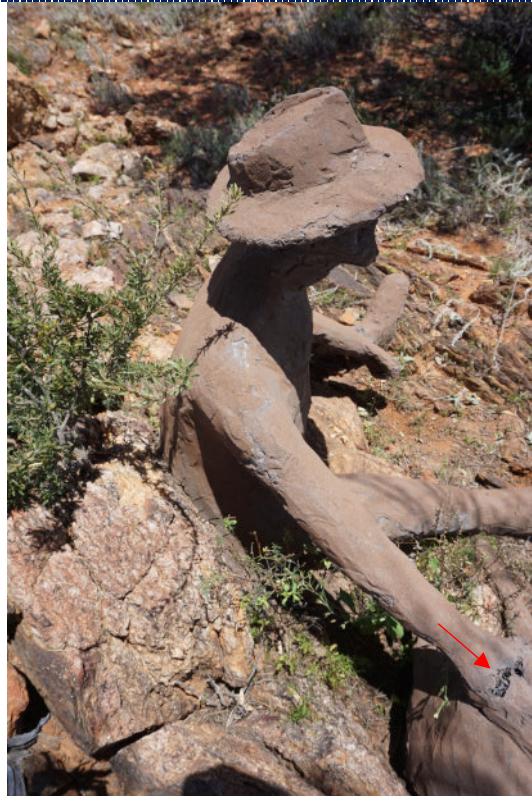
Figure 16: Detail – loss to concrete fondue revealing chicken wire and iron armature.

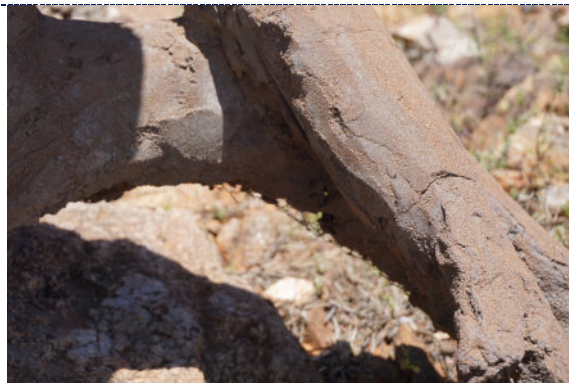
Figure 18: Detail – horizontal crack.

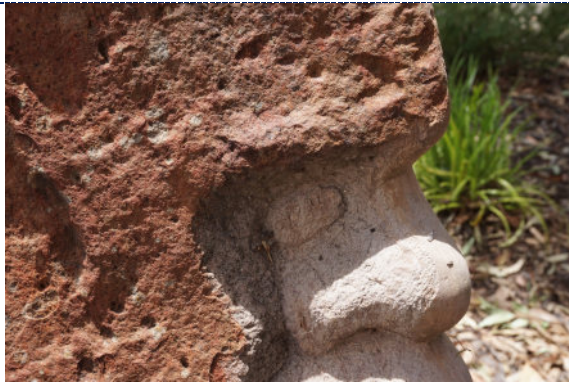
Figure 5: Detail – Component 1 – dirt particulate and spider webs.

Routine Maintenance	Frequency
<ul style="list-style-type: none">• Surface clean to remove dirt particulate, biomatter, and bird excrement.• Monitor possible stone delamination.	Biennially 2 years

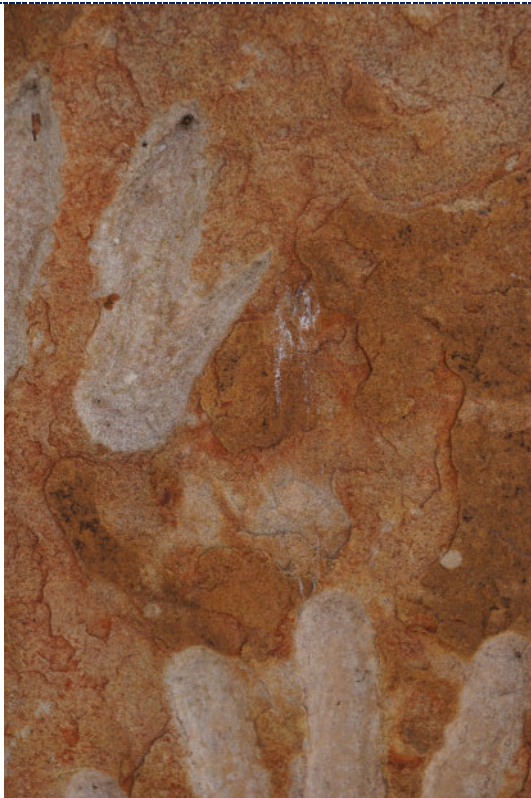
Figure 7: Detail – Component 1 – surface accretion, likely bird excrement.

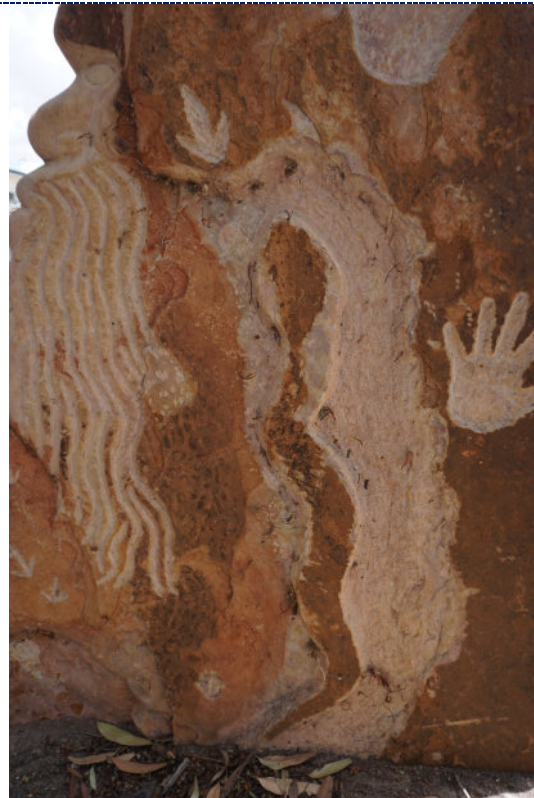
Figure 8: Detail – Component 1 – dirt particulate and spider webs.

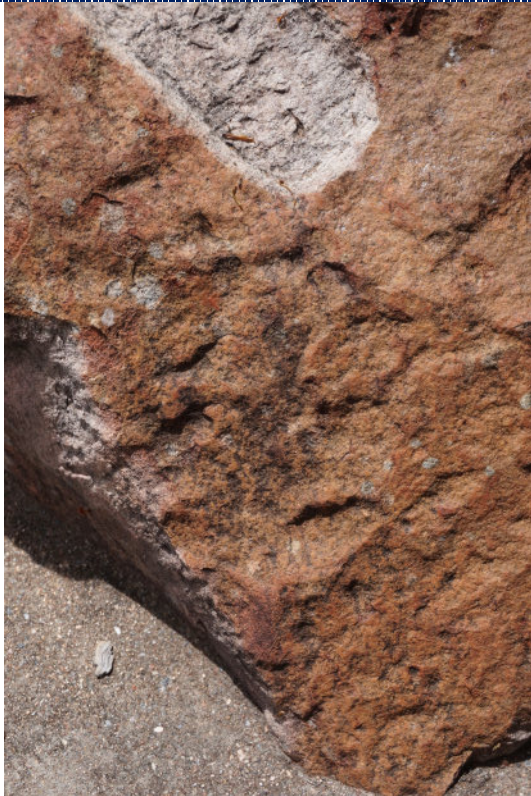
Figure 9: Detail – Component 1 – dirt particulate and spider webs.

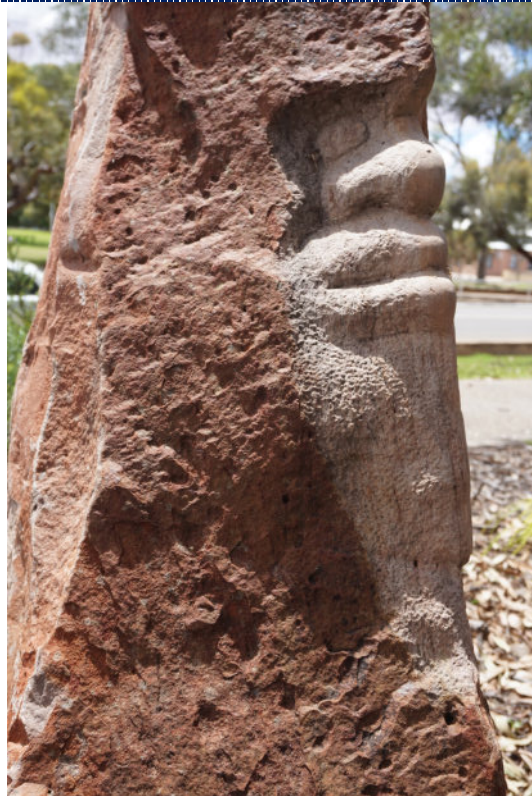
Figure 10: Detail – Component 1 – dirt particulate and spider webs.

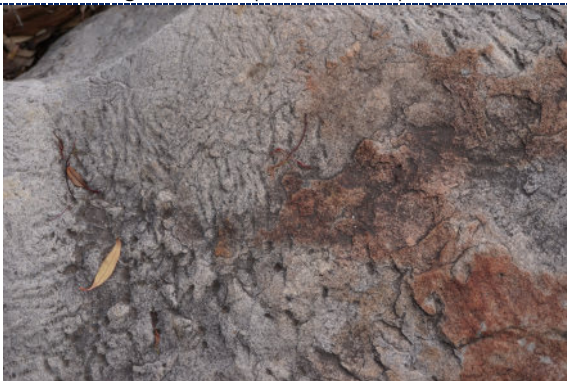
Figure 15: Detail – Component 2 – dirt particulate and spider webs.

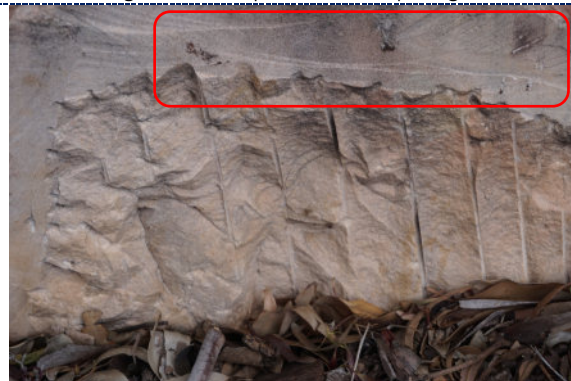
Figure 16: Detail – Component 2 – dirt particulate and bird excrement.

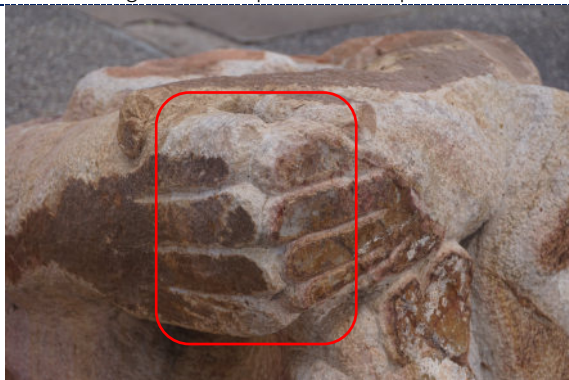
Figure 21: Detail – Component 3 – possible small losses to the sandstone.

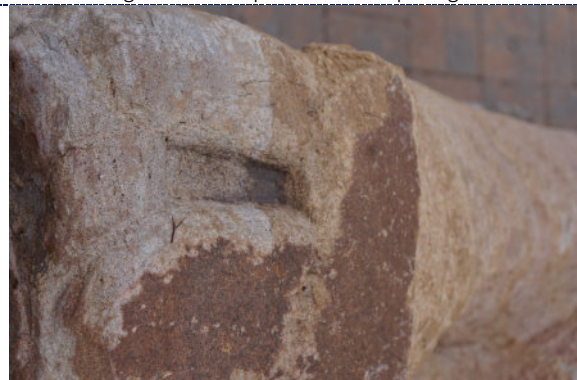
Figure 22: Detail – Component 3 – dirt particulate and spider webs.

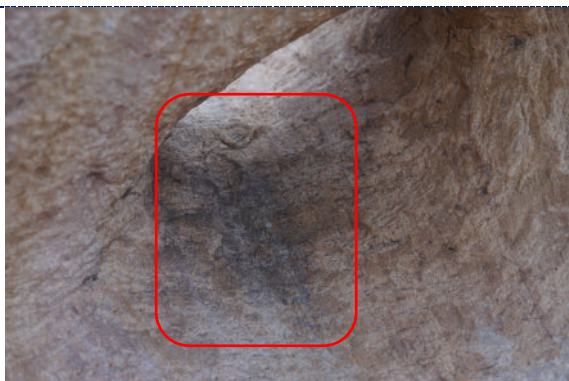
Figure 23: Detail – Component 3 – dirt particulate.

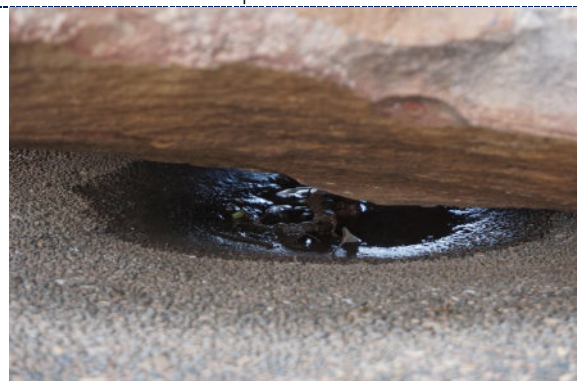
Figure 24: Detail – Component 3 – pooling water and biomatter.

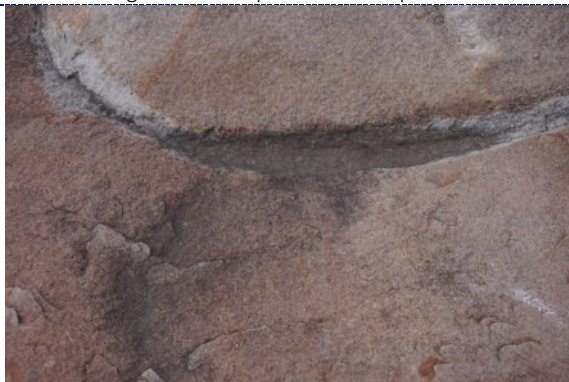
Figure 28: Detail – Component 4 – dirt particulate.

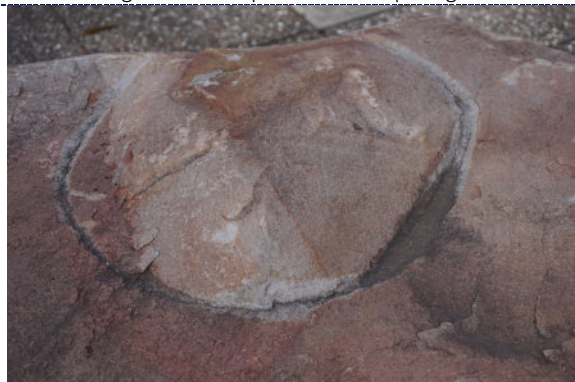
Figure 29: Detail – Component 4 – dirt particulate.

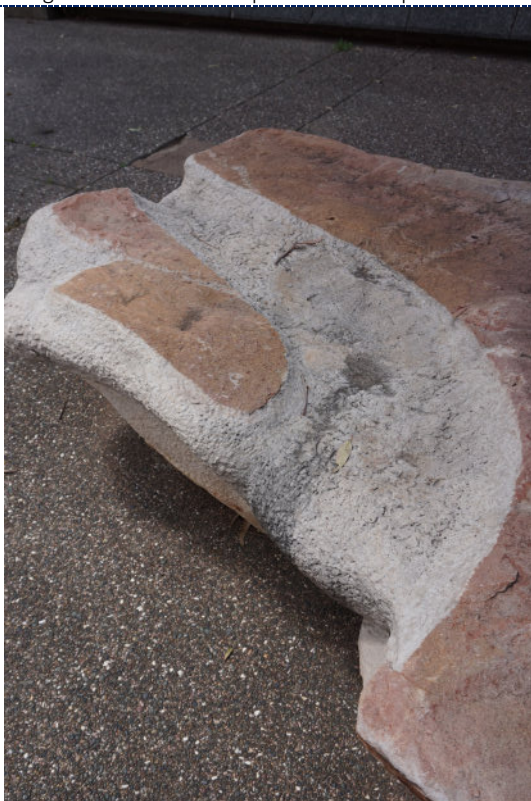
Figure 30: Detail – Component 4 – dirt particulate from water pooling.

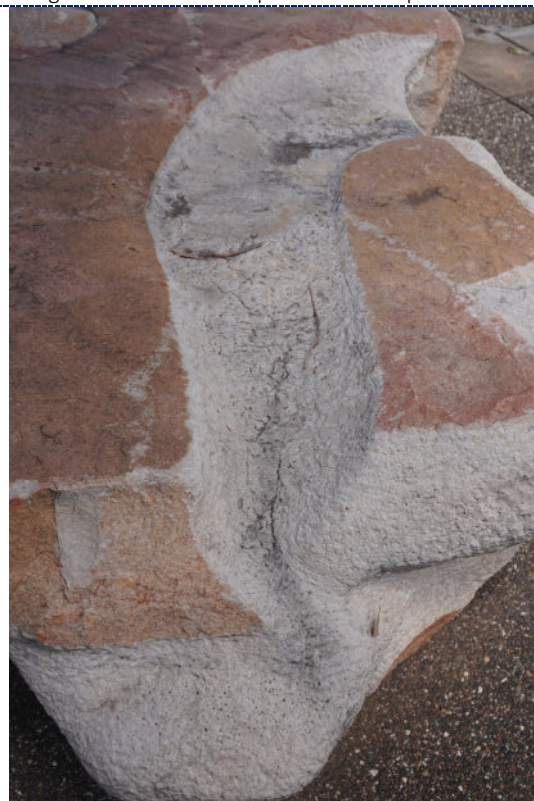
Figure 31: Detail – Component 1 – dirt particulate from water pooling.

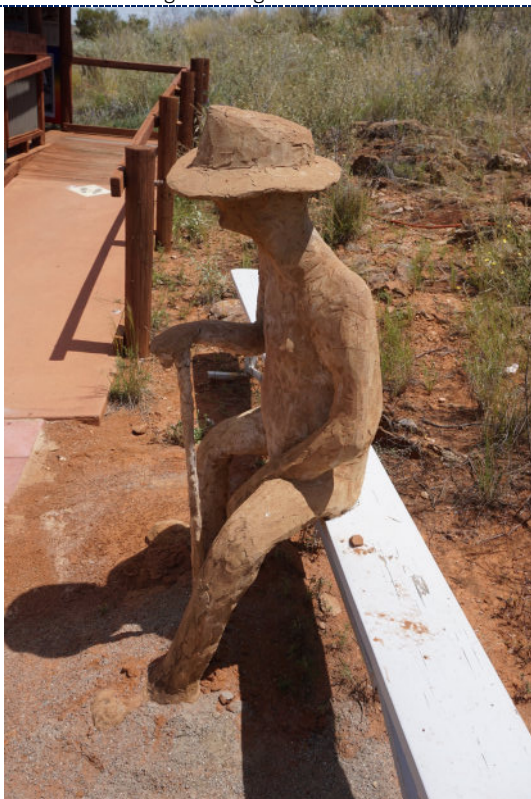
Figure 3: Figure 1 – Proper left

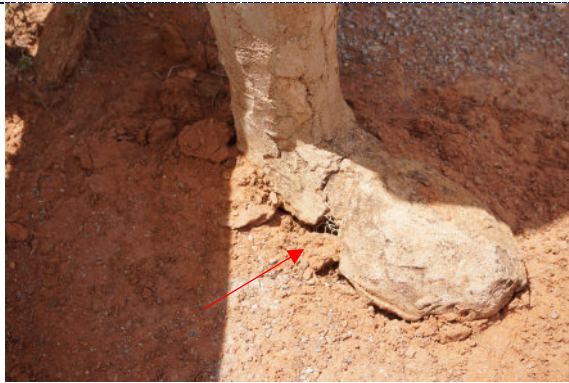
Figure 5: Detail – dirt particulate, large crack and loss revealing internal iron armature at foot.
