Broken Hill Public Art Condition Survey and Conservation Plan

Prepared for: Broken Hill City Council
Submission Date: February 2023

This report presents the results of a condition survey assessing the works held within Broken Hill City Council's public art collection. A total of 56 works were condition assessed.

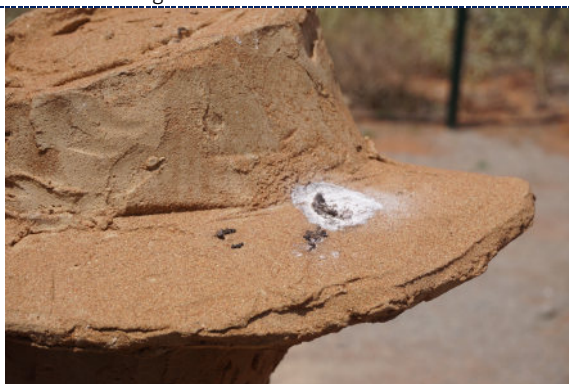
Figure 9: Detail – dirt particulate, bird excrement.

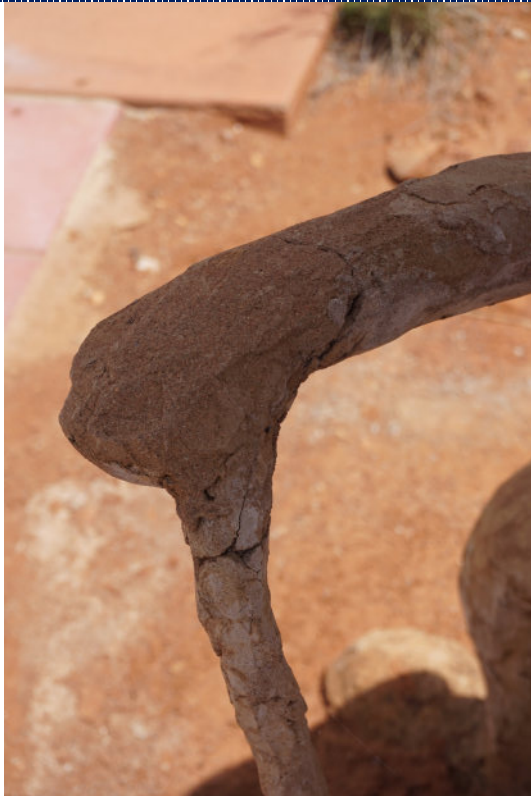
Figure 11: Detail – dirt particulate, large cracks and small losses at hand holding cane.

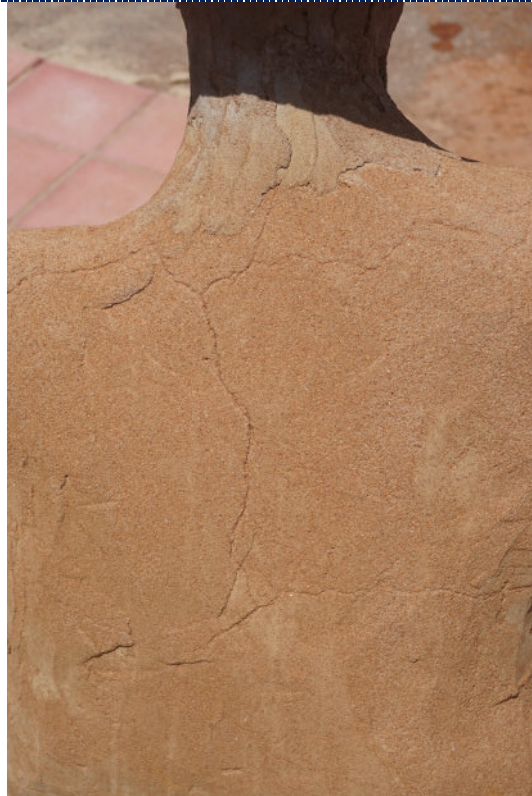
Figure 12: Detail – cracks at figure back.

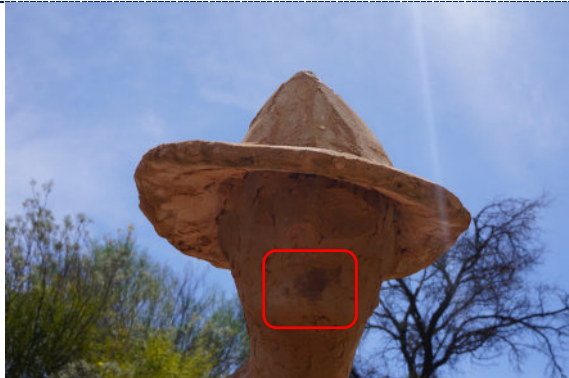
Figure 13: Detail – dirt particulate, abrasion at figure's face.

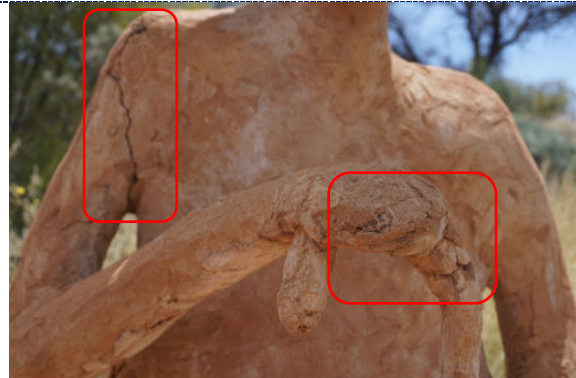
Figure 14: Detail – dirt particulate, large cracks and small losses at hand holding cane; large crack at proper right shoulder.

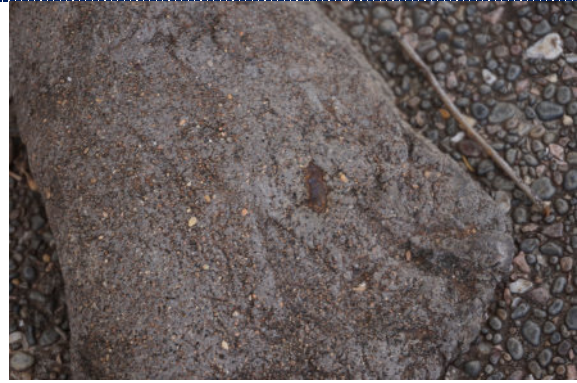
PRIMARY STRUCTURE	MATERIALS:	
CONDITION	✓	NOTES
Abrasions/ dents		
Areas of loss/ detached or missing component	✓	Significant losses to the concrete fondue were overserved to all 3 figures (figs. 5-6,17-19, 22, 32, 34). The loss to the back of figure 2 appears to stem from a sharp impact, possible from a stomp or kick (fig. 22).
Corrosion	✓	The iron internal armature exhibits evidence of corrosion (figs. 5-6). Many of the cracks in the cement fondue likely stem from expansion to the armature as it corrodes.
Cracks/ splitting	✓	Numerous cracks were observed throughout all 3 figures. These range from hairline through to substantial (figs. 5, 7-12, 19, 21, 27, 3-32, 35-36).
Disjoin/ Loose component	✓	The cement fondue is friable in areas surrounding impact losses.
Distortion		
Pest damage		
Previous treatment/ repair		
Rotting

Figure 6: Figure 1 – Detail – dirt particulate, small loss revealing internal iron armature.

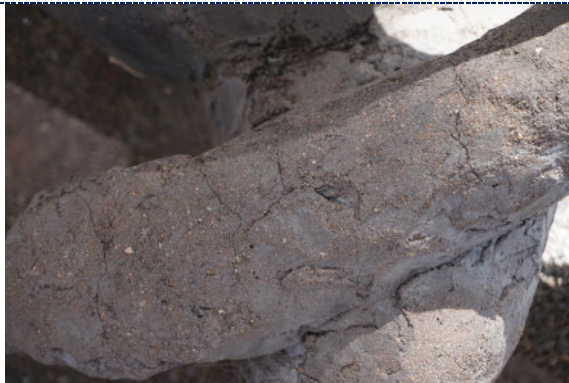
Figure 7: Figure 1 – Detail – dirt particulate, surface cracks

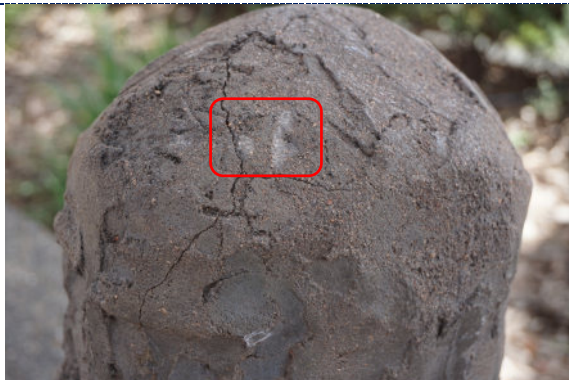
SURFACE/ COATING	MATERIALS:	
CONDITION	✓	NOTES
Abrasions/ dents	✓	Several surface abrasions were observed (figs. 8-9, 17-18).
Accretion	✓	Several surface accretions were observed on figures 2 and 3 (figs. 18, 28, 30, 33).
Areas of loss		
Corrosion	✓	Surface corrosion is evident to visible elements of the iron armature (figs. 5-6).
Cracks		
Delamination		
Dust/ dirt	✓	Dirt particulate and spider webs were observed throughout, consistent with display outdoors. Biomatter has collected at the base of the work (fig. 20).
Fading		
Flaking/Friable	✓	The cement fondue is friable in areas surrounding impact losses.
Mould/ mould damage		
Pest damage		
Previous treatment		
Staining/ discolouration		
OTHER

Figure 9: Figure 1 – Detail – dirt particulate, surface cracks and surface abrasion.

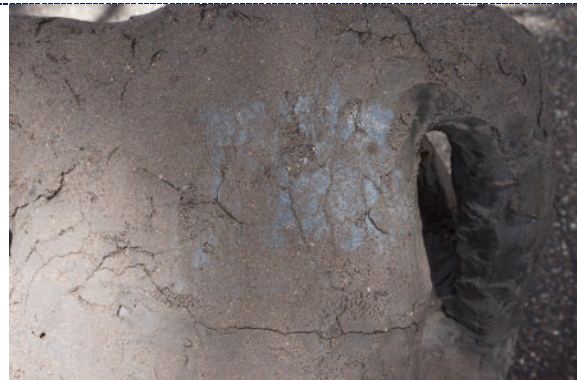
Figure 10: Figure 1 – Detail – dirt particulate, surface cracks and surface paint (likely graffiti).

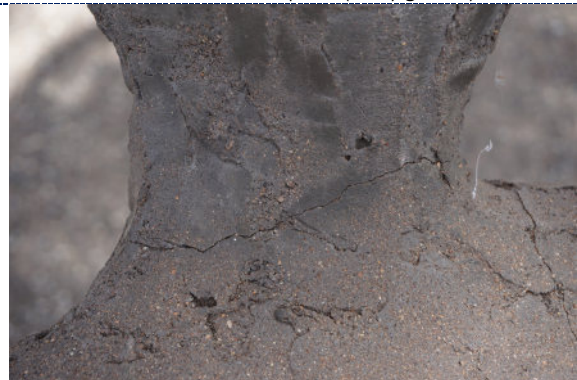
Figure 12: Figure 1 – Detail – dirt particulate, surface cracks.

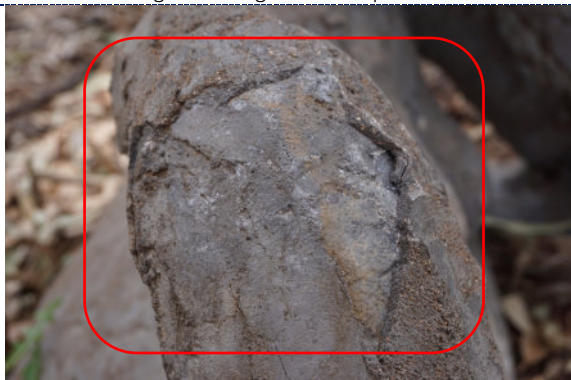
Figure 17: Figure 2 – Detail – dirt particulate, surface abrasion, loss to layer of cement fondue.

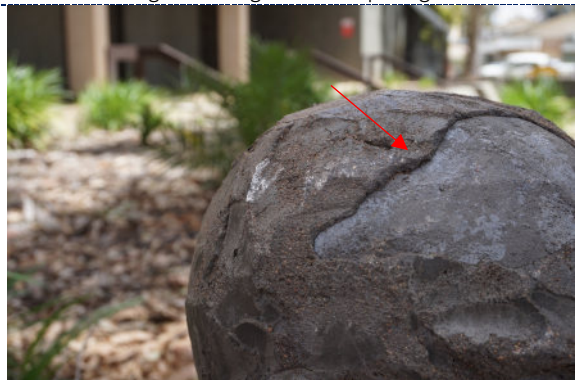
Figure 18: Figure 2 – Detail – dirt particulate, surface abrasion, surface accretion, loss to layer of cement fondue (arrow).

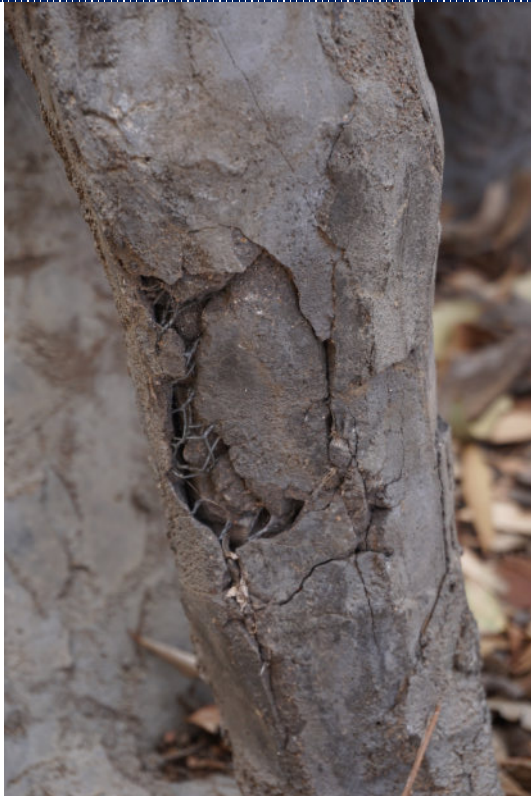
Figure 19: Figure 2 – Detail – dirt particulate, large crack and loss revealing internal 'chicken wire' armature.

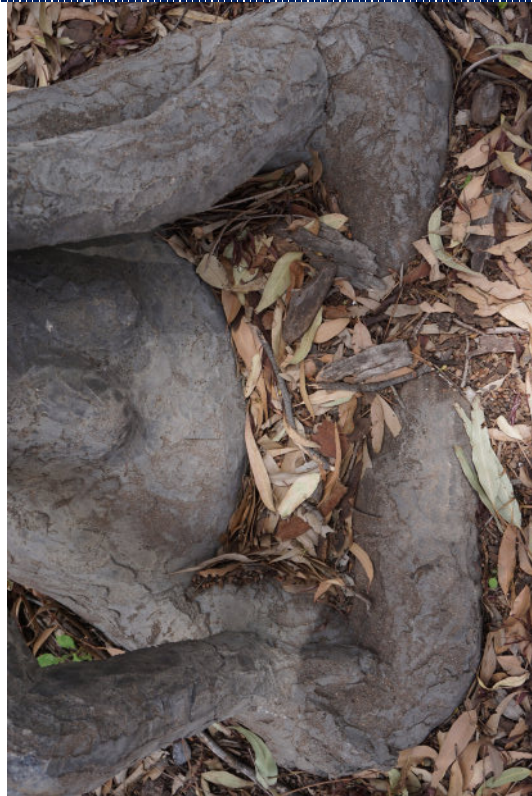
Figure 20: Figure 2 – Detail – dirt particulate, accumulation of biomatter.

Routine Maintenance	Frequency
<ul style="list-style-type: none">• Surface clean to remove dirt particulate and accumulation of biomatter from adjacent trees.	1 year

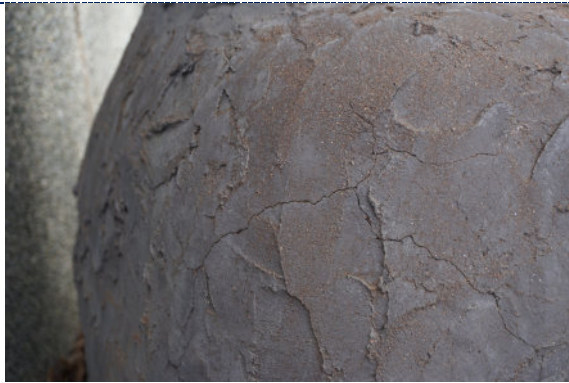
Figure 27: Figure 3 – Detail – dirt particulate, surface cracks.

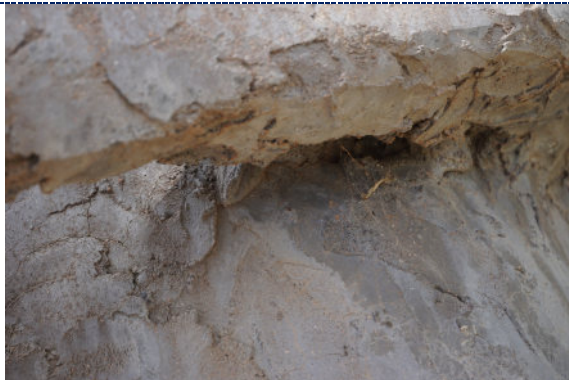
Figure 29: Figure 3 – Detail – dirt particulate, spider webs.

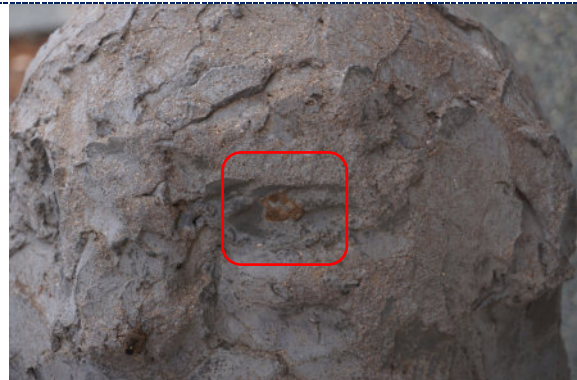
Figure 30: Figure 3 – Detail – dirt particulate, surface accretion.

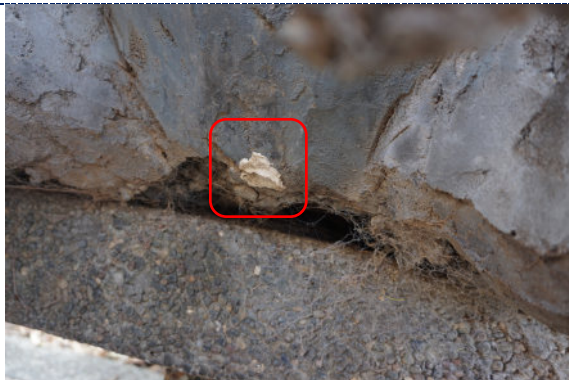
Figure 33: Figure 3 – Detail – dirt particulate, surface cracks and spider webs.

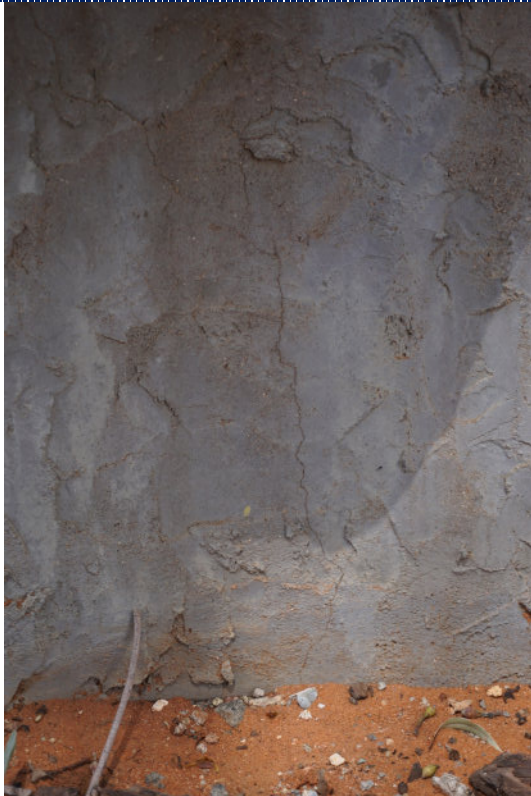
Figure 35: Figure 3 – Detail – dirt particulate, surface cracks.

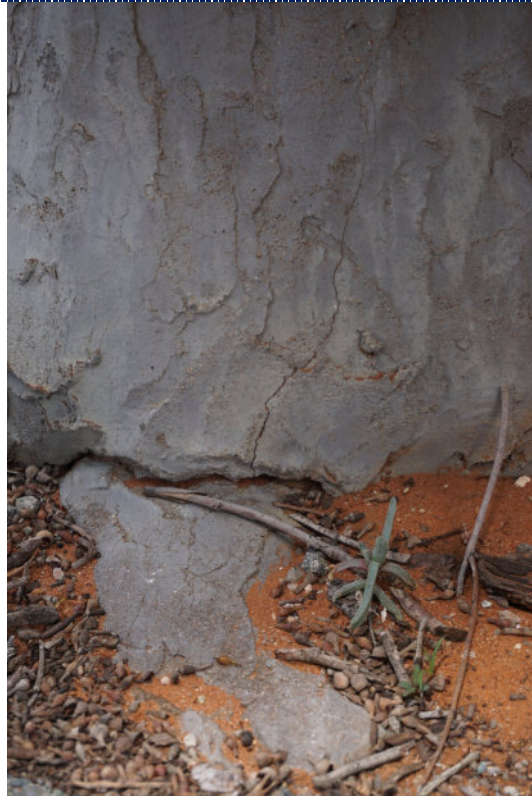
Figure 36: Figure 3 – Detail – dirt particulate, surface cracks.

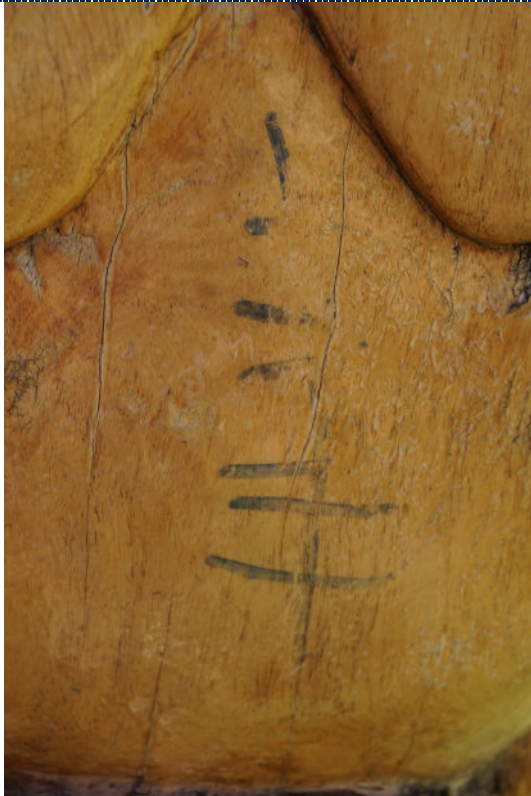
SURFACE/ COATING	MATERIALS:	
CONDITION	✓	NOTES
Abrasions/ dents		
Accretion	✓	Tar-like accretion residues were observed throughout and may stem from previous attempts at waterproofing (figs. 16,20).
Areas of loss		
Corrosion	✓	The iron mount structure also exhibits evidence of corrosion (figs. 22-24).
Cracks	✓	Small surface cracks are located throughout.
Delamination		
Dust/ dirt	✓	Dirt particulate, bird excrement (fig. 26) and spider webs (fig. 15) were observed throughout, consistent with display outdoors.
Fading		
Flaking/Friable		
Mould/ mould damage		
Pest damage		
Previous treatment		
Staining/ discolouration	✓	Iron corrosion product staining is evident on the wooden substrate, adjacent to iron elements (figs. 16,19).
OTHER	Inked graffiti was observed on the female figure's face and torso (figs. 5-6).

Figure 5: Detail – exterior, inked graffiti.

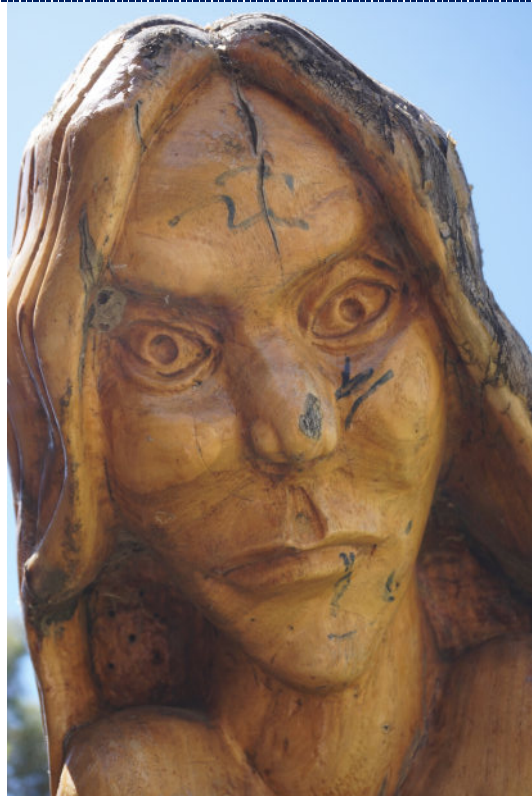
Figure 6: Detail – exterior, inked graffiti.

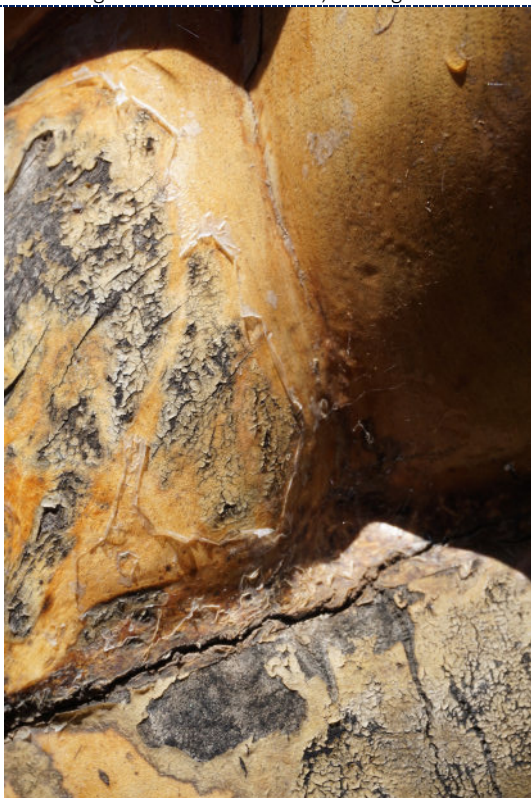
PRIMARY STRUCTURE	MATERIALS:	
CONDITION	✓	NOTES
Abrasions/ dents		
Areas of loss/ detached or missing component	✓	Extensive areas of loss to the paint and varnish substrates are evident throughout, and likely stem from prolonged exposure to UV radiation and outdoor weather condition (figs. 7-23, 25-26). Varnish layers on the bottom of the canoe and in more protected areas are in a better condition than those exposed to direct sunlight. A black polypropylene liner fixed to the interior as a water barrier is significantly degraded (figs. 11-16). One copper alloy screw is missing from the interpretive plaque (fig. 26).
Corrosion	✓	Iron pins fixing the two figure heads to the main structure at each end exhibit significant evidence of corrosion (figs. 19-20). Iron staples used to fix the polypropylene liner are also heavily corroded (figs. 11-13, 15-16).
Cracks/ splitting	✓	Cracks and splitting following the grain of the wood are evident throughout. These likely stem from movement in the material as it is exposed to different forces and degradation mechanisms.

Figure 7: Detail – exterior, degraded and peeling varnish, UV degradation (darkening) to wood surface.

Routine Maintenance	Frequency
<ul style="list-style-type: none"> Surface clean to remove dirt particulate and bird excrement. Sand-back and reapply varnish. Monitor for the presence of destructive biological agents (termites, etc.). 	6 months 2-3 years 1 Year

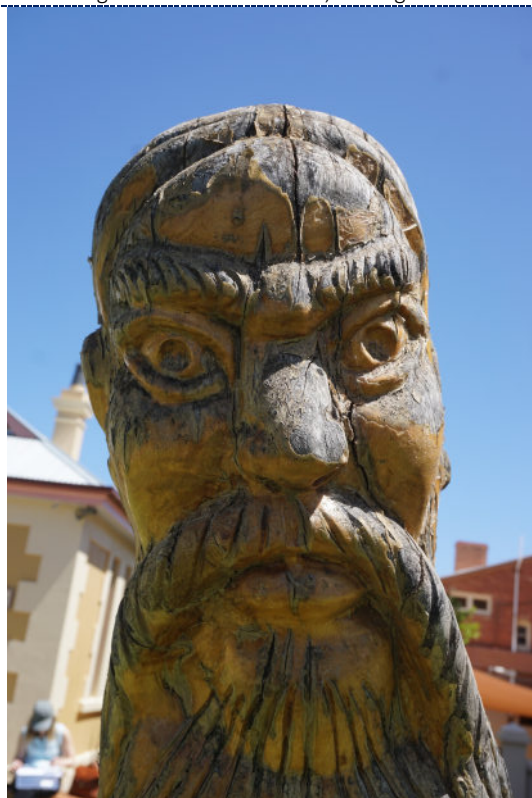
Figure 8: Detail – exterior, degraded and peeling varnish, UV degradation (darkening) to wood surface.

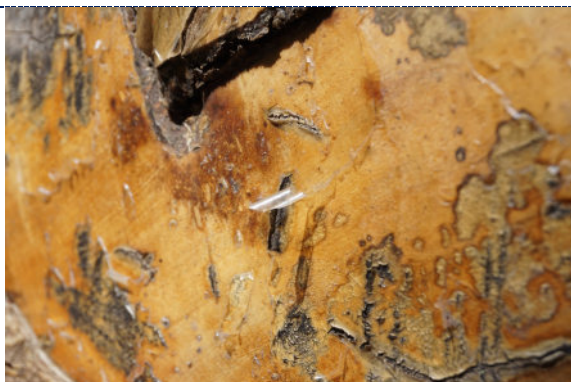
Figure 9: Detail – exterior, degraded and peeling varnish, UV degradation (darkening) to wood surface.

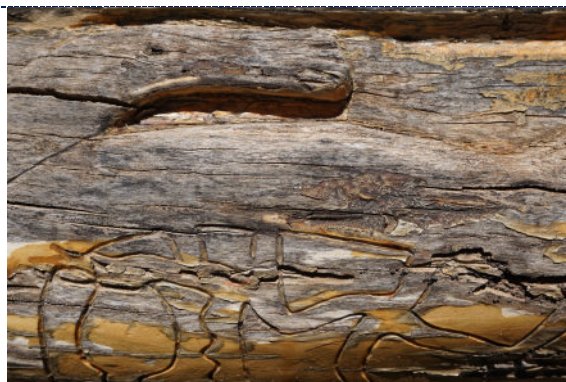
Figure 10: exterior, degraded and peeling varnish, UV degradation (darkening) to wood surface.

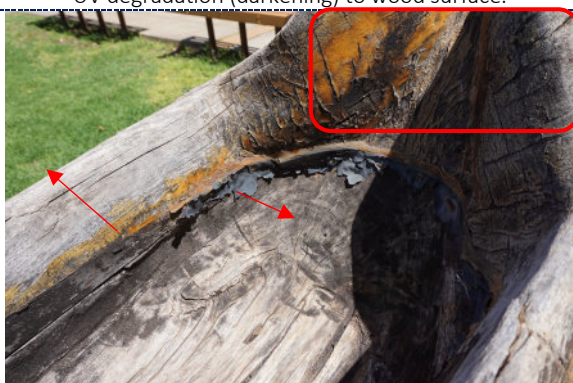
Figure 11: Detail – interior, degraded and peeling varnish, UV degradation (darkening) to wood surface. Interior poly propylene liner, silicon sealant and iron staples heavily degraded.

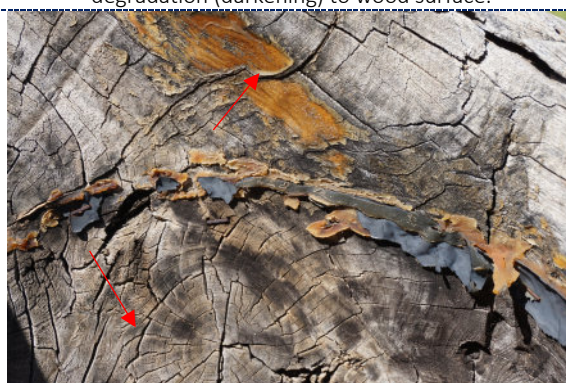
Figure 12: Detail – interior, degraded and peeling varnish, UV degradation (darkening) to wood surface. Interior poly propylene liner, silicon sealant and iron staples heavily degraded.

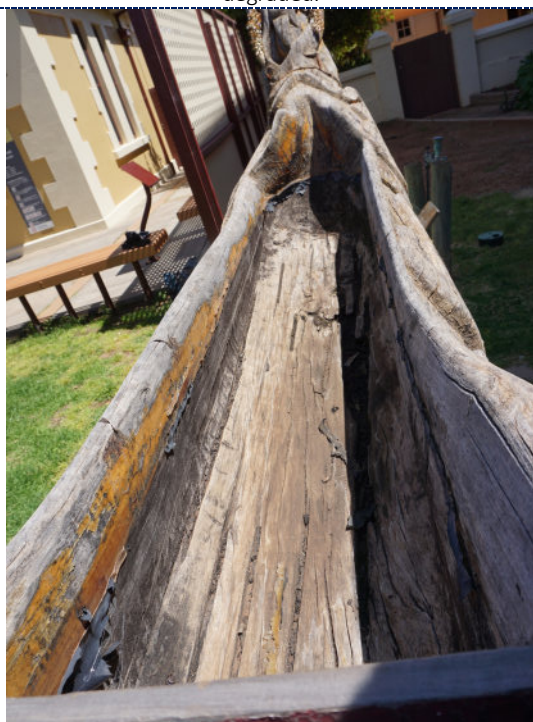
Figure 13: Detail – interior, degraded and peeling varnish, UV degradation (darkening) to wood surface. Interior poly propylene liner, silicon sealant and iron staples heavily degraded. Loose dirt particulate and debris.

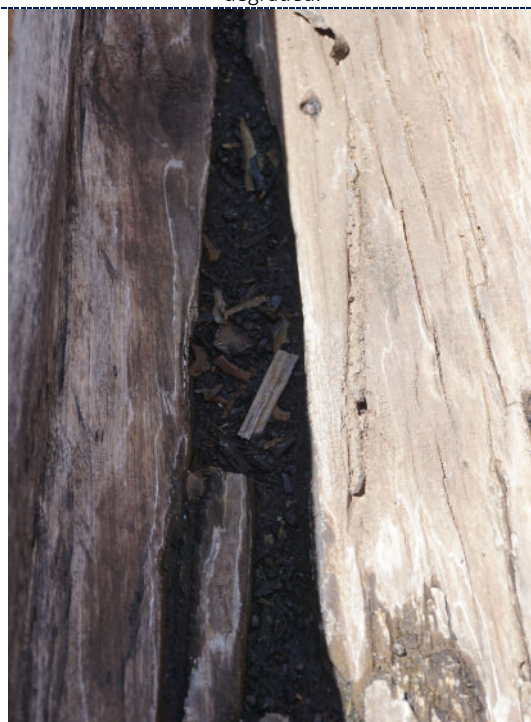
Figure 14: Detail – interior, degraded and peeling varnish, UV degradation (darkening) to wood surface. Interior poly propylene liner, silicon sealant and iron staples heavily degraded. Loose dirt particulate and debris.

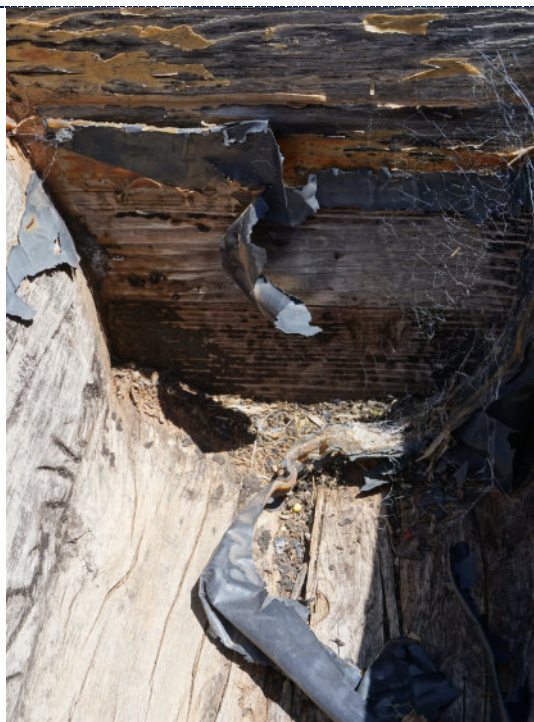
Figure 15: Detail – interior, degraded and peeling varnish, UV degradation (darkening) to wood surface. Interior poly propylene liner, silicon sealant and iron staples heavily degraded. Loose dirt particulate, spider webs and debris.

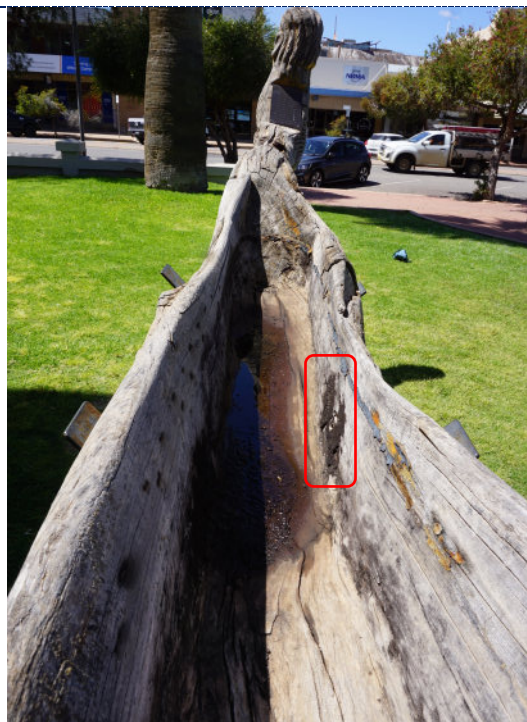
Figure 16: Detail – interior, degraded and peeling varnish, UV degradation (darkening) to wood surface. Interior poly propylene liner, silicon sealant and iron staples heavily degraded. Standing water, loose dirt particulate and debris. A tar-like accretion was visible on the interior surface.

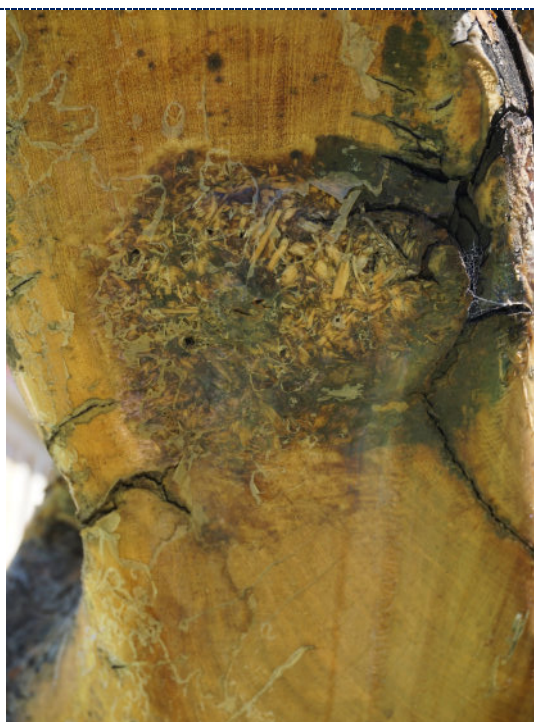
Figure 17: Detail – exterior-bottom, degraded and peeling varnish.

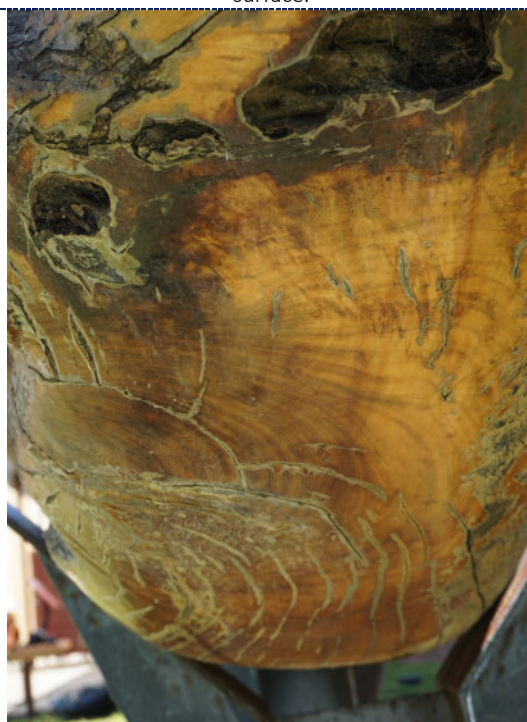
Figure 18: Detail – exterior-bottom, degraded and peeling varnish.

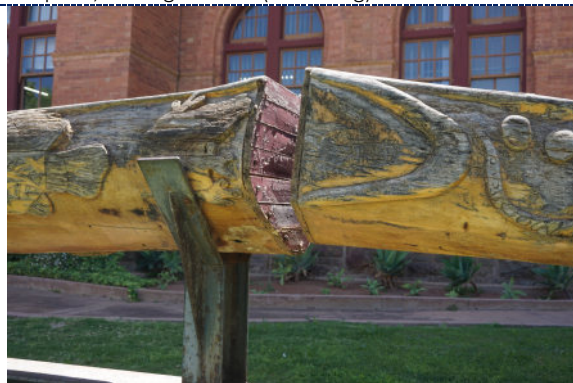
Figure 23: Detail – exterior, degraded and peeling varnish, UV degradation (darkening) to wood surface, degraded and peeling maroon paint. Corrosion on mount.

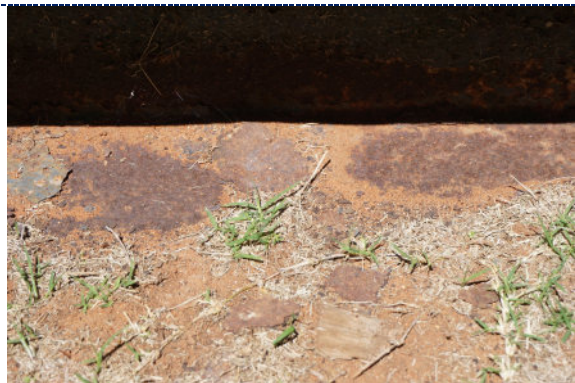
Figure 24: Detail – corrosion product on the ground stemming from the canoe mount.

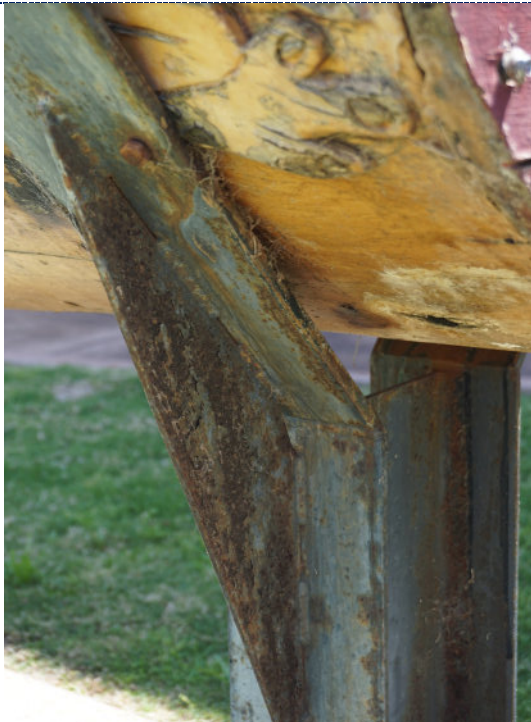
Figure 25: Detail – exterior, degraded and peeling varnish, UV degradation (darkening) to wood surface. Corrosion on mount.

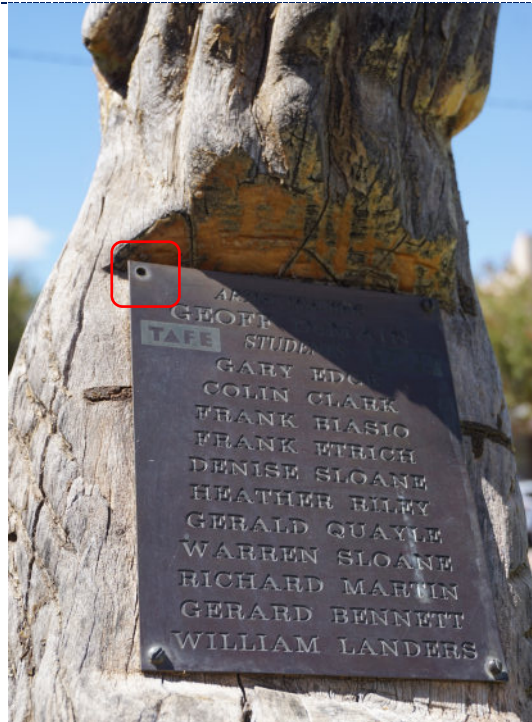
Figure 26: Detail – copper alloy plaque with bird excrement and one screw missing.

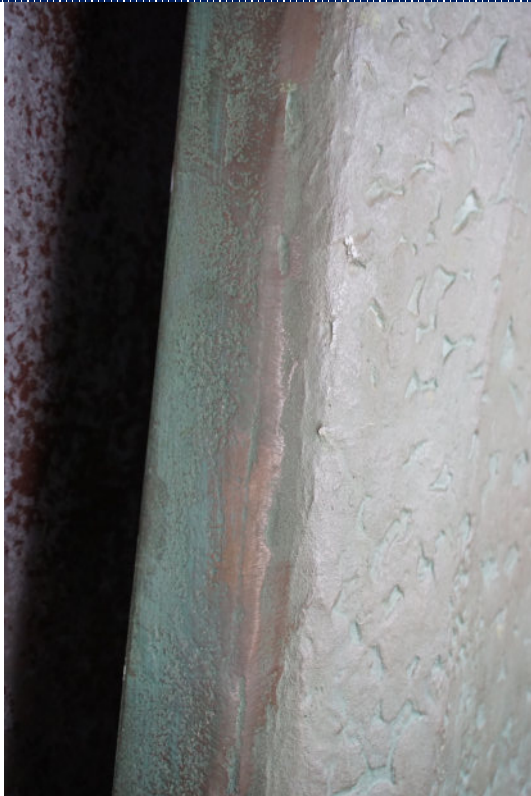
Figure 5: Detail – green patina, likely stemming from the patination process during manufacture.

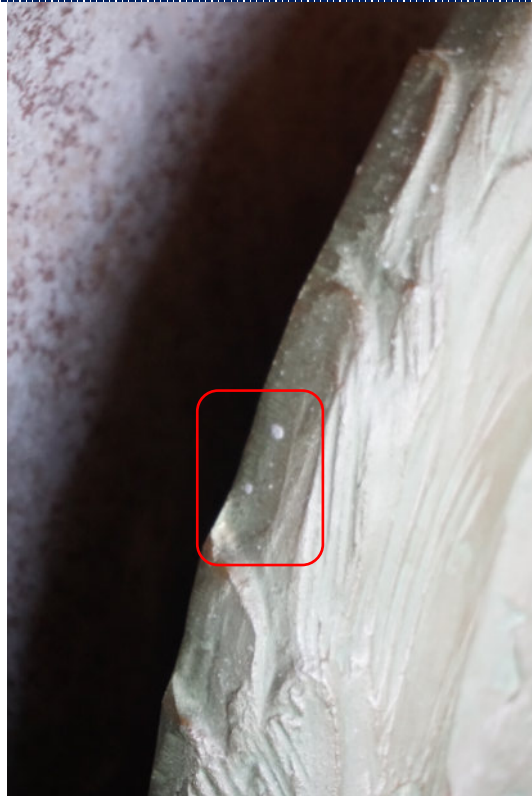
SURFACE/ COATING	MATERIALS:	
CONDITION	<input checked="" type="checkbox"/>	NOTES
Abrasions/ dents	<input type="checkbox"/>	
Accretion	<input checked="" type="checkbox"/>	Surface accretions, likely white paint splatter, observed throughout (figs. 6-10).
Areas of loss	<input type="checkbox"/>	
Corrosion	<input type="checkbox"/>	
Cracks	<input type="checkbox"/>	
Delamination	<input type="checkbox"/>	
Dust/ dirt	<input checked="" type="checkbox"/>	Light dirt particulate observed throughout.
Fading	<input type="checkbox"/>	
Flaking/Friable	<input type="checkbox"/>	
Mould/ mould damage	<input type="checkbox"/>	
Pest damage	<input type="checkbox"/>	
Previous treatment	<input type="checkbox"/>	
Staining/ discolouration	<input type="checkbox"/>	
OTHER

Figure 6: Detail – surface accretion, likely white paint spray.

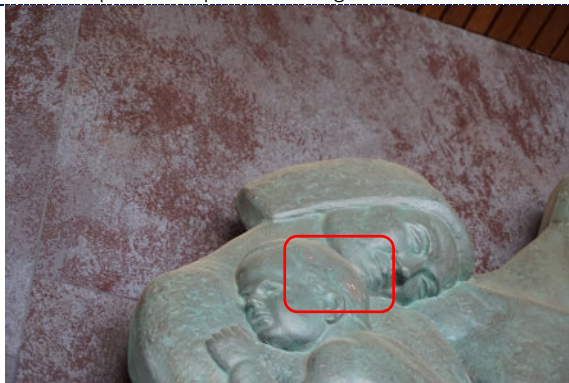
Figure 7: Detail – surface accretion, likely white paint spray.

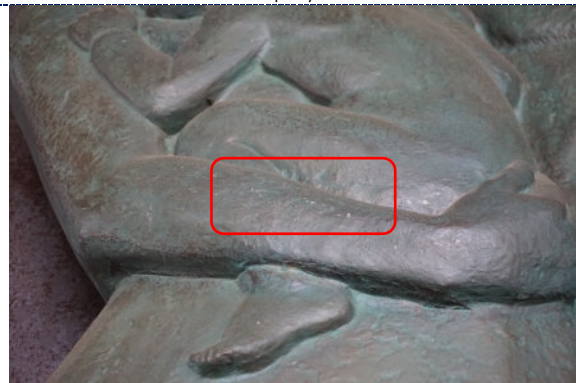
Figure 8: Detail – surface accretion, likely white paint spray.

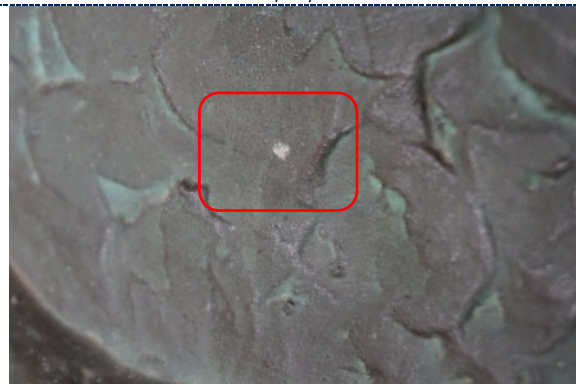
Figure 10: Detail – surface accretion, likely white paint spray.
